SITE NUMBER AND NAME: <b>C030 Slide and Erosion Site</b>		HIGHWAY & KM: 734:12, 40.628	PREVIOUS INSPECTION DATE: June 23, 2016	INSPECTION DATE: <b>June 12, 2017</b>
LEGAL DESCRIPTION: 09-10-19-033-08 W5M	NAD 83 COORDINATES: UTM Northing Easting 11 5745765 629598		RISK ASSESSMENT: PF: 1 CF: 1 TOTAL: 1	
AVERAGE ANNUAL DAILY TRAFFIC (AADT): 160 (south) (Ref No. 51280)			CONTRACT MAINTENANCE AREA (CMA): 18

PRIMARY SITE ISSUE: Two slides on the south side (northbound lane) of Hwy 734 where the highway traverses the north slope of the James River Valley. Erosion damage caused by flooding in 2005 was previously repaired in September 2005. Additional drainage improvements were completed between 2014 and 2016 as part of AT's high-water-mitigation program.

# HIGH WATER RELATED MITIGATION WORKS

## H734:12 - SITES C30 40.5 km, C37-I 41.8 km , AND C37-II 42.9 km

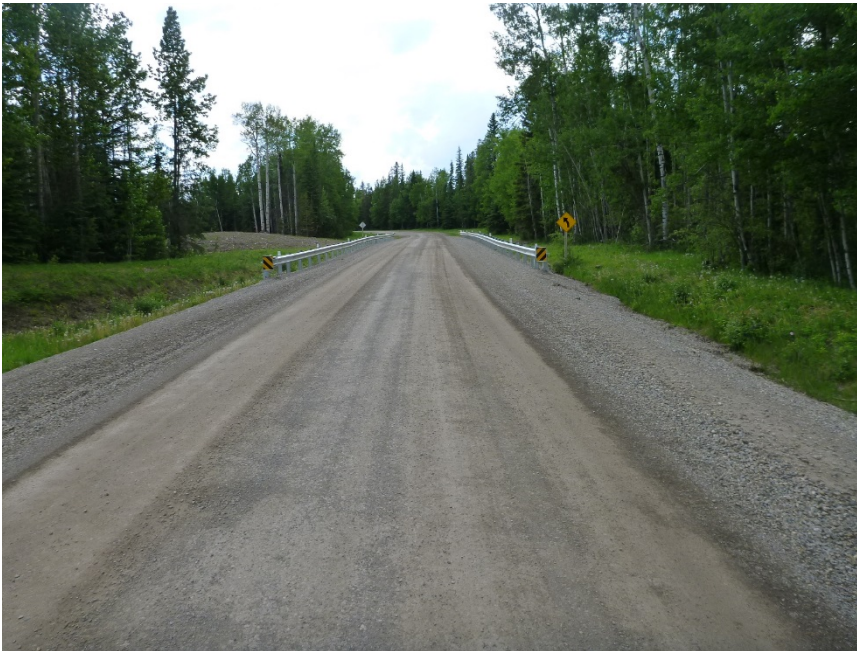
**Photo 1**      **The C030 high-water-mitigation site. Photo taken June 12, 2017 looking southwest.**

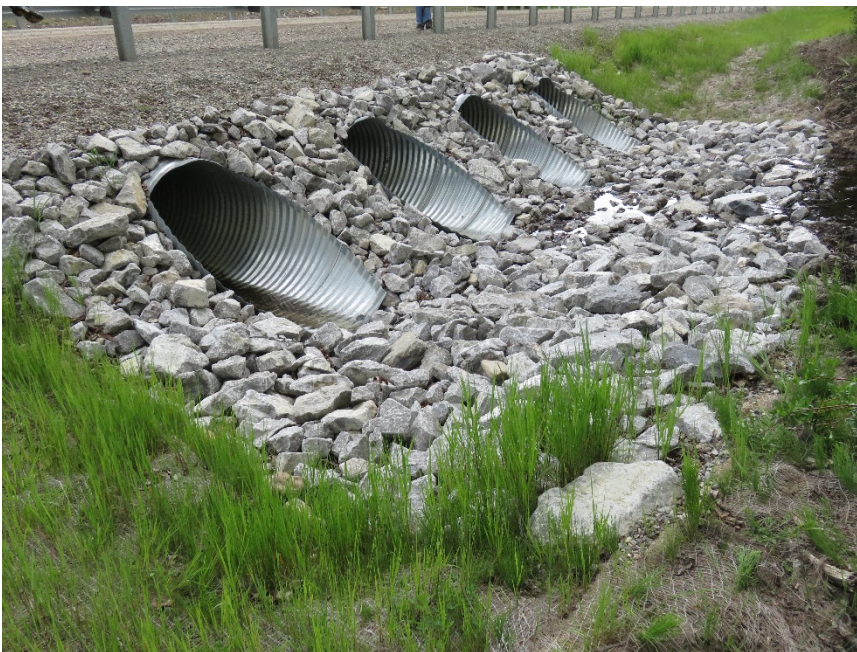
Vegetation is establishing itself on the east bank of the riprap armored channel, and growing through the erosion control cloth that was placed around the culverts and in the ditches in June 2016. The stockpile on the west bank of the riprap armored channel remains poorly vegetated.

**Photo 2**      **The inlets of the four 1000-mm culverts that were installed in June 2016. Vegetation is growing through the erosion control cloth that was placed around the culverts and in the ditch in June 2016. Photo taken June 12, 2017 looking southwest.**

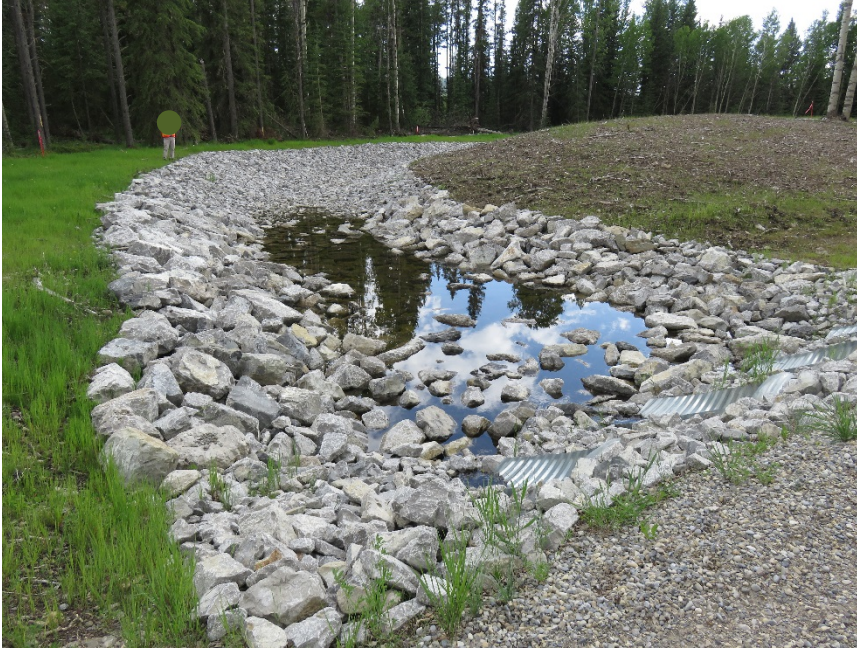
The quantity and diameter of culverts installed at the site resulted in the site becoming a bridge file (BF83183). The stockpile of excavated soil from the C030, C037-I, and C037-II sites has not vegetated. The contractor used broadcast seeding instead of drill seeding. Vegetation is growing in other areas on site. The warranty inspection

**Photo 3** The outlet of the 1000-mm culverts, and the riprap armoured channel that were installed/constructed in June 2016. Vegetation is establishing itself on the east bank of the riprap armoured channel; however, the stockpile on the west bank remains poorly vegetated. Photo taken June 12, 2017 looking south.

should include assessment of the vegetation growth on the stockpile.  
This site should be inspected every two years to monitor the landslide at the outlet of the riprap armoured channel and to assess vegetation growth.

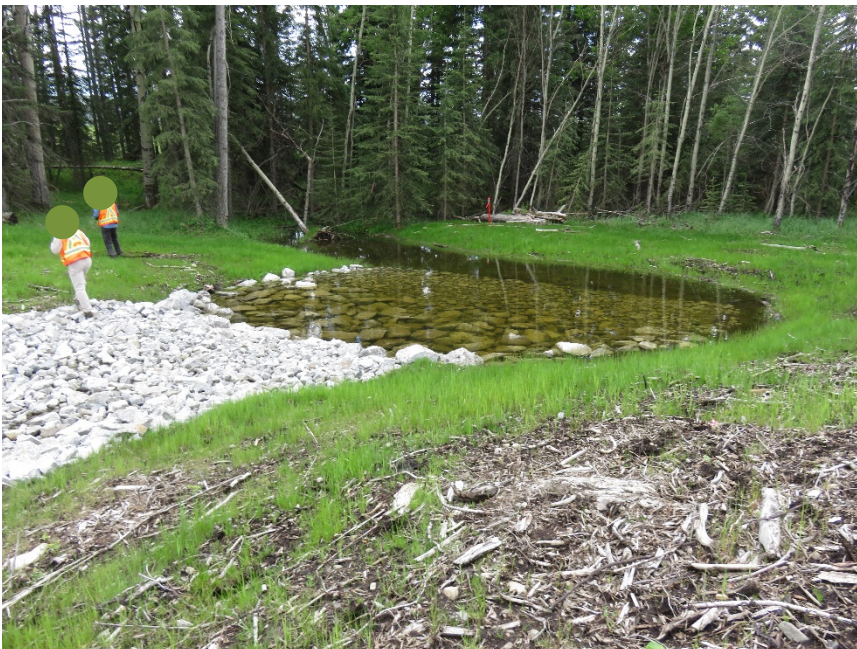
**Photo 4** Ponded water at the end of the riprap armoured channel. Photo taken June 12, 2017 looking south.

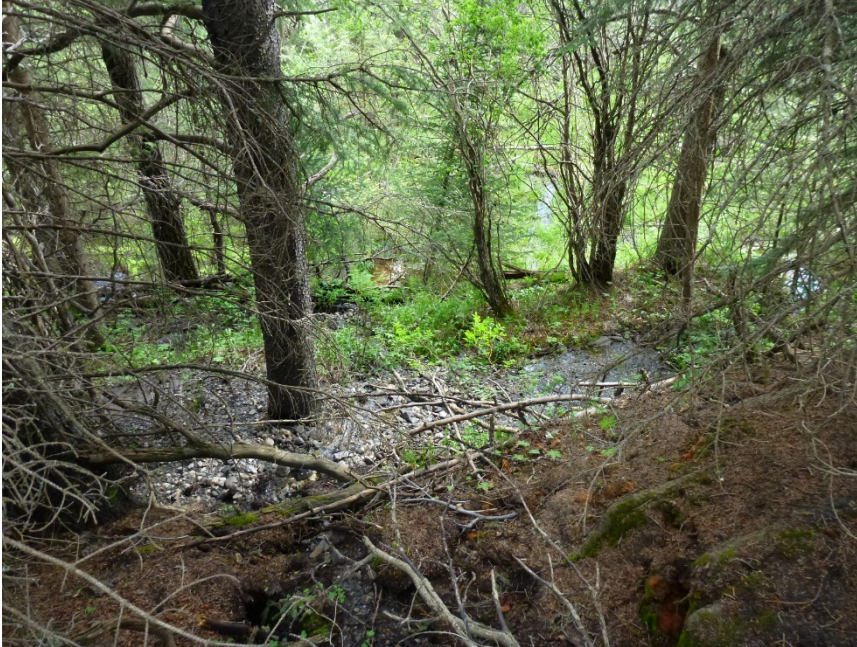
The culverts were damaged during construction. The MCI and AT bridge branch should inspect the culverts periodically to monitor their performance. The minimum 600 mm covering fill was present at the time of inspection. Drainage from the riprap armored channel is draining towards the crest of the James River valley slope. Drainage from the riprap armored channel is exacerbating a historic slide on the north slope (outside bend) of the James River Valley.

**Photo 5** Drainage from the riprap armored channel is exacerbating a historic slide on the north slope (outside bend) of the James River Valley. Photo taken June 12 2017 looking south to southwest.

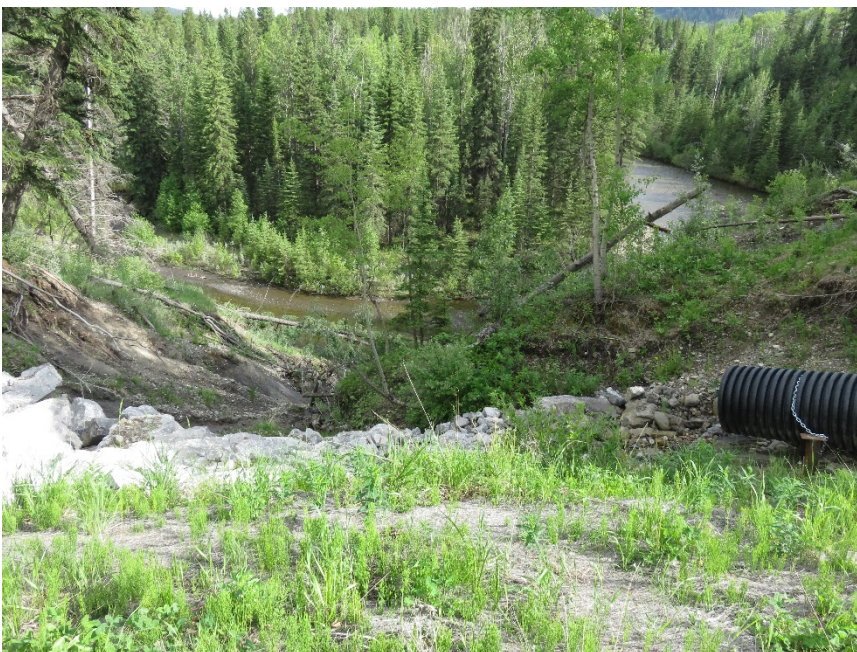
**Photo 6** The erosion gully and slide area located on the north slope of the James River Valley, downstream of the drain outfall. The site is the original C030 site that the high-water-mitigation drainage works were designed to divert water away from. Photo taken June 12, 2017 looking southeast.
