SITE NUMBER AND NAME: C030 Slide and Erosion Site		HIGHWAY & KM: 734:12, 40.628	PREVIOUS INSPECTION DATE: June 23, 2016	INSPECTION DATE: July 9, 2019
LEGAL DESCRIPTION: SW 29-33-8-W5	NAD 83 COORDINATES: UTM Northing Easting 11 5745765 629598		RISK ASSESSMENT: PF: 1 CF: 1 TOTAL: 1	
AVERAGE ANNUAL DAILY TRAFFIC (AADT): 100 (southbound) & 60 (northbound) (Ref No. 51280)			CONTRACT MAINTENANCE AREA (CMA): 18

NOTES: 1. HORIZONTAL DATUM: NAD83 2. GRID ZONE: UTM Zone 12N 3. IMAGE SOURCE: Bing Maps, Microsoft Corporation 2019	CLIENT 	PROJECT CENTRAL REGION GEOHAZARD RISK MANAGEMENT PROGRAM
		TITLE Site Plan C030 Hwy 734:12, km 40.628
SCALE 1:1,000	PROJECT No. A05115A02	FIG No. 1

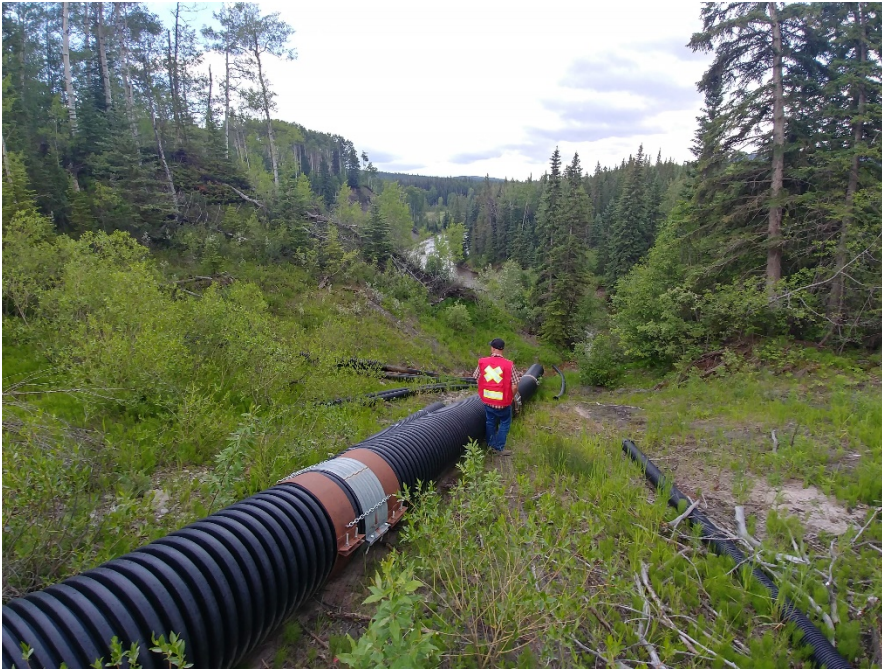
Photo 1 Condition of oversized slope drain and subsurface drainage pipes. Subsurface drainage pipes were observed flowing during inspection. The slope was saturated below this point (waypoint 878). Photo taken July 9, 2019 looking south.

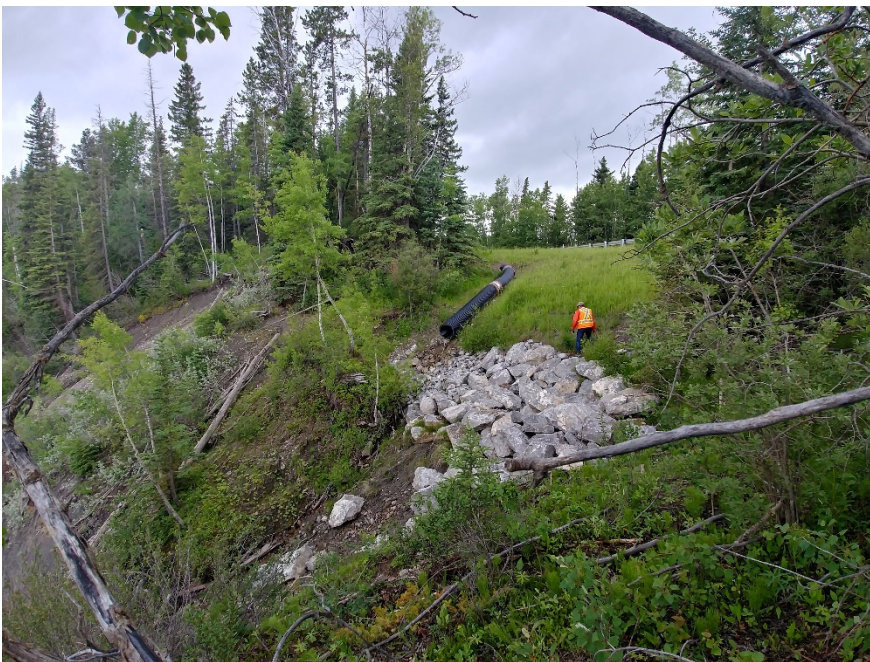
Photo 2 Condition of western slope drain and riprap armouring. Photo taken July 9, 2019 looking northwest.

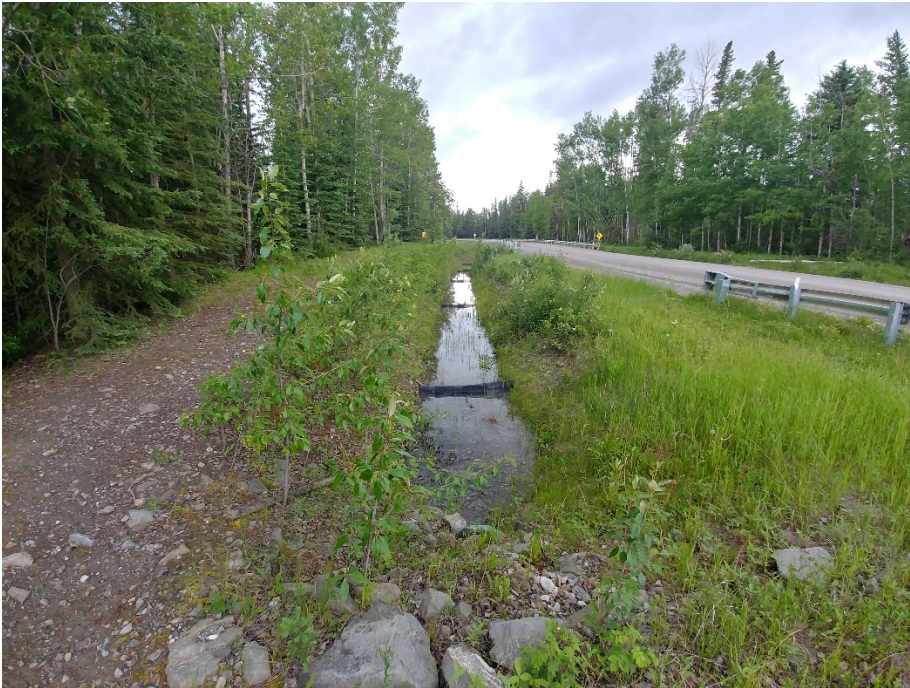
Photo 3 Condition of ditch along south side of highway that drains to western slope drain.
Photo taken July 9, 2019 looking west.

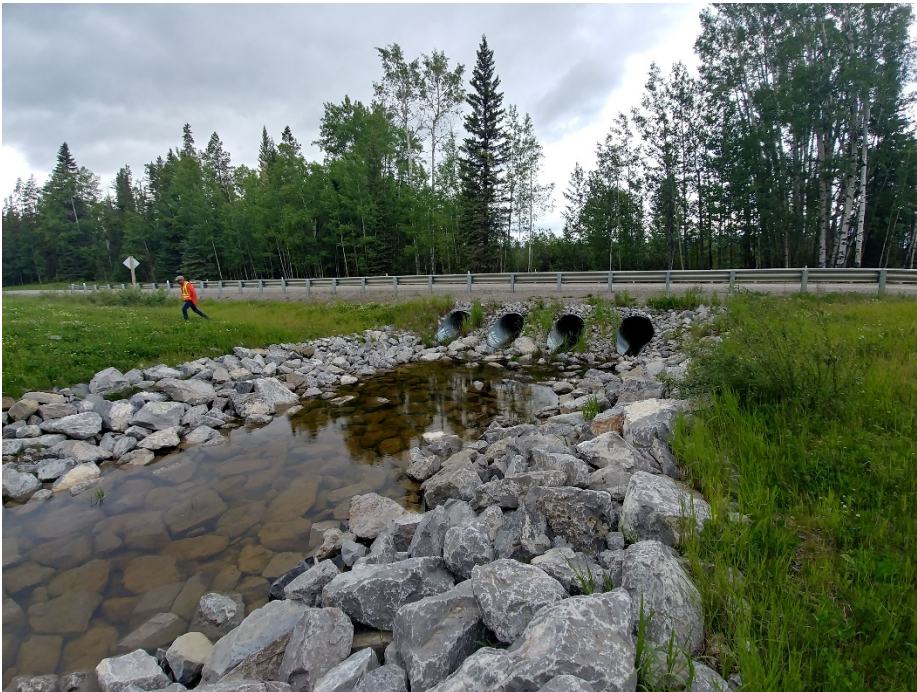
COMMENTS
Site repaired as part of the AT High Water Mitigation Works by installation of culverts upstream of slide to re-route surface water flow through an alternate route that appeared to be a historic, pre-highway drainage channel. The diameter and number of culverts constructed at this site resulted in the crossing becoming a bridge file (BF83183).
The east and west oversize slope drains were in good condition. The subsurface drainage pipes at the east location are performing adequately and were observed to be flowing during the inspection. The slope below the subsurface drainage pipes at the east location was saturated.
The ditch along the south side of the highway that feeds the west slope drain is in good condition and the synthetic ditch barriers are intact.
The four CSP culverts installed below the highway at the west end of the site appear to be in good condition. All four of these culverts were damaged during construction. The north section of the west-most culvert and the south section of the east-most culvert were removed and replaced after being damaged. The inner two culverts were left in place. The condition of the culverts does not appear to have changed since 2016. Some vegetation is growing

in the riprap armouring at the outlet and along the outlet channel.

Photo 4 Photo showing the culvert outlets and riprap armoured stilling basin on south side of highway. Photo taken July 9, 2019 looking northwest.

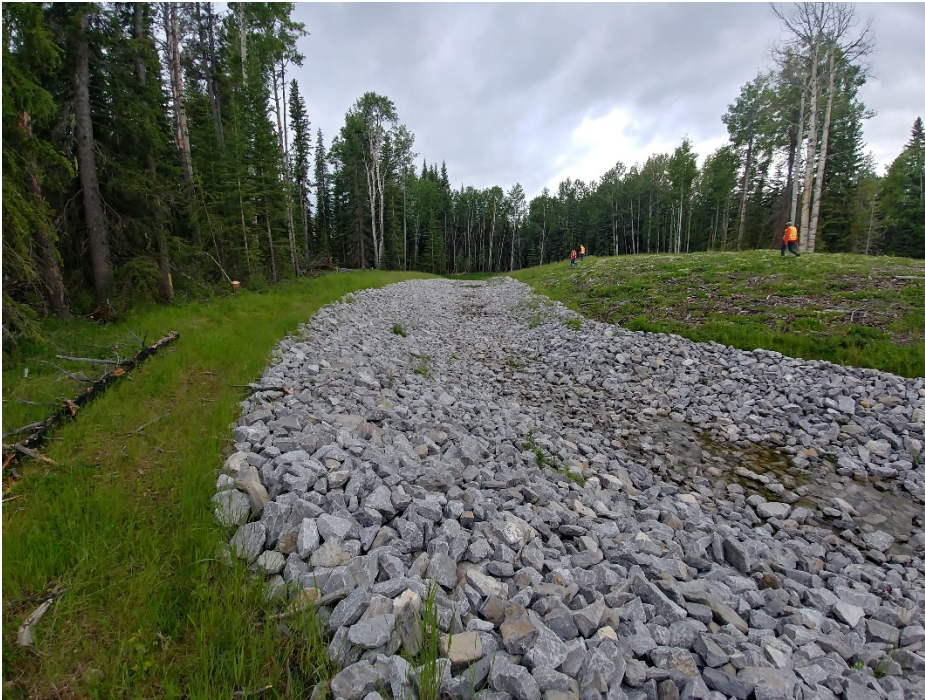
Photo 5 Riprap armoured channel downstream of culvert outlets. Photo taken July 9, 2019 looking southwest.

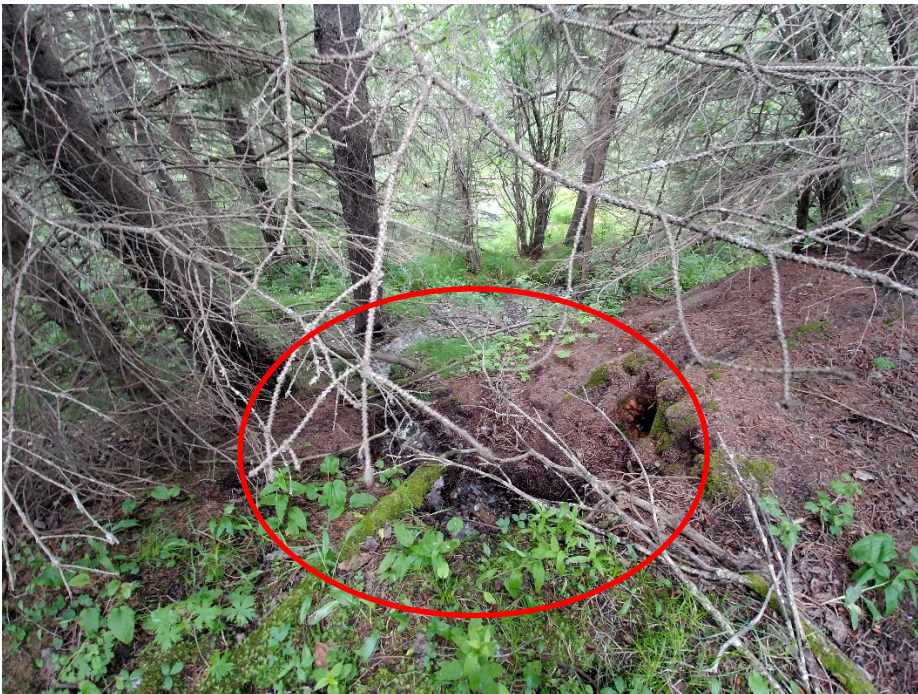
Water was observed to be flowing through the forested area and over the river valley slope downstream of the armoured outlet channel (waypoint 879). A landslide that was observed in 2017 where the water flows over the crest of the valley slope does not appear to have worsened.

Photo 6 Photo showing the location where water is discharging over the river valley slope from the armoured outlet channel (waypoint 879). Photo taken July 9, 2019.
