CENTRAL REGION GEOHAZARD RISK ASSESMENT SITE INSPECTION FORM

211211,1212-011-01,1-0111,1								
SITE NUMBER AND NAME		HIGHWAY & KM	PREV			INSP	ECTION DAT	E
C44 H760:02 Slide			INSPE	ECTIO	N DATE		luna 22 2	010
C44 H760:02 Slide		3	June	26, 2	2008	J	lune 23, 2	.010
LEGAL DESCRIPTION	NAD 83 COORDI	INATES	RISK	(ASS	SESMEN'	Τ		
NE 19-48-5-W4	N 5890109	E 519390	PF:	1	CF:	1	TOTAL:	1

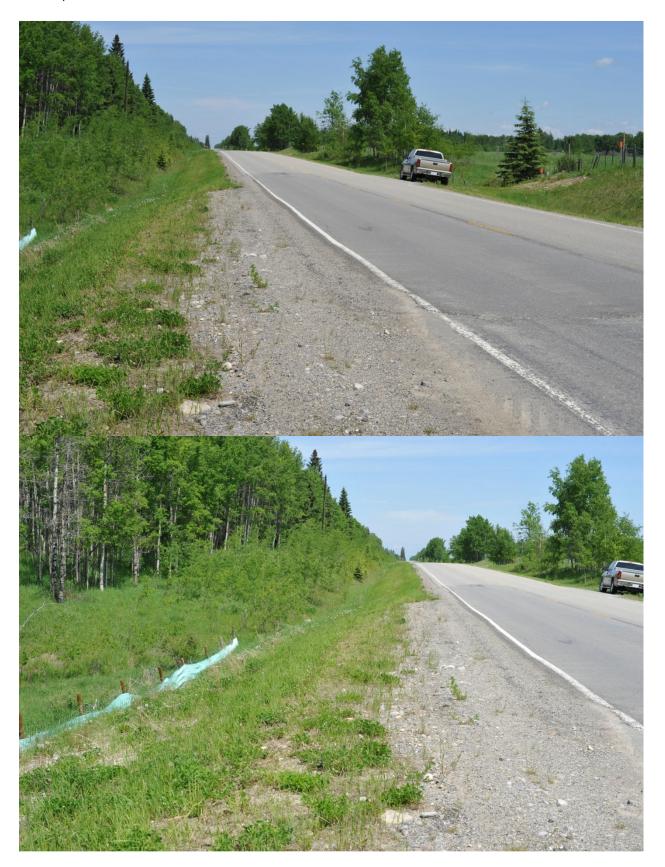
ITEM	CONDITION EXISTS		DESCRIPTION AND LOCATION		NOTICABLE CHANGE FROM LAST INSPECTION				
	YES	NO		YES	NO				
Pavement Distress		Х	A few reflective cracks near shoulder in asphalt patch.	Х					
Slope Movement		X	Stabilized slope is performing well. No evidence of slope movement is apparent.		X				
Erosion		Χ			X				
Seepage		Х			X				
Culvert Distress		Х			Х				
COMMENTS									
Refer to attached photos and previous reports.
