**CENTRAL REGION  
GEOHAZARD RISK ASSESMENT  
SITE INSPECTION FORM**

SITE NUMBER AND NAME <b>C20 H771:02 Pavement</b>		HIGHWAY & KM	PREVIOUS INSPECTION DATE May 23, 2003	INSPECTION DATE <b>May 12, 2004</b>
LEGAL DESCRIPTION SW 3-41-1-W5	NAD 83 COORDINATES N 5820026 E 698635	RISK ASSESMENT PF: 9 CF: 1 TOTAL: <b>9</b>

## 1. SITE C20: H771:02 PAVEMENT DISTRESS

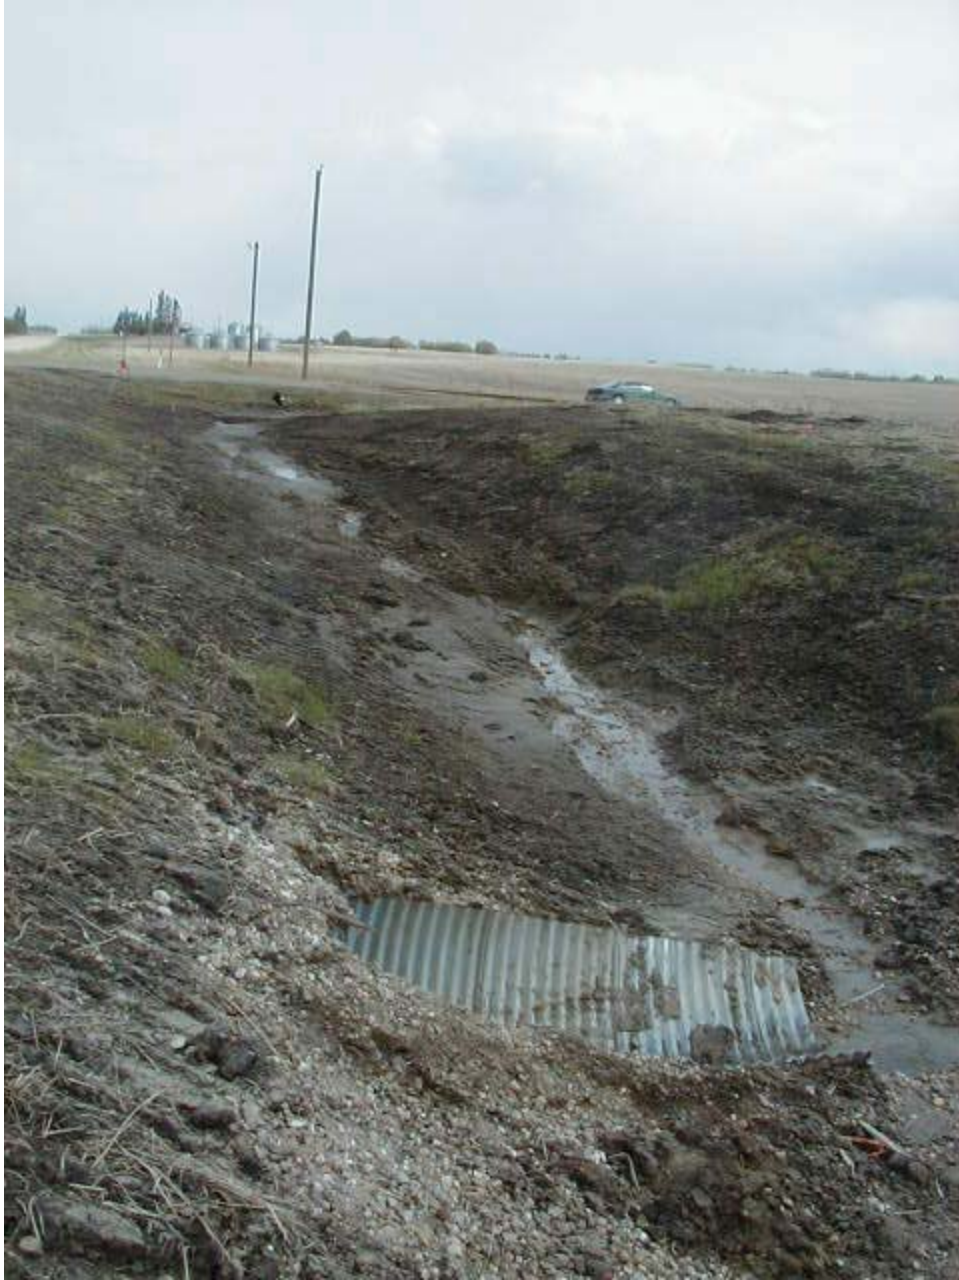
East ditch looking north over new culvert inlet.

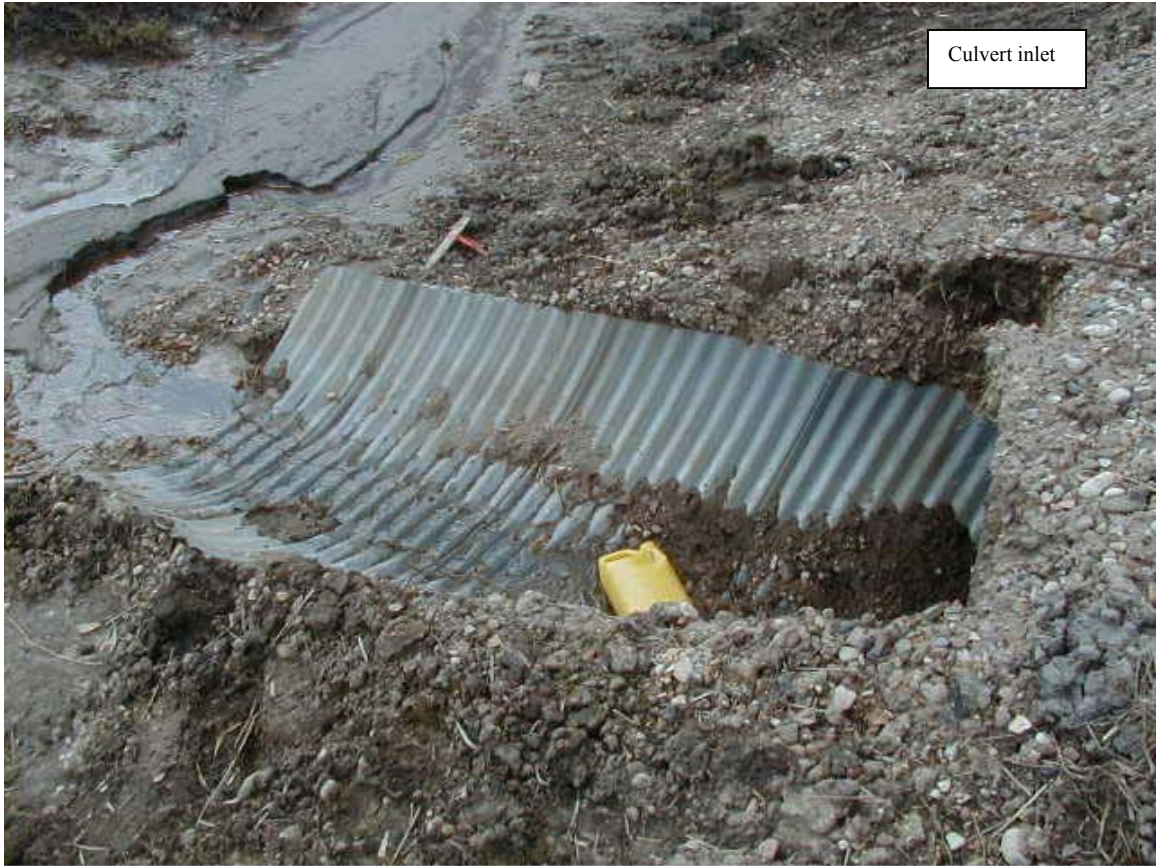
Culvert inlet

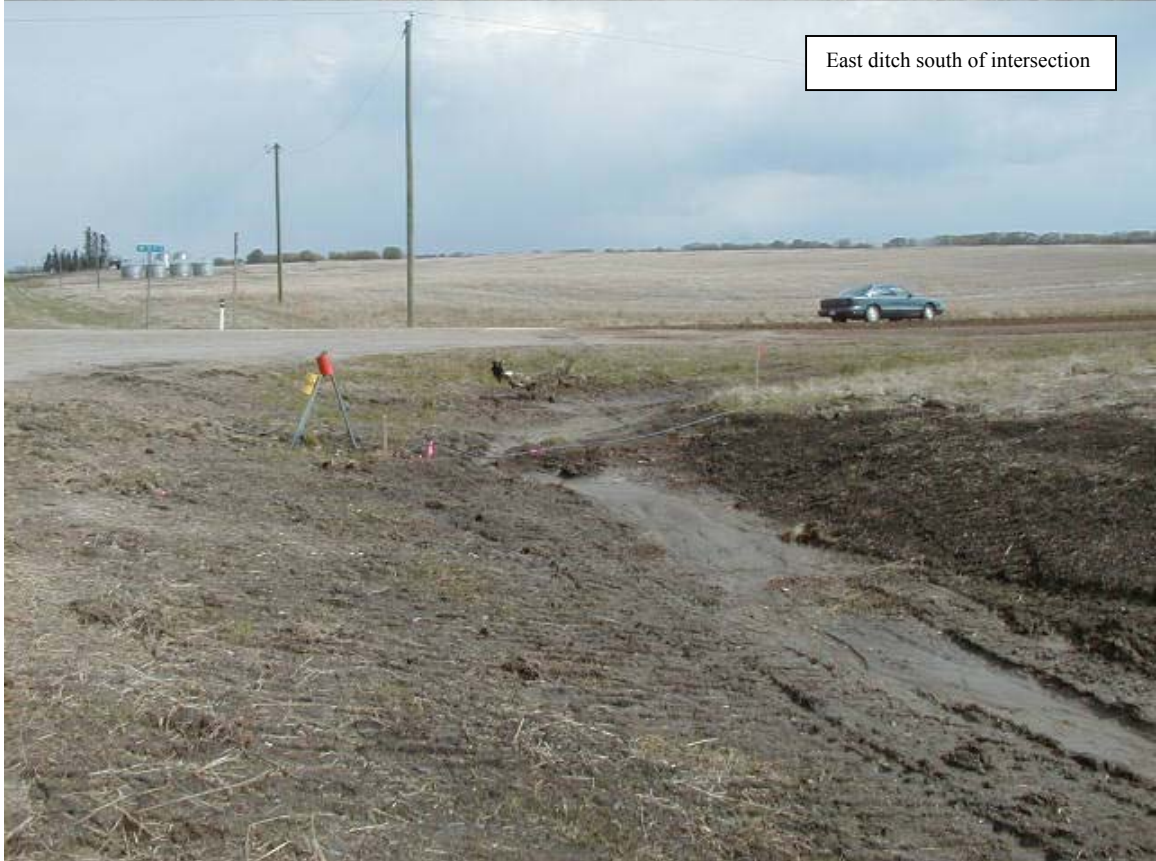
Some clean up work is required in the ditches and it is understood that the contractor will complete the work this year.

East ditch south of intersection

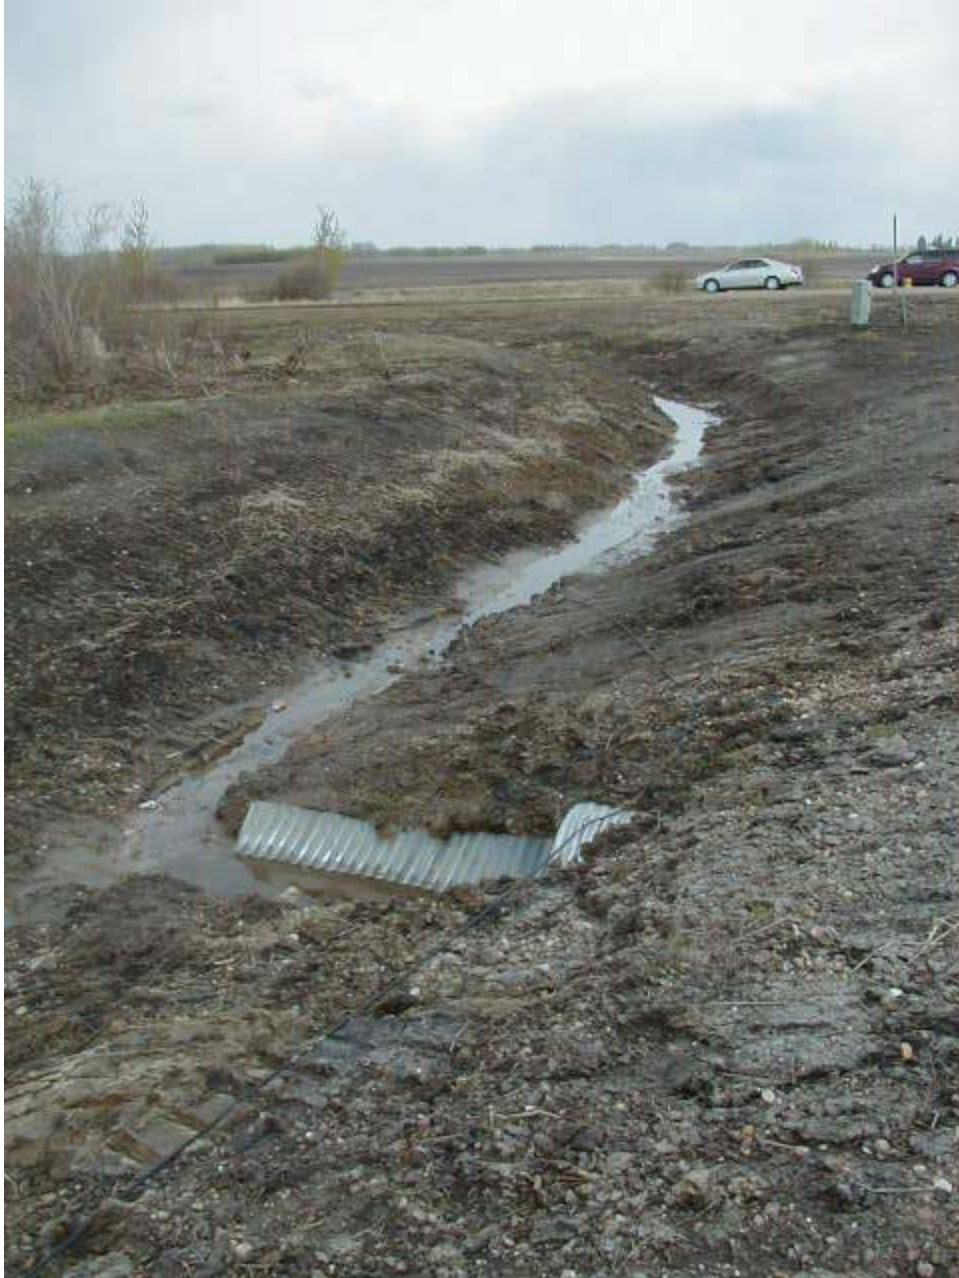
Looking north at culvert outlet in west ditch.

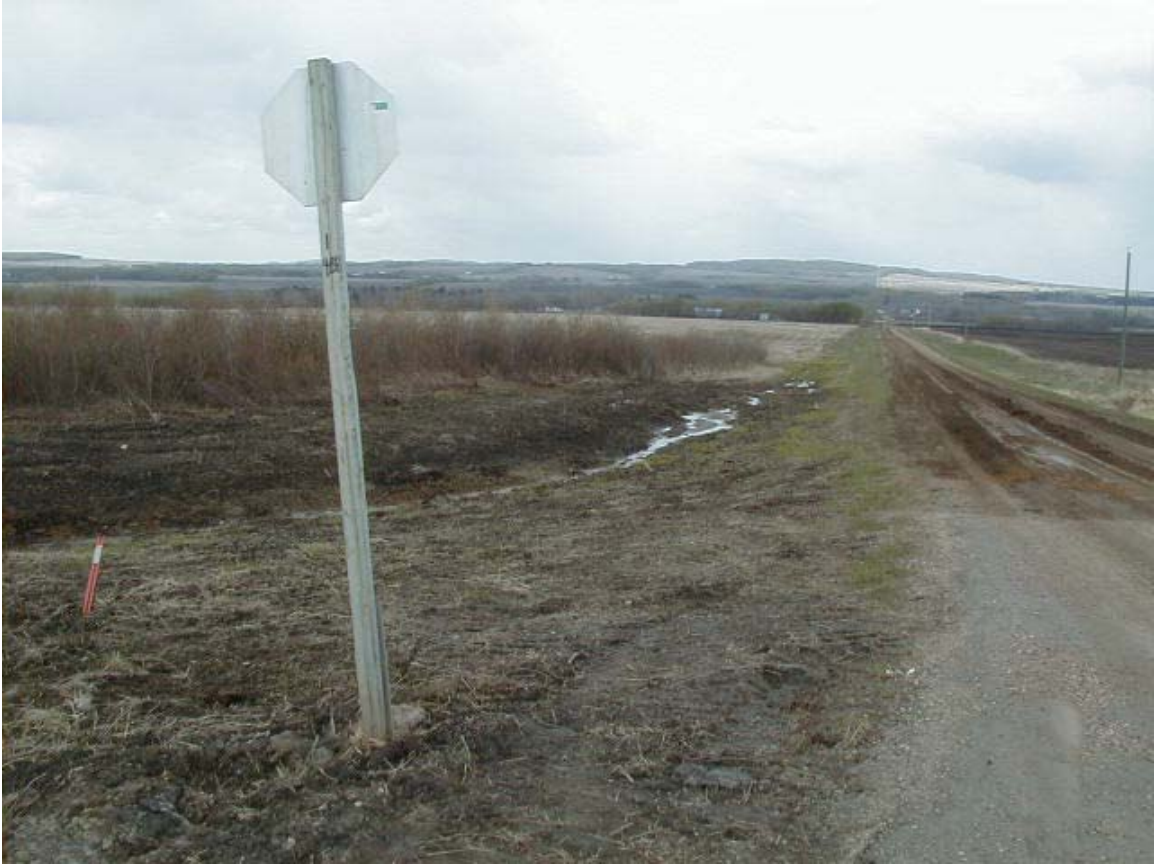
Looking west.
