SITE NUMBER AND NAME <b>C14 H771:04</b>		HIGHWAY & KM	PREVIOUS INSPECTION DATE May 15, 2007	INSPECTION DATE <b>June 26, 2008</b>
LEGAL DESCRIPTION NW 34-45-1-W5	NAD 83 COORDINATES N 5868190 E 696622		RISK ASSESMENT PF: 1 CF: 1 TOTAL: 1

Site C14 H771:04 Slide  
June 26, 2008

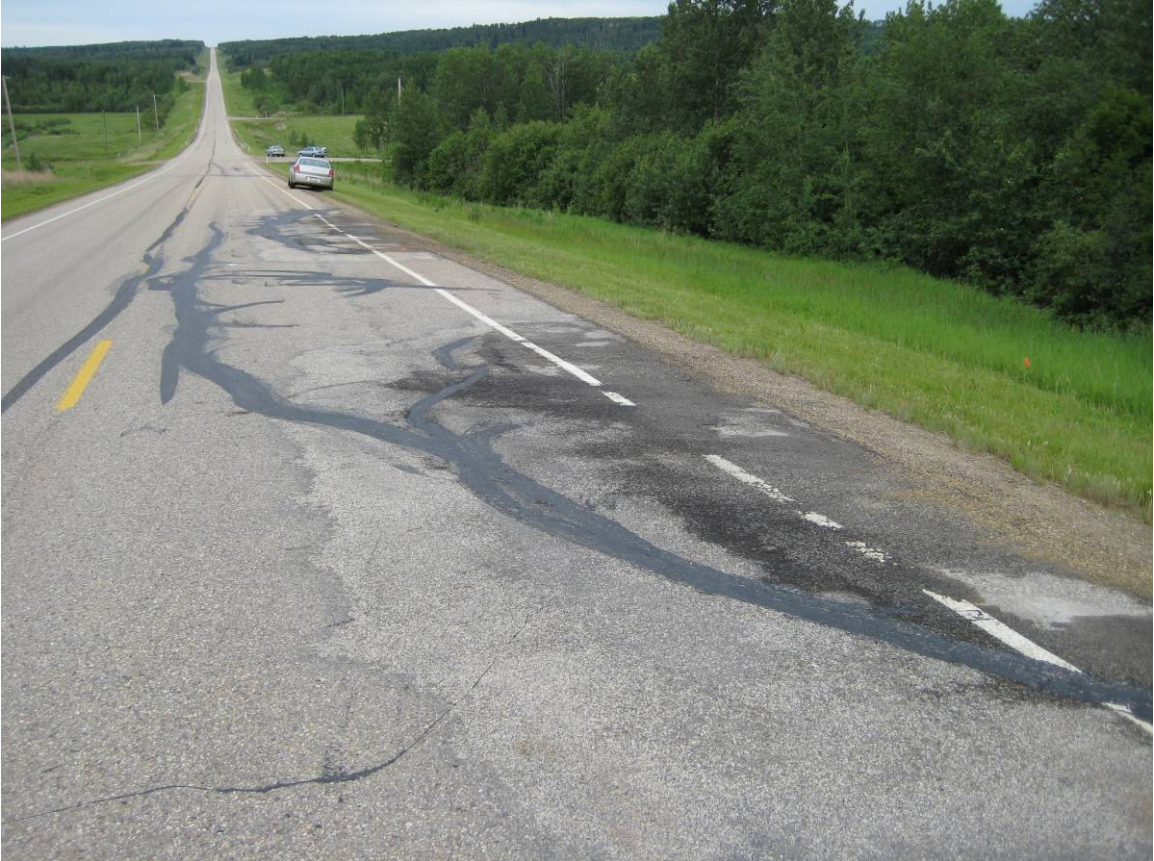
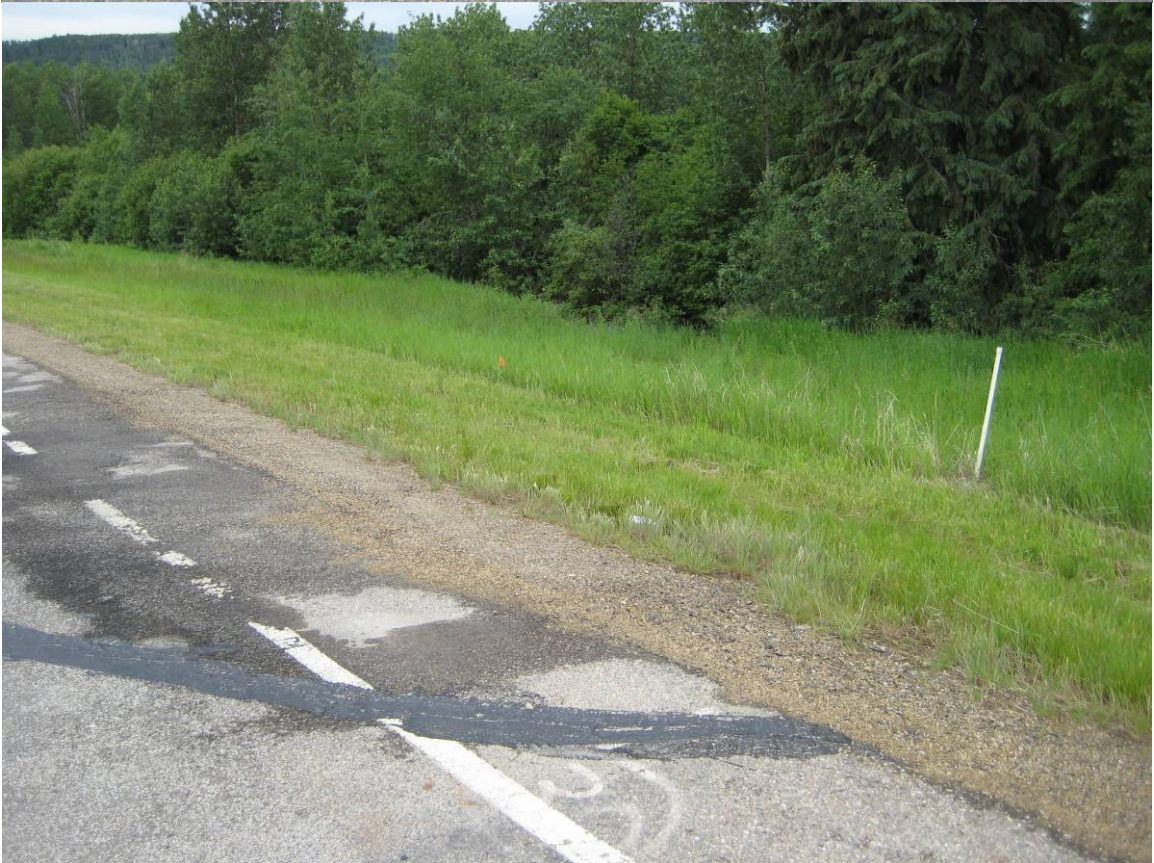
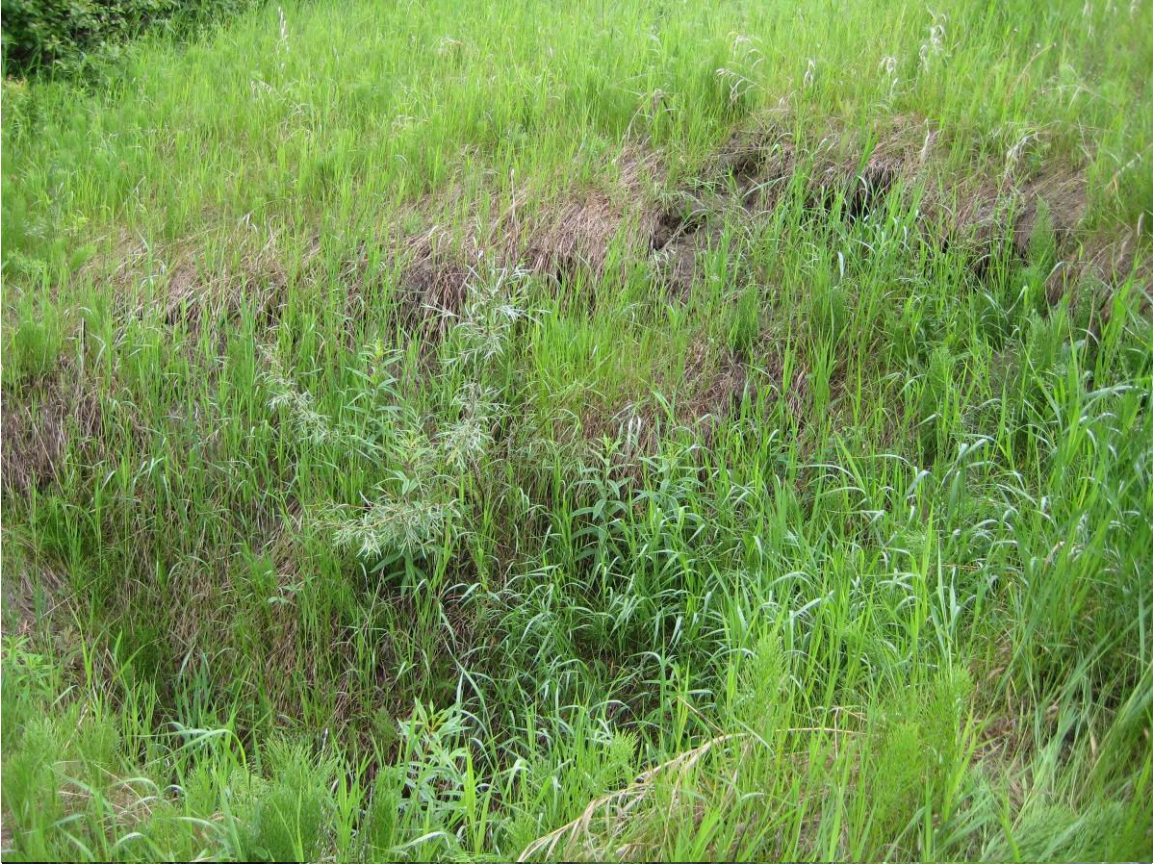
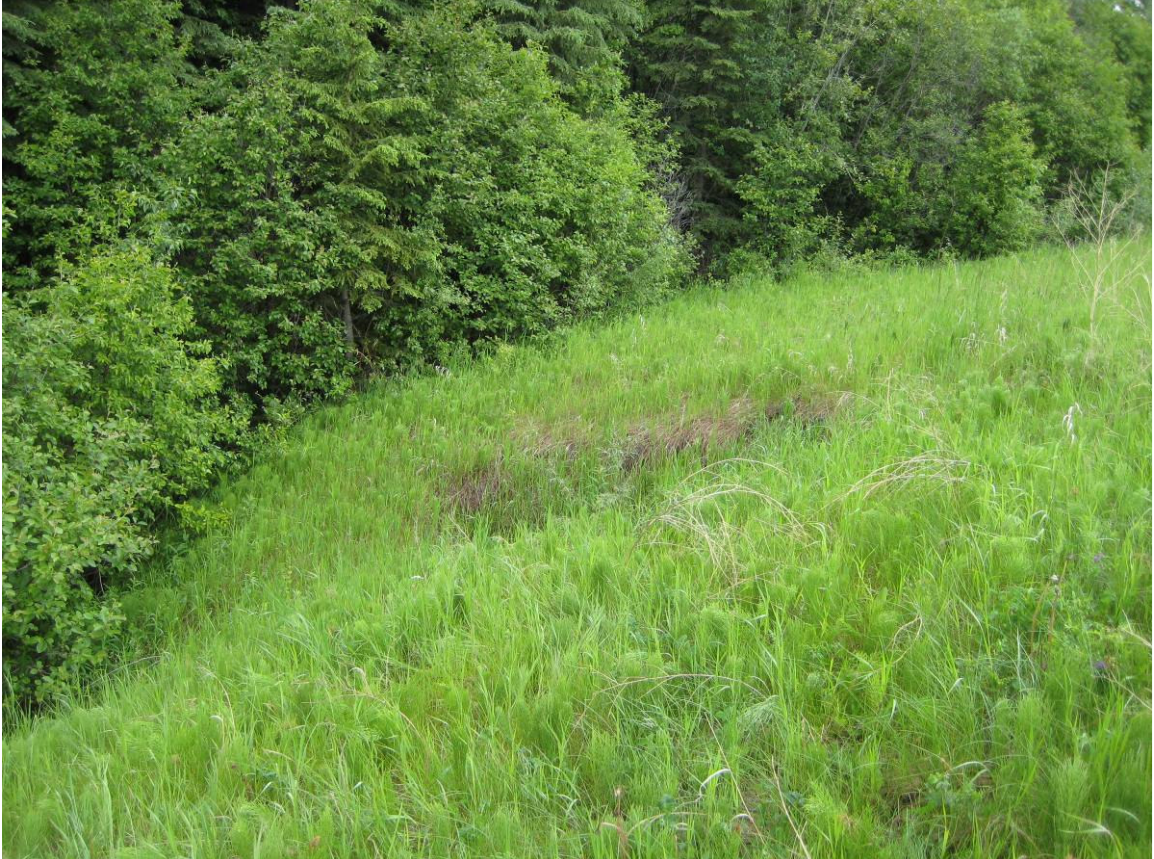
ITEM	CONDITION EXISTS		DESCRIPTION AND LOCATION	NOTICABLE CHANGE FROM LAST INSPECTION	
	YES	NO		YES	NO
Pavement Distress	X		Pavement marked for patching.		X
Slope Movement	X		Slope nailed in June 2007. No movement is apparent.		X
Erosion		X			X
Seepage		X			X
Culvert Distress	X		Culvert is flowing. No significant changes to instability downstream of outlet.		X
