SITE NUMBER AND NAME H834:02 Frost Heave		HIGHWAY & KM 12	PREVIOUS INSPECTION DATE	INSPECTION DATE May 15, 2007
LEGAL DESCRIPTION	NAD 83 COORDINATES		RISK ASSESMENT PF: 9 CF: 3 TOTAL: 27

LAST READING DATE:		
PRIMARY SITE ISSUE: Frost Heave		
APPROXIMATE DIMENSIONS: Approximately 300 m long section.		
DATE OF ANY REMEDIAL ACTION:

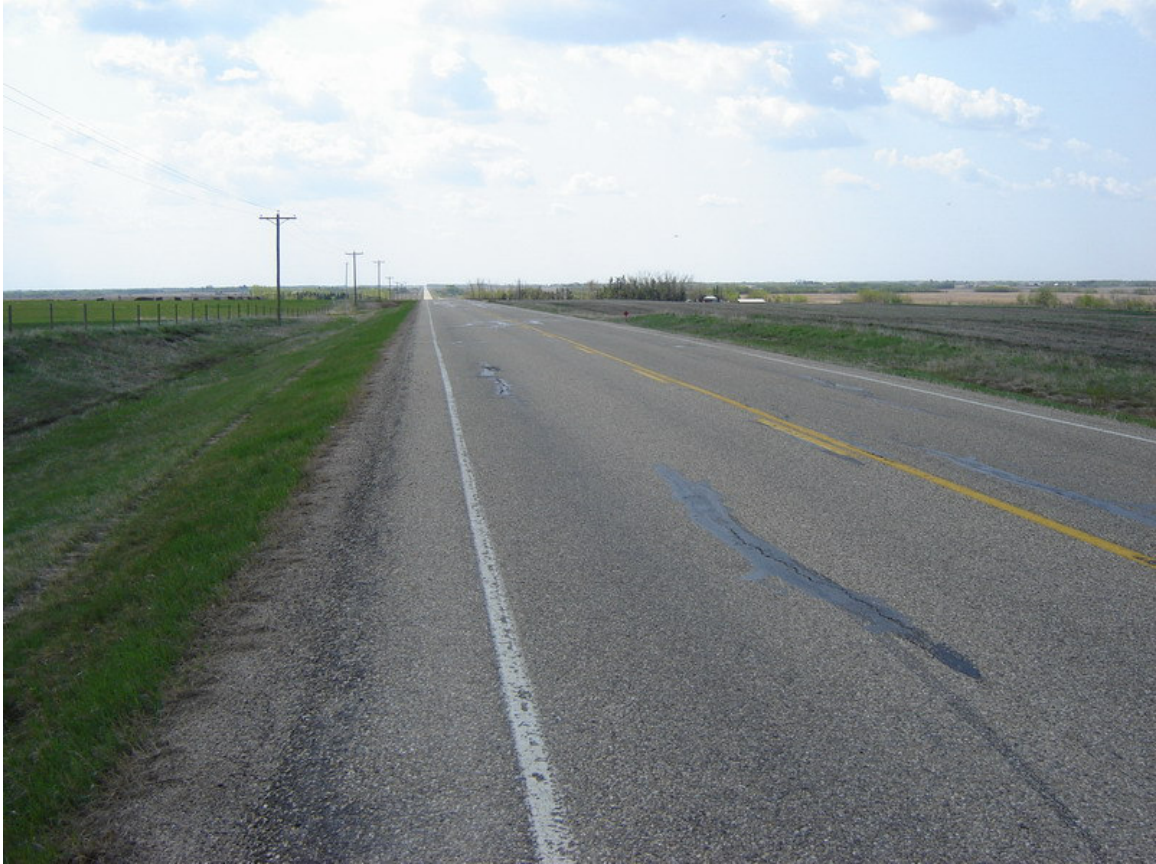
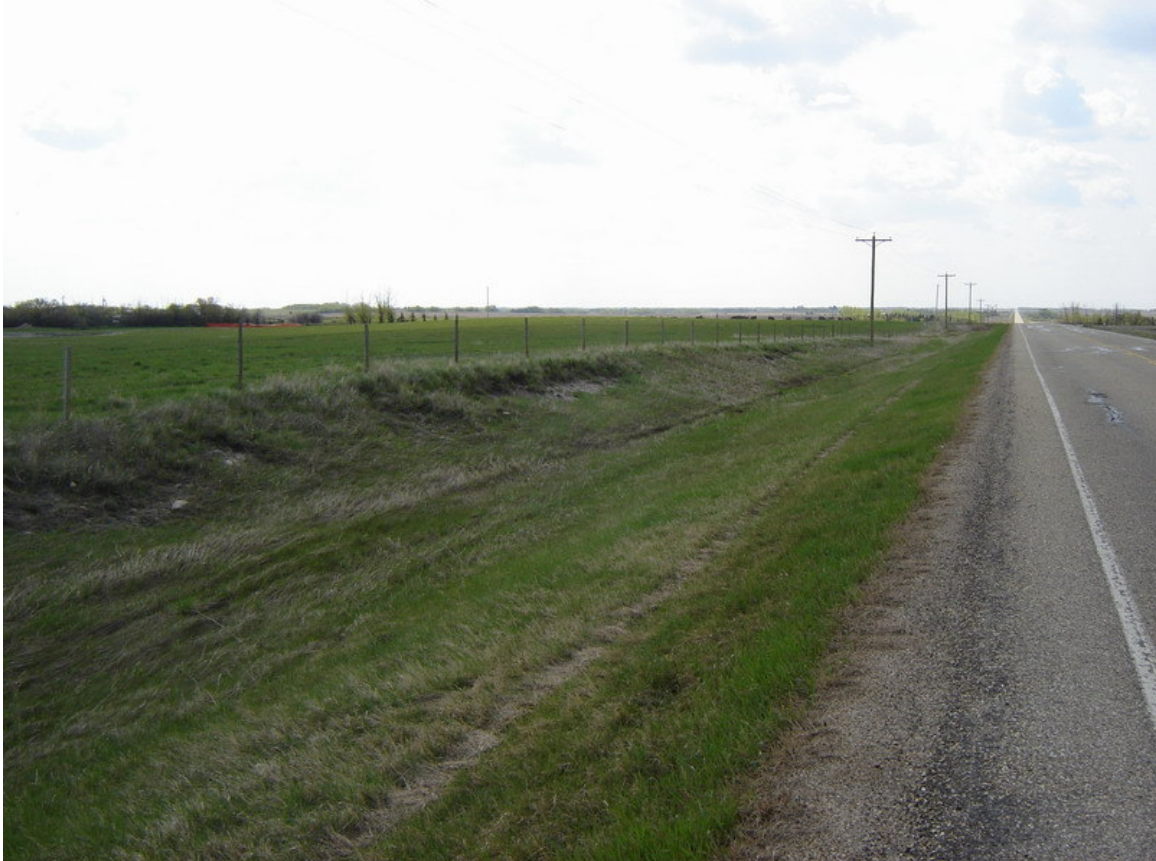
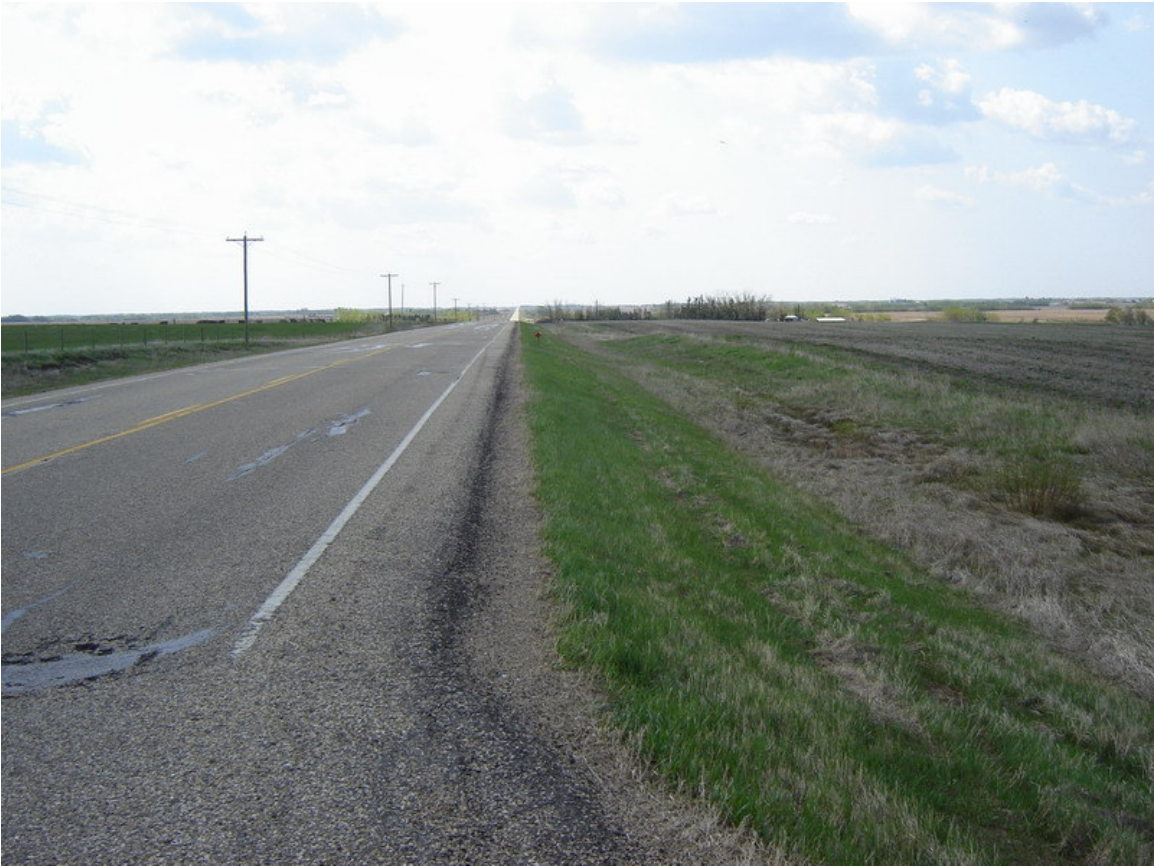
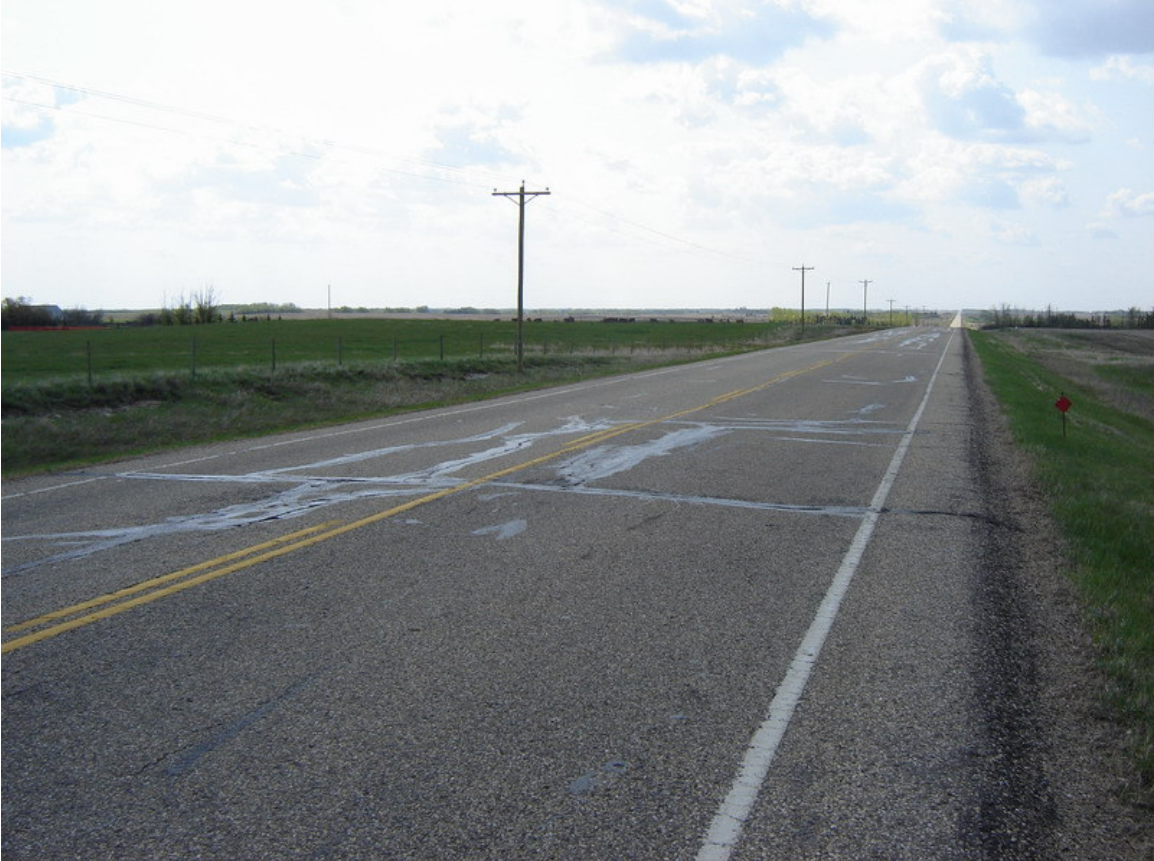
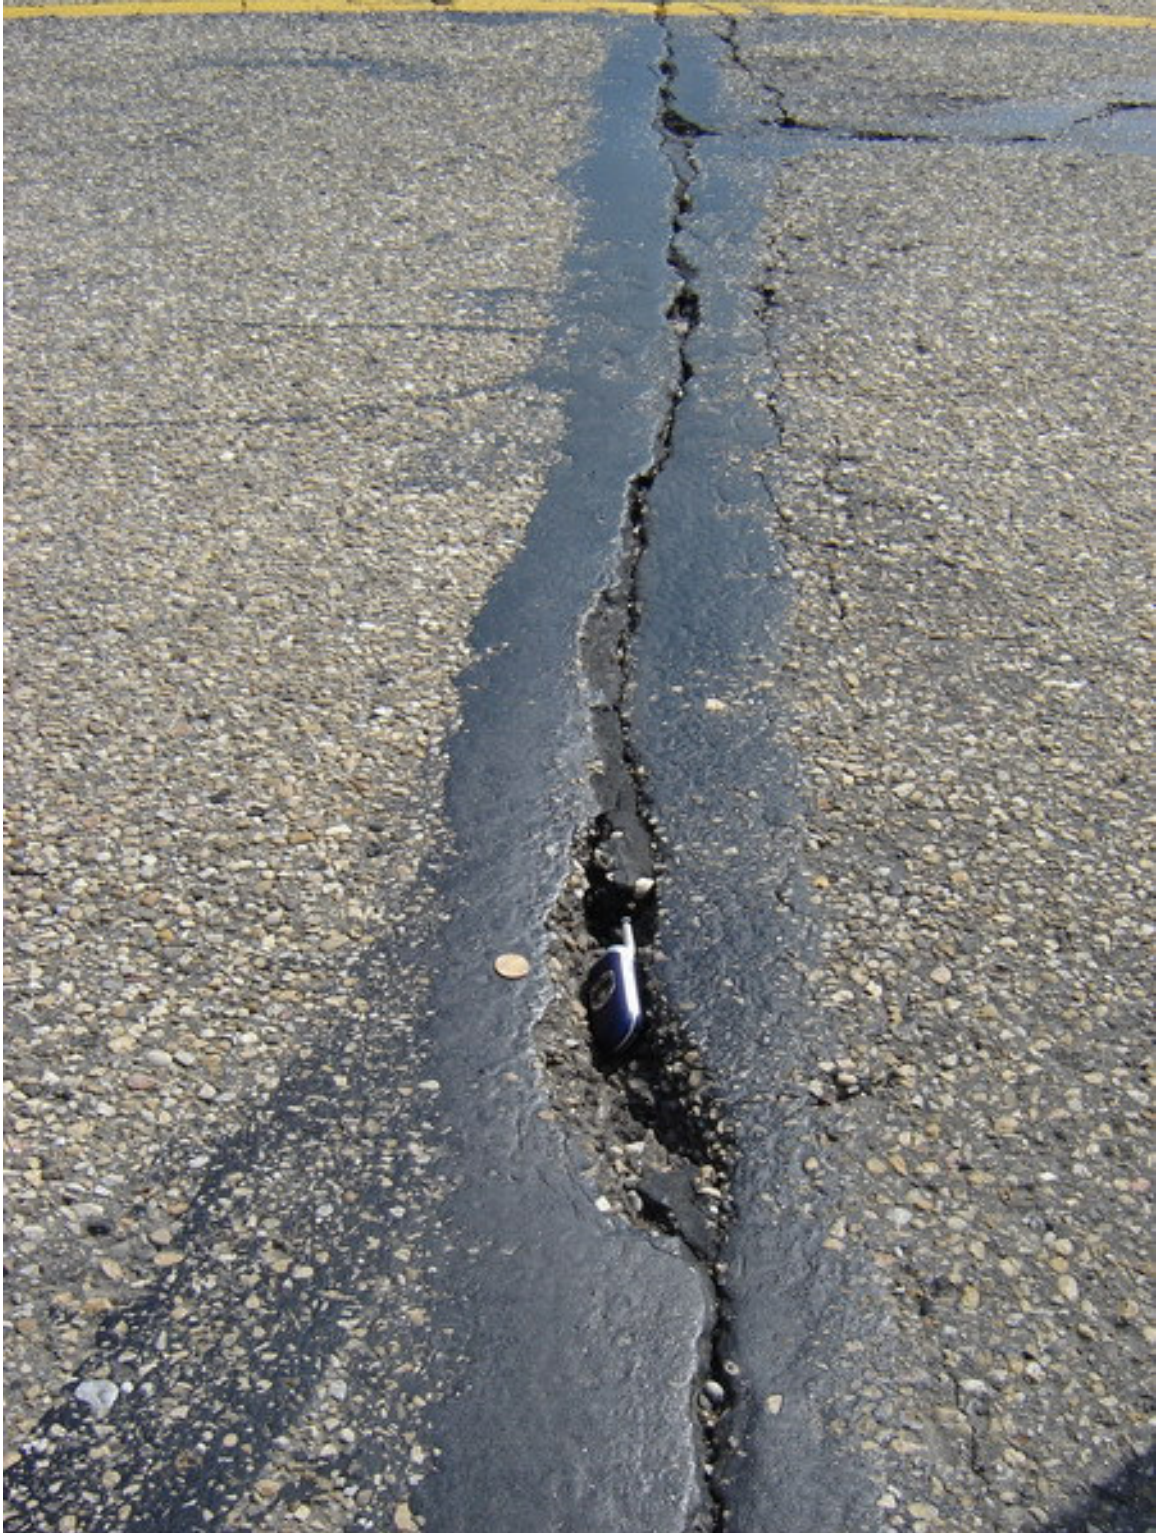
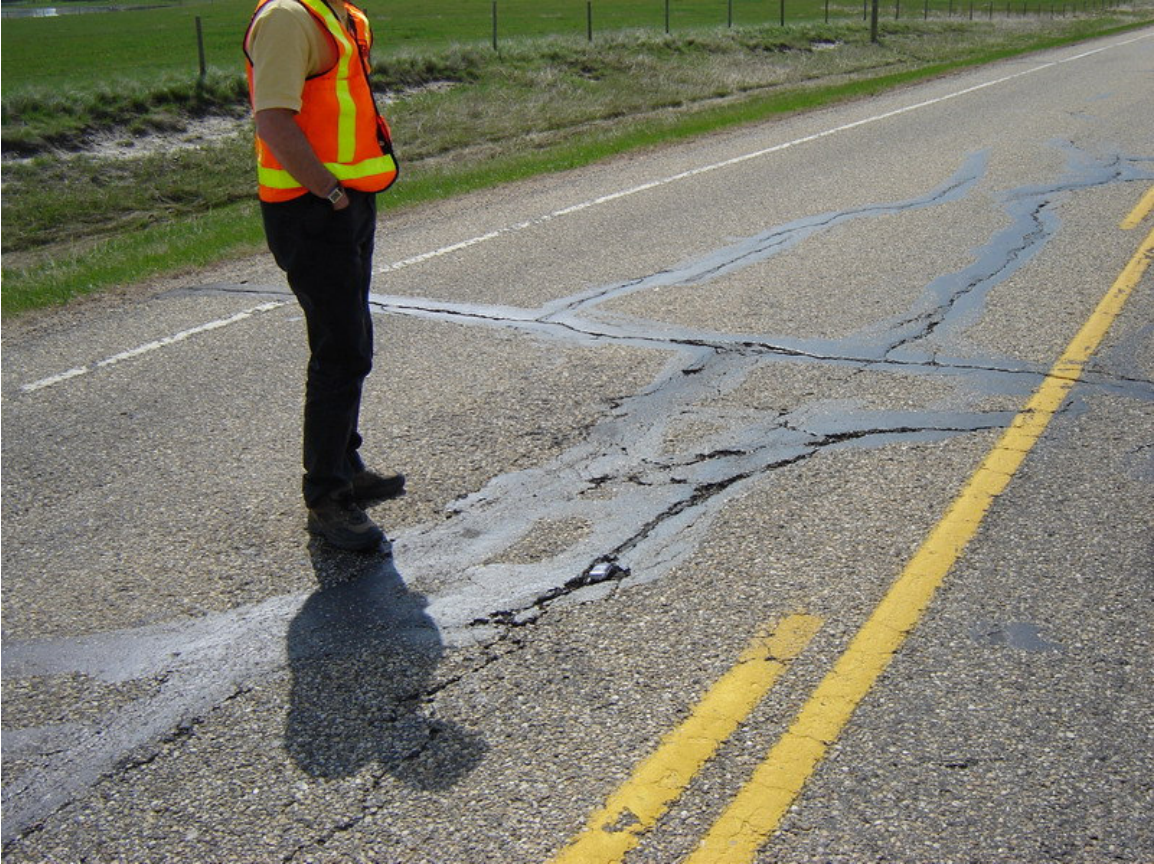
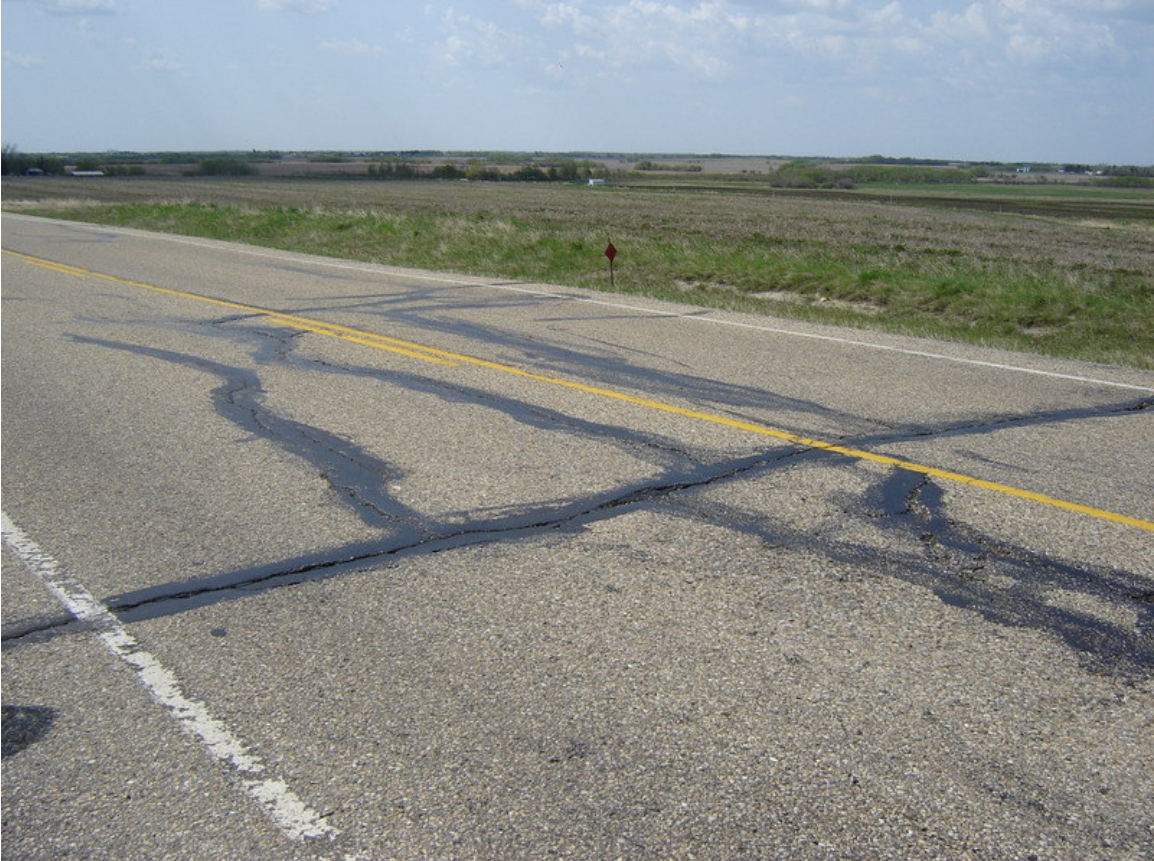
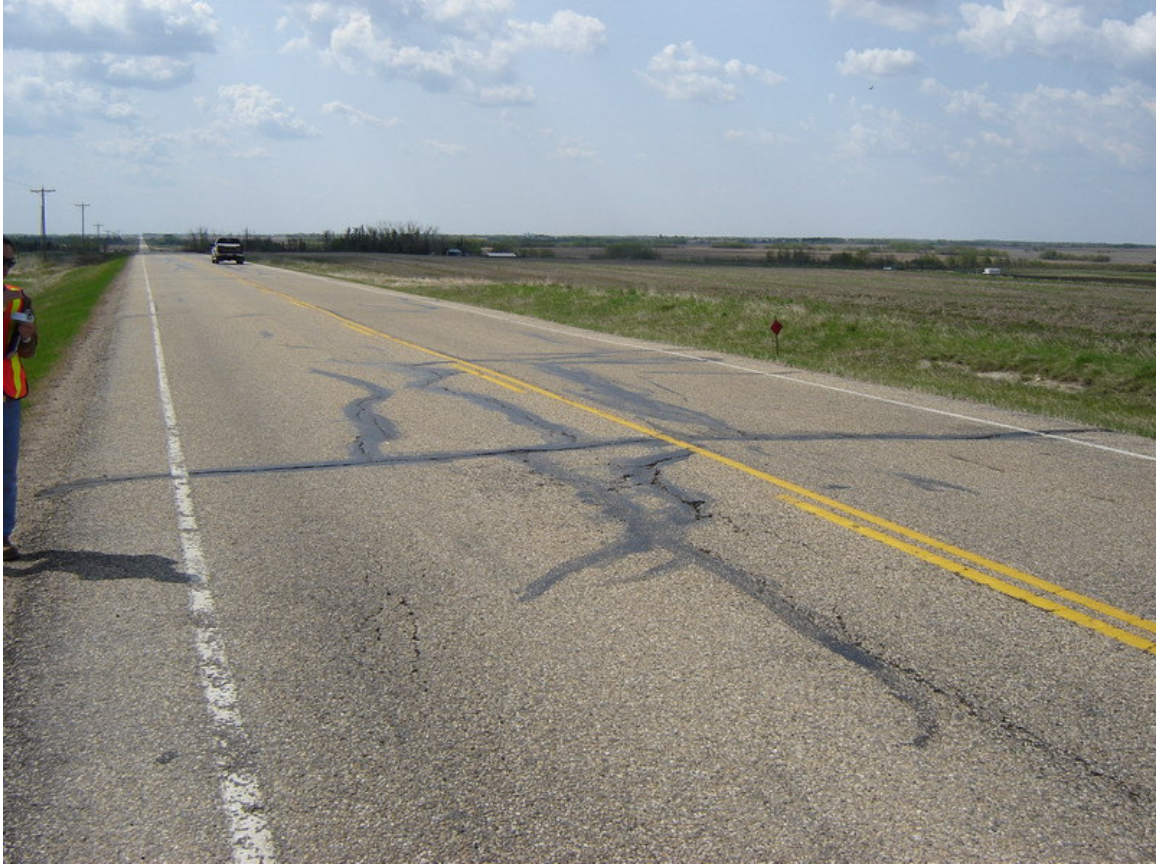
ITEM	CONDITION EXISTS		DESCRIPTION AND LOCATION	NOTICABLE CHANGE FROM LAST INSPECTION	
	YES	NO		YES	NO
Pavement Distress	X		Pavement distress due to frost heave. Cracks up to 50 mm wide were observed.		X
Slope Movement		X			X
Erosion		X			X
Seepage		X			X
Culvert Distress		X			X

COMMENTS
Refer to attached photographs.
It does not appear that drainage of the site can be improved and so insulation or material replacement remediation methods must be adopted.
It is recommended that the site be inspected in January / February 2008 to determine the extent of the heaving area.
