SITE NUMBER AND NAME C40 H841:02 Slide		HIGHWAY & KM 11.7	PREVIOUS INSPECTION DATE Oct 11, 2005	INSPECTION DATE May 15, 2006
LEGAL DESCRIPTION 16-28-20-W4	NAD 83 COORDINATES N 5694845 E 376882		RISK ASSESMENT PF: 9 CF: 4 TOTAL: 36

LAST READING DATE:		
PRIMARY SITE ISSUE: Slope failure on east slope		
APPROXIMATE DIMENSIONS: 15 m wide (from highway edge down to culvert)		
DATE OF ANY REMEDIAL ACTION: Slope repaired Nov 2005 (Ledcor)

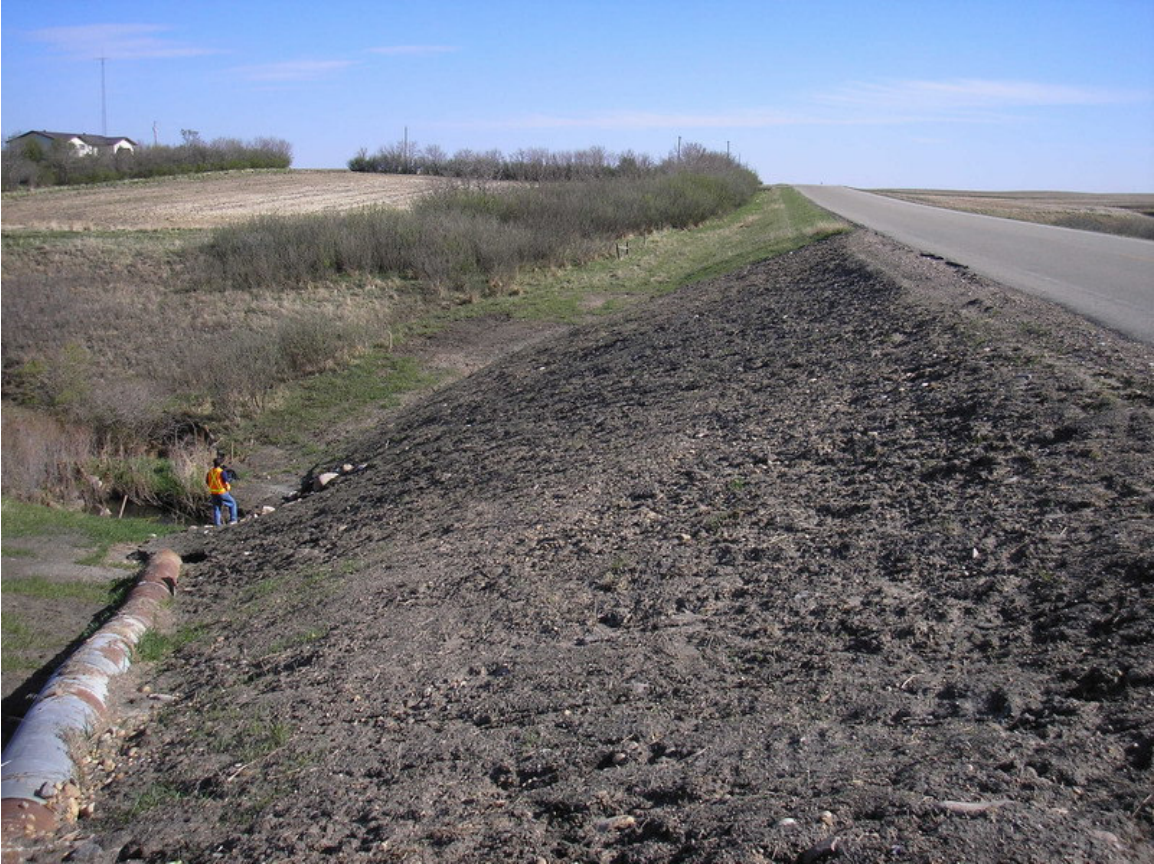
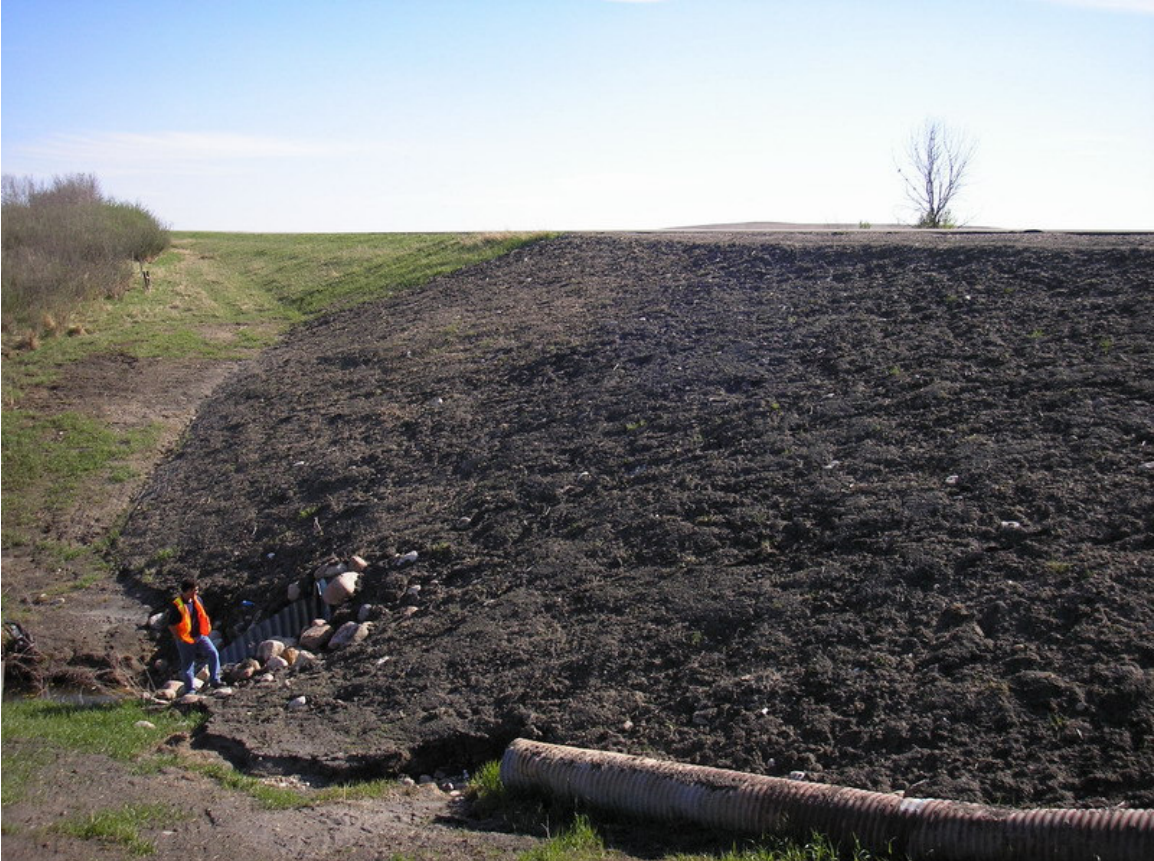
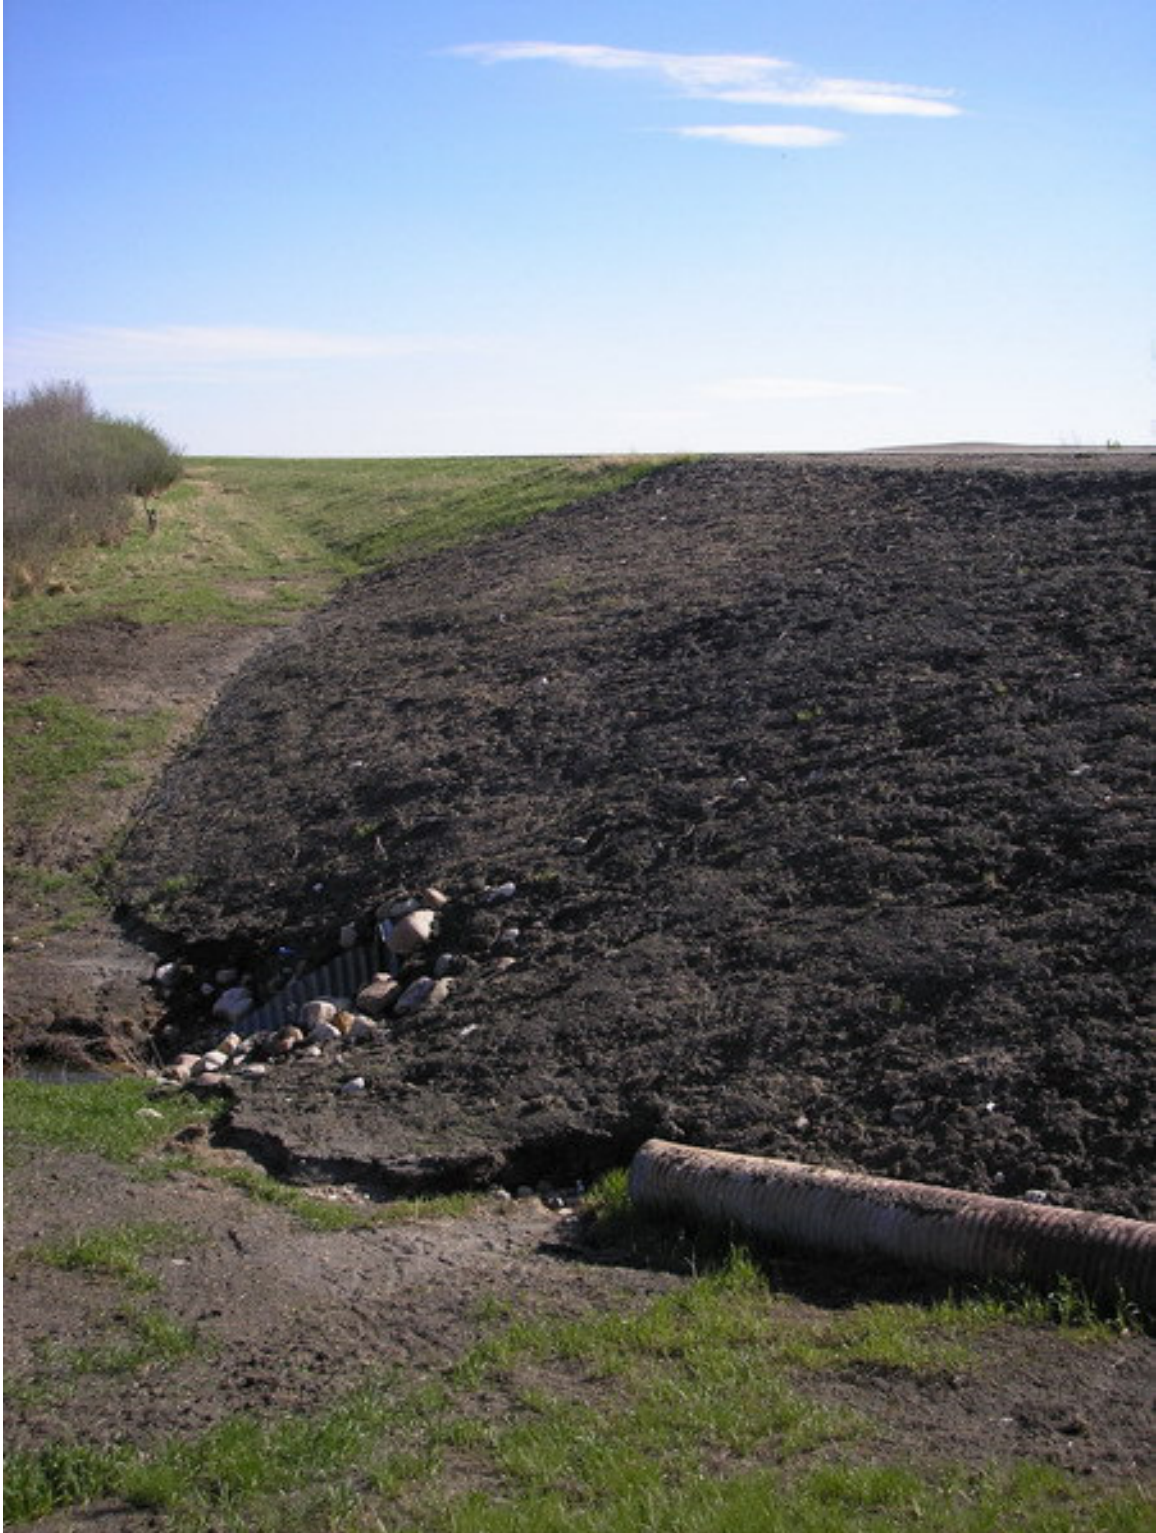
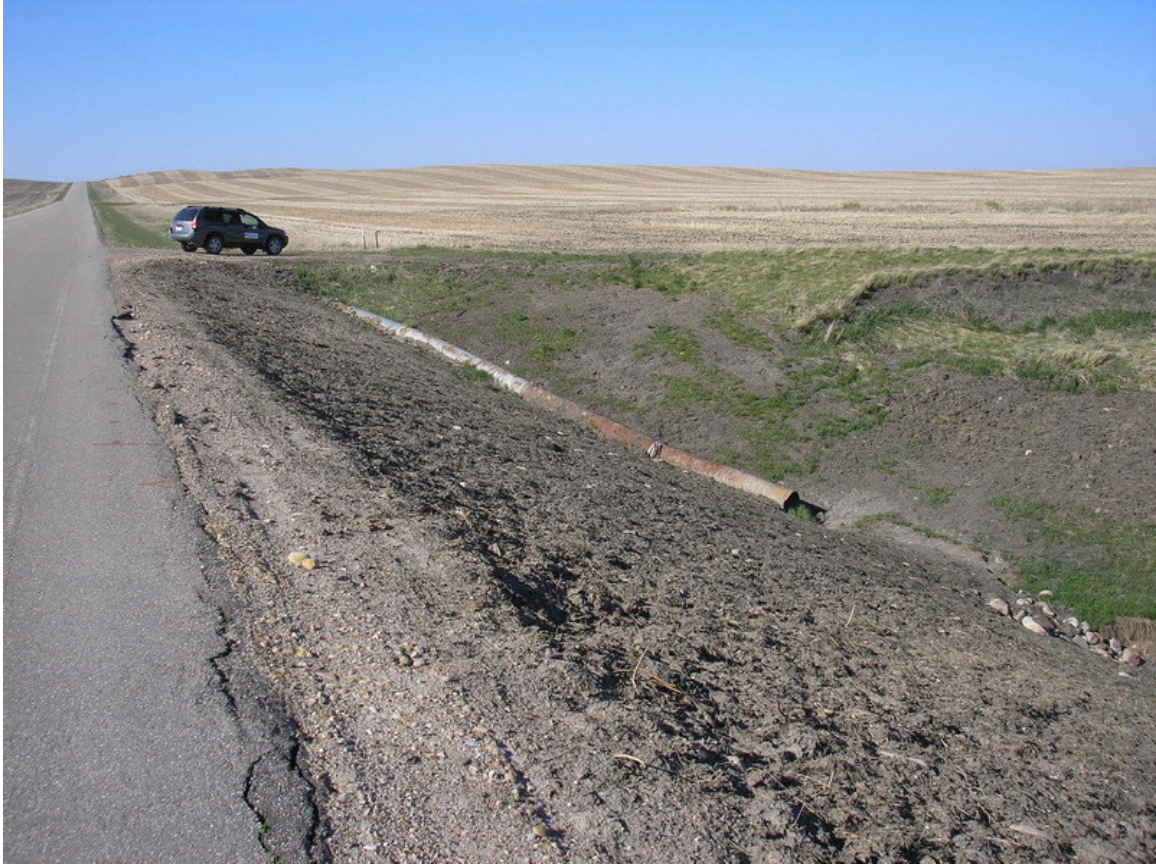
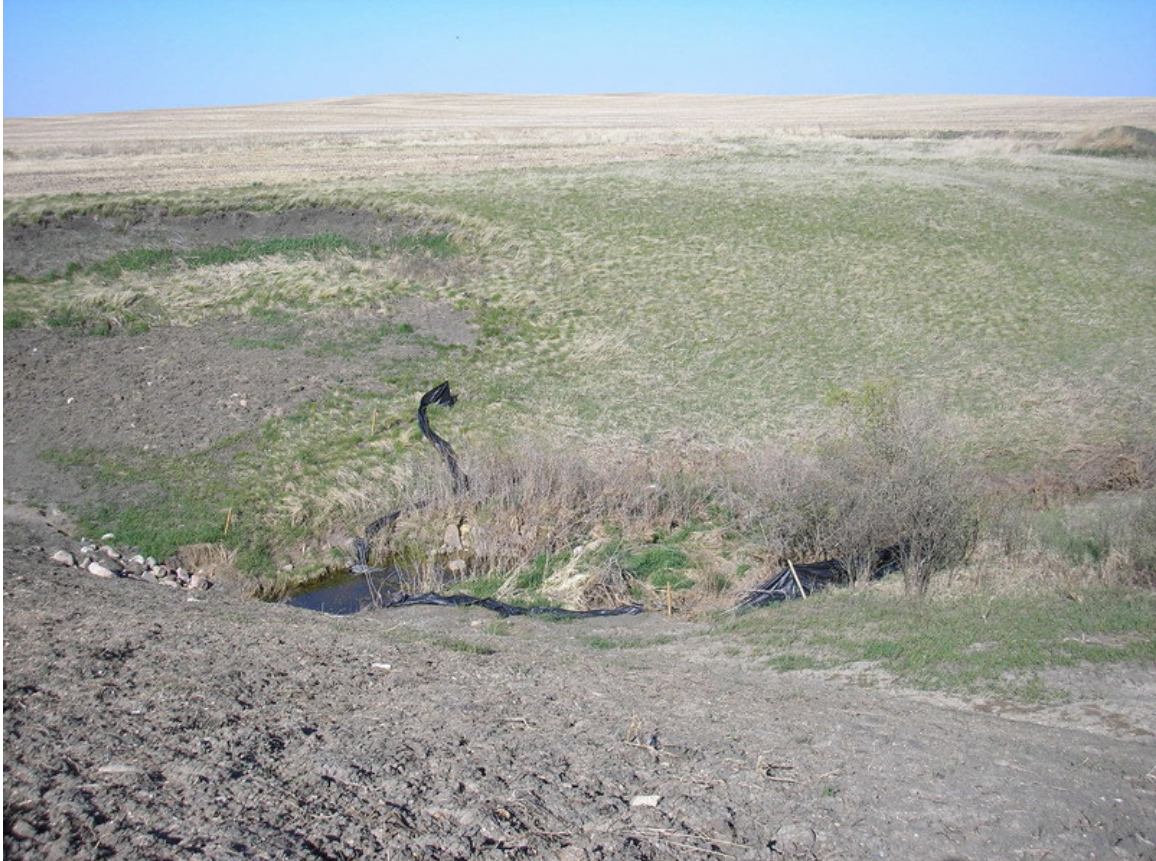
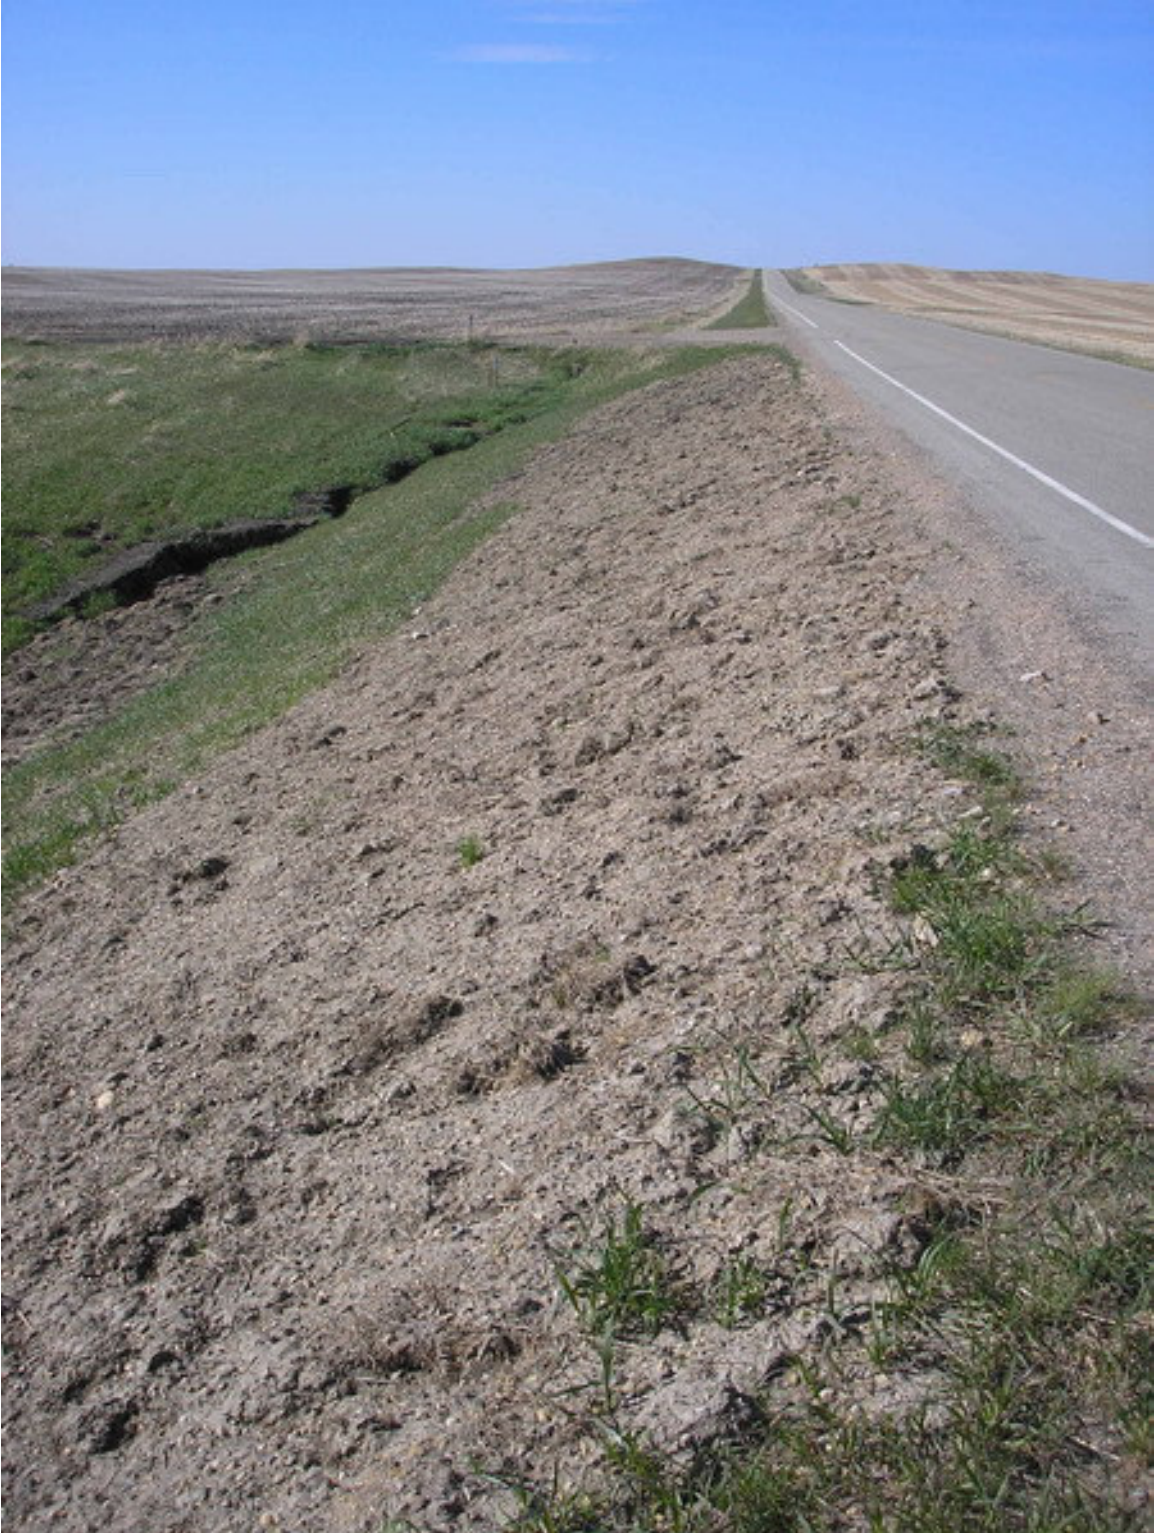
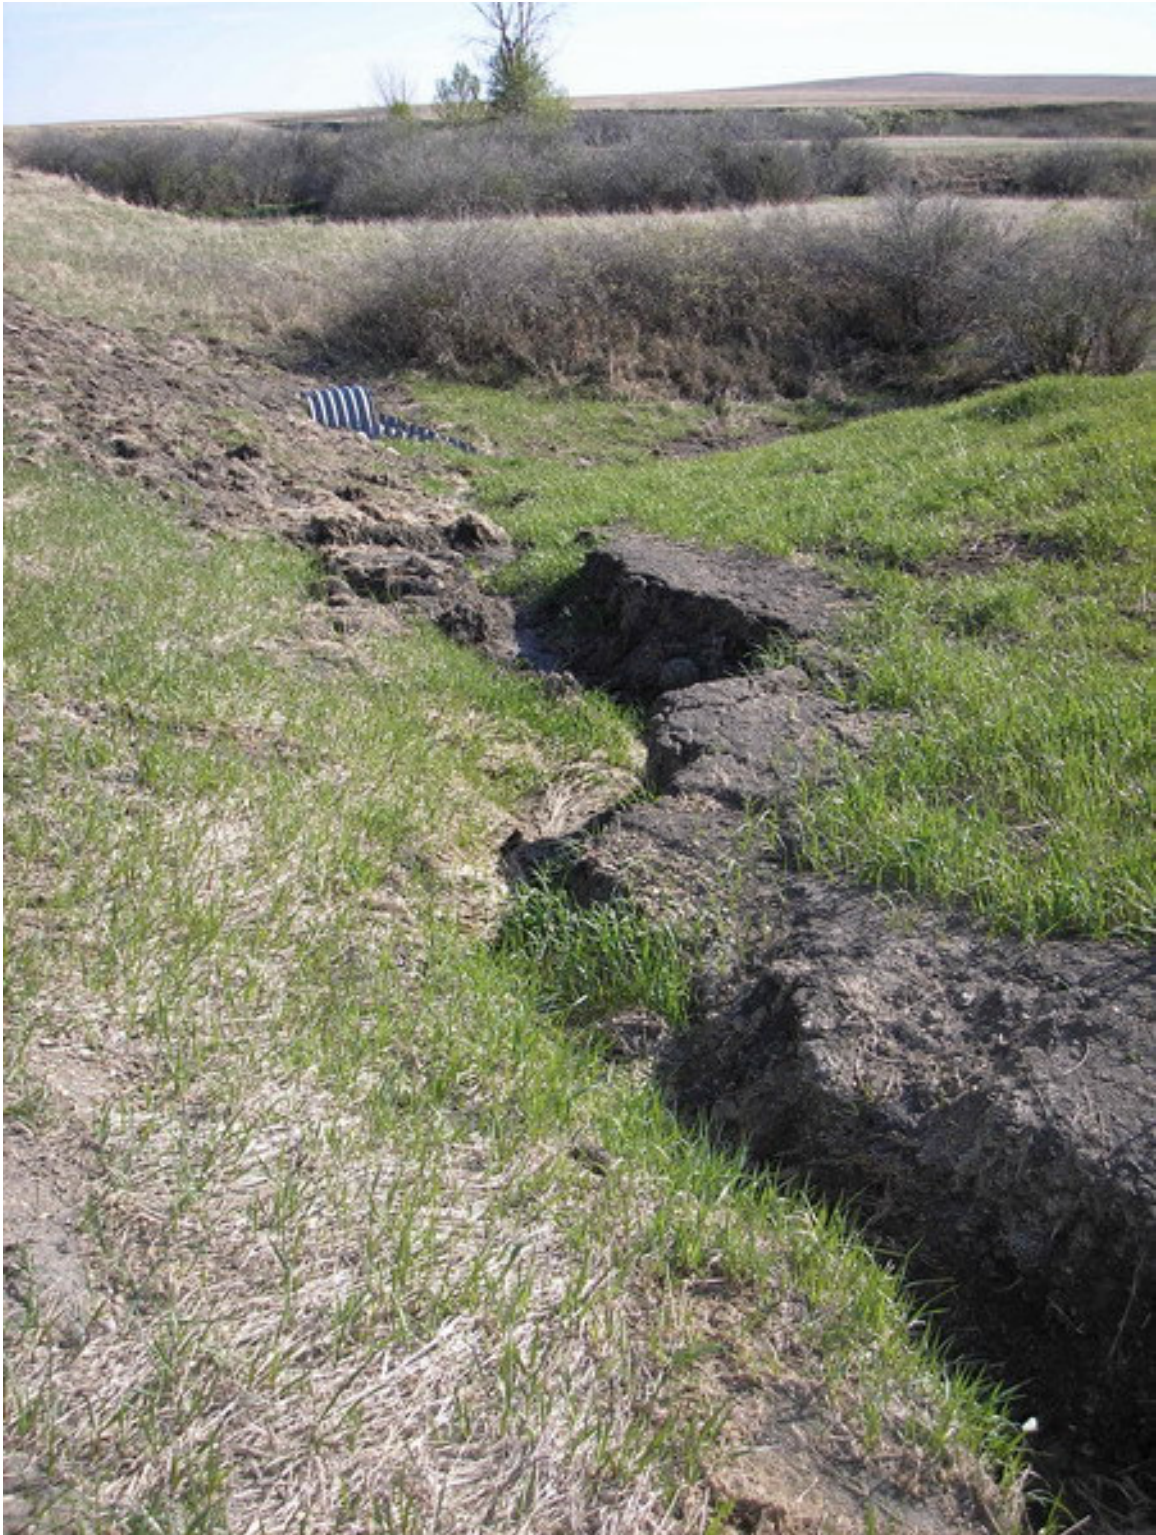
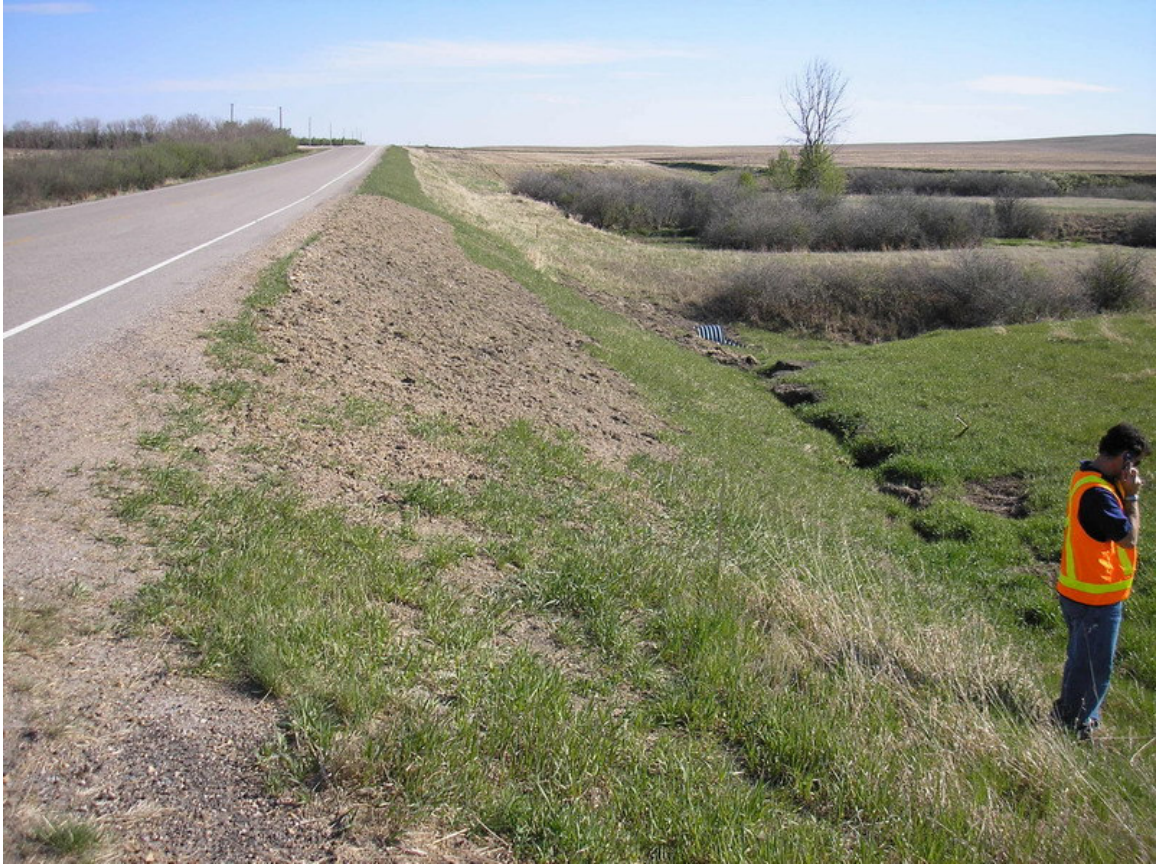
COMMENTS
Refer to previous callout report, construction report and attached photos
Repair work appears to have been successful, except that the slope seeding does not appear completed.
