SITE NUMBER AND NAME C52 H849:02 Erosion		HIGHWAY & KM km 1	PREVIOUS INSPECTION DATE June 1, 2007	INSPECTION DATE June 13, 2008
LEGAL DESCRIPTION NW 15-28-19-W4	NAD 83 COORDINATES N 5695492 E 390091		RISK ASSESMENT PF: 9 CF: 3 TOTAL: 27

Site C52 H849:02 Erosion
June 13, 2008

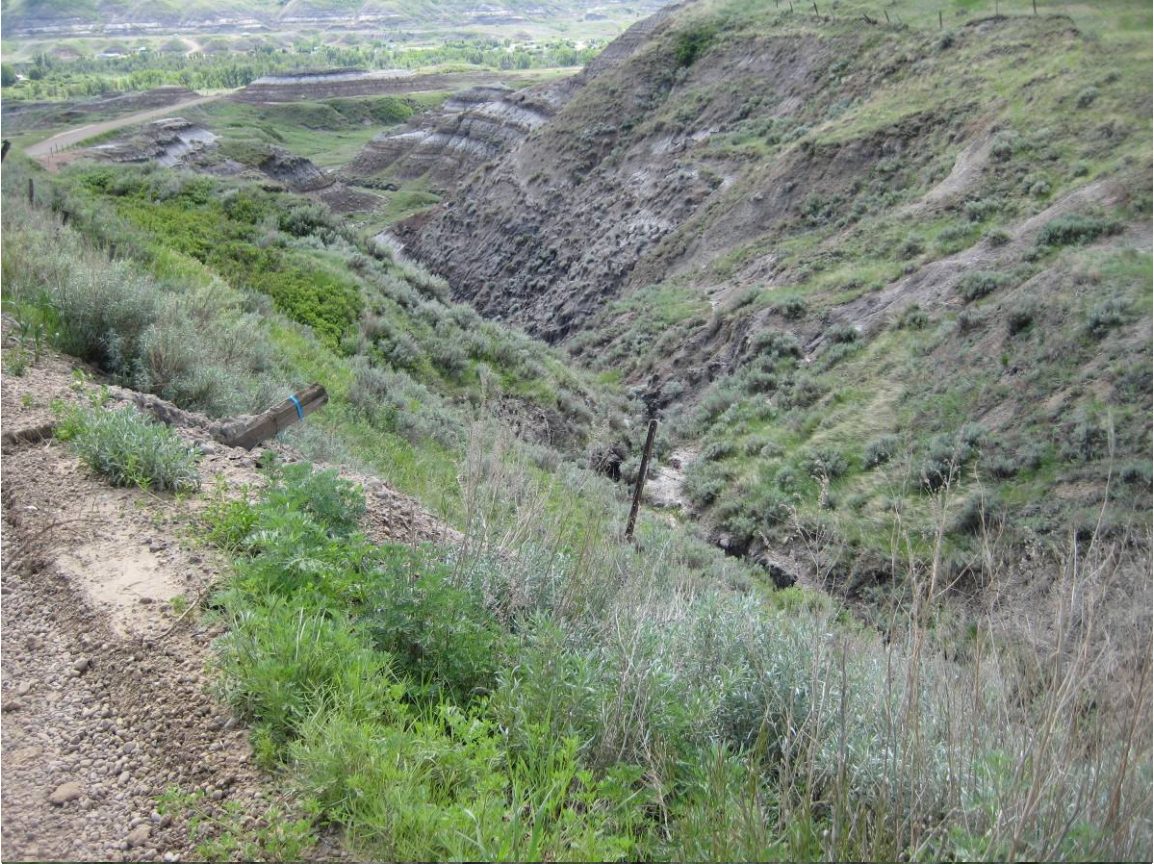
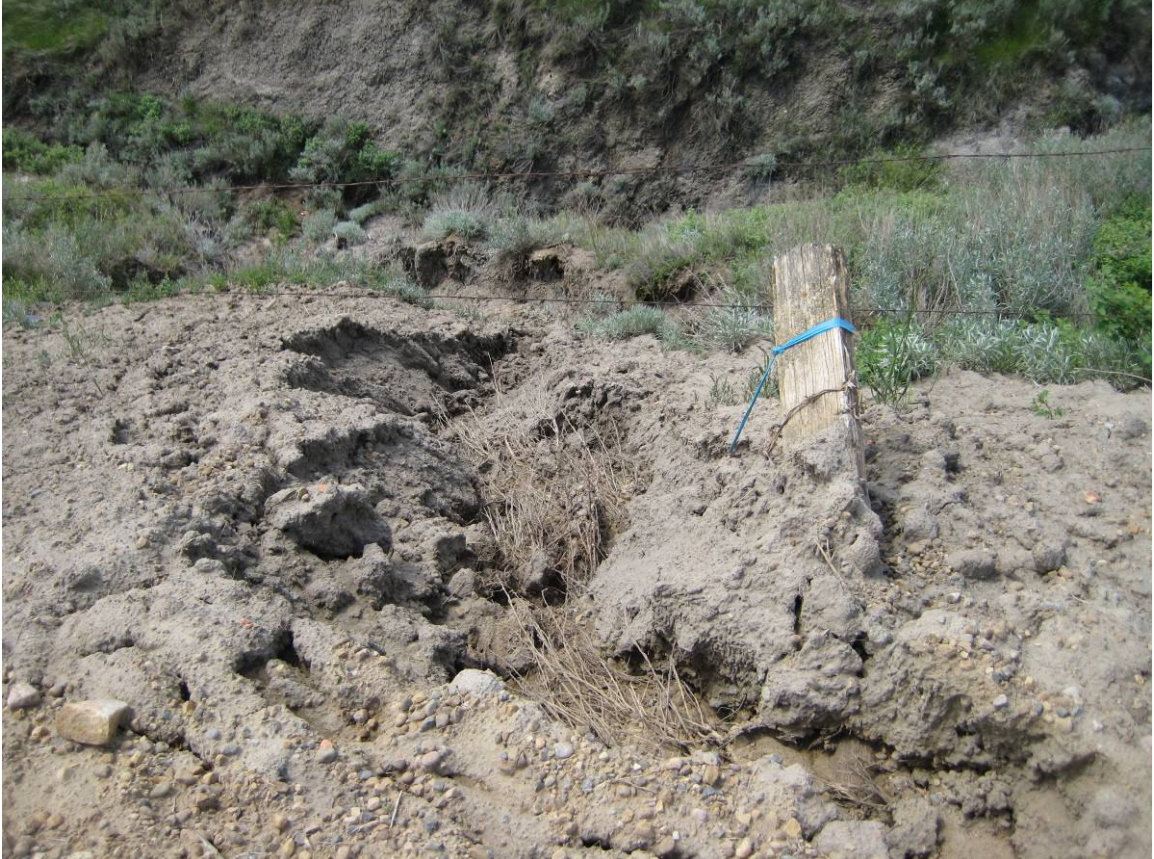
ITEM	CONDITION EXISTS		DESCRIPTION AND LOCATION	NOTICABLE CHANGE FROM LAST INSPECTION	
	YES	NO		YES	NO
Pavement Distress		X			X
Slope Movement		X			X
Erosion	X		Slope eroded to road edge along a steep valley.		X
Seepage		X			X
Culvert Distress		X			X

A small diameter HDPE "culvert" crosses the road in the vicinity of the erosion.

It was recommended that pitrun gravel be placed over the side of the road into the erosion feature to widen the road section slightly, however, waste fill was placed over the slope edge in 2007. It was also recommended that a gravel berm should be built up along the road edge to deflect water from draining off the highway at this point. A barricade or short length of guardrail should be placed at this location. This site should be monitored with additional fill placed as required.
