| SITE NUMBER AND NAME H857:04 Frost Heave | | HIGHWAY & KM 4 | PREVIOUS INSPECTION DATE | INSPECTION DATE May 14, 2007 |

| PRIMARY SITE ISSUE: Frost Heave resulting in damage claims to vehicles | |

| | | Ⓕ | | | | SCALE N.T.S | | | | H857 : 04 Km 4 FROST HEAVE SITE PLAN | | | |

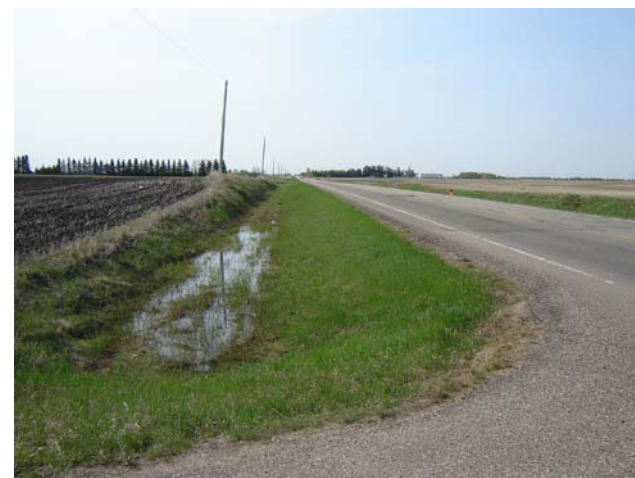
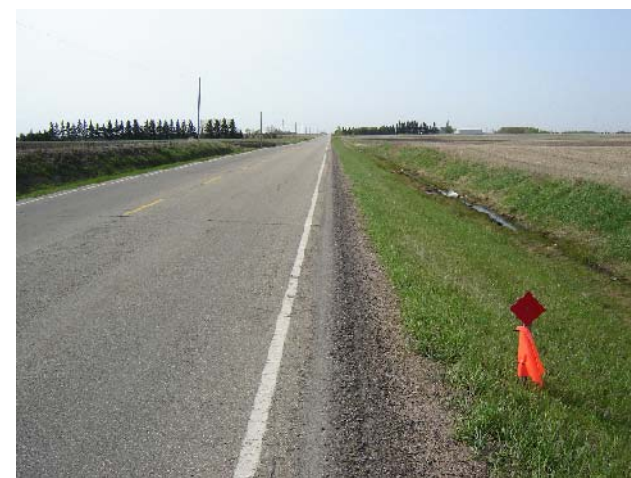
LOOKING SOUTH

A 150 m long section of Highway 857:04 about 4 km north of H16A in Vegreville suffers severe pavement distress due to frost heave in winter months. Standing water was observed in the ditches and the surrounding topography is essentially flat.

Based on the cost comparison of the two methods, it is recommended to adopt the insulation remediation method at this site. Further details about the Frostwick system can be obtained from Diamond J Industries Ltd.
