SITE NUMBER AND NAME C33 H862:08 Steep Slopes		HIGHWAY & KM 12 km S of H9 30 km N of H570	PREVIOUS INSPECTION DATE May 26, 2005	INSPECTION DATE May 15, 2006
LEGAL DESCRIPTION 10-30-15-W4	NAD 83 COORDINATES N 5711518 E 4275876	RISK ASSESMENT PF: 9 CF: 4 TOTAL: 36

LAST READING DATE:	
PRIMARY SITE ISSUE: Steep embankment slopes (culverts too short)	
APPROXIMATE DIMENSIONS:	
DATE OF ANY REMEDIAL ACTION:

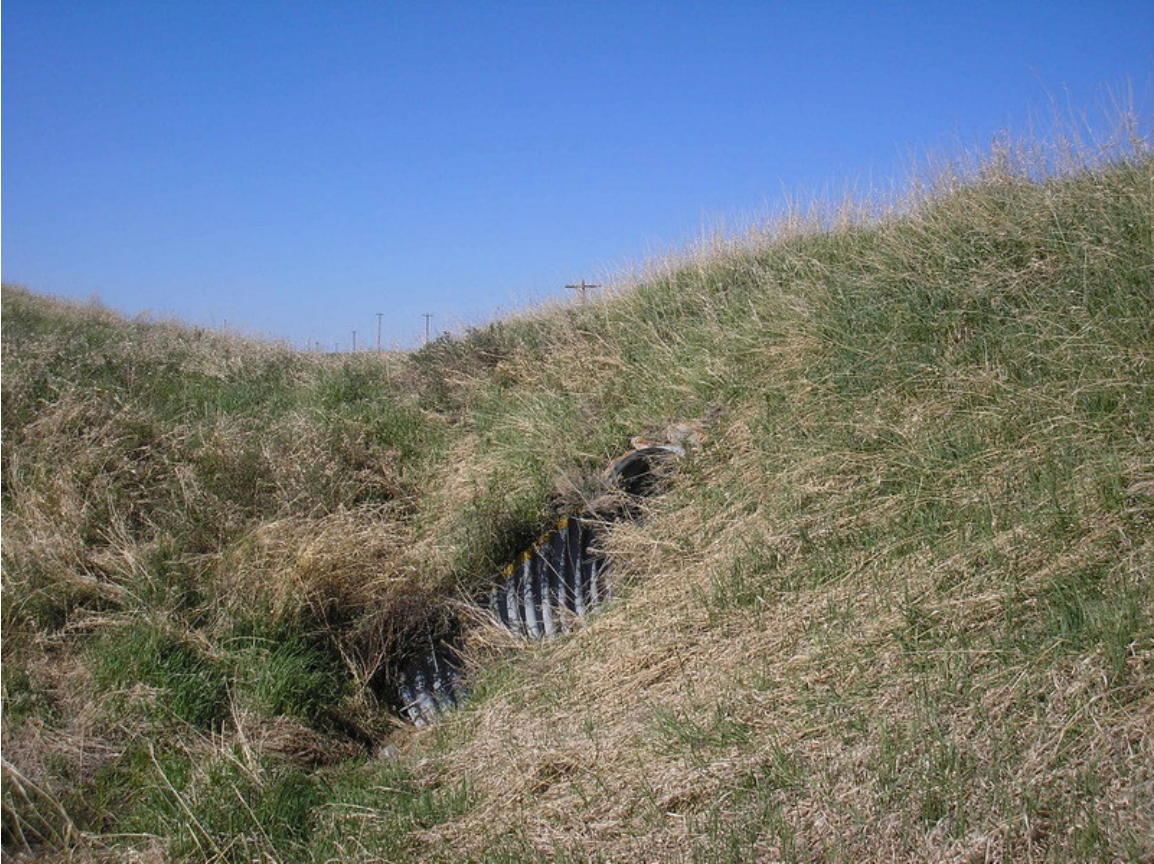
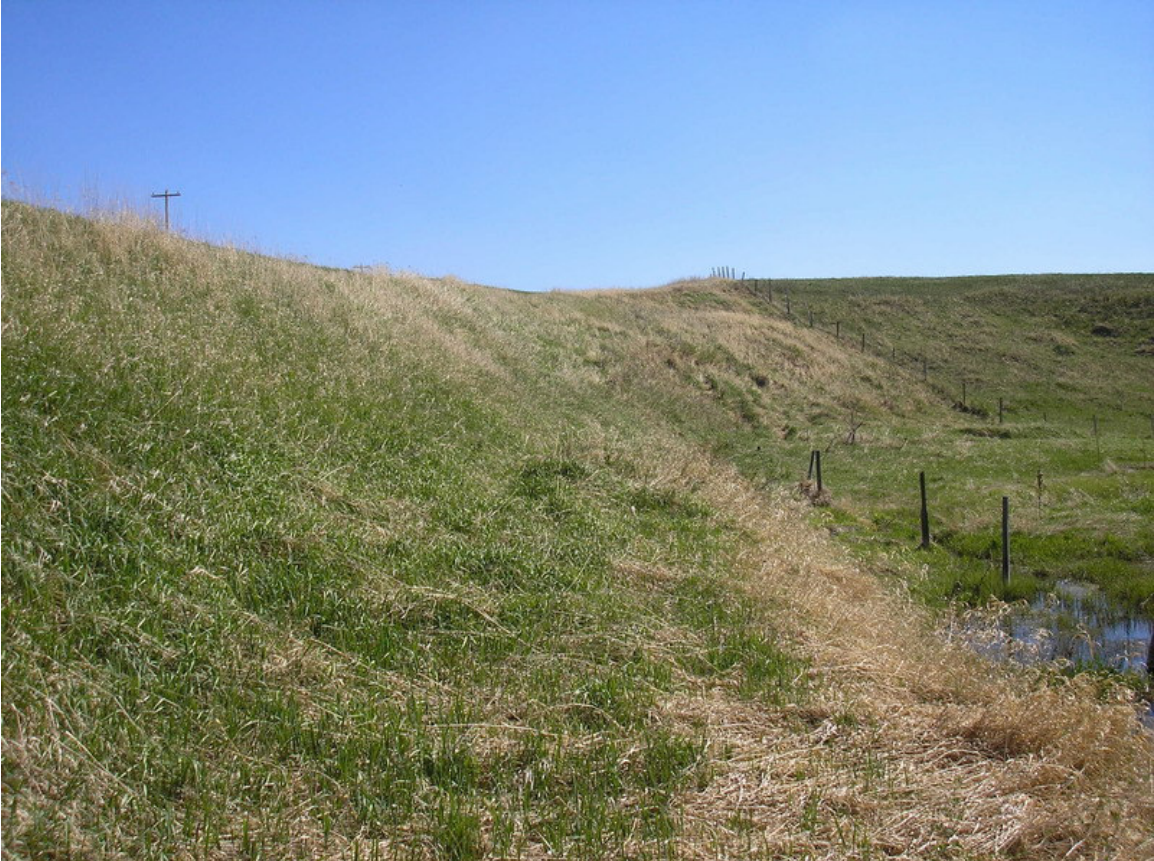
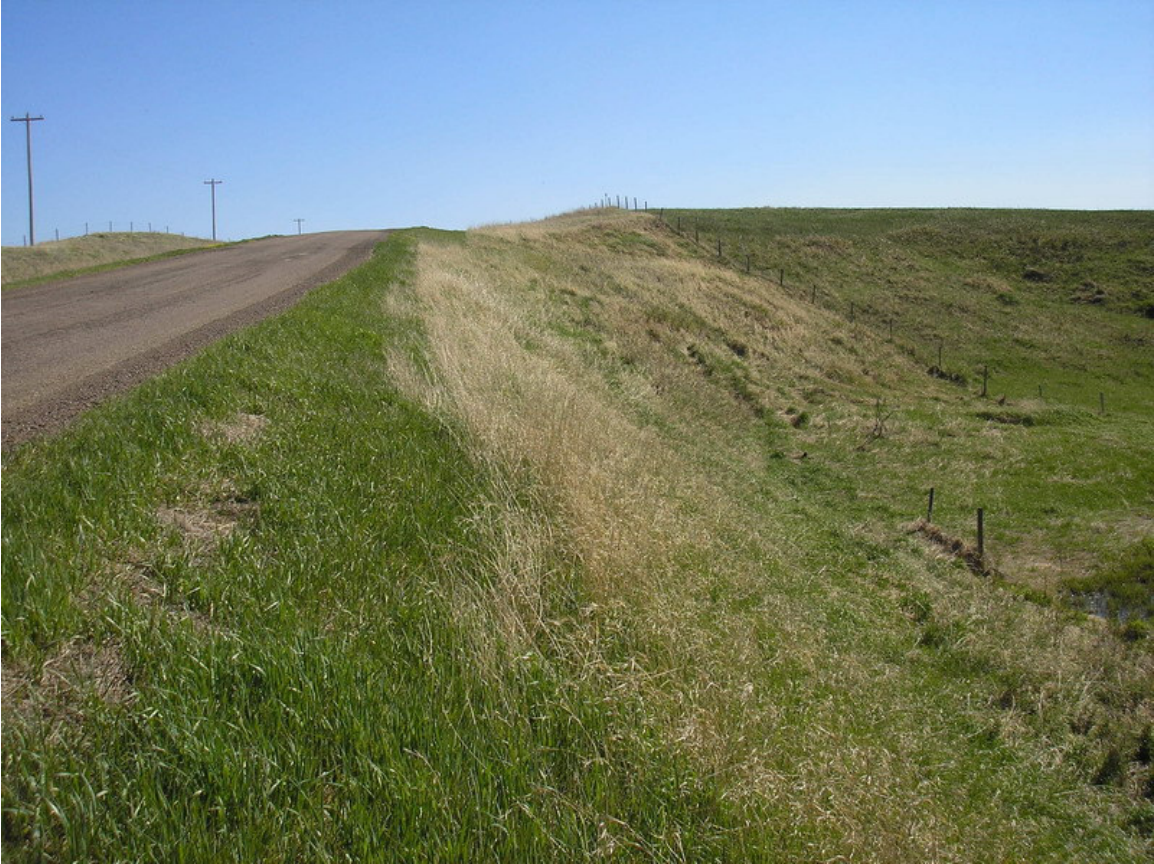
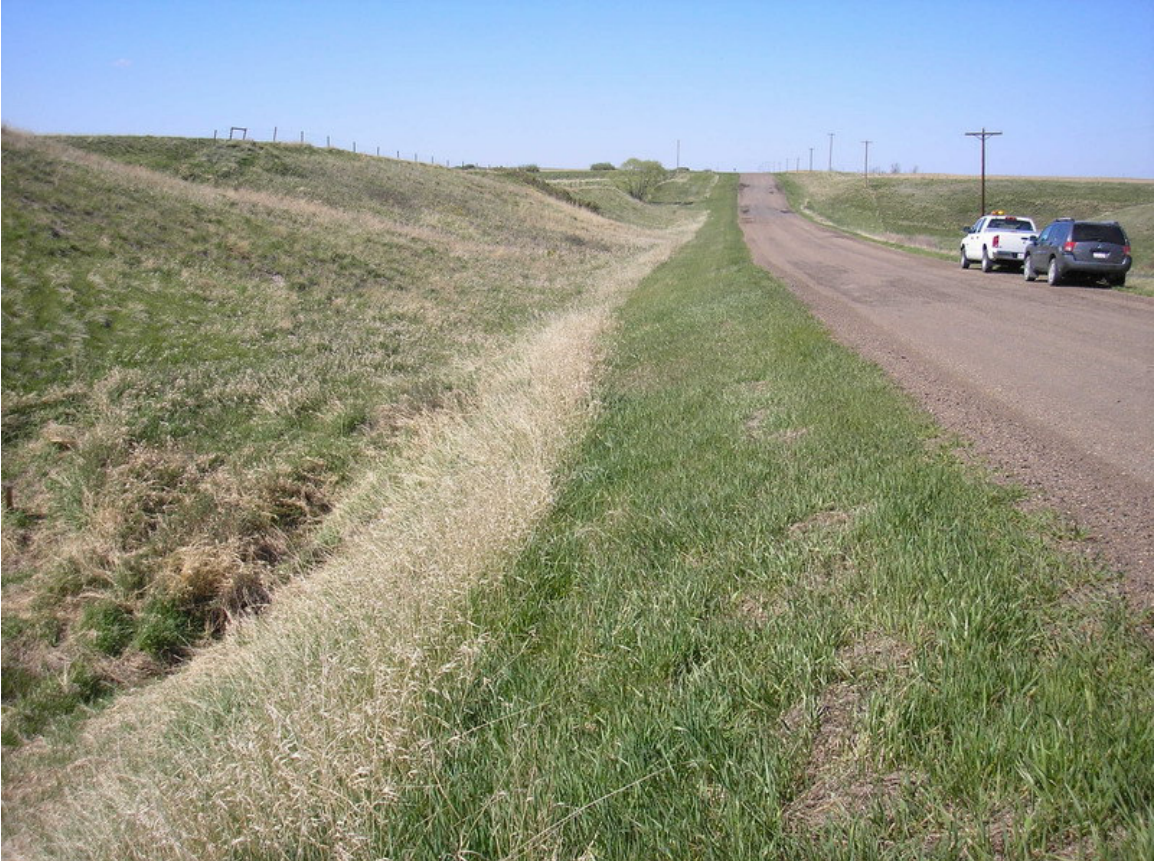
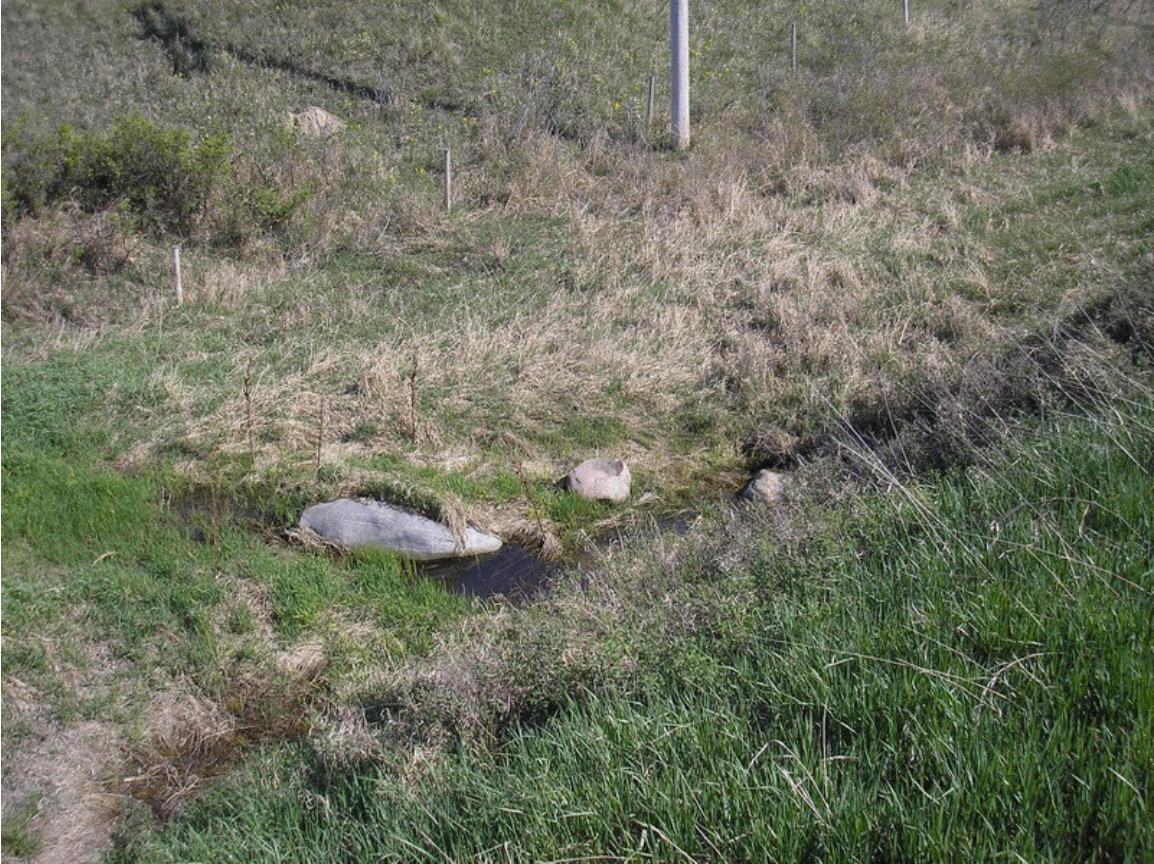
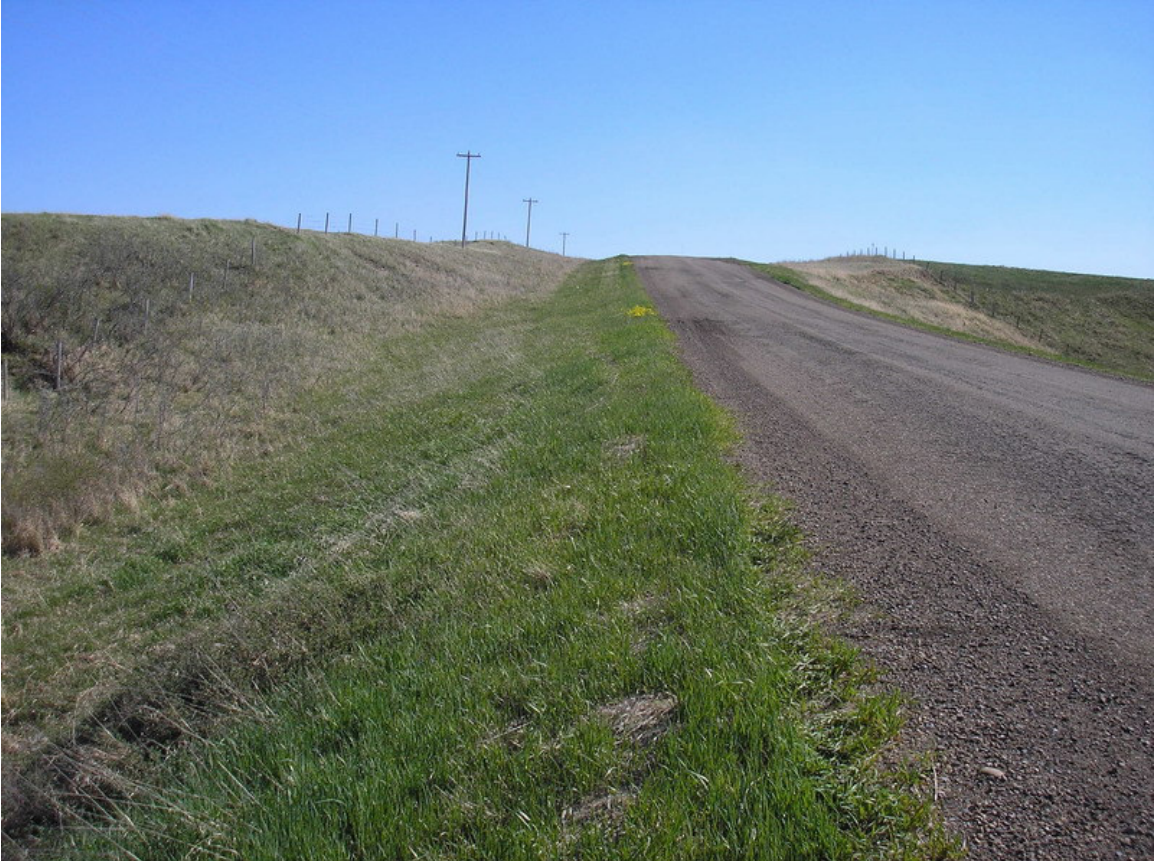
COMMENTS
Refer to attached photos and recommendations
Although no geotechnical problem exists at this site, the steep embankment slopes on the west side of the highway have been reported as a potential hazard. Options include providing guardrail or flattening the slopes. However, the present length of the culvert is insufficient to permit slope flattening. It is recommended that the culvert be lengthened by about 5 m to permit the slope to be flattened to about 3H:1V. Assuming a cost of \$500 per m, the cost is about \$2,500.
Topsoil will need to be stripped and stockpiled for reuse in reclamation. Based on an approx. av. existing 4 m high slope of 1.5H:1V, the fill required is about 12 m ³ per m. Assuming a 100 m long embankment requires about 1,200 m ³ of fill material. At about \$25/m ³ , the estimated cost is about \$30,000.
