SITE NUMBER AND NAME: C034 Abraham Lake Erosion		HIGHWAY & KM: 11:04, 11.056	PREVIOUS INSPECTION DATE: June 12, 2017	INSPECTION DATE: June 11, 2018
LEGAL DESCRIPTION: 07-07-038-17 W5M	NAD 83 COORDINATES: UTM Northing Easting 11 5789173 539996		RISK ASSESSMENT: PF: 13 CF: 6 TOTAL: 78	
AVERAGE ANNUAL DAILY TRAFFIC (AADT): 225 (west) & 216 (east) (Ref No. 50110250)			CONTRACT MAINTENANCE AREA (CMA): 18

PRIMARY SITE ISSUE: Erosion and retrogression of a slope along the east side (eastbound lane) of Hwy 11/west side of Abraham Lake – a reservoir created by the Bighorn Dam on the North Saskatchewan River. The erosion is caused by pavement surface runoff, seepage, and wave action when the reservoir level is high.

PROJECT CENTRAL REGION GEOHAZARD RISK MANAGEMENT PROGRAM		
TITLE Site Plan C034 - Abraham Lake Hwy 11:02, km 11.056		
SCALE 1:2,000	PROJECT No. A05115A02	FIG No. 1

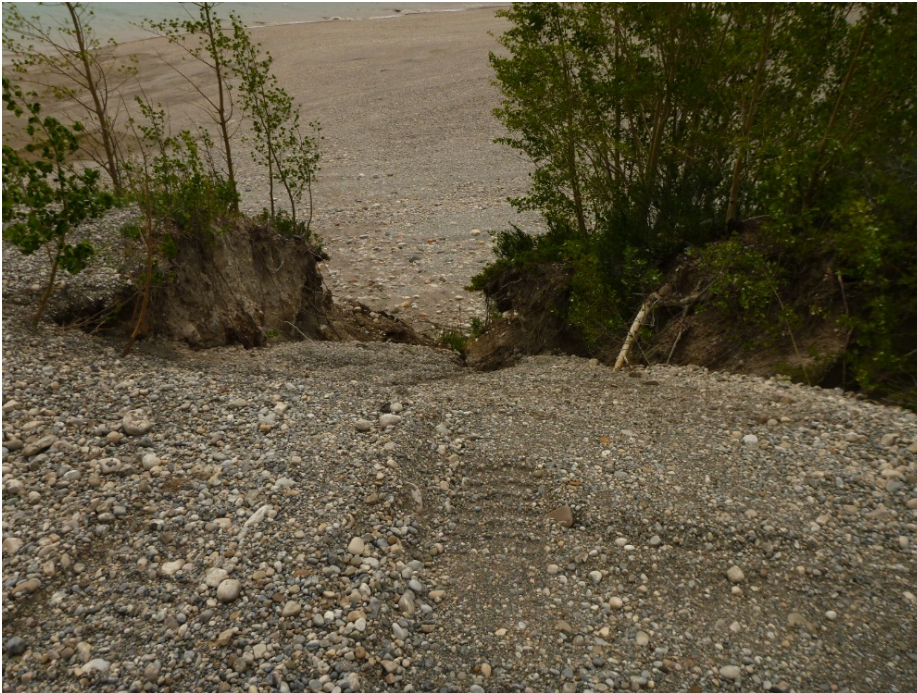
Gravel backfill has been placed in the existing erosion gullies on the south shoulder of the highway. Gravel fill is beginning to erode due to surface water runoff and seepage just below the pavement surface. Tension cracks in the gravel fill have appeared near the crest of the embankment.

Photo 1 Gravel backfill placed in the western most erosion gully on the south side (east bound lane) of the highway. Photo taken June 11, 2018 looking south.

Discussed remedial actions: Replace removed sections of asphalt curb to divert surface run off flows away from gravel fill areas to reduce erosion and extend the asphalt curb across the entire length of the eroding slope; replace all w-beam guardrail with HTCB; extend the curb to provide more protection from surface runoff erosion; construct a rockfill toe berm with riprap armoring; and repair the east culvert and retrieve the detached culvert segment (to be tendered in the fall of 2017 for construction in 2018).

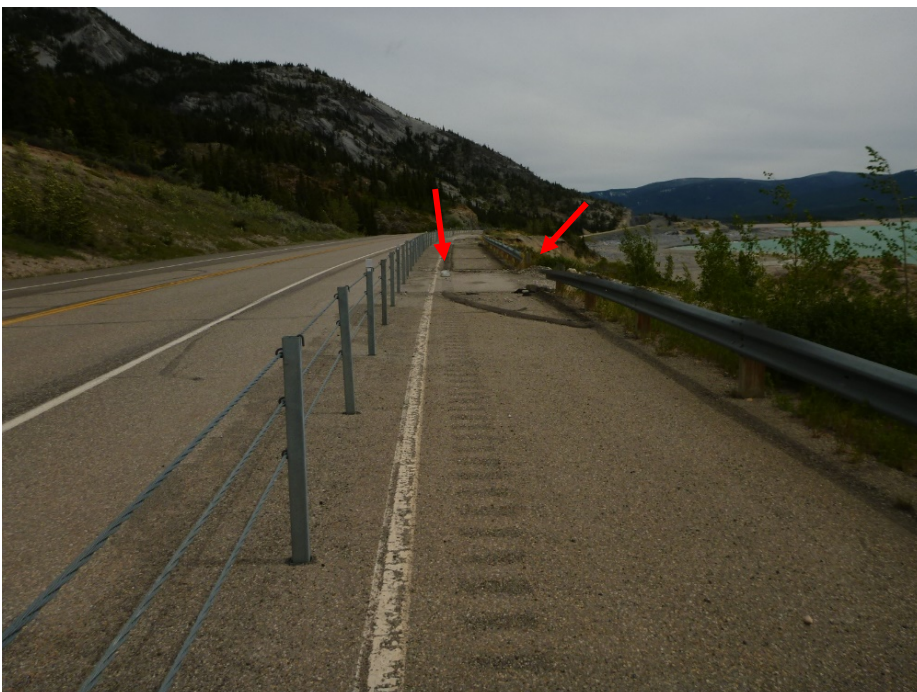
During gravel placement, a 5 m and 15 m section of asphalt curb was removed (waypoint 675 and 676, respectively).

Photo 2 Photo showing the section of asphalt curb and guardrail removed (approx. 5m) during placement of gravel backfill in the western most erosion gully (way. Photo taken June 11, 2018 looking northeast.

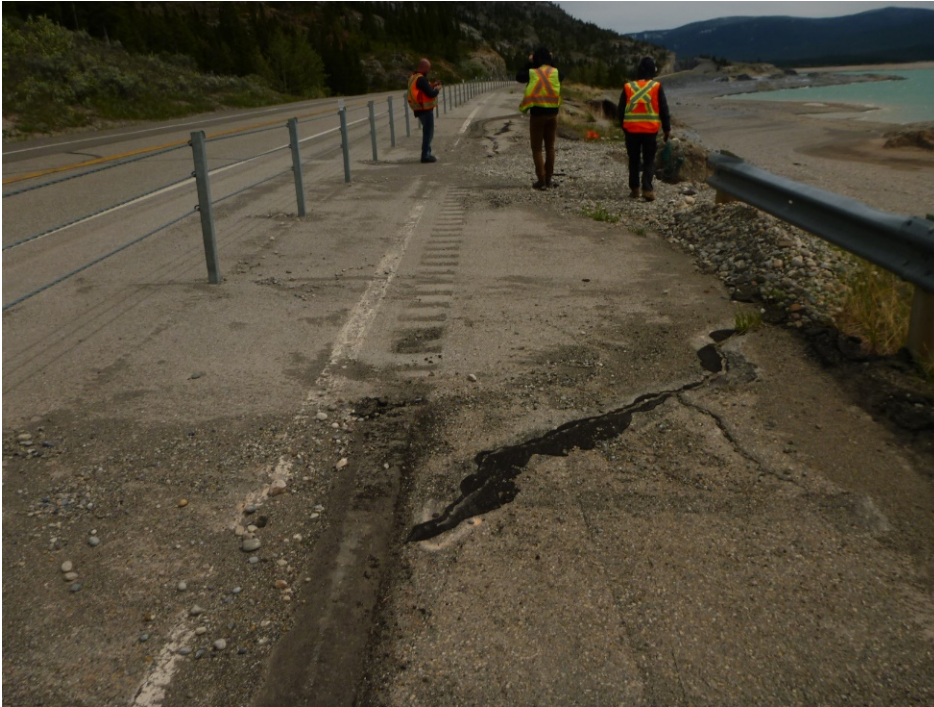
Photo 3 Photo showing the length of asphalt curb removed (approx. 15) during placement of gravel fill at eastern erosion zone (waypoint 676). Photo taken June 11, 2018 looking northeast.

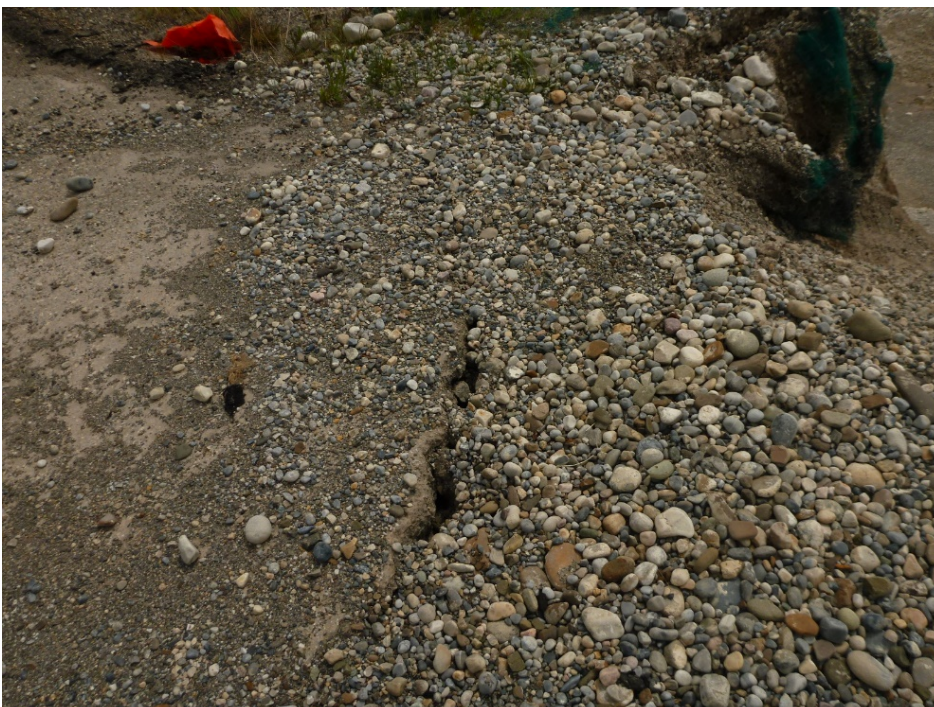
Photo 4 Tension cracks observed in the gravel fill at the crest of the embankment. Photo taken June 11, 2018 looking northeast.

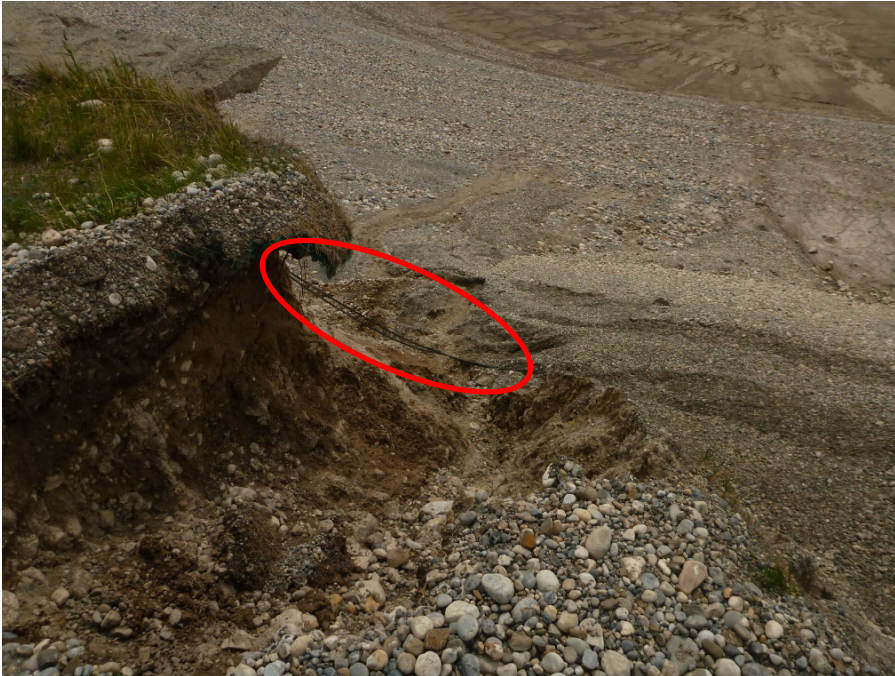
A buried utility cable is exposed at several locations along the slope.

Photo 5 Gravel fill continuing to erode due to surface run-off flows and subsurface seepage. Exposed buried cable can be seen hanging from embankment material (red circle). Photo taken June 11, 2018 looking south.

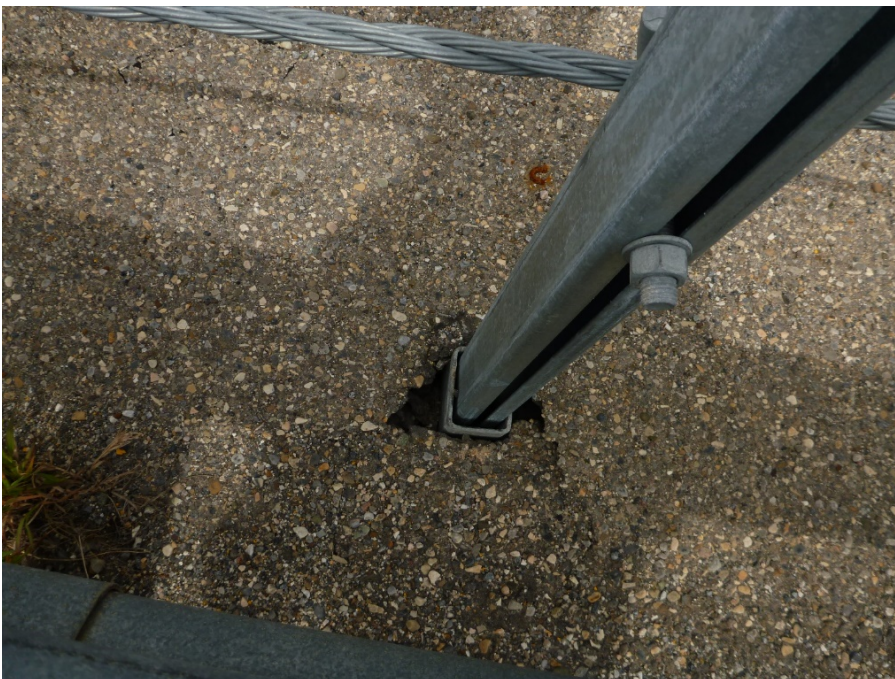
Three posts of the high-tension-cable barrier (HTCB) close to the edge of asphalt are exhibiting pavement collapse around the base (waypoint 674). The pavement collapse appears to be due to erosion of the underlying materials exposed when the HTCB posts were installed.

Photo 6 Asphalt collapse due to erosion at the base of one of the high-tension cable barrier (HTCB) posts near western extent of the barrier. Photo taken June 12, 2017 looking north.
