SITE NUMBER AND NAME: <b>C034 Abraham Lake Erosion</b>		HIGHWAY & KM: 11:04, 11.056	PREVIOUS INSPECTION DATE: June 11, 2018	INSPECTION DATE: <b>July 9, 2019</b>
LEGAL DESCRIPTION: 07-07-038-17 W5M	NAD 83 COORDINATES: UTM Northing Easting 11 5789173 539996		RISK ASSESSMENT: PF: 12 CF: 5 TOTAL: 60	
AVERAGE ANNUAL DAILY TRAFFIC (AADT): 225 (west) & 216 (east) (Ref No. 50110250)			CONTRACT MAINTENANCE AREA (CMA): 18

PROJECT CENTRAL REGION GEOHAZARD RISK MANAGEMENT PROGRAM		
TITLE Site Plan C034 - Abraham Lake Hwy 11:02, km 11.056		
SCALE 1:2,000	PROJECT No. A05115A02	FIG No. 1

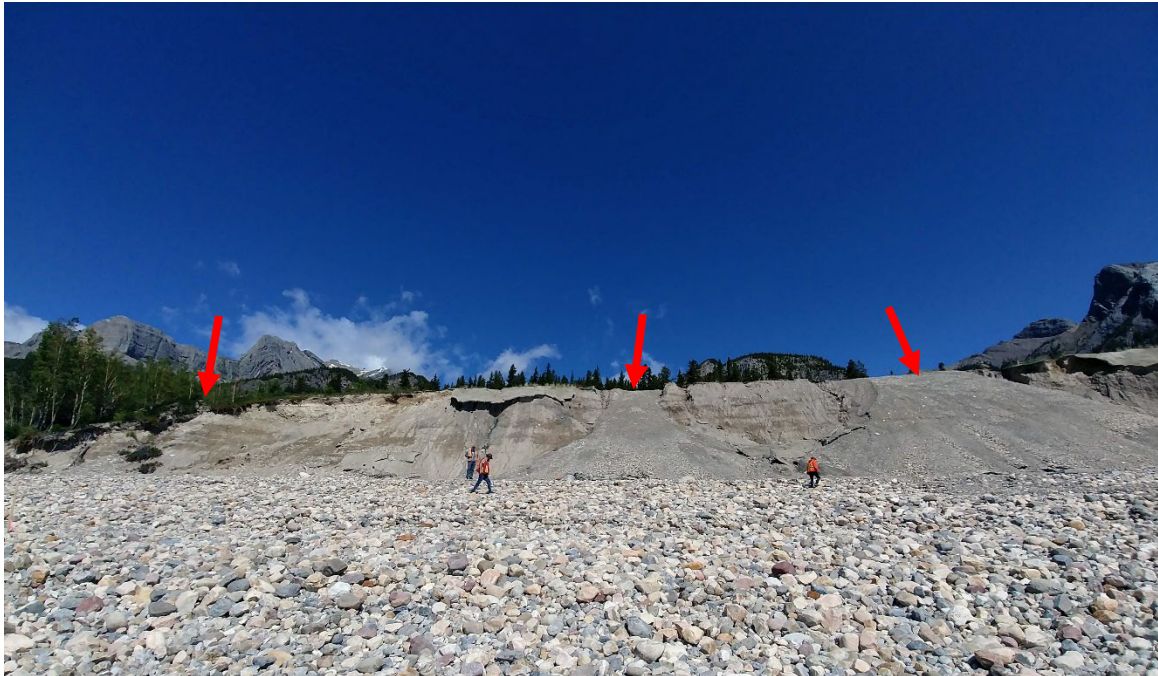
**Photo 1** View of slope from beach. Arrows indicate where granular fill was placed in March 2018. Photo taken July 9, 2019 looking northwest.

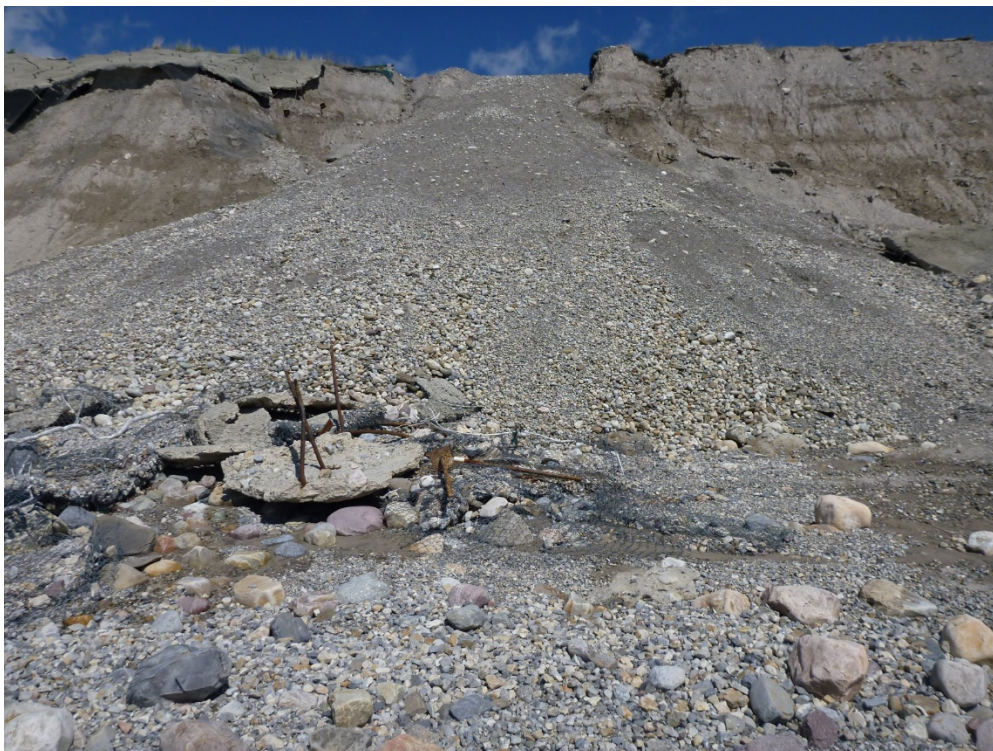
The soil nail, steel mesh, and shotcrete repair continue to be undermined by erosion, and debris from the failed repair is accumulating at the toe of the slope.

**Photo 2** Shotcrete debris and steel mesh accumulating at the toe of the slope. Photo taken July 9, 2019 looking north.

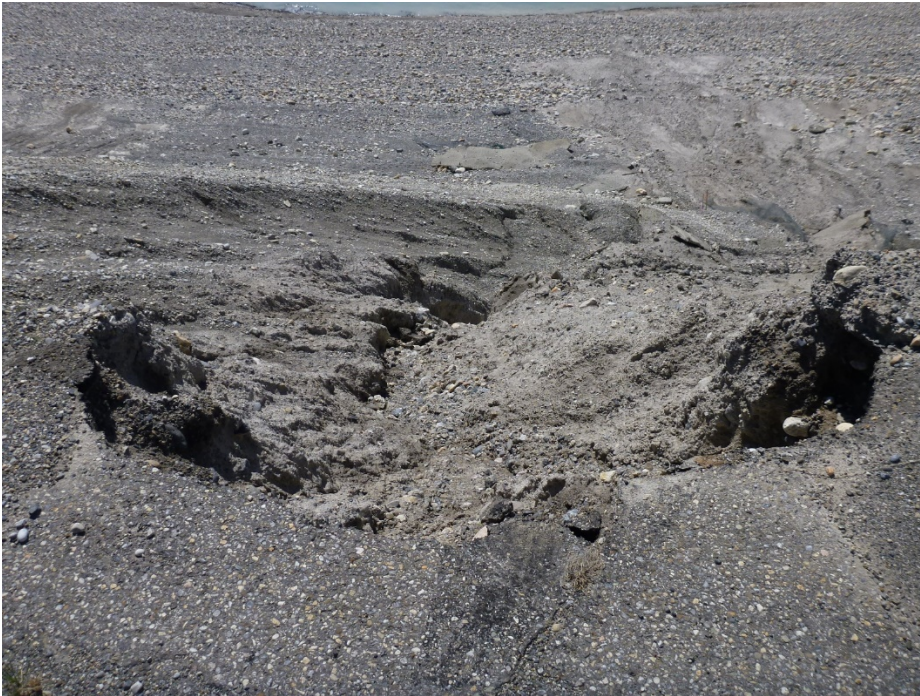
Erosion of the natural soils around the edges of the dumped granular fill is occurring due to surface water runoff and seepage below the pavement surface.

**Photo 3** Photo showing erosion occurring around the edges of dumped granular fill. Photo taken July 9, 2019 looking south.

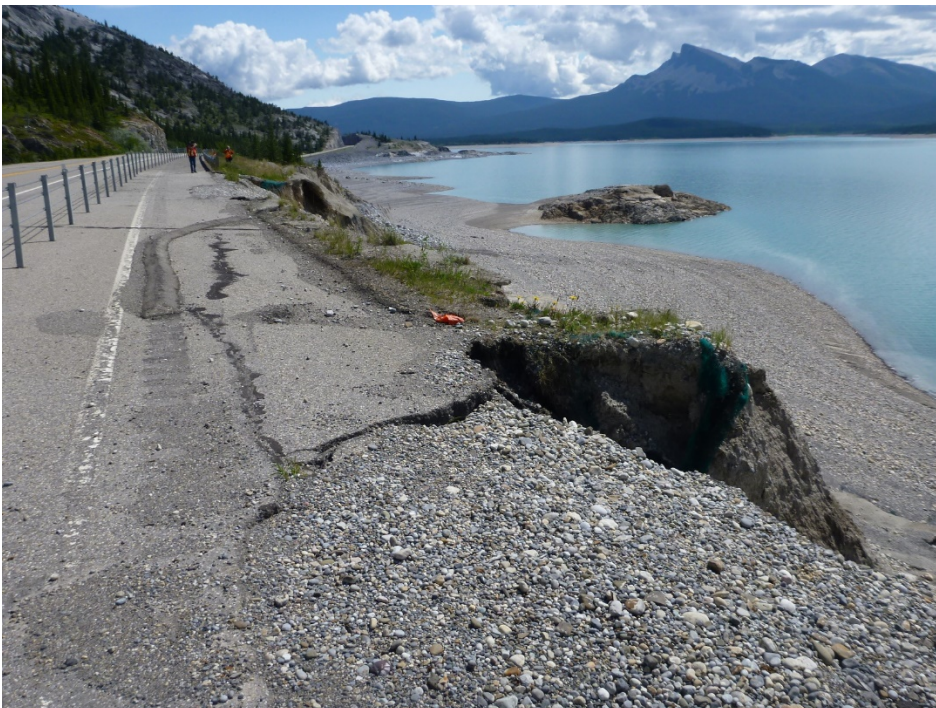
The slope continues to retrogress into the eastbound shoulder. Pavement cracks have extended to the white line marking the boundary of the old eastbound lane.

**Photo 4** Photo showing the condition of the pavement above the main erosion gullies. Pavement cracks have extended to the white line marking the edge of the old eastbound lane. Photo taken July 9, 2019 looking northeast.

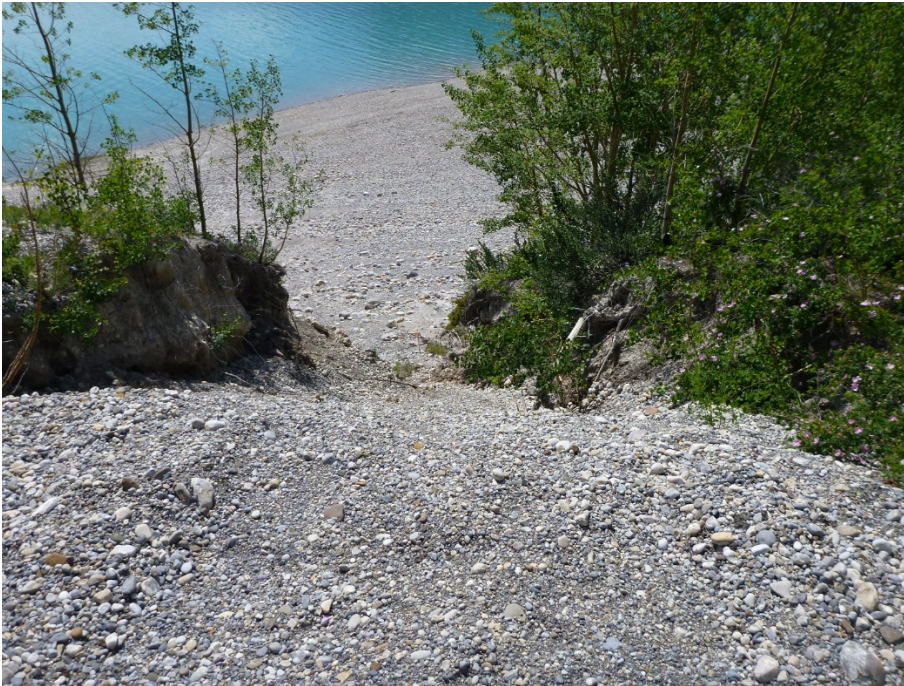
**Photo 5** Condition of dumped granular fill in western-most erosion gully. Photo taken July 9, 2019 looking south.

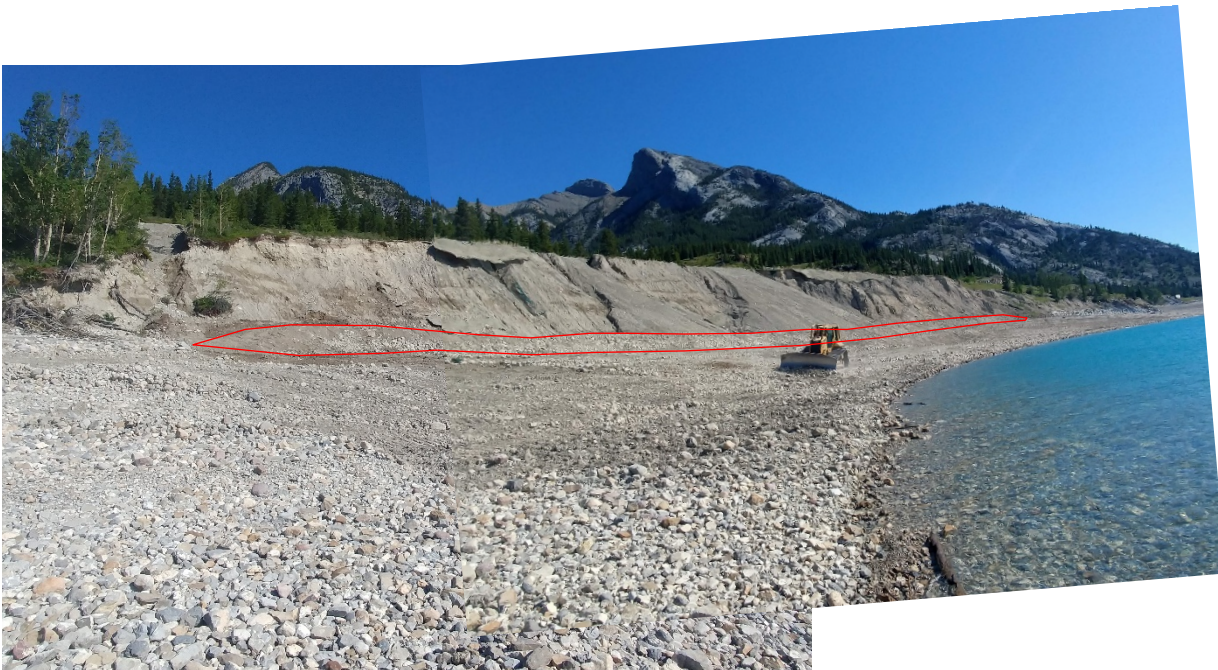
**Photo 6** Photo showing the extent of temporary rock-fill berm constructed at the toe of the eroding slope. Berm was constructed by PME as part of the 2019 Temporary Works at the C034 site. Photo taken July 23, 2019 looking north.

A contract for slope stabilization repair work was awarded to PME Inc. in 2019 (AT contract CON0019442). Construction was planned for summer 2019 but delays in contract signing allowed the reservoir level to rise too high to complete the full scope of work in 2019. Instead, temporary construction works were carried out by PME from July 19 to 23, 2019. The temporary work included the construction of a 3-m wide by 2-m high temporary berm at the toe of the slope to reduce the possibility of further erosion until spring/summer 2020 when the full scope of work can be completed. The temporary berm was constructed with coarse beach surface materials comprising cobbles, gravel, and sand. The availability of coarse material was limited to a layer approximately 0.3 m thick on exposed beach above the rising reservoir level.

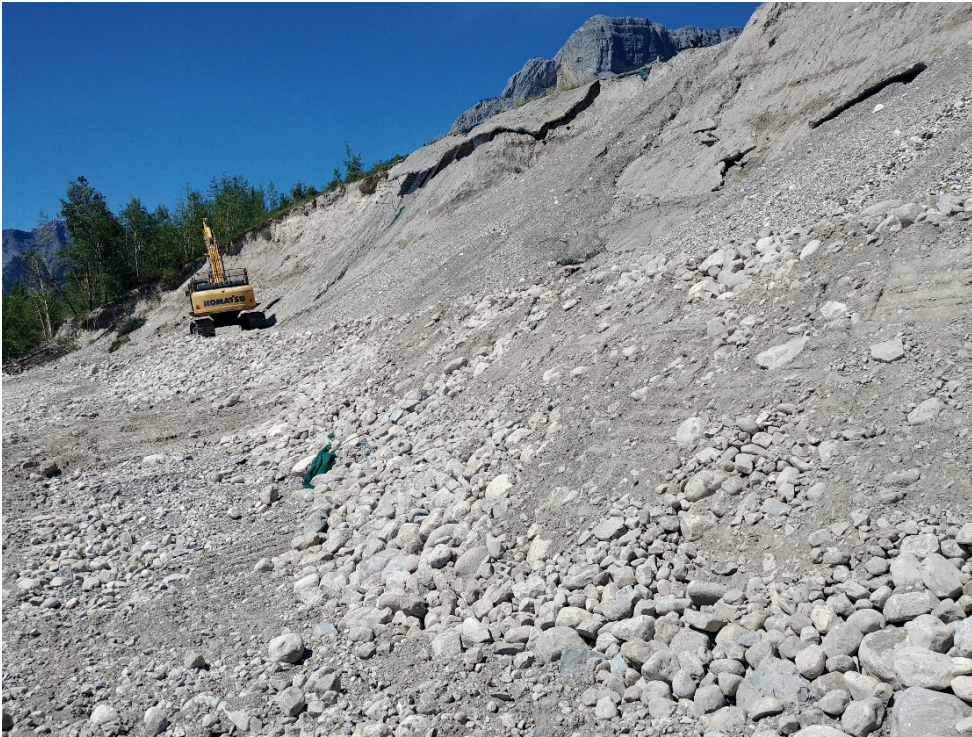
**Photo 7** Close-up view of the finished temporary berm slope comprising cobbles, gravel, and sand from the beach. Photo taken July 22, 2019 looking northwest.
