SITE NUMBER AND NAME: C034 Abraham Lake Erosion	HIGHWAY & KM: 11:04, 10.445 to 12.250	PREVIOUS INSPECTION DATE: June 27, 2023	INSPECTION DATE: June 9, 2025
LEGAL DESCRIPTION: 07-07-38-17 W5M	NAD 83 COORDINATES: UTM Northing Easting 11 5789173 539996	RISK ASSESSMENT: C034-1: PF: 1 CF: 4 TOTAL: 4 C034-2: PF: 1 CF: 4 TOTAL: 4 C034-3: PF: 10 CF: 2 TOTAL: 20	
HIGHWAY SERVICE CLASSIFICATION: 2		CONTRACT MAINTENANCE AREA (CMA): 514	
AVERAGE ANNUAL DAILY TRAFFIC (AADT): 395 (west) & 375 (east) (Ref No. 50110250)

PRIMARY SITE ISSUE: Erosion and retrogression of the highway embankment slope along the south (eastbound lane of Hwy 11:04 on the west side of Abraham Lake (a reservoir created by the Bighorn Dam (owned and operated by TransAlta Generation Partnership) on the North Saskatchewan River). The erosion is caused by precipitation, surface water runoff from the highway surface, and wave action when the reservoir level is high.
APPROXIMATE DIMENSIONS: The sites are approximately 110 m to 300 m long, slope is between approximately 6 m to 20 m high, and sloped between approximately near vertical to 2H:1V.
DATE OF ANY REMEDIAL ACTION: C034-1: July 2006 – slope reinforced with soil nails, ste

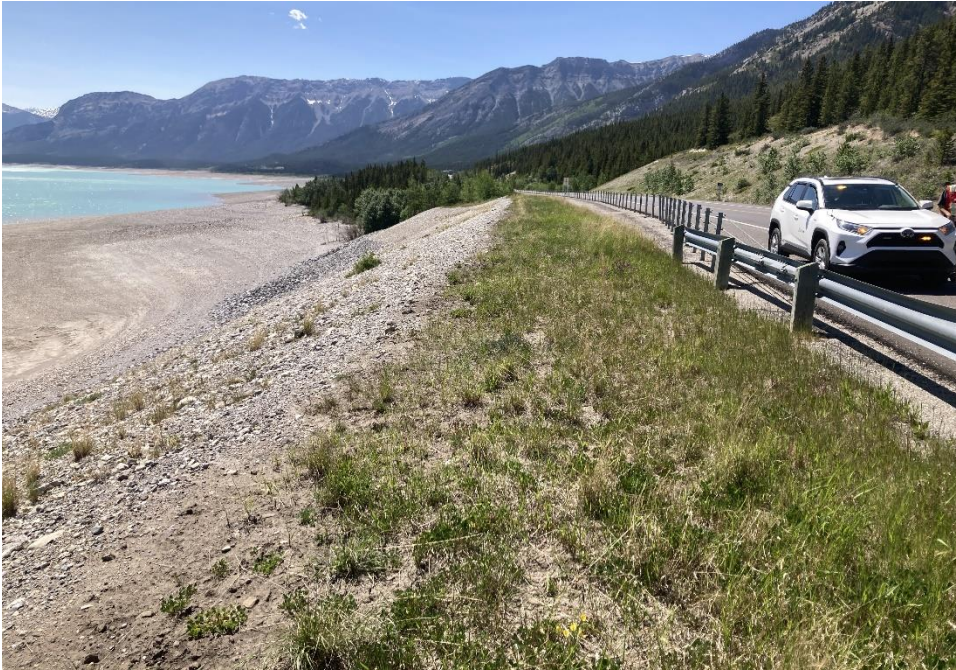
- The site was repaired by PME Inc., and the work was performed under Contract No. CON0019442. KCB monitored construction and our Final Details Report was issued to TEC on November 6, 2020.
- The crest of the slope, along the shoulder of Hwy 11:04, is well vegetated (Photo 1).
- The slope was not visually inspected in detail during the 2025 inspection. However, from visual observations made from the shoulder of the highway above the C034-1 site and the beach surface at the C034-2 site, the 2020 repair appeared to be performing well (Photo 2) and no pavement distress (cracking or settlement) was observed.
- The erosion rills at the crest of the slope have not worsened between the 2023 and 2025 inspections (Photo 3).

Photo 1 The crest of the slope along C034-1 is well vegetated and in good condition. Photo taken June 9, 2025 facing west.

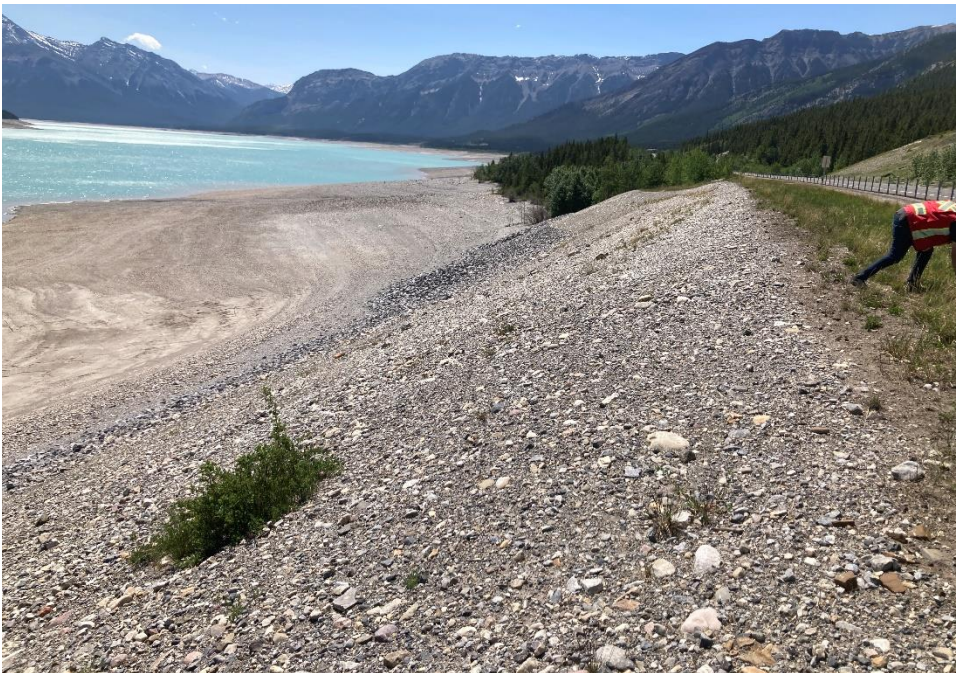
Photo 2 The repaired slope along C034-1 appears to be in good condition and is performing well. Photo taken June 9, 2025 facing west.

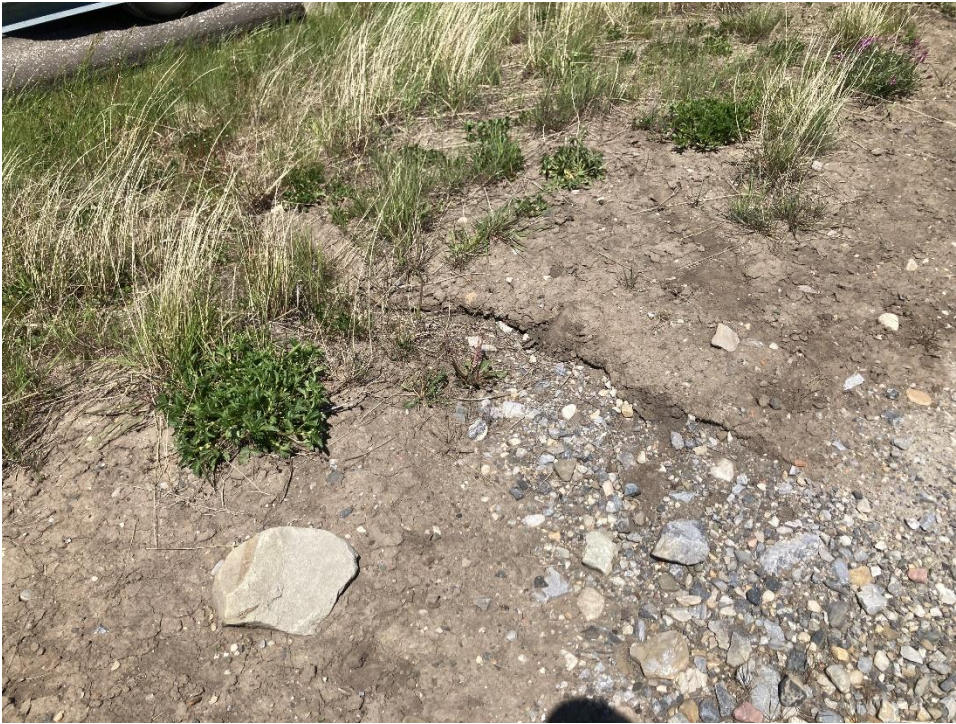
Photo 3 **Minor rill erosion observed along the crest of C034-1. Photo taken June 9, 2025 facing northeast.**

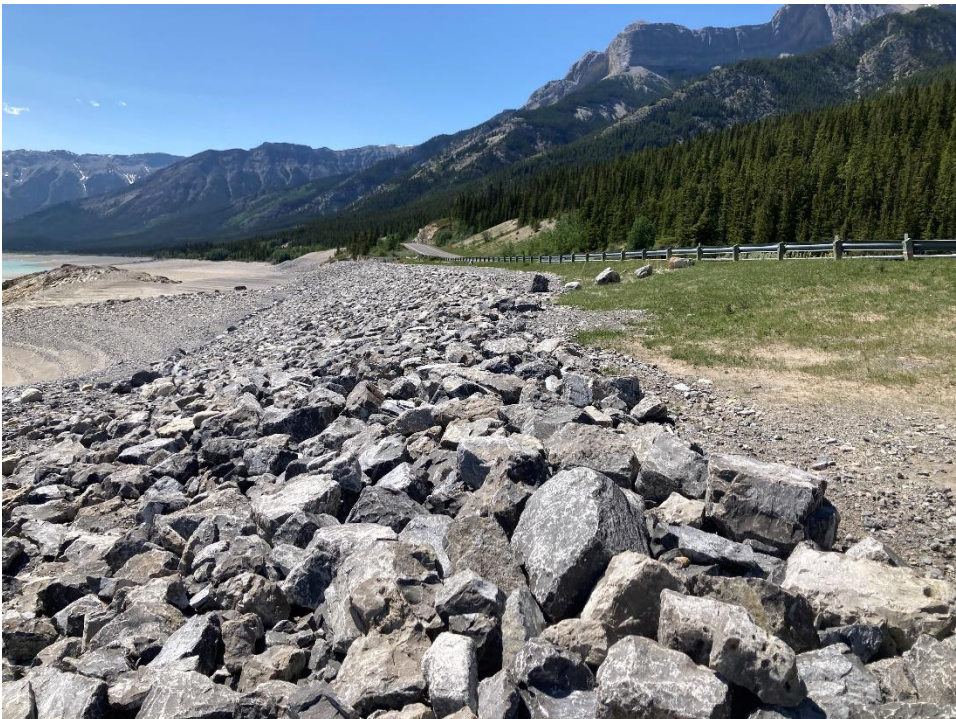
- The crest of the slope was relatively well vegetated (Photo 4) excluding area used for access during construction. Boulders were placed west of the access area/break in the guardrail to reduce vehicle traffic onto the crest of the repair and remain in place (Photo 6).

- The rockfill crest and riprap armoured slope (Class 2) were in good condition and the repair appeared to be performing well (Photo 4 and 5).
- Along the east extent of the repair, non-woven geotextile was visible along the crest of the repair between the riprap and existing ground (Photo 4). There was no erosion observed during the inspection. KCB believes there is a low risk of erosion, as the water level remains below the crest of the rockfill embankment most of the year and is only near full supply level in late-summer/early-fall for approximately one month.

Photo 4 **The repaired slope along C034-2 appears to be in good condition and is performing well. Photo taken June 9, 2025 facing west.**

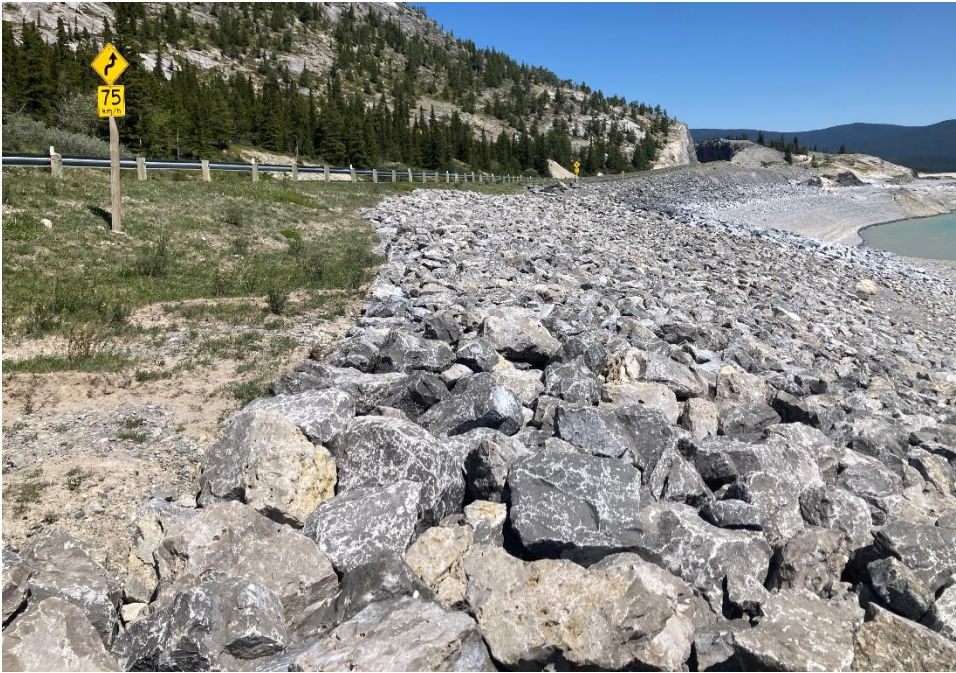
Photo 5 The repaired slope along C034-2 appears to be in good condition and is performing well. Photo taken June 9, 2025 facing northeast.

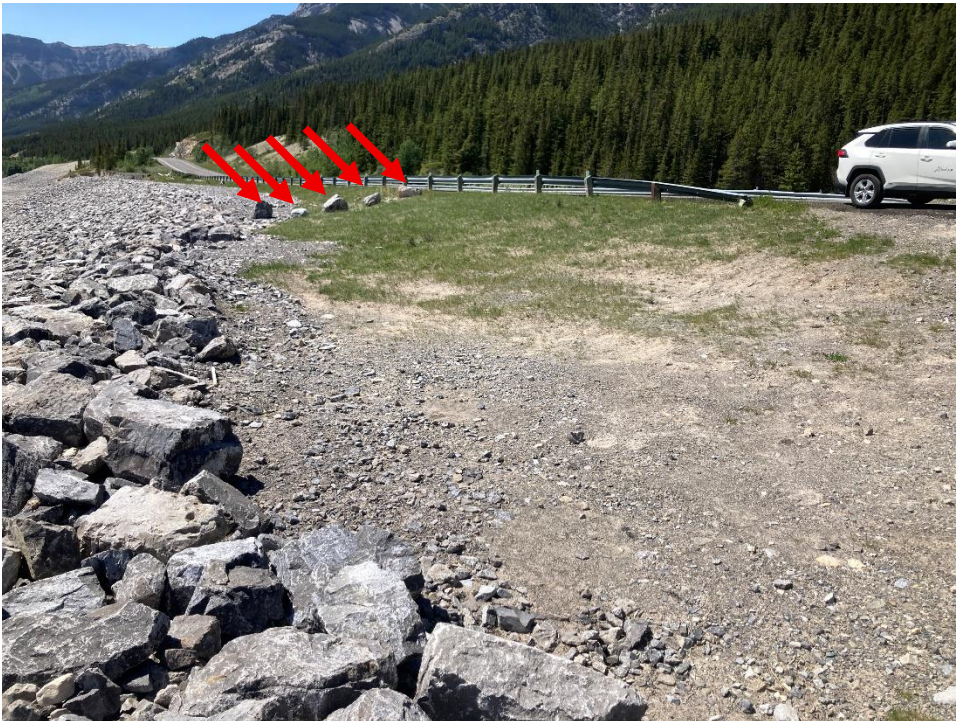
Photo 6 Boulders (indicated by red arrows) placed near the break in the guardrail in an attempt to reduce traffic along the crest of the C034-2 repair. Photo taken June 9, 2025 facing northwest.

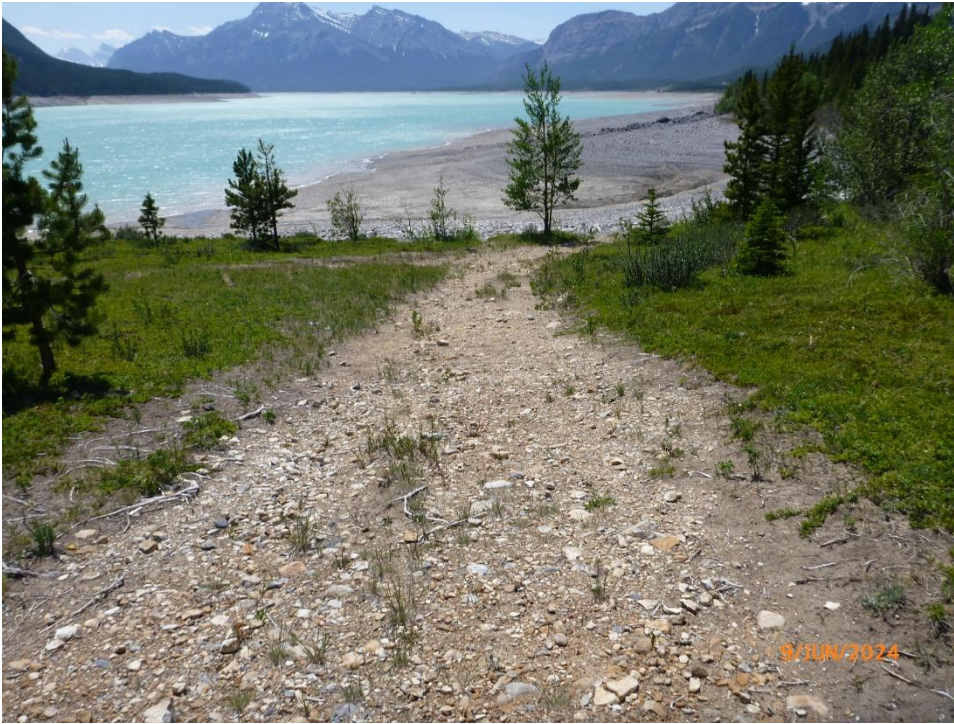
Photo 7 **Pedestrian trail down to the west shoreline of Abraham Lake east of the C034-3 site.**
Photo taken June 9, 2025 facing west-southwest.

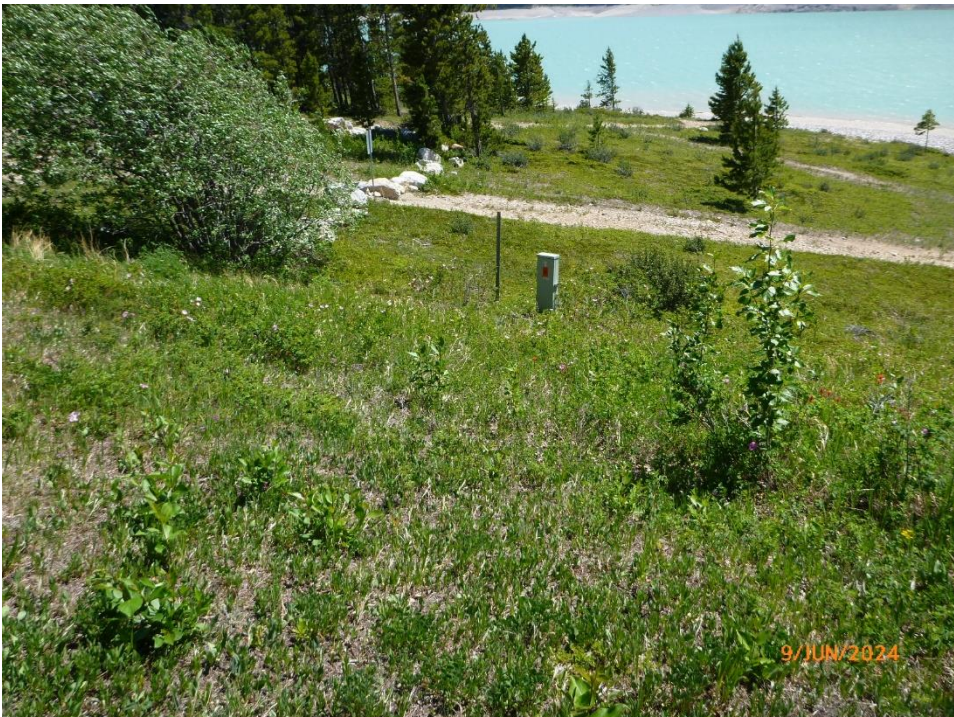
Photo 8 **TELUS monument located on the north side of the access trail east of the C034-3 site.**
Photo taken June 9, 2025 facing south.

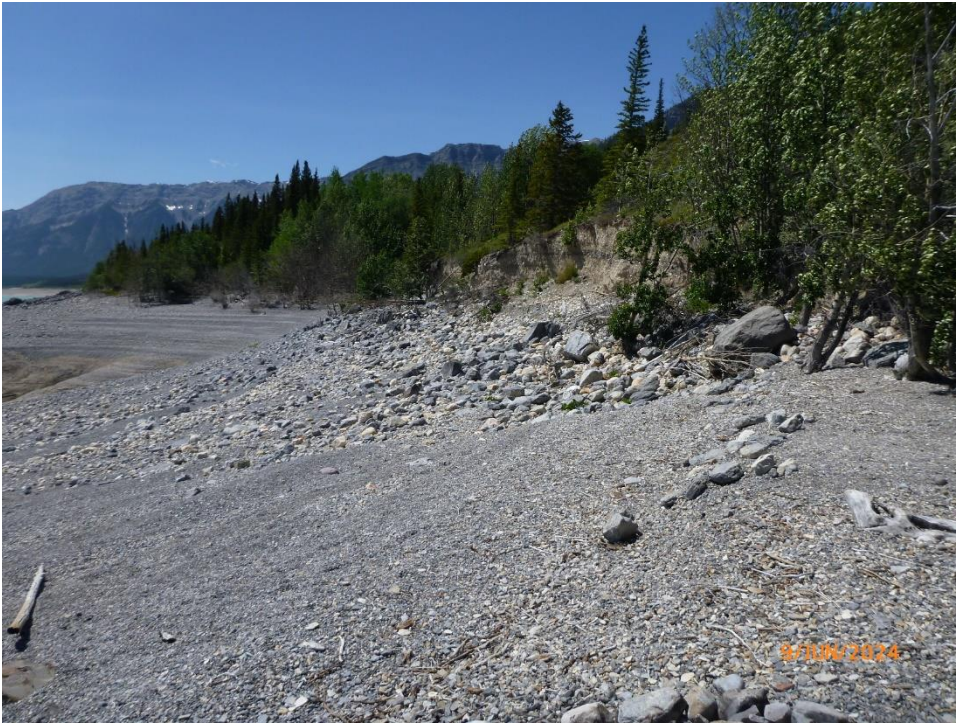
- The C034-3 site is located approximately 650 m west of the C034-1 site (repaired in 2020) and 225 m west of the Abraham Lake Ice Bubbles viewpoint. There is easy access to the breach surface below the eroding slope from the west extent of the viewpoint parking lot (boulders placed to restrict vehicle access) (Photos 7 and 8).
- There is a TELUS monument on the north side of the access path near the east extent of the site (Photo 8).
- The site is approximately 110 m long and the eroded near vertical slope is approximately 3 m to 4 m tall. The highway embankment is approximately 10 m high. The slope is likely being eroded primarily due to wave action during high reservoir levels, similar to the C034-1 and -2 sites before they were repaired (Photos 9 through 11).

Photo 9 East extent of the C034-3 site and the beach surface. Photo taken June 9, 2025 facing west.

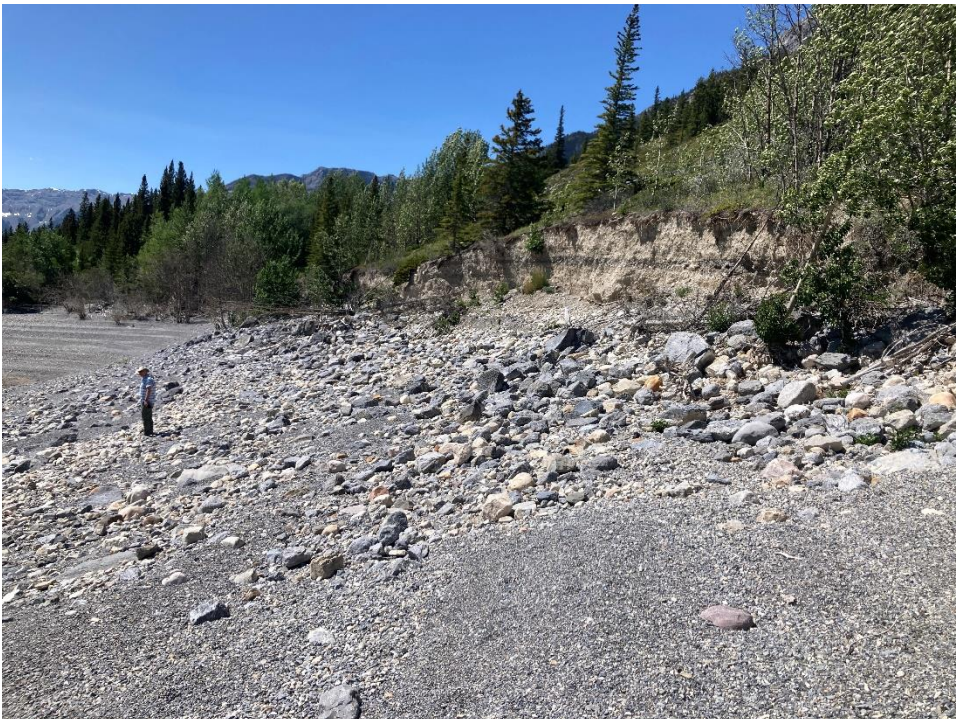
Photo 10 The eroding slope along the C034-3 is approximately 110 m long and 3 m to 4 m tall. Photo taken June 9, 2025 facing west.

- The site should be regularly inspected by TEC's Maintenance Contract Inspector (MCI), especially after significant precipitation events.
- The site should continue to be inspected every two years as part of the Central Region GRMP Section B inspections.
- KCB will prepare a proposal to prepare a repair design for the C034-3 (to be confirmed) site. Our proposal should include background review, retaining a surveying subcontractor to perform a topographic survey, perform a test pit investigation along the toe of the slope to assess if potential weak thin clay layers are present to support design work, environmental and regulatory work (including an Environmental Evaluation), design work, and tendering (preparing tender specifications, Environmental Risk Assessment, Issued for Tender drawings, C-estimate, and submission letter).

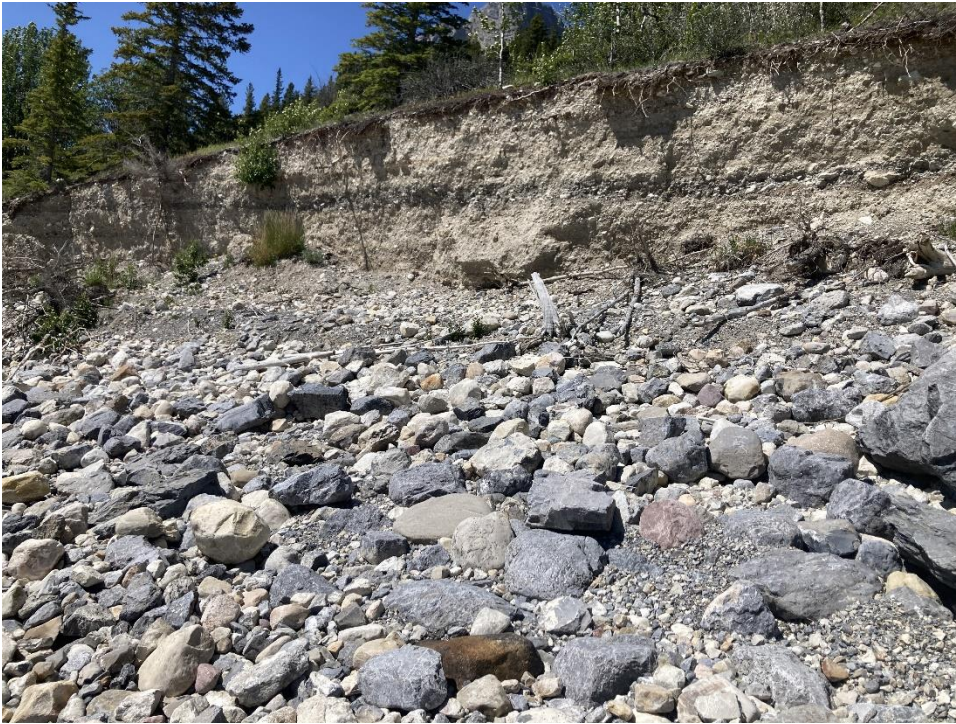
Photo 11 Eroding slope near the midpoint of C034-3. Cobbles and boulders are located along the toe of the slope. Photo taken June 9, 2025 facing northwest.

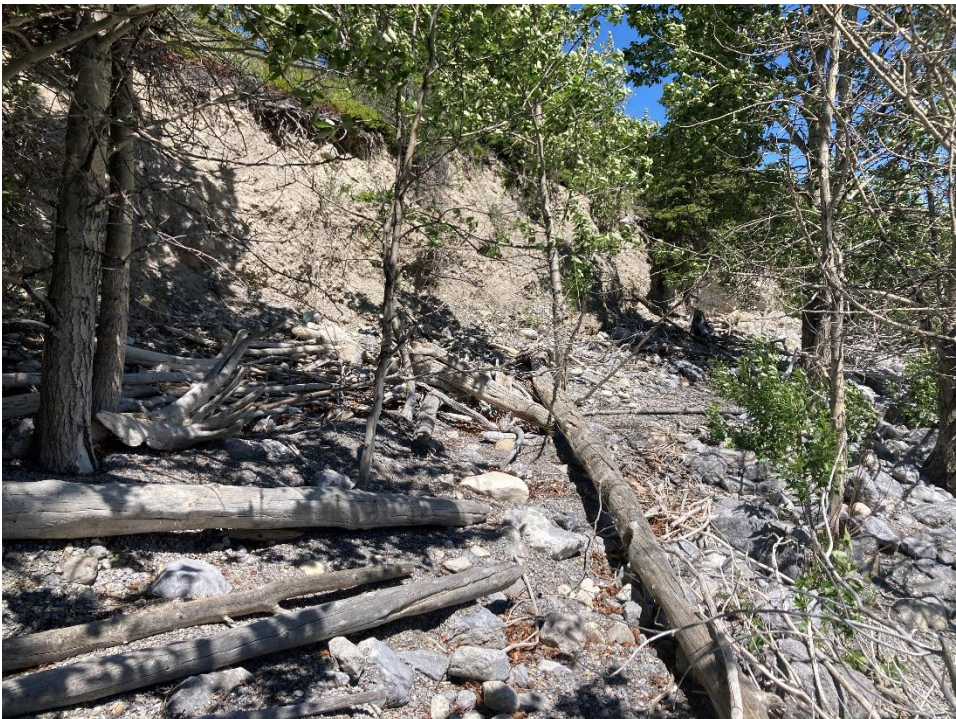
Photo 12 Trees and driftwood near the west extent of the C034-3 site. Photo taken June 9, 2025 facing north-northeast.

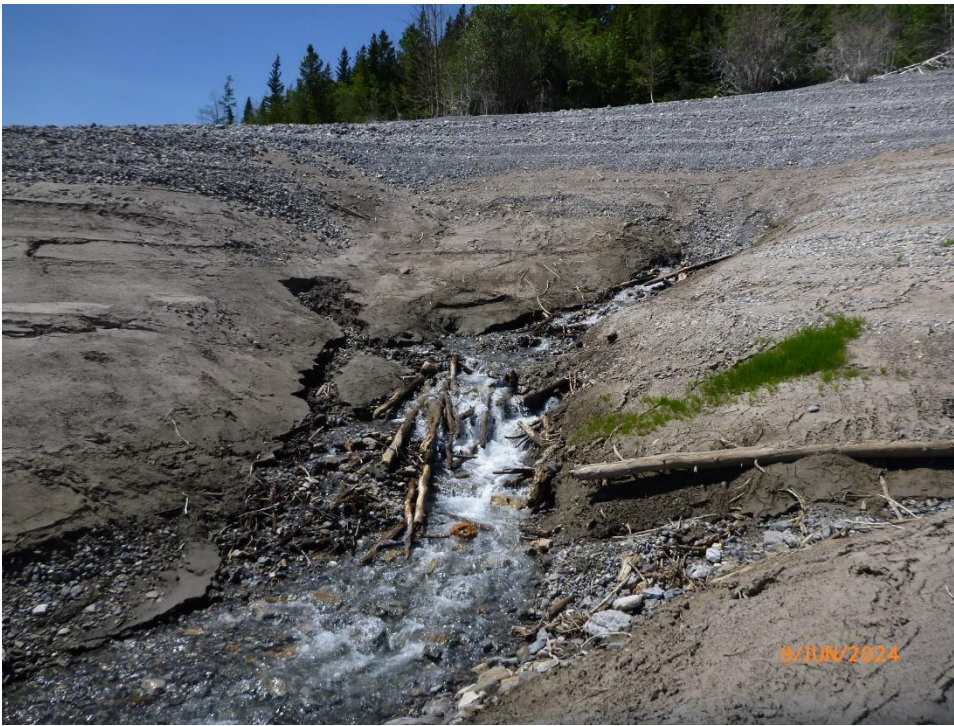
- The slope above and to the east and west of the eroding face is well vegetated with grass, shrubs, and trees.
- A zone of very high seepage was observed on the beach slope approximately 85 m downslope (south) of eroding slope and approximately 8 m below the highway elevation (Photo 13).

- KCB estimated the rate of seepage between approximately 0.3 m³/s to 0.5 m³/s.
 - A second seepage zone appeared to be present just east of the seeping zone, however, it was dry during the 2025 inspection (Photo 14). TEC informed KCB on-site that it had been observed seeping during previous site visits.

Photo 13 **Active seepage located approximately 85 m downslope (south) of the eroding slope. Photo taken June 9, 2025 facing northwest.**

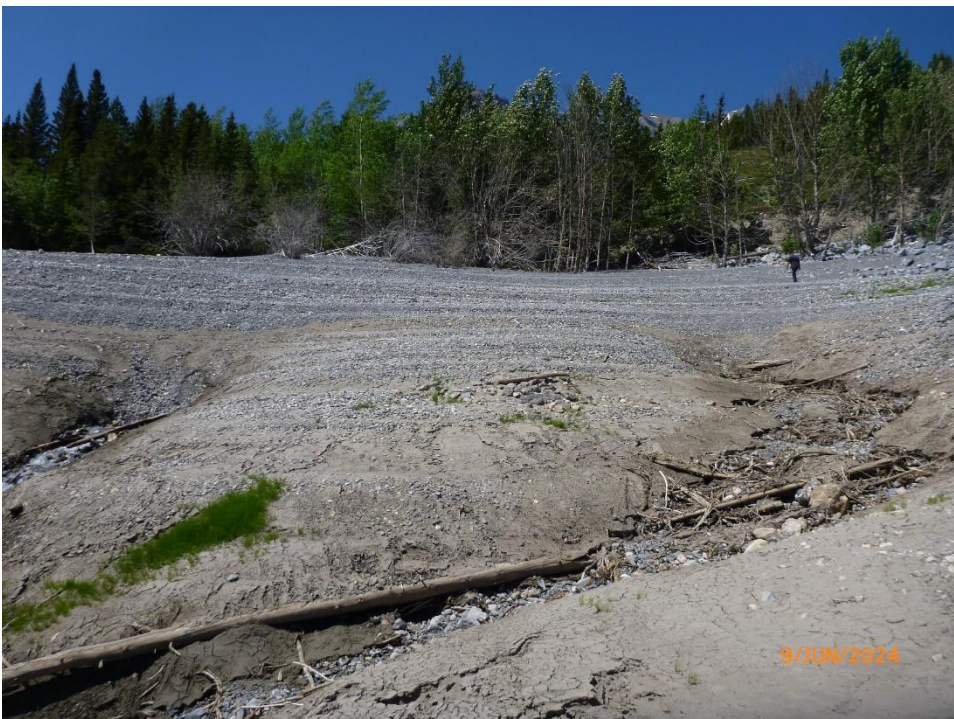
Photo 14 **Inactive (dry) seepage zone approximately 10 m to 15 m east of the active seepage zone. Photo taken June 9, 2025 facing north.**

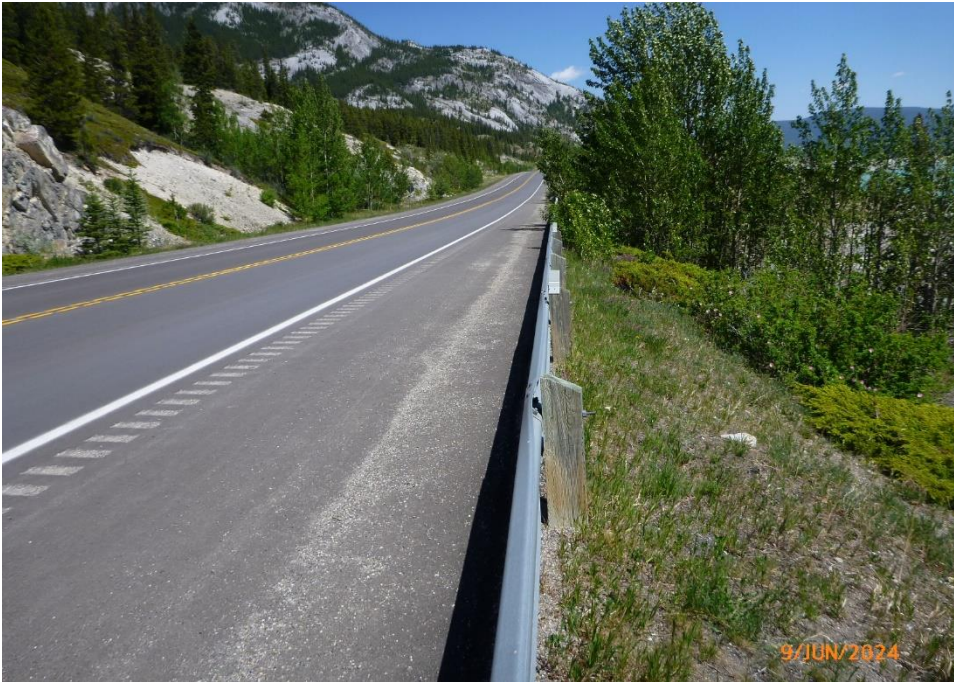
- The highway surface and guardrail upslope of the eroding slope were in good condition (Photo 15).
- A bedrock outcrop is located north (upslope) of the site on the north side of the highway that likely underlies coarse till (Photo 16). However, there does not appear to be a valley on the upstream side of the highway that could concentrate flow and contribute to the seepage. The seepage may be caused by an infilled valley with a coarse seepage zone (e.g., alluvial fan) or a fault in the bedrock discharging through and/or into beach materials.

Photo 15 Pavement and guardrail and in good condition upslope of C034-3. Photo taken June 9, 2025 facing east.

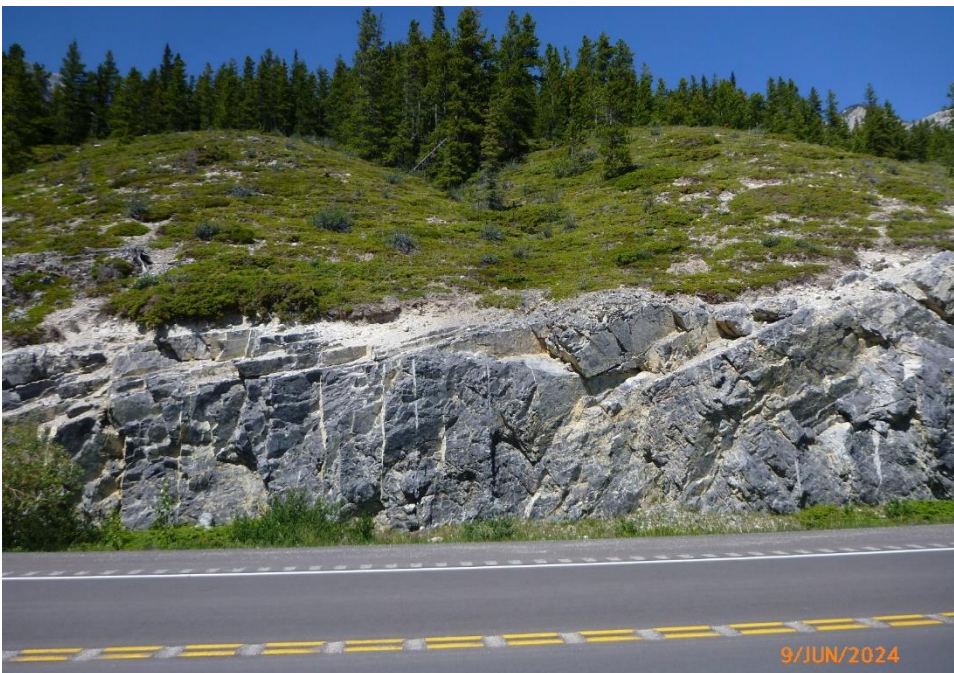
Photo 16 Bedrock outcrop in the north highway backslope upslope of the C034-3 site. Photo taken June 9, 2025 facing north.
