SITE NUMBER AND NAME: Unnumbered site – H11 Shunda Creek Rock Fall Site		HIGHWAY & KM: H11:06, 6.17	PREVIOUS INSPECTION DATE: N/A	INSPECTION DATE: June 27, 2023
LEGAL DESCRIPTION: 16-36-40-15 W5	NAD 83 COORDINATES: UTM Northing Easting 11 5816109 566557		RISK ASSESSMENT: PF: 11 CF: 2 TOTAL: 22	
AVERAGE ANNUAL DAILY TRAFFIC (AADT): 1,380 (west) & 1,340 (east) (Ref No. 7000875 & 70000507)			CONTRACT MAINTENANCE AREA (CMA): 514

CENTRAL REGION GEOHAZARD RISK MANAGEMENT PROGRAM

Site Plan
Unnumbered Site - Shunda Creek
Hwy 11:06, km 6.17

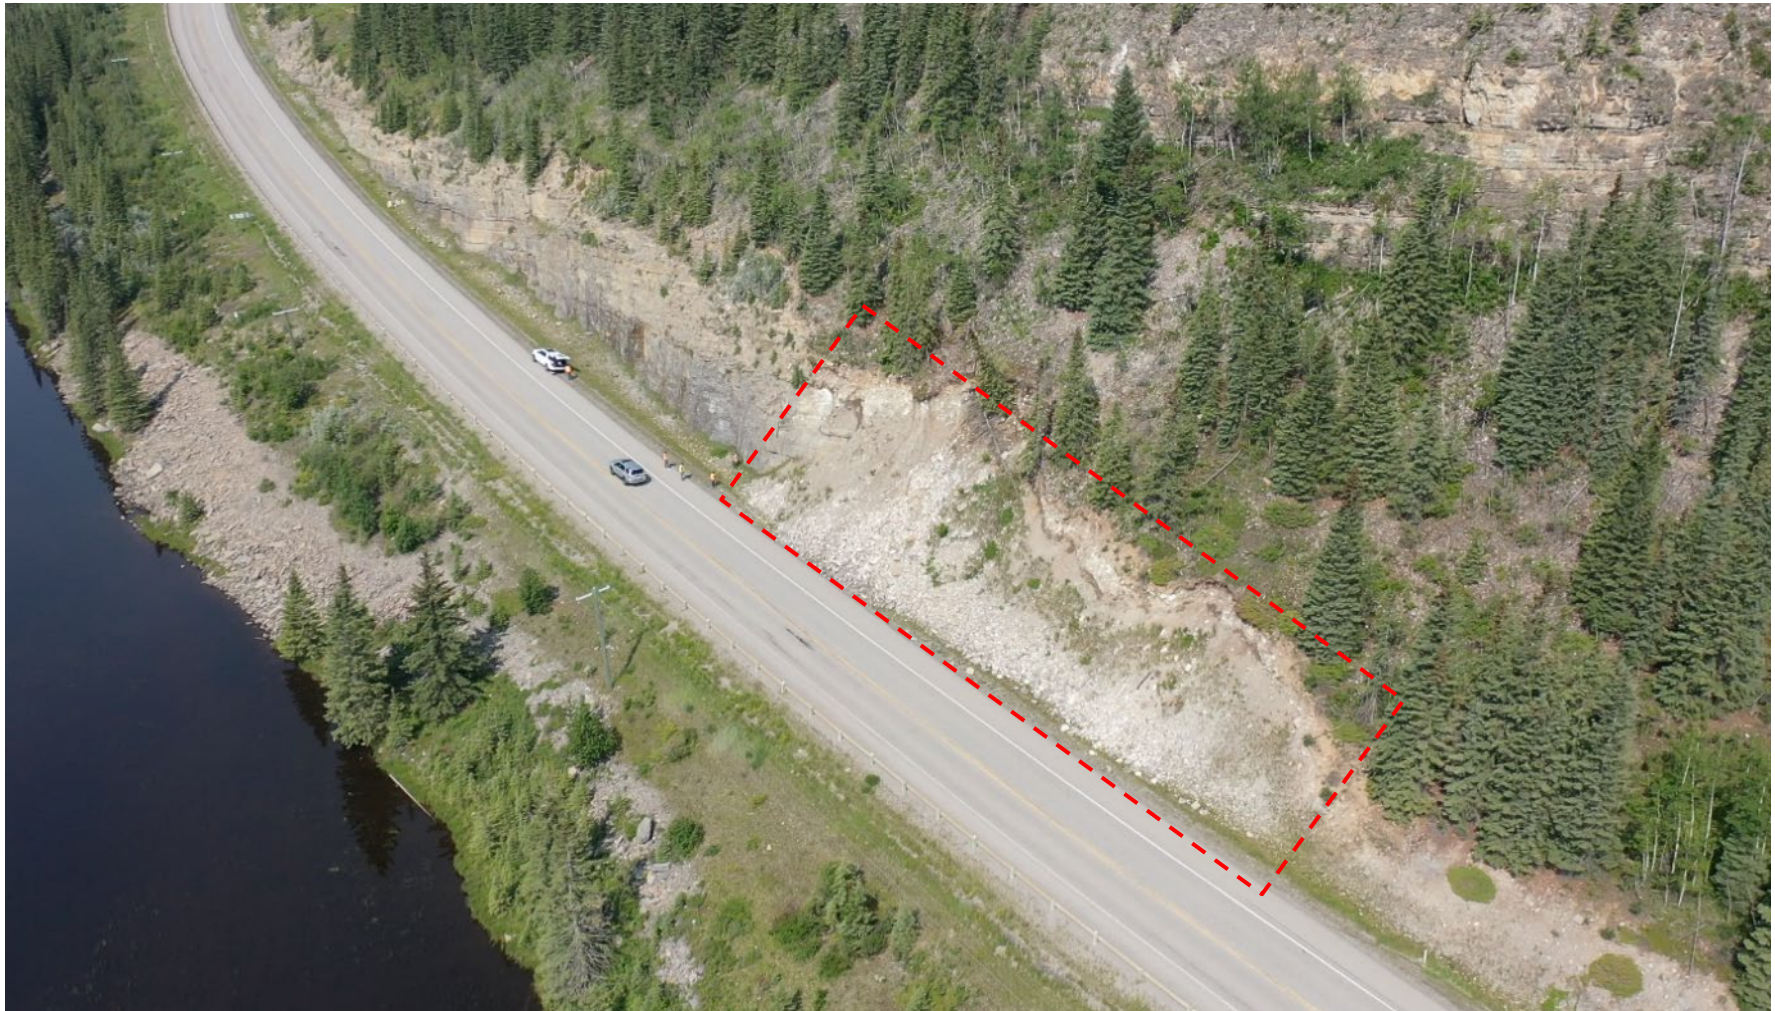
COMMENTS
The height of the rock slope north of Hwy 11 is approximately 8 m to 10 m.
The entire rock slope along this length of Hwy 11:06 is approximately 370 m in length. However, only the east 180 m was inspected during the 2023 inspection (Photo 1 and 2) as the west portion of the rock slope was not as tall and appeared more stable.
Rockfall hazard signs were observed on either side of the site.
There appears to be a bench at the crest of the rock slope, with more slope above the bench.
KCB has observed rockfall particles on the in the north (westbound) ditch near the shoulder of the highway (Photo 3). The public have been stopping at this location to pick up rocks for personal use.
There are talus deposits in the ditch over the eastern half of the slope (east of Waypoint 363), with rock particles filling the ditch in places and rock fall particles on the shoulder of the highway (Photos 1 through 3).

Photo 1 An aerial photo of the unnumbered site near Shunda Creek along H11:06. Rockfall particles are accumulating in the ditch bottom along the east portion of the site (indicated by red dashed line) with a more intact rock slope towards the west. Photo taken June 27, 2023, facing northwest.

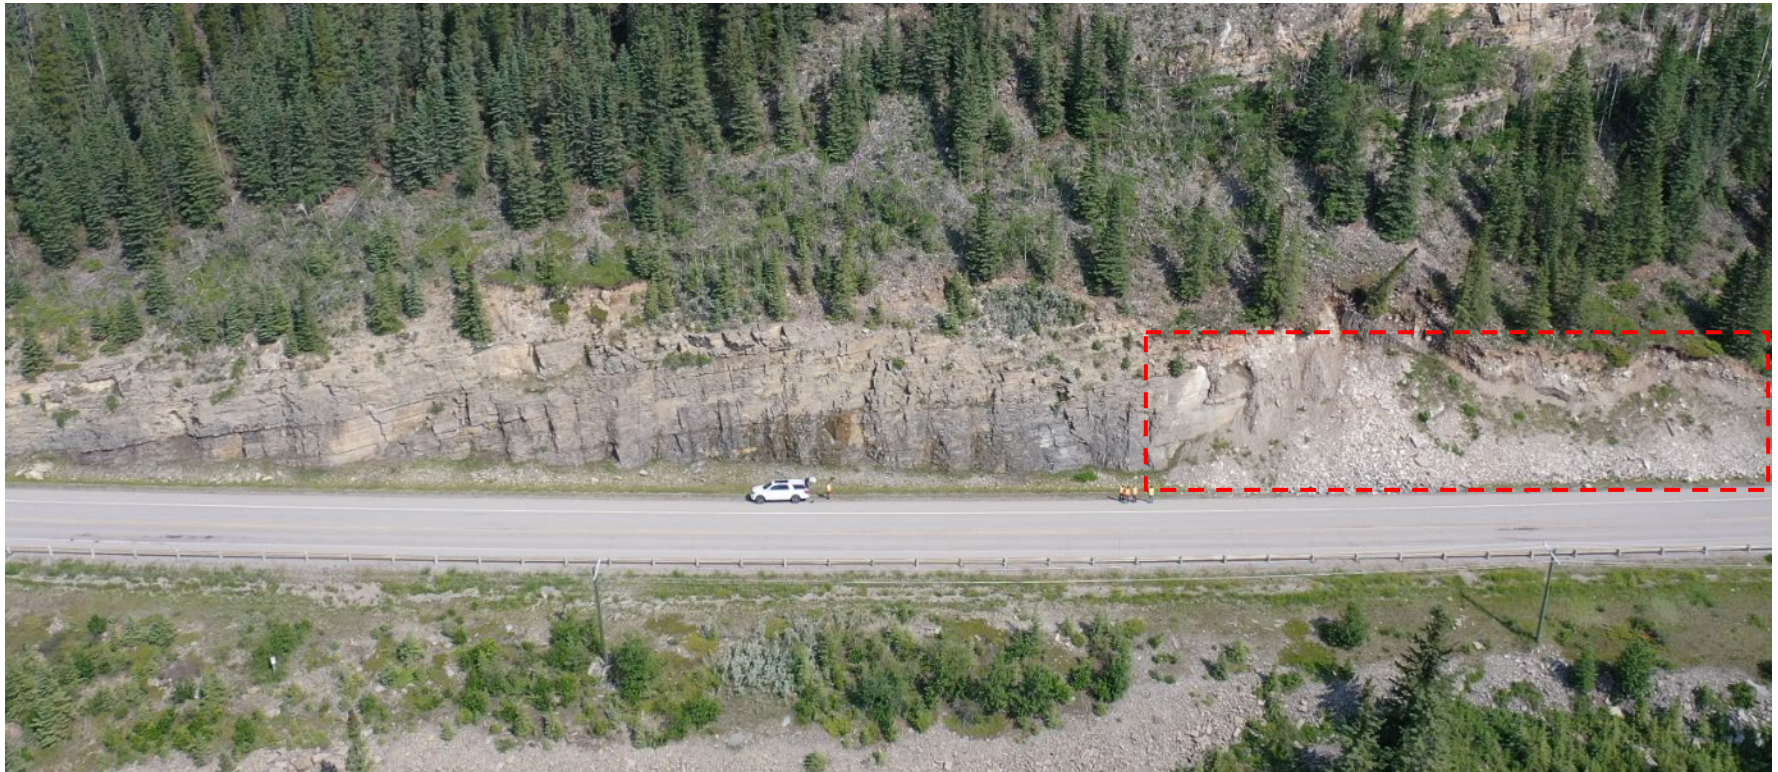
Photo 2 **An aerial photo of the unnumbered site near Shunda Creek along H11:06. The area where rockfall particles have accumulated in the ditch bottom is indicated by red dashed line (shown in Photo 4). The rock slope towards the west is more intact with significantly less rockfall particles accumulating in the ditch (shown in Photo 3). Photo taken June 27, 2023, facing north.**

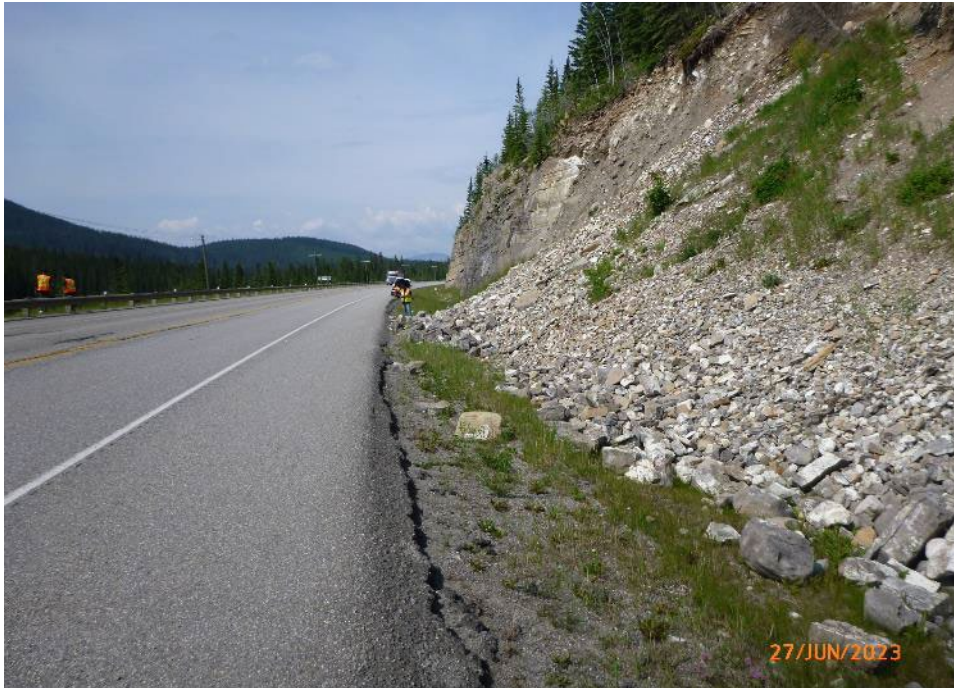
Rockfall particles in the ditch at Waypoint 364 are mostly cobbles and small boulders with an average size of approximately 0.2 m and a maximum size of approximately 1.0 m diameter (Photo 3). The larger particles are generally platy (i.e., much wider and longer than they are thick)
The rockslope on the eastern third (approximately) of the slope appears to be bedrock overlain with a coarse-grained till with cobbles and boulders (Photo 4). The talus deposits of cobbles and boulders in the ditch appear to be from the till but could also be from bedrock near the brow of the slope where exposed fractured bedrock with open joints is present approximately 8 m up the slope.
There are trees at the brow of the slope, and they are leaning. Further undermining of the trees will eventually cause them to topple, releasing more material from the brow of the slope.
At Waypoint 365, the discontinuity spacing becomes tighter, approximately 0.3 m (Photo 5).

The talus slopes filling the ditch will impede highway drainage and make it more likely for rockfall particles to roll or bounce onto the highway.
In the western half of the slope, the rock slope is a near vertical bedrock cut.

Photo 3 Material from the talus slope is accumulating in the north (westbound) ditch at the east portion of the site. Some rock fall particles are almost encroaching onto the north shoulder. Photo taken June 27, 2023, facing west.

- The site should regularly be inspected by TEC's Maintenance Contract Inspector (MCI).
- The debris and rock fall in the north (westbound) highway ditched should be removed regularly by TEC's Highway Maintenance Contractor (HMC) to maintain the ditch capacity. Continued buildup of rockfall materials will eventually allow rockfall particles to reach the road. As a preliminary start, TEC should plan to clean out the ditch once every two years and monitor how quickly the ditch refills with particles. Ditch cleaning should not excavate the toe of the slope, as excavating the toe will increase the frequency of rockfall and ditch infilling. TEC operations should verify that there are no buried services in the ditch before starting ditch cleaning.

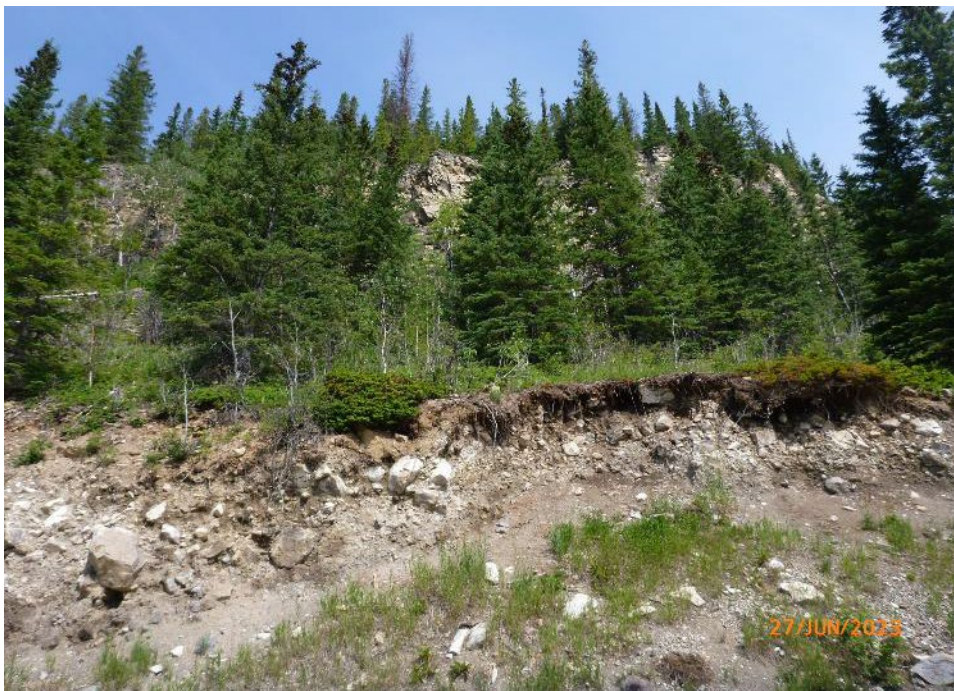
Photo 4 Overburden overhanging the crest of the slope near the east extent of the site. Photo taken June 27, 2023, facing north.

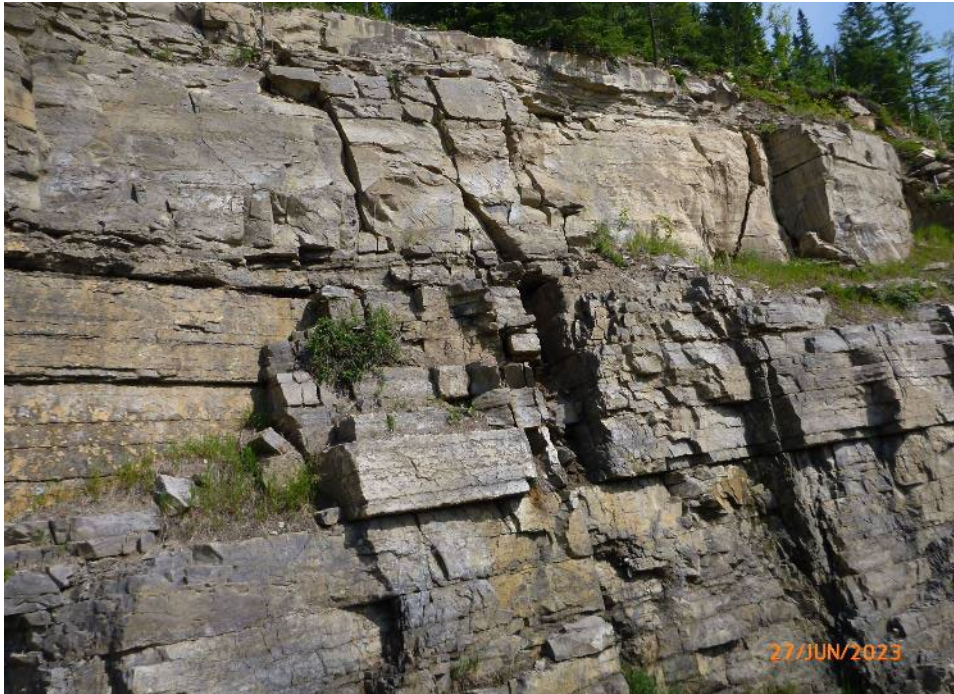
The eastern third of the slope is sloped at approximately 75% and the western two thirds of the slope is standing near vertical and consists of bedrock with closely to widely spaced discontinuities (Photo 5 and 6). The bedrock appears to be sedimentary with bedding planes slope at approximately 5 degrees to 10 degrees as exposed on the slope face. Discontinuity orientation measurements were not taken.
The bedrock in the western two thirds of the slope is generally massive but with closer spaced discontinuities near the brow of the slope.
The ditch below the western two thirds of the slope is generally empty with a few particles at the ditch bottom (Photo 7). In general, the ditch appears to be fairly wide and deep for the rockslope, estimated to be 5.0 m wide and 1.2 m to 1.5 m deep.
Pavement damage was not observed, nor were there any rockfall particles observed across the highway behind the south (eastbound) guardrail (Photo 8). However, tall vegetation during the time of the inspection may have obscured rockfall particles across the highway behind the guardrail.

Photo 5 A portion of the rock slope near west extent of the site where the discontinuity spacer becomes tighter (approximately 0.3 m) (Waypoint 365). Photo taken June 27, 2023, facing north.

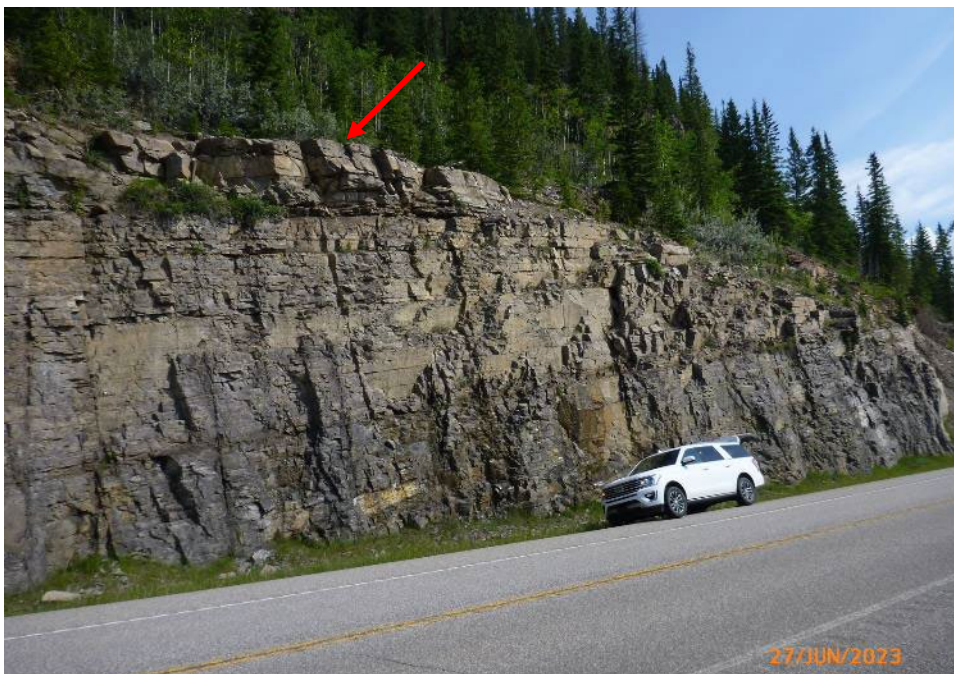
Photo 6 The relatively intact rock slope along the middle and west portion of the site. There is a potentially unstable shelf of rock at the top of the rock slope (indicated by red arrow). Photo taken June 27, 2023, facing north-northeast.

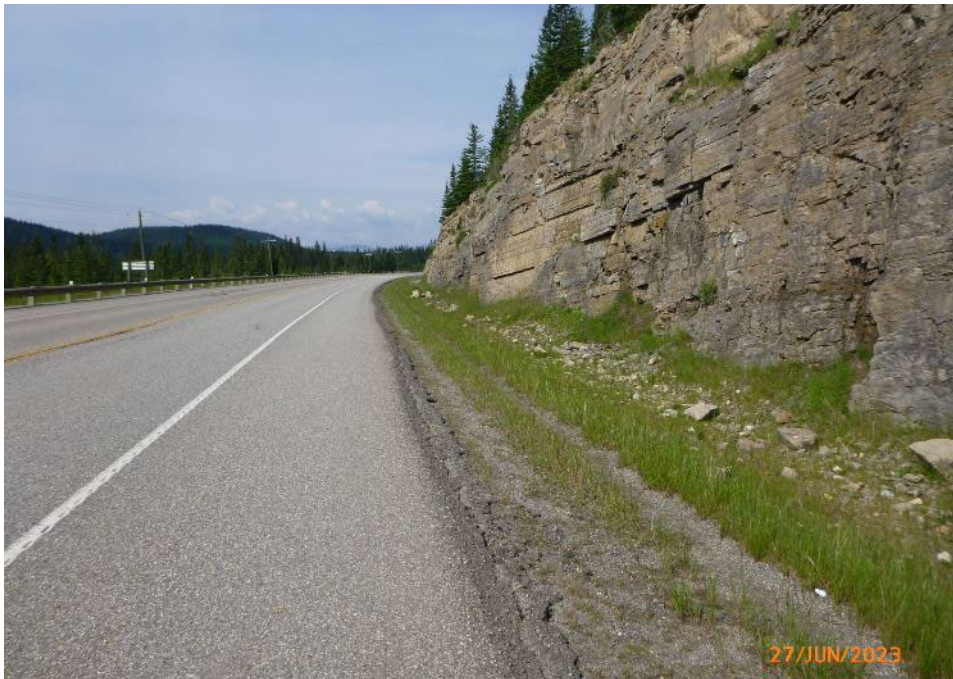
Photo 7 **Very little rock fall has accumulated in the north (westbound) ditch at the toe of the rock slope. Photo taken June 27, 2023, facing west.**

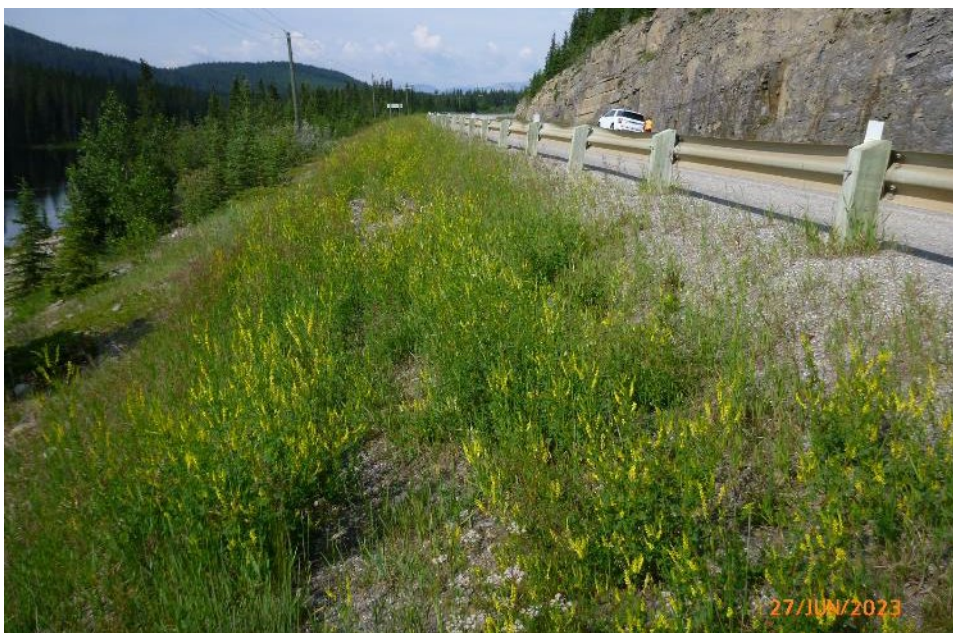
Photo 8 **The south (eastbound) highway embankment slope is relatively well vegetated and appears to be in good condition. No rockfall particles were observed on the south side of the highway during the 2023 inspection. Photo taken June 27, 2023, facing west.**
