SITE NUMBER AND NAME: C078 Shunda Creek Rockfall	HIGHWAY & KM: H11:06, 6.17	PREVIOUS INSPECTION DATE: June 27, 2023	INSPECTION DATE: June 9, 2025
LEGAL DESCRIPTION: 16-36-40-15 W5	NAD 83 COORDINATES: UTM Northing Easting 11 5816109 566557	RISK ASSESSMENT: PF: 11 CF: 2 TOTAL: 22	
HIGHWAY SERVICE CLASSIFICATION: 2		CONTRACT MAINTENANCE AREA (CMA): 514	
AVERAGE ANNUAL DAILY TRAFFIC (AADT): 1,380 (west) & 1,340 (east) (Ref No. 7000875 & 70000507)

PRIMARY SITE ISSUE: The site is a rockfall geohazard site along Hwy 11:06. The rock slope is on the north side of the highway and rockfall particles are accumulating in the north (westbound) ditch.
APPROXIMATE DIMENSIONS: The rock slope is approximately 8 m to 10 m in height with an overall slope of approximately 75%. The rock slope is approximately 370 m long at the site and the more active zone is approximately 60 m long.
DATE OF ANY REMEDIAL ACTION: N/A

PROJECT CENTRAL REGION GEOHAZARD RISK MANAGEMENT PROGRAM		
TITLE Site Plan C078 - Shunda Creek Rockfall Hwy 11:06, km 6.17		
SCALE 1:2,000	PROJECT No. A05116A02	FIG No. 1

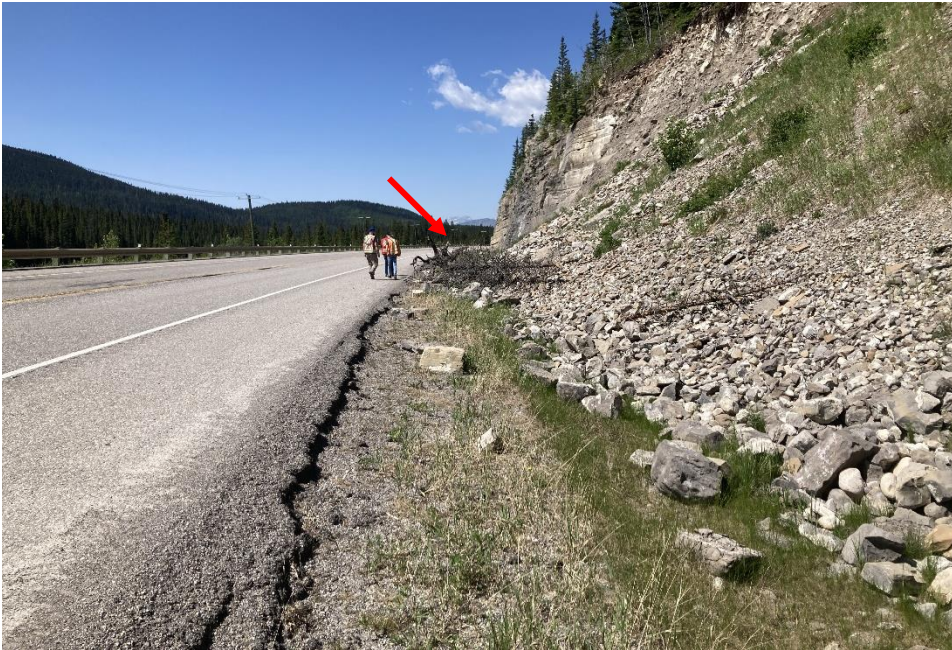
- The eastern third of the slope is sloped at approximately 75%.
- Material has accumulated in the north (westbound) ditch and was nearly encroaching upon the shoulder of the highway (Photo 1). The material being deposited into the ditch was a combination of rockfalls, overburden material being eroded from the brow of the slope, and vegetation. Between 2023 and 2025, a tree fell down the slope and was near the edge of the highway (Photo 1).

- Rockfall particles in the ditch were mostly cobbles and small boulders with an average size estimated to be approximately 0.2 m and a maximum size of approximately 1.0 m diameter (Photo 1). The larger particles were generally platy (i.e., much wider and longer than they are thick).

- There were talus deposits in the ditch along the higher activity zone (Photos 1). The talus slopes filling the ditch will impede highway drainage and make it more likely for rockfall particles to roll or bounce onto the highway.

- Photo 1** Material from the talus slope is accumulating in the north (westbound) ditch and is almost encroaching onto the north shoulder. A tree (indicated by red arrow) fell down the slope between the 2023 and 2025 inspections. Photo taken June 9, 2025 facing west.

- The debris and rockfall in the north (westbound) highway ditched should be removed regularly by TEC's Highway Maintenance Contractor (HMC) to maintain the ditch capacity. Continued buildup of rockfall materials will eventually allow rockfall particles to reach the road. As a preliminary start, TEC should plan to clean out the ditch once every two years and monitor how quickly the ditch refills with particles. Ditch cleaning should not excavate the toe of the slope, as excavating the toe will increase the frequency of rockfall and ditch infilling. TEC operations should verify that there are no buried services in the ditch before starting ditch cleaning.

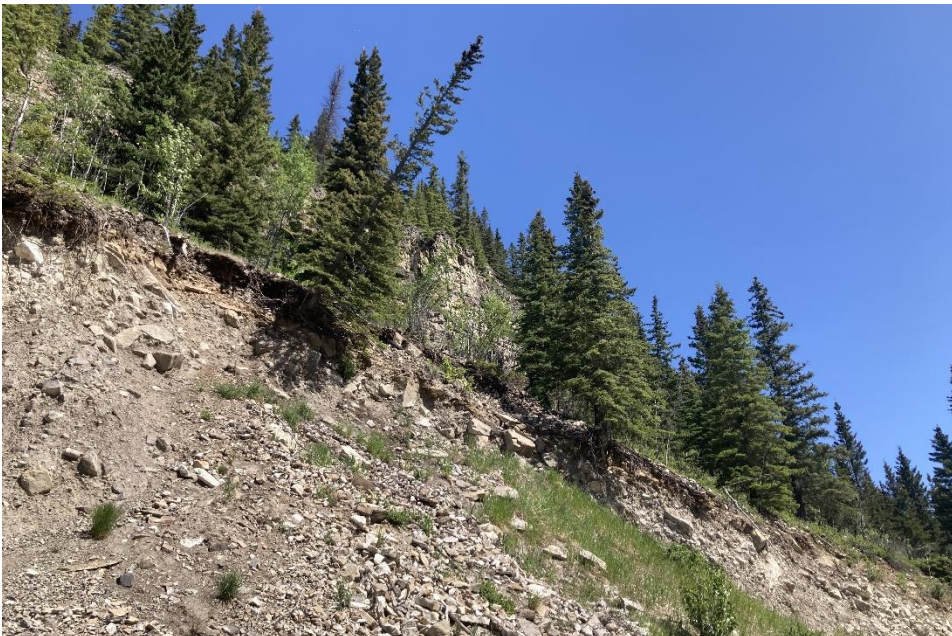
- The rock slope on the eastern third (approximately) of the site appears to be bedrock overlain with a coarse-grained till with cobbles and boulders (Photo 2). The talus deposits of cobbles and boulders in the ditch appear to be from the till but could also be from bedrock near the brow of the slope where exposed fractured bedrock with open joints were present approximately 8 m up the slope.

- There were trees at the brow of the slope and the ones closest to the edge are leaning (Photo 2). Further undermining of the trees will eventually cause them to topple, releasing more material from the brow of the slope.

- Photo 2** Overburden overhanging the crest of the slope and two leaning trees in the eastern third of the site. Photo taken June 9, 2025 facing northeast.

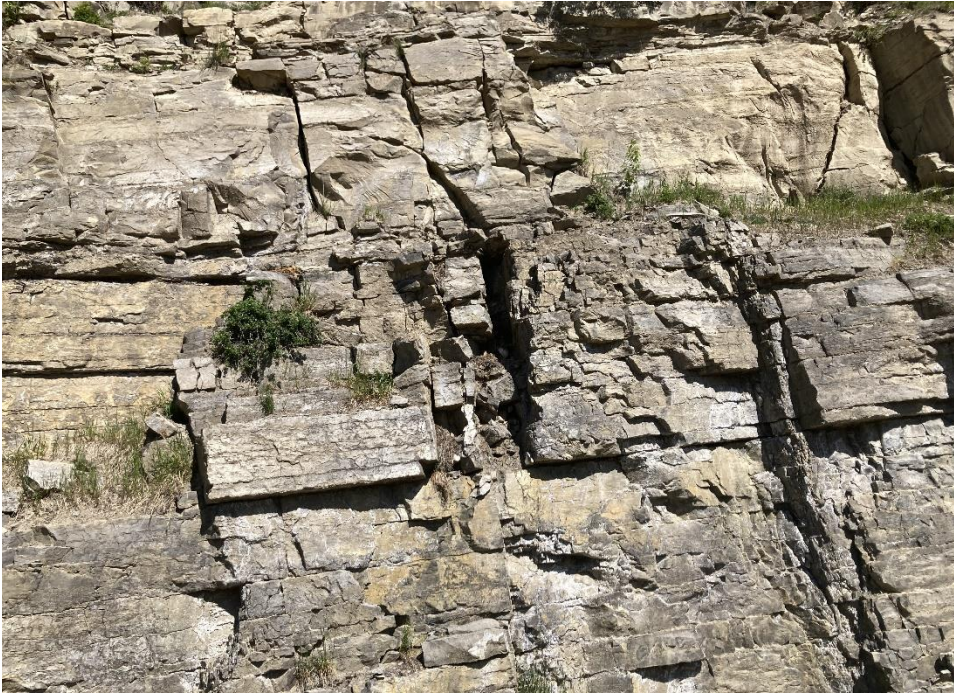
- In the lower activity zone, the discontinuity spacing was tighter, approximately 0.3 m (Photo 3). The rock slope is a near vertical bedrock cut.
- The slope consists of bedrock with closely to widely spaced discontinuities (Photo 3 through 6). The bedrock appeared to be sedimentary with bedding planes slope at approximately 5 degrees to 10 degrees as exposed on the slope face. Discontinuity orientation measurements were not taken.
- The bedrock is generally massive but with closer spaced discontinuities near the brow of the slope.
- The ditch was generally empty with a few particles at the ditch bottom (Photo 4 and 5). In general, the ditch appeared wide and deep for the rock slope, estimated to be 5.0 m wide and 1.2 m to 1.5 m deep. During the 2025 inspection, larger rockfalls up to 1 m long consisted of platy particles were observed at the west extent of the site (Photo 6).

Photo 3 A portion of the rock slope near west extent of the site where the discontinuity spacer becomes tighter (approximately 0.3 m). Photo taken June 9, 2025 facing north.

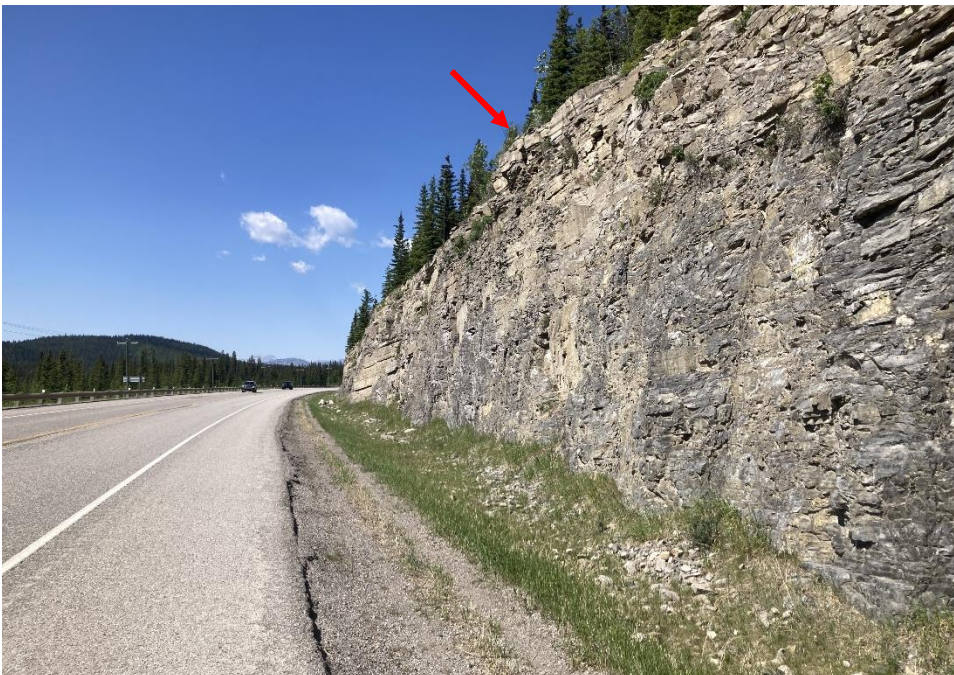
Photo 4 The relatively intact rock slope along the west portion of the site. There is a potentially unstable shelf of rock at the top of the rock slope (indicated by red arrow). Photo taken June 9, 2025 facing west-northwest.

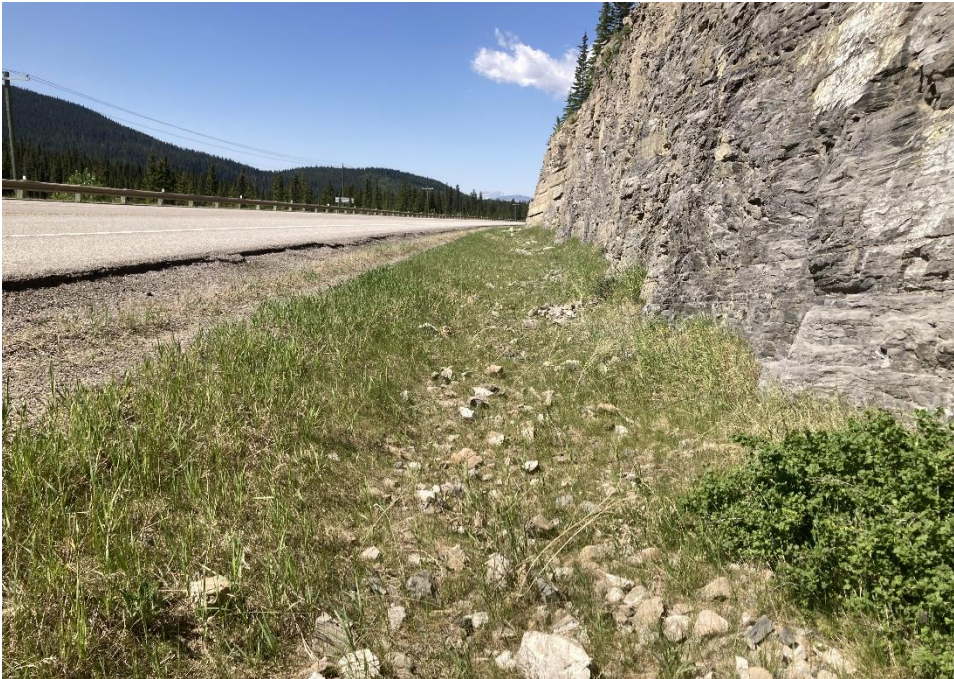
Photo 5 **Very little rock fall has accumulated in the north (westbound) ditch at the toe of the rock slope. Photo taken June 9, 2025 facing west.**

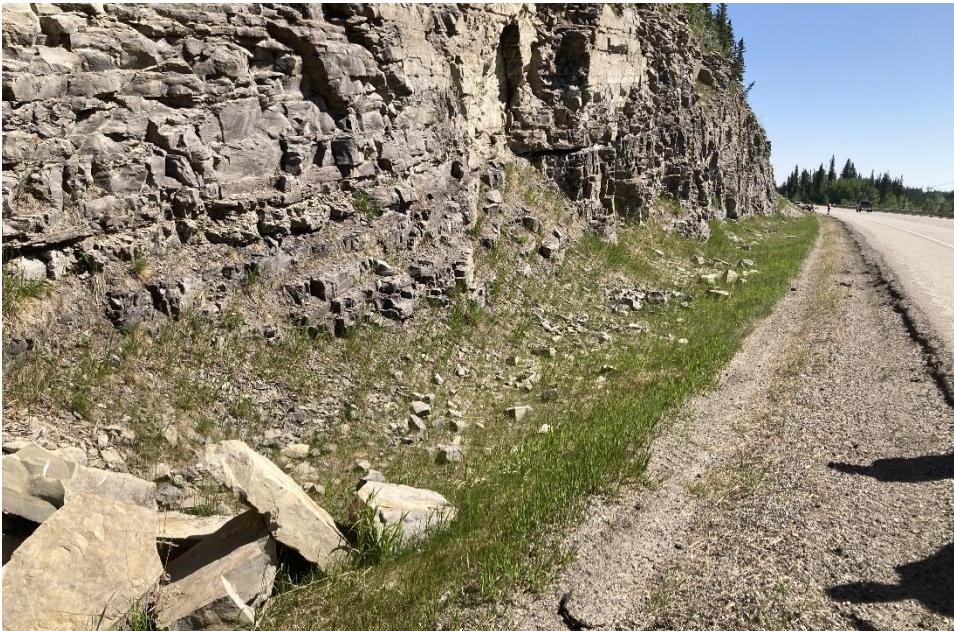
Photo 6 **Larger rockfalls up to approximately 1 m long in the north (westbound) ditch at the west extent of the site were deposited between the 2023 and 2025 inspections. Photo taken June 9, 2025 facing east.**
