<b>SITE NUMBER AND NAME</b> C063 Frost Heave	<b>HIGHWAY &amp; KM</b> H11:12 km 24.734	<b>PREVIOUS INSPECTION DATE</b> March 2, 2017	<b>INSPECTION DATE</b> <b>Feb 28, 2018</b>
<b>LEGAL DESCRIPTION</b> NE 24-38-1 W5	<b>NAD 83 COORDINATES</b> Northing Easting 52°16.999' 114°0.579'	<b>RISK ASSESSMENT</b> PF: 8 CF: 3 TOTAL: 24	
2017 Average Annual Daily Traffic (Ref. 70000488) (AADT): 16180 (westbound) 16420 (eastbound)		Contract Maintenance Area (CMA): 19

<b>NOTES:</b> 1. HORIZONTAL DATUM: NAD83 2. GRID ZONE: UTM Zone 11N 3. IMAGE SOURCE: Bing Maps 2018, Microsoft Corporation. Image dated September 2013 4. Site visit photos dated February 28, 2018	CLIENT 	PROJECT CENTRAL REGION GEOHAZARD RISK MANAGEMENT PROGRAM
		TITLE C063 - Site Inspection Hwy 11:12, km 24.734
	SCALE 1:2,500	PROJECT No. A05115A02
		FIG No. 1

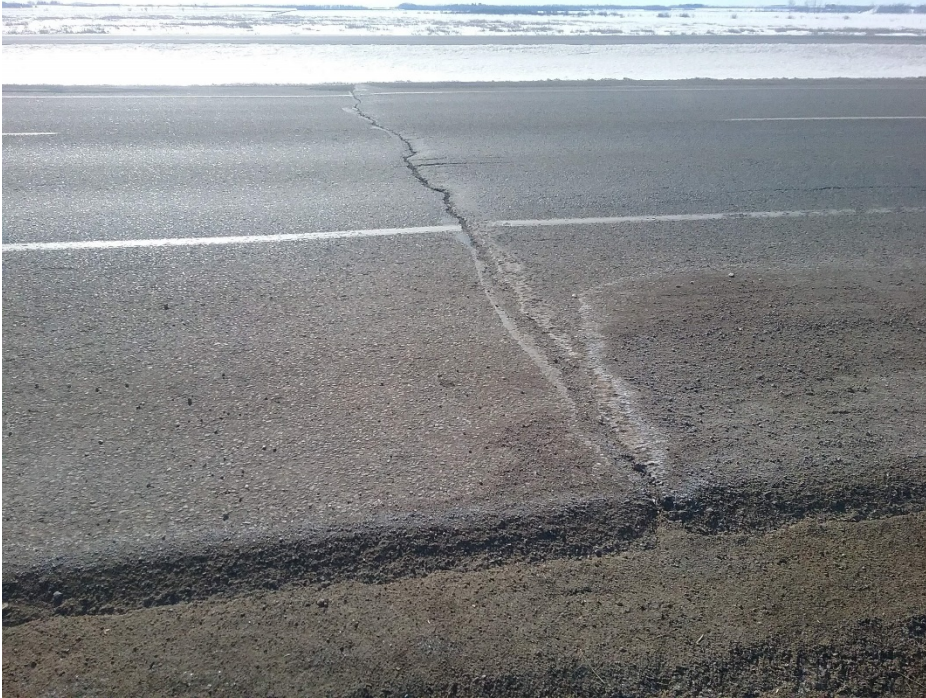
**Photo 1** Transverse pavement cracking along westbound lane (east section). Cracking generally aligns with horizontal drains. Photo taken February 28, 2018 looking south.

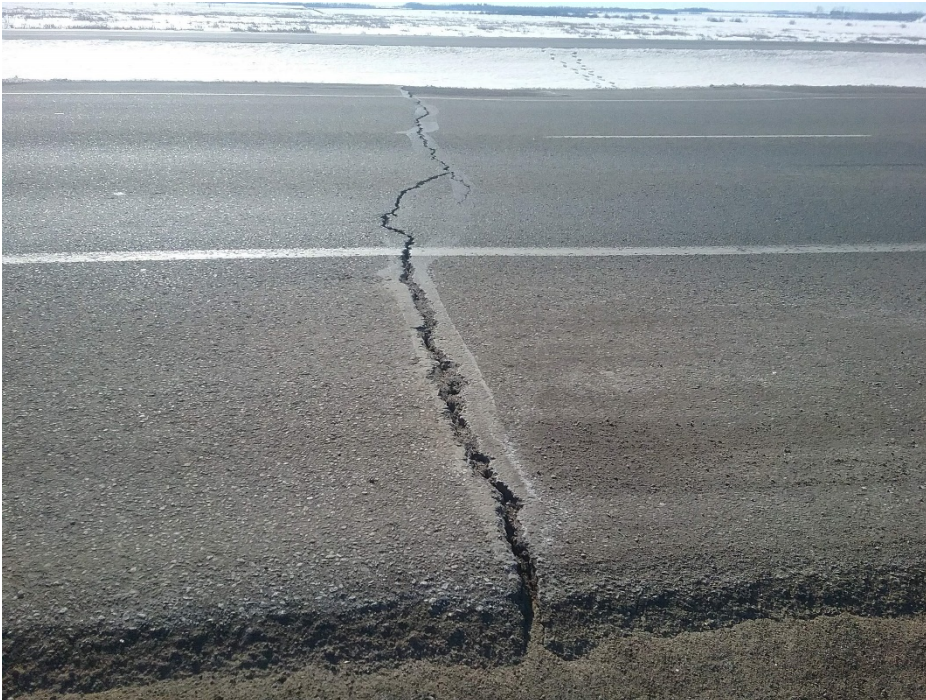
**Photo 2** Transverse pavement cracking and depression along westbound lane (east section). Photo taken February 28, 2018 looking south.

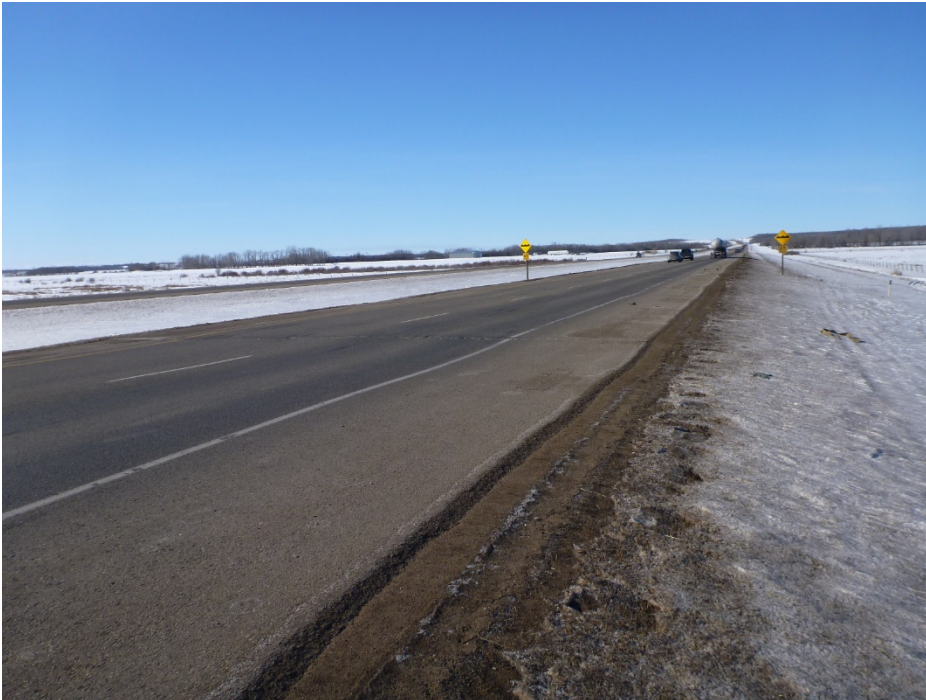
**Photo 3** Location of frost heave site (east section). Photo shows a rolling pavement condition. Photo taken on February 28, 2018 looking southwest.

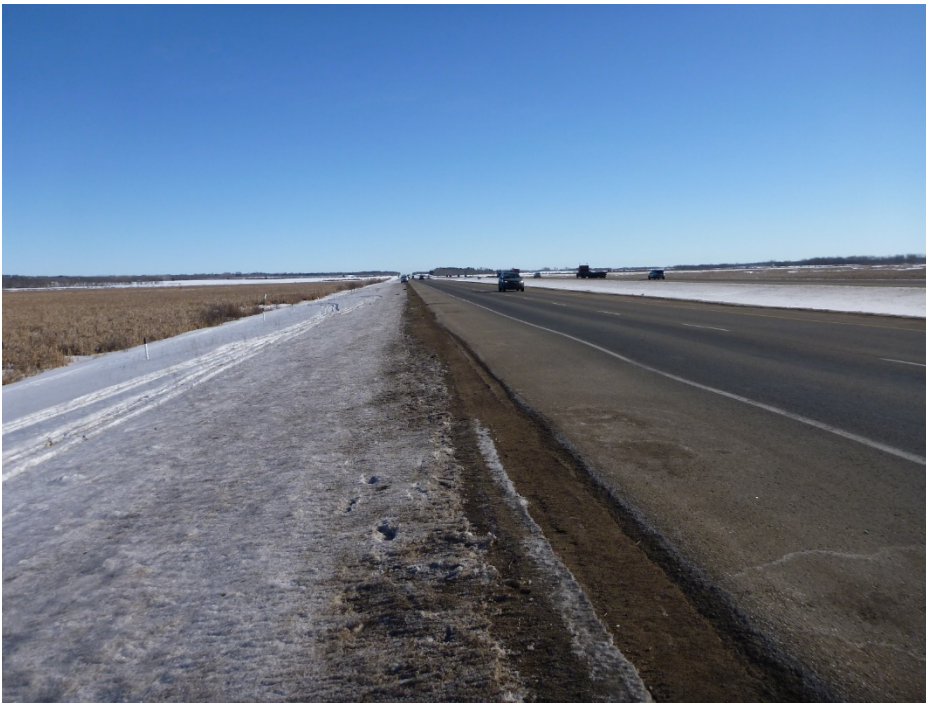
**Photo 4** Location of frost heave site (east section). Photo taken on February 28, 2018 looking east.

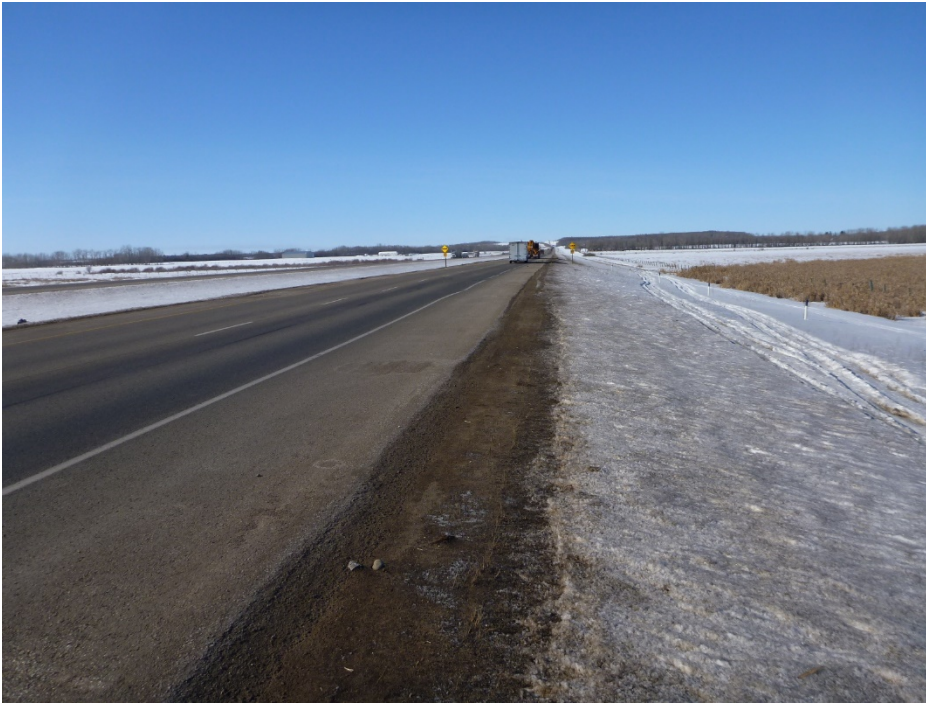
**Photo 5**      **Location of frost heave site (east section). White posts indicate drain outlets. Photo taken on February 28, 2018 looking west.**
