SITE NUMBER AND NAME C063 Frost Heave		HIGHWAY & KM 11:12, 24.734	PREVIOUS INSPECTION DATE Feb 28, 2018	INSPECTION DATE Feb 21, 2019
LEGAL DESCRIPTION NE 24-38-1 W5	NAD 83 COORDINATES: UTM Northing Easting 11 5796735 703911		RISK ASSESSMENT PF: 8 CF: 3 TOTAL: 24	
AVERAGE ANNUAL DAILY TRAFFIC (AADT): 16,180 (west) & 16,420 (east) (Ref. No. 70000488)			CONTRACT MAINTENANCE AREA (CMA): 19

PROJECT CENTRAL REGION GEOHAZARD RISK MANAGEMENT PROGRAM		
TITLE C063 - Site Inspection Hwy 11:12, km 24.734		
SCALE 1:2,500	PROJECT No. A05115A02	FIG No. 1

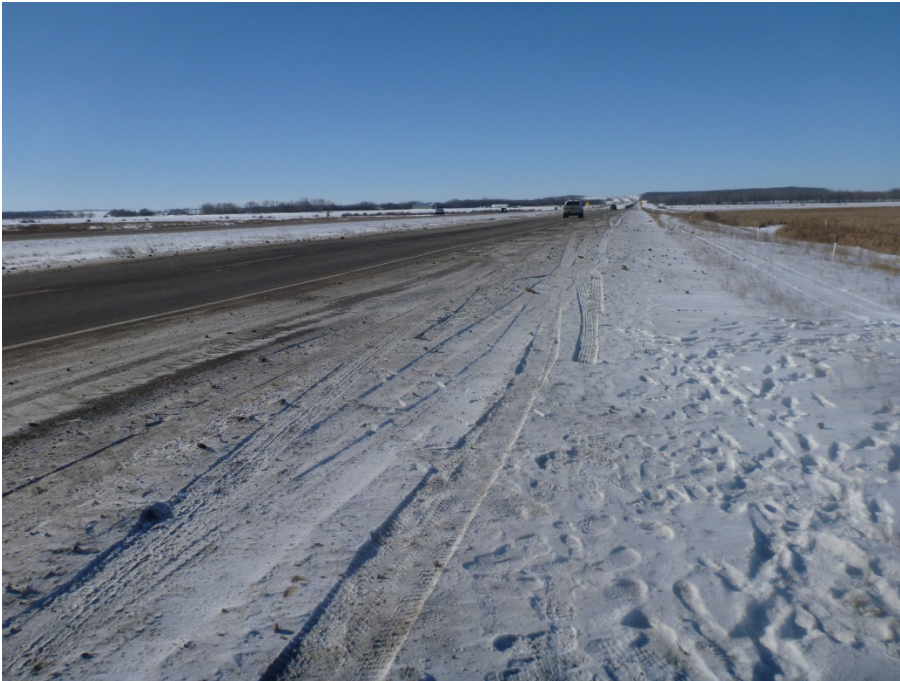
PRIMARY SITE ISSUE:
Frost heave occurring in the westbound highway embankment. Frost heave exacerbated by the installation of 26 drains (8 in the west section, 18 in the east section) across the westbound highway embankment during the twinning of the highway in 2008. Differential heaving is occurring between frost susceptible highway fill and non-frost-susceptible drain backfill resulting in a "rolling" pavement surface

COMMENTS
Frost heaving on the highway appears to occur at the drain backfill locations. Frost heaving was observed to be worse than in the previous year; with the west section heaving more than the east section.
The site will be repaired in Spring 2019 as detailed in Alberta Transportation Tender TND0019153.

Photo 1 **Location of frost heave site (east section). Photo shows the rolling pavement condition. Photo taken on February 21, 2018 looking west.**
