SITE NUMBER AND NAME: C007 Kenilworth Lake		HIGHWAY & KM: 16:30, 23.89	PREVIOUS INSPECTION DATE: July 12, 2019	INSPECTION DATE: June 24, 2020
LEGAL DESCRIPTION: 11-27-050-04 W4M	NAD 83 COORDINATES: UTM Northing Easting 12 5910761 532907		RISK ASSESSMENT: PF: 3 CF: 2 TOTAL: 6	
AVERAGE ANNUAL DAILY TRAFFIC (AADT): 7,710 (west) & 7,460 (east) (Ref No. 137470 & 134470)			CONTRACT MAINTENANCE AREA (CMA): 512

NOTES: 1. HORIZONTAL DATUM: NAD83 2. GRID ZONE: UTM Zone 12N 3. IMAGE SOURCE: World Imagery from ESRI ArcGIS Online. Image dated May 21, 2015 4. Location of instruments is approximate (not surveyed)	CLIENT 	PROJECT CENTRAL REGION GEOHAZARD RISK MANAGEMENT PROGRAM
		TITLE Site Plan C007 - Kenilworth Lake Slide Hwy 16:30, km 23.890
	SCALE 1:1,000	PROJECT No. A05115A02
		FIG No. 1

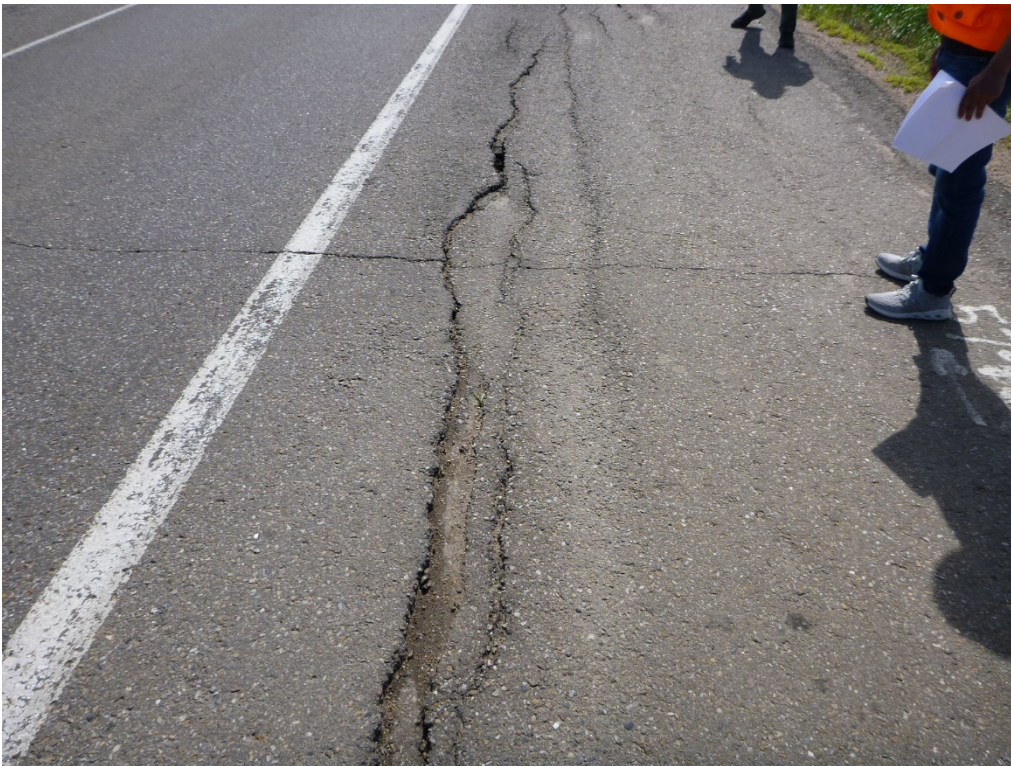
Photo 1 Asphalt cracking observed west of the guardrail on the south side of Hwy 16. Photo taken June 24, 2020 facing east.

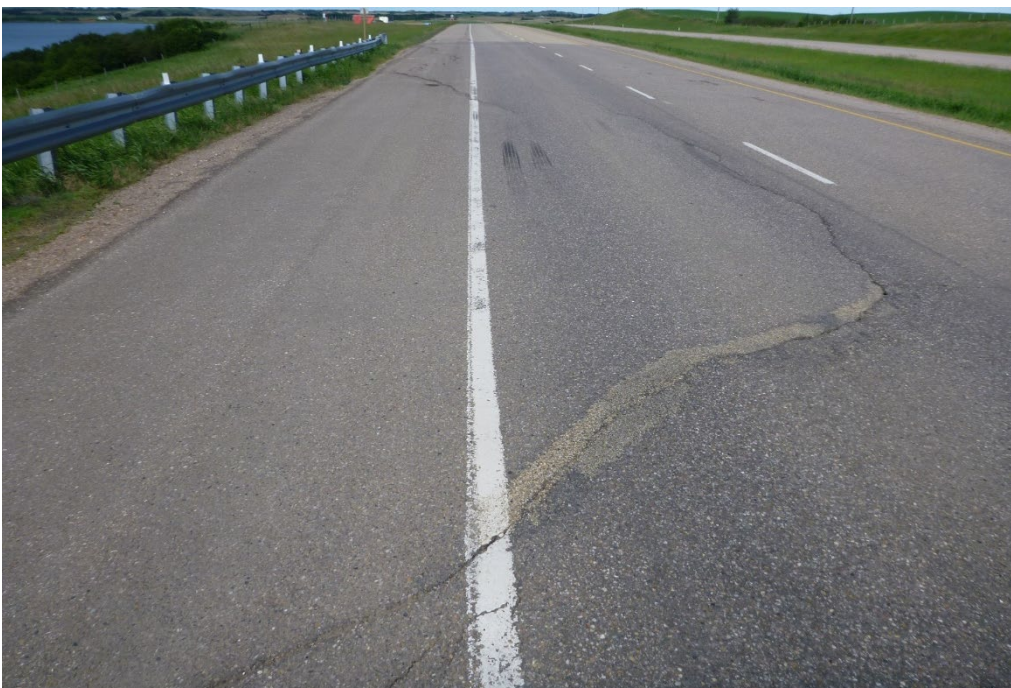
Photo 2 Asphalt cracking and settlement area observed in the eastbound lane. Photo taken June 22, 2020 facing west.

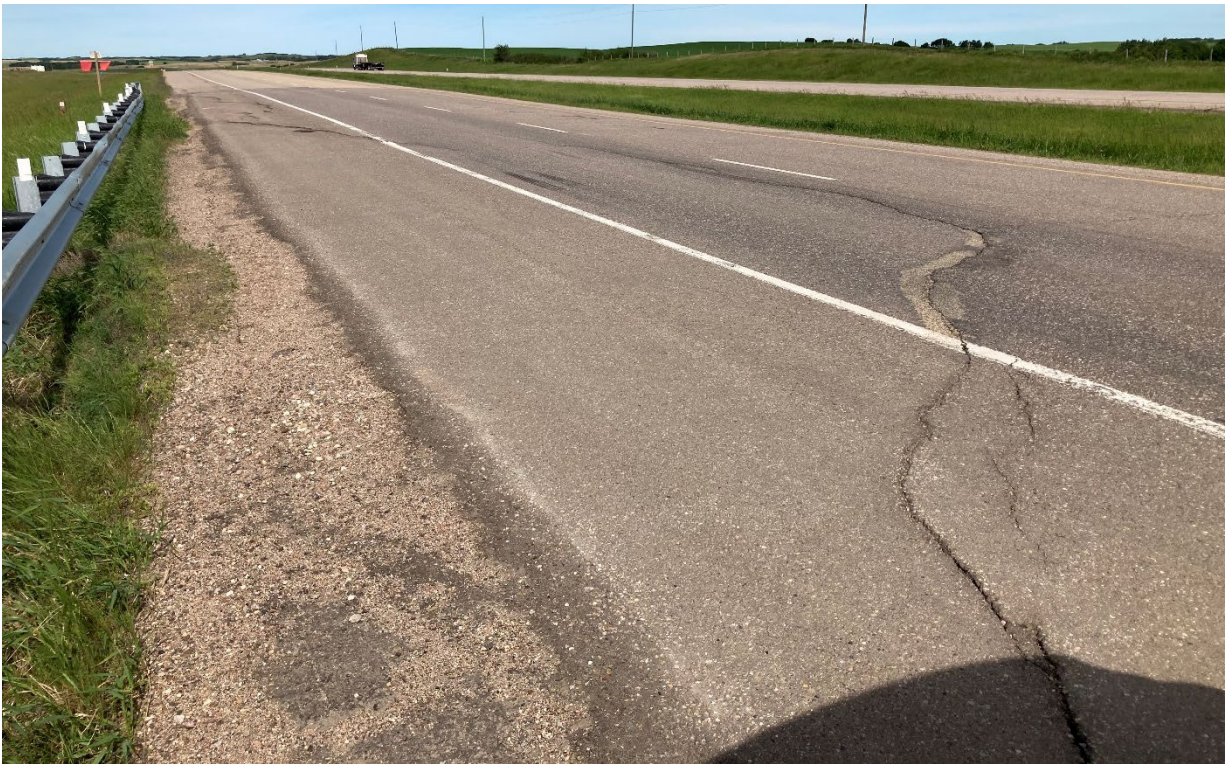
Photo 3 Settlement continuing to develop in the eastbound lane along the length of the H-pile wall. Photo taken June 22, 2020 facing northwest.

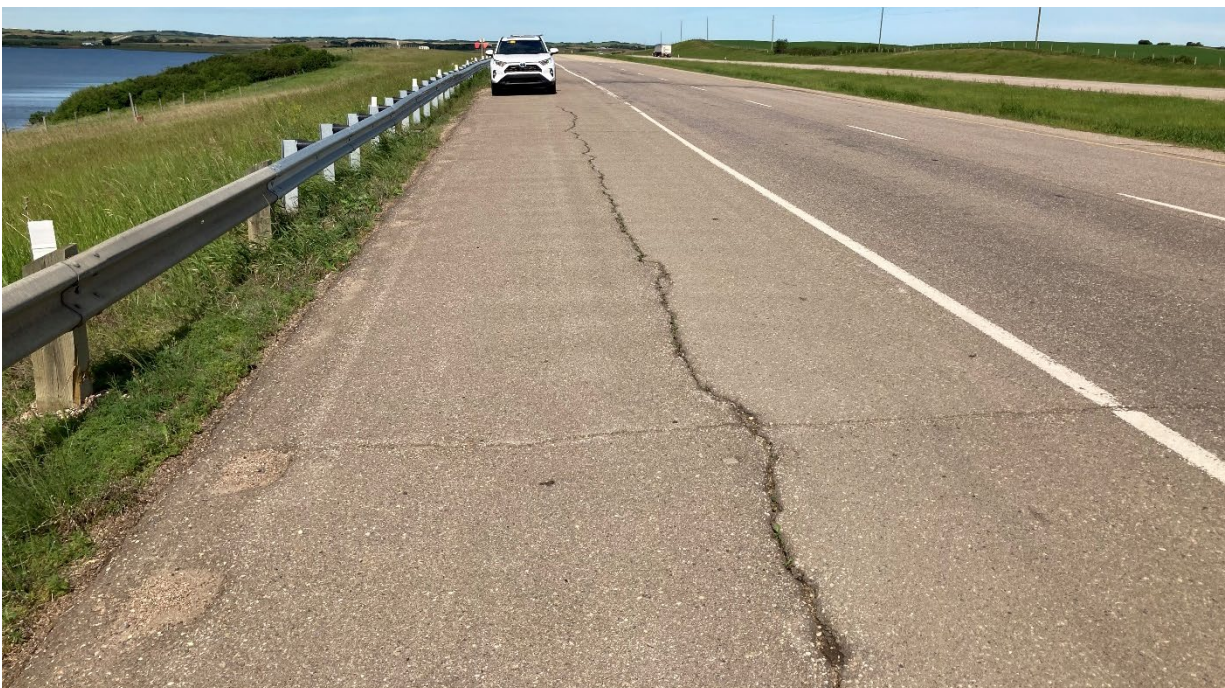
Photo 4 Asphalt cracking in the shoulder of the eastbound lane, east of the existing H-pile wall. Photo taken June 24, 2020 facing west.

- Extend pile wall to the east and west to encompass area where pavement cracks have extended past the ends of the H-pile wall. KCB's initial proposal for design of pile-wall extension was submitted to AT on September 12, 2019 and re-issued on April 27, 2020. The proposal included pile wall design for four central region sites (C007, C043, C048, and C065).
- A tender for multiple pile walls on four sites will be released in the fall of 2020 that will include the C007 site.
- After the pile wall is constructed the Highway Maintenance Contractor will replace the asphalt in the work area (approximately 130 m in length).
