September 12, 2022

Alberta Transportation  
4th Floor, Provincial Building  
4920 51 Street  
Red Deer, Alberta  
T4N 6K8

**CON0022160 Central Region GRMP Instrumentation Monitoring  
Site C007; H16:30, km 23.890 Kenilworth Lake Slide  
Section C – 2022 Spring Readings**

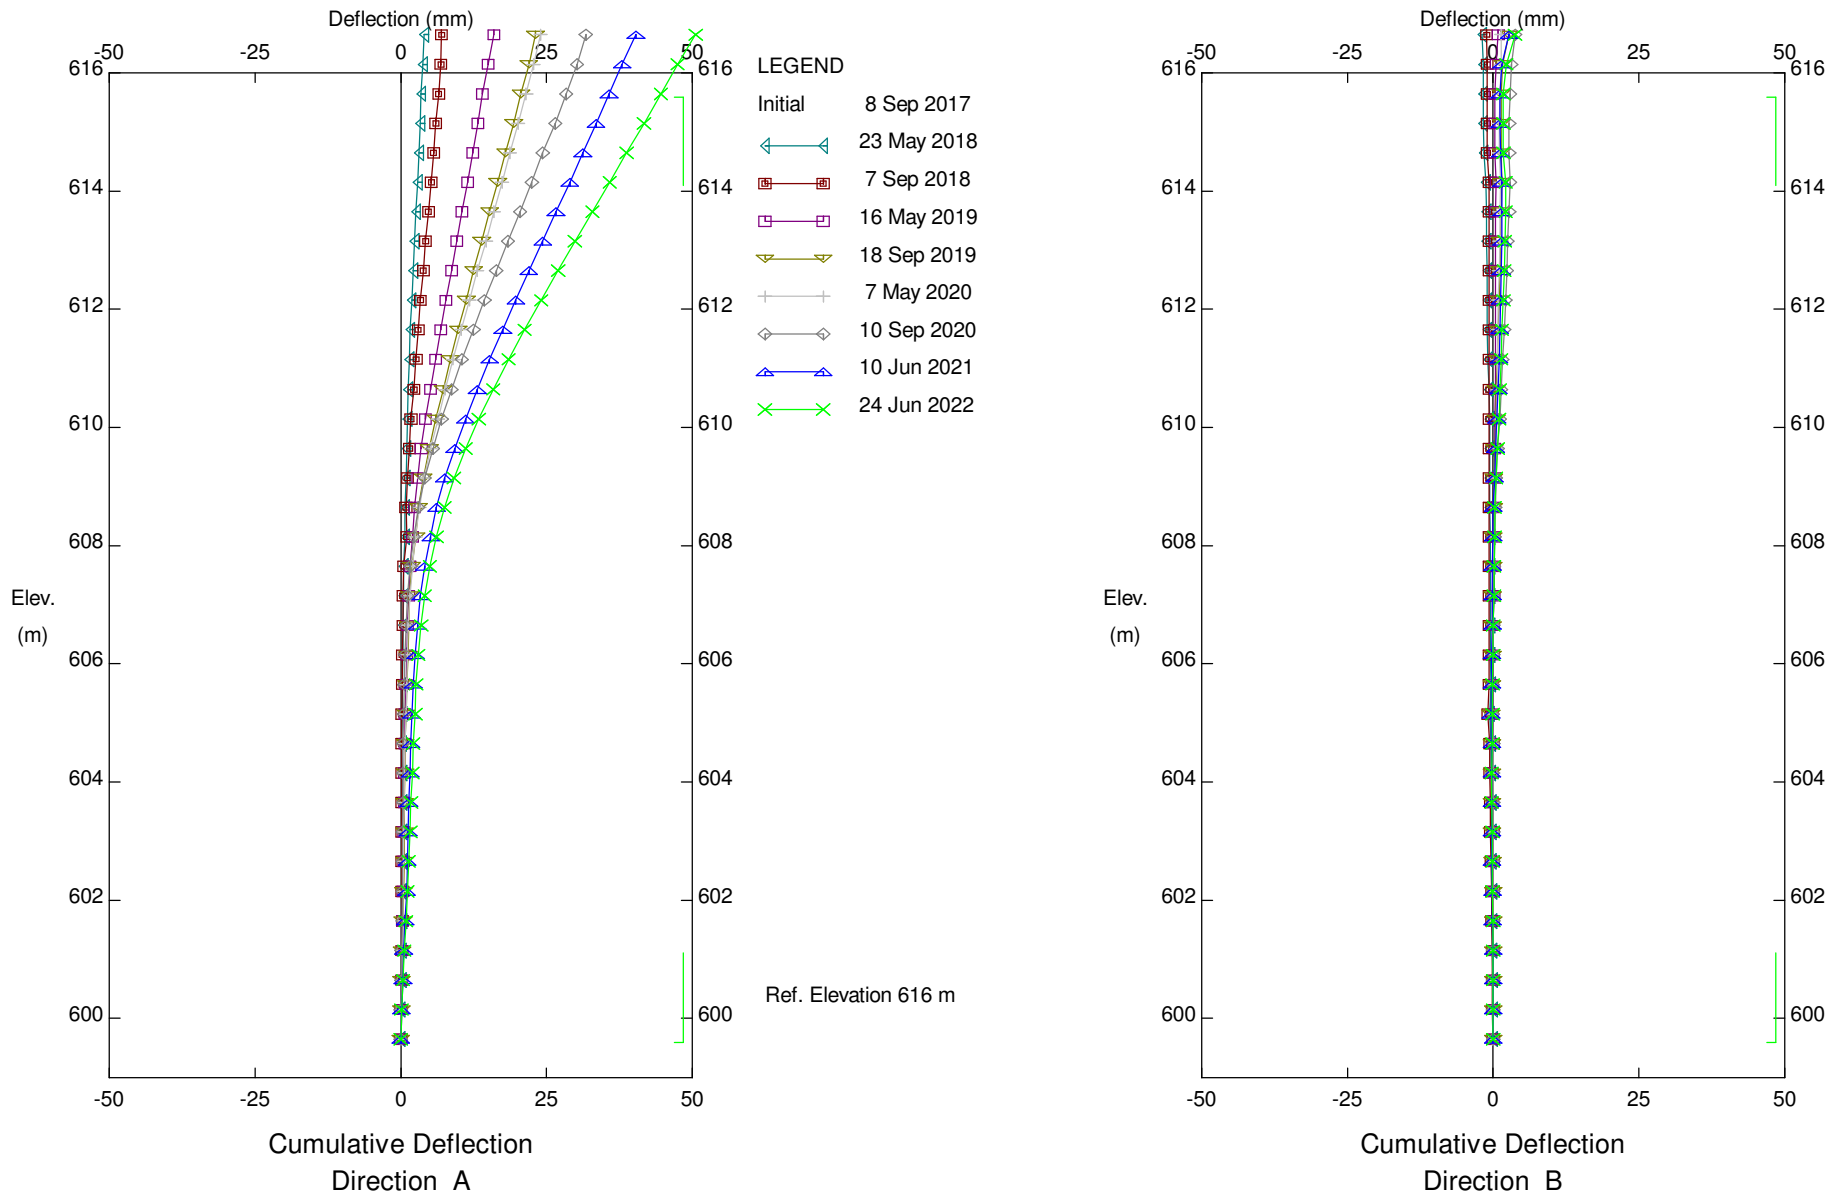
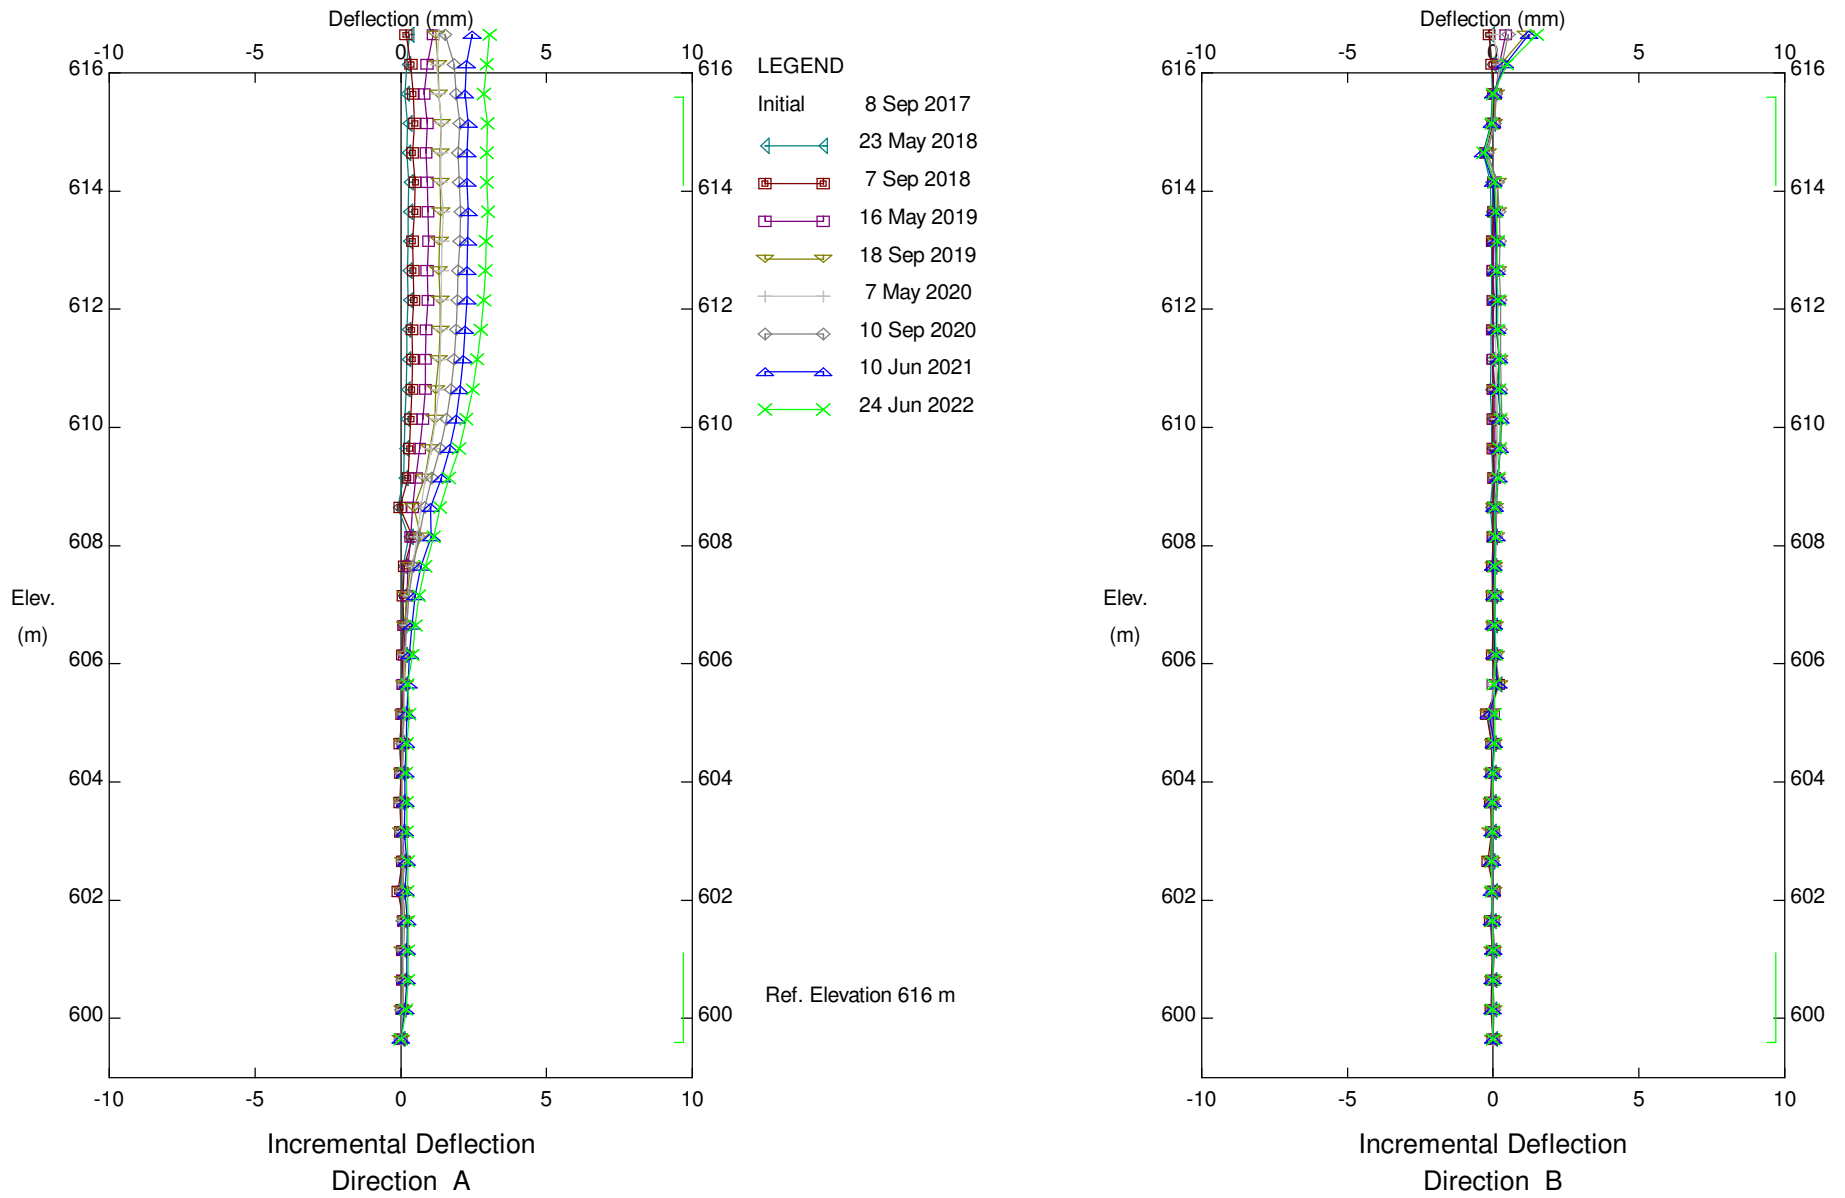
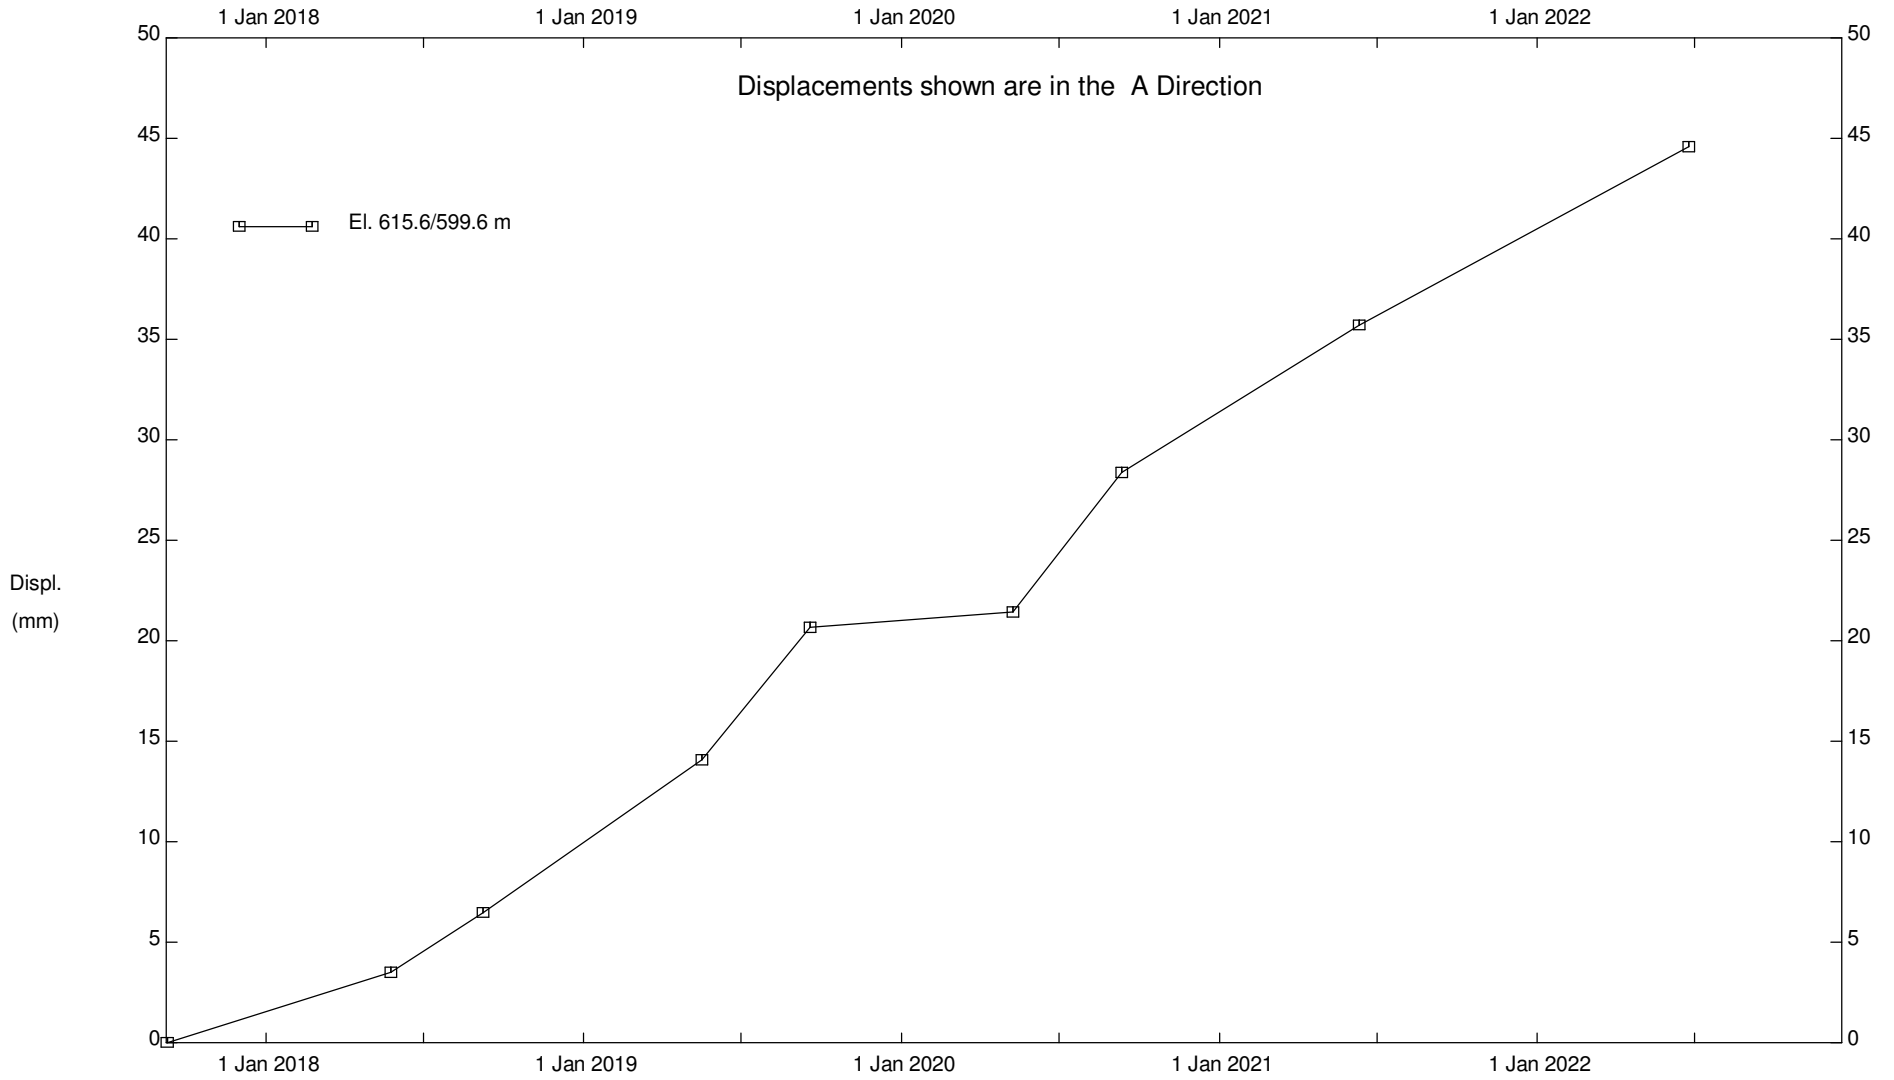
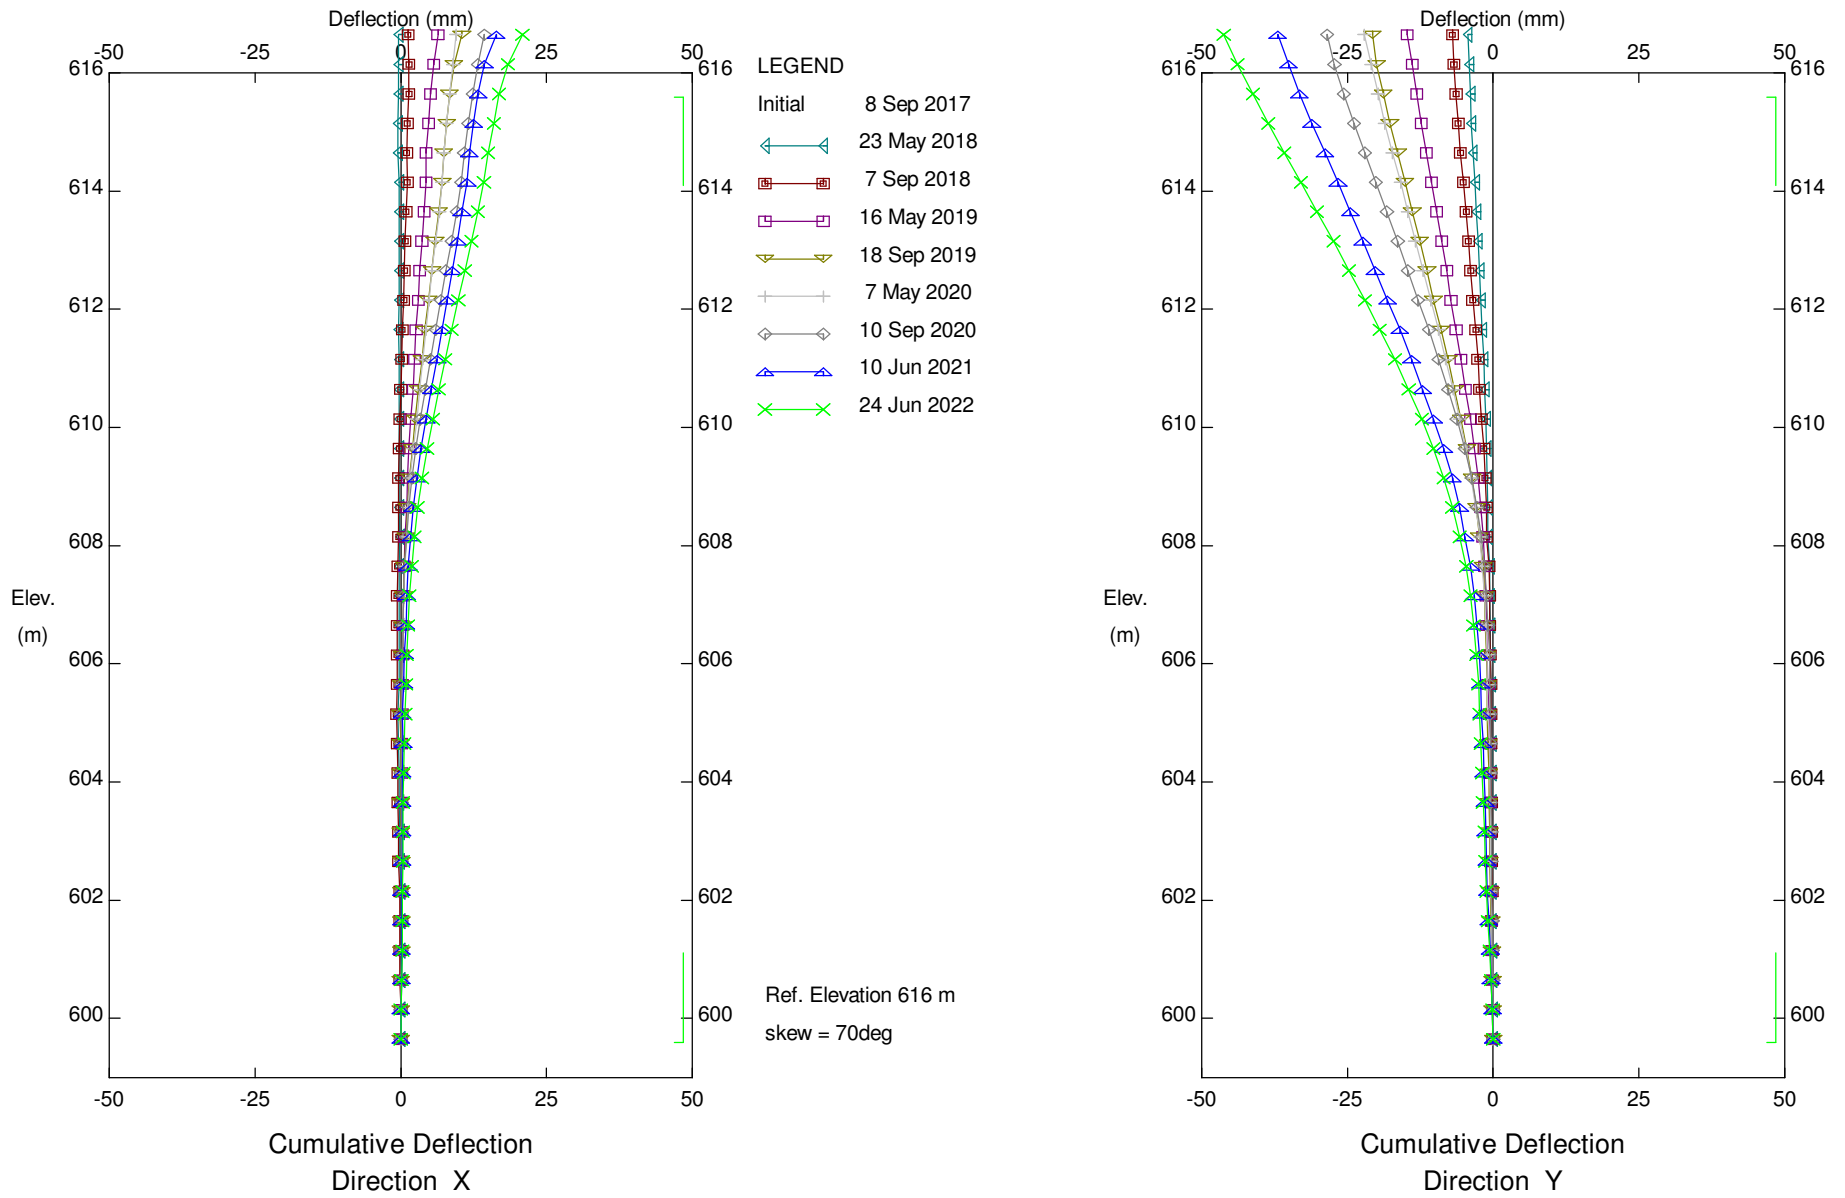
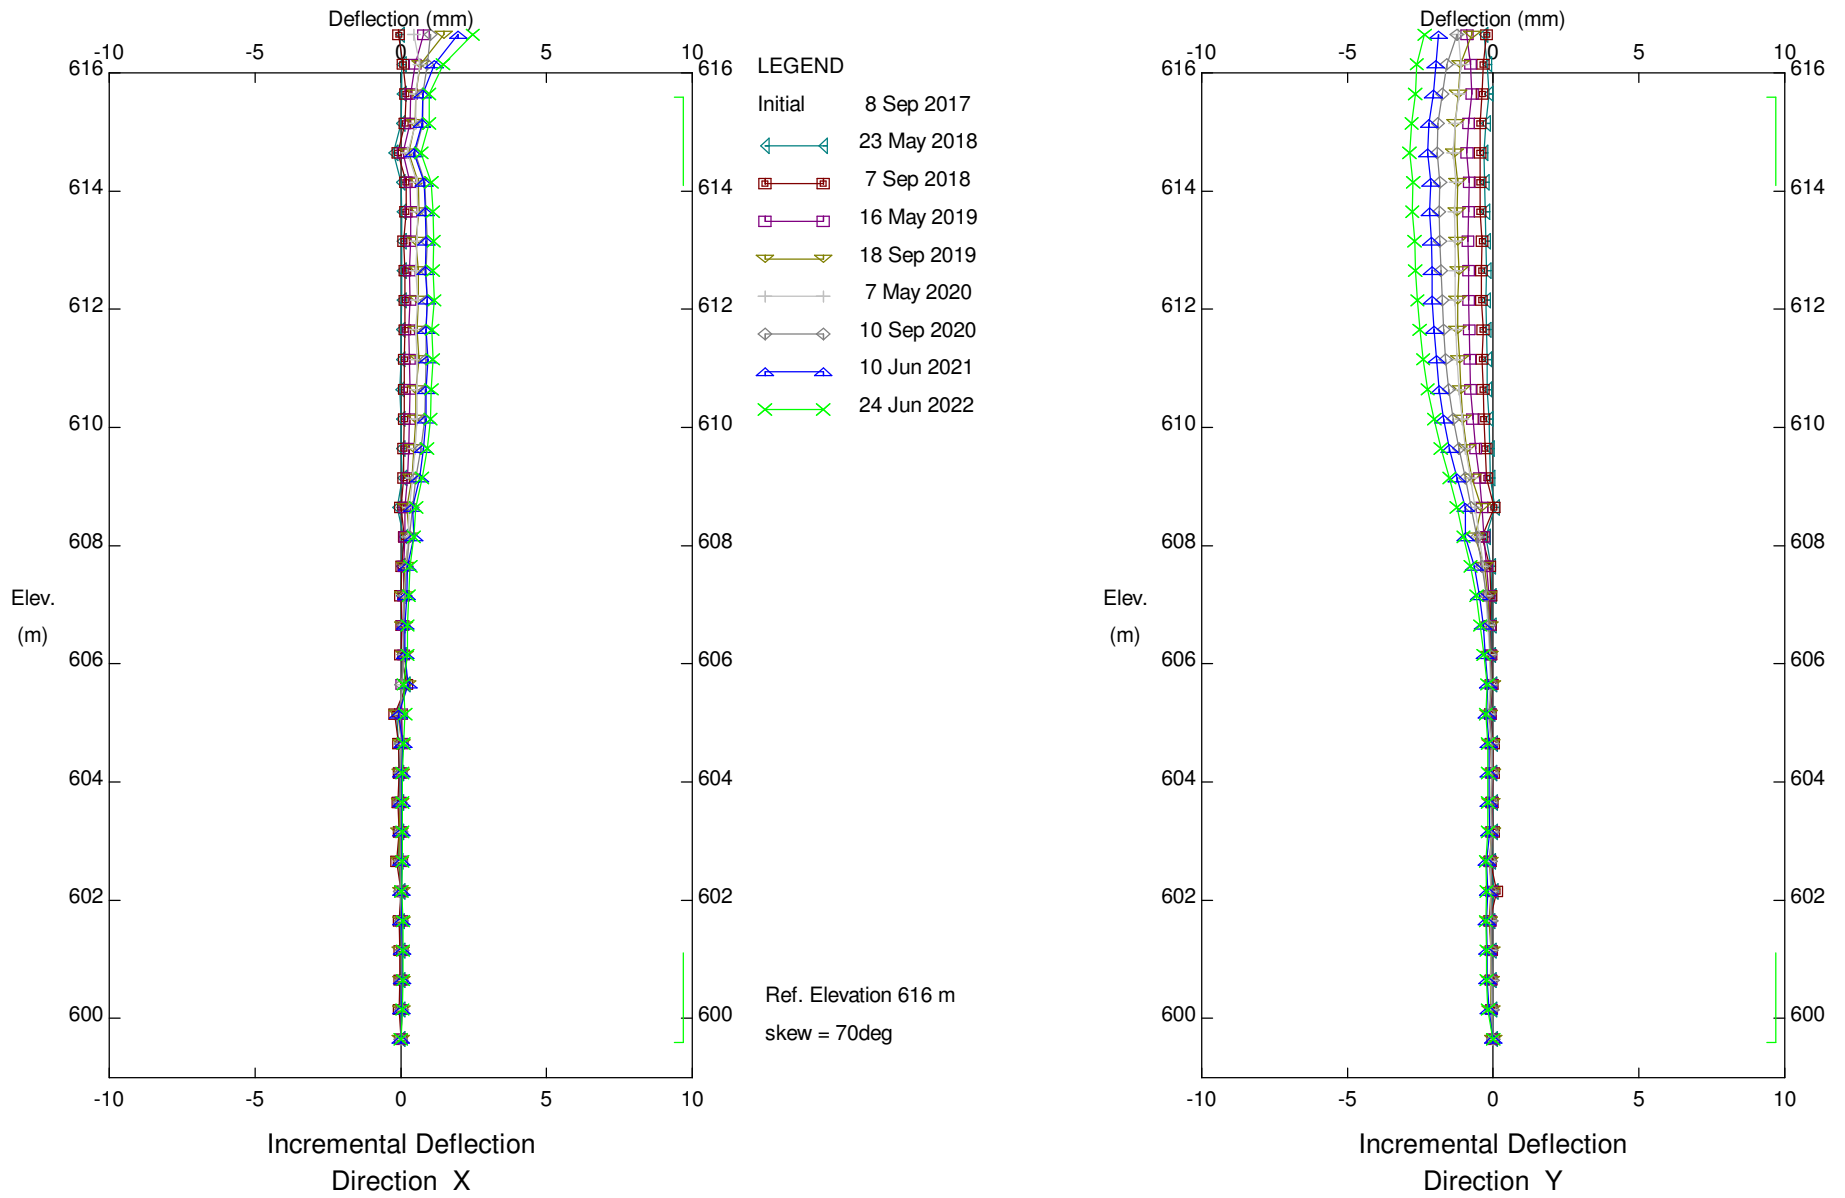
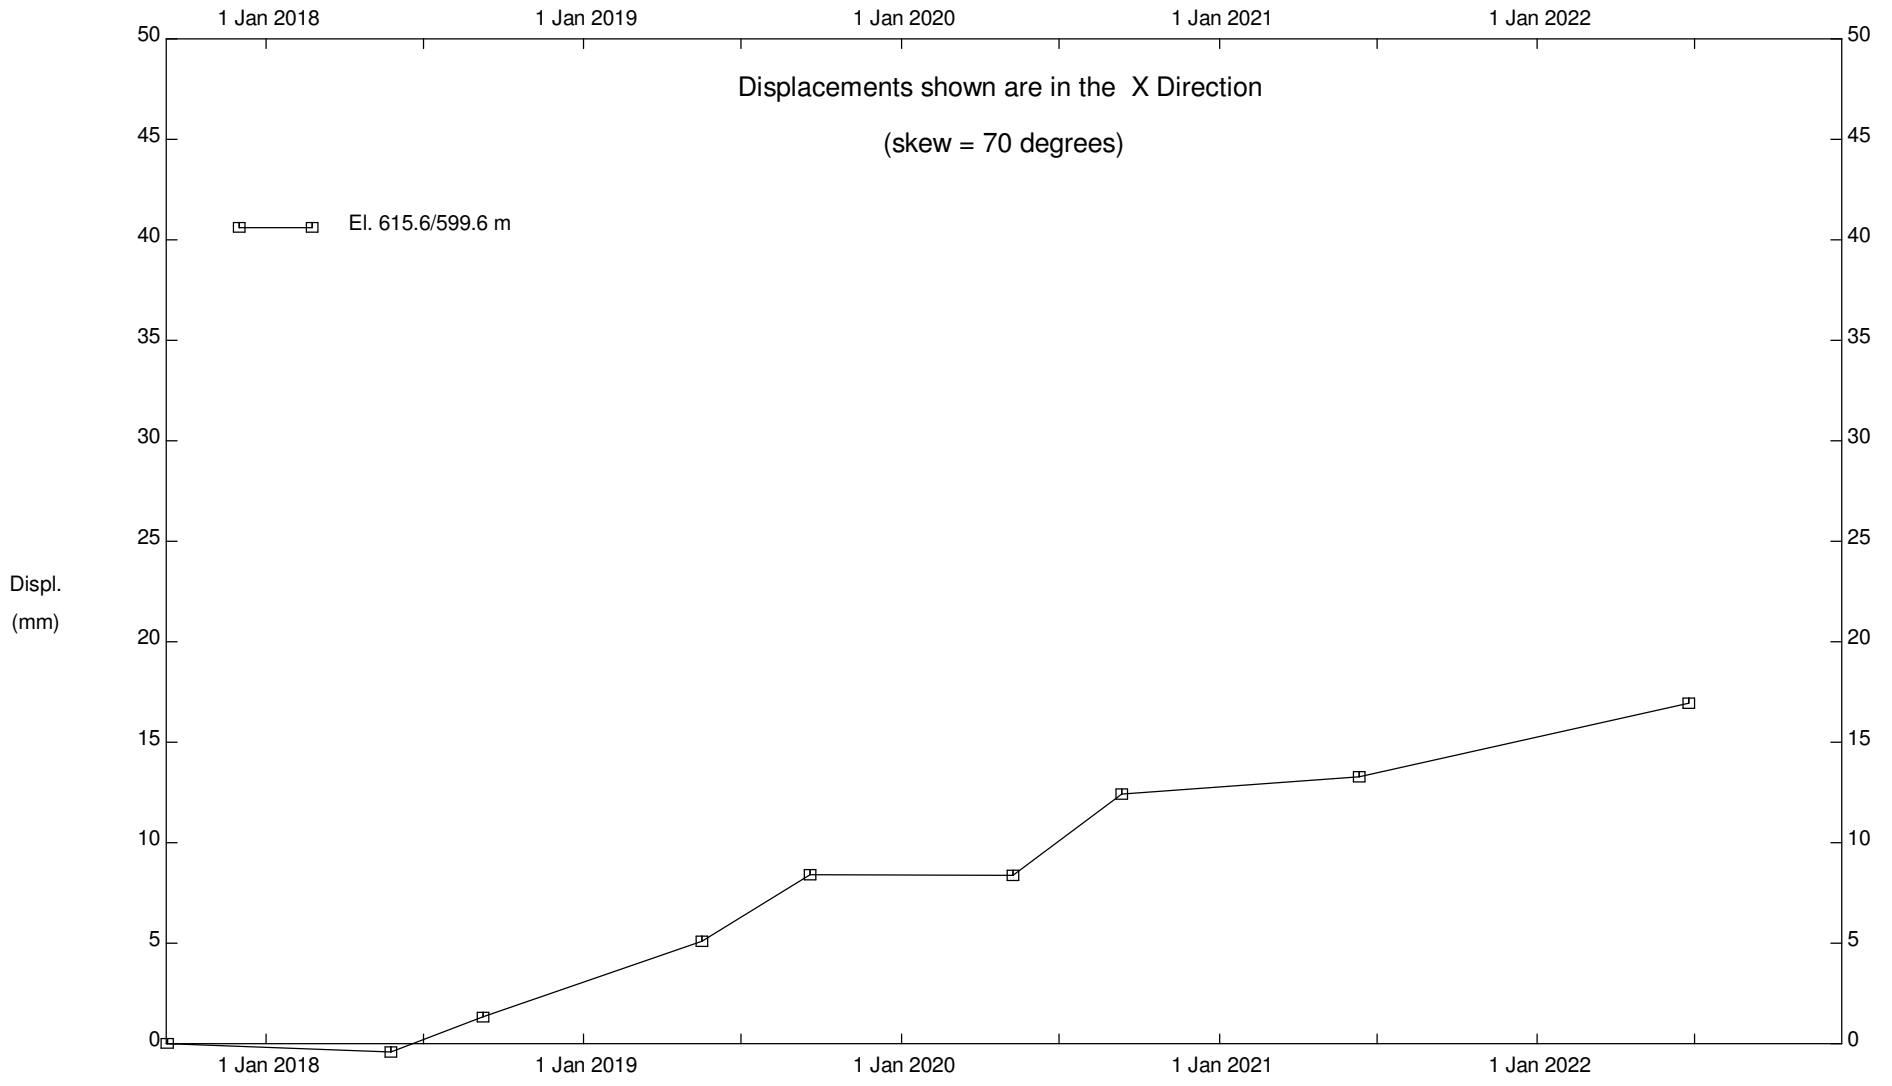
C007; H16:30, Kenilworth Lake Slide, Inclinator SI15-01

The June 2022 data obtained from SI15-01 and SI15-02 indicates that the top of the original H-pile wall has deflected between approximately 170 mm and 133 mm, respectively, since installation, with most of the displacement occurring before June 2015. The maximum rate of movement recorded in SI15-01 and SI15-02 occurred in June 2015, one month after the H-pile wall was installed and was approximately 655 mm/year and 293 mm/year, respectively. The rate of movement has since decreased and is now generally less than 10 mm/year.

Based on KCB's 2014 design report, the top 8 m of the original H-pile wall was expected to deflect up to 200 mm over the three to four years following installation (i.e., the estimated time for the H-pile wall to pick-up the load and stabilize the sliding mass). Based on the overall relatively slow rate of movement (less than 10 mm/year) recorded in these SIs since they were re-initialized in 2017, the H-pile wall will likely not reach 200 mm of deflection for another 5 to 10 years.

Before SI15-01 was re-initialized in September 2017, approximately 135 mm of distributed movement (i.e., from top to bottom of casing) was recorded in the B-direction. It is unknown if this movement was due to post installation SI casing flexure, shifting in the steel pocket, or twist of the H-piles that occurred when the H-pile wall picked up load while stabilizing the sliding mass. However, movements in the B-direction have attenuated and no additional movement has been recorded in the B-direction of this instrument since it was re-initialized.

Instrument re-initialized in September 2017 when the SI equipment was changed.
