September 12, 2022

Alberta Transportation  
4th Floor, Provincial Building  
4920 51 Street  
Red Deer, Alberta  
T4N 6K8

**CON0022160 Central Region GRMP Instrumentation Monitoring  
Site C007; H16:30, km 23.890 Kenilworth Lake Slide  
Section C – 2022 Spring Readings**

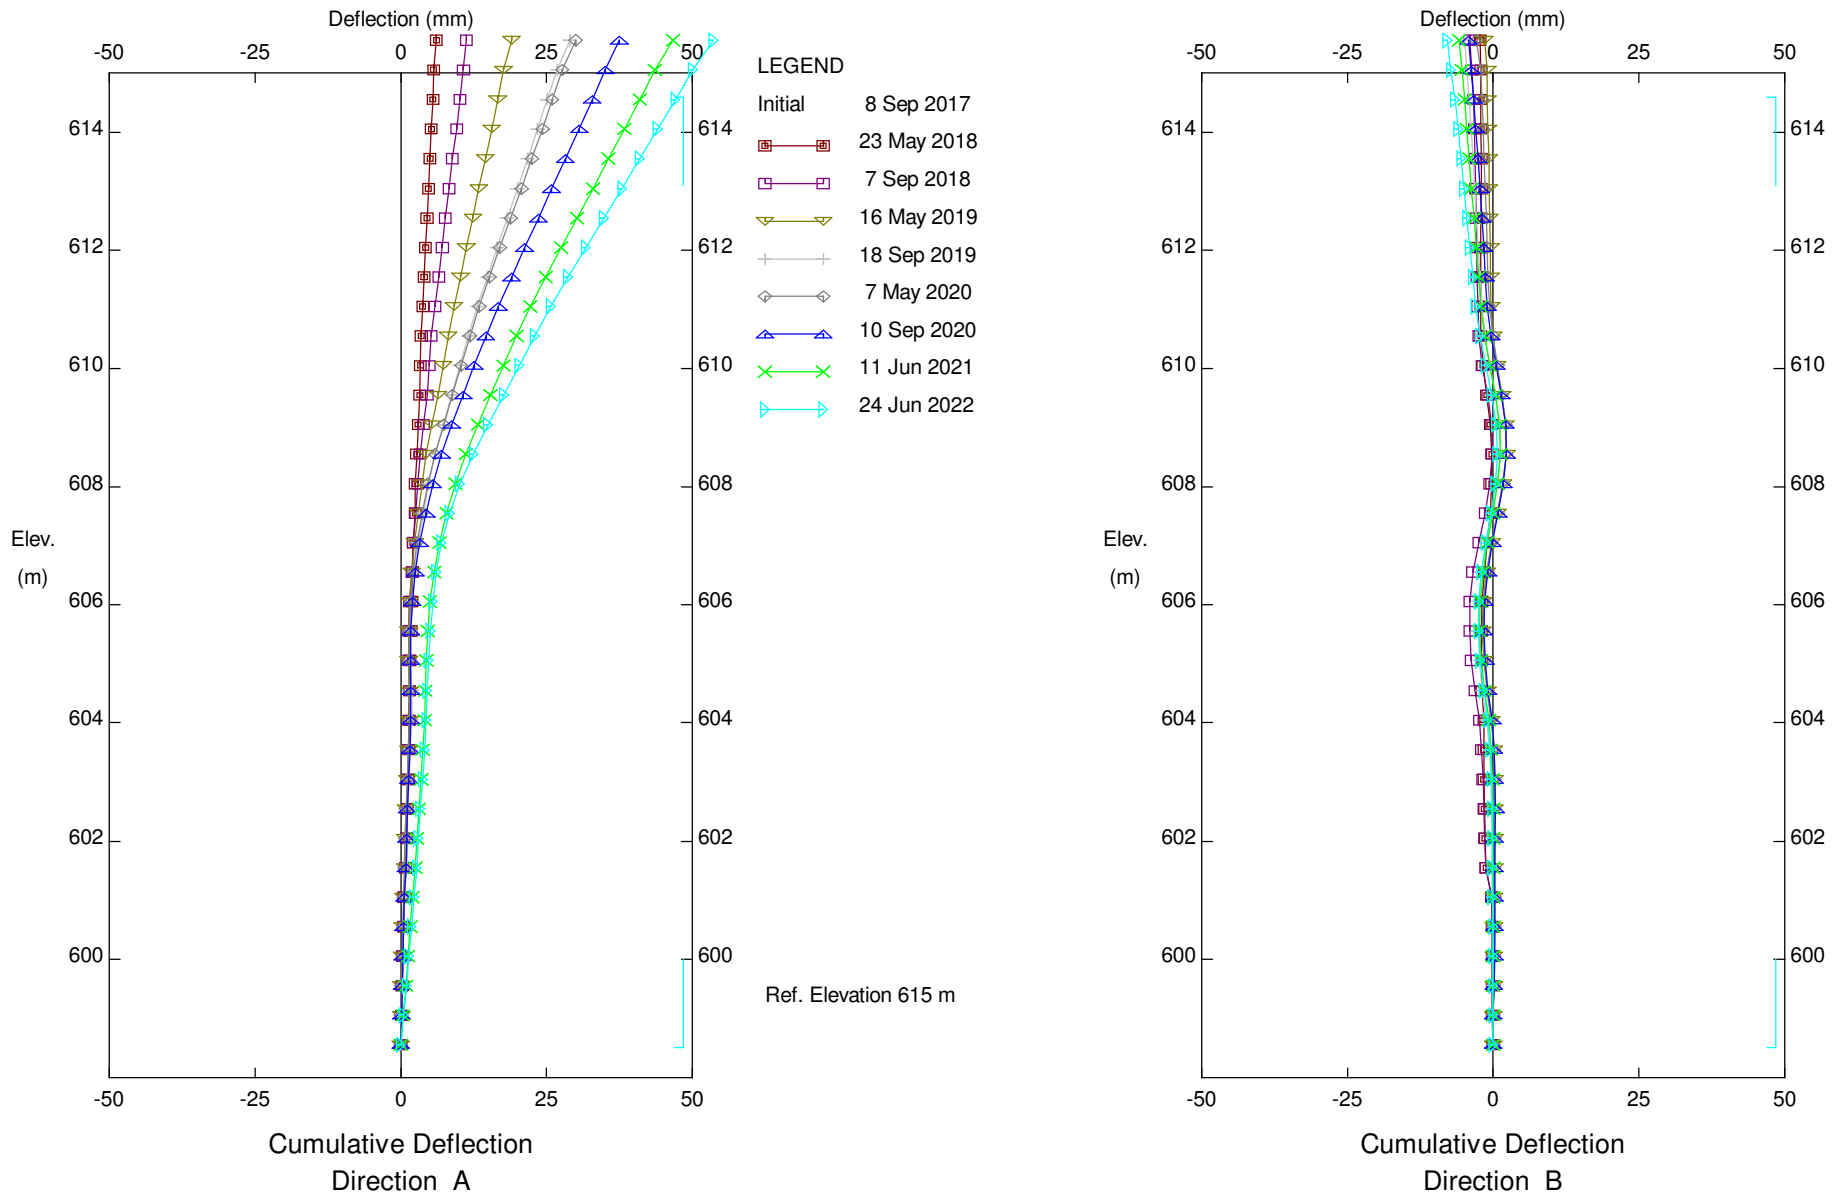
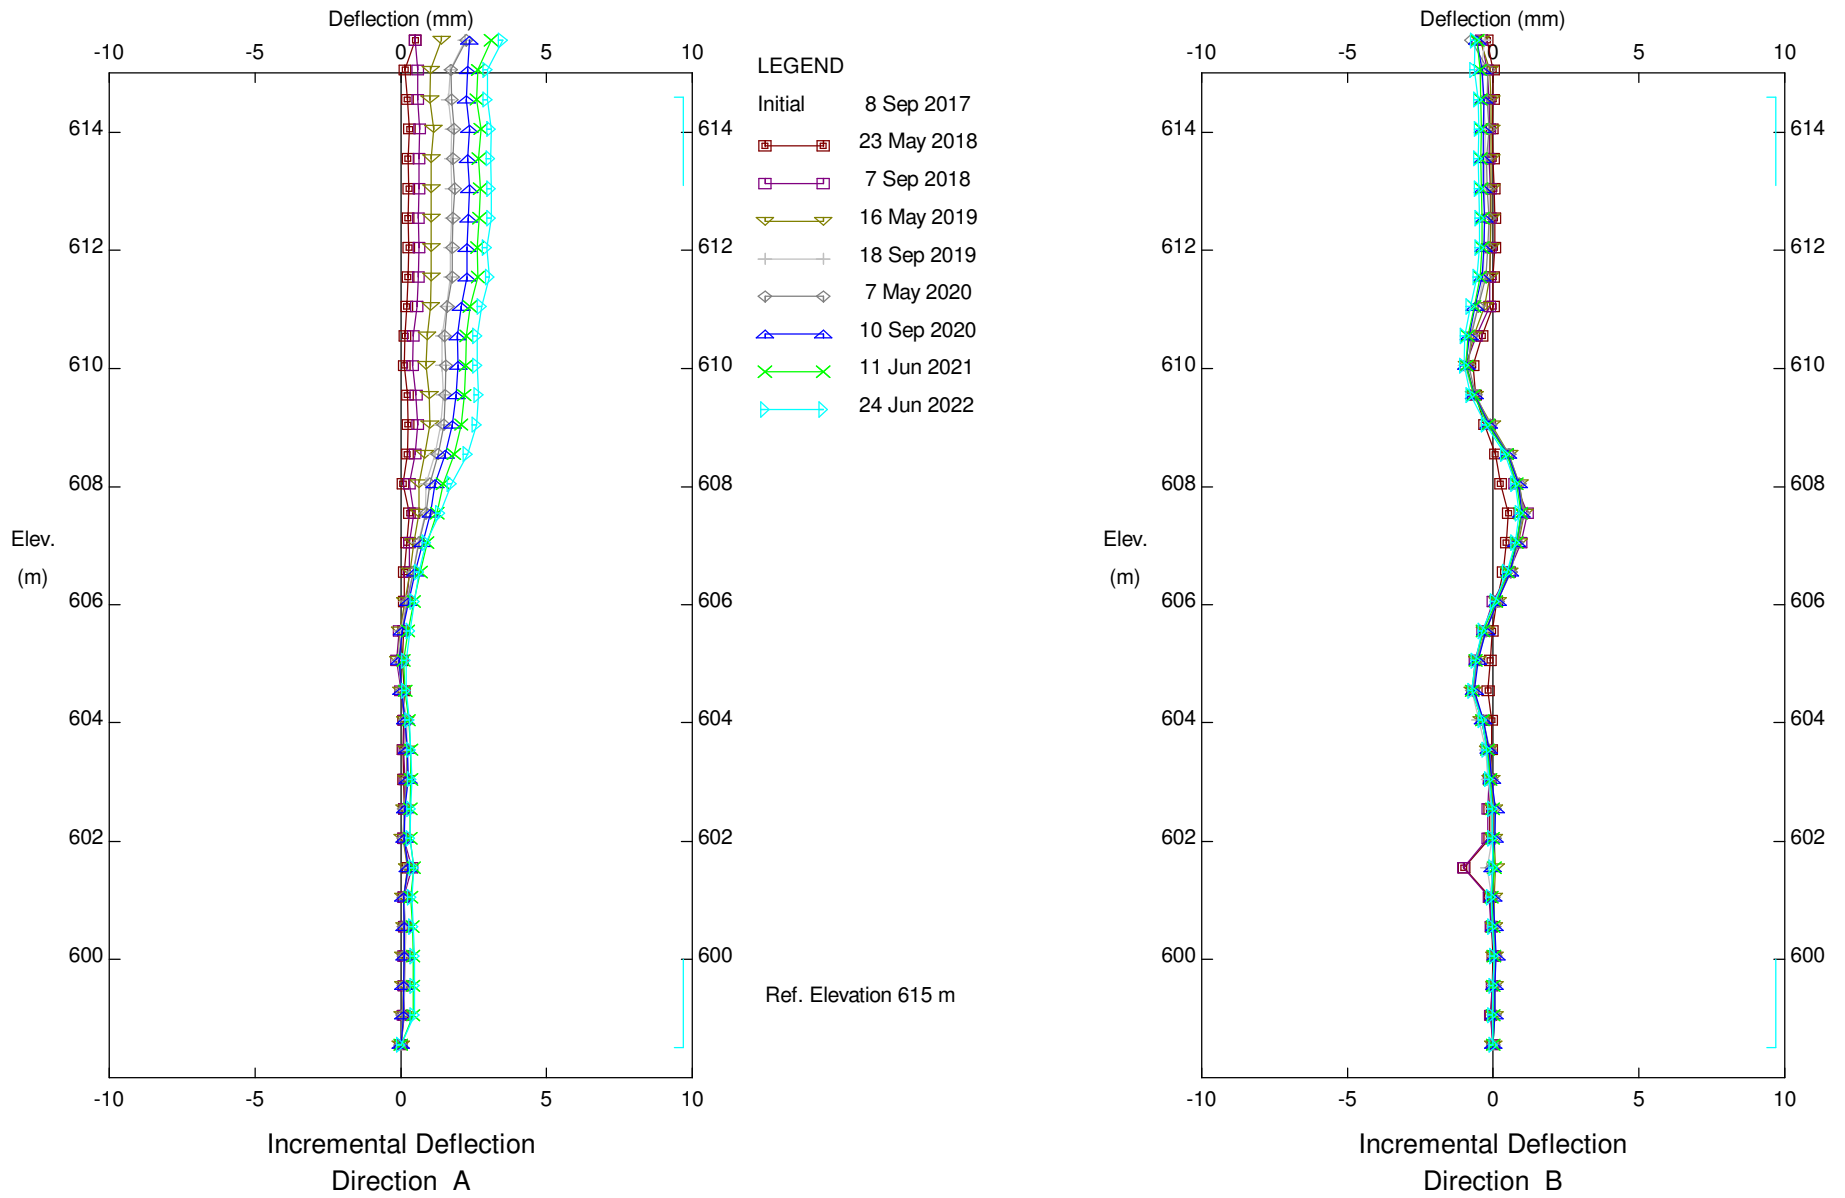
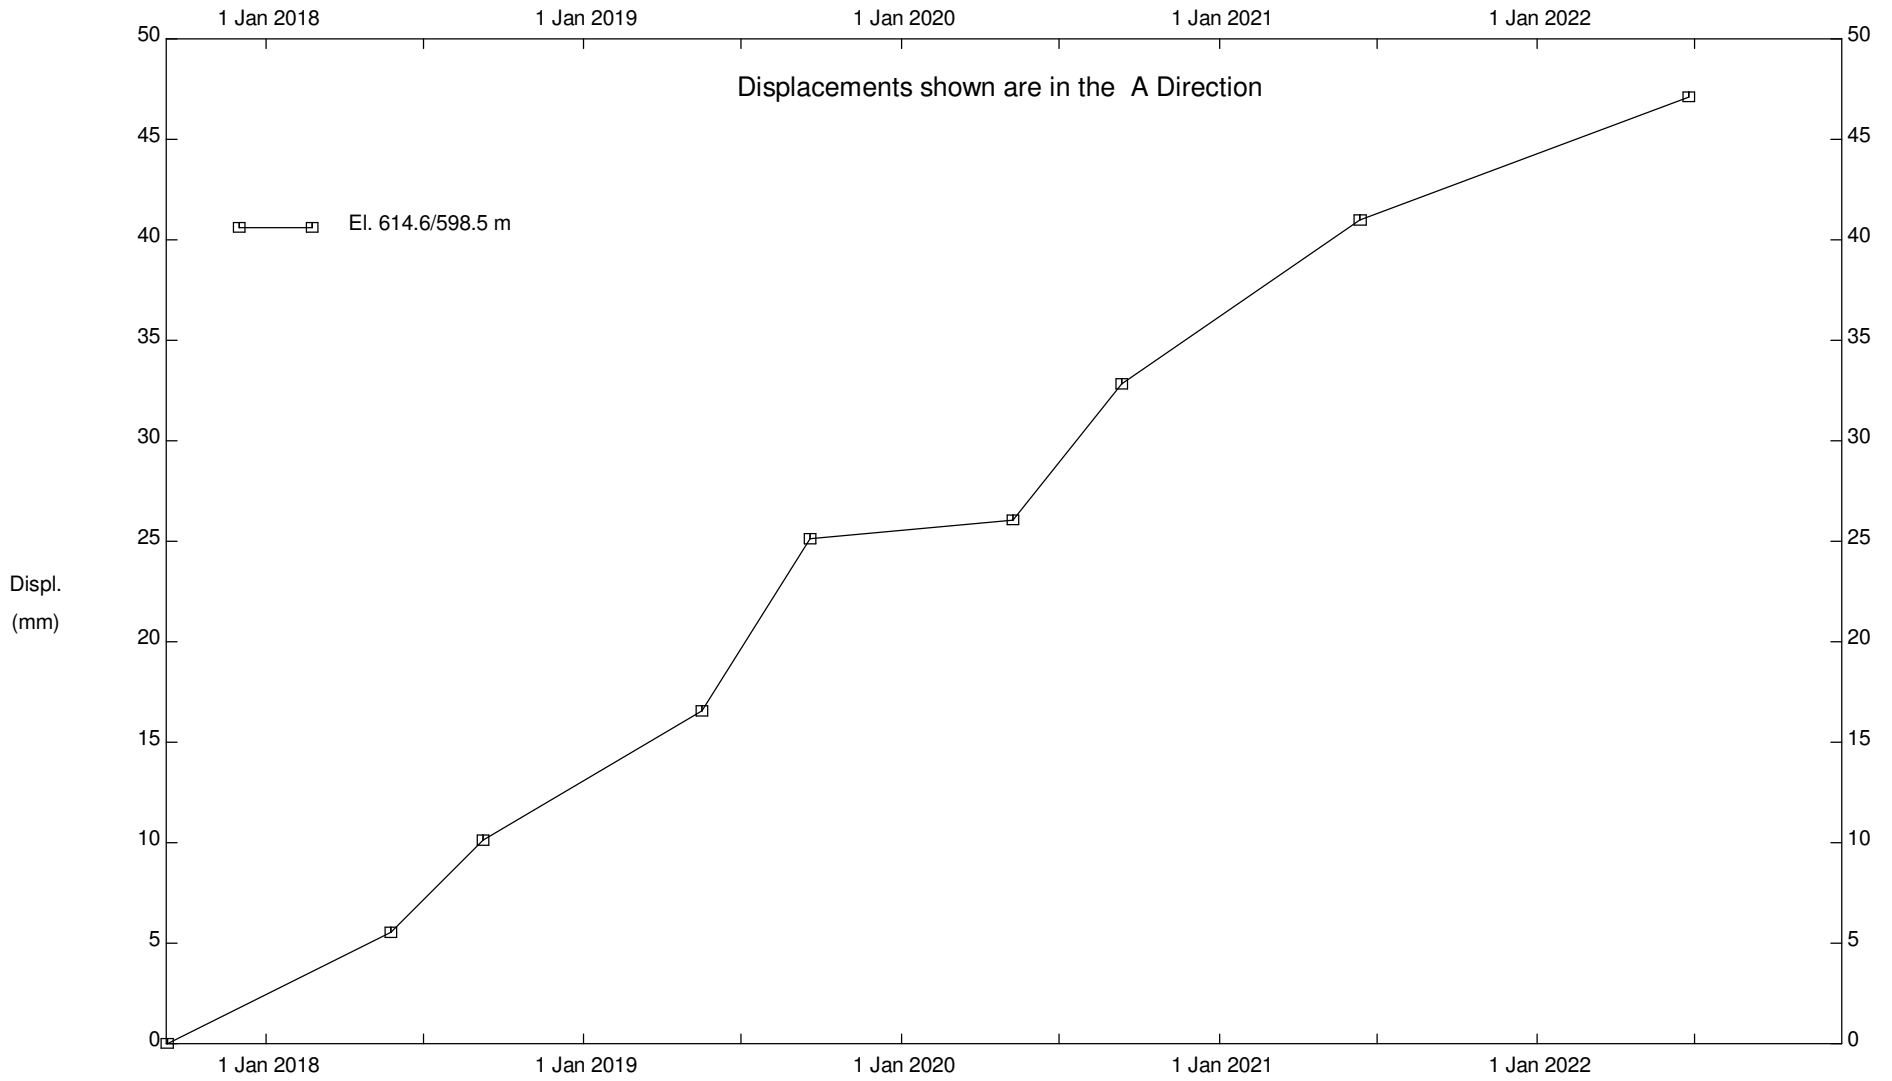
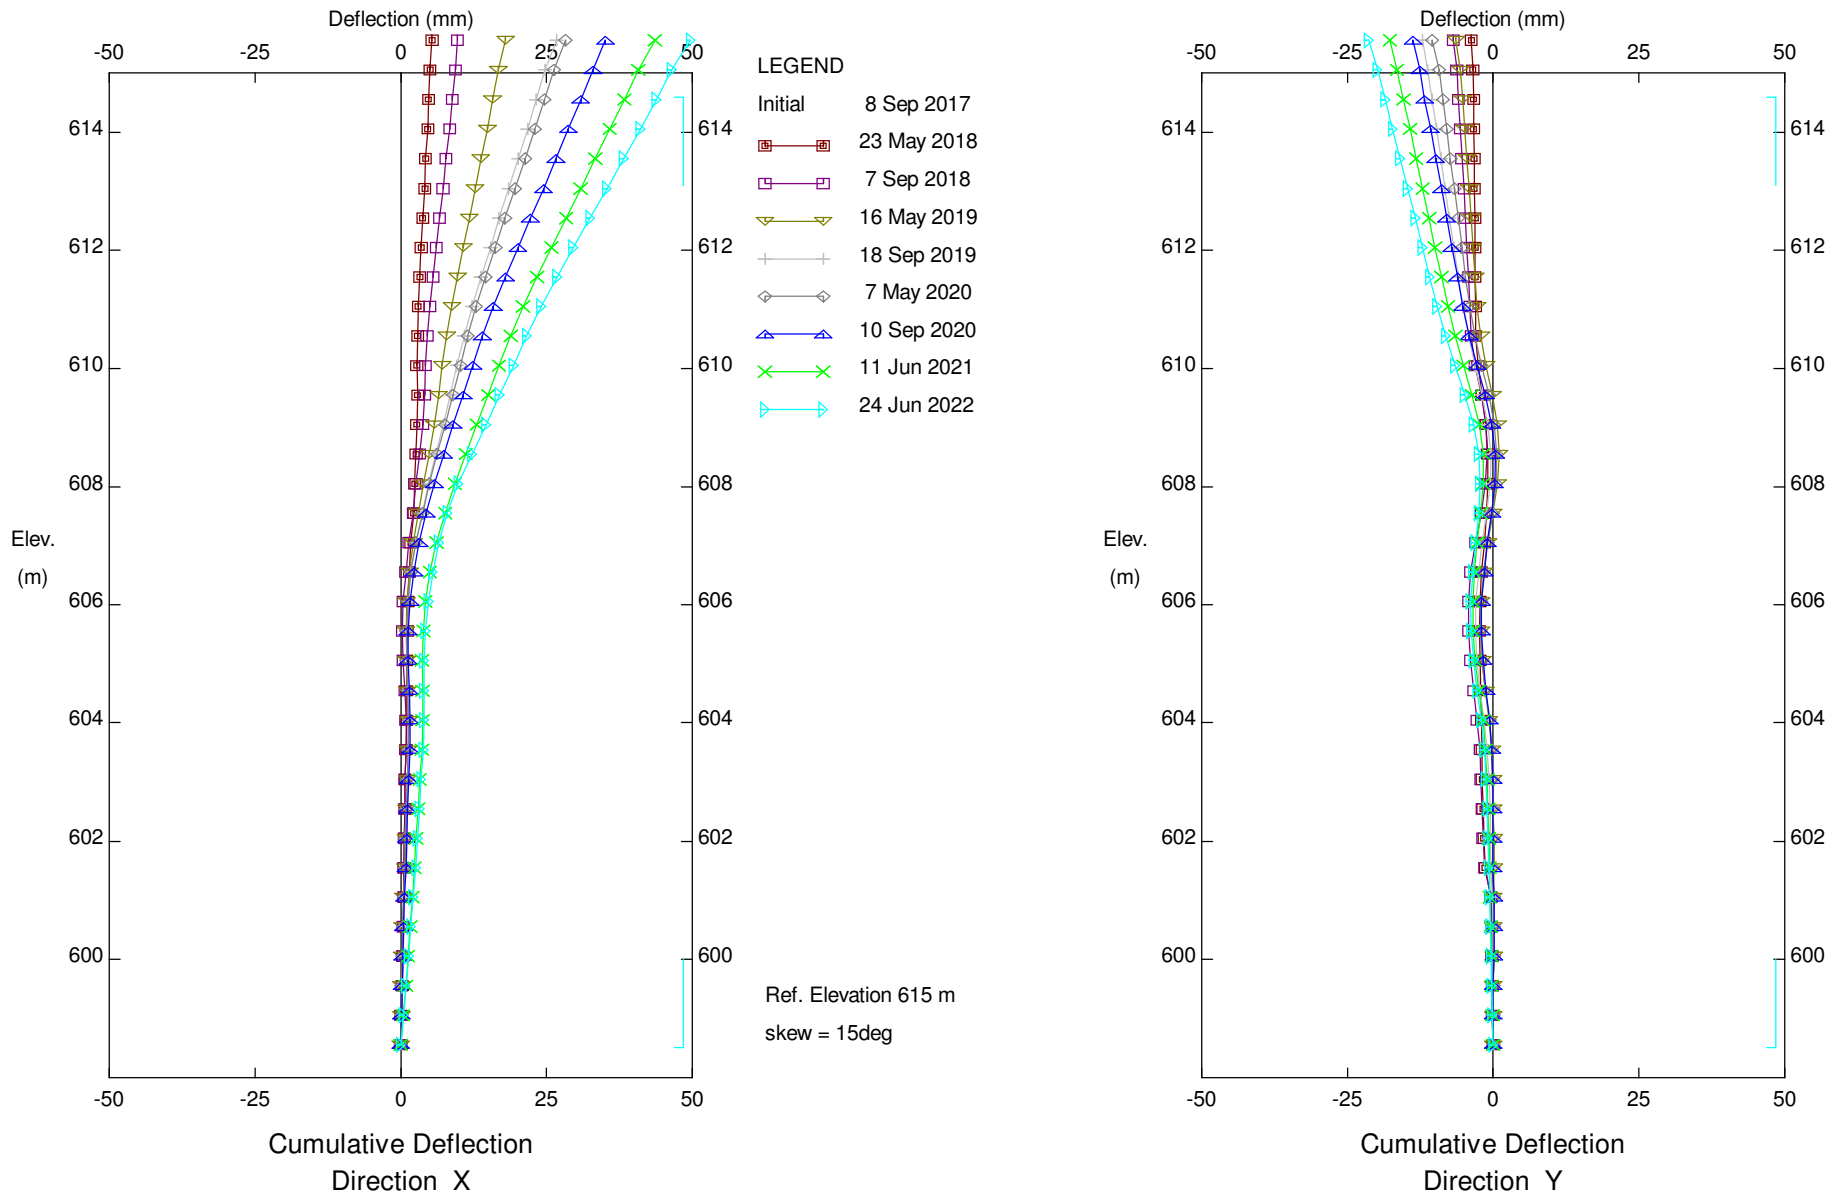
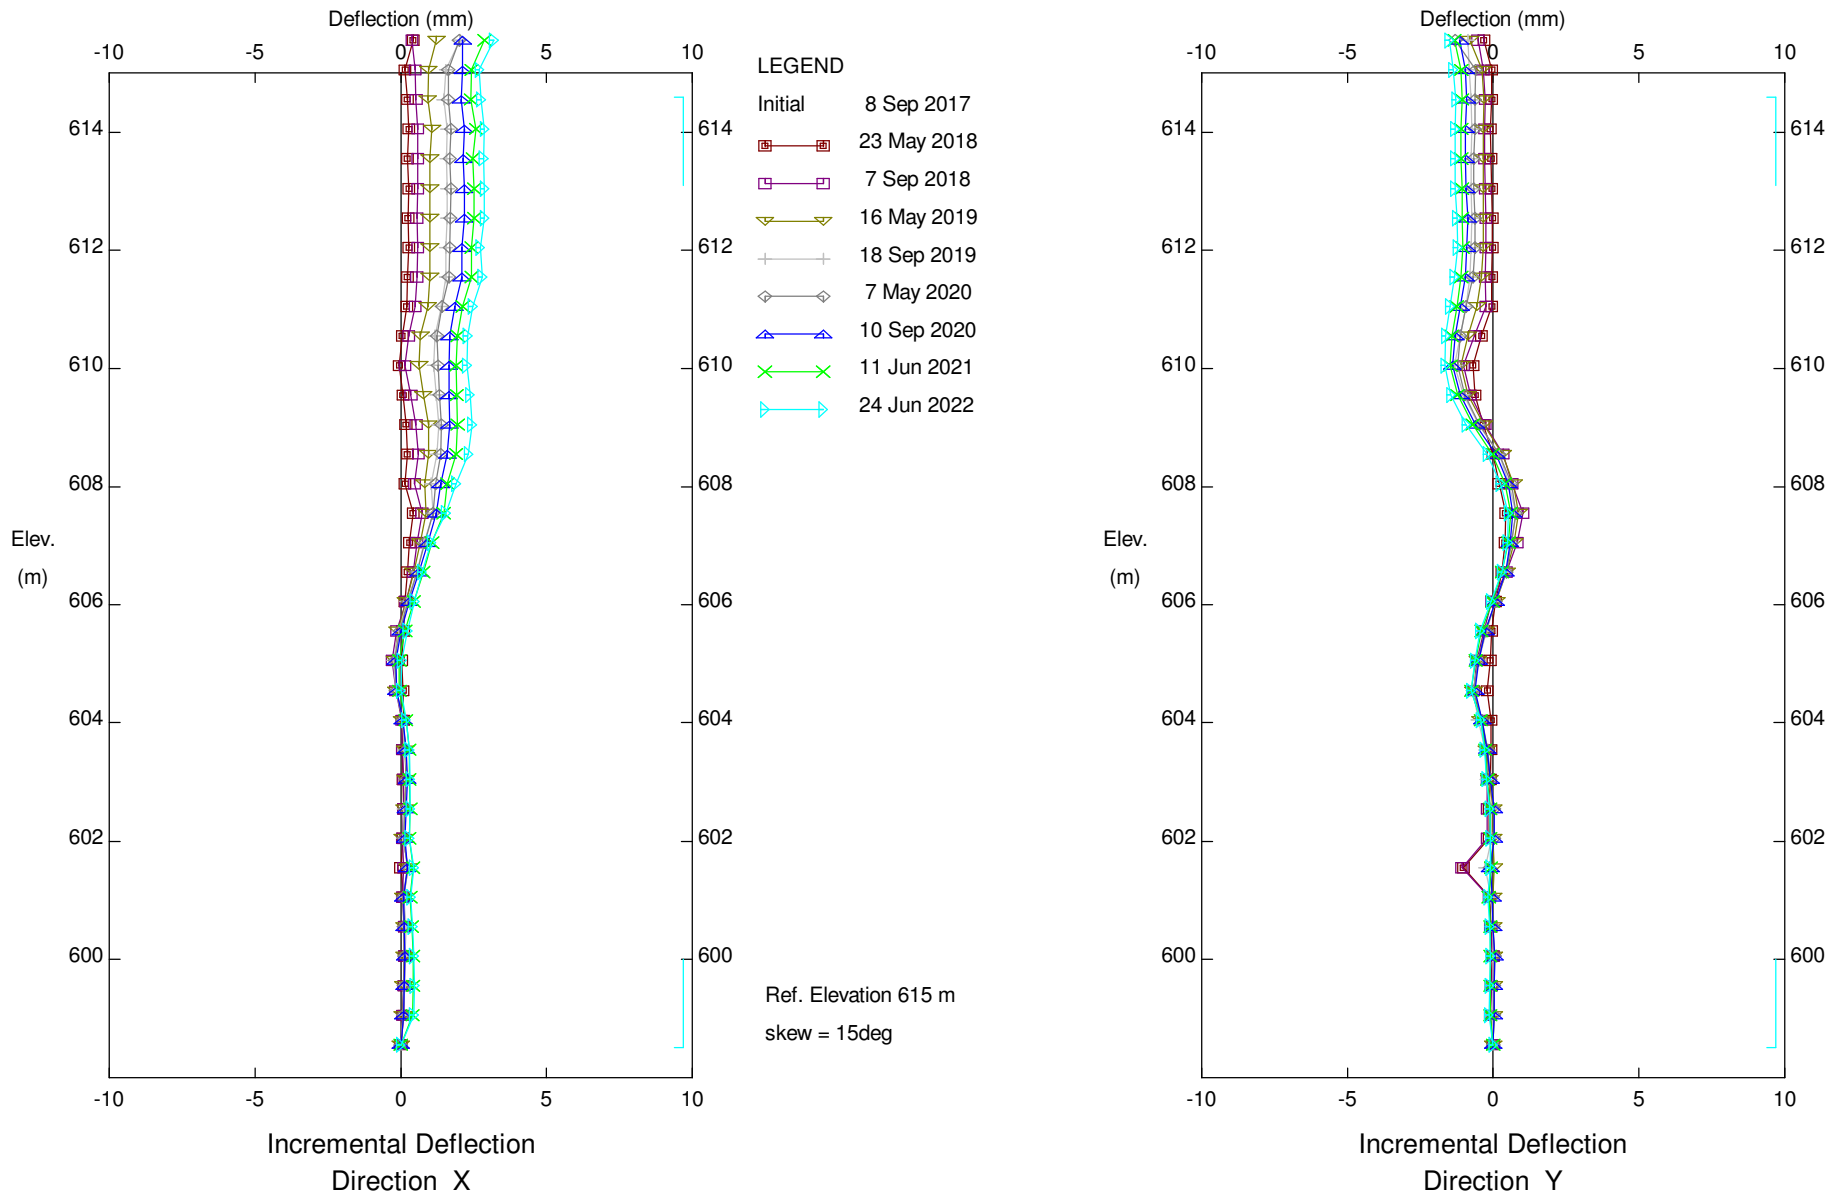
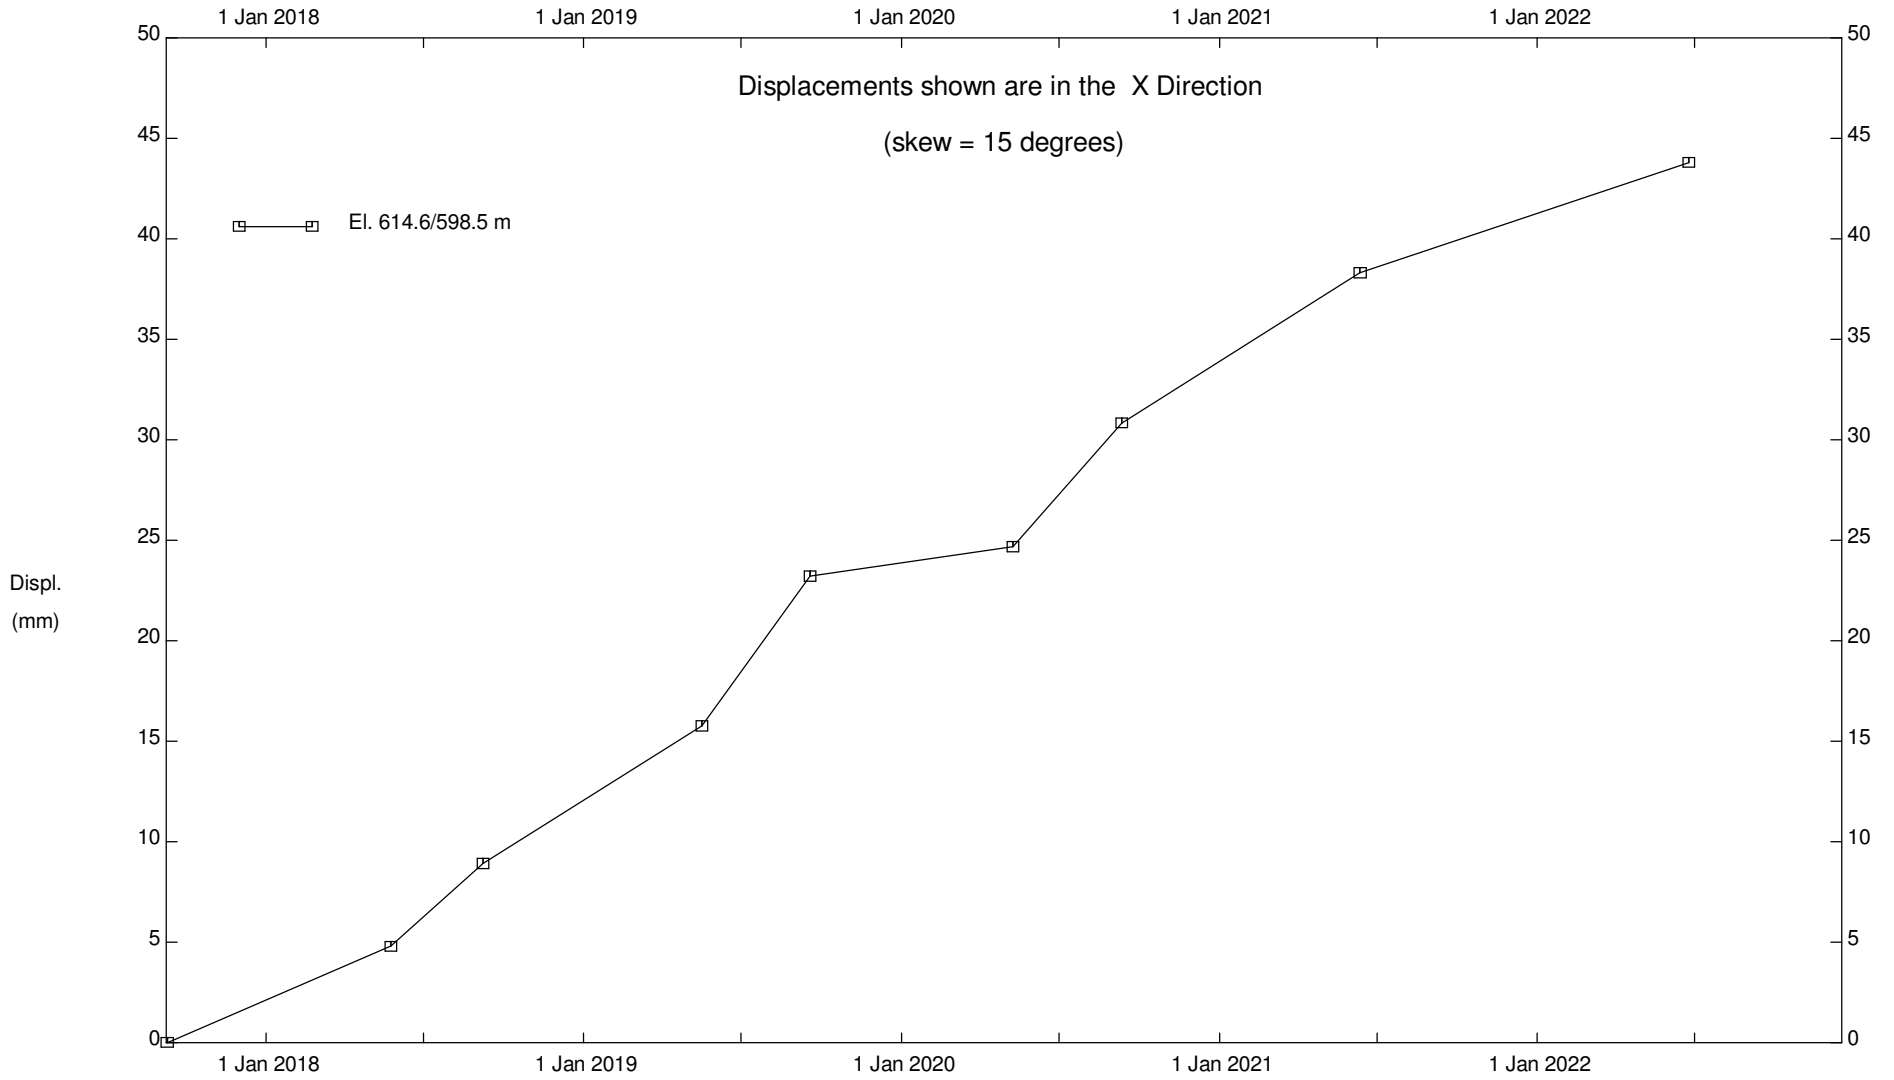
C007; H16:30, Kenilworth Lake Slide, Inclinometer SI15-02

The June 2022 data obtained from SI15-01 and SI15-02 indicates that the top of the original H-pile wall has deflected between approximately 170 mm and 133 mm, respectively, since installation, with most of the displacement occurring before June 2015. The maximum rate of movement recorded in SI15-01 and SI15-02 occurred in June 2015, one month after the H-pile wall was installed and was approximately 655 mm/year and 293 mm/year, respectively. The rate of movement has since decreased and is now generally less than 10 mm/year.

Based on KCB's 2014 design report, the top 8 m of the original H-pile wall was expected to deflect up to 200 mm over the three to four years following installation (i.e., the estimated time for the H-pile wall to pick-up the load and stabilize the sliding mass). Based on the overall relatively slow rate of movement (less than 10 mm/year) recorded in these SIs since they were re-initialized in 2017, the H-pile wall will likely not reach 200 mm of deflection for another 5 to 10 years.

Instrument re-initialized in September 2017 when the SI equipment was changed.

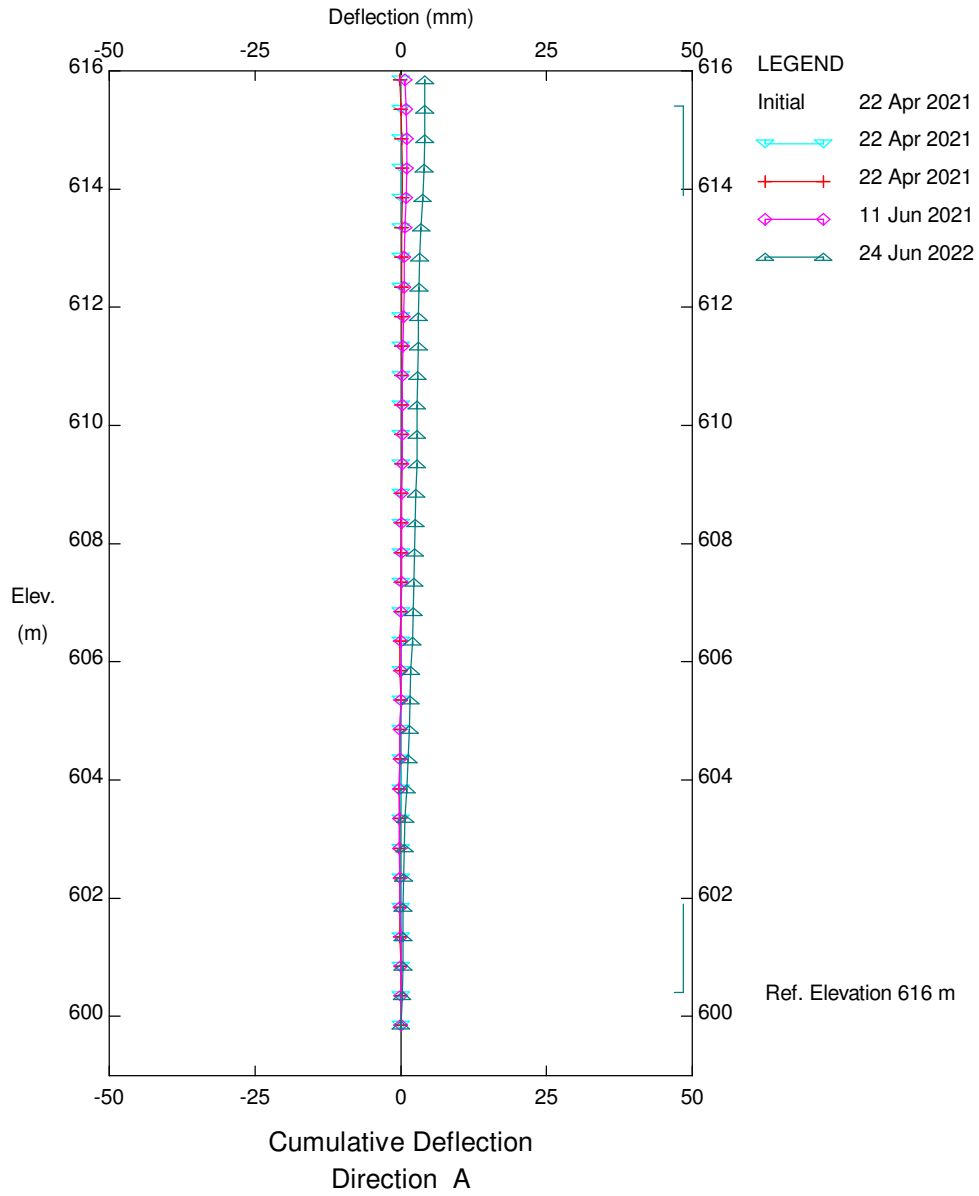
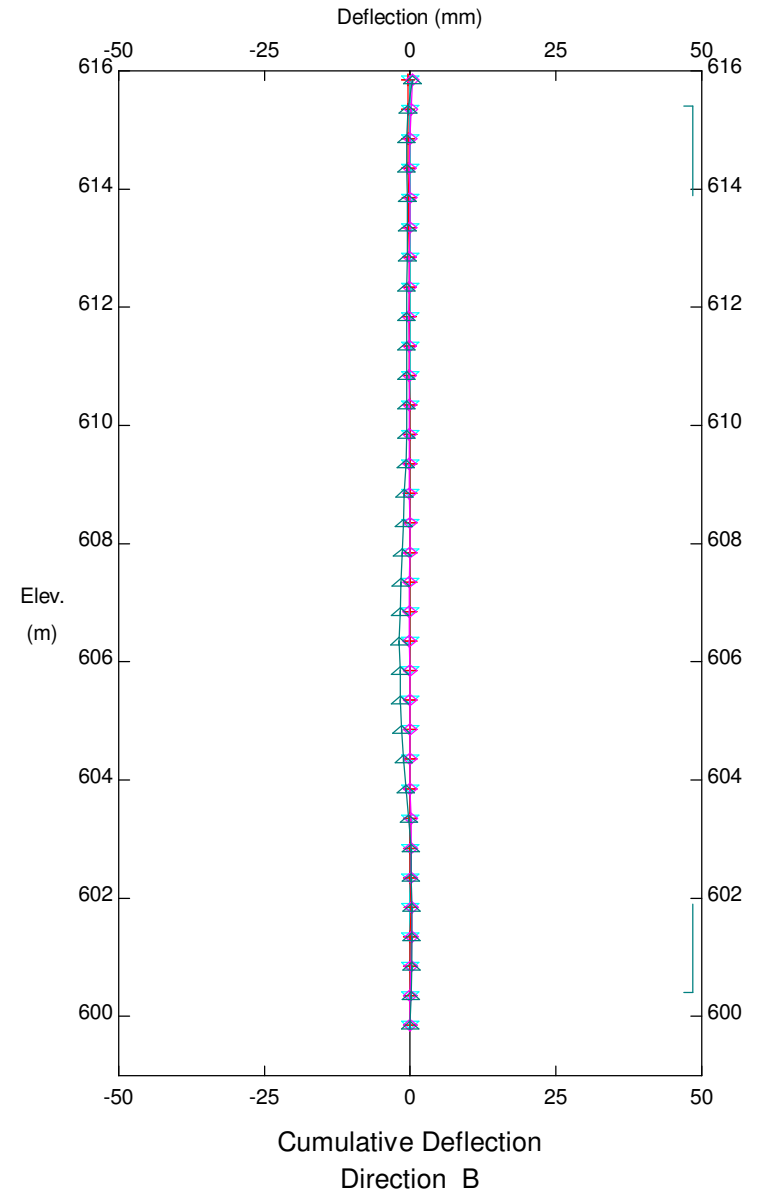
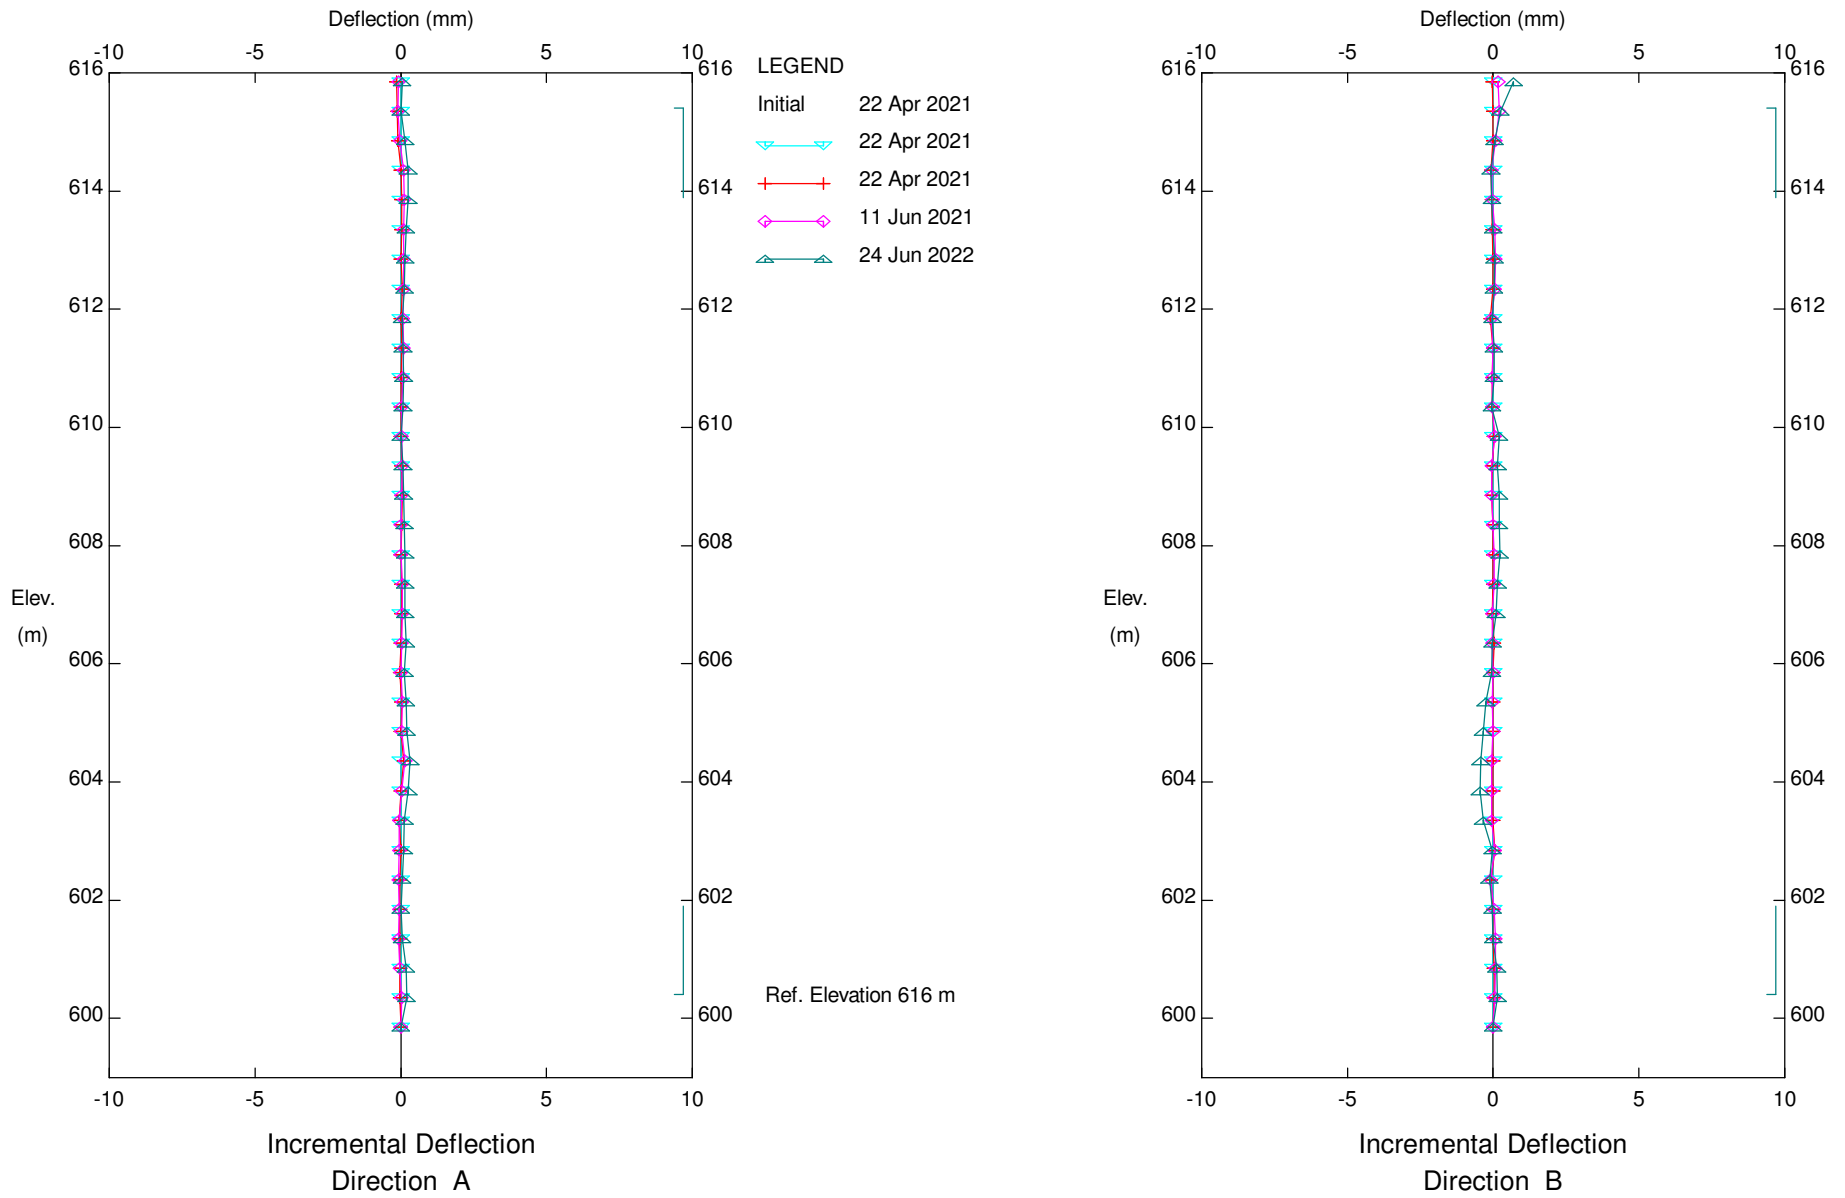
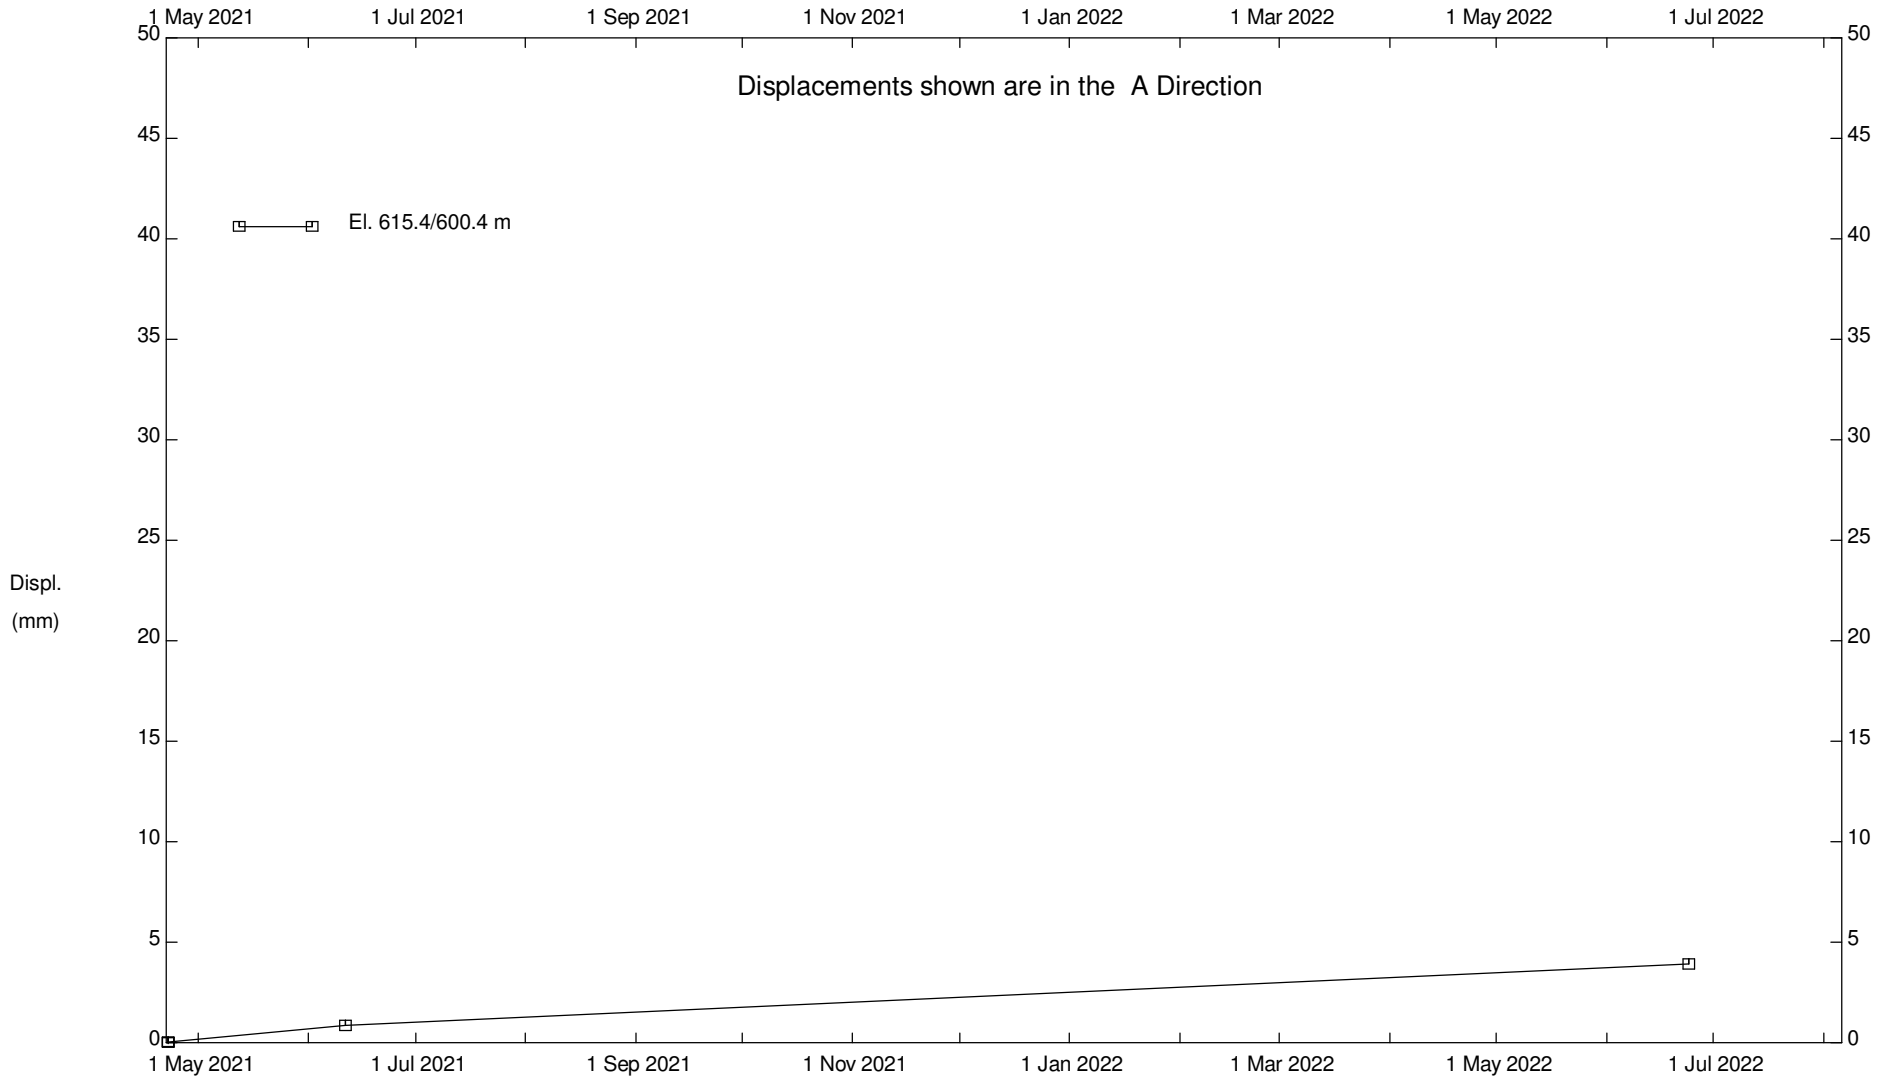
C007; H16:30; Kenilworth Lake Slide, Inclinator SI21-C07-01

The June 2022 data obtained from SI21-C07-01 through SI21-C07-03 indicates that the top of the west and east H-pile wall extensions have deflected up to approximately 4 mm and 14 mm, respectively, since installation. In the spring of 2021, shortly after construction of the H-pile wall extensions, the maximum rate of movement recorded in these SIs was between approximately 6 mm/year and 40 mm/year. The rate of movement has since decreased and is now less than 10 mm/year. KCB anticipated that the rate of movement shortly after installation would be highest and would decrease as the H-pile wall picked up load stabilizing the sliding mass.
