September 12, 2022

Alberta Transportation  
4th Floor, Provincial Building  
4920 51 Street  
Red Deer, Alberta  
T4N 6K8

**CON0022160 Central Region GRMP Instrumentation Monitoring  
Site C007; H16:30, km 23.890 Kenilworth Lake Slide  
Section C – 2022 Spring Readings**

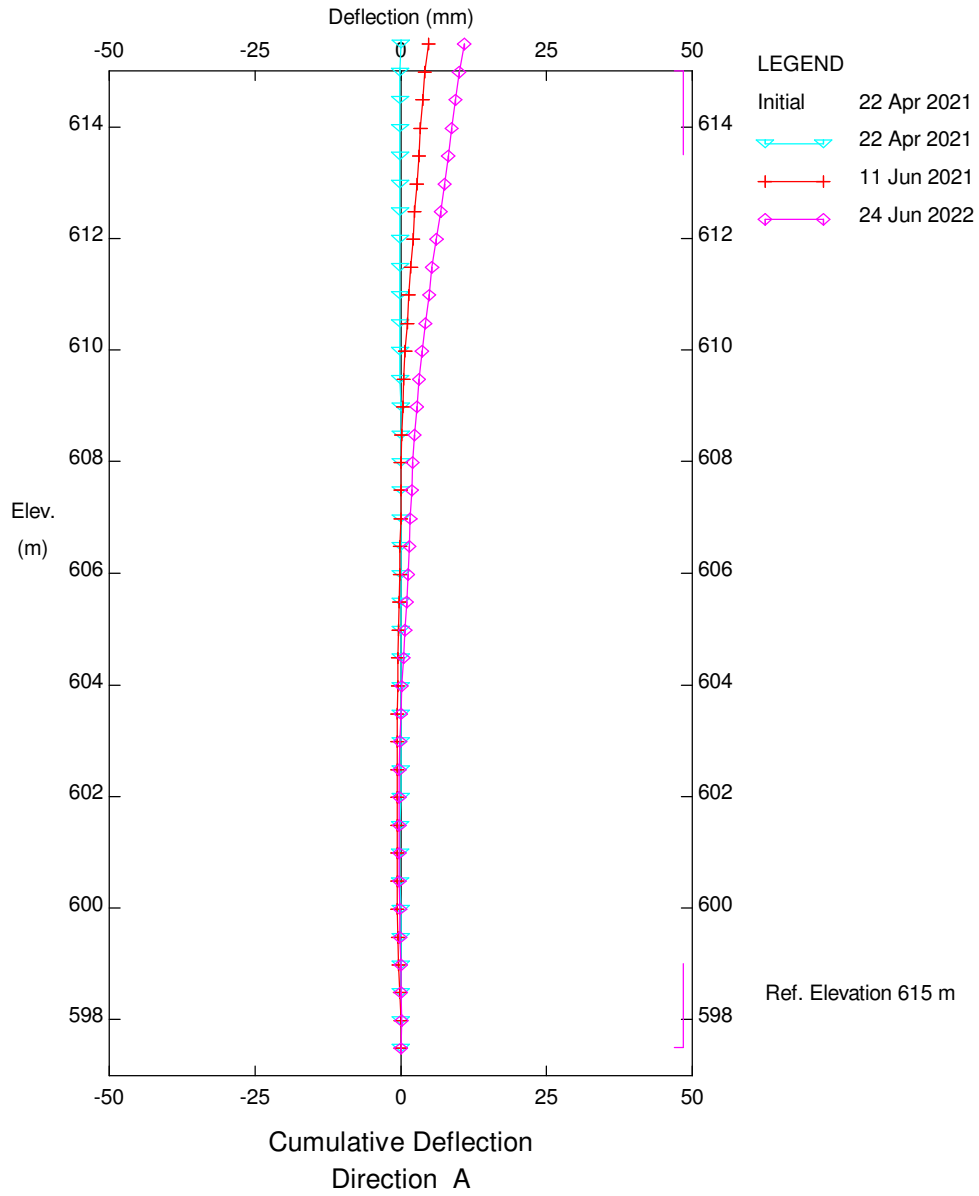
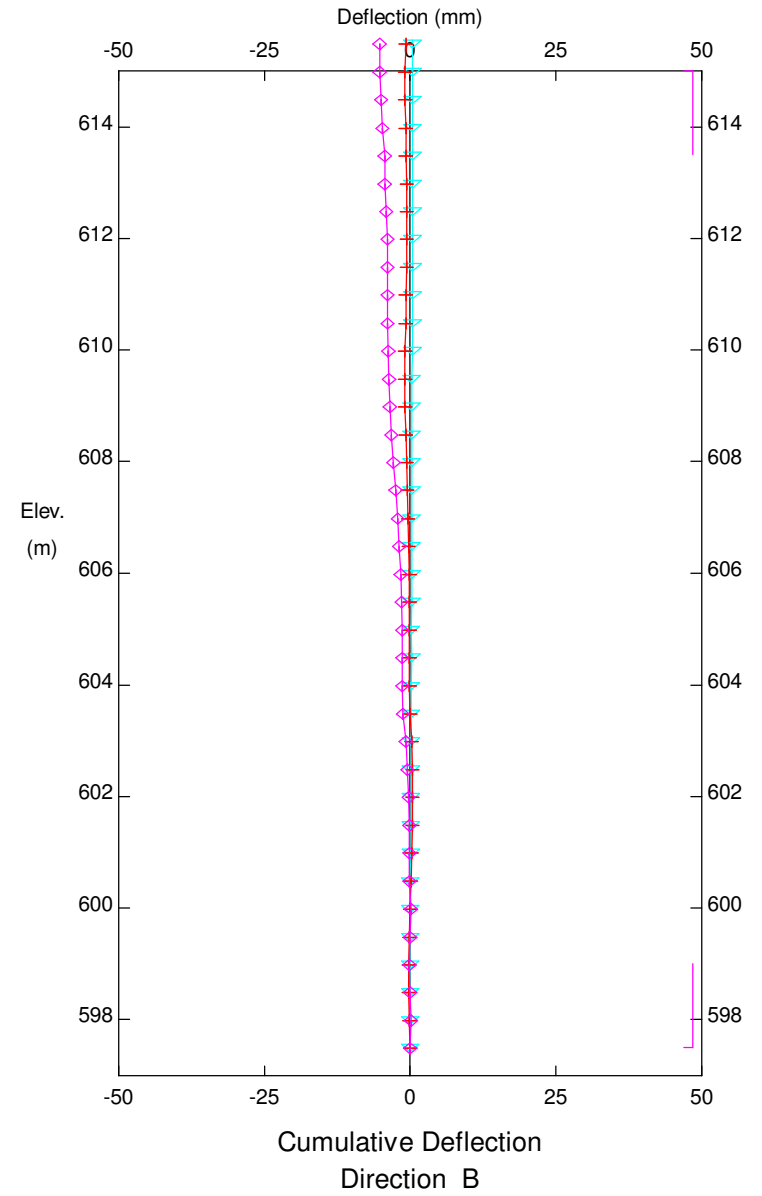
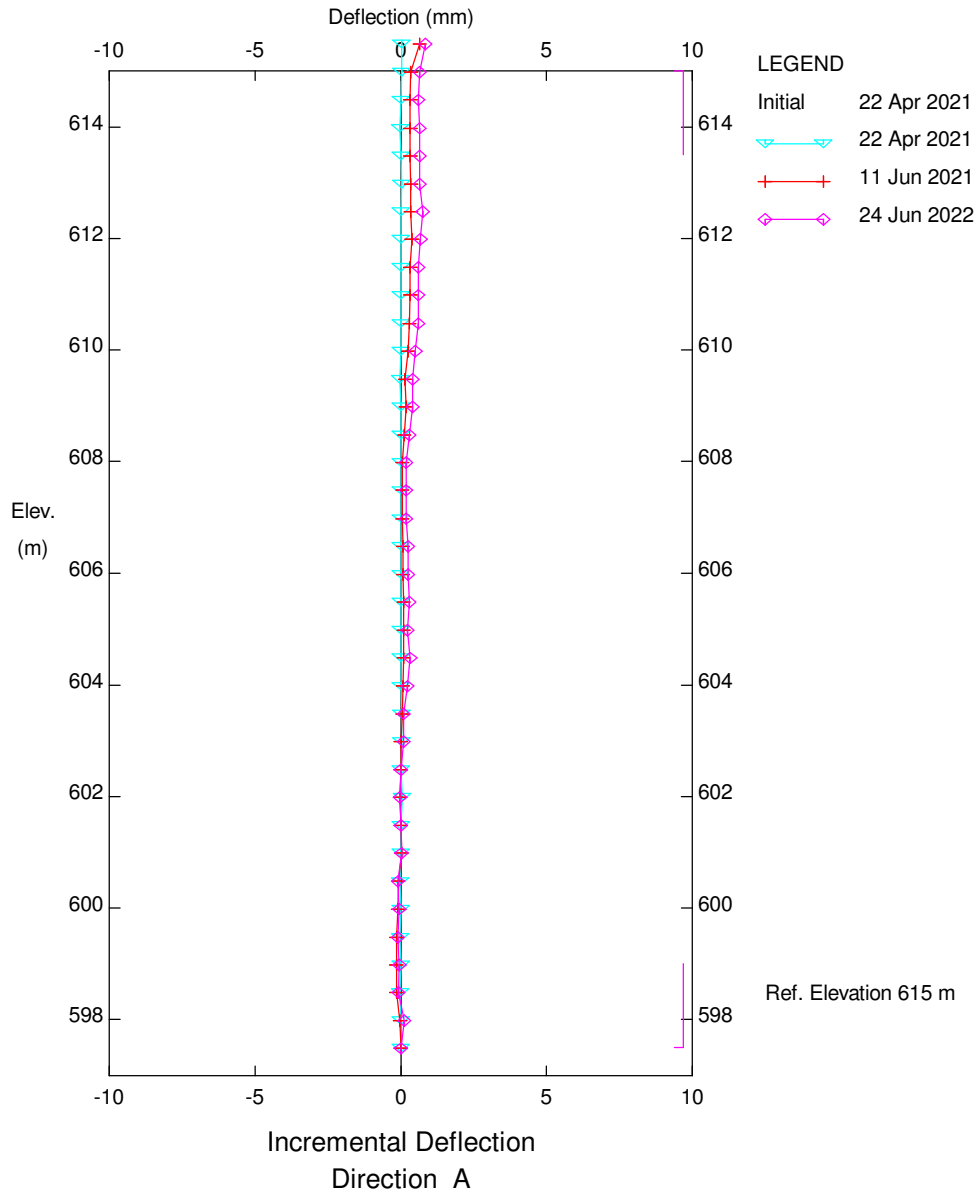
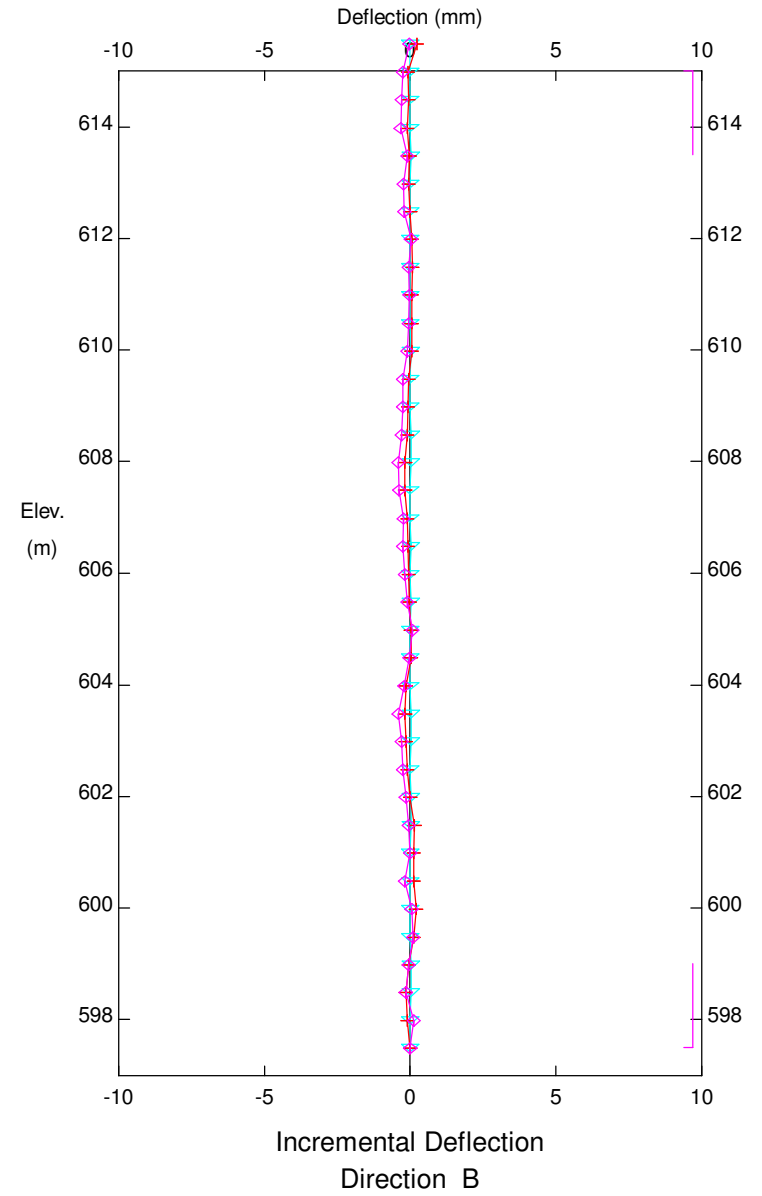
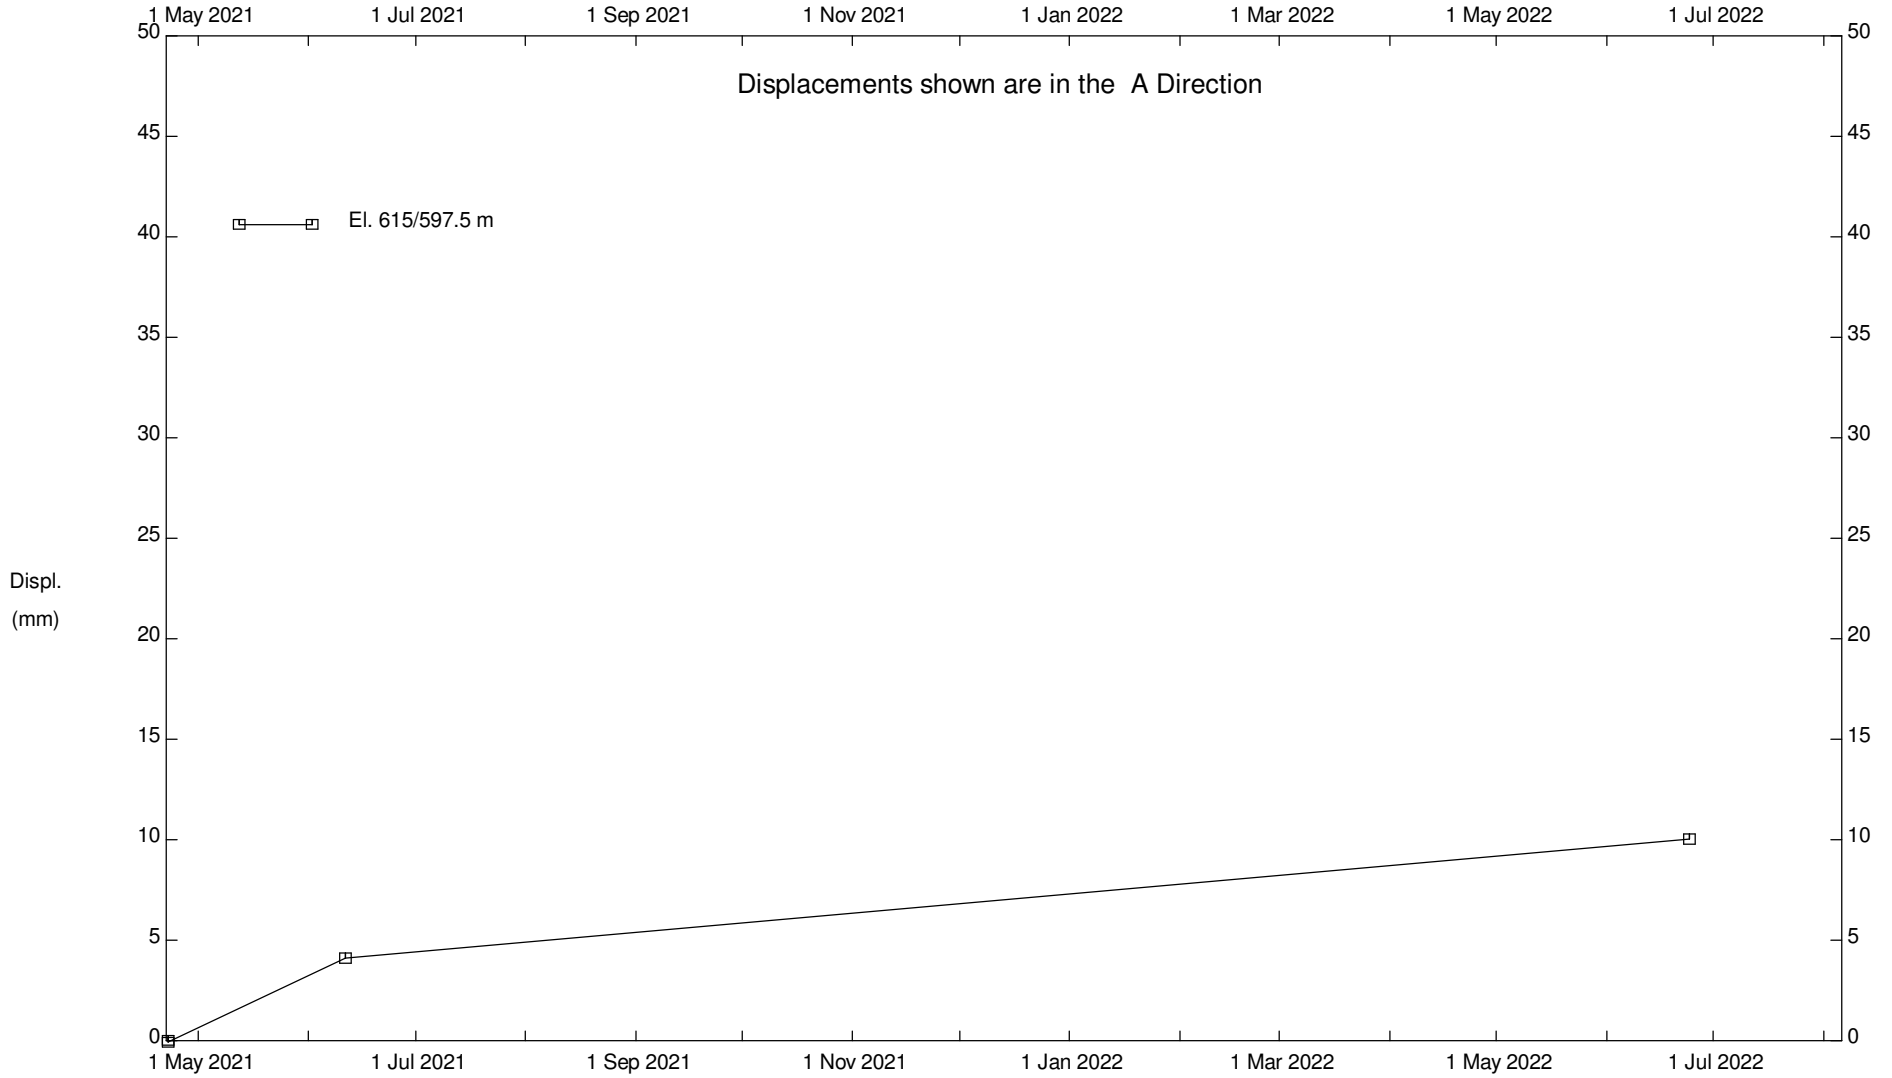
C007; H16:30; Kenilworth Lake Slide, Inclinometer SI21-C07-02

The June 2022 data obtained from SI21-C07-01 through SI21-C07-03 indicates that the top of the west and east H-pile wall extensions have deflected up to approximately 4 mm and 14 mm, respectively, since installation. In the spring of 2021, shortly after construction of the H-pile wall extensions, the maximum rate of movement recorded in these SIs was between approximately 6 mm/year and 40 mm/year. The rate of movement has since decreased and is now less than 10 mm/year. KCB anticipated that the rate of movement shortly after installation would be highest and would decrease as the H-pile wall picked up load stabilizing the sliding mass.
