July 15, 2025

**CON0022160 Central Region GRMP Instrumentation Monitoring**  
**Site C007; H16:30, km 23.890 Kenilworth Lake Slide**  
**Section C – 2025 Spring Readings**

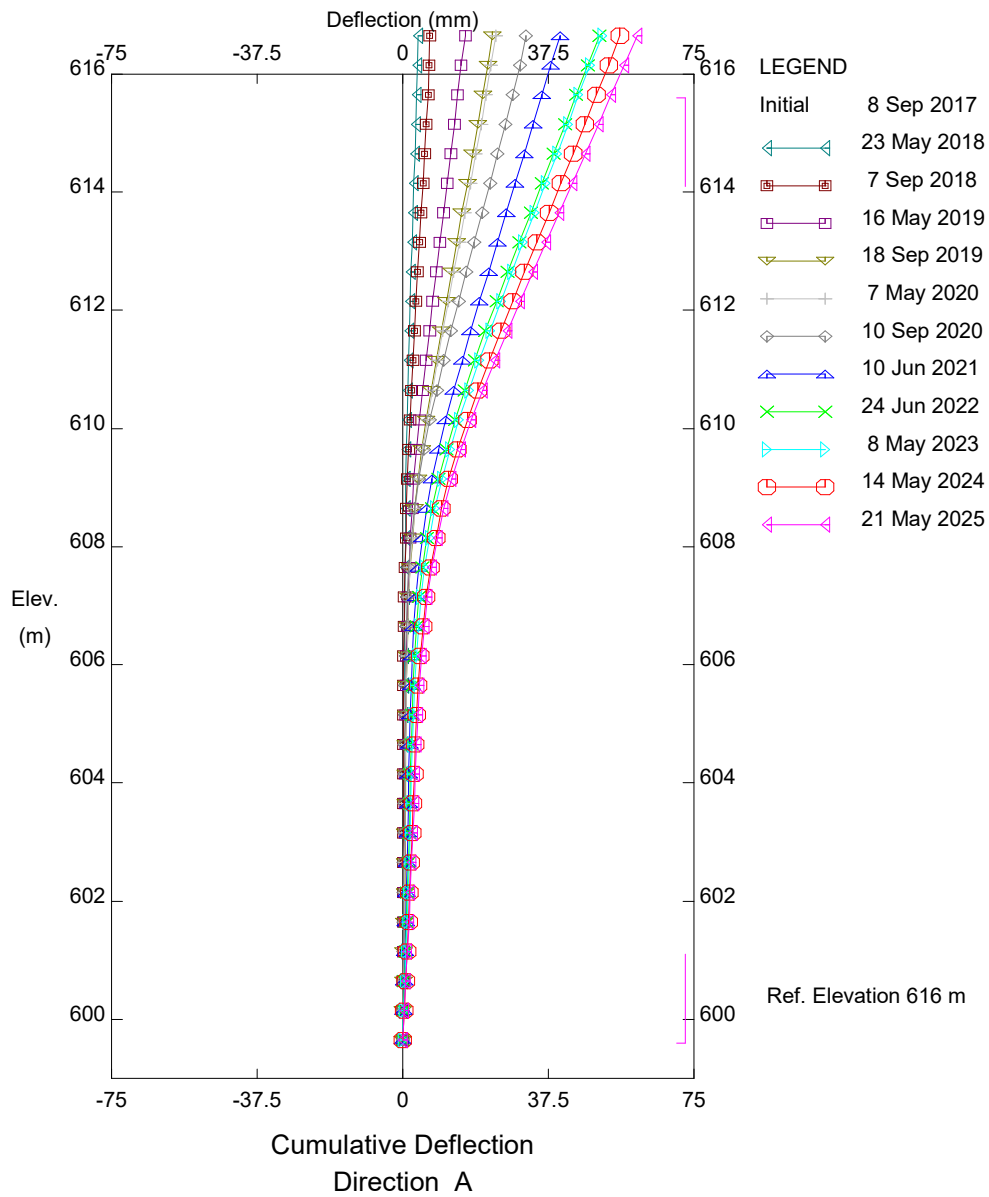
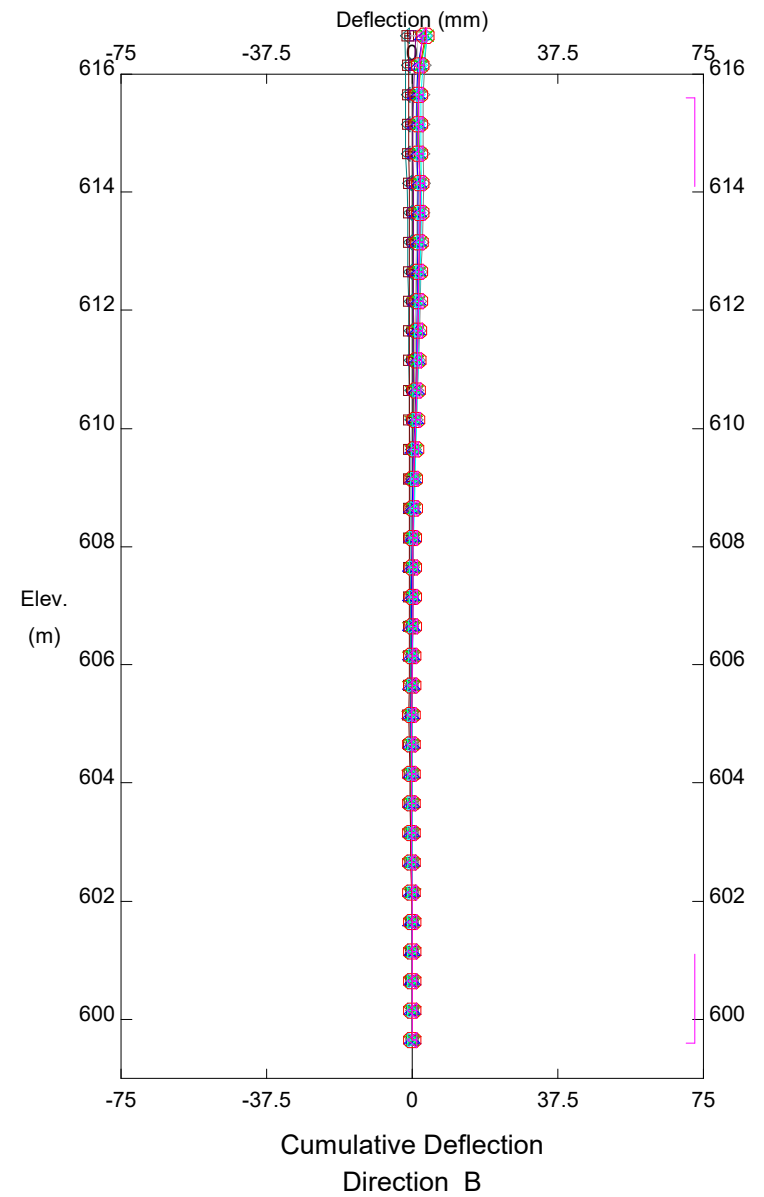
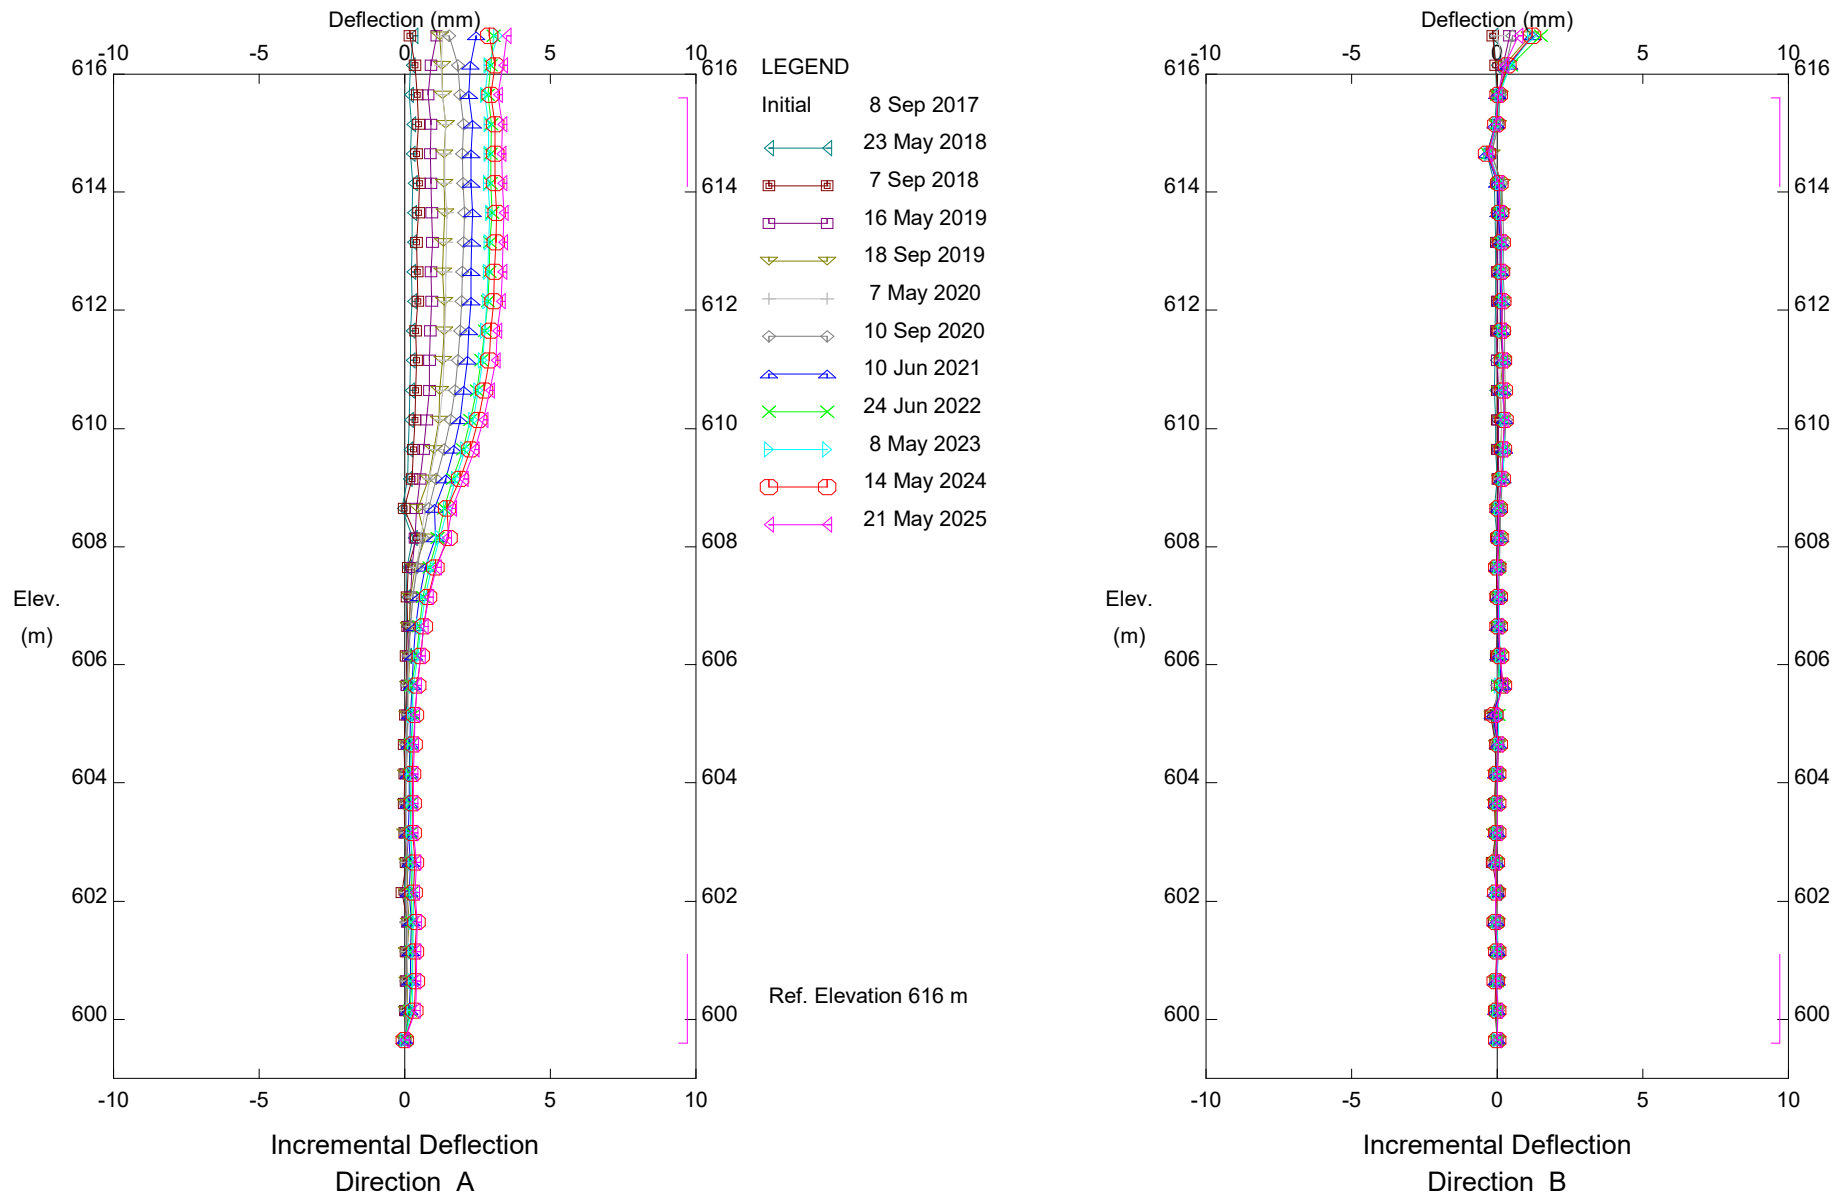
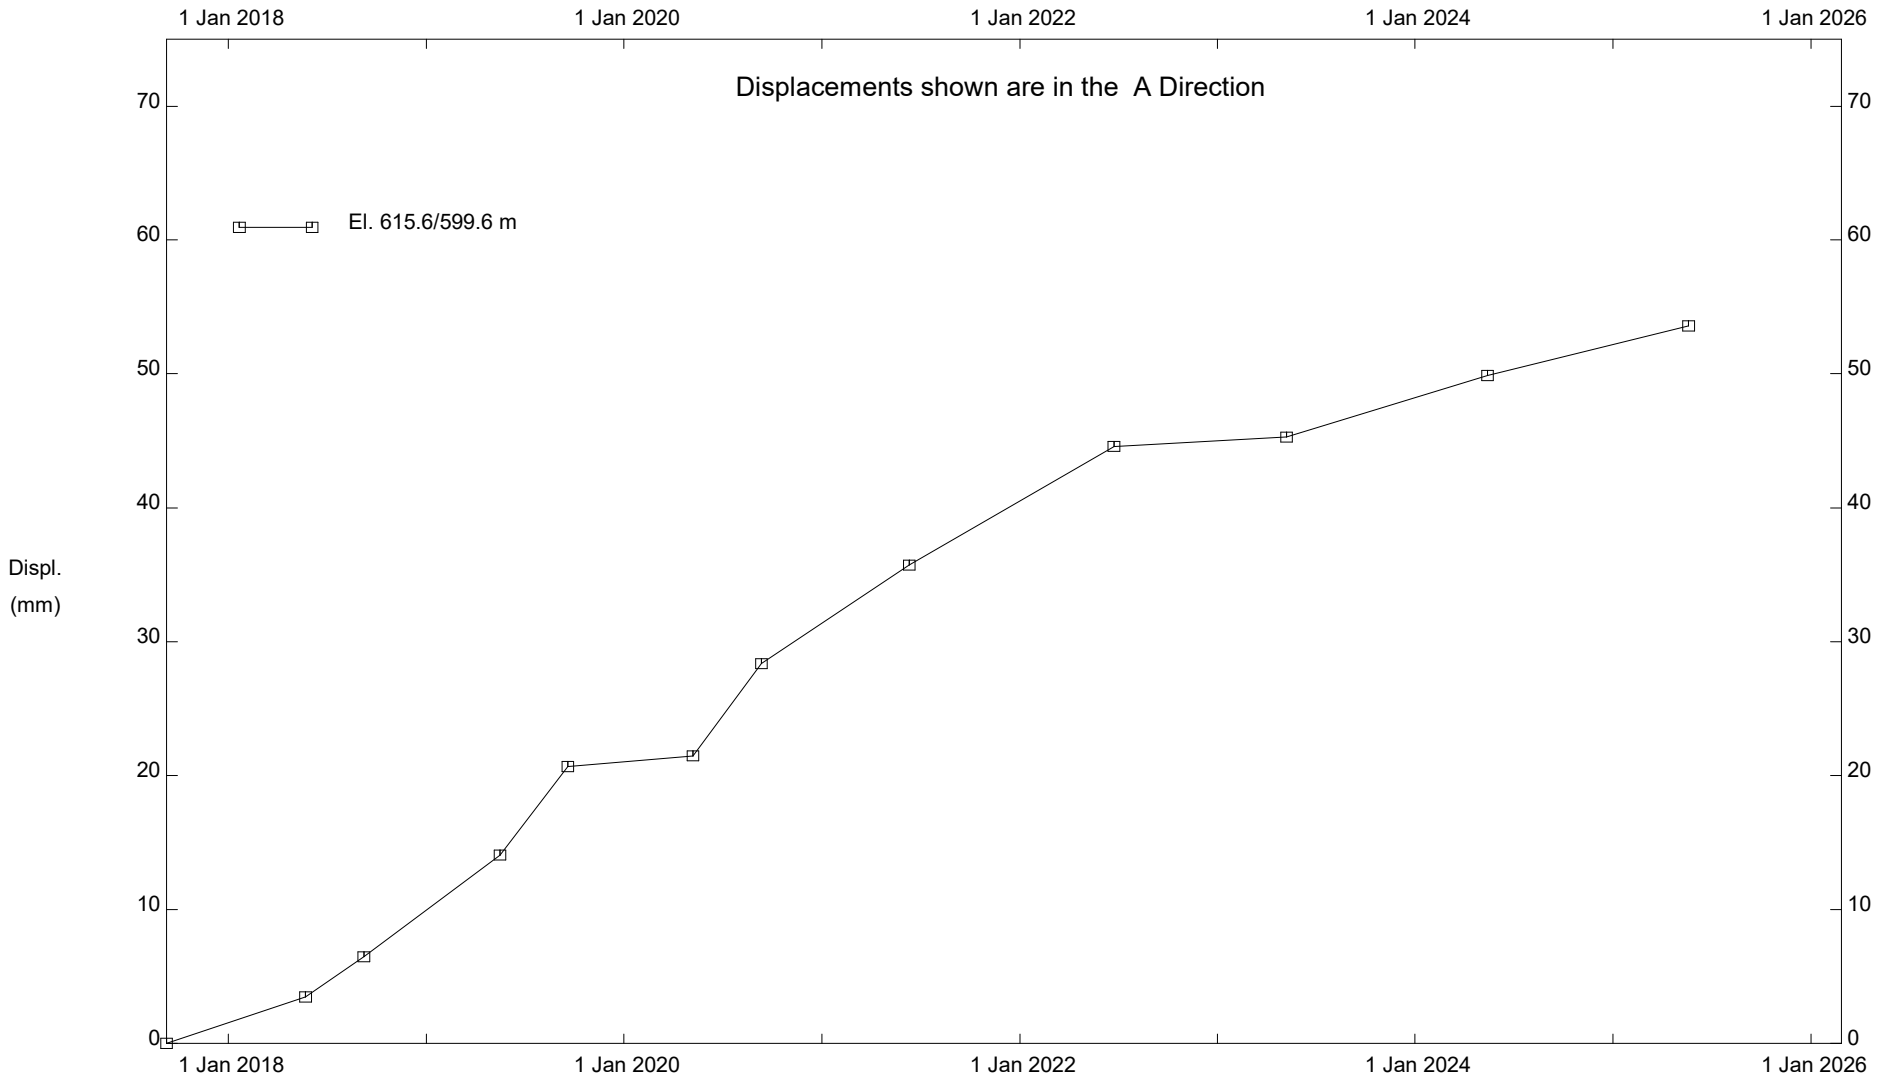
C007; H16:30, Kenilworth Lake Slide, Inclinometer SI15-01

- SI15-01 and SI15-02 (original H-pile wall) from ground surface to an approximate depth of 8 m to 9 m below ground surface, respectively;
- SI21-C07-01 and SI21-C07-02 (west H-pile wall extension) to an approximate depth of 16 m and 12 m below ground surface, respectively; and,

The May 2025 data obtained from SI15-01 and SI15-02 indicates that the top of the original H-pile wall has deflected between approximately 207 mm and 141 mm, respectively, since installation, with most of the displacement occurring before June 2015. The maximum rate of movement recorded in SI15-01 and SI15-02 occurred in June 2015, one month after the H-pile wall was installed and was approximately 655 mm/year and 293 mm/year, respectively. The rate of movement has since decreased and is now less than approximately 5 mm/year.

Before SI15-01 was re-initialized in September 2017, approximately 135 mm of distributed movement (i.e., from top to bottom of casing) was recorded in the B-direction. It is unknown if this movement was due to post installation SI casing flexure, shifting in the steel pocket, or twist of the H-piles that occurred when the H-pile wall picked up load while stabilizing the sliding mass. However, movements in the B-direction have attenuated and no additional movement has been recorded in the B-direction of this instrument since it was re-initialized.

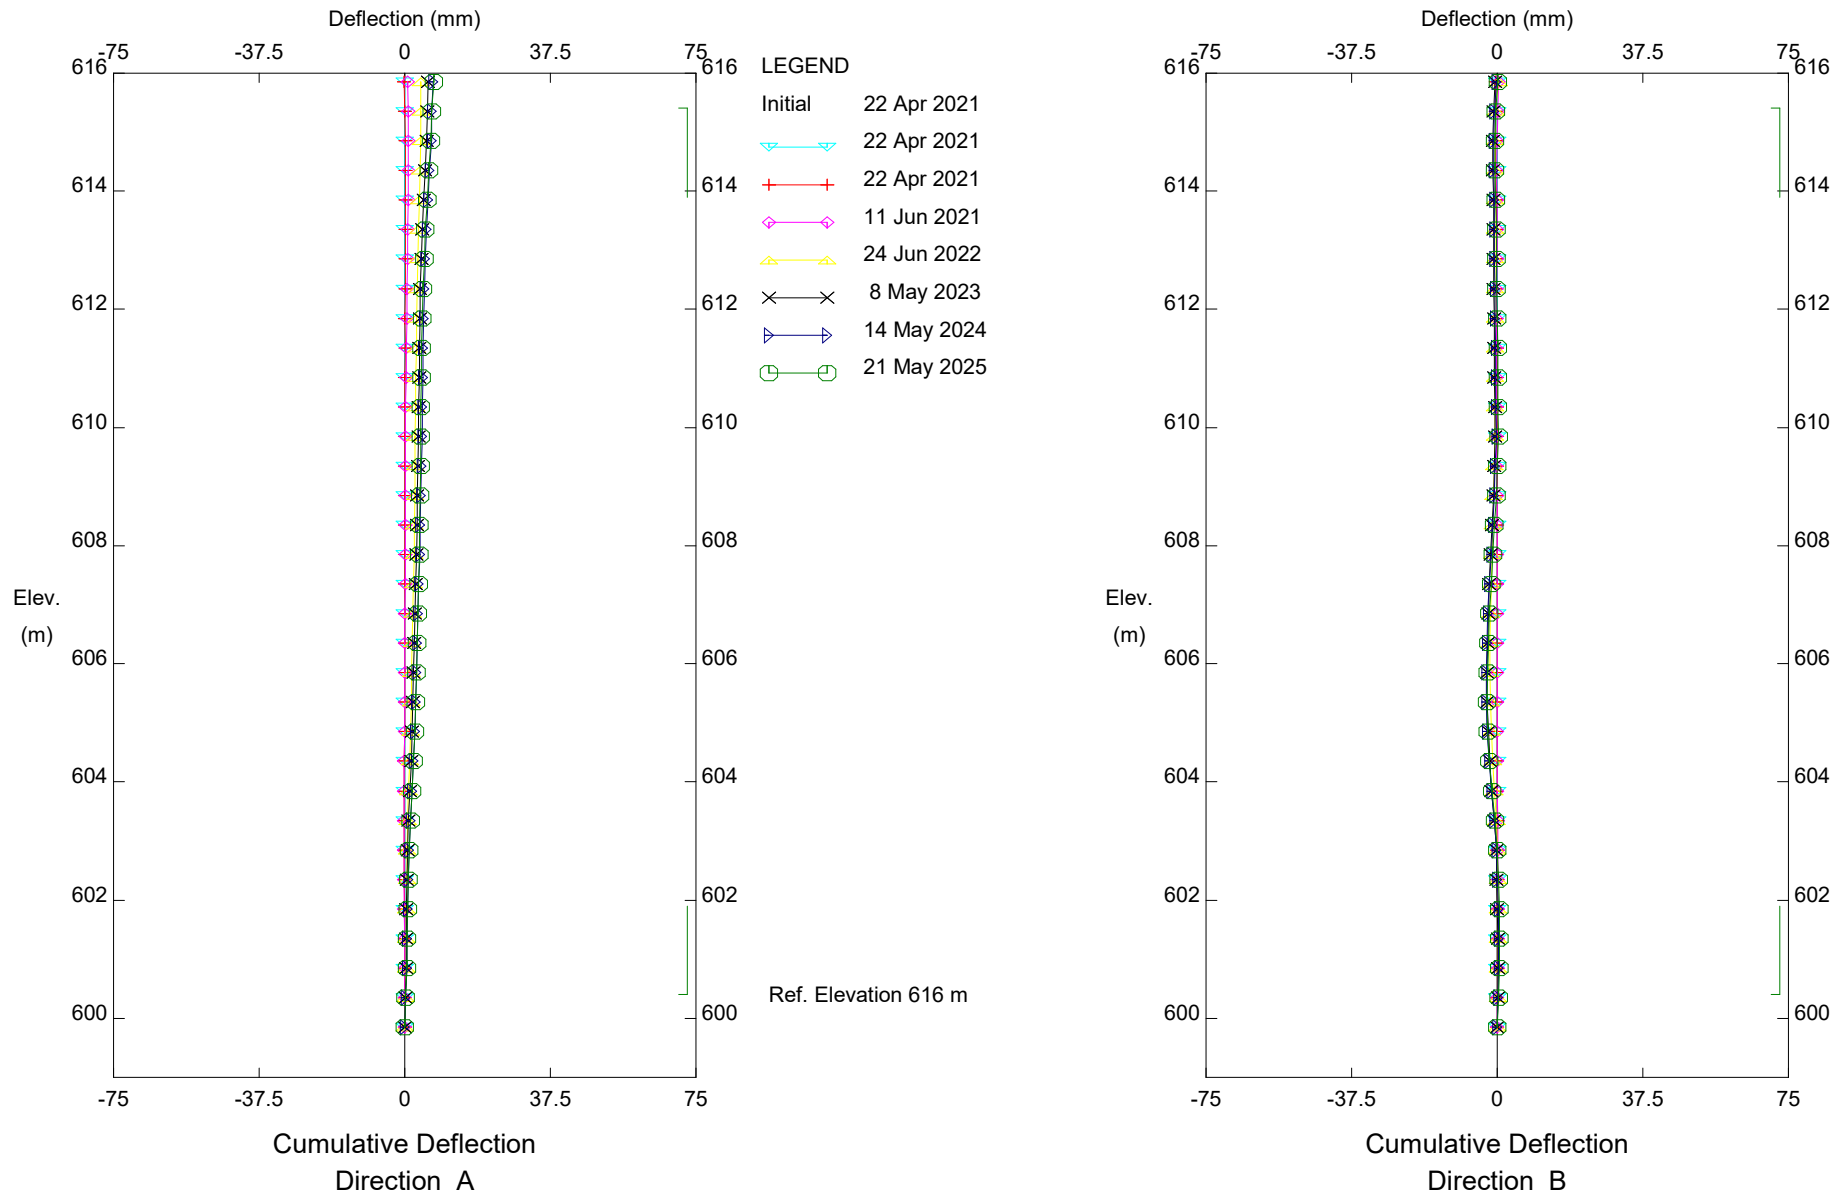
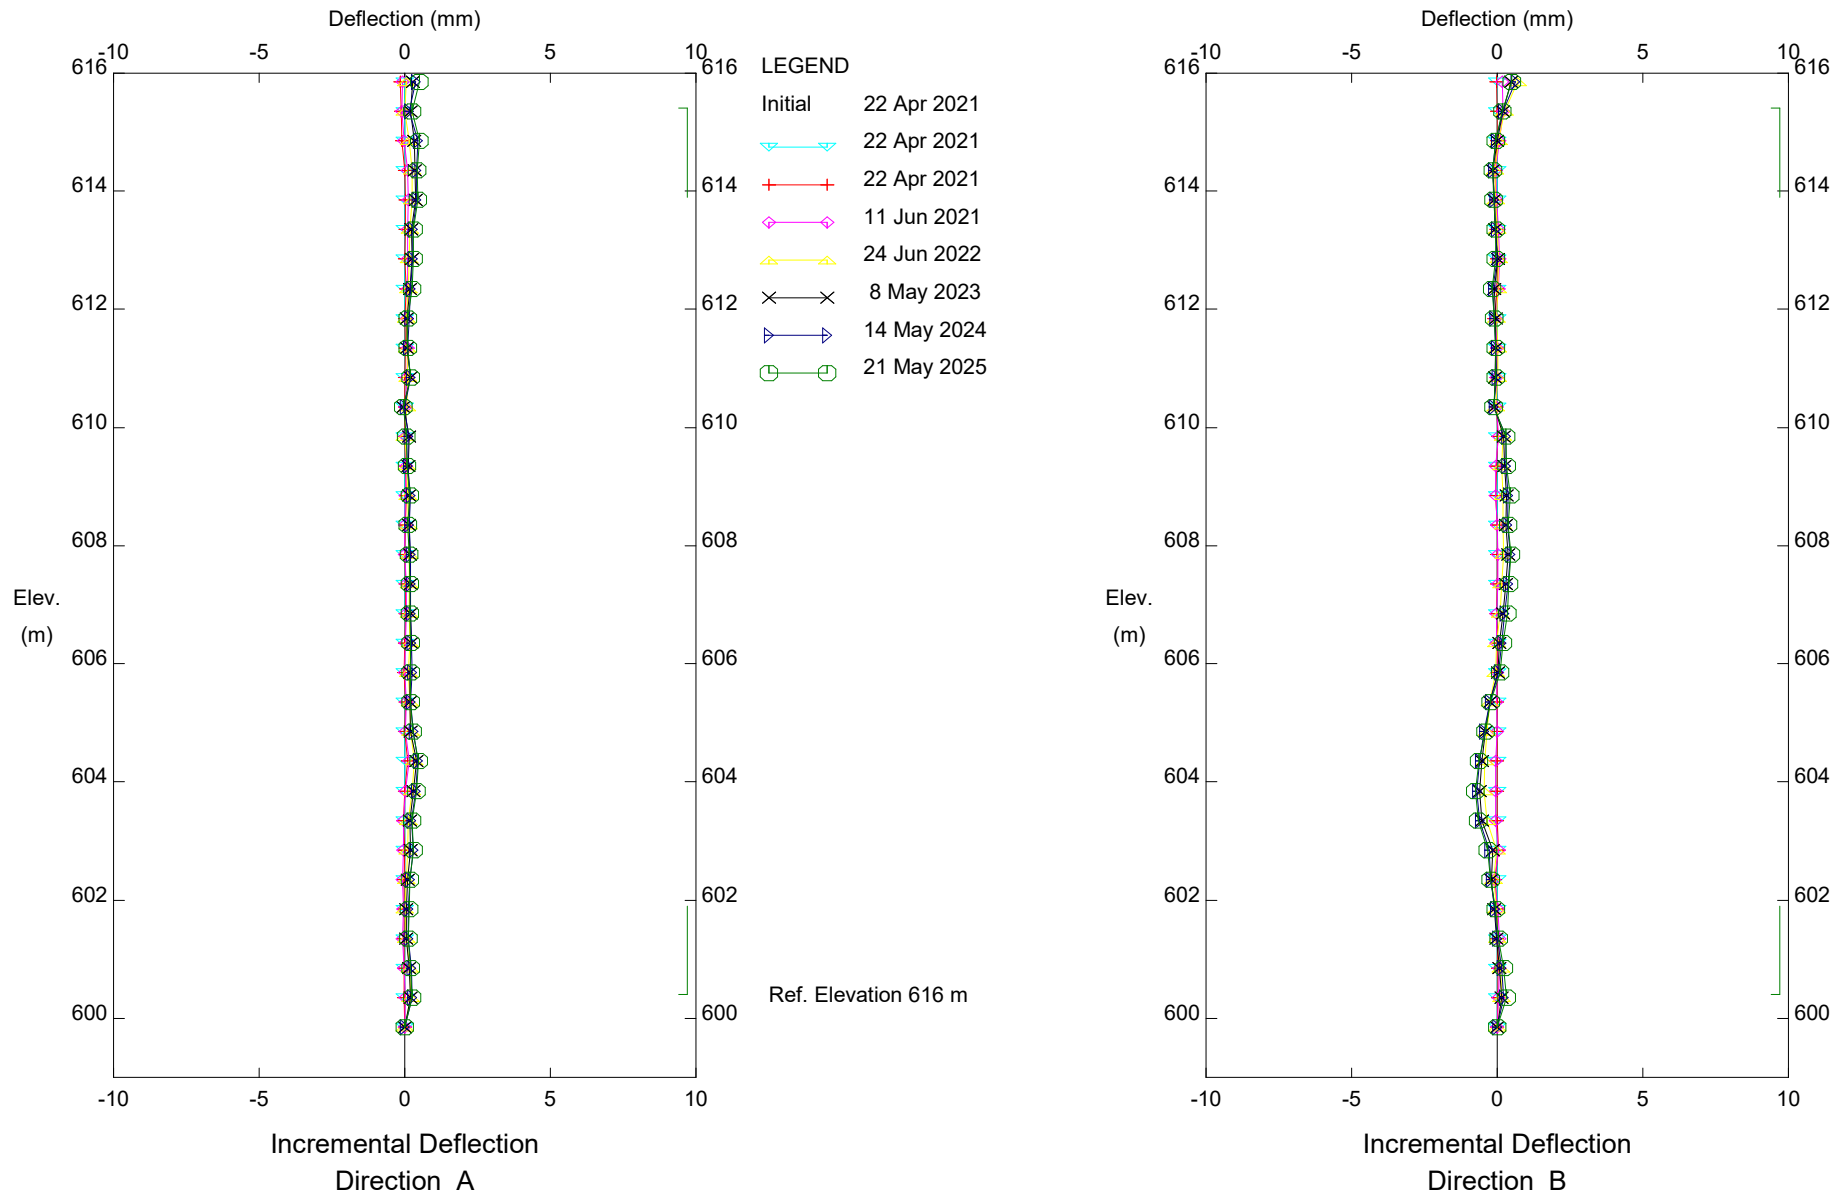
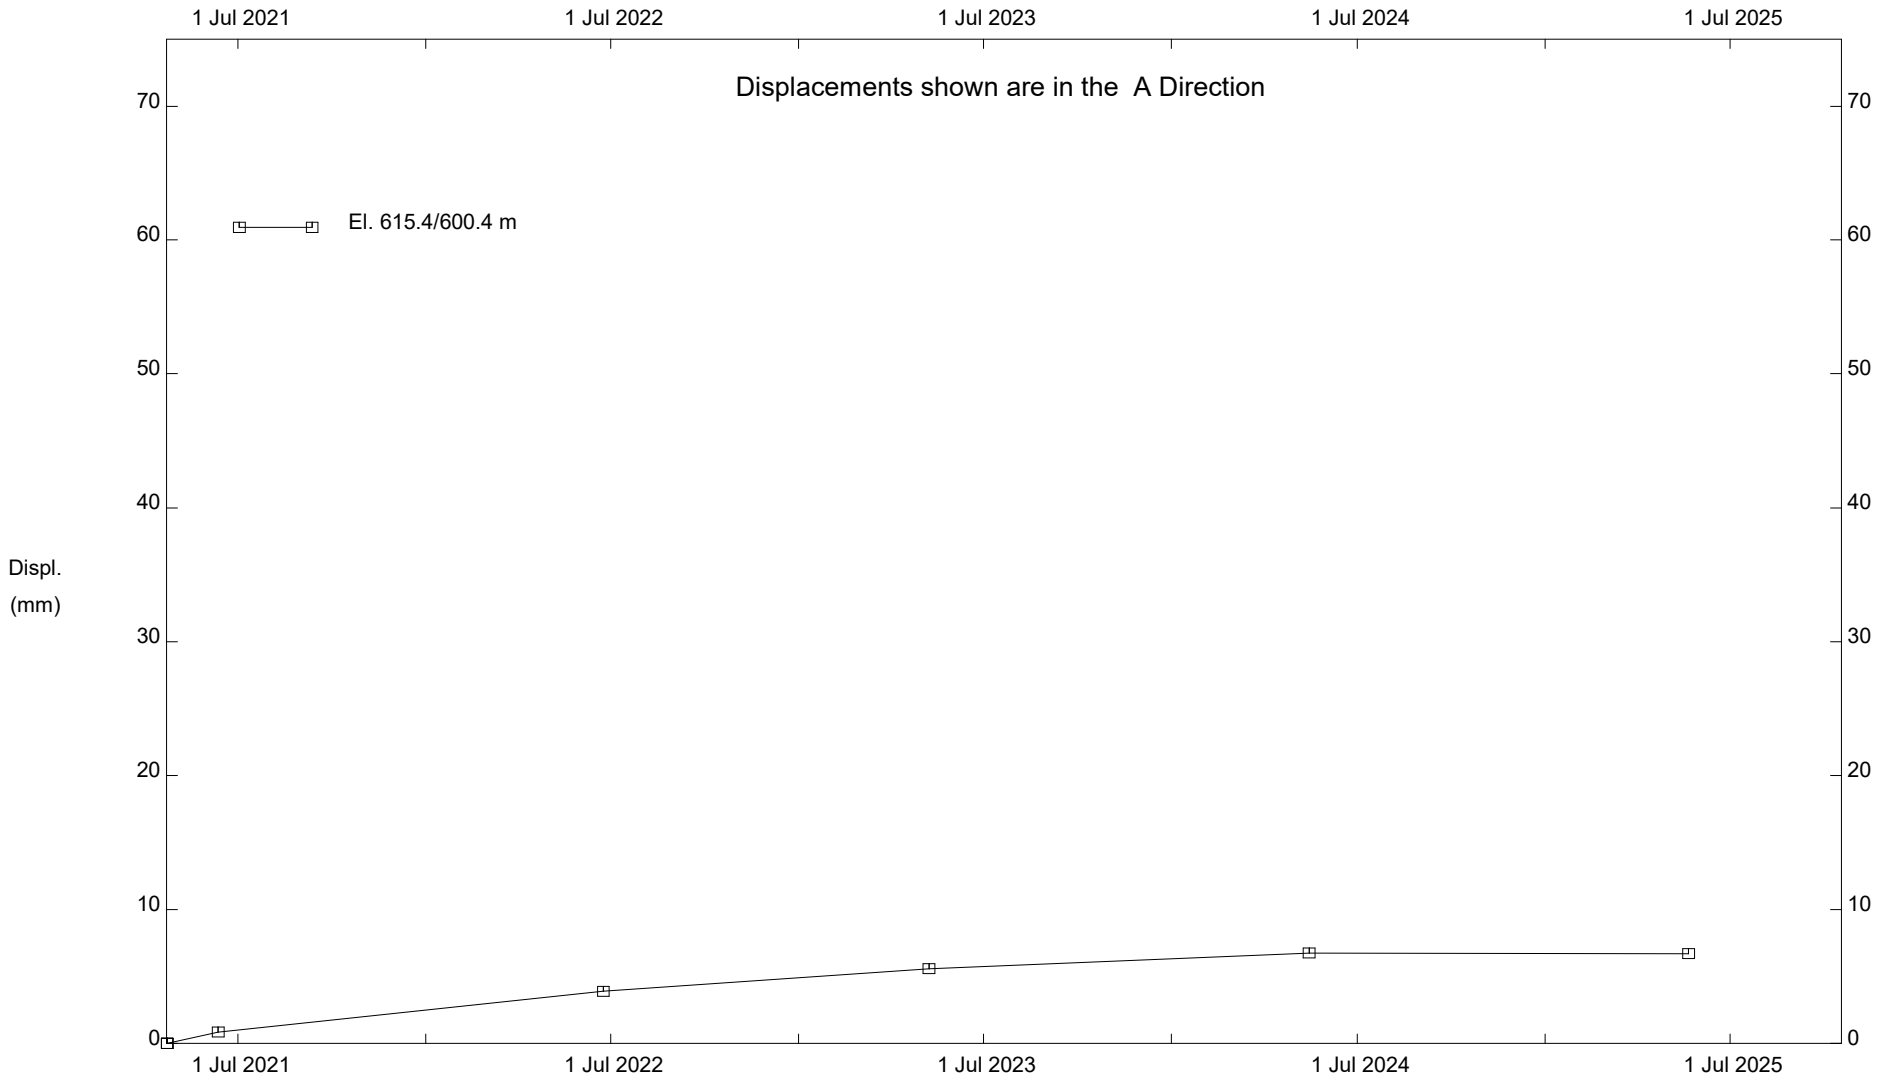
C007; H16:30; Kenilworth Lake Slide, Inclinometer SI21-C07-01

The May 2025 data obtained from SI21-C07-01 through SI21-C07-03 indicates that the top of the west and east H-pile wall extensions have deflected up to approximately 7 mm and 17 mm, respectively, since installation. In the spring of 2021, shortly after construction of the H-pile wall extensions, the maximum rate of movement recorded in these SIs was between approximately 6 mm/year and 40 mm/year. The rate of movement has since decreased and is now less than approximately 3 mm/year. KCB anticipated that the rate of movement shortly after installation would be highest and would decrease as the H-pile wall picked up load stabilizing the sliding mass.

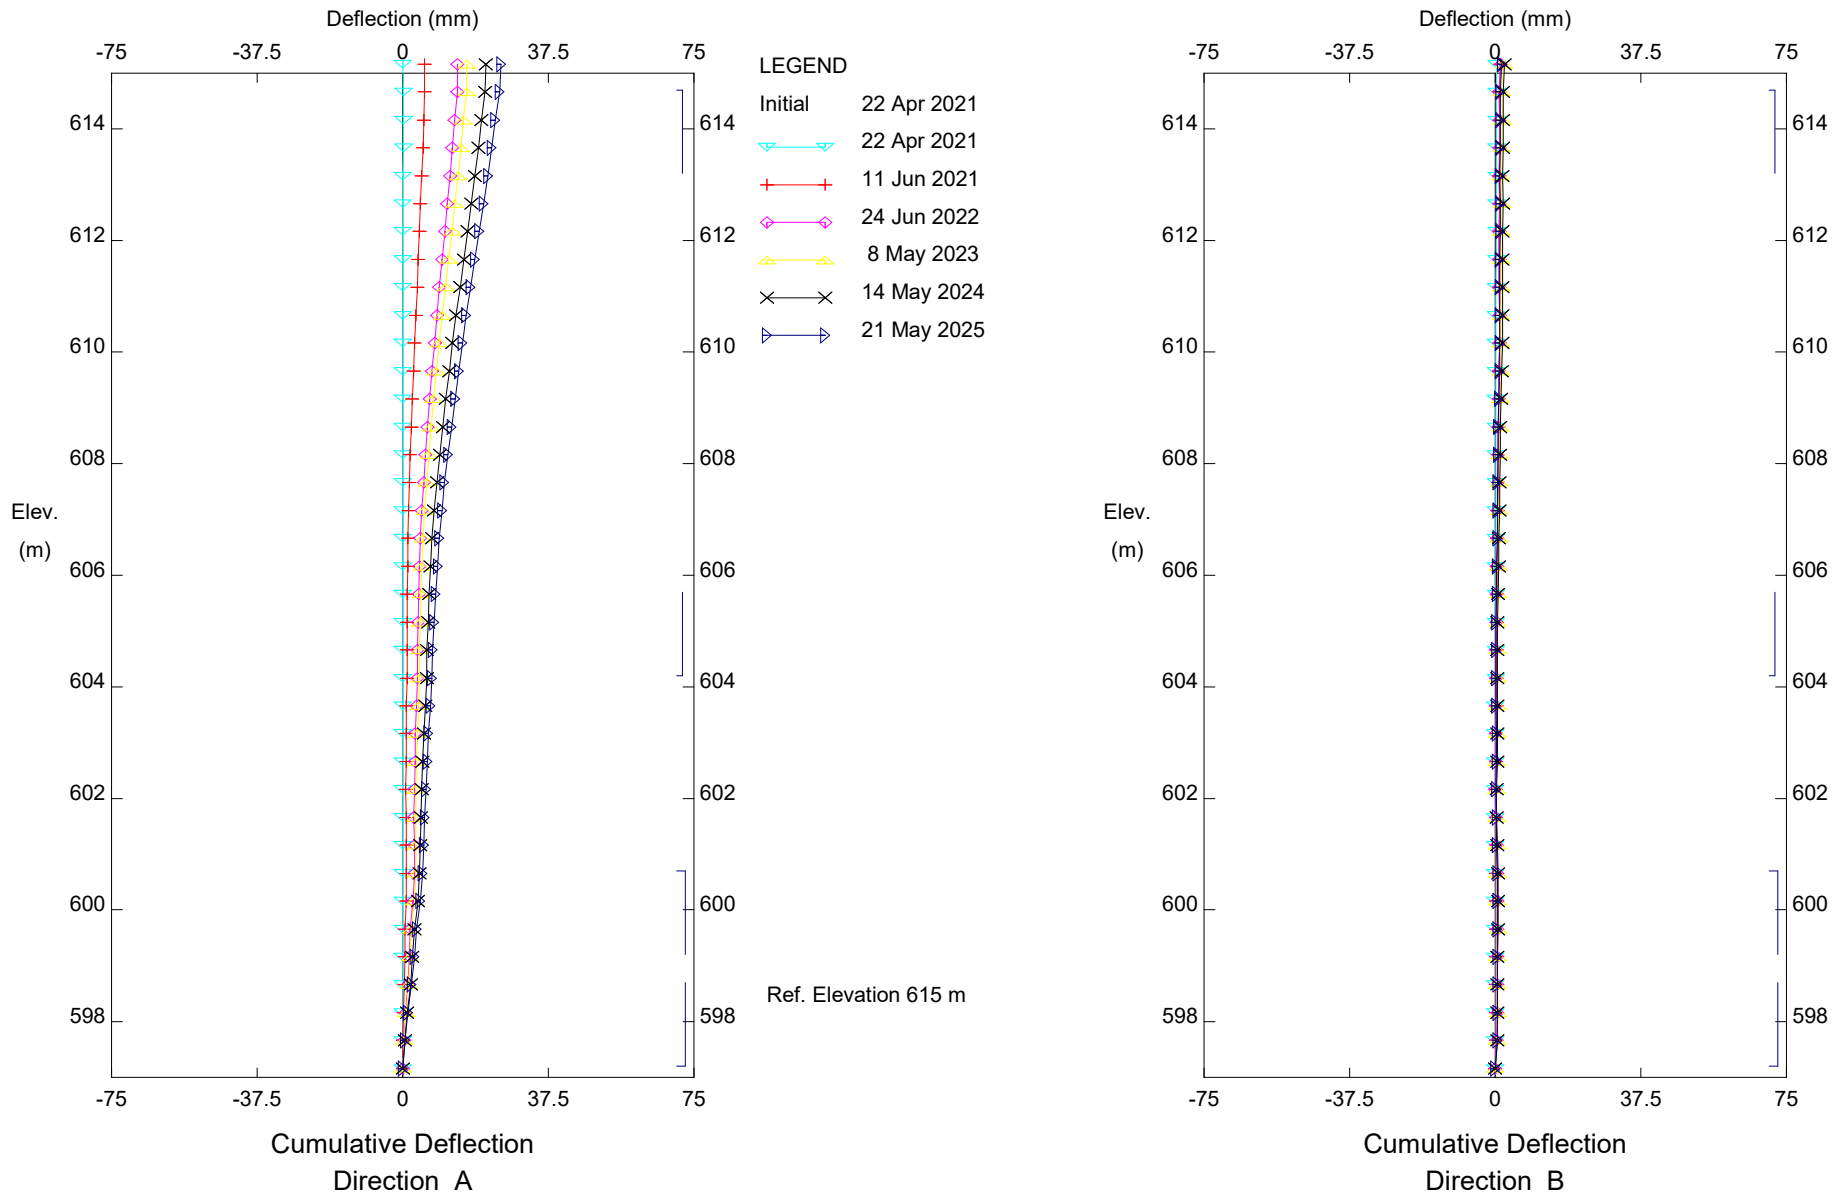
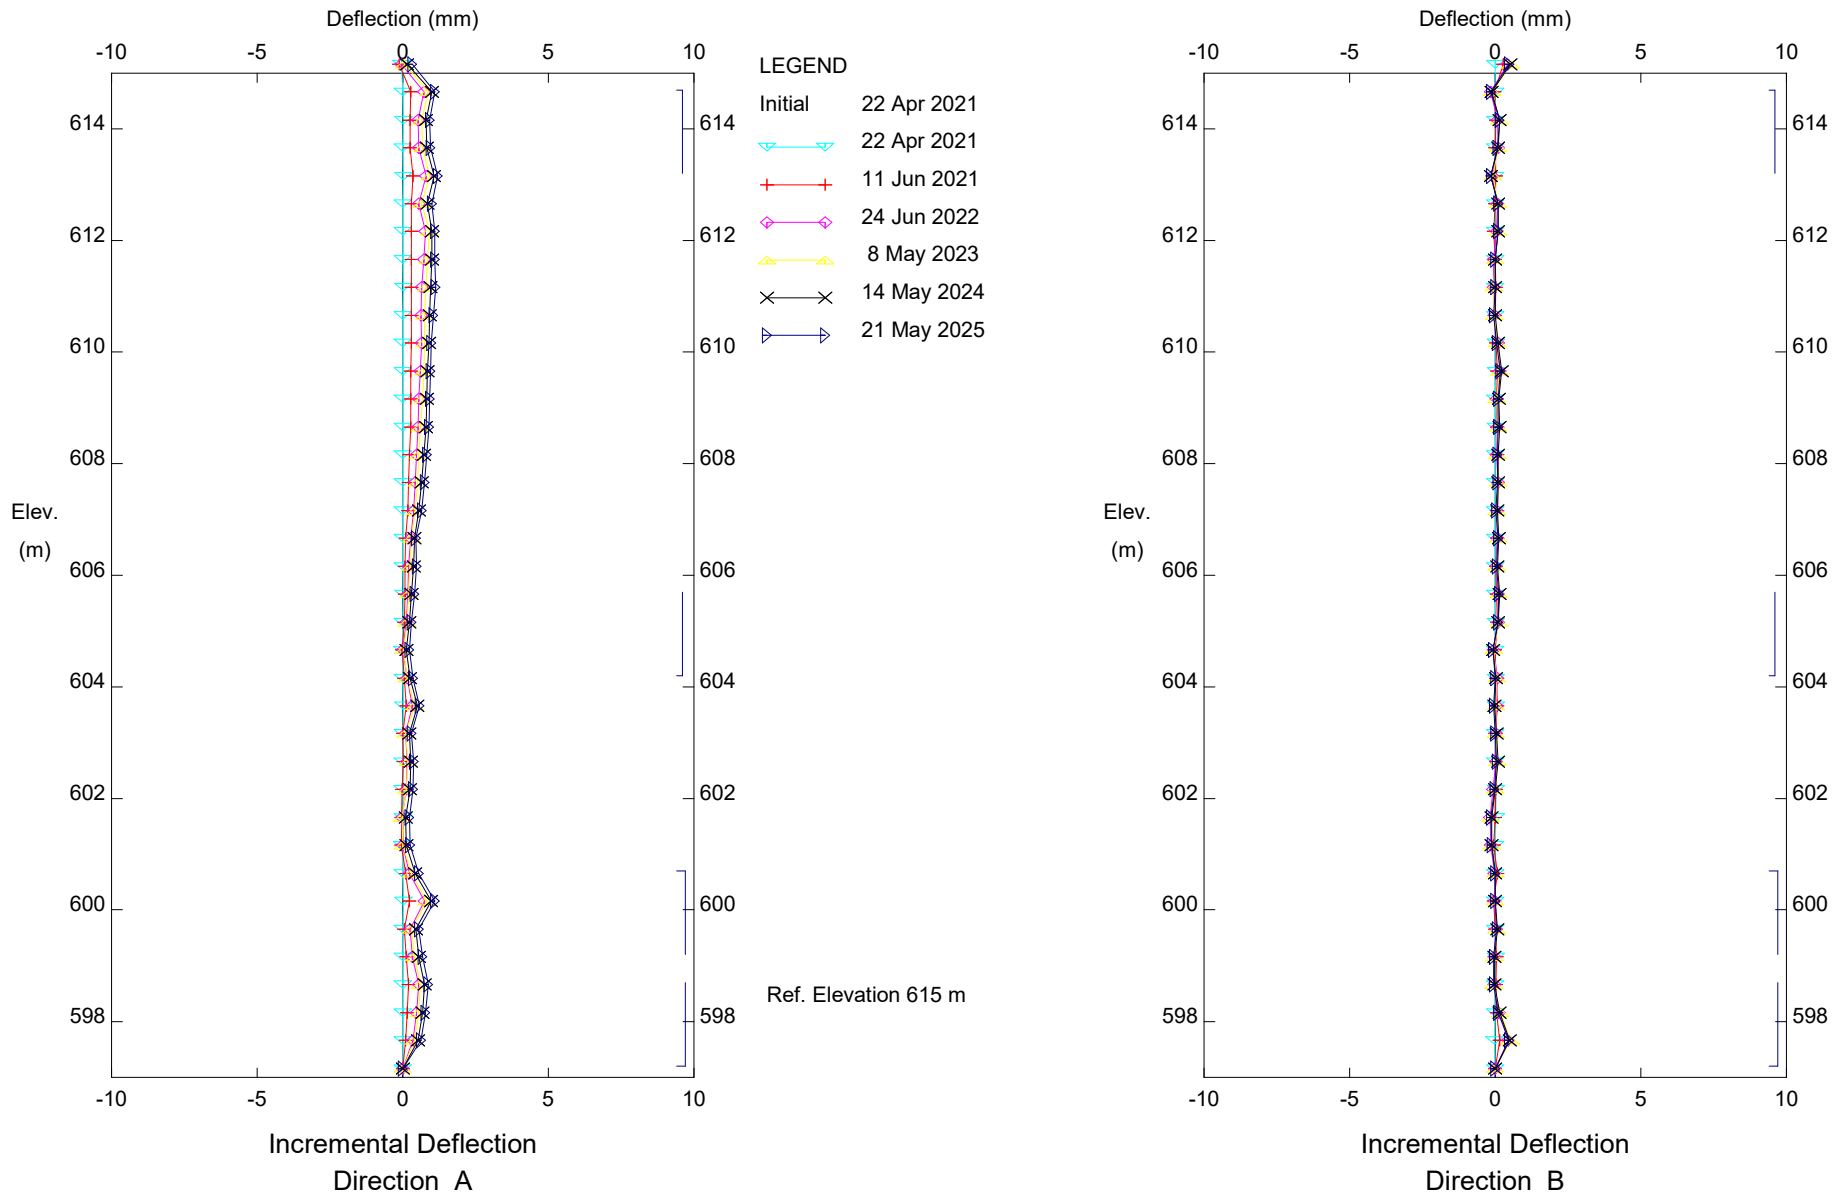
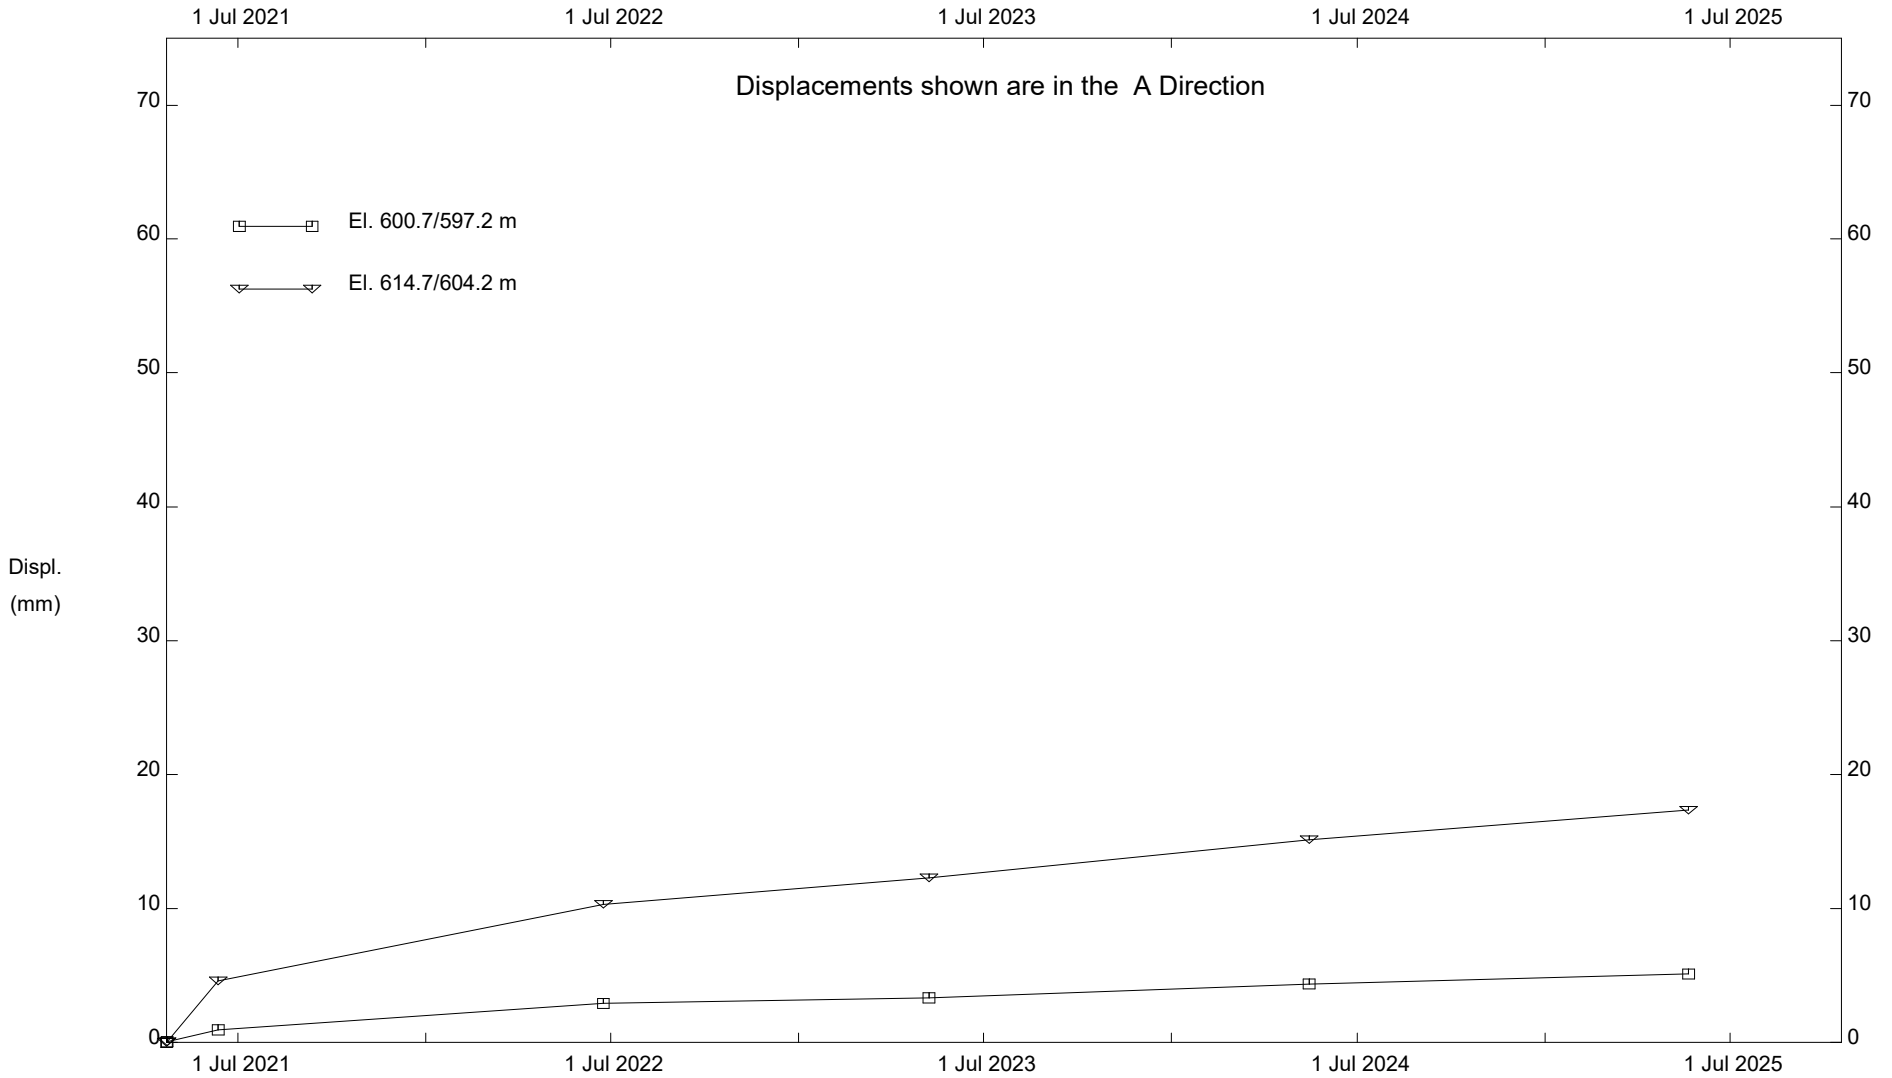
C007; H16:30; Kenilworth Lake Slide, Inclinometer SI21-C07-03

- SI21-C07-03 (east H-pile wall extension) from ground surface to an approximate depth of 8 m below ground surface. A smaller amount of distributed movement (approximately 3 mm) is occurring near the bottom of the casing (approximately 15 m to 18 m below ground surface).

The depth of movement being recorded in the pile-wall SIs (excluding SI21-C07-03) appears to be occurring approximately 5 m above the base of the H-pile walls and approximately 3 m below the depth of movement previously recorded in SI13-01 and SI13-02. SI21-C07-03 is also experiencing deeper seated movement approximately 3 m above the base of the H-pile walls. This indicates the H-pile walls have intercepted the failure surface and are continuing to deflect, transferring load to depths below the failure plane as the piles stabilize the slide mass.
