SITE NUMBER AND NAME: C067 Kneehill Creek Slide		HIGHWAY & KM: 21:14, 12.988	PREVIOUS INSPECTION DATE: June 23, 2016	INSPECTION DATE: July 11, 2019
LEGAL DESCRIPTION: 19-29-23-W4M	NAD 83 COORDINATES: UTM Northing Easting 12 5707671 344892		RISK ASSESSMENT: PF: 8 CF: 5 TOTAL: 40	
AVERAGE ANNUAL DAILY TRAFFIC (AADT): 893 (southbound) and 844 (northbound) (Ref No. 60211450)			CONTRACT MAINTENANCE AREA (CMA): 20

PROJECT CENTRAL REGION GEOHAZARD RISK MANAGEMENT PROGRAM		
TITLE Site Plan C067 - Kneehill Creek Slide Hwy 21:14, km 12.988		
SCALE 1:3,000	PROJECT No. A05115A02	FIG No. 1

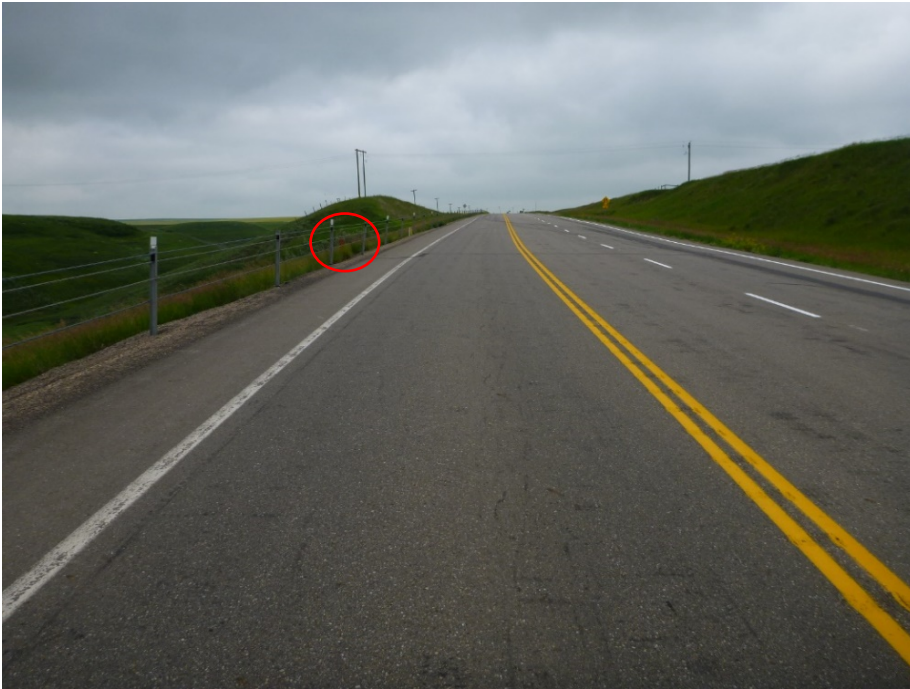
Photo 1 No new pavement cracks or deflection observed at the C067 Site A. The location of SI17-C67-02 indicated by red circle. Photo taken July 11, 2019 looking north.

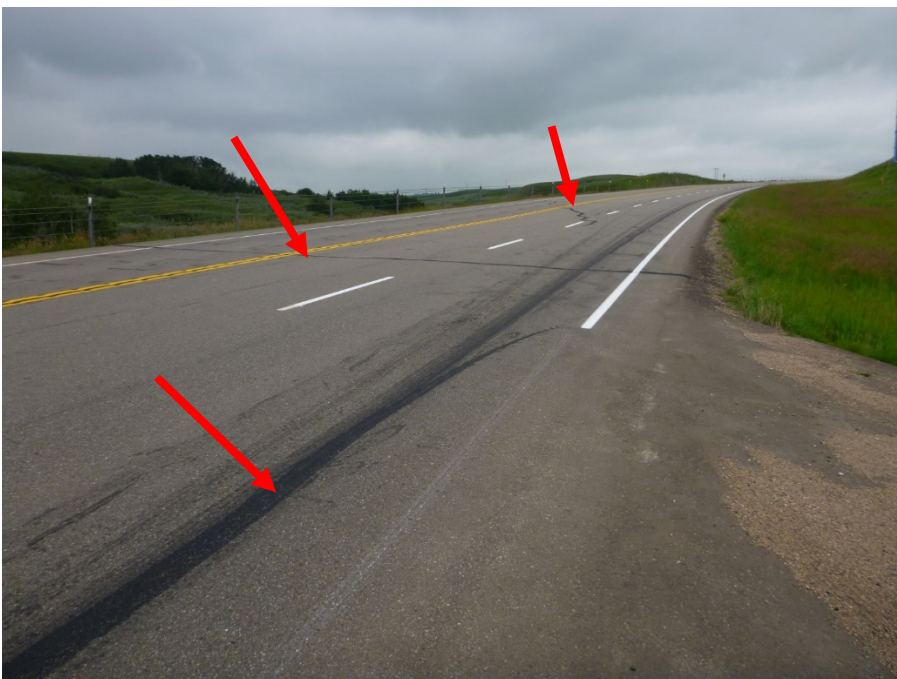
Photo 2 View of pavement surface north at C067 Site B. Sealed pavement cracks (red arrows) do not appear to have gotten worse since 2018. Photo taken July 11, 2019 looking northwest.
