November 29, 2022

**CON0022160 Central Region GRMP Instrumentation Monitoring**  
**Site C067; H21:14, km 12.988 Kneehill Creek Slide**  
**Section C – 2022 Fall Readings**

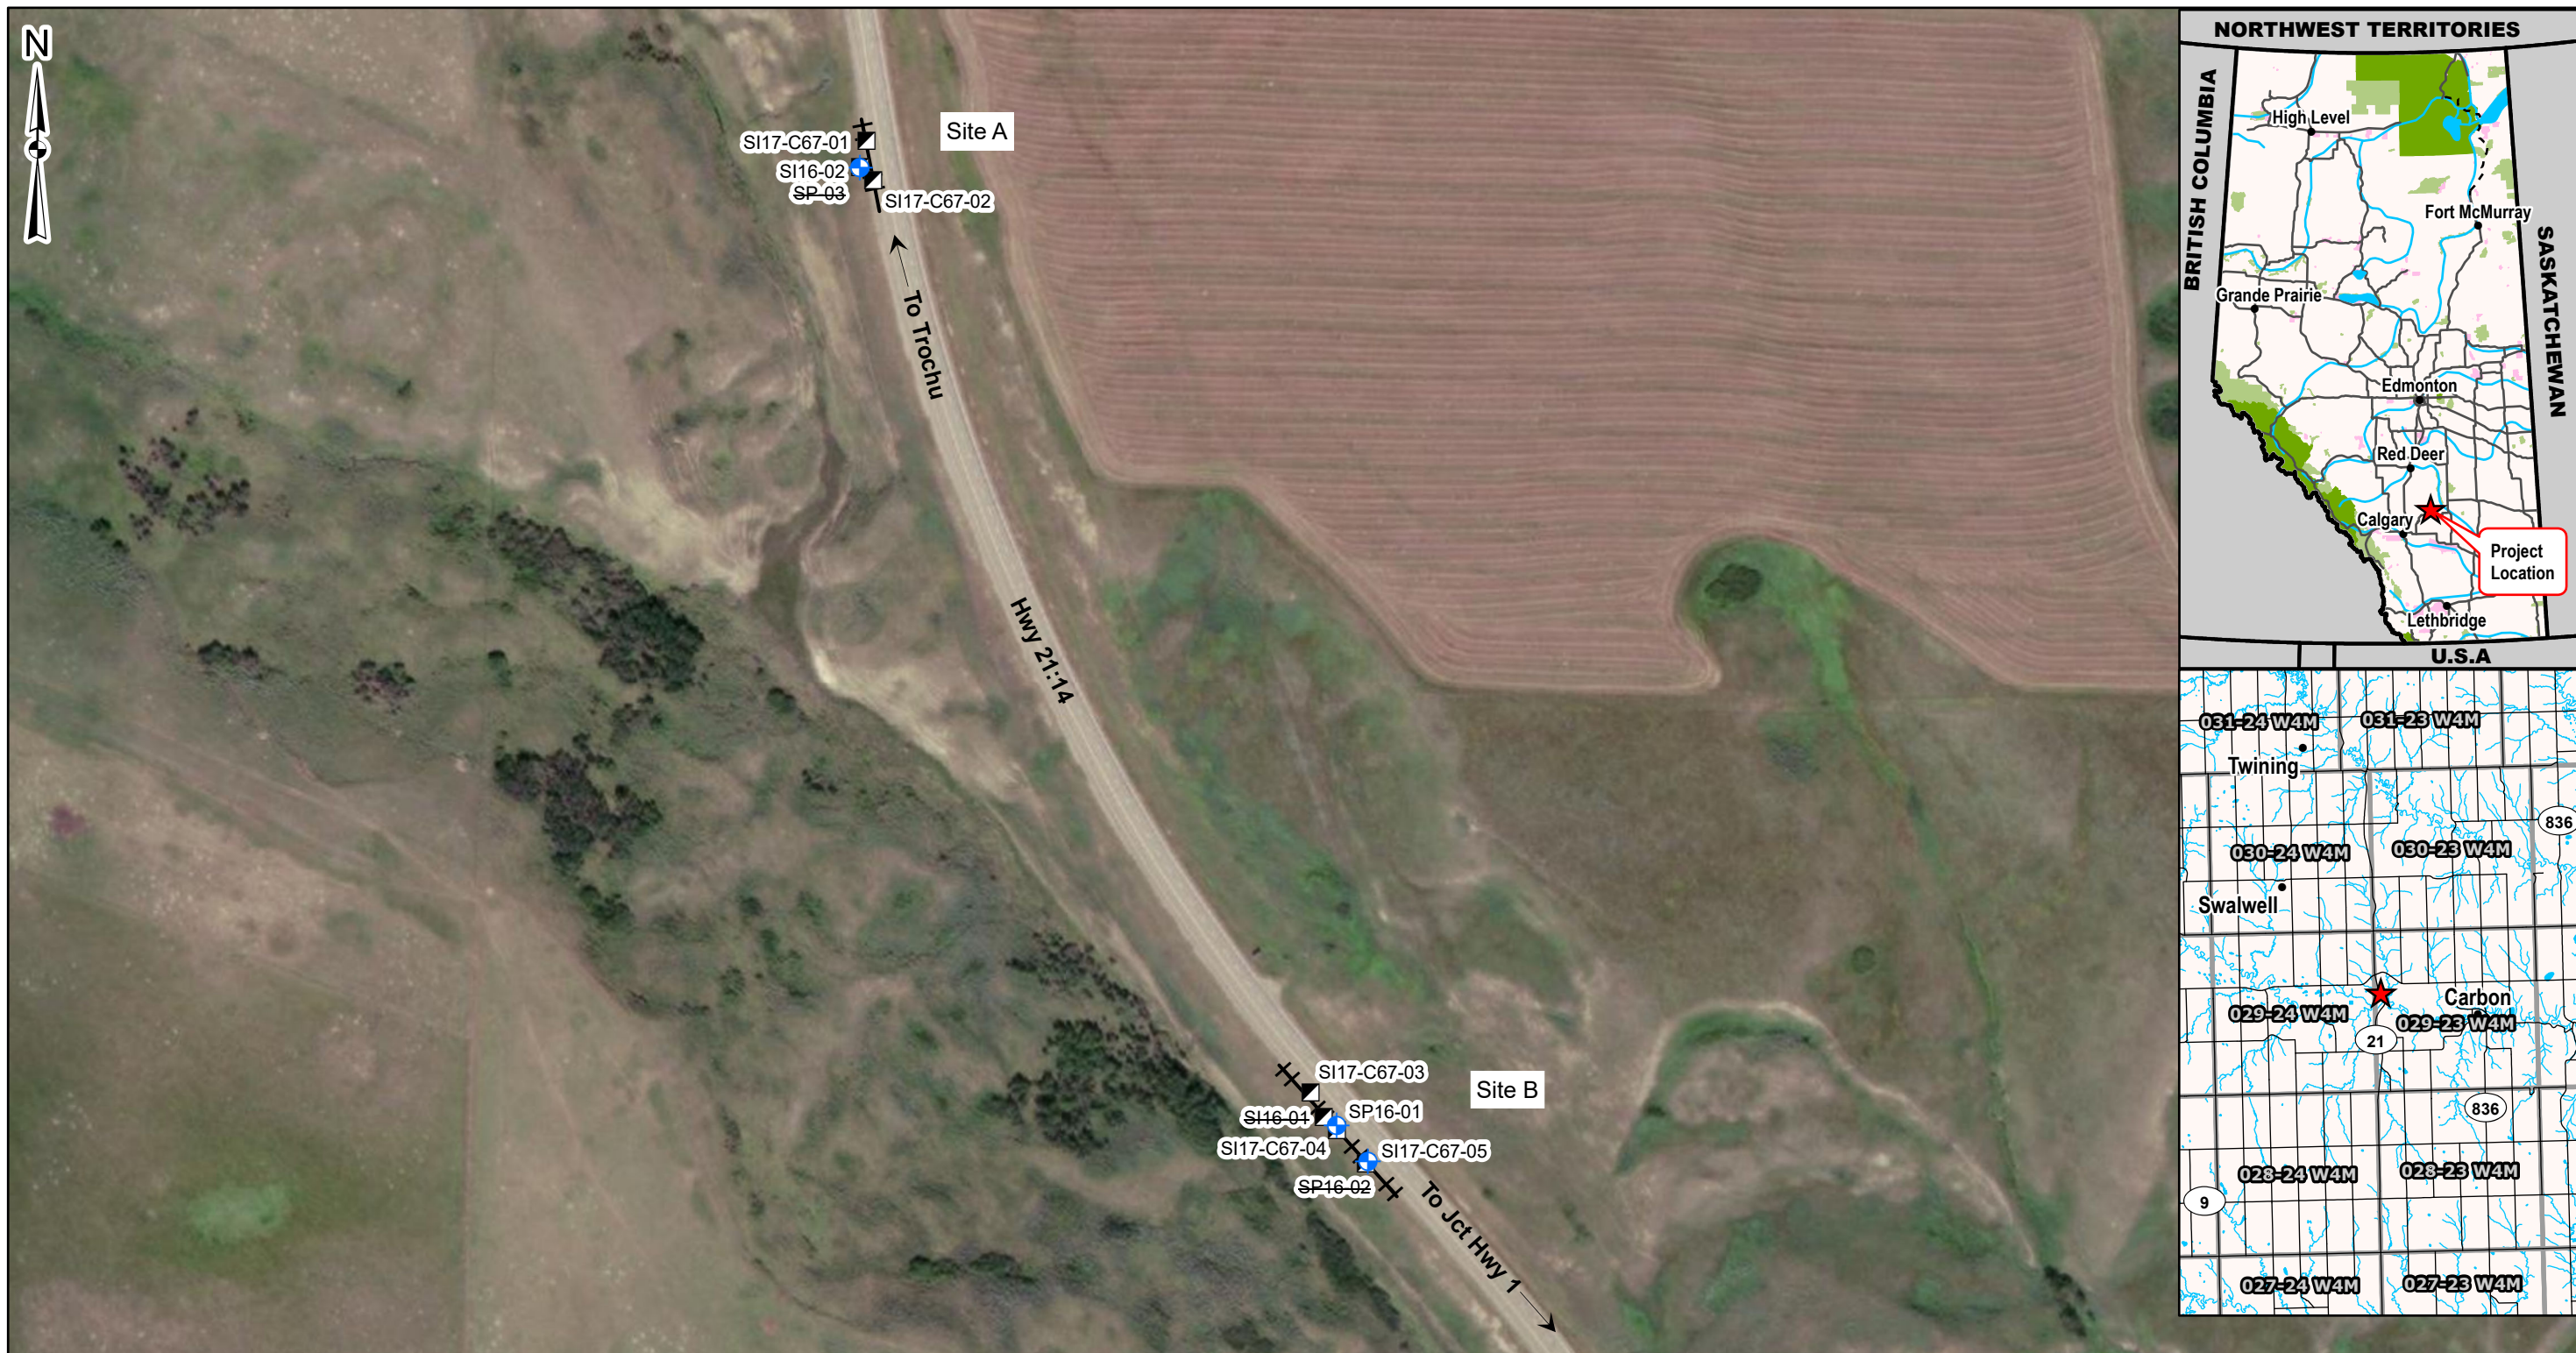
PROJECT CENTRAL REGION GEOHAZARD RISK MANAGEMENT PROGRAM		
TITLE Site Plan C067 - Kneehill Creek Slide Hwy 21:14, km 12.988		
SCALE 1:3,000	PROJECT No. A05116A02	FIG No. 1

The geohazard at the C067 site consists of two slope failures along the west slope (southbound lane) of Hwy 21:14. The two slope failures are referred to as Site A, which is at the north extent of the site, and Site B, which is at the south extent of the site. In April 2017, a 15-m deep, 80-m long H-pile wall (H360X132) consisting of 112 piles was installed at Site A, and a 16-m deep, 42.5-m long H-pile wall (H360X132) consisting of 60 piles were installed at Site B. The location and extents of the H-pile walls are depicted in Figure 1. Additional remedial actions include regular pavement patching.

In 2016, KCB installed one SI (SI16-02) and one SP (SP16-03) at Site A, and one SI (SI16-01) and two SPs (SP16-01 and SP16-02) at Site B to monitor depth of movement and groundwater conditions, respectively. The instruments were installed on the west shoulder (southbound lane) of Hwy 21:13 between the guardrail and H-pile walls. By May 2019, SI16-01 (sheared), SP16-02, and SP16-03 were inoperable.

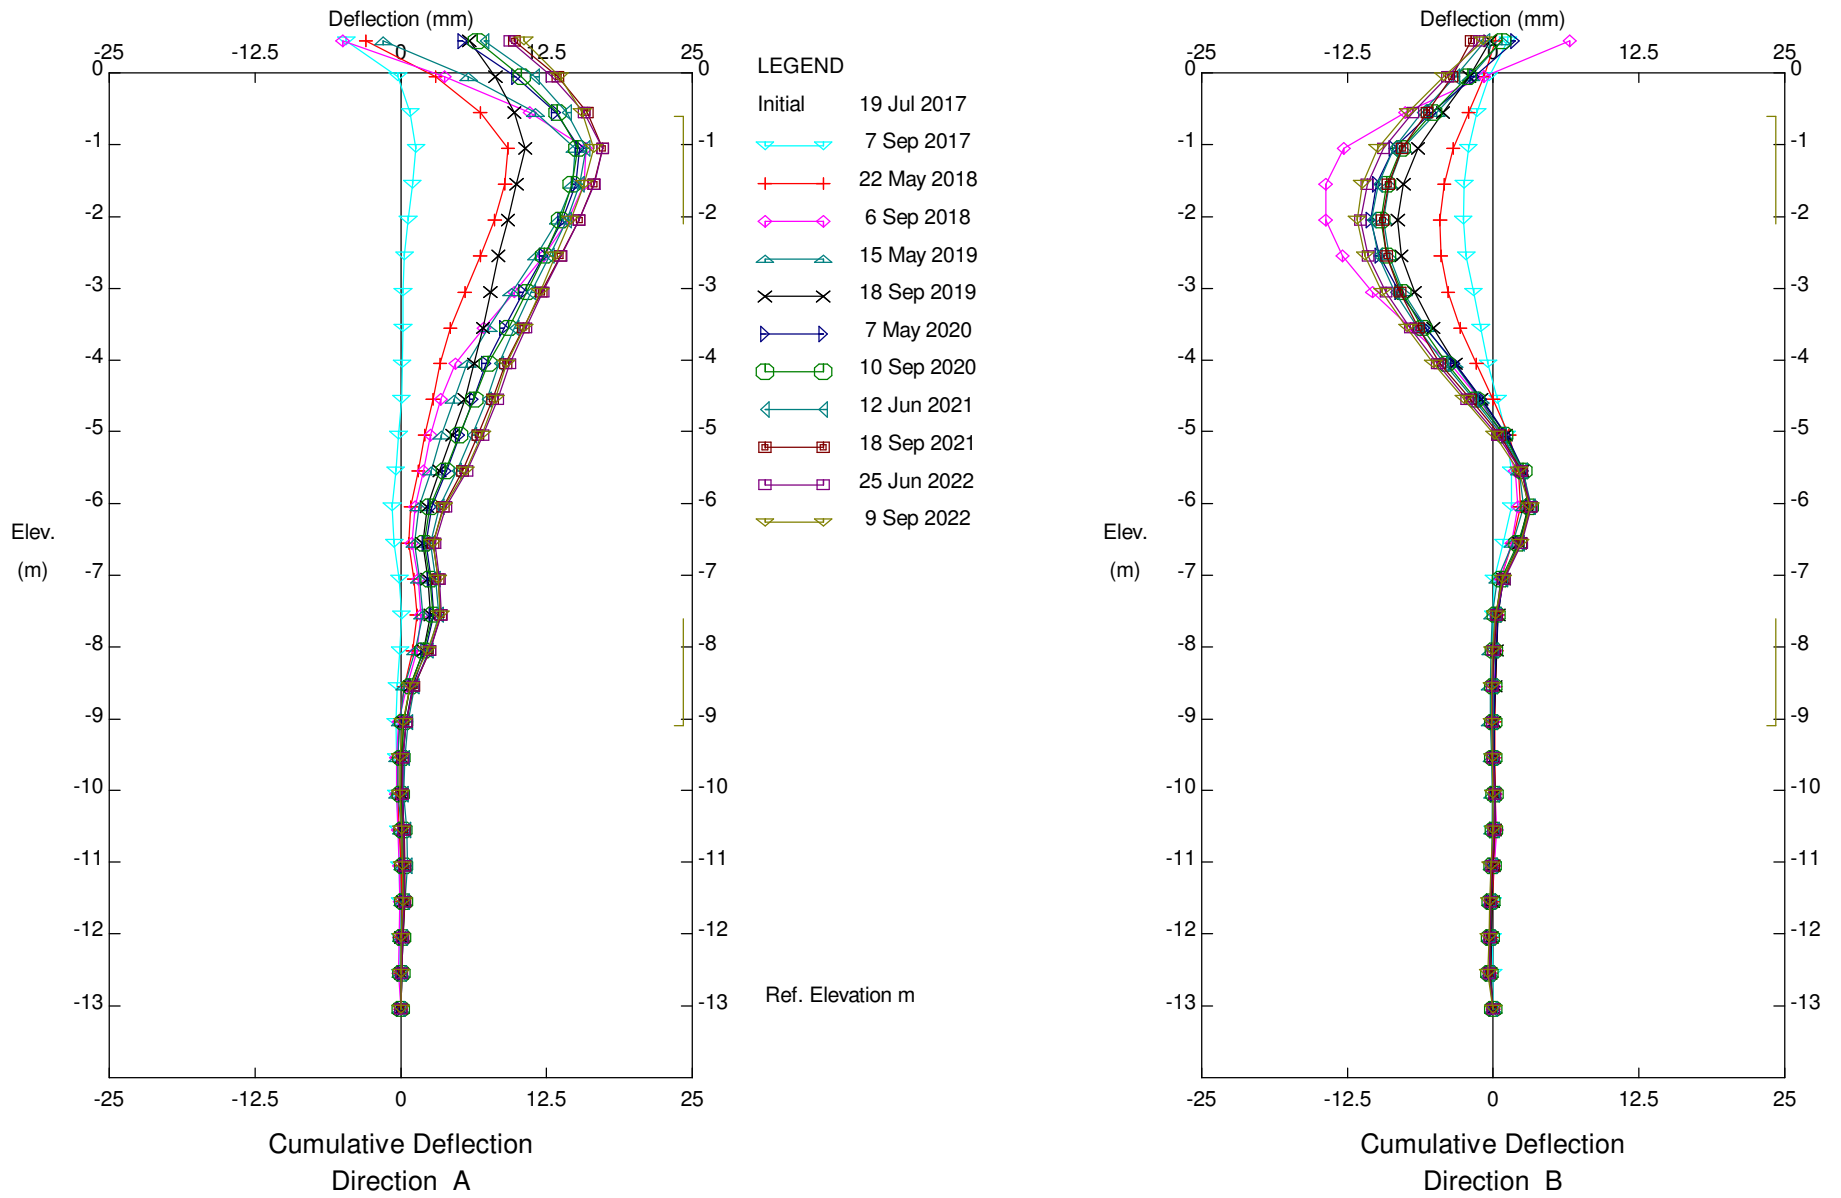
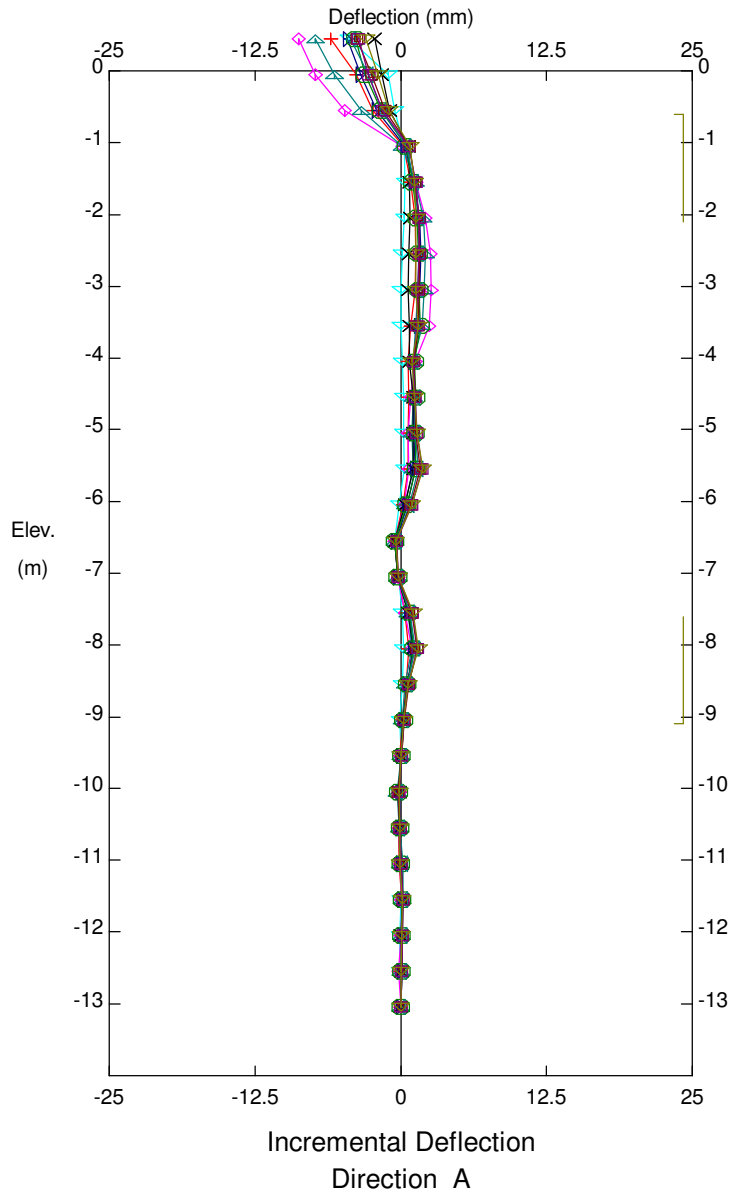
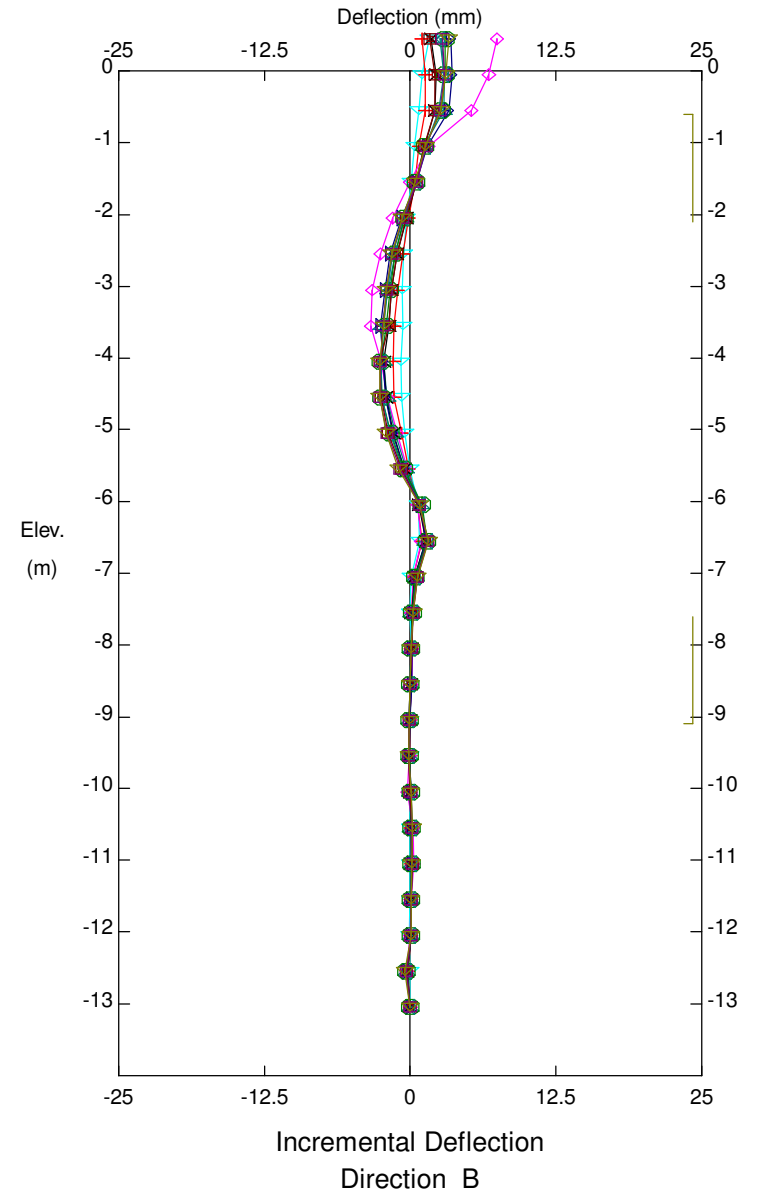
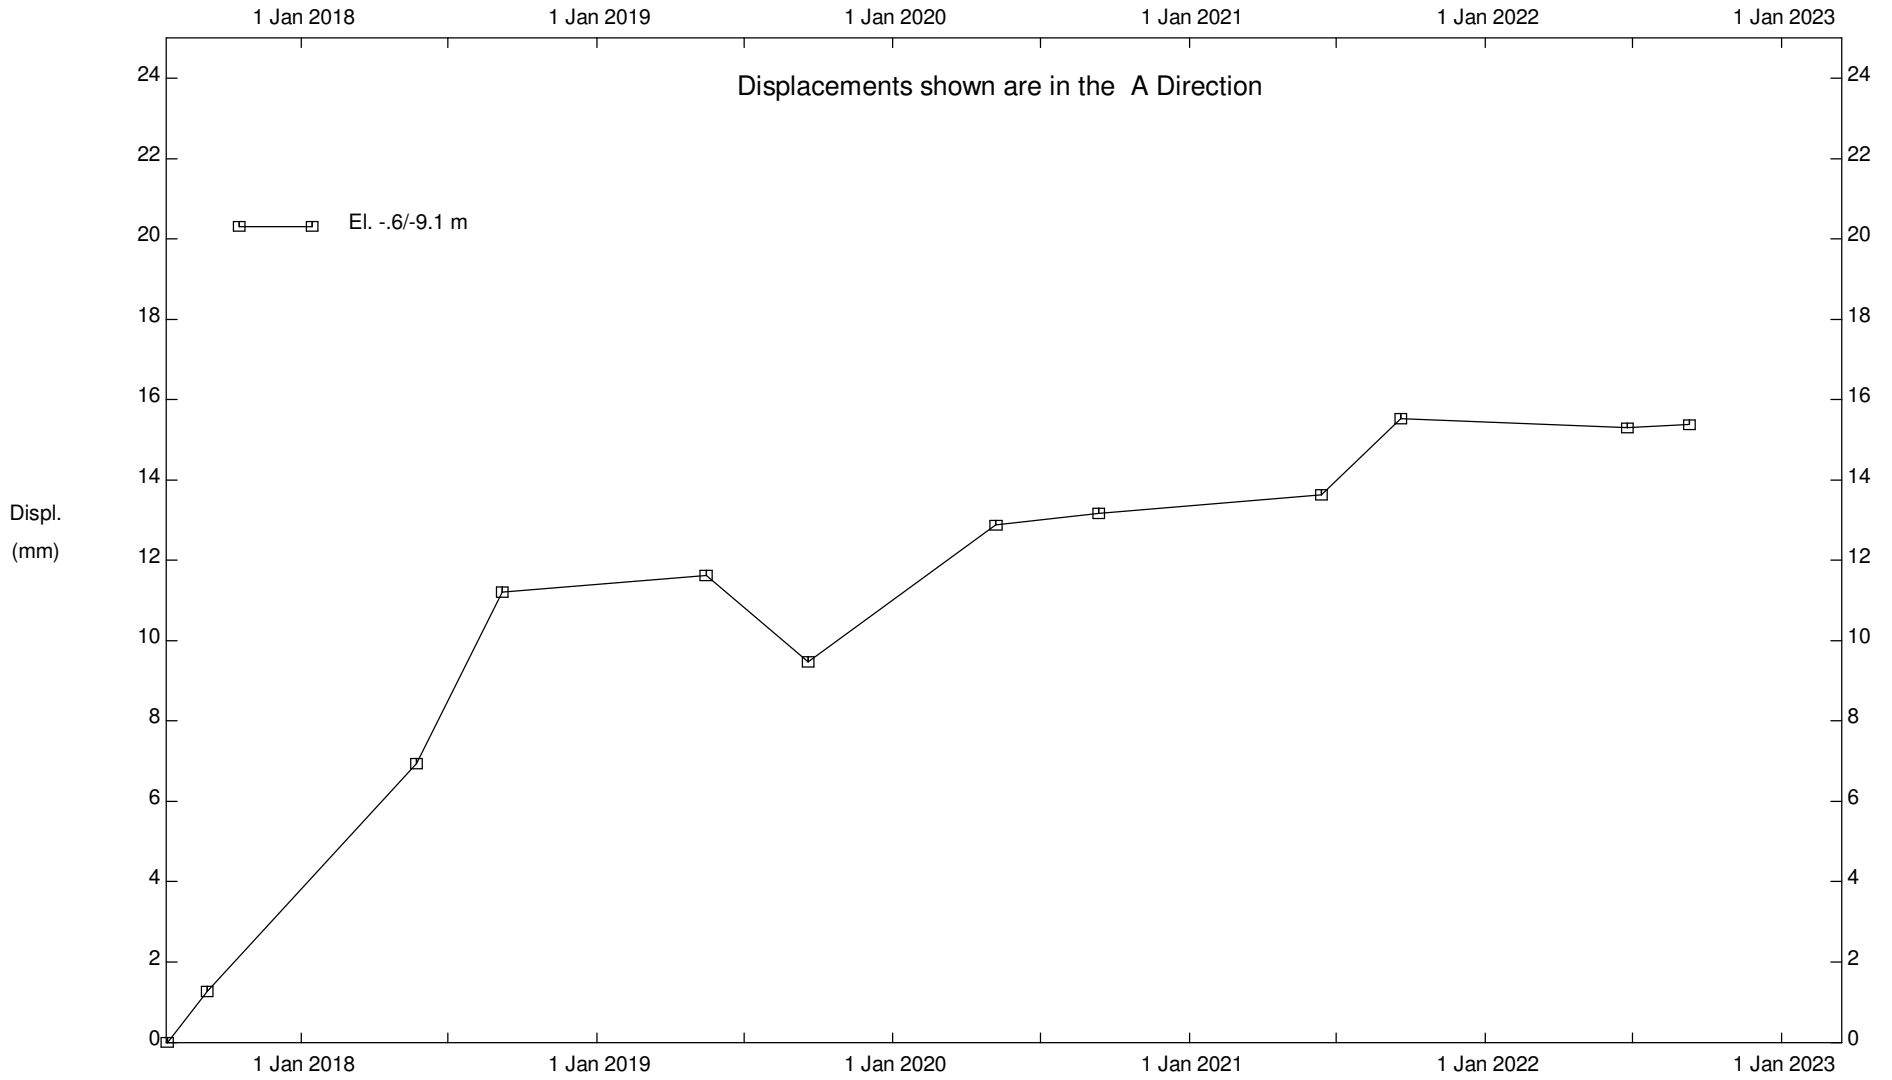
C067; H21:14, Kneehill Creek Slide, Inclinometer SI16-02

Before installation of the H-pile wall, movement was being recorded in SI16-02 at an approximate depth of 9.1 m below ground surface.

Data obtained from SI16-02 (installed upslope of the H-pile wall) indicates the active block upslope of the H-pile wall continues to creep as the H-pile wall stabilizes the sliding mass. Before the H-pile wall was installed, the maximum rate of movement recorded in SI16-02 was approximately 204 mm/year on February 21, 2017. Between April and May 2017, after installation of the H-pile wall, the rate of movement recorded in SI16-02 increased to approximately 345 mm/year. Since September 2018, the overall rate of movement recorded in this instrument has been slow (approximately 1 mm/year).

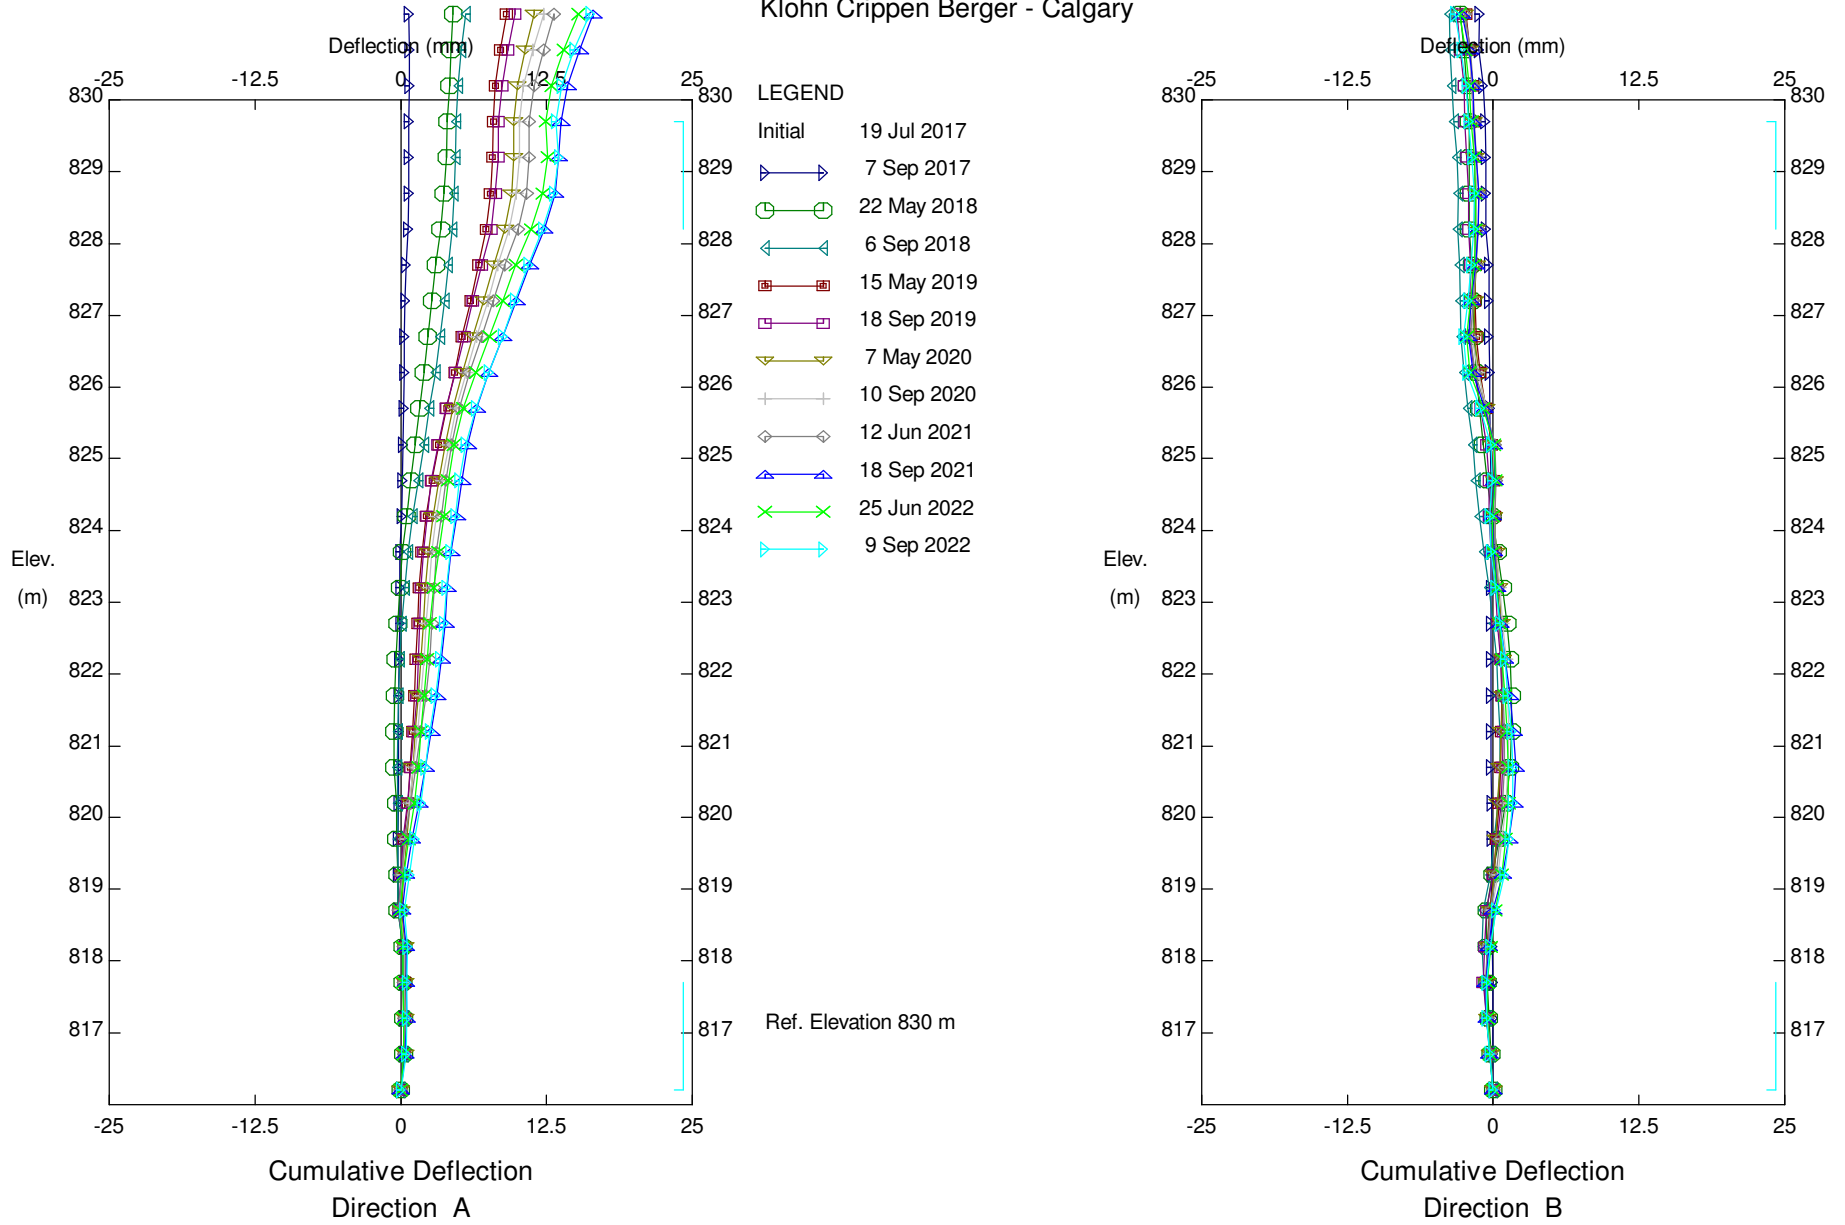
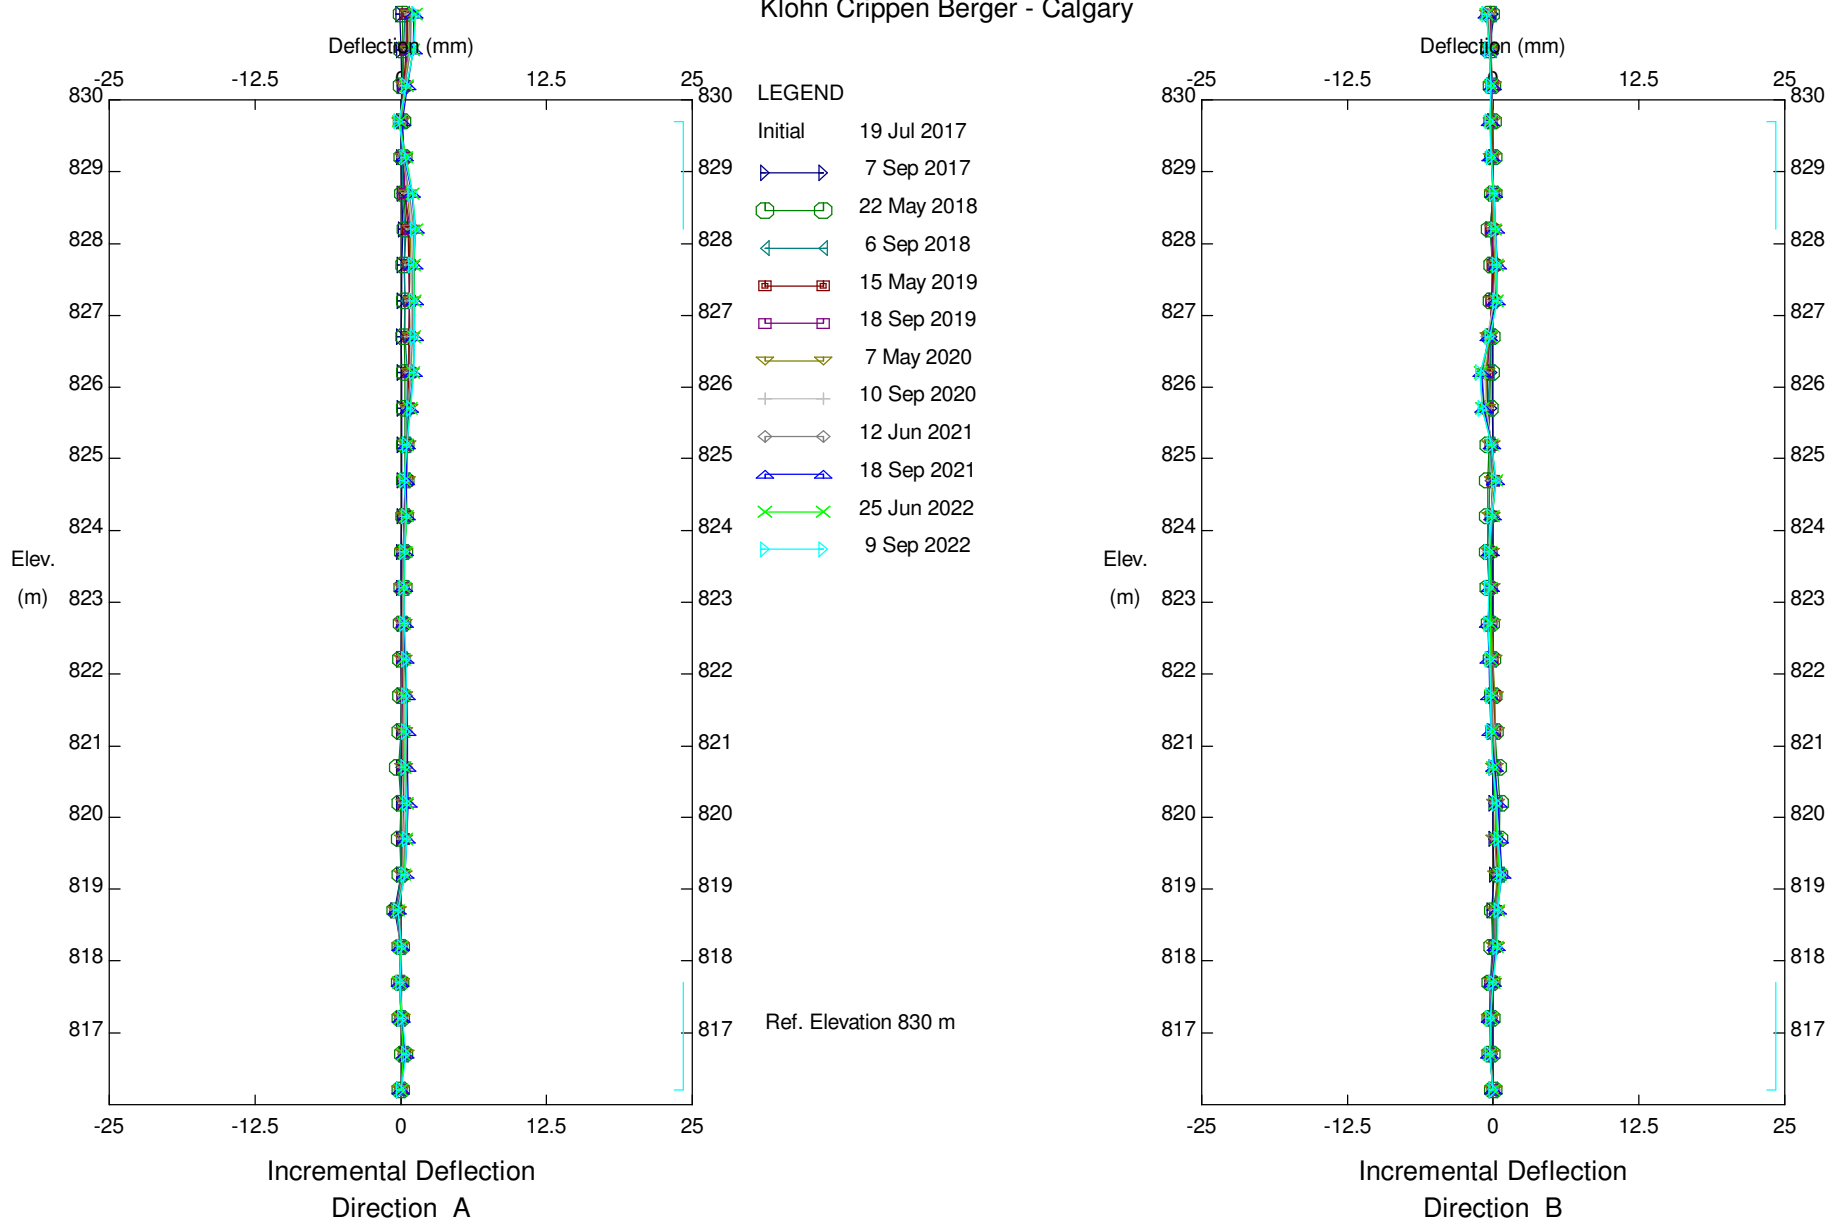
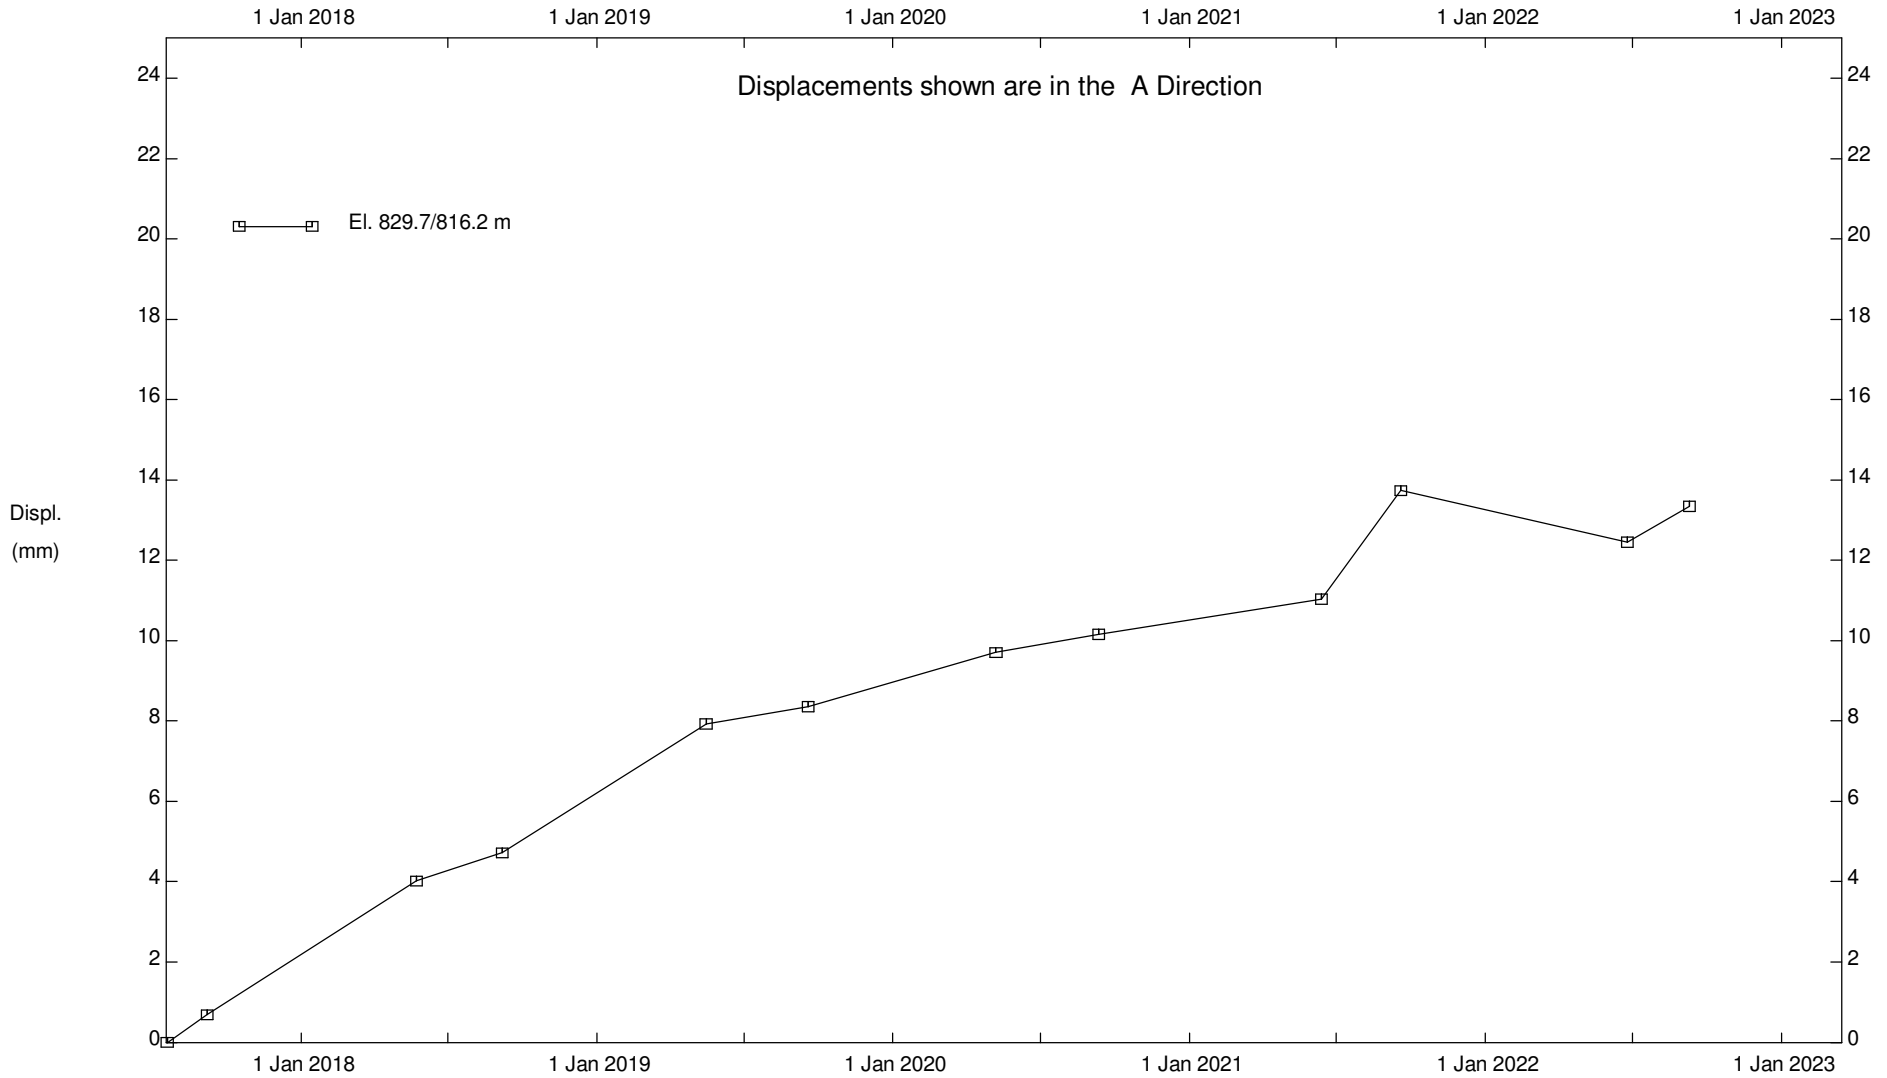
C067; H21:14, Kneehill Creek Slide, Inclinator SI17-C67-01

Distributed movement is being recorded in the SIs installed in the H-pile wall (SI17-C67-01 and SI17-C67-02) from top of casing to an approximate depth of 11.3 m and 11.8 m, respectively. The H-pile wall is 15 m deep at Site A, and the SIs are approximately 13.3 m to 14.2 m deep.

The lowest depth at which movement is being recorded in the pile-wall SIs (SI17-C67-01 and SI17-C67-02) appears to be occurring approximately 2 m to 3 m below the depth of movement recorded in SI16-02. This indicates the H-pile wall has intercepted the failure surface and is continuing to deflect, transferring load to depths below the failure plane as the piles stabilize the sliding mass.

The September 2022 data obtained from SI17-C67-01 and SI17-C67-02 indicates the top of the H-pile wall at Site A has deflected between approximately 14 mm and 21 mm since installation. The maximum rate of movement recorded in SI17-C67-01 and SI17-C67-02 was approximately 45 mm/year in May 2017, one month after the H-pile wall was installed. The rate of movement has since decreased and is now generally less than 10 mm/year.

Between June and September 2022, an increased rate of movement (between approximately 4 mm/year and 9 mm/year) was recorded in SI17-C67-01 and SI17-C67-02 likely in response to wet weather in June and July 2022. The previous year and the spring of 2022 were relatively dry.
