November 29, 2022

**CON0022160 Central Region GRMP Instrumentation Monitoring**  
**Site C067; H21:14, km 12.988 Kneehill Creek Slide**  
**Section C – 2022 Fall Readings**

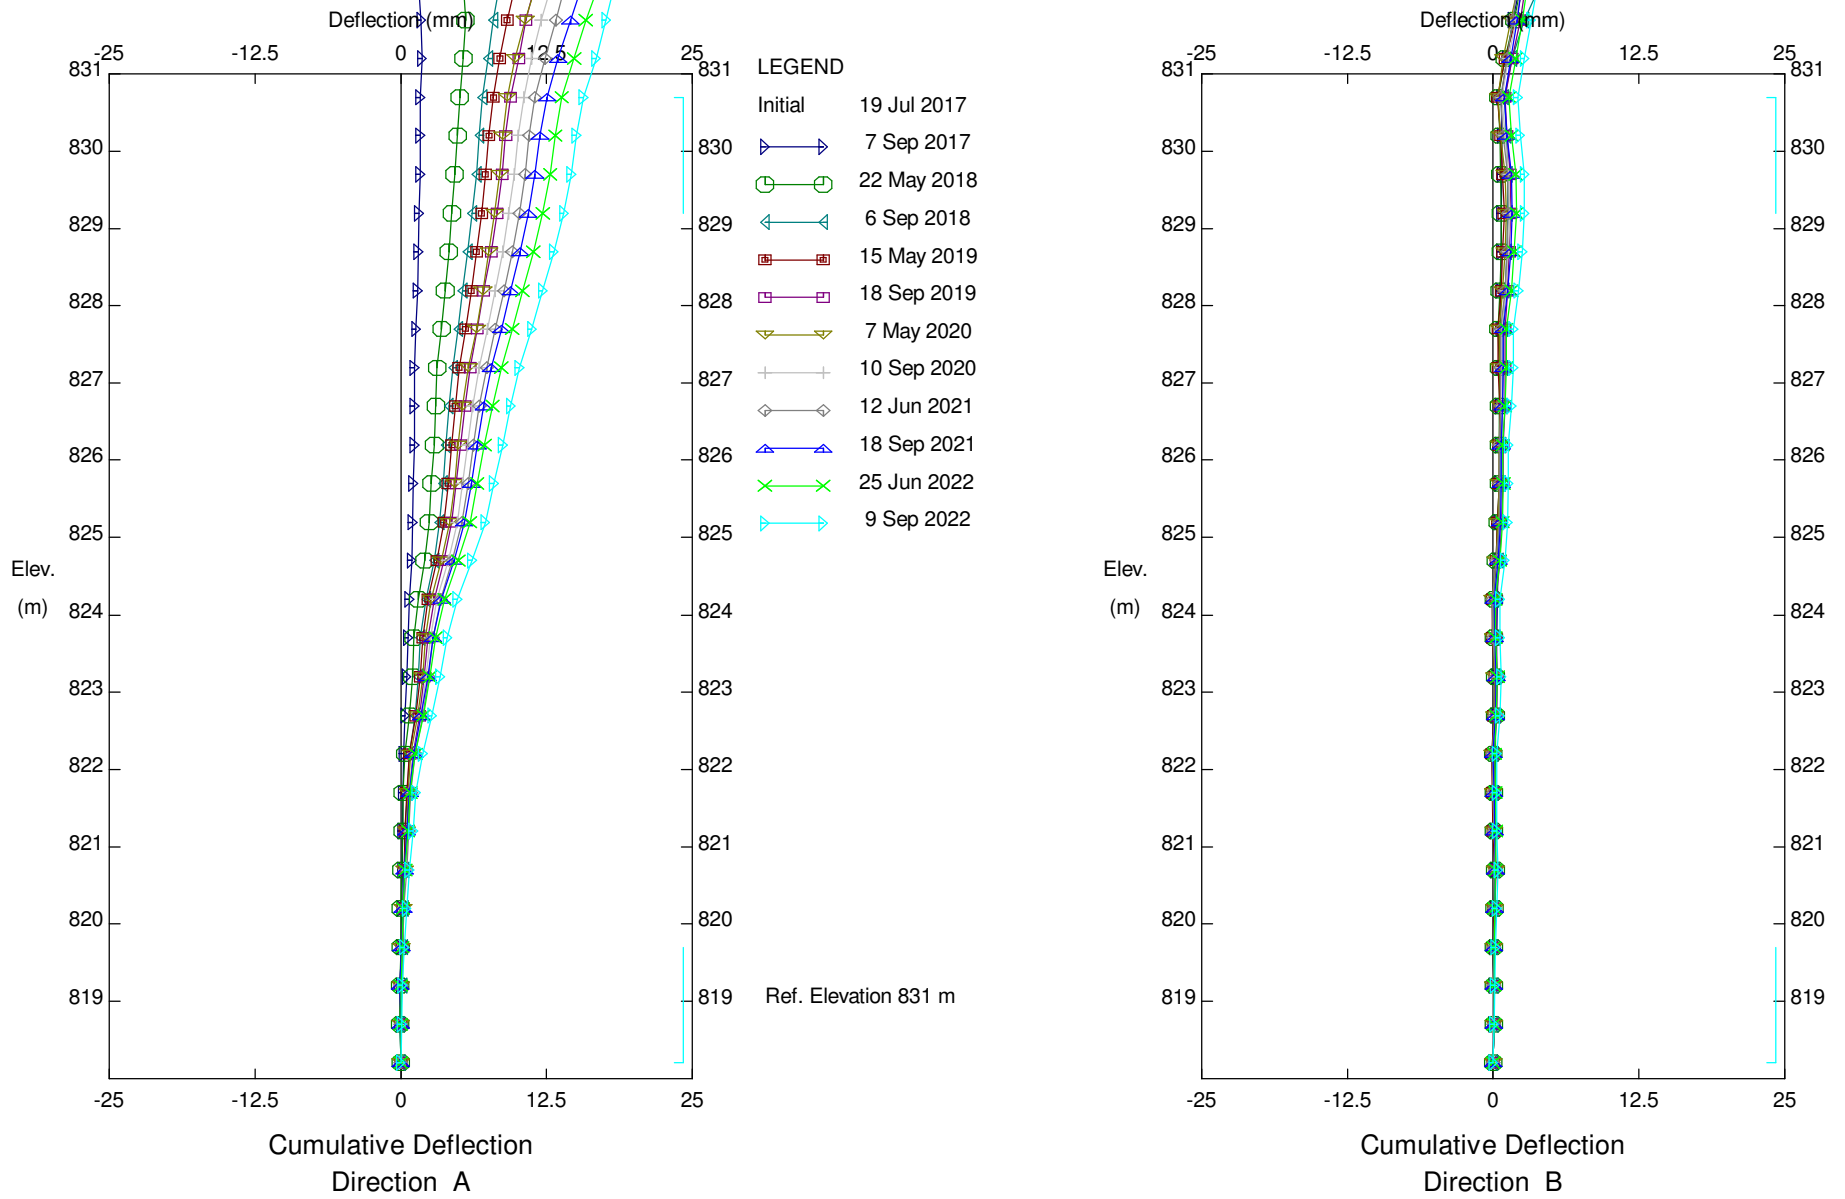
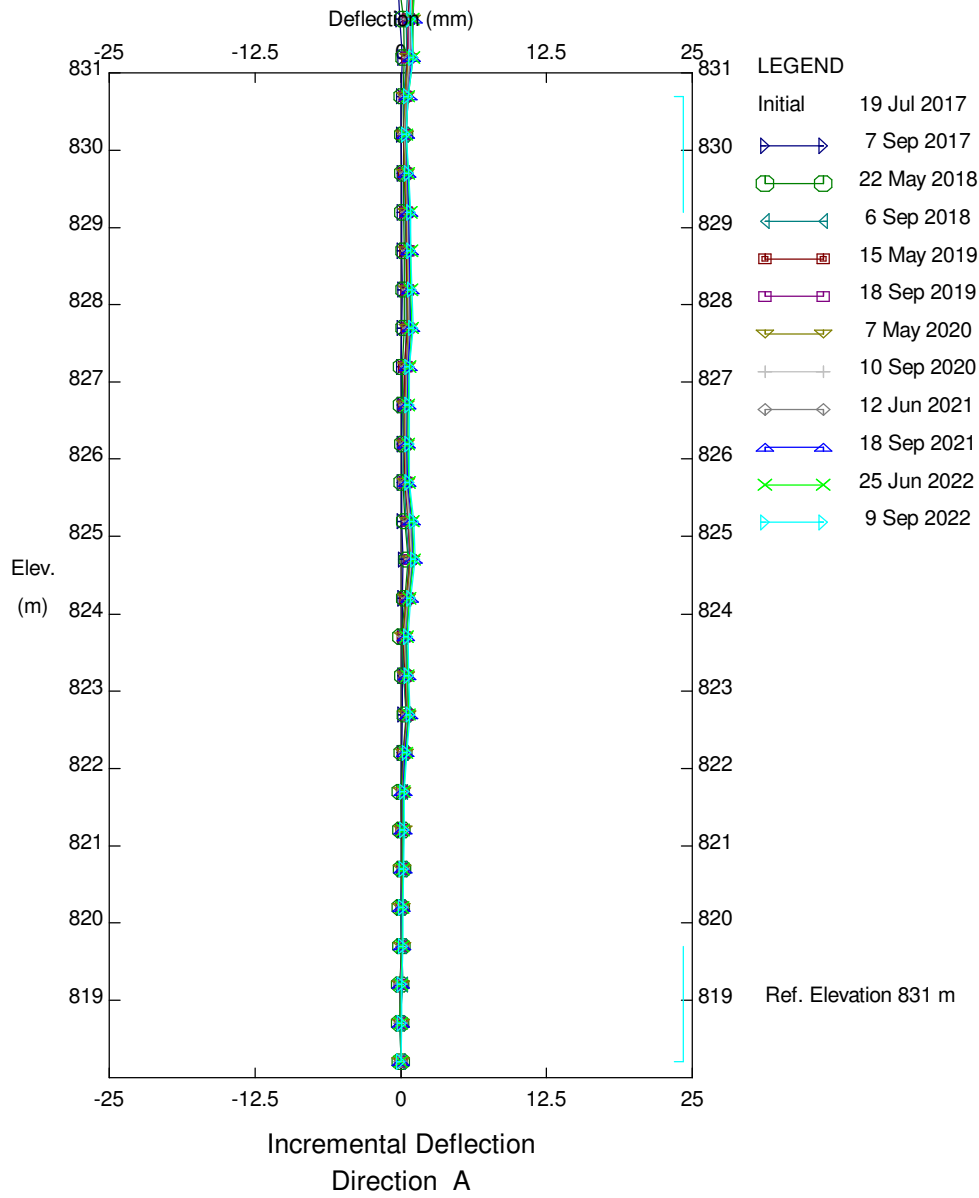
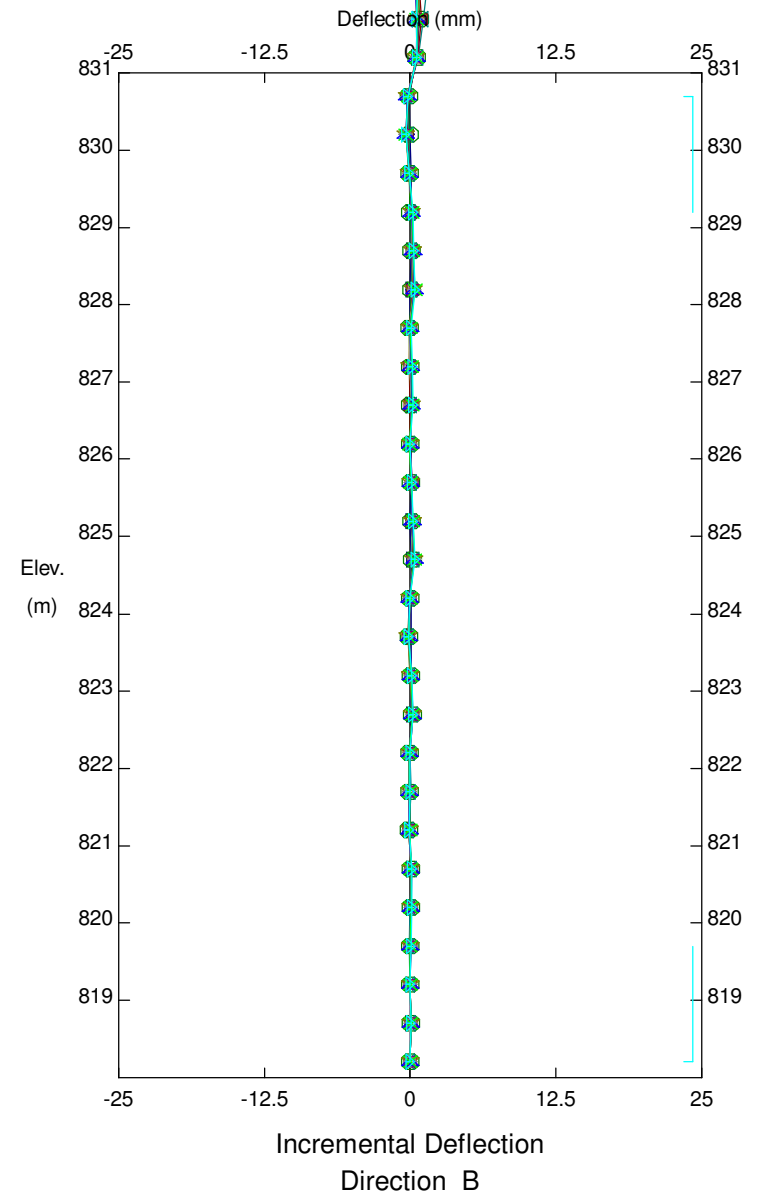
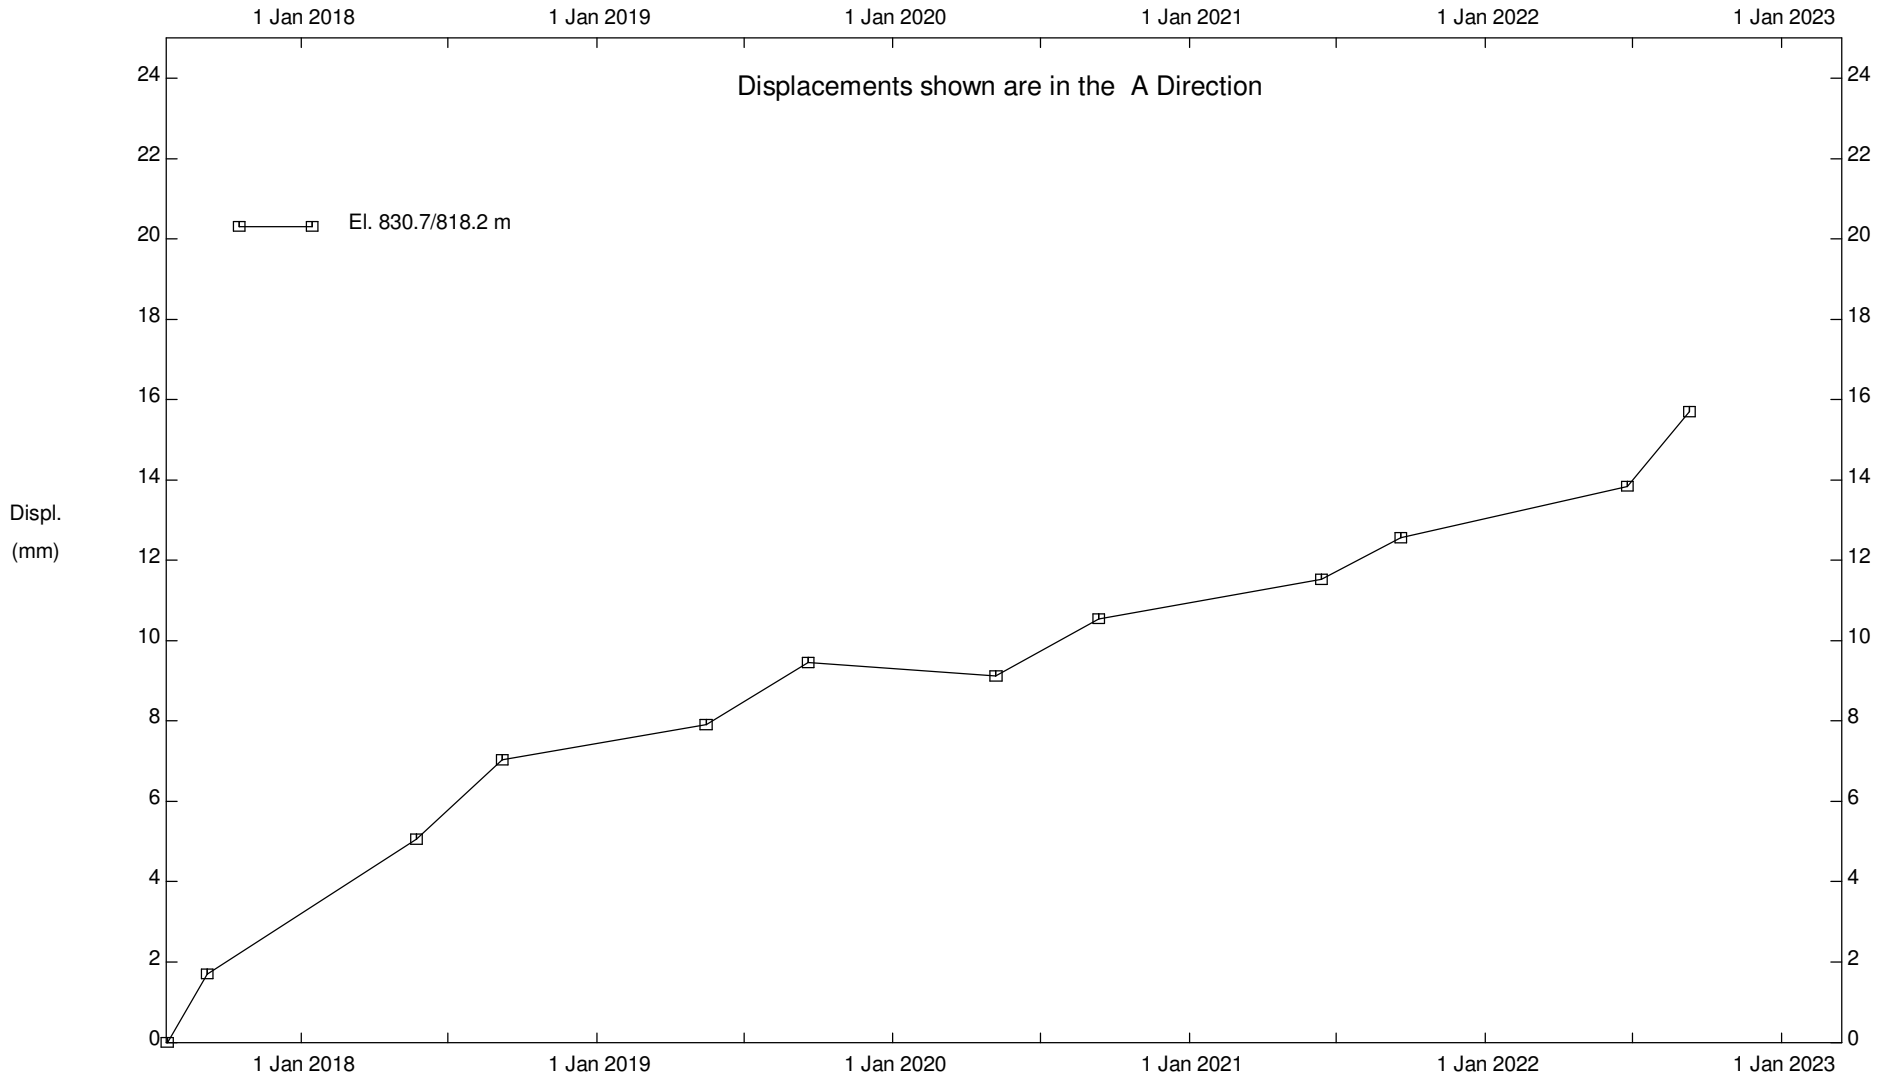
C067; H21:14, Kneehill Creek Slide, Inclinator SI17-C67-02

Distributed movement is being recorded in the SIs installed in the H-pile wall (SI17-C67-01 and SI17-C67-02) from top of casing to an approximate depth of 11.3 m and 11.8 m, respectively. The H-pile wall is 15 m deep at Site A, and the SIs are approximately 13.3 m to 14.2 m deep.

The lowest depth at which movement is being recorded in the pile-wall SIs (SI17-C67-01 and SI17-C67-02) appears to be occurring approximately 2 m to 3 m below the depth of movement recorded in SI16-02. This indicates the H-pile wall has intercepted the failure surface and is continuing to deflect, transferring load to depths below the failure plane as the piles stabilize the sliding mass.

The September 2022 data obtained from SI17-C67-01 and SI17-C67-02 indicates the top of the H-pile wall at Site A has deflected between approximately 14 mm and 21 mm since installation. The maximum rate of movement recorded in SI17-C67-01 and SI17-C67-02 was approximately 45 mm/year in May 2017, one month after the H-pile wall was installed. The rate of movement has since decreased and is now generally less than 10 mm/year.

Between June and September 2022, an increased rate of movement (between approximately 4 mm/year and 9 mm/year) was recorded in SI17-C67-01 and SI17-C67-02 likely in response to wet weather in June and July 2022. The previous year and the spring of 2022 were relatively dry.

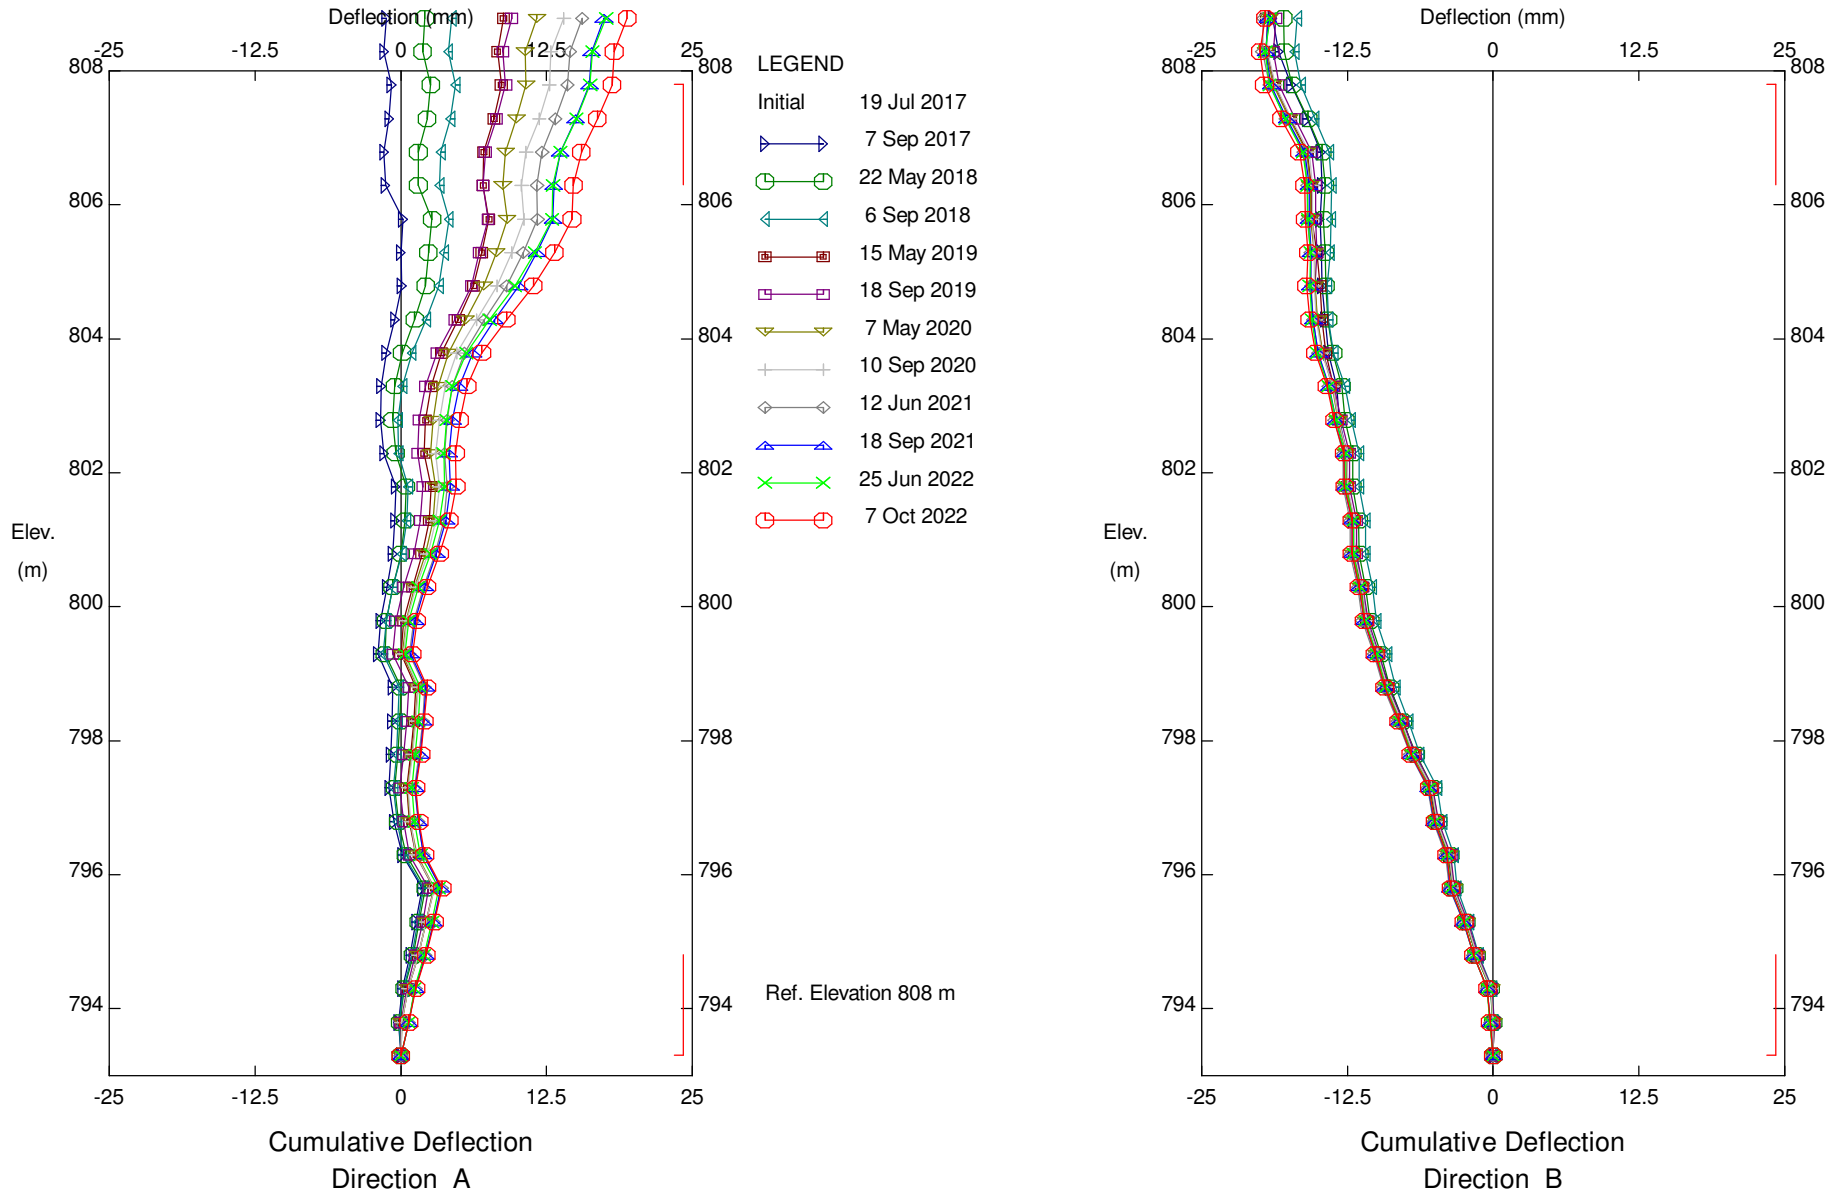
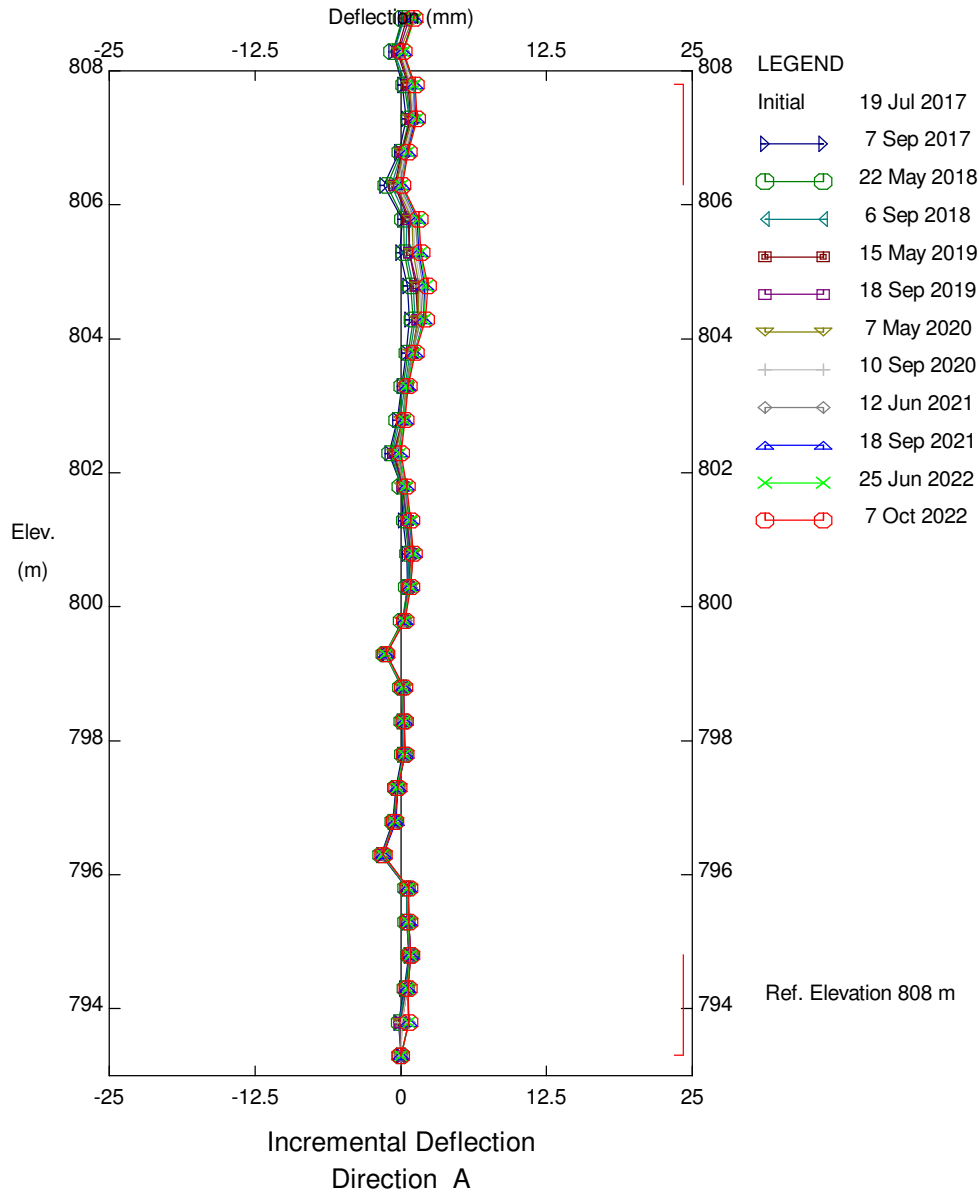
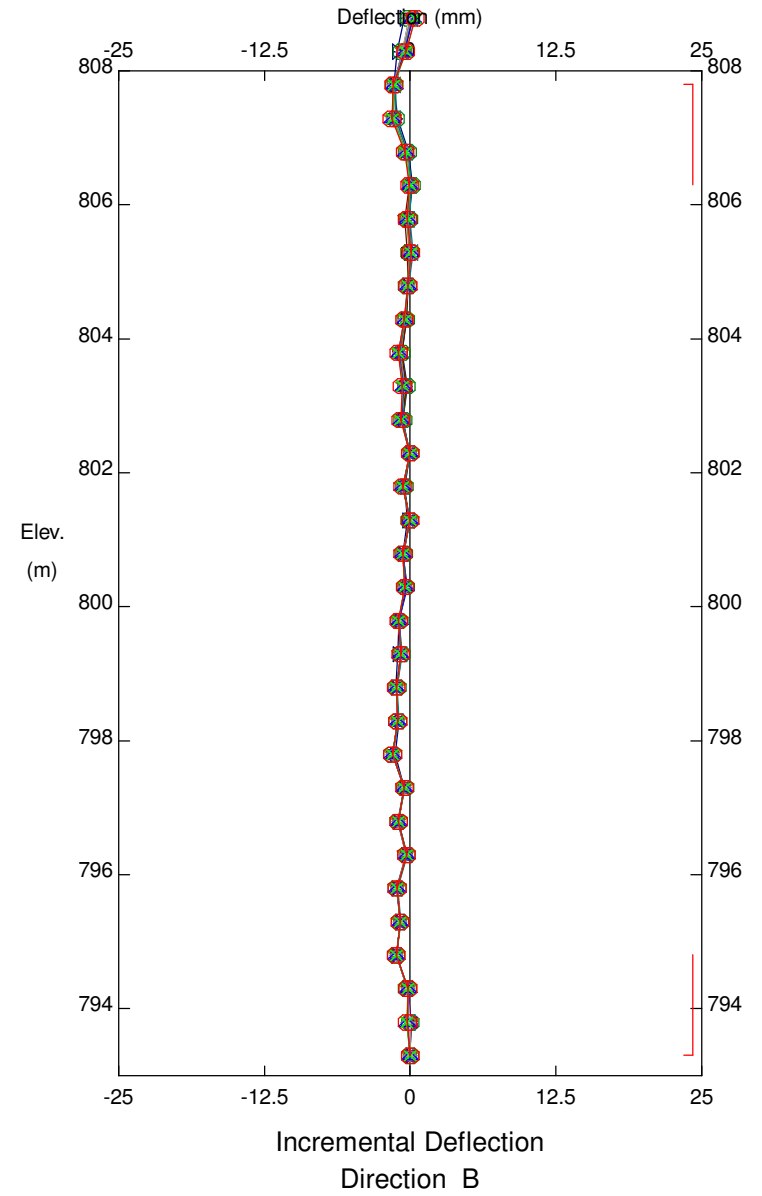
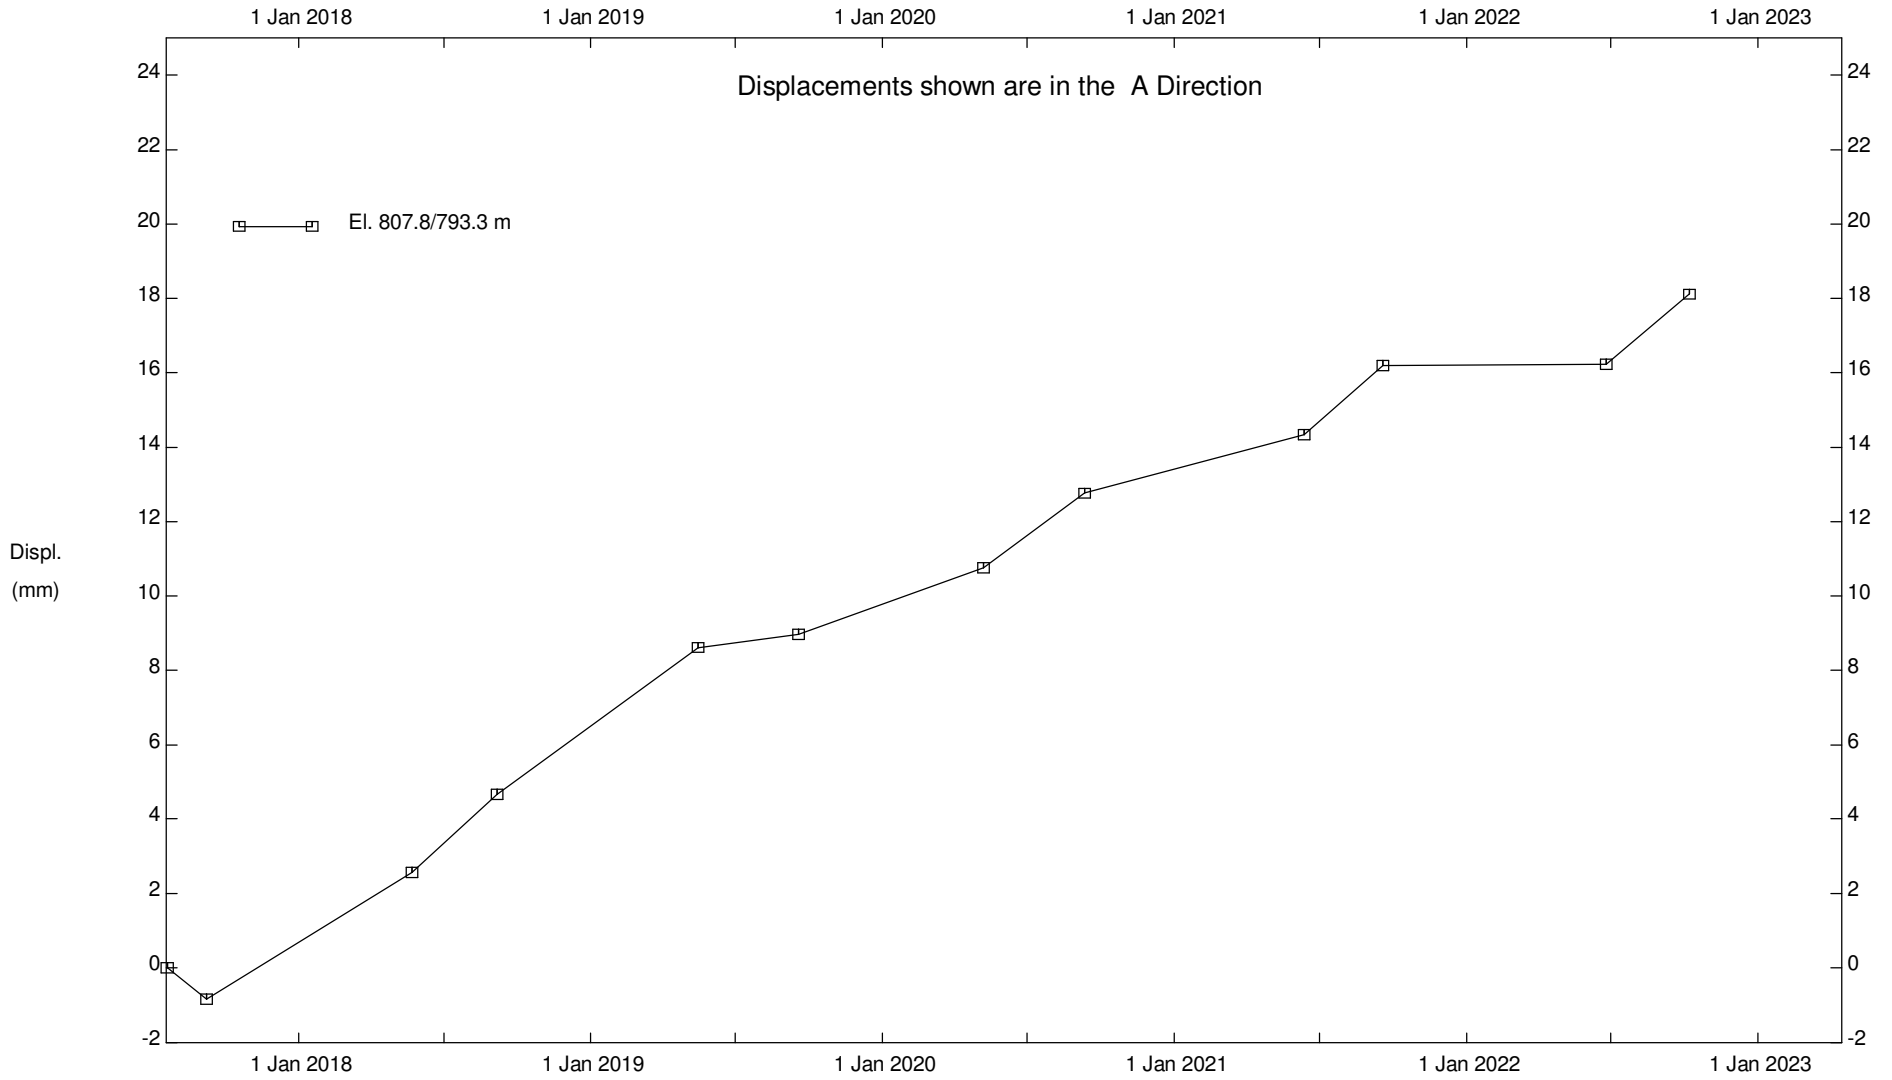
C067; H21:14, Kneehill Creek Slide, Inclinometer SI17-C67-03

Distributed movement is being recorded in the SIs installed in the H-pile wall (SI17-C67-03 though and SI17-C67-05) from top of casing to an approximate depth of 8.7 m, 6.8 m, and 6.5 m, respectively. The H-pile wall is 15 m deep at Site B, and the SIs are approximately 12.8 m to 14.9 m deep.

The depth of movement being recorded in the pile-wall SIs (SI17-C67-03 through SI17-C67-05) appears to be occurring 2 m to 4 m below the depth of movement previously recorded in SI16-01. This indicates the H-pile wall has intercepted the failure surface and is continuing to deflect, transferring load to depths below the failure plane as the piles stabilize the sliding mass.

The September 2022 data obtained from SI17-C67-03 through SI17-C67-05 indicates the top of the H-pile wall has deflected between approximately 17 mm and 27 mm since installation. The maximum rate of movement recorded in SI17-C67-03 through SI17-C67-05 was approximately 71 mm/year to 115 mm/year in May 2017, one month after the H-pile wall was installed. The rate of movement has since decreased and is now generally less than 10 mm/year.

Between June and September 2022, an increased rate of movement (between approximately 6 mm/year and 7 mm/year) was recorded in SI17-C67-03 and SI17-C67-04 likely in response to wet weather in June and July 2022. The previous year and the spring of 2022 were relatively dry.

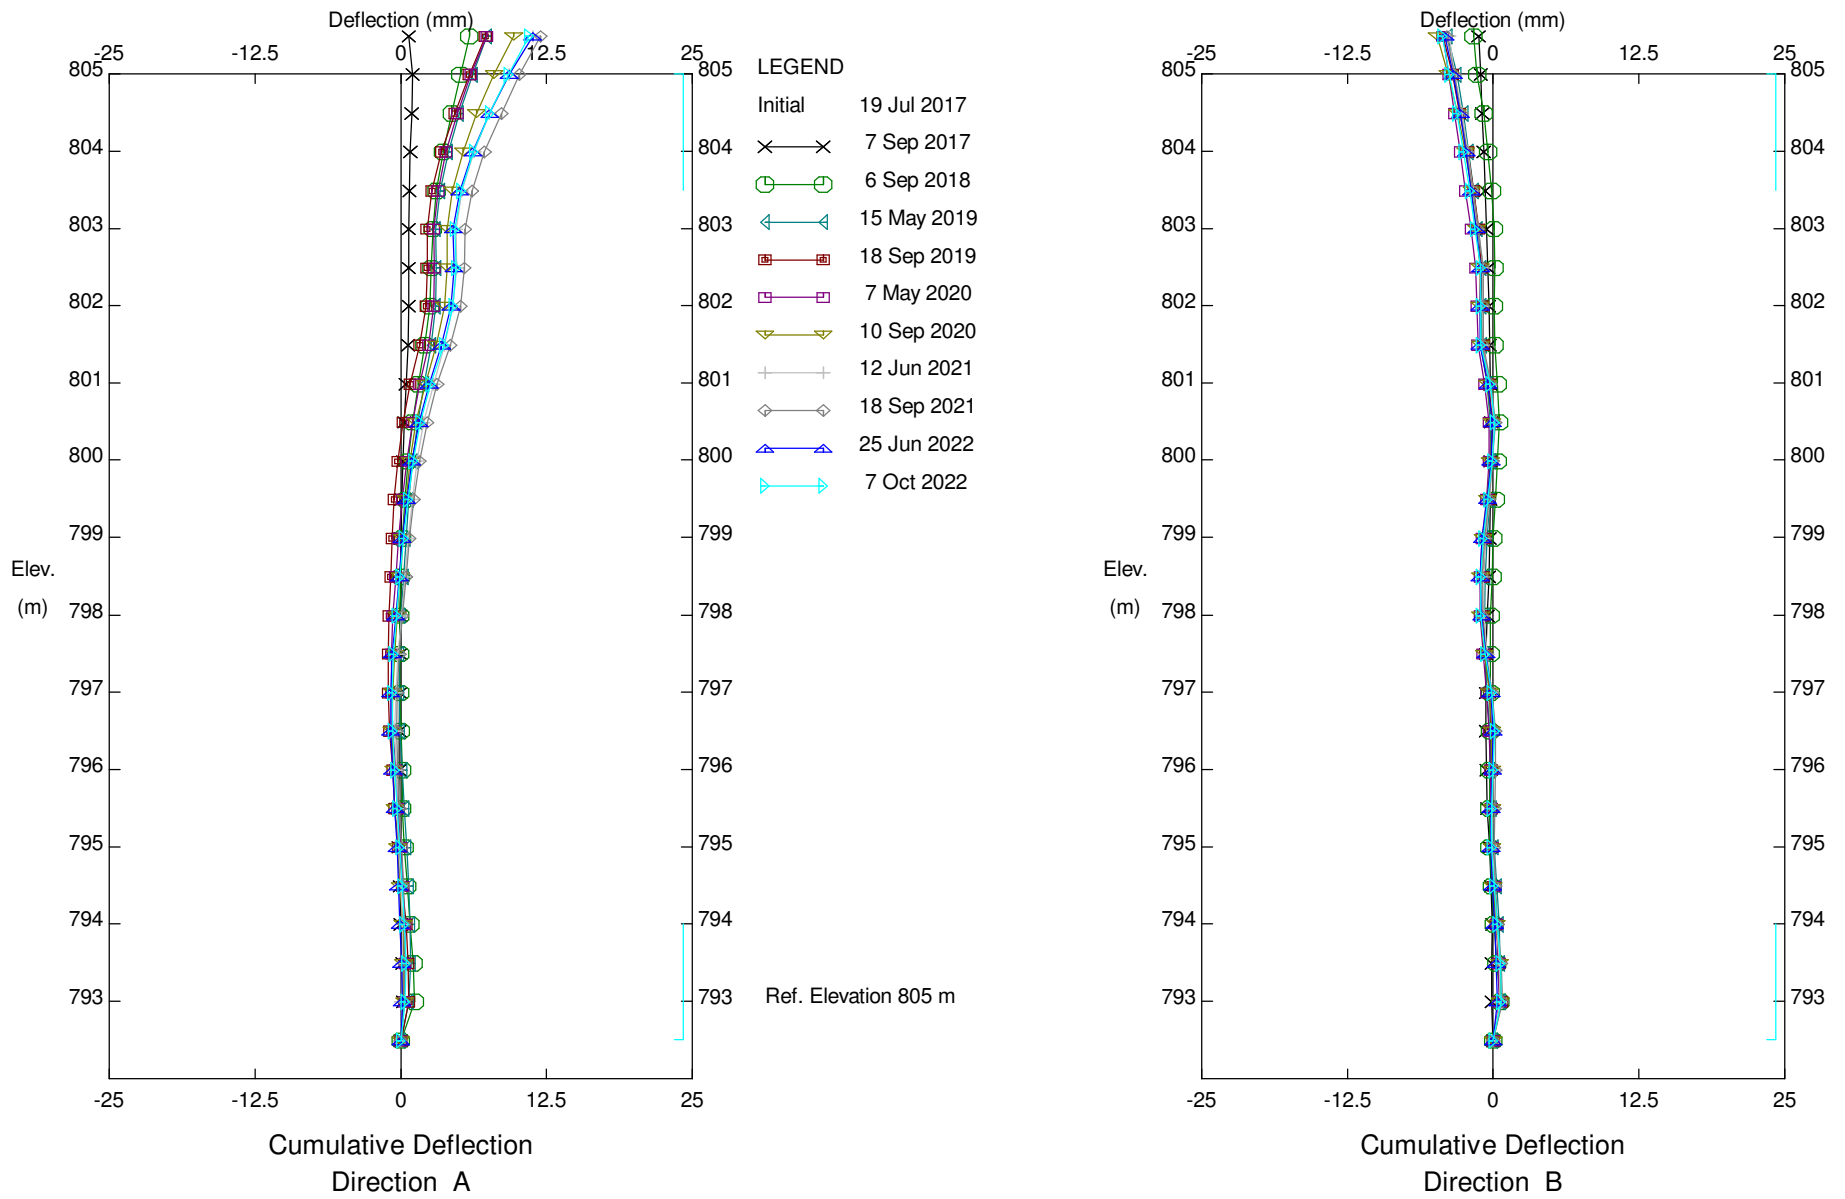
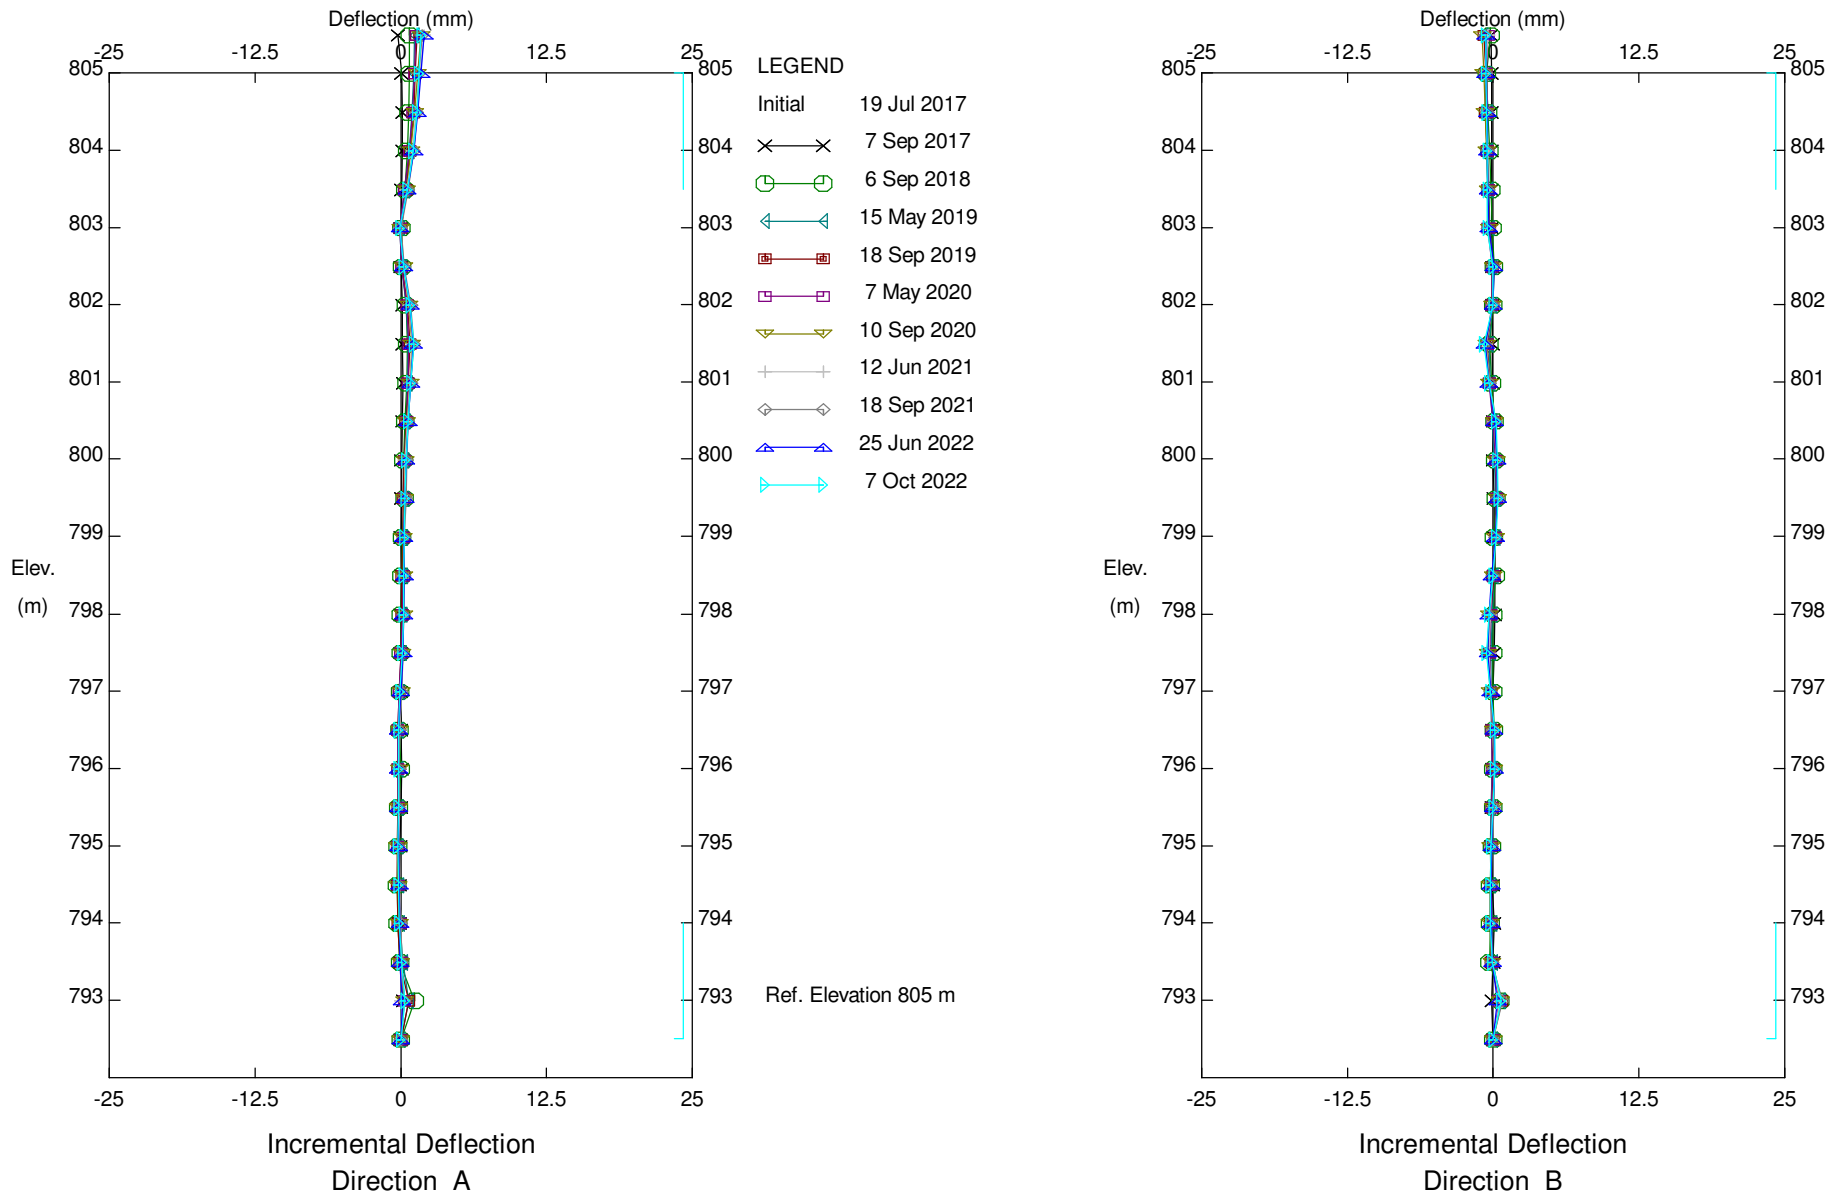
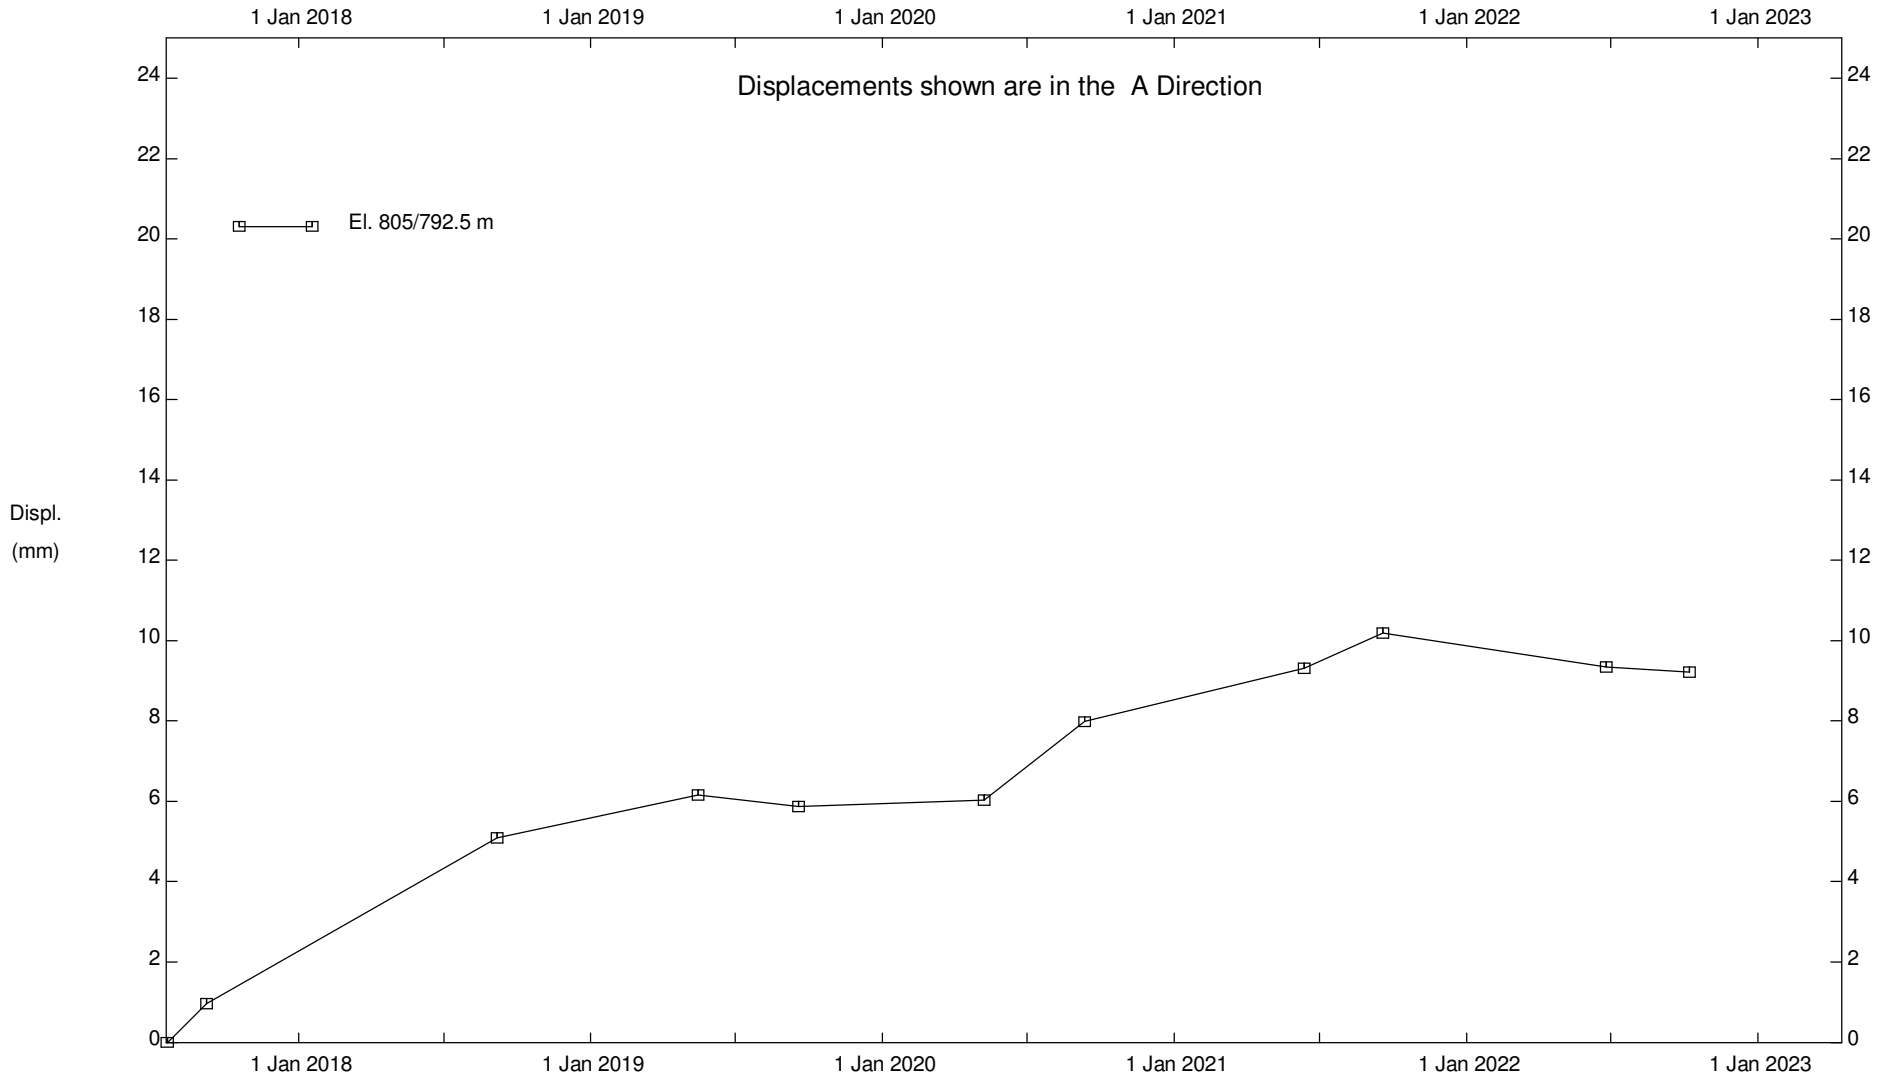
C067; H21:14, Kneehill Creek Slide, Inclinometer SI17-C67-05

The negative displacement recorded in SI21-C67-05 may be attributed to movement within the reading accuracy of the equipment or noisy data (KCB has previously observed the readings can sometimes take longer-than-usual to stabilize at the Site B SIs).

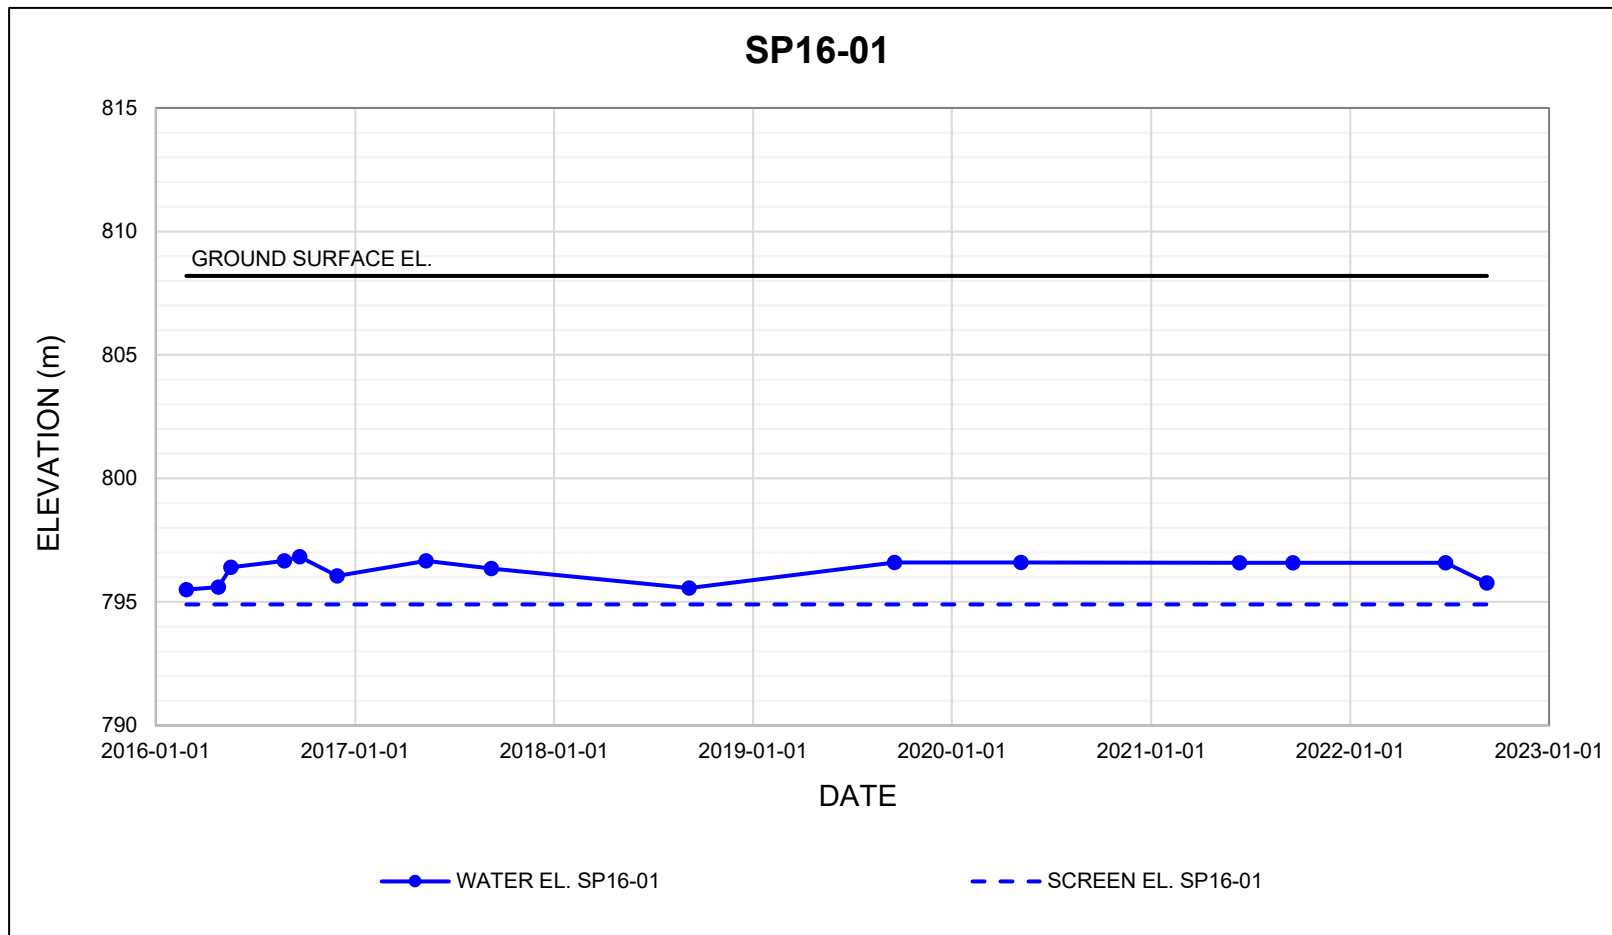
PROJECT CENTRAL REGION GEOHAZARD RISK MANAGEMENT PROGRAM	
	TITLE Piezometer Data C067 - Kneehill Creek Slide Hwy 21:14, km 12.988

Since installation in February 2016, water levels recorded in SP16-01 have been relatively steady varying from 11.4 m to 12.7 m below ground surface. The September 2022 reading of 12.4 m below ground surface was consistent with historical trends observed in this instrument.
