September 29, 2025

Alberta Transportation and Economic Corridors  
4<sup>th</sup> Floor, Provincial Building  
4920 – 51<sup>st</sup> Street  
Red Deer, Alberta  
T4N 6K8

**CON0022160 Central Region GRMP Instrumentation Monitoring**  
**Site C067; H21:14, km 12.988 Kneehill Creek Slide**  
**Section C – 2025 Fall Readings**

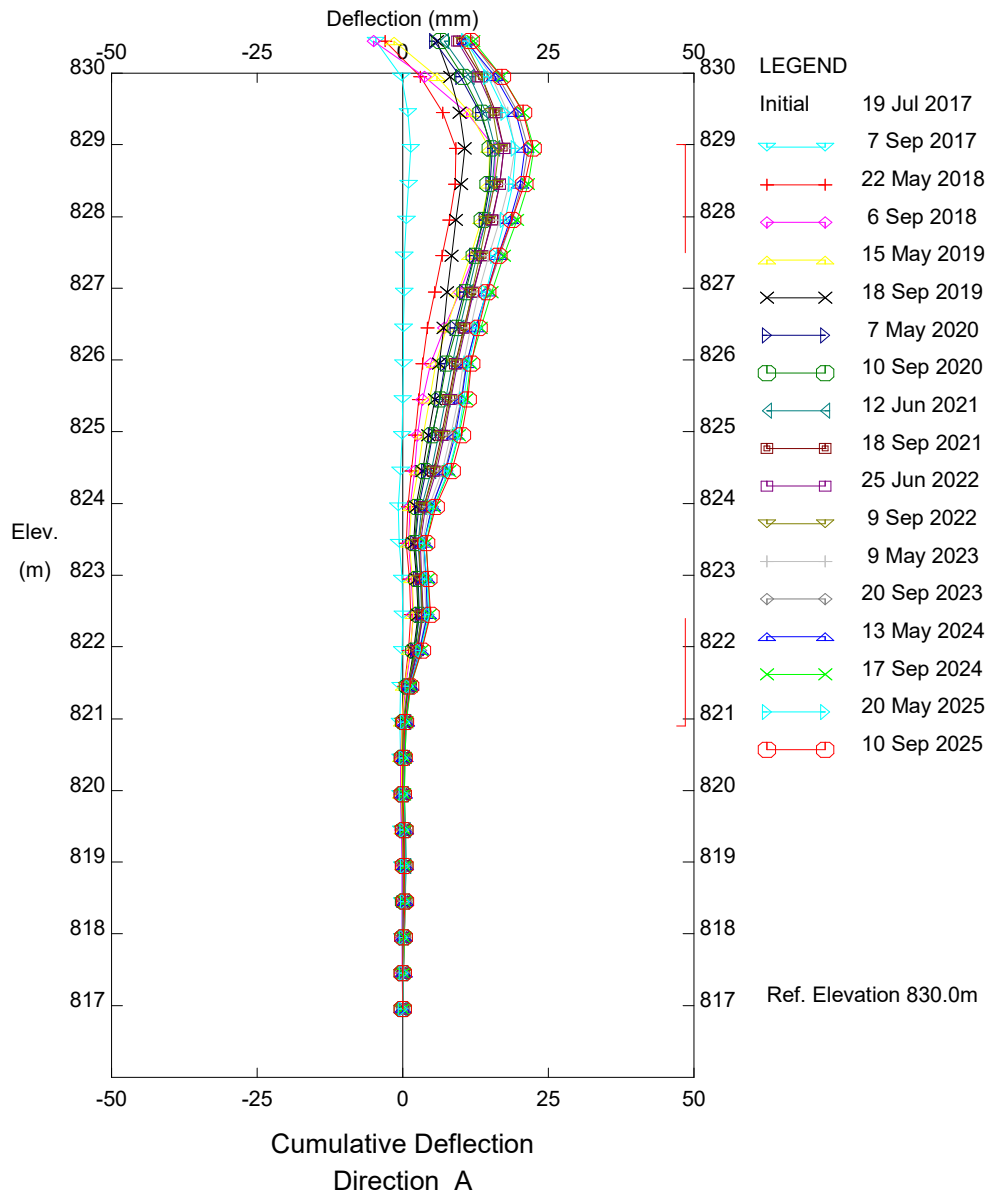
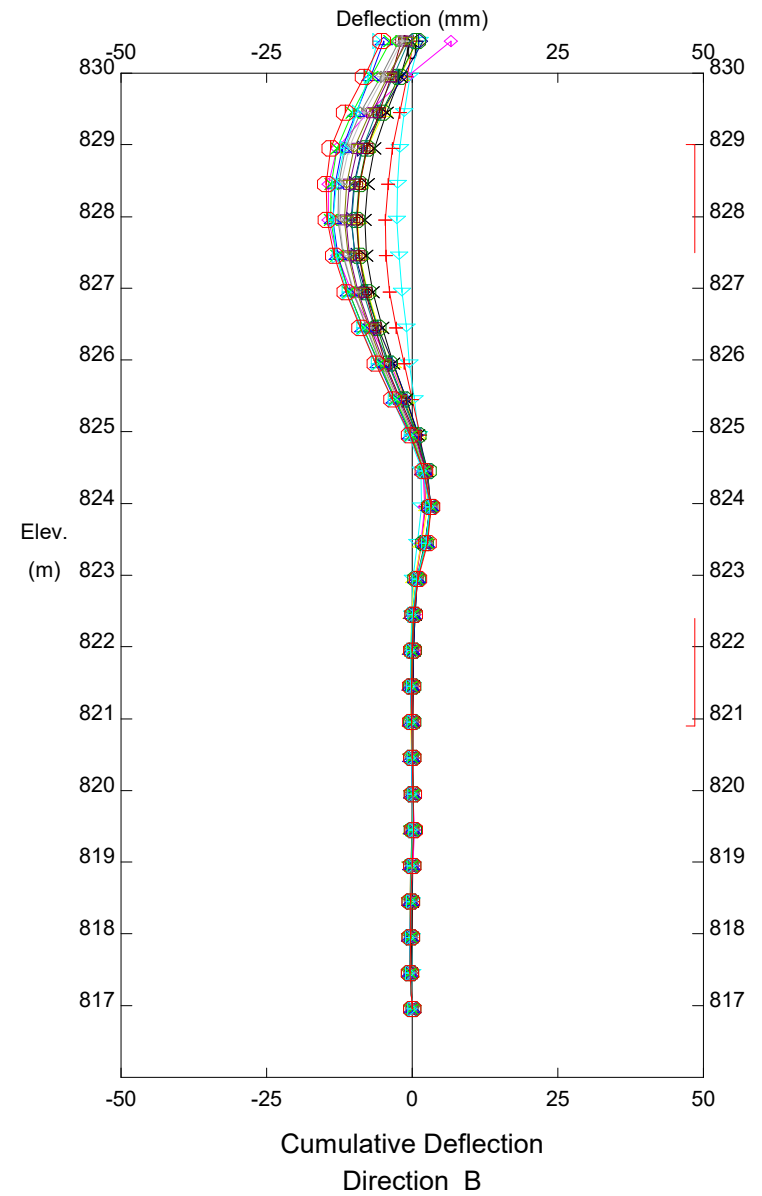
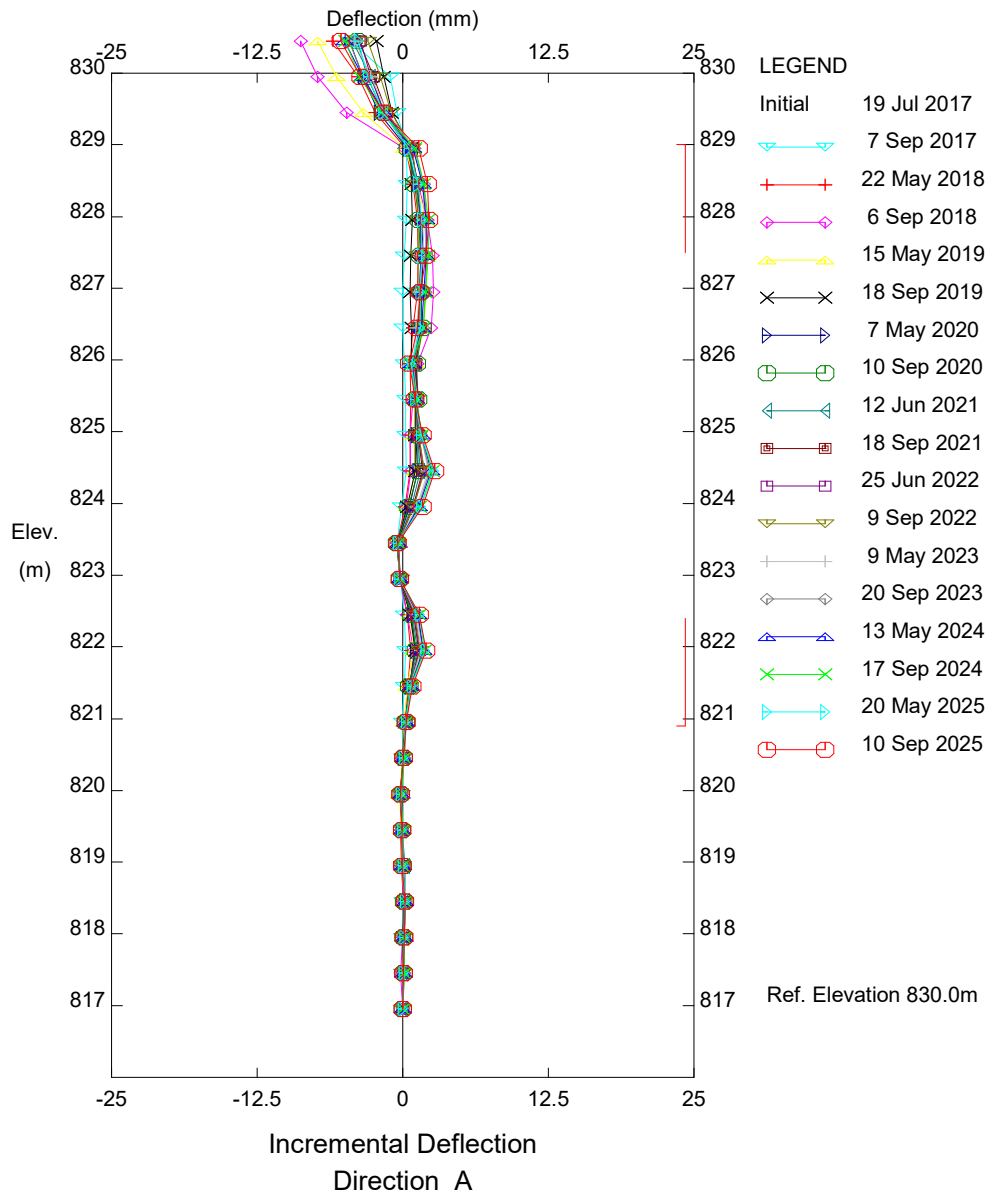
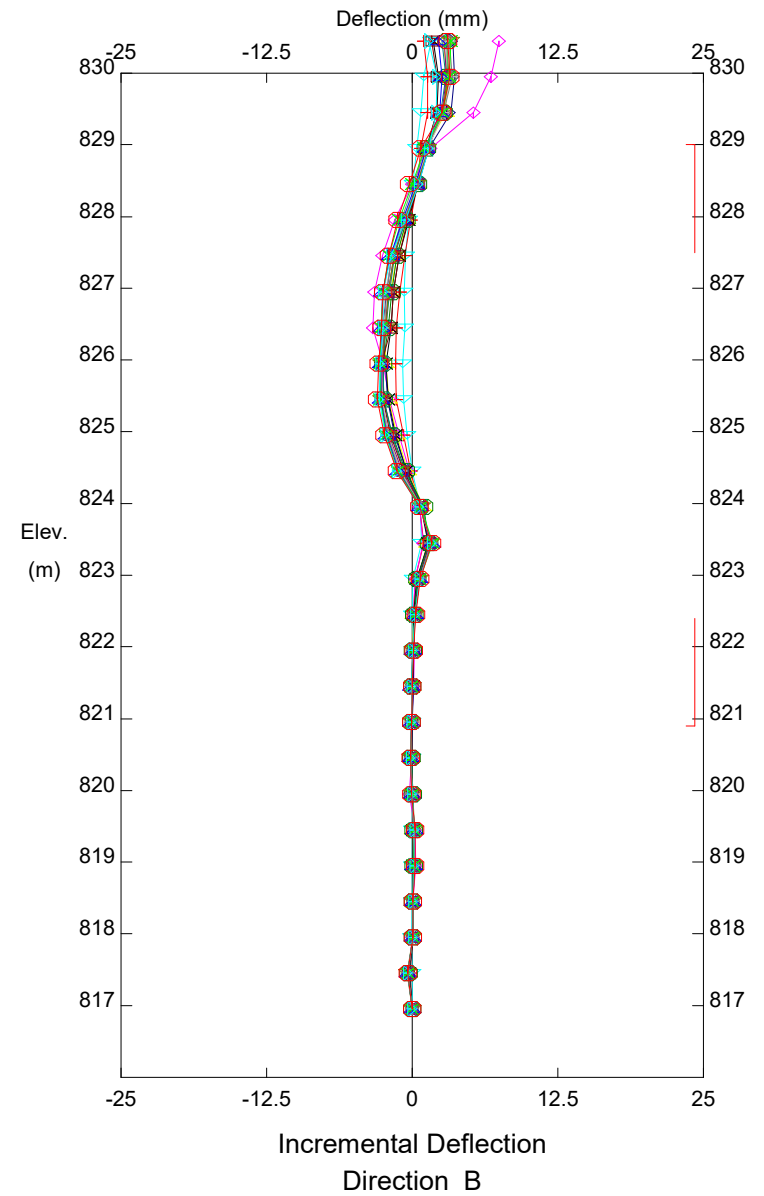
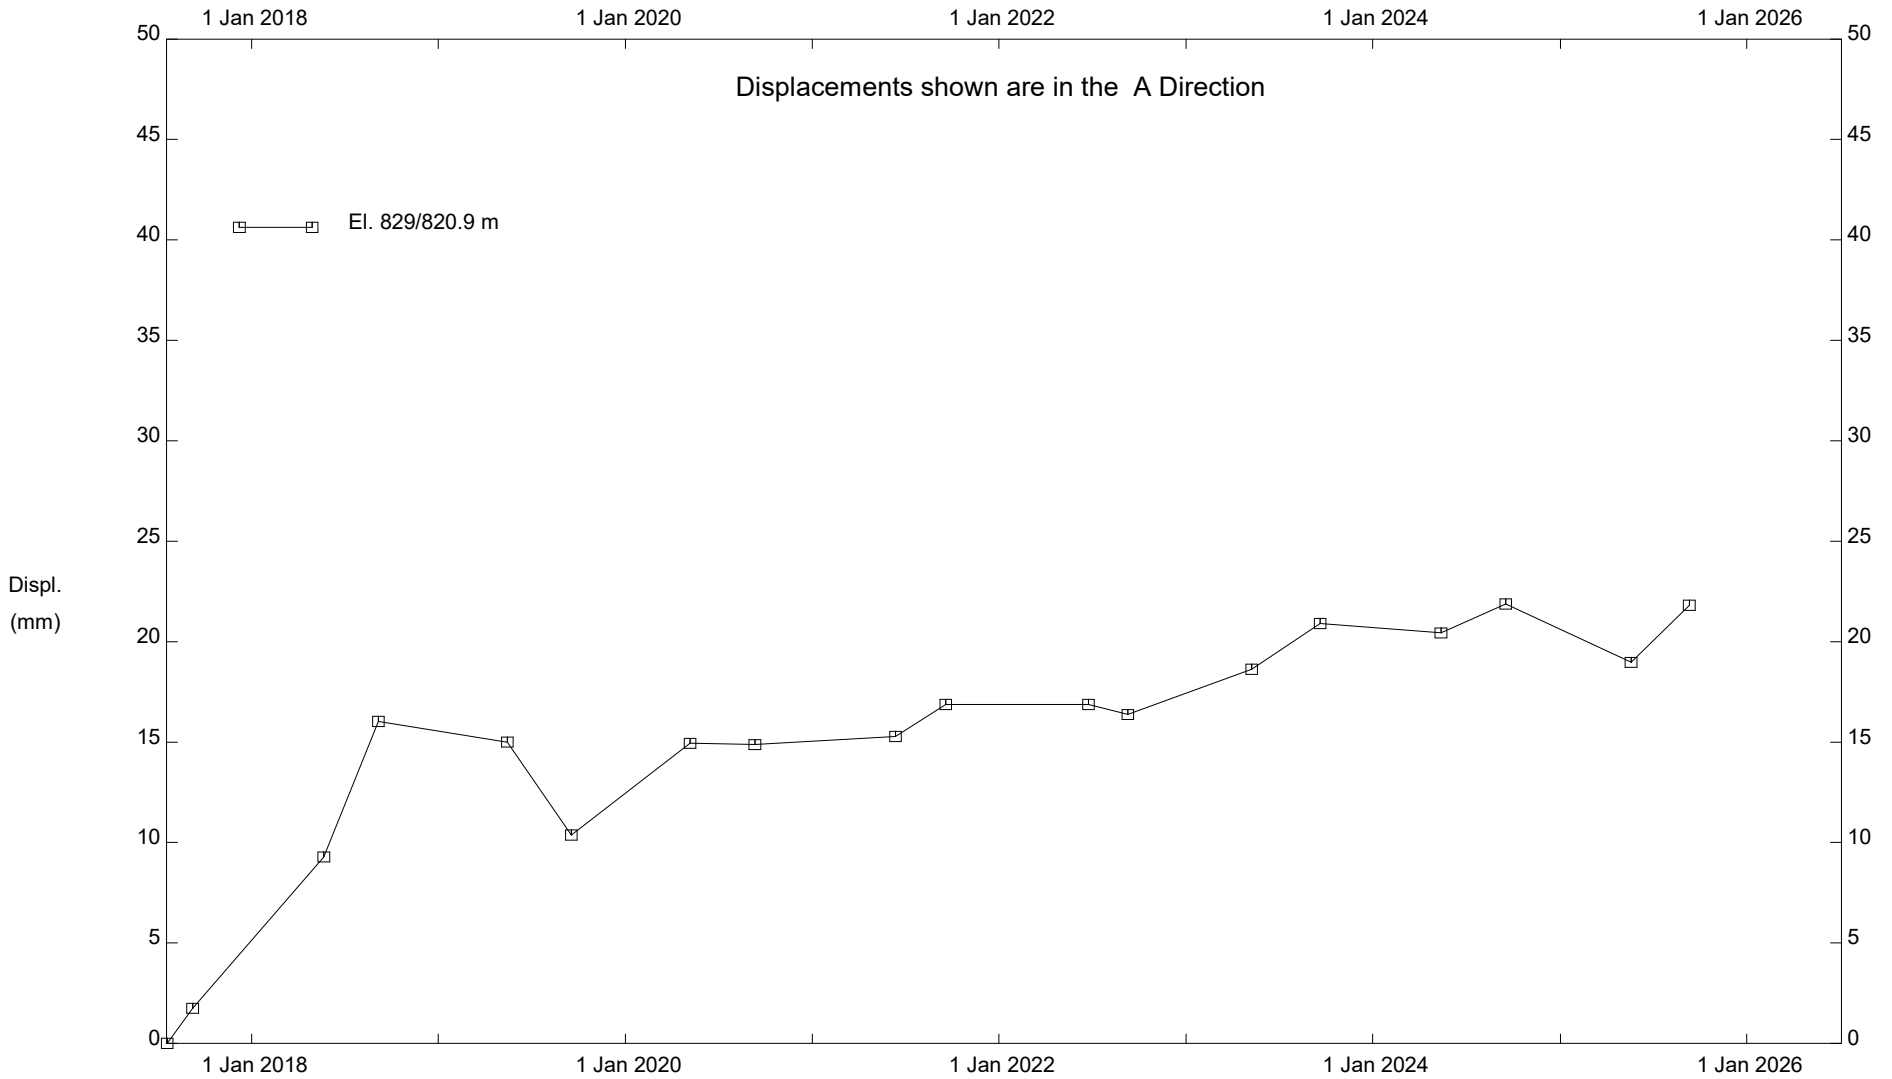
C067; H21:14, Kneehill Creek Slide, Inclinometer SI16-02

Distributed movement is being recorded in SI16-02 (downslope of the Site A H-pile wall) from near ground surface to approximately 9 m below ground surface or approximately 6.5 m above the base of the H-pile wall.

Data obtained from SI16-02 (installed upslope of the H-pile wall) indicates the active block upslope of the H-pile wall continues to creep as the H-pile wall stabilizes the sliding mass. Before the H-pile wall was installed, the maximum rate of movement recorded in SI16-02 was approximately 205 mm/year on February 21, 2017. Between April and May 2017, after installation of the H-pile wall, the rate of movement recorded in SI16-02 increased to approximately 345 mm/year. Since September 2018, the overall rate of movement recorded in this instrument has been relatively steady (less than approximately 3 mm/year). The relatively large negative displacement recorded in May 2025 may be due to noise. The September 2025 data was consistent with historical readings for the instrument.

- Increased rate of movement of approximately 9 mm/year and 7 mm/year was recorded in SI16-02 and SI17-C067-01 in September 2025. This increase was likely attributed to noise in May 2025 data which resulted in relatively large negative displacements recorded in both instruments.

Negative rates of movement recorded in May 2025 in both SI16-02 and SI17-C067-01 indicate the movement in Site A is slow and within the reading accuracy of the SI equipment.

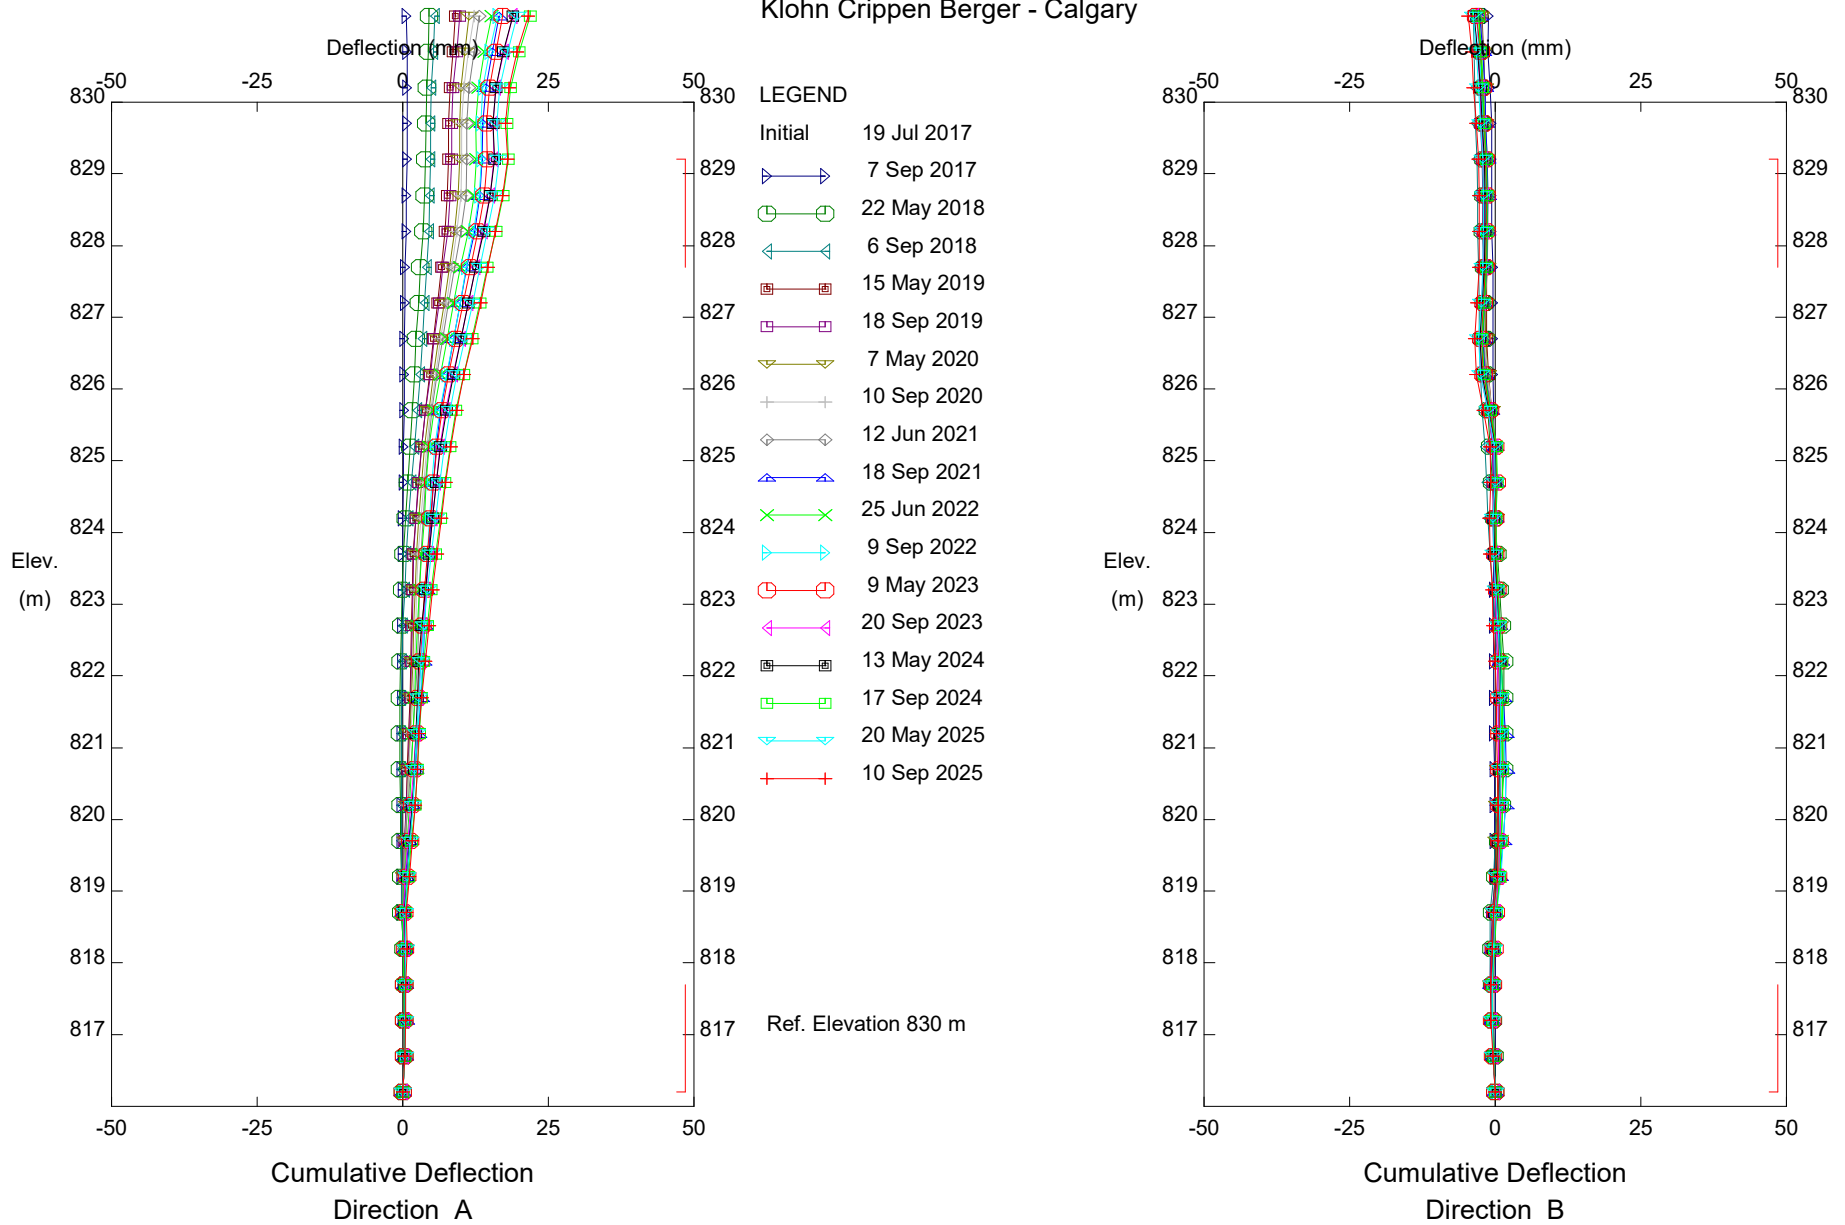
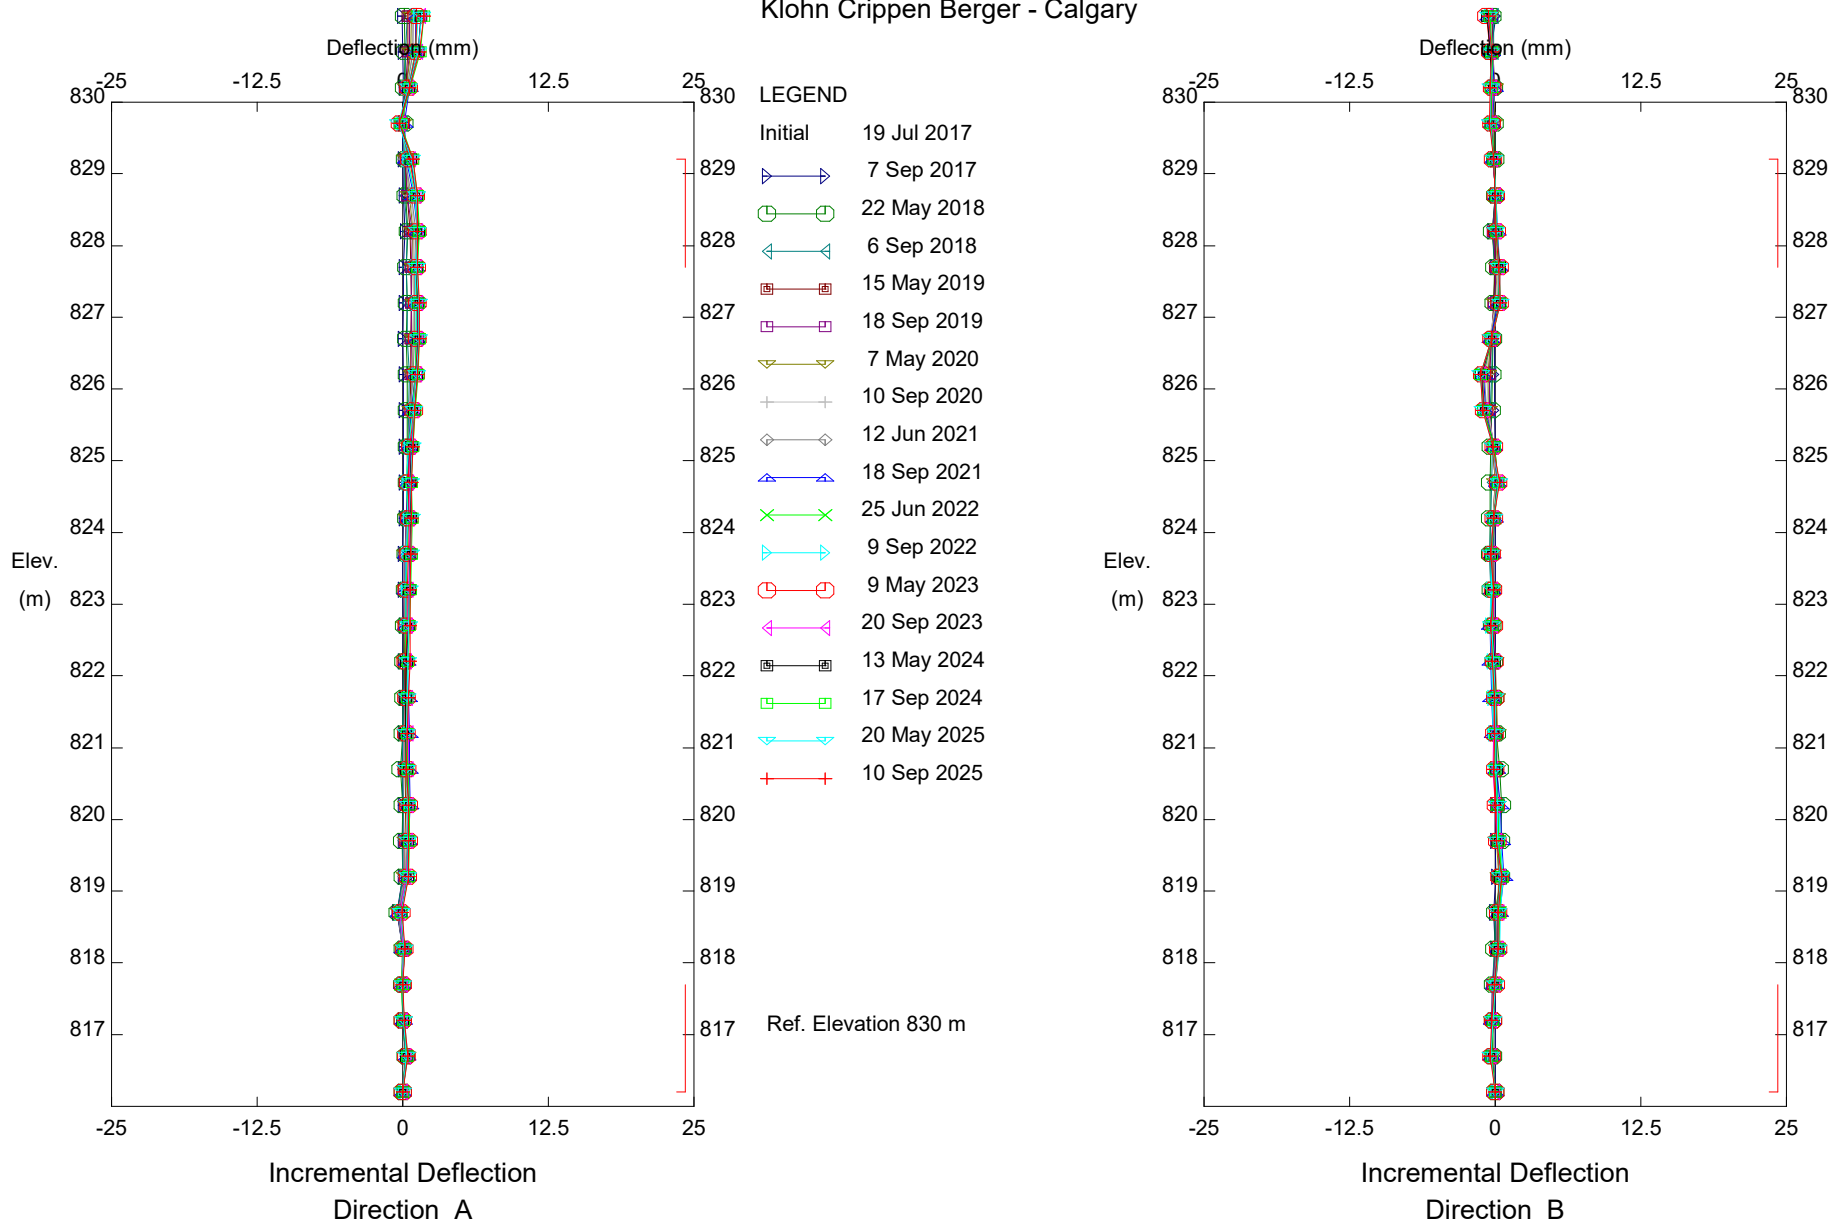
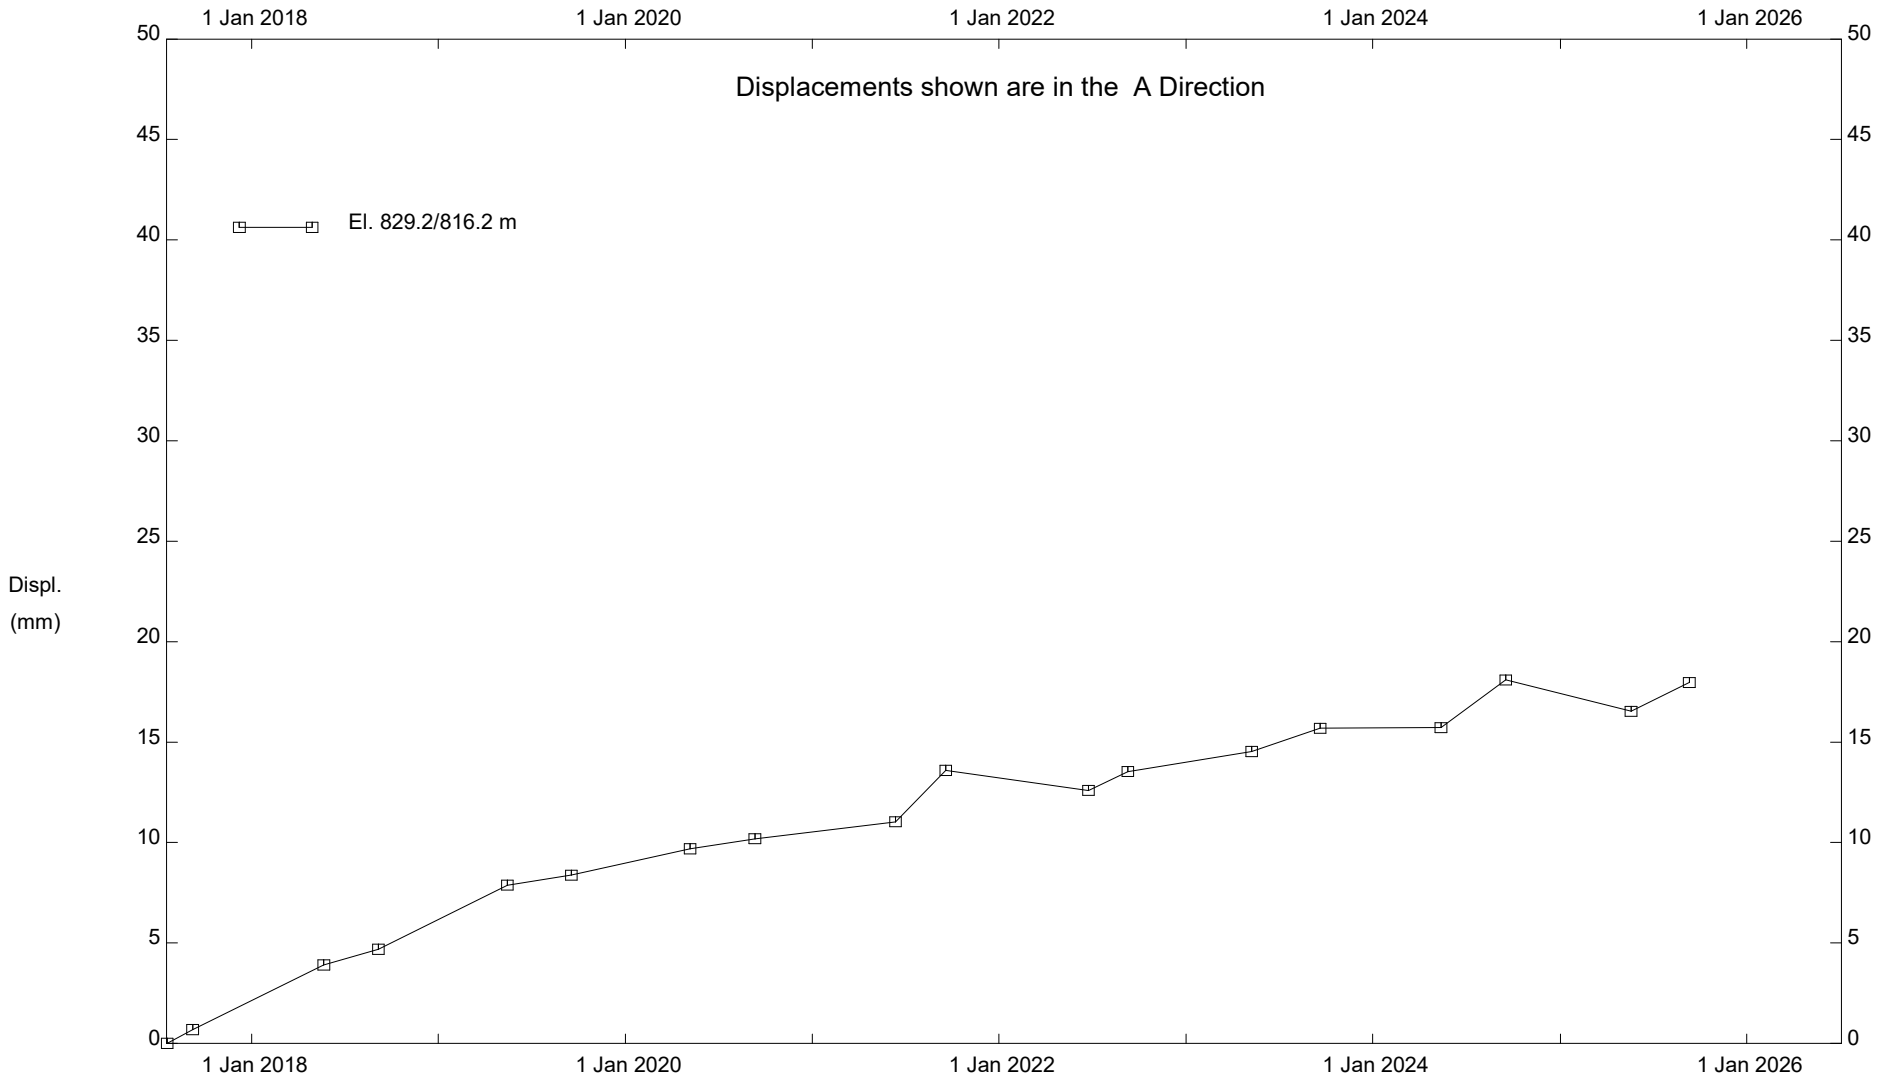
C067; H21:14, Kneehill Creek Slide, Inclinometer SI17-C67-01

Distributed movement is being recorded in the SIs installed in the H-pile wall (SI17-C67-01 and SI17-C67-02) from top of casing to an approximate depth of 11 m below ground surface or approximately 4 m above the base of the H-pile wall.

The deepest zone of movement being recorded in the pile-wall SIs (SI17-C67-01 and SI17-C67-02) appears to be approximately 2 m below the depth of movement recorded in SI16-02. This indicates the H-pile wall has intercepted the failure surface and is continuing to deflect, transferring load to depths below the failure plane as the piles stabilize the sliding mass.

The September 2025 data obtained from SI17-C67-01 and SI17-C67-02 indicates the top of the H-pile wall at Site A has deflected between approximately 18 mm to 25 mm since installation. In May 2017, the maximum rate of movement recorded in SI17-C67-01 and SI17-C67-02 was approximately 45 mm/year, one month after the H-pile wall was installed. The rate of movement has since slowed and is now generally less than 3 mm/year, excluding:

- Between May and September 2021, when an increased rate of movement of approximately 10 mm/year was recorded in SI17-C067-01, which may be attributed to wet weather in summer 2021. A similar increase was not recorded in SI17-C067-02.

- Increased rate of movement was recorded in SI17-C67-01 between May and September 2024 of approximately 7 mm/year. The increased rate of movement may be attributed to construction activities on site (chip sealing along the C067 site was completed in summer 2024) and wet weather in August 2024 (approximately 55 mm precipitation versus the average of 45 mm recorded between 2015 and 2024).

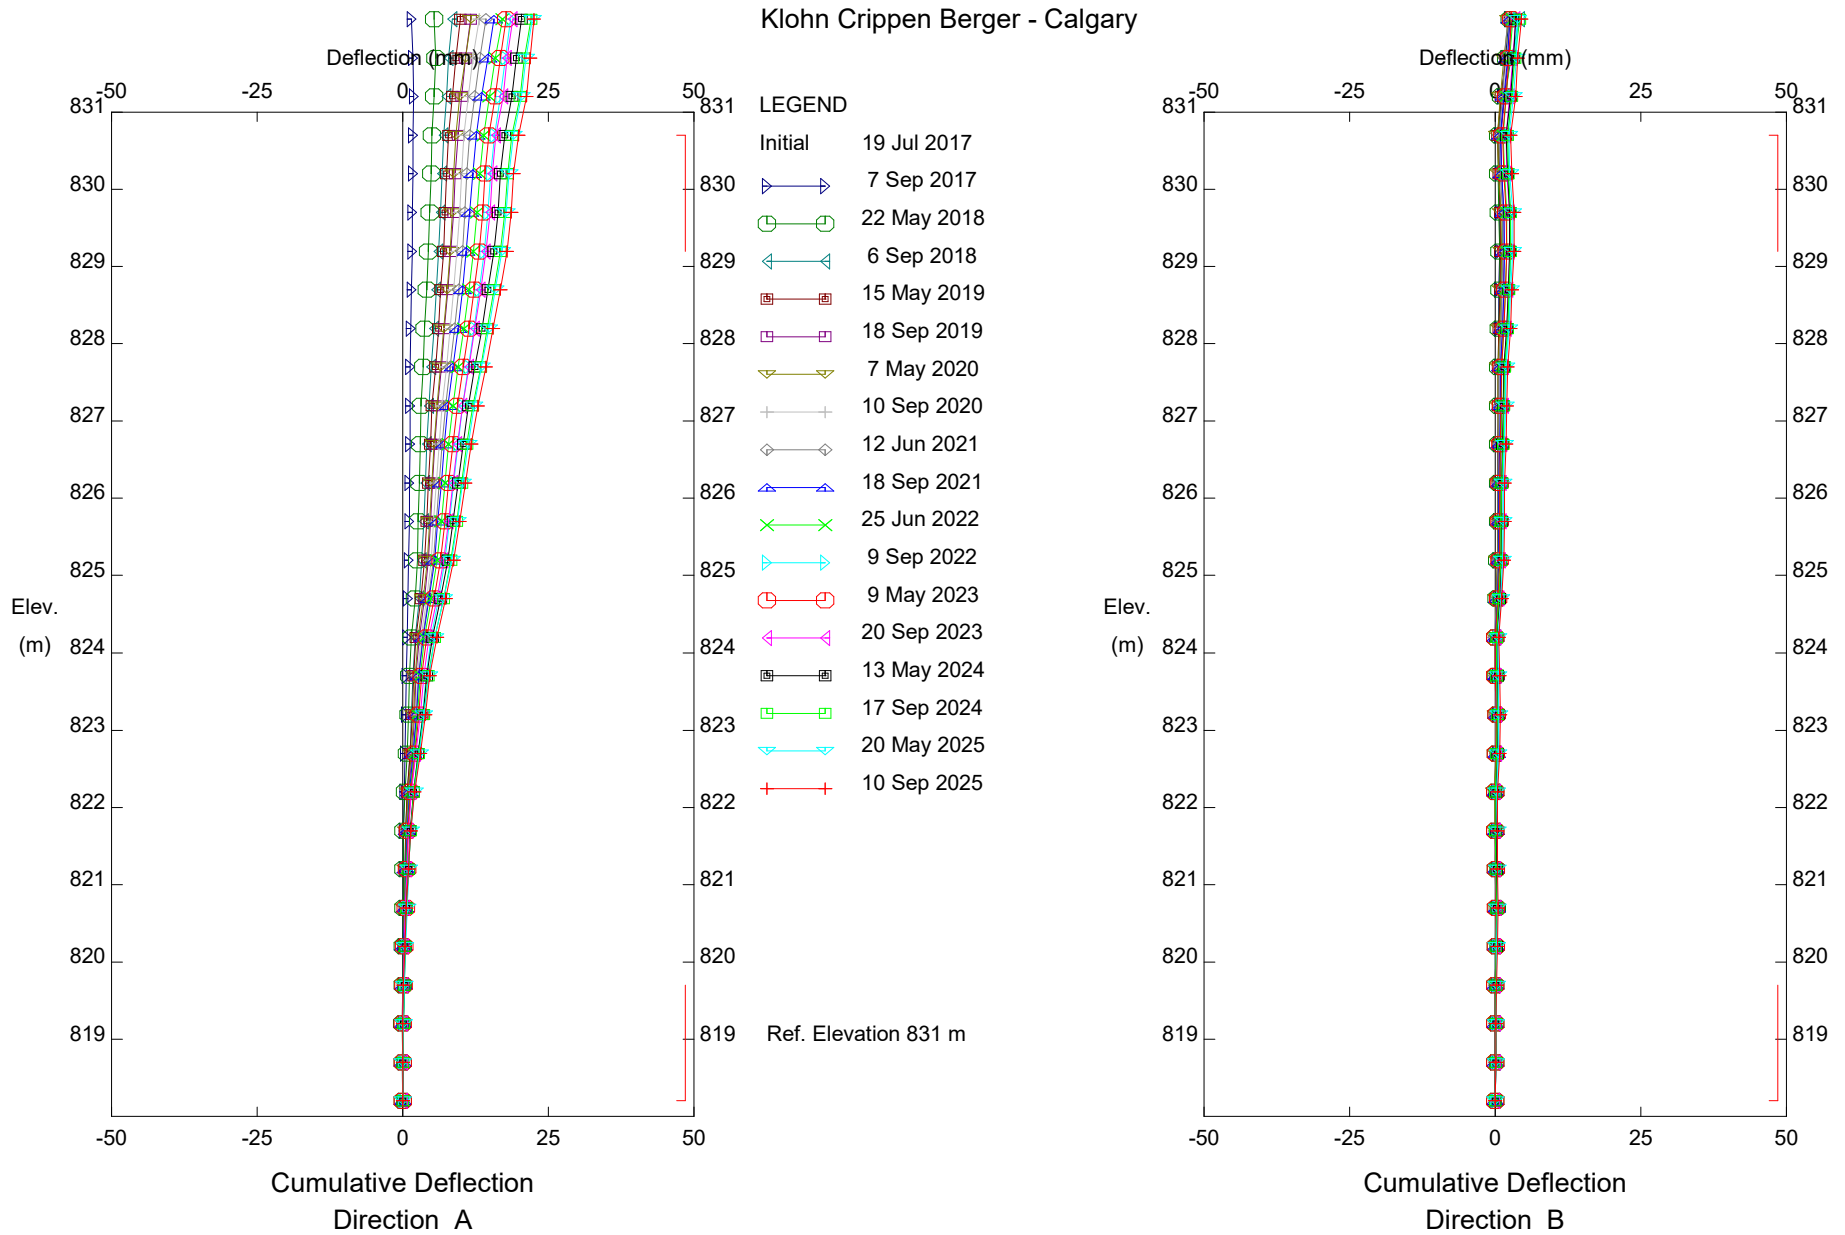
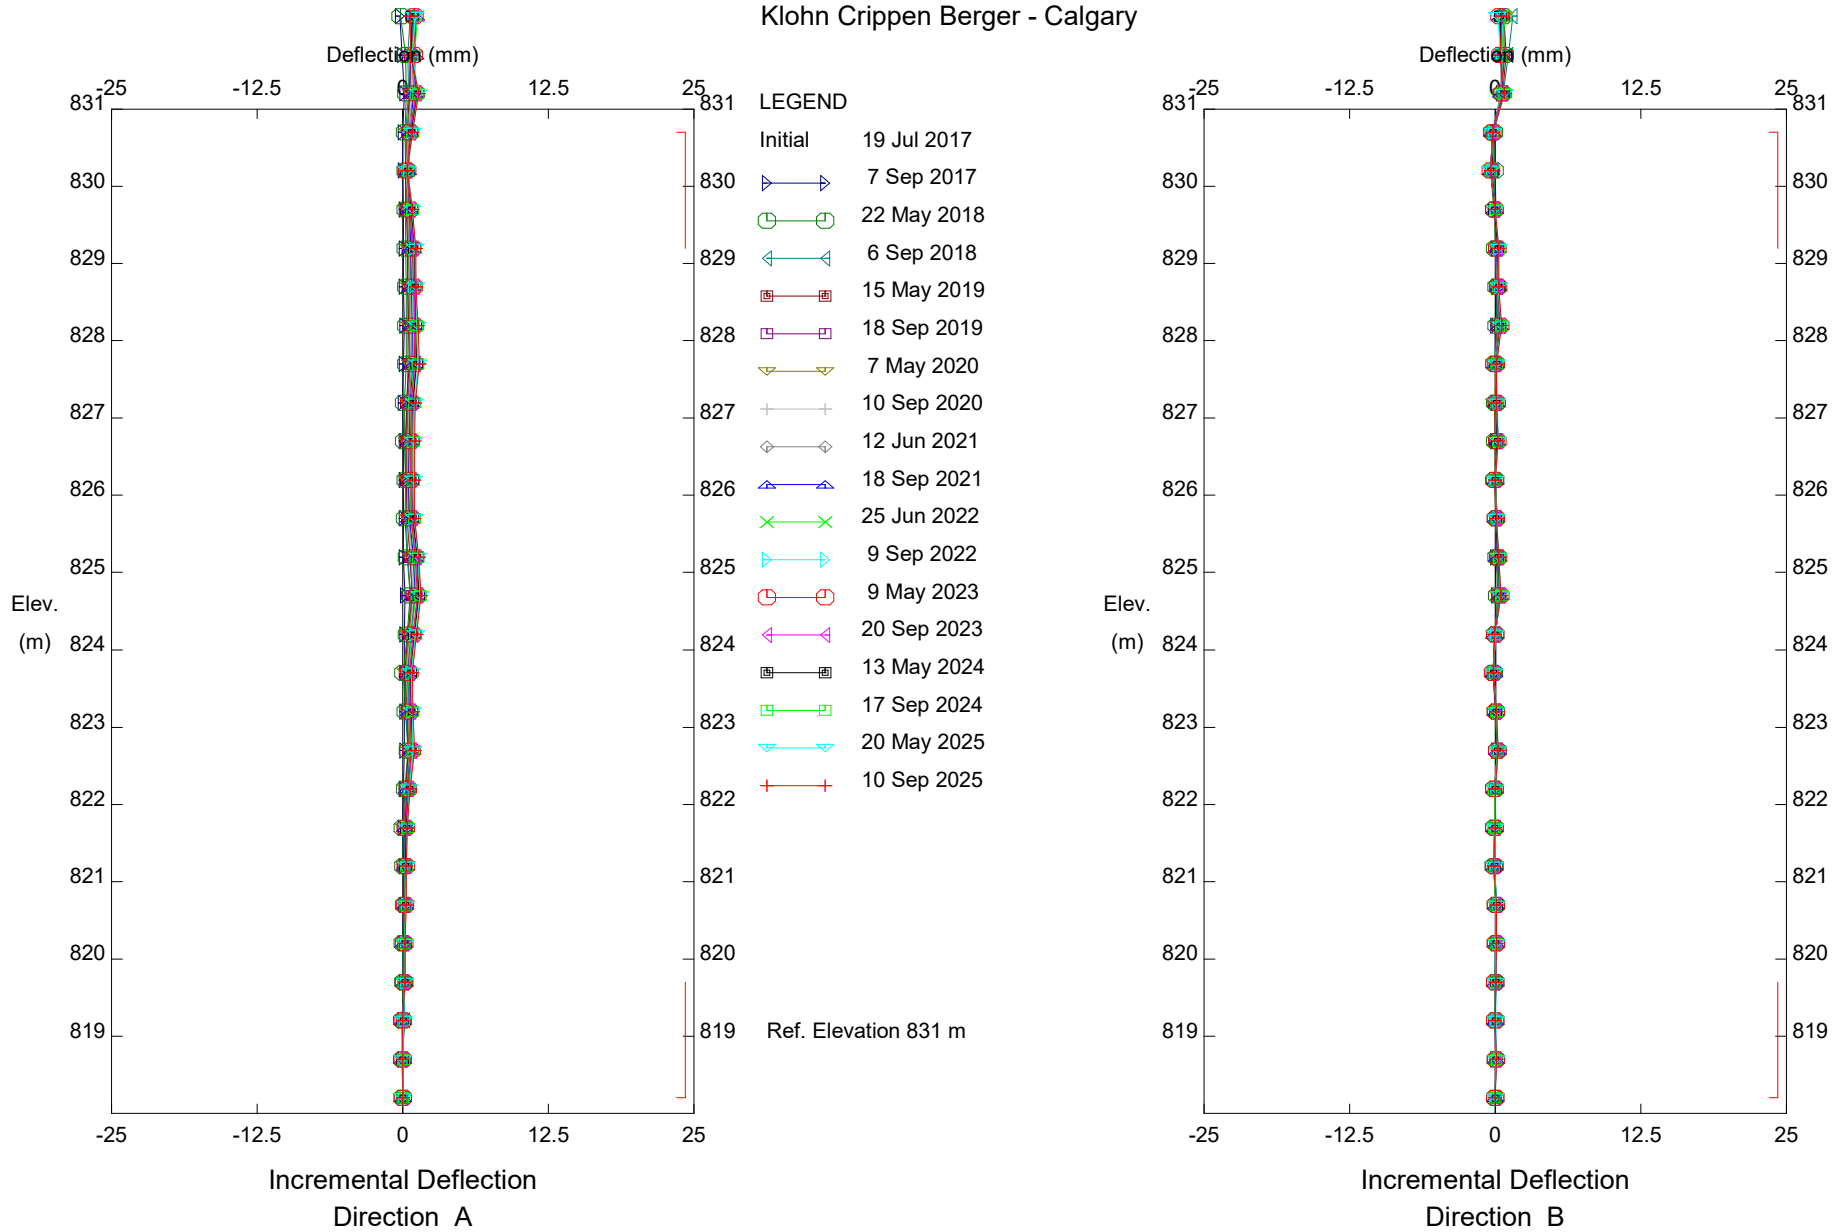
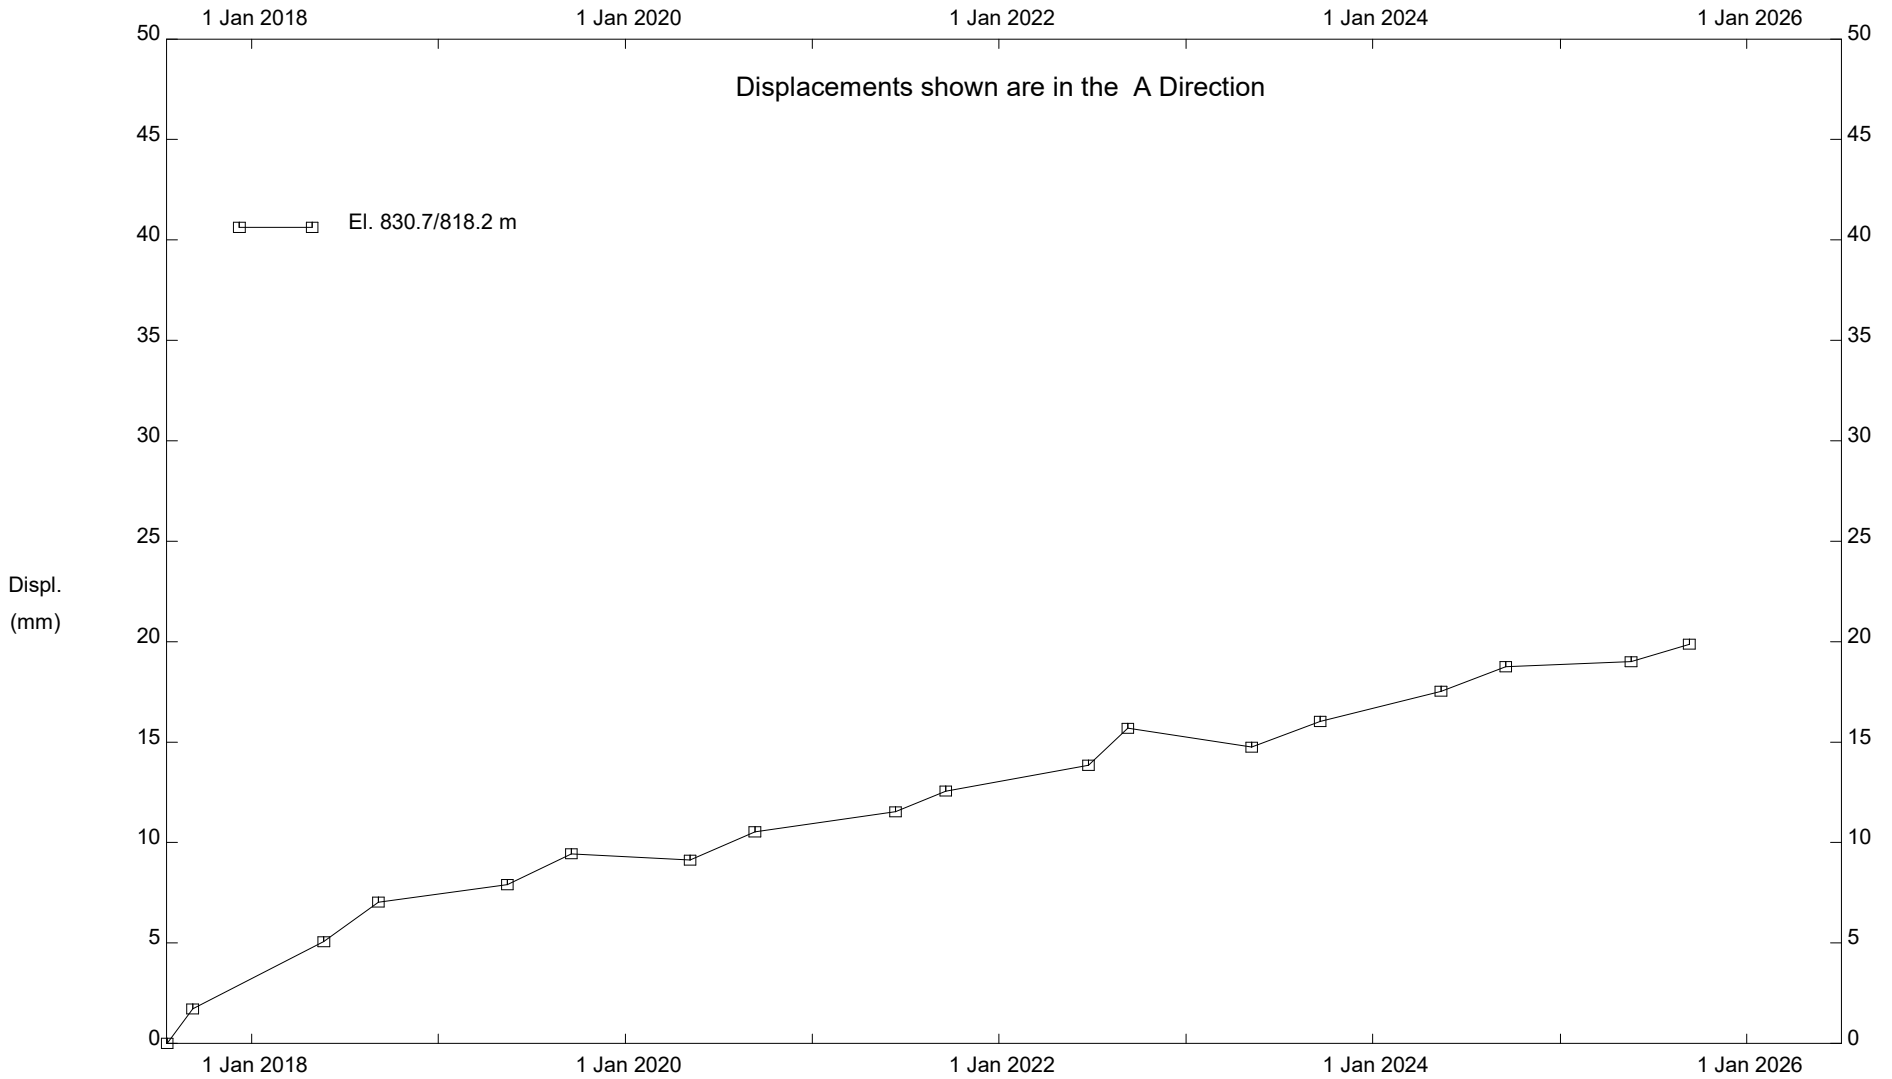
C067; H21:14, Kneehill Creek Slide, Inclinometer SI17-C67-02

- Between June and September 2022, when an increased rate of movement of approximately 4 mm/year and 9 mm/year was recorded in SI17-C67-01 and SI17-C67-02, respectively, likely in response to wet weather in June and July 2022.
