September 29, 2025

Alberta Transportation and Economic Corridors  
4<sup>th</sup> Floor, Provincial Building  
4920 – 51<sup>st</sup> Street  
Red Deer, Alberta  
T4N 6K8

**CON0022160 Central Region GRMP Instrumentation Monitoring**  
**Site C067; H21:14, km 12.988 Kneehill Creek Slide**  
**Section C – 2025 Fall Readings**

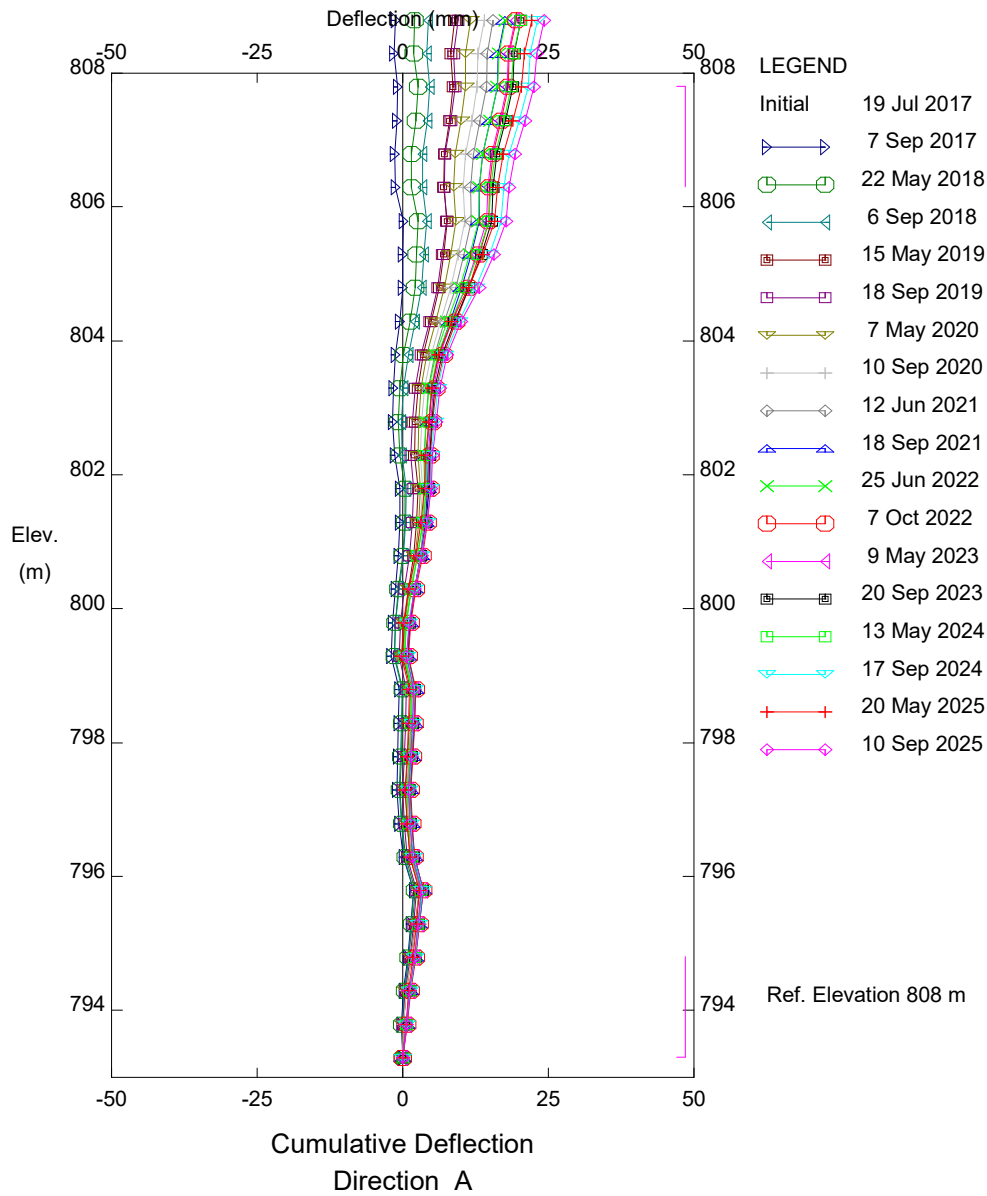
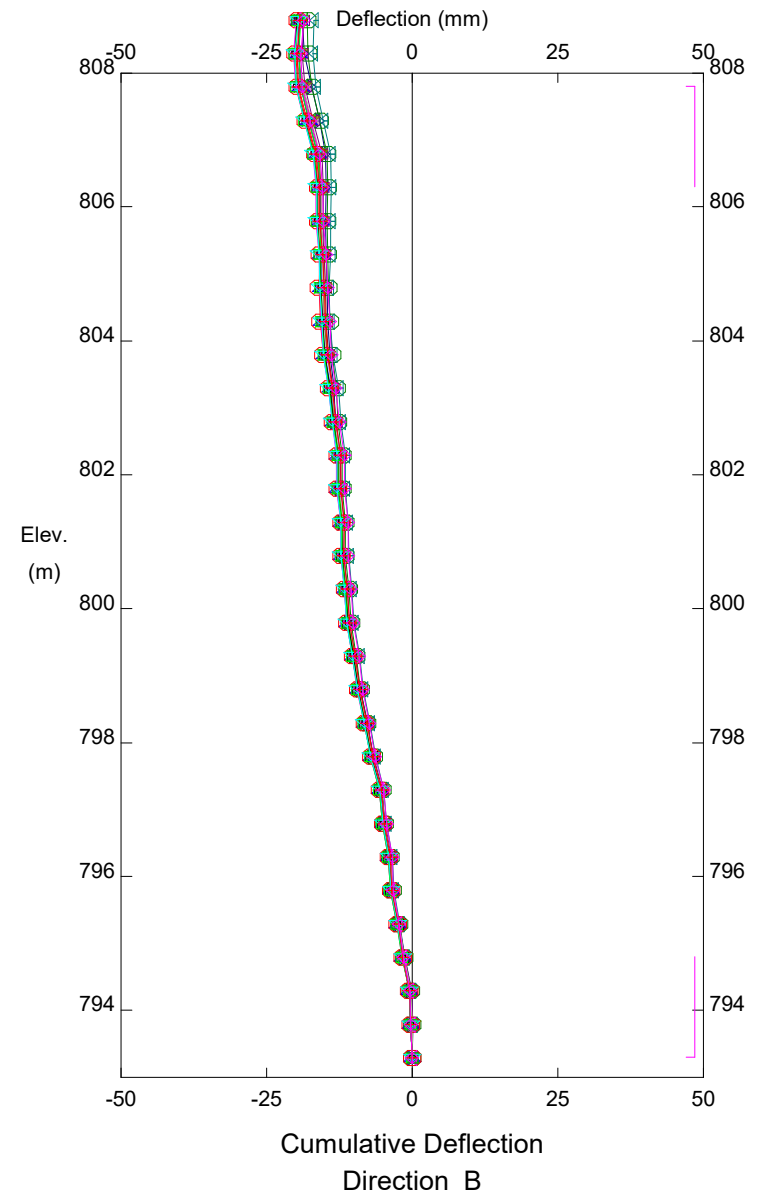
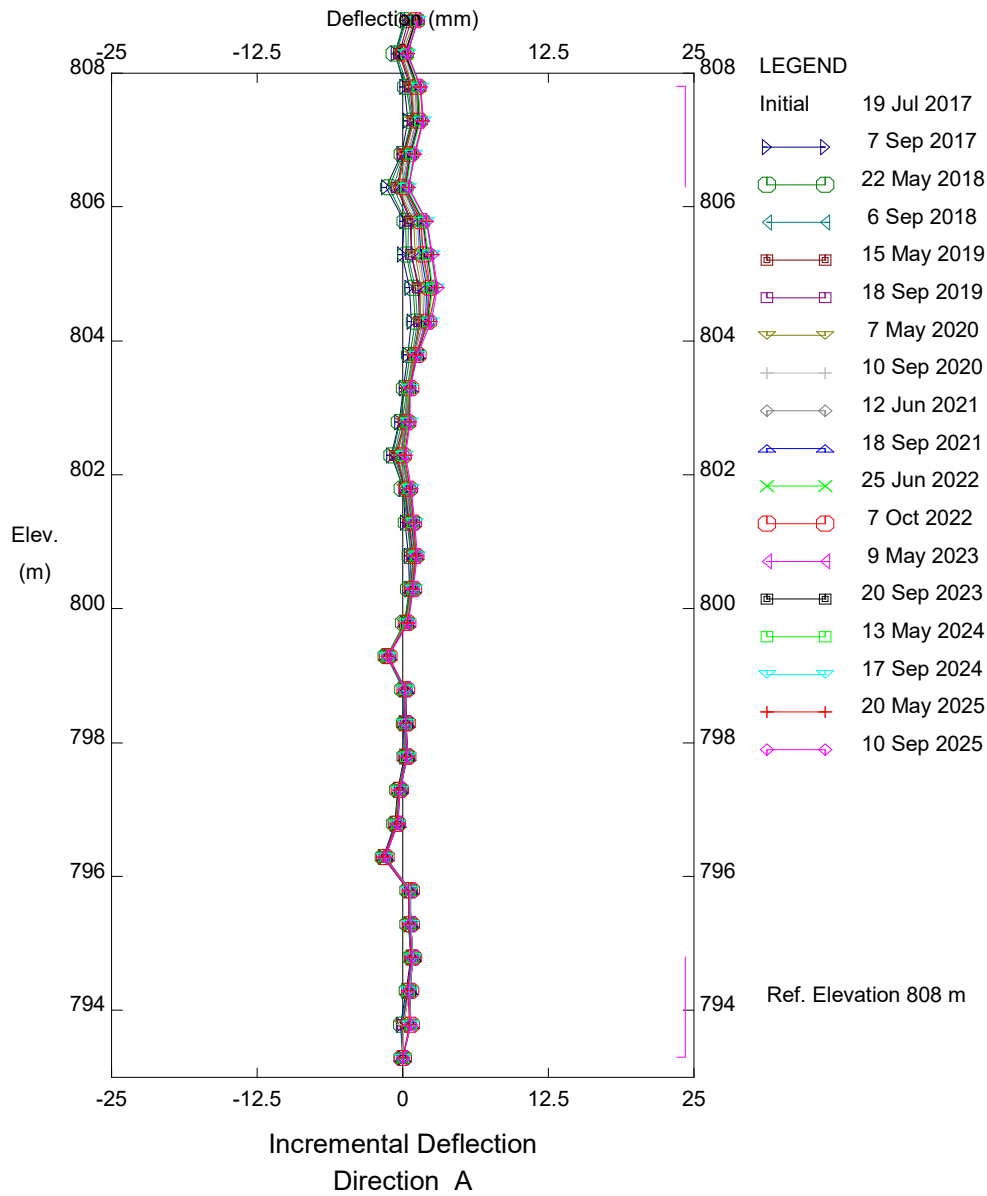
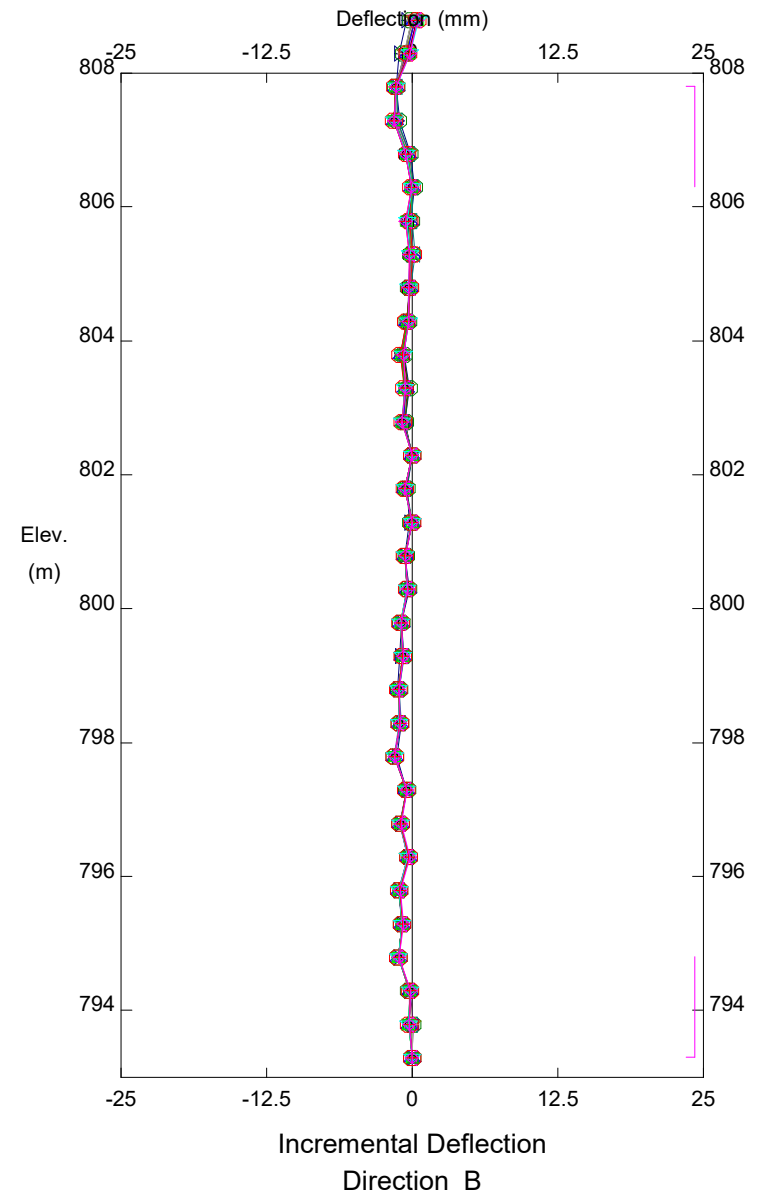
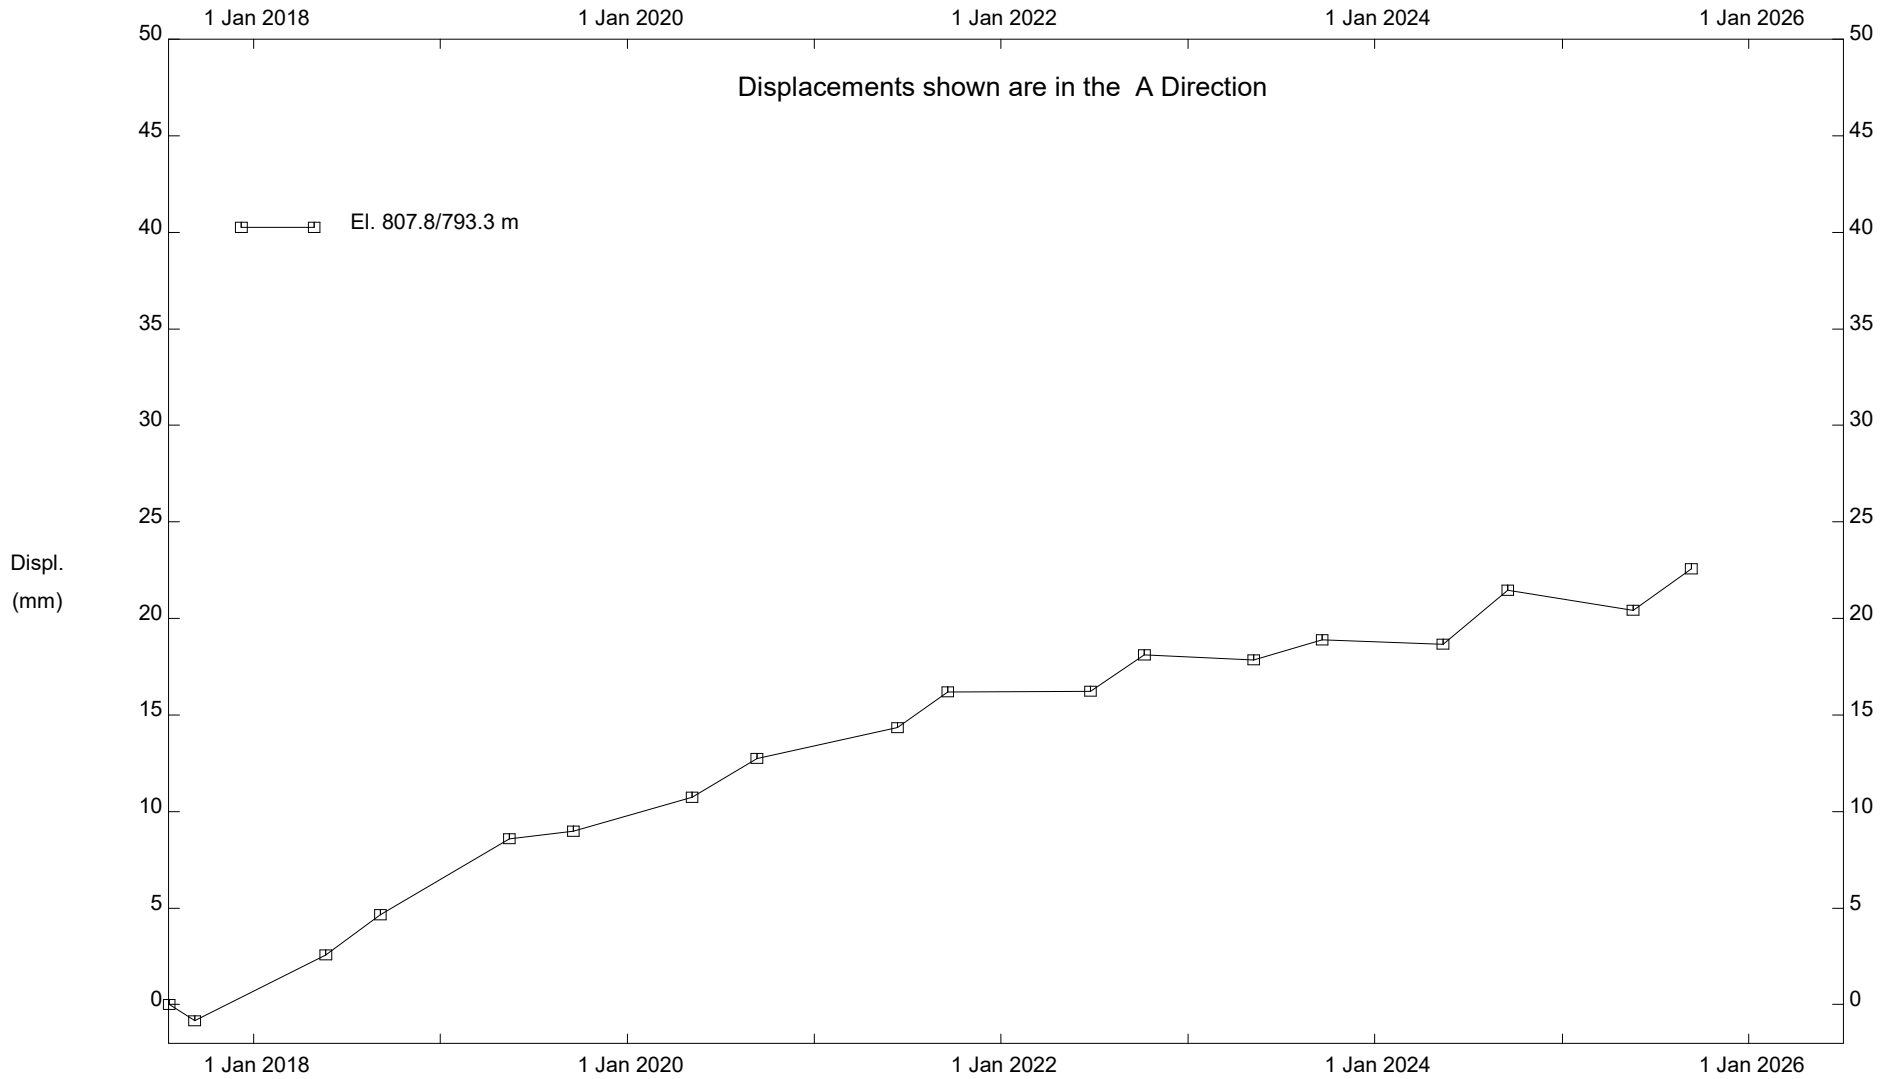
C067; H21:14, Kneehill Creek Slide, Inclinator SI17-C67-03

Distributed movement is being recorded in the SIs installed in the H-pile wall (SI17-C67-03 though and SI17-C67-05) from top of casing to an approximate depth of 8.7 m, 7.8 m, and 6.5 m, respectively.

The depth of movement being recorded in the pile-wall SIs (SI17-C67-03 through SI17-C67-05) appears to be occurring 2 m to 4 m below the depth of movement previously recorded in SI16-01 (inoperable). This indicates the H-pile wall has intercepted the failure surface and is continuing to deflect, transferring load to depths below the failure plane as the piles stabilize the sliding mass.

The September 2025 data obtained from SI17-C67-03 through SI17-C67-05 indicates the top of the H-pile wall has deflected between approximately 16 mm and 33 mm, since installation. The maximum rate of movement recorded in SI17-C67-03 through SI17-C67-05 was approximately 71 mm/year to 115 mm/year in May 2017, one month after the H-pile wall was installed. The rate of movement has since decreased and is now generally less than 3 mm/year, excluding:

- In September 2024, the rate of movement recorded in SI17-C67-03 through SI17-C67-05 increased from less than approximately 2 mm/year to up to approximately 8 mm/year. The increased rate of movement may be attributed to construction activities on site (chip sealing along the site was completed in summer 2024).

- In September 2025, increased rates of movement of approximately 7 mm/year were recorded in SI17-C67-03 and SI17-C67-03. However, negative displacement was recorded in May 2025, likely due to noise. The two instruments were re-read during the May 2025 readings. The second reading replicated the negative displacement, confirming it was not a reading error.

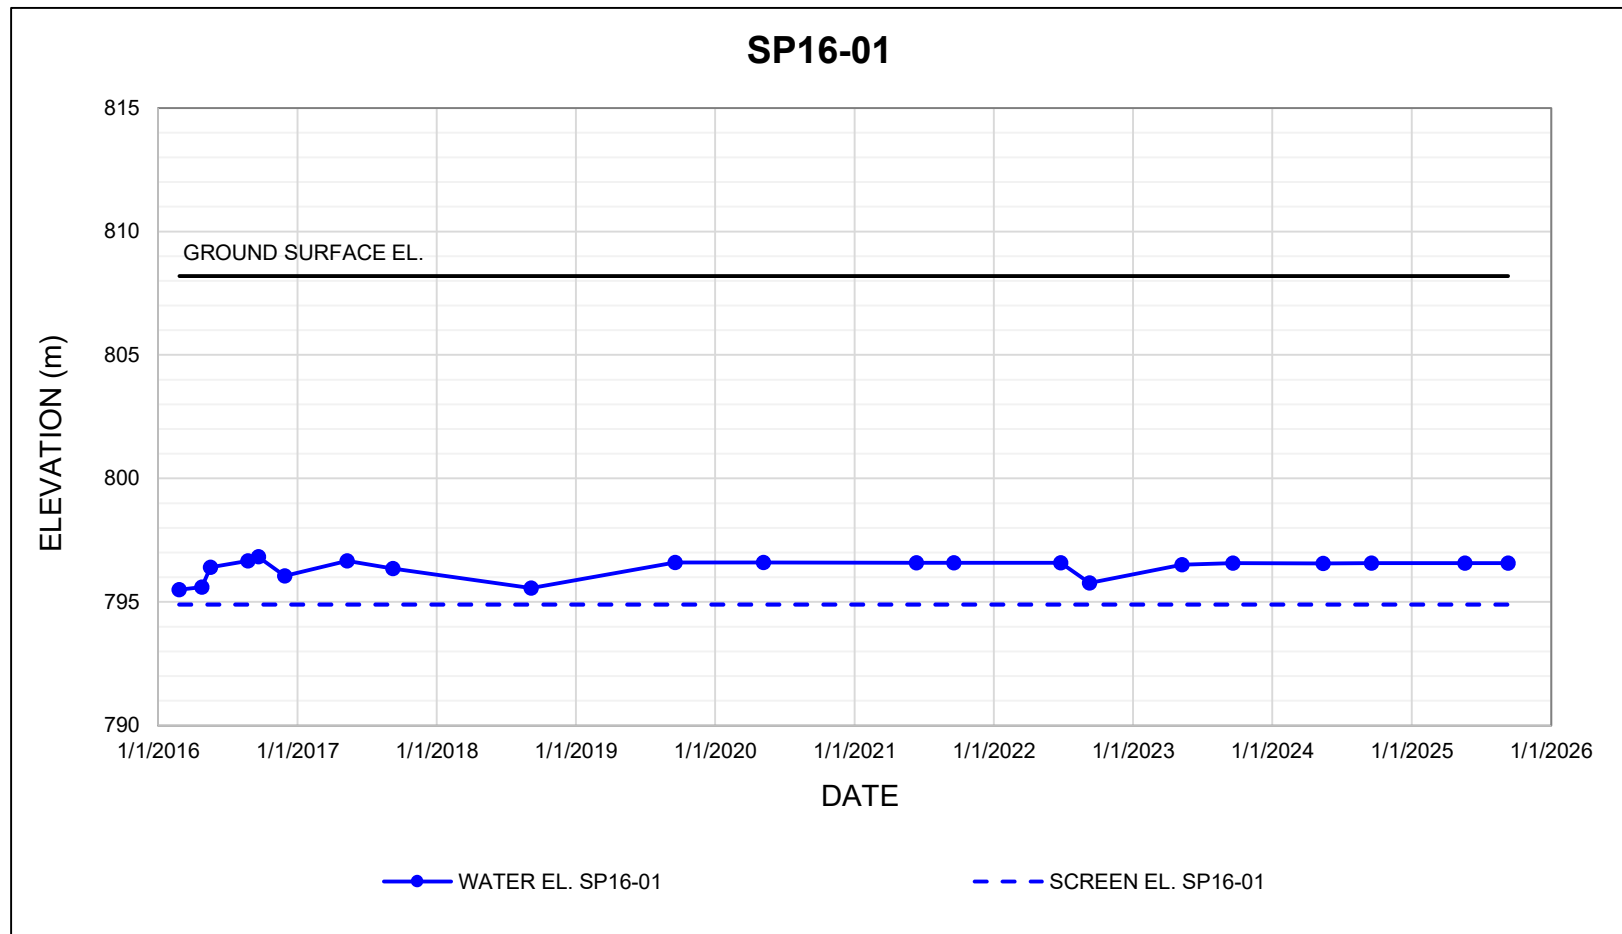
Since installation in February 2016, water levels recorded in SP16-01 have been relatively steady, varying between approximately 11.4 m to 12.7 m below ground surface. The recorded water level has been approximately 11.6 m below ground surface since September 2023. The September 2025 reading is consistent with historical trends observed in this instrument.
