SITE NUMBER AND NAME: C067 Kneehill Creek Slide	HIGHWAY & KM: 21:14, 12.988	PREVIOUS INSPECTION DATE: June 26, 2023	INSPECTION DATE: June 10, 2025
LEGAL DESCRIPTION: 19-29-23-W4M	NAD 83 COORDINATES: UTM Northing Easting 12 5707671 344892	RISK ASSESSMENT: Site A: PF: 4 CF: 3 TOTAL: 12 Site B: PF: 4 CF: 9 TOTAL: 36	
HIGHWAY CLASSIFICATION NUMBER: 2		CONTRACT MAINTENANCE AREA (CMA): 517	
AVERAGE ANNUAL DAILY TRAFFIC (AADT): 867 (south) and 863 (north) (Ref No. 60211450)

PRIMARY SITE ISSUE: Two previous embankment slope failures (repaired in 2017) along the west slope (southbound) lane of highway referred to as Site A and Site B.
APPROXIMATE DIMENSIONS: Site A is approximately 80 m wide, and Site B is approximately 40 m wide. The slopes at both sites are approximately 15 m high and sloped at approximately 4H:1V.
DATE OF ANY REMEDIAL ACTION: In April 2017, a 15-m-deep, 80-m-long H-pile was installed at Site A and a 16-m-deep, 42.5-m-long H-pile wall was installed at Site B.

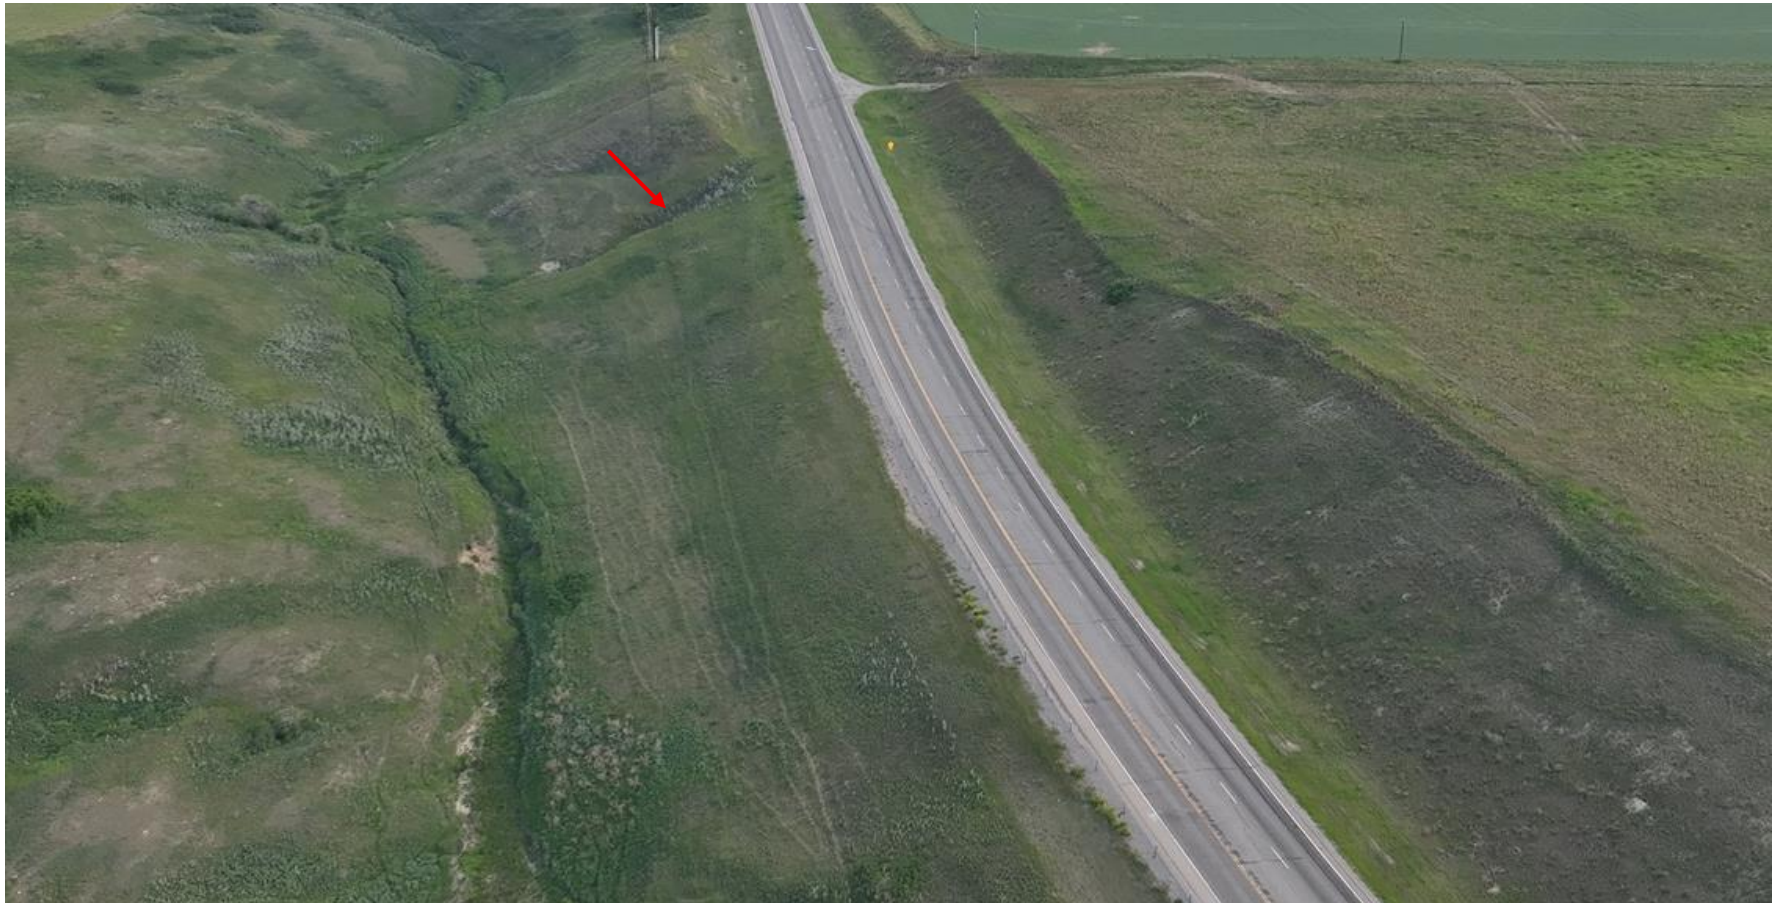
- The west (southbound) highway embankment was well vegetated, and no new signs of slope deformation were observed during the 2025 inspection (Photos 1 through 4).
- No new pavement distress was observed upslope of the H-pile wall (Photo 4). Since 2017, there has been approximately 20 mm of movement in the Site A H-pile wall, with current movement rates (recorded in May 2025) less than approximately 1 mm/year. The relatively slow rate of movement, along with no new pavement distress being observed, indicates the H-pile wall is performing well.
- There was an erosion gully upslope (north) of the site that diverts flow from the west (southbound) ditch and a culvert underlying Hwy 21:14 to Kneehill Creek, located along the toe of the slope (Photos 1 and 2). The erosion gully was well vegetated and did not appear to be impacting the highway embankment stability.

- Photo 1** **Aerial photo of the C067 Site A upslope (northwest) of Site B. The highway embankment slope is well vegetated, no pavement distress attributed to slide movement was observed, and an erosion gully is at the north extent of the site (indicated by red arrow). Photo taken June 10, 2025 facing north.**

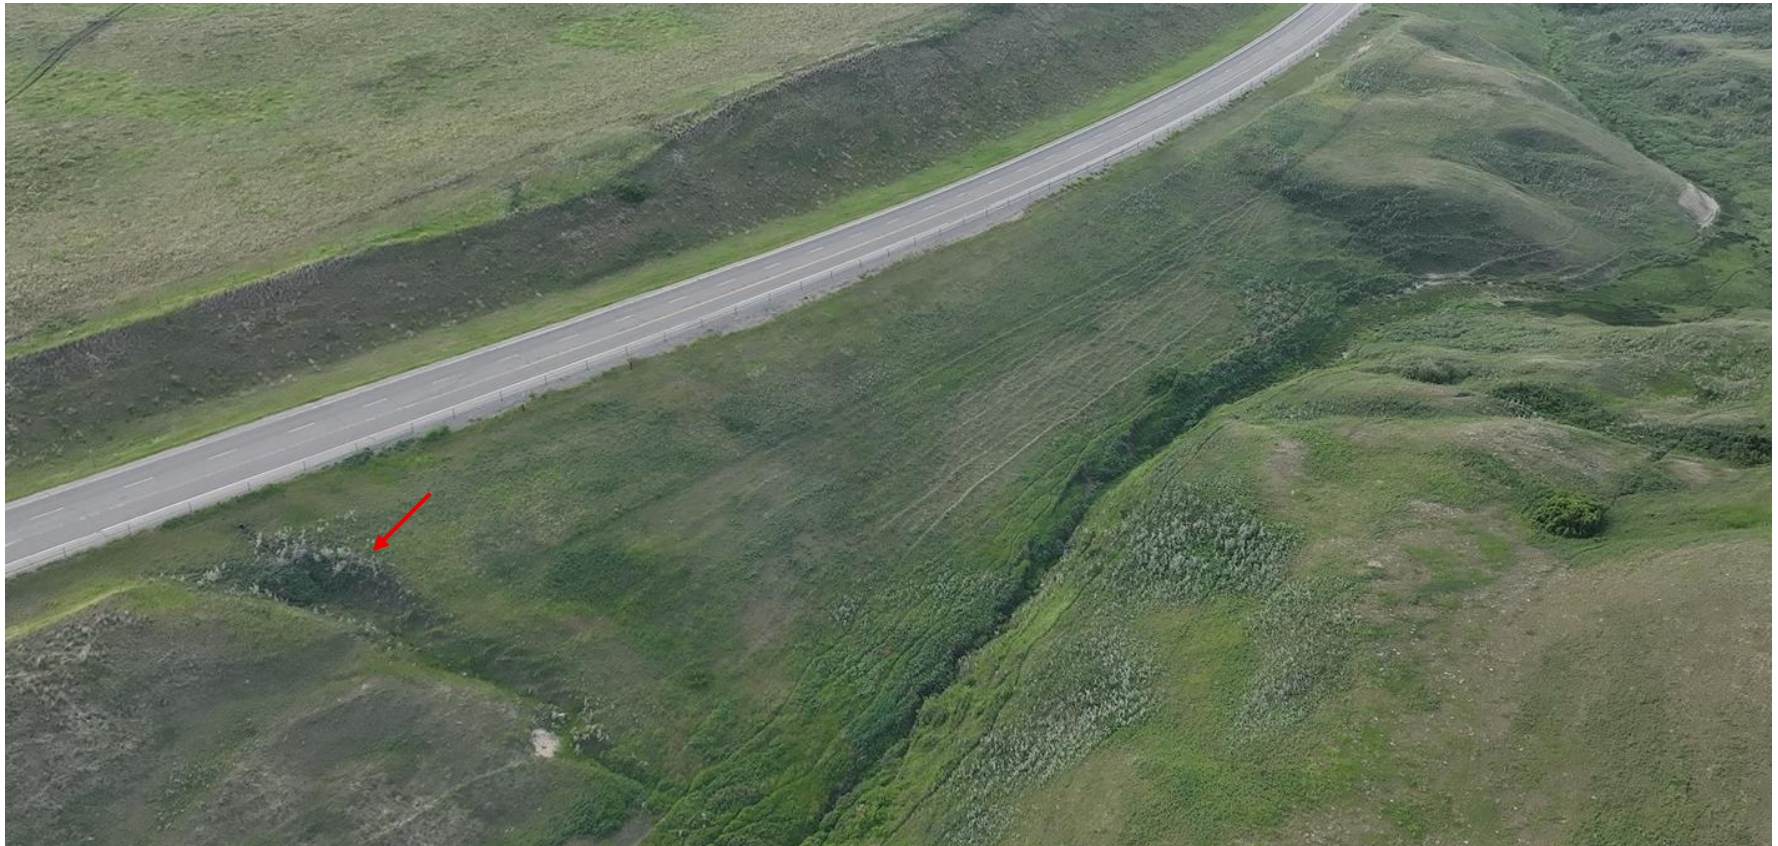
Photo 2 **Aerial photo of the C067 Site A upslope (northwest) of Site B. The highway embankment slope is well vegetated, no pavement distress attributed to slide movement was observed, and an erosion gully is at the north extent of the site (indicated by red arrow). Photo taken June 10, 2025 facing southeast.**

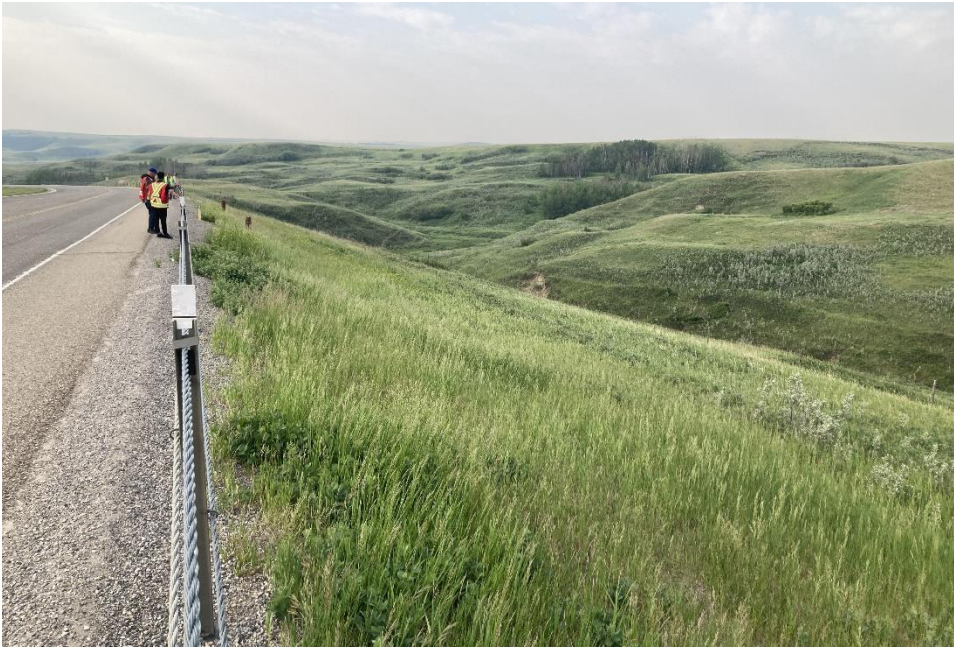
Photo 3 The west (southbound) highway embankment at Site A is well vegetated and appears to be in good condition. Photo taken June 10, 2025 facing south.

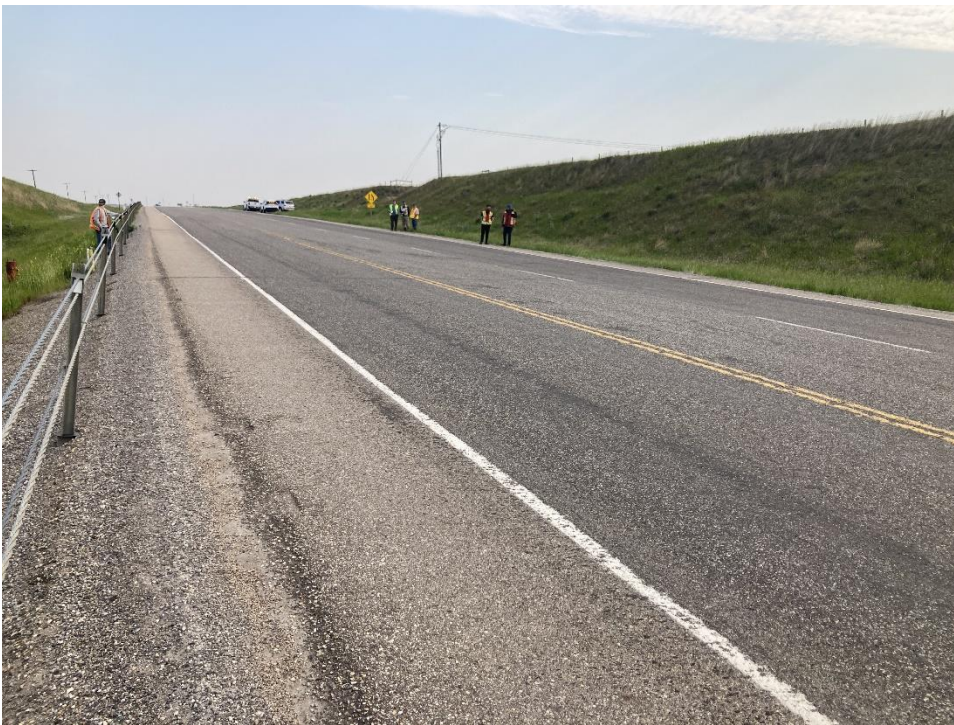
Photo 4 The pavement at Site A upslope of the H-pile wall appears to be in good condition. Photo taken June 10, 2025 facing north-northeast.

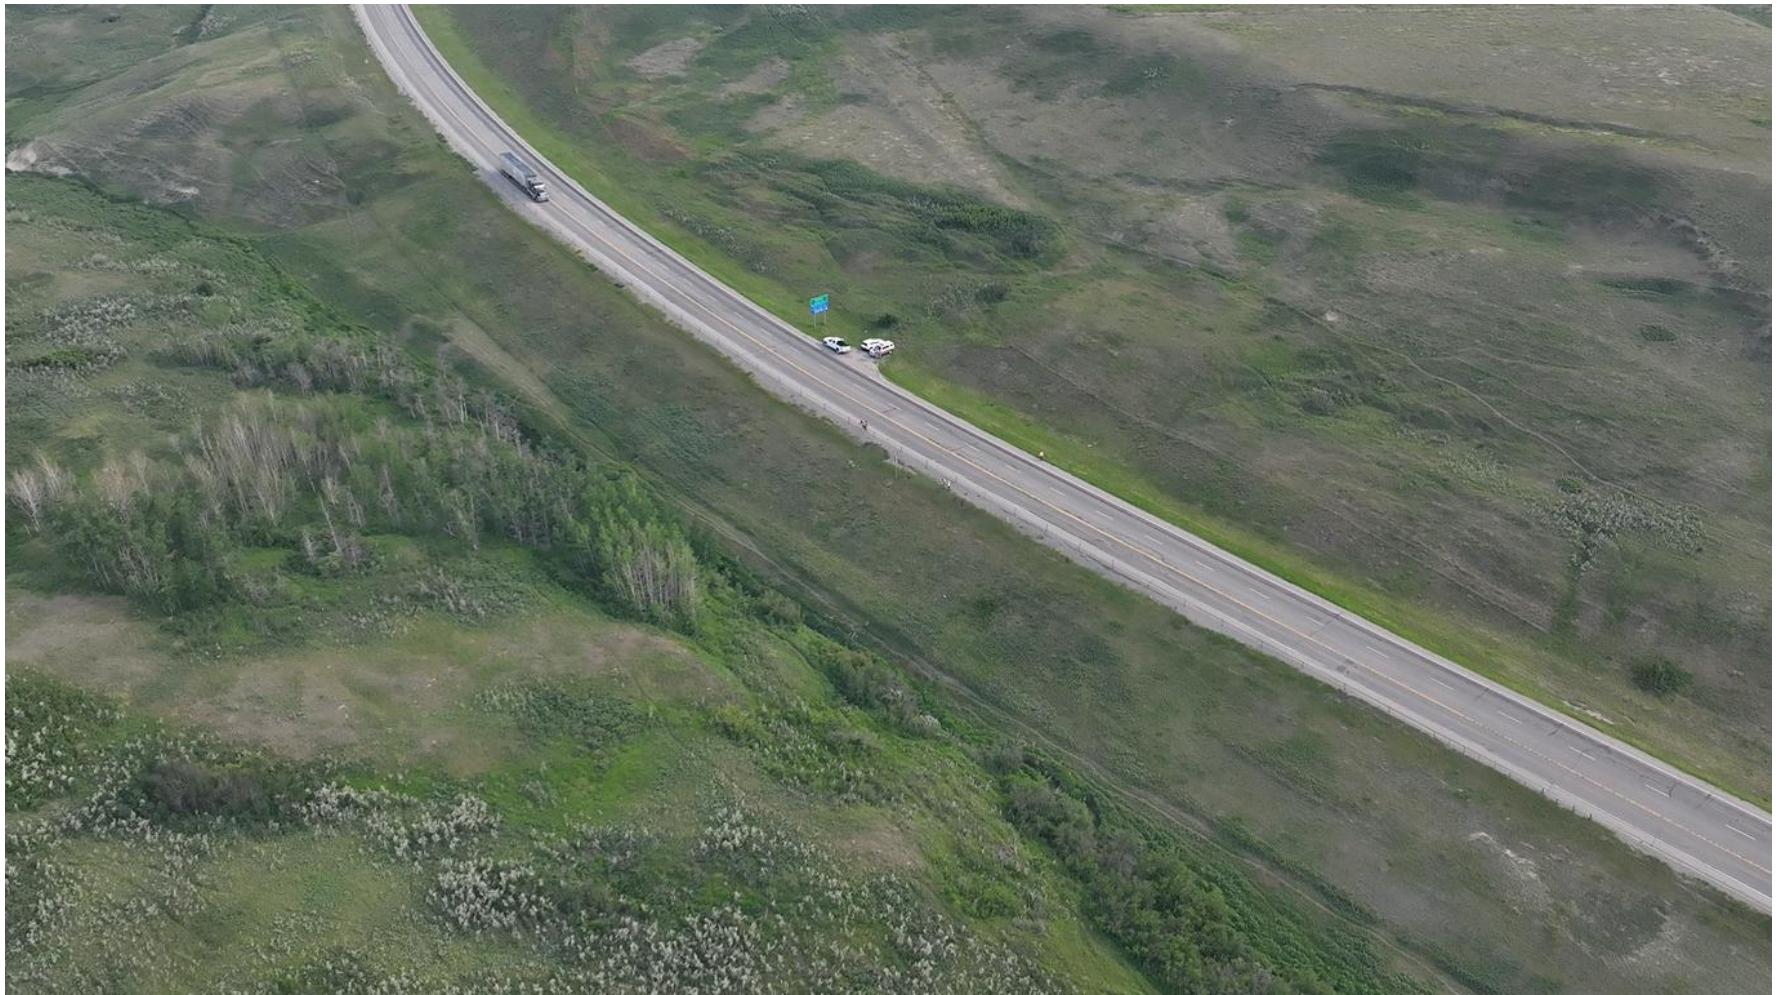
Photo 5 **Aerial photo of C067 Site B located downslope (southeast) of Site A. The highway embankment slope is well vegetated and generally even, indicating the H-pile wall is performing well. Photo taken June 10, 2025 facing north-northwest.**

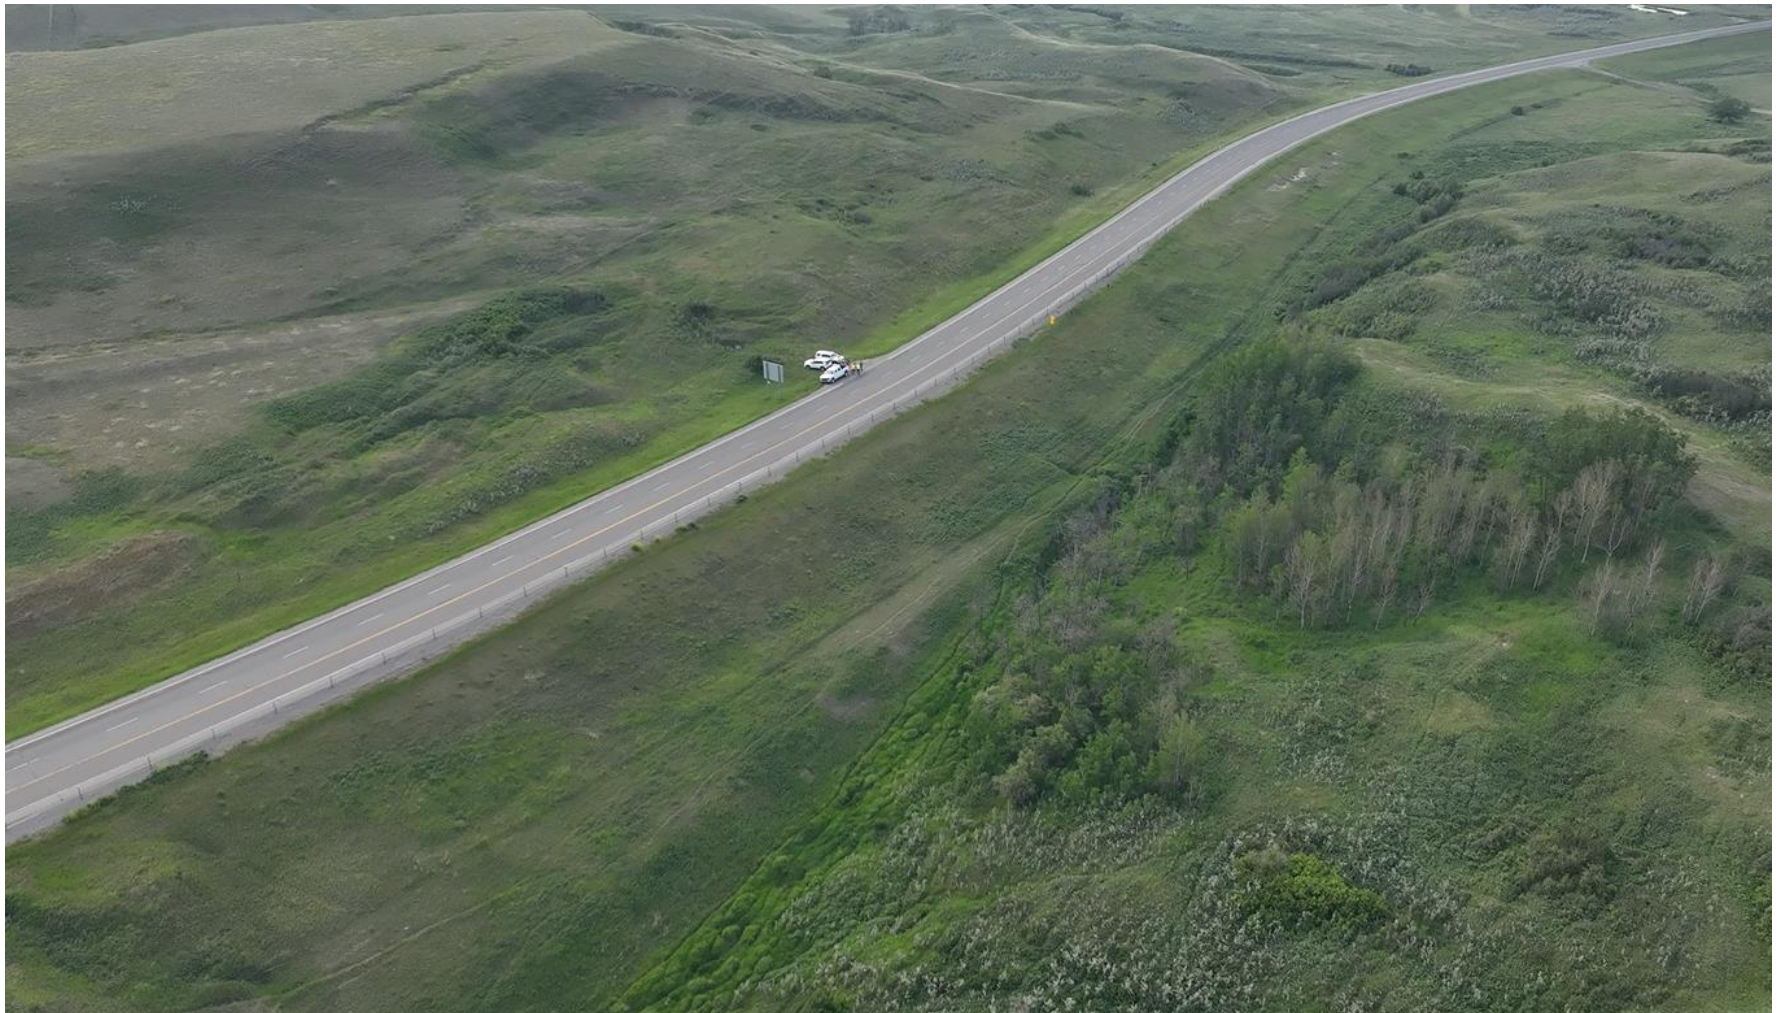
Photo 6 **Aerial photo of C067 Site B located downslope (southeast) of Site A. The highway embankment slope is well vegetated and generally even, indicating the H-pile wall is performing well. Photo taken June 10, 2025 facing east.**

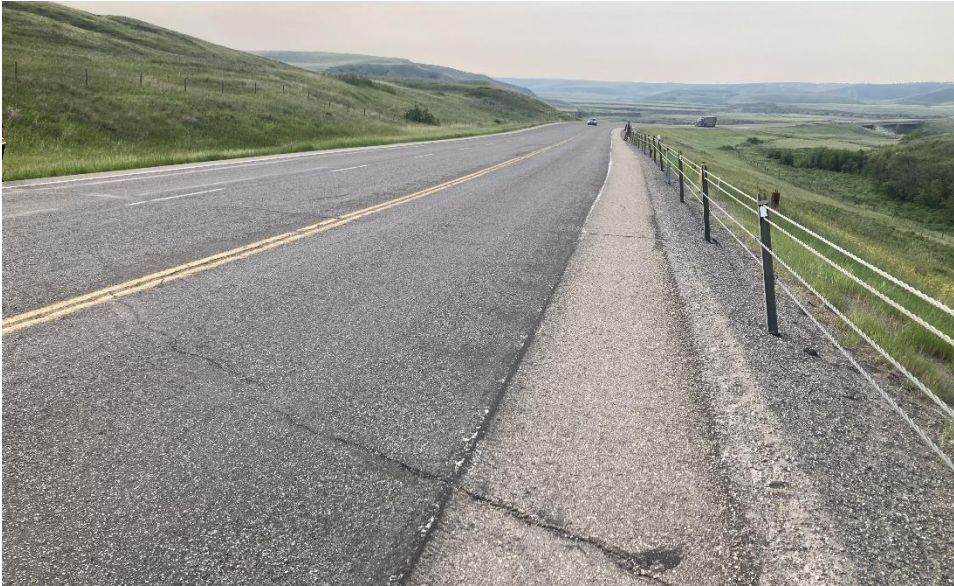
- Pavement cracking was observed in the west (southbound) and extended into the east (northbound) driving lane (Photo 7). Pavement cracks were up to 25 mm wide during the 2023 inspection but were partially obscured during the 2025 inspection due to highway resurfacing (chip sealing) completed in 2024 (Photos 7 and 8).

Photo 7 At Site B, a transverse pavement crack was observed in the west (southbound) lane, extending into the east (northbound) passing lane. The pavement crack has reflected through the 2024 chip sealing. Photo taken June 10, 2025 facing southeast.

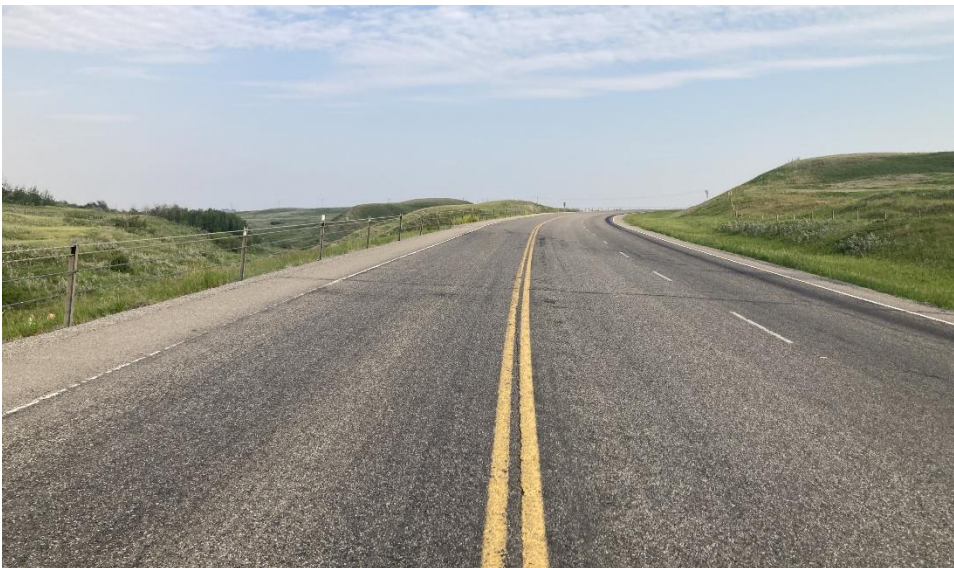
Photo 8 Pavement along Site B was resurfaced (chip sealing) in summer 2024, generally obscuring pavement distress (settlement and cracking) observed during previous inspections. Photo taken June 10, 2025 facing northwest.

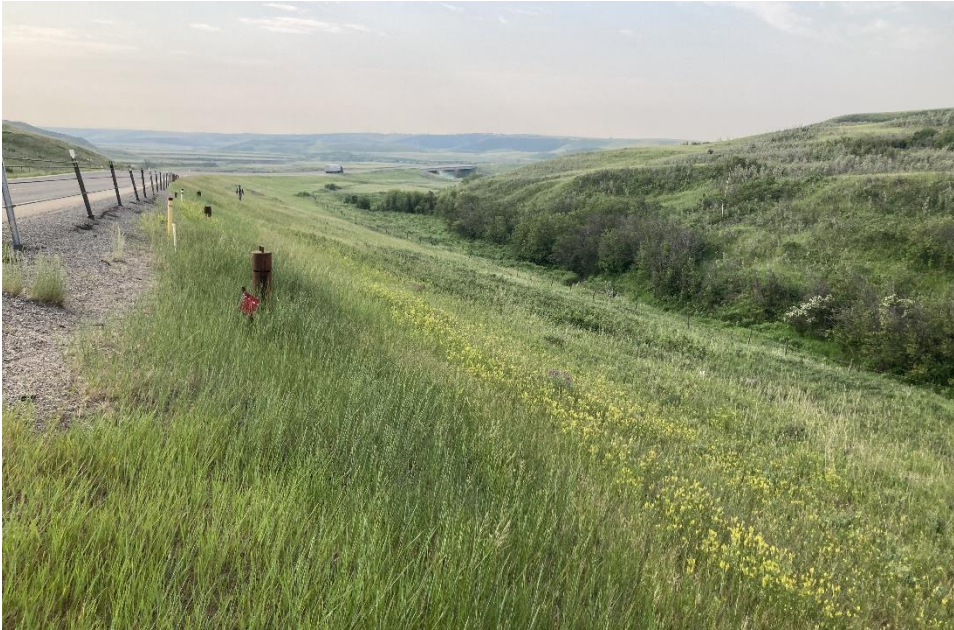
- The highway embankment slope was well vegetated and generally even. An area of dense vegetation was located in the bottom third of the slope, below the H-pile wall, which could indicate an area of seepage or elevated groundwater table (Photo 9).

Photo 9 The west (southbound) highway embankment at Site B is well vegetated and appears to be in good condition. Dense vegetation (grass and small shrubs) observed in the lower third of the slope. Photo taken June 10, 2025 facing south-southeast.

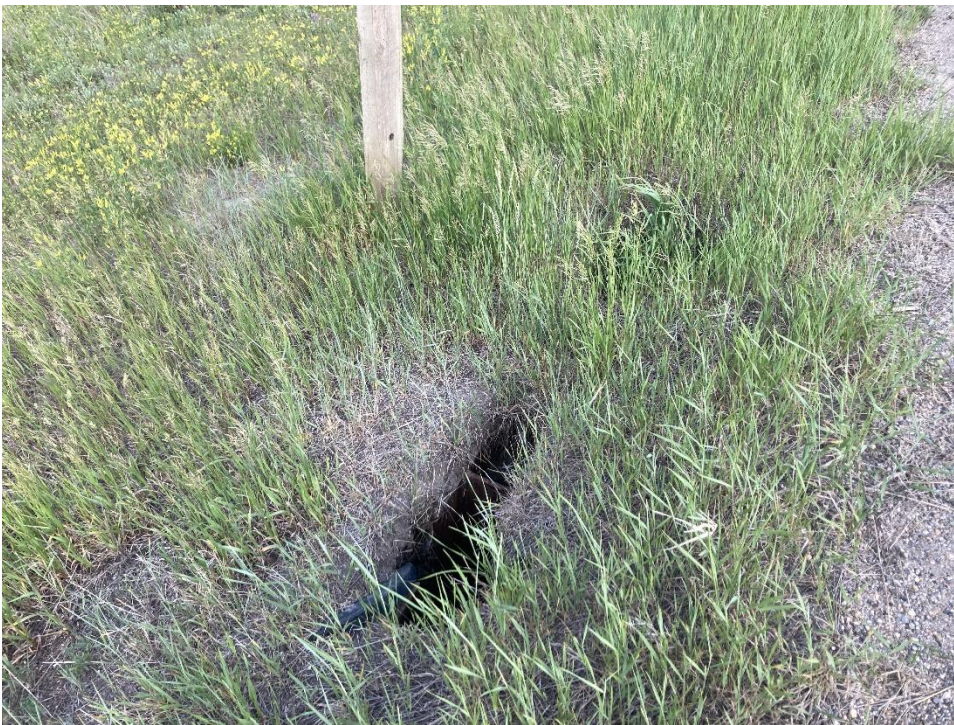
- There were sinkholes located along the top of the H-pile wall (approximately 5 voids have been observed since 2021) (Photo 10). One sinkhole was located near a hazard sign near the west extent of the H-pile wall (Photo 9).

Photo 10 Voids are located along the Site B above the 2017 H-pile wall. Photo taken June 10, 2025 facing west.

- The site should be regularly inspected by the Highway Maintenance Contractor (HMC).
- The sinkholes above the H-pile walls should be backfilled with sand and gravel.
