SITE NUMBER AND NAME: C072 Chicken Creek Slide	HIGHWAY & KM: 22:24, 9.80	PREVIOUS INSPECTION DATE: June 27, 2023	INSPECTION DATE: June 9, 2025
LEGAL DESCRIPTION: 09-33-040-07 W5M 12-34-040-07 W5M	NAD 83 COORDINATES: UTM Northing Easting 11 5817436 640058	RISK ASSESSMENT: PF: 1 CF: 4 TOTAL: 4	
HIGHWAY CLASSIFICATION NUMBER: 2		CONTRACT MAINTENANCE AREA (CMA): 514	
AVERAGE ANNUAL DAILY TRAFFIC (AADT): 2,320(north) & 3,020 (south) (Ref No. 990020)

CENTRAL REGION GEOHAZARD RISK MANAGEMENT PROGRAM

Site Plan
C072 - Chicken Creek Slide
Hwy 22:24, km 9.8

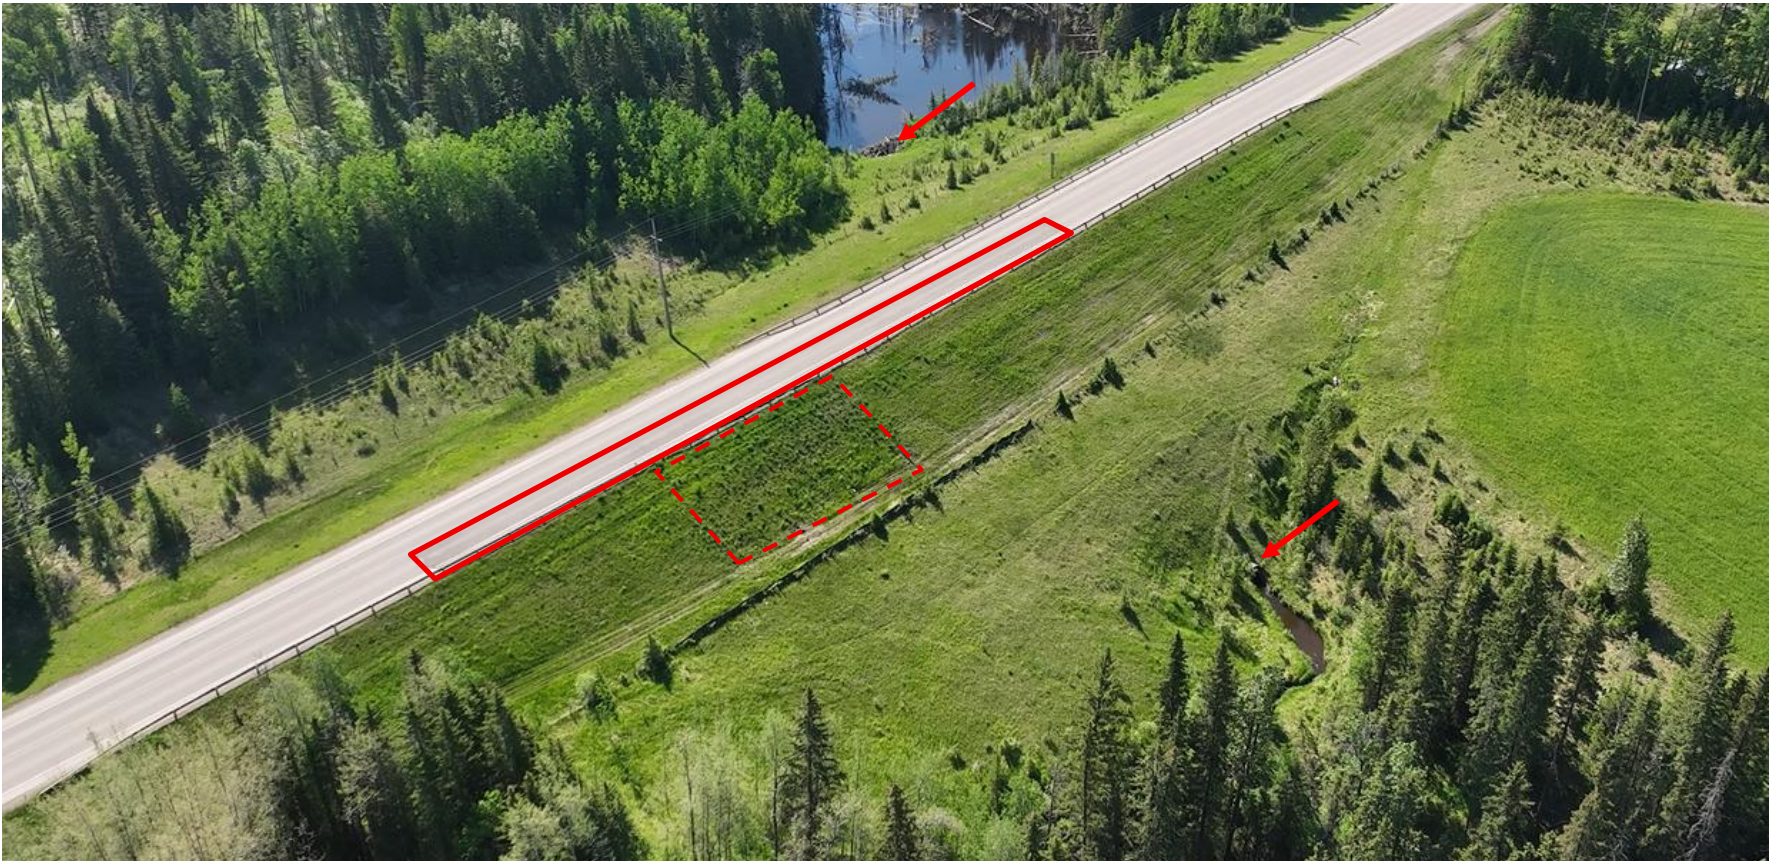
- The 1800-mm-diameter multi-plate corrugated-steel-pipe (CSP) culvert (Bridge File No. 13457) was sleeved with a 1300-mm-diameter CSP culvert (date unknown). The culvert is underlying Hwy 22:24 (oriented east-west) south of the 2021 repair (Photo 1 and 2).
- During the 2025 inspection, there was a red diamond hazard sign installed above the culvert along the west (southbound) guardrail (Photo 3).

- The west (southbound) lane was patched during 2021 construction (Photos 1, 2, 3, and 5). A thin pavement crack (less than approximately 10 mm to 15 mm wide) was observed in the patch upslope of the 2021 repair but does not appear to have widened between the 2023 and 2025 inspections (Photo 5). KCB suspects this may be a previous saw cut that is reflected through the pavement patch and not attributed to slide movement.

- The shallow highway embankment slide was repaired in November 2021 with geogrid-reinforced granular fill (Photos 1 through 4). The coir roll installed at the crest of the slope appeared to be in good condition.

- The 2021 repaired slope was relatively smooth, well vegetated (mostly grass), and appeared to be performing well (Photos 1 through 4). The embankment slope appeared drier than inspections before the 2021 repair, indicating the drainage improvements (granular fill and buried perforated pipe drains) are performing well.

Photo 1 An aerial photo of the C072 site, highlighting the location of the pavement patch (red line), slide repair extents (red dashed line), and culvert (Bridge File No. 13457) inlet and outlet (red arrows). Photo taken June 9, 2025 facing southeast.

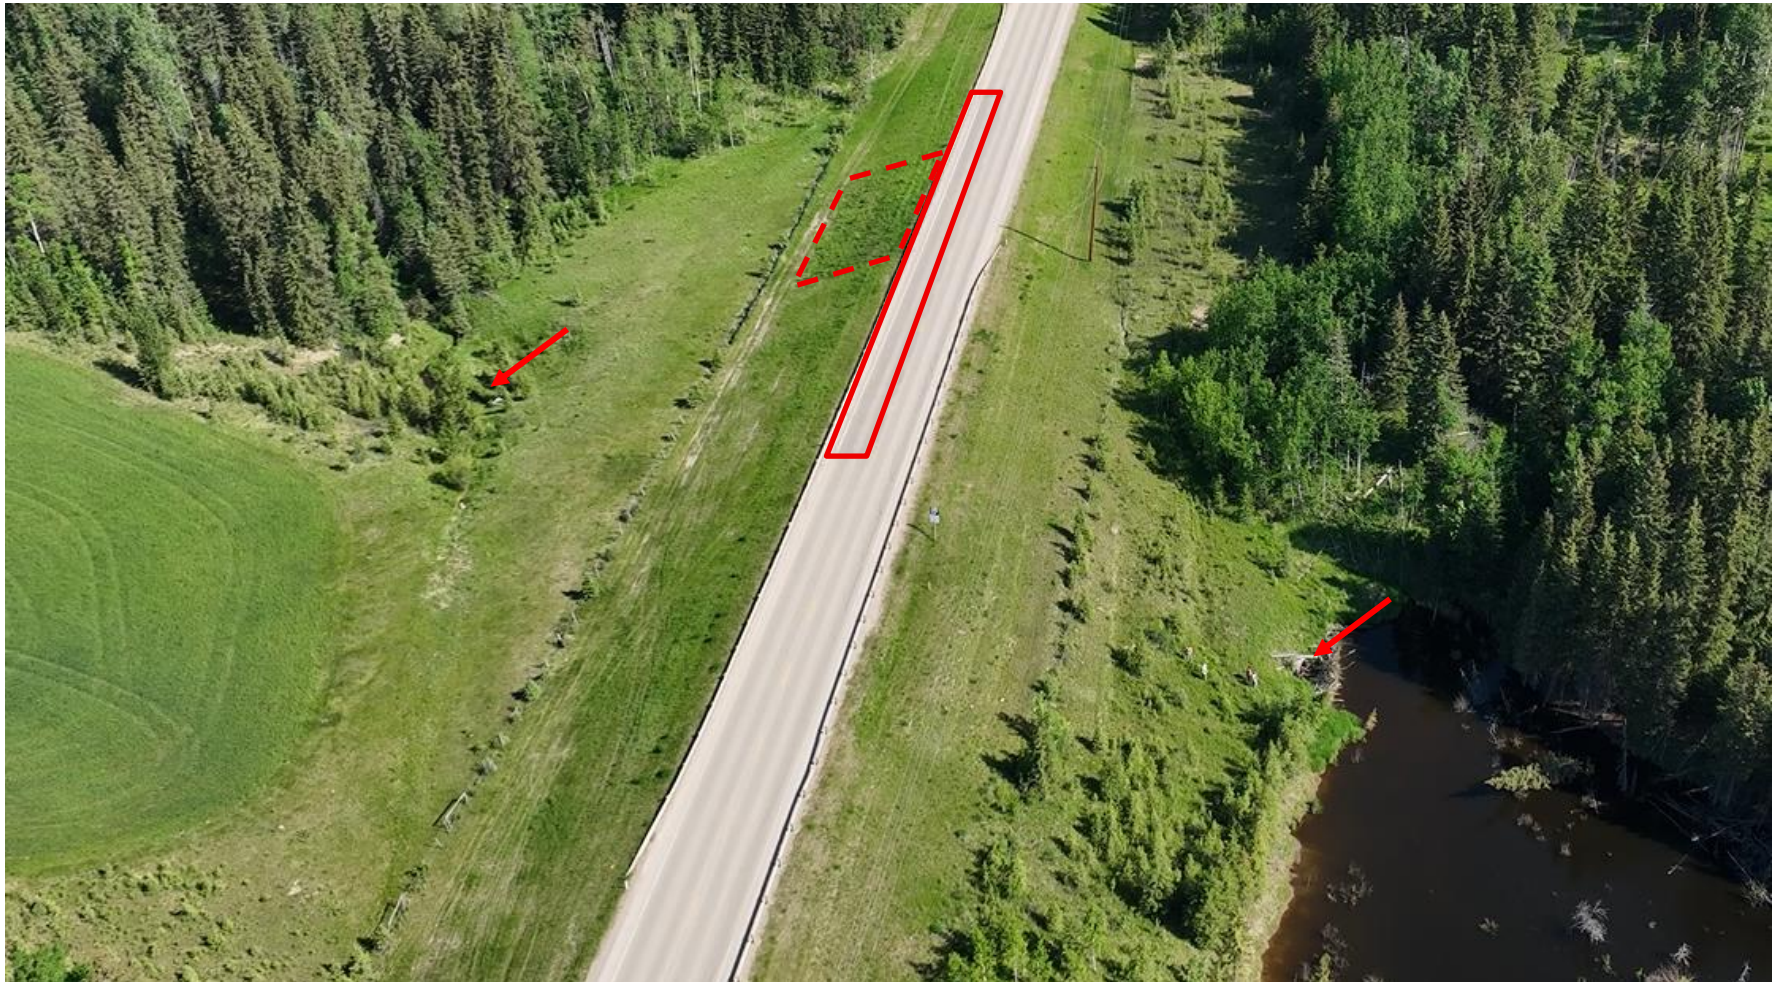
Photo 2 An aerial view of the C072 site, highlighting the pavement patch (red line), slide repair extents (red dashed line), and culvert (Bridge File No. 13457) inlet and outlet (indicated by red arrows). Photo taken June 9, 2025 facing north-northwest.

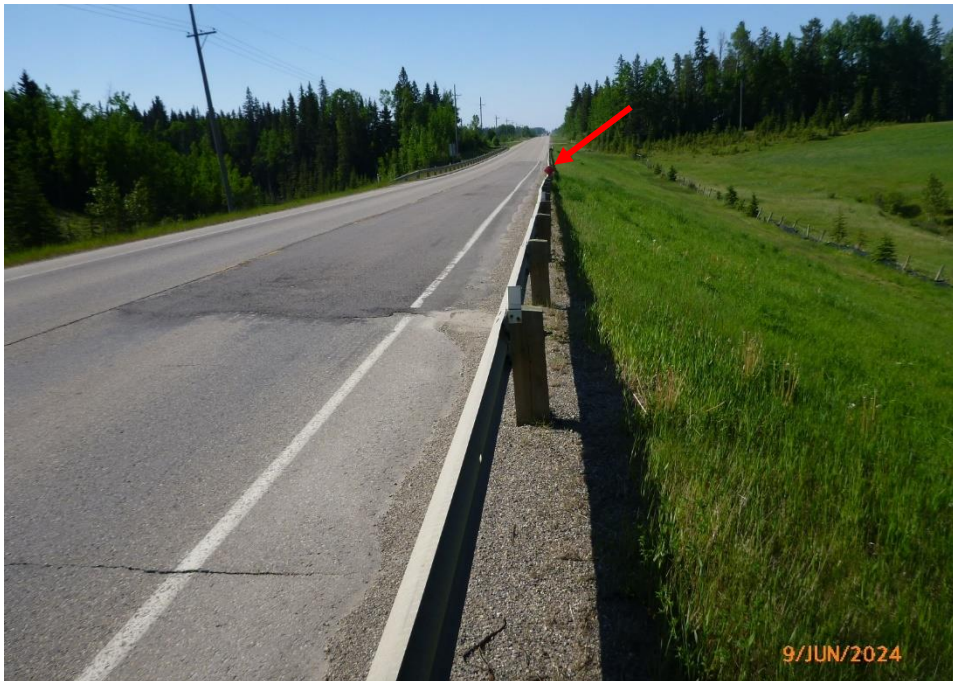
Photo 3 Guardrail and pavement patch in west (southbound) lane. Red diamond hazard sign indicated by red arrow. Photo taken June 9 2025 facing south.

- The site should continue to be regularly inspected by TEC's Maintenance Contract Inspector (MCI).
- The site should be removed from TEC's list of active Central Region GRMP sites.
- The beaver dam at the 1300-mm-diameter CSP culvert inlet should be removed.
- The red diamond hazard sign should be removed.

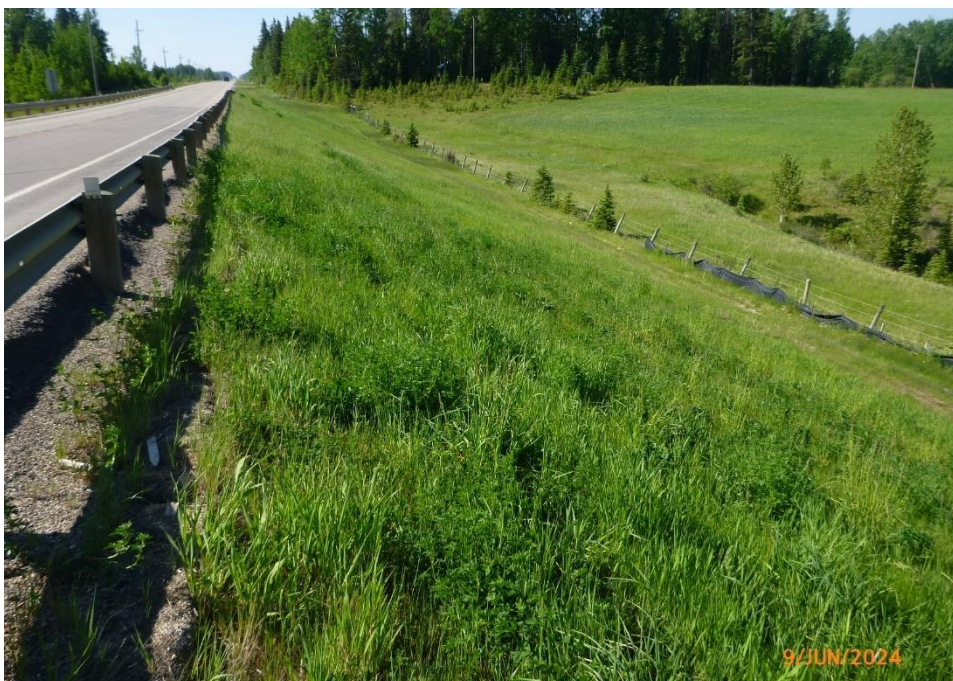
Photo 4 The repair of the highway embankment slope is well vegetated and appears to be performing well. Photo taken June 9, 2025 facing south-southwest.

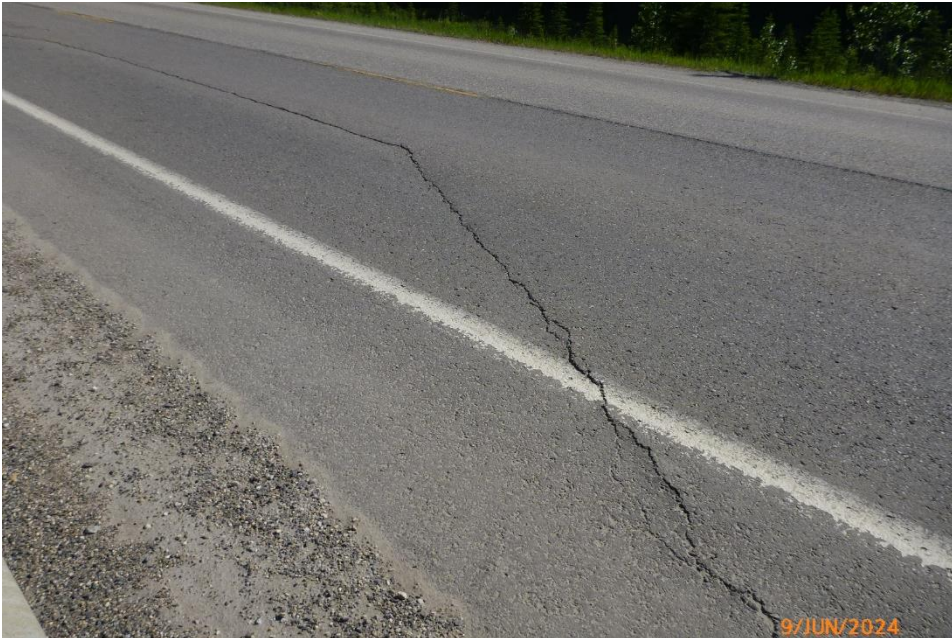
- Photo 5** **Thin (less than 15 mm) pavement crack in the west (southbound) pavement patch. The pavement crack may be attributed to construction and does not appear to have worsened since the 2023 inspection. Photo taken June 9, 2025 facing north-northeast.**

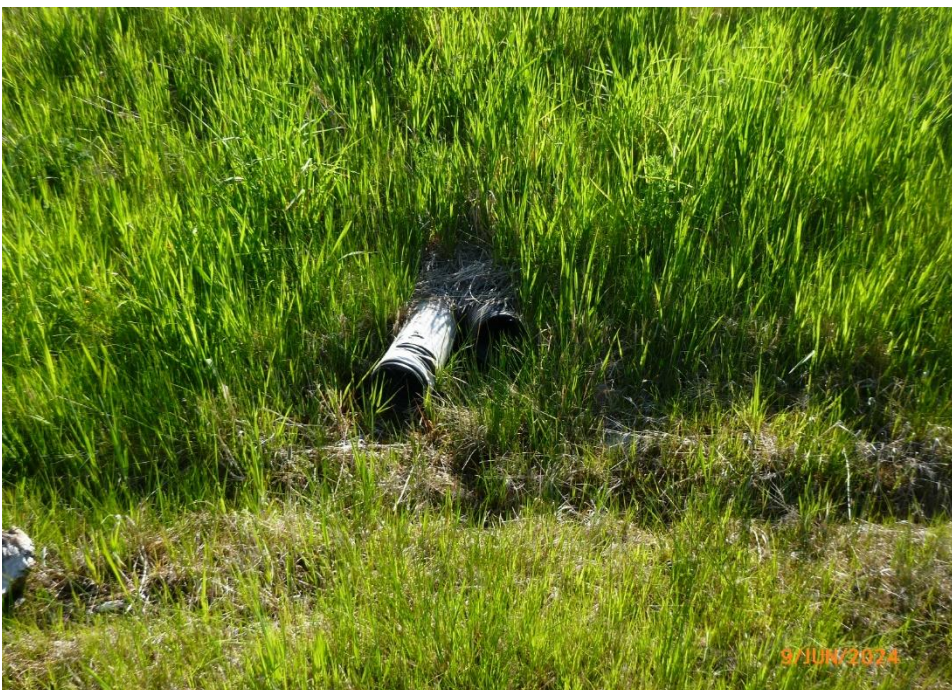
- Four buried perforated pipe drains (wrapped in filter fabric) were installed at the base of the excavation and daylight near the toe of the slope. The drain outlets were dry during both the 2023 and 2025 inspections (Photo 6). The toe of the highway embankment was relatively wet during the 2025 inspection and appears to be poorly drained.

- Photo 6** **The drains installed during the slide repair, daylighting at the toe of the west (southbound) embankment slope, do not appear to be flowing and were dry during the inspection. Photo taken June 9, 2025 facing east.**

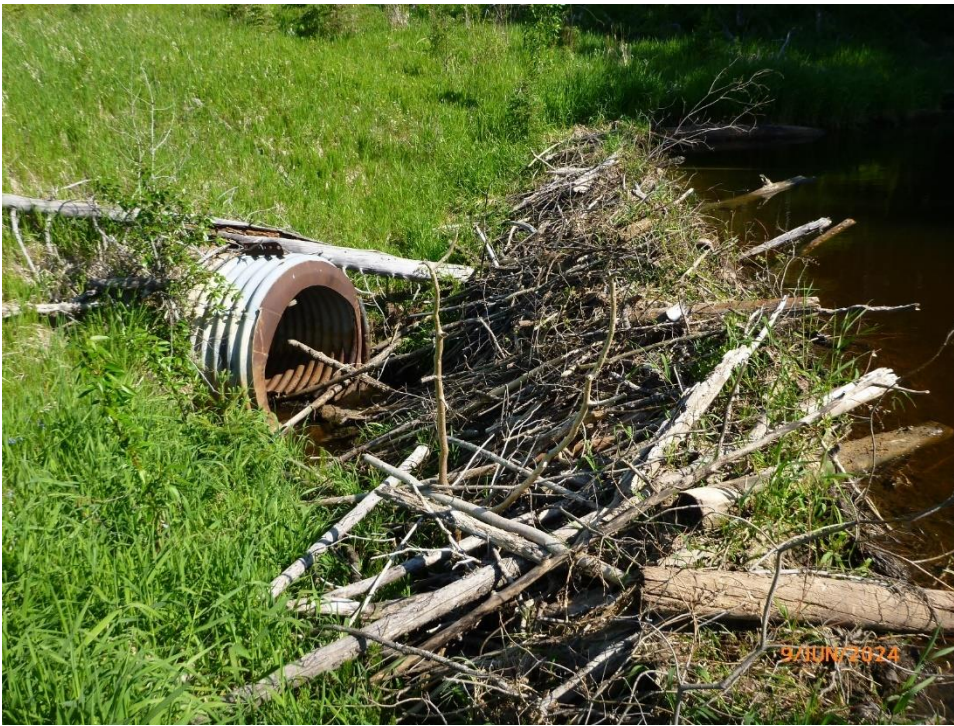
- During the 2017 inspection, debris was observed at or just above the crown of the culvert inlet, indicating the culvert may have insufficient capacity to handle flow volumes during spring freshet or significant precipitation events. The culvert outlet was not inspected during the 2023 inspection. During the 2025 inspection, a beaver dam was observed at the culvert inlet (Photo 7). The beaver dam was approximately 1.5 m to 2.0 m high, extended above the crown of the culvert, and was impounding water.

Photo 7 Beaver dam, approximately 1.5 m to 2.0 m in height, was observed at the culvert (Bridge File No. 13457) inlet. Photo taken Jun 9, 225 facing north.

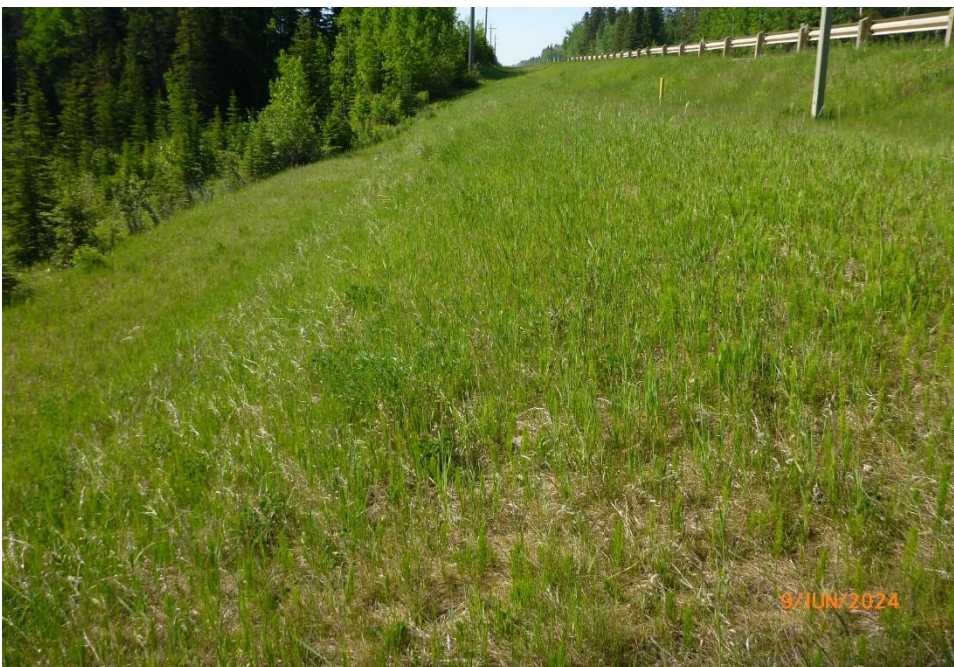
- The highway embankment slope was well vegetated and the previous repair completed in 1990 generally appears to be performing well (Photo 8). During the 2025 inspection, evidence of minor movement (thin ground cracks) was observed in the lower portion of the highway embankment slope. Movement may be attributed to increased water levels in Chicken Creek, due to the beaver dam at the culvert inlet, increasing the groundwater level and reducing the overall stability of the slope.

Photo 8 East highway embankment slope above culvert inlet is well vegetated and appears to be performing satisfactorily. Minor evidence of movement (ground cracks) observed near the embankment toe. Photo taken June 9, 2025 facing south.
