SITE NUMBER AND NAME: C072 North of Rocky Mountain House (RMH)		HIGHWAY & KM: 22:24, 9.8	PREVIOUS INSPECTION DATE: June 12, 2017	INSPECTION DATE: June 11, 2018
LEGAL DESCRIPTION: 09-33-040-07 W5M 12-34-040-07 W5M	NAD 83 COORDINATES: UTM Northing Easting 11 5817436 640058		RISK ASSESSMENT: PF: 6 CF: 4 TOTAL: 24	
AVERAGE ANNUAL DAILY TRAFFIC (AADT): 2,540 (north) (Ref No. 990020)			CONTRACT MAINTENANCE AREA (CMA): 17

PROJECT
 CENTRAL REGION GEOHAZARD RISK MANAGEMENT PROGRAM

TITLE
 Site Plan
 C072 – North of Rocky Mountain House (RMH)
 Hwy 22:24, km 9.8

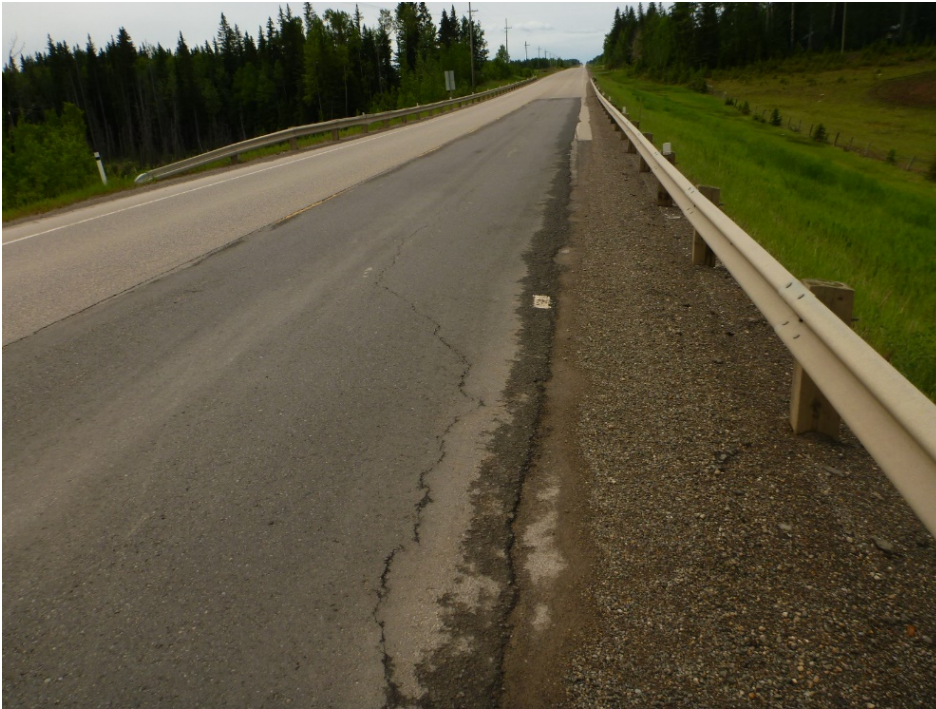
COMMENTS
A new asphalt patch (approximately 100 m long) has been placed since the 2017 inspection. The old pavement cracks appear to be reflecting through the new patch and new cracks have appeared at the south end of the patch.
The fence at the toe of the embankment is deflected slightly to the west. Standing water was observed at the toe of the embankment, likely due to recent rainfall in the area.
Cracking in the southbound lane could indicate potential retrogression of the backscarp onto the highway.
Southbound vehicles were observed to drive into the northbound lane around the patched area that is subsided and cracked.
The presence of wet areas on the bench, near the deflected section of fence, indicate the bench is poorly drained.
During the previous inspection, debris (e.g., branches, and small logs-flotsam) was observed at or just above the

Photo 1 Old pavement cracks are being reflected through the recent asphalt patch. Photo taken June 11, 2018 looking south.

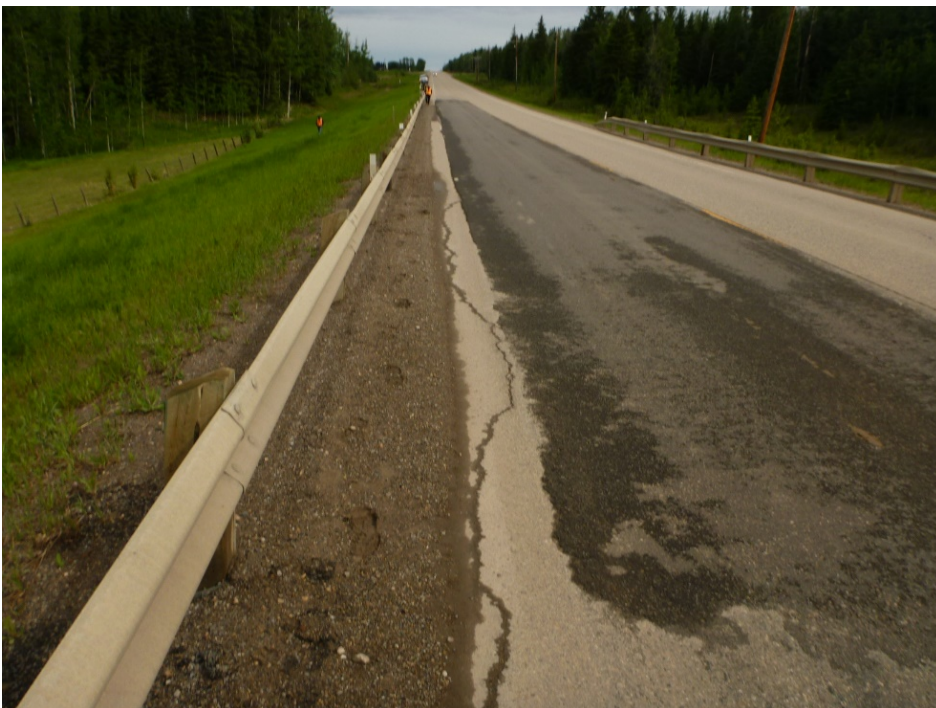
Photo 2 New pavement cracking (approximately 8 m in length) at the south end of the asphalt patch. Photo taken June 11, 2018 looking north.

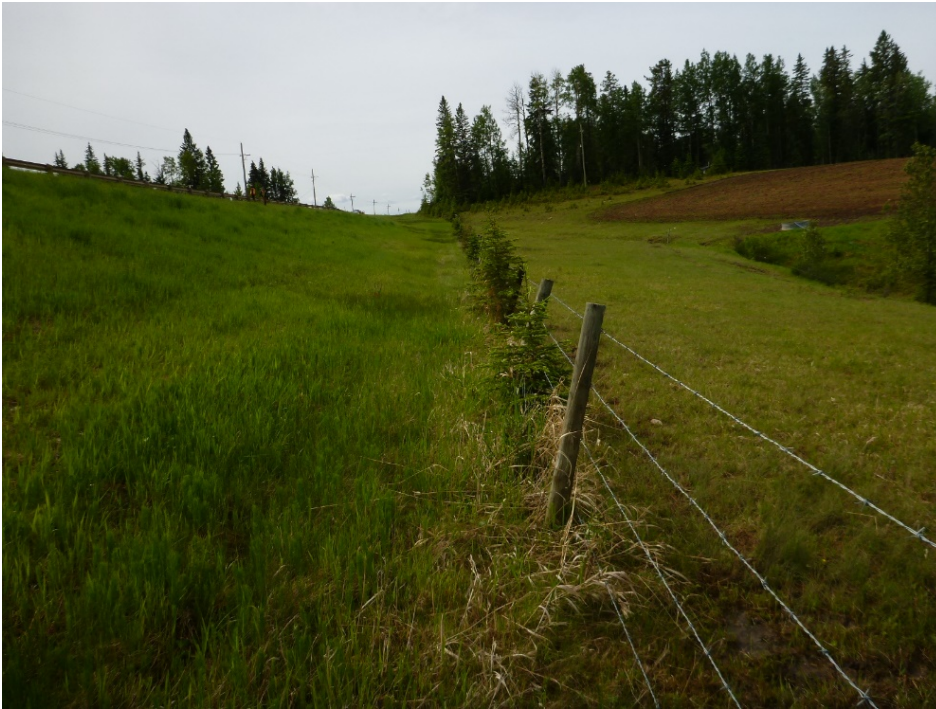
Photo 3 The fence line at the toe of the slide showing a slight deflection towards the west.
Photo taken June 11, 2018 looking south.

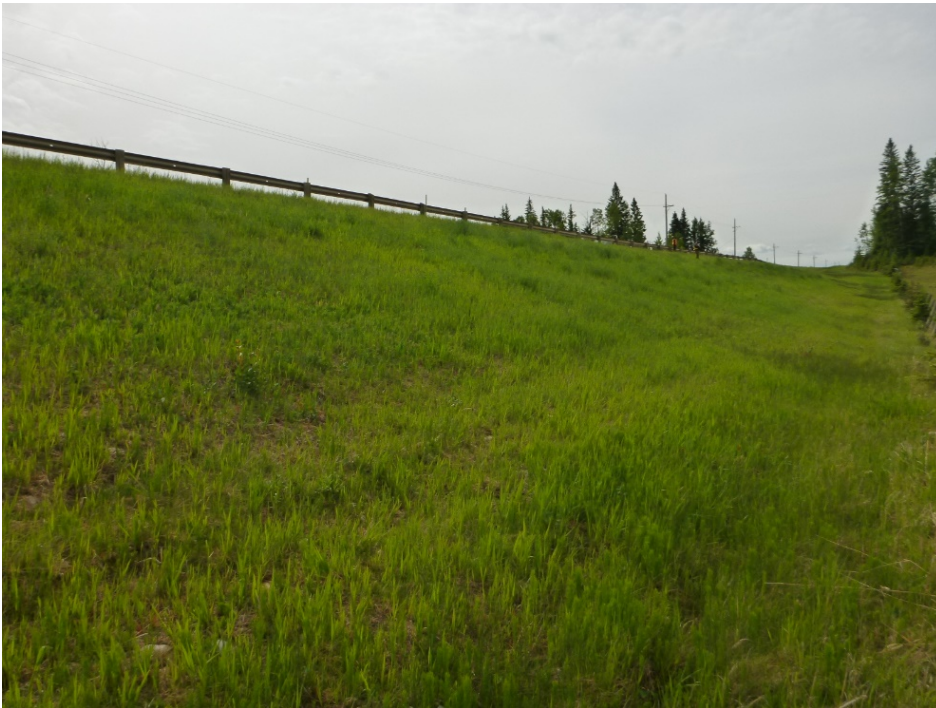
Photo 4 Condition of the slope below the asphalt patch. Photo taken June 11, 2018 looking southeast.

A geotechnical site investigation (e.g., drilling, laboratory testing, and instrumentation installation and monitoring program) should be conducted on the west slope to assess subsurface conditions; and to monitor depth of movement, and groundwater conditions.

Discussed remedial actions: Repair of the upper slide area could include excavating the slide area and reconstructing the upper portion of the slope with geosynthetic reinforced fill, with a shear key and subsurface drainage. The bridge culvert should be inspected with a remotely operated video camera, and a hydrologic assessment should be conducted to assess the discharge capacity of the culvert. If needed, a new culvert could be drilled through the base of the embankment.
