SITE NUMBER AND NAME: C072 North of Rocky Mountain House (RMH)		HIGHWAY & KM: 22:24, 9.8	PREVIOUS INSPECTION DATE: June 11, 2018	INSPECTION DATE: July 09, 2019
LEGAL DESCRIPTION: 09-33-040-07 W5M 12-34-040-07 W5M	NAD 83 COORDINATES: UTM Northing Easting 11 5817436 640058		RISK ASSESSMENT: PF: 8 CF: 4 TOTAL: 32	
AVERAGE ANNUAL DAILY TRAFFIC (AADT): 2,540 (north) (Ref No. 990020)			CONTRACT MAINTENANCE AREA (CMA): 17

PROJECT CENTRAL REGION GEOHAZARD RISK MANAGEMENT PROGRAM		
TITLE Site Plan C072 – North of Rocky Mountain House (RMH) Hwy 22:24, km 9.8		
SCALE 1:2,000	PROJECT No. A05115A02	FIG No. 1

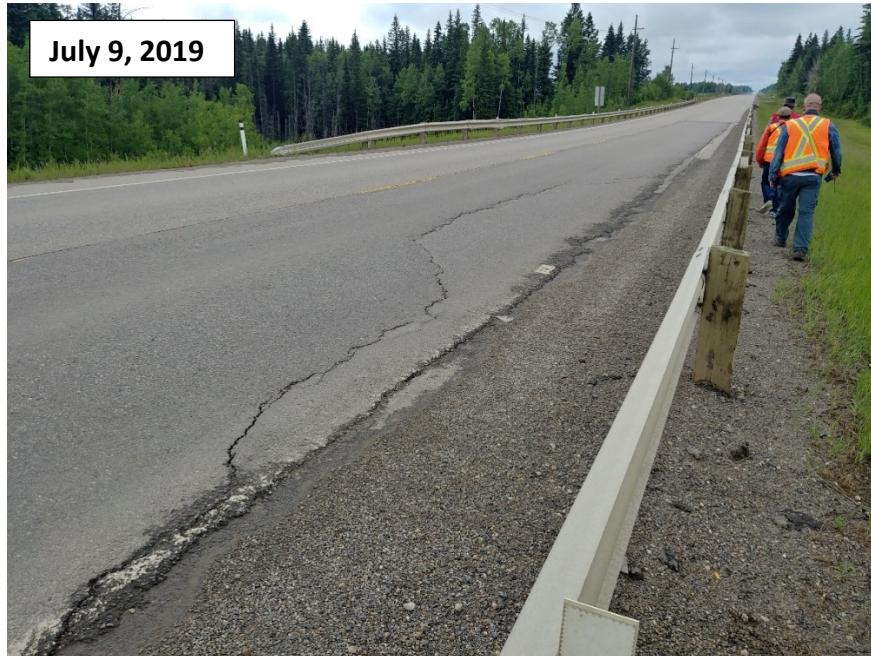
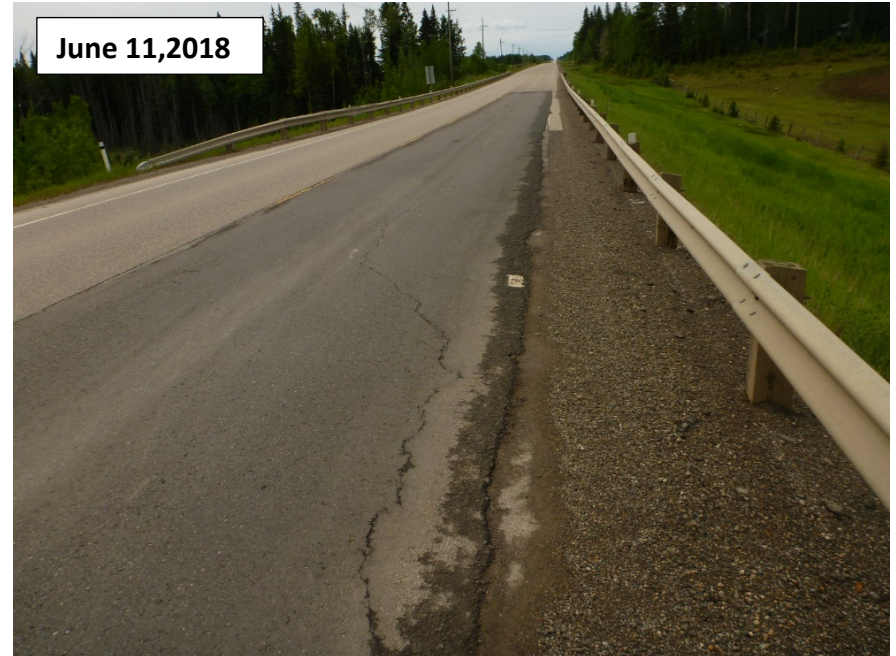
COMMENTS
No new cracking was observed in the pavement patch placed in 2017. The old pavement cracks that are reflecting through the patch appear to have expanded slightly. The cracking at the south end of the patch observed during the 2018 inspection does not appear to have expanded.
The fence at the toe of the embankment is deflected slightly to the west with little to no change from the 2018 inspection. The slope below the crest of the highway and the bench were both wet (likely due to recent rainfall).
Cracking in the southbound lane could indicate potential retrogression of the backscarp onto the highway.
The presence of wet areas on the slope, bench, and near the deflected section of fence, indicate the slope is poorly drained.
During the 2017 inspection, debris (e.g., branches, and small logs - flotsam) was observed at or just above the crown elevation of the culvert inlet indicating that the water level at some point was at or just above the crown

Photo 1 Pavement cracking in asphalt patch appears to have expanded. Photo taken July 9, 2019 looking south. (Photo from 2018 inspection included for comparison)

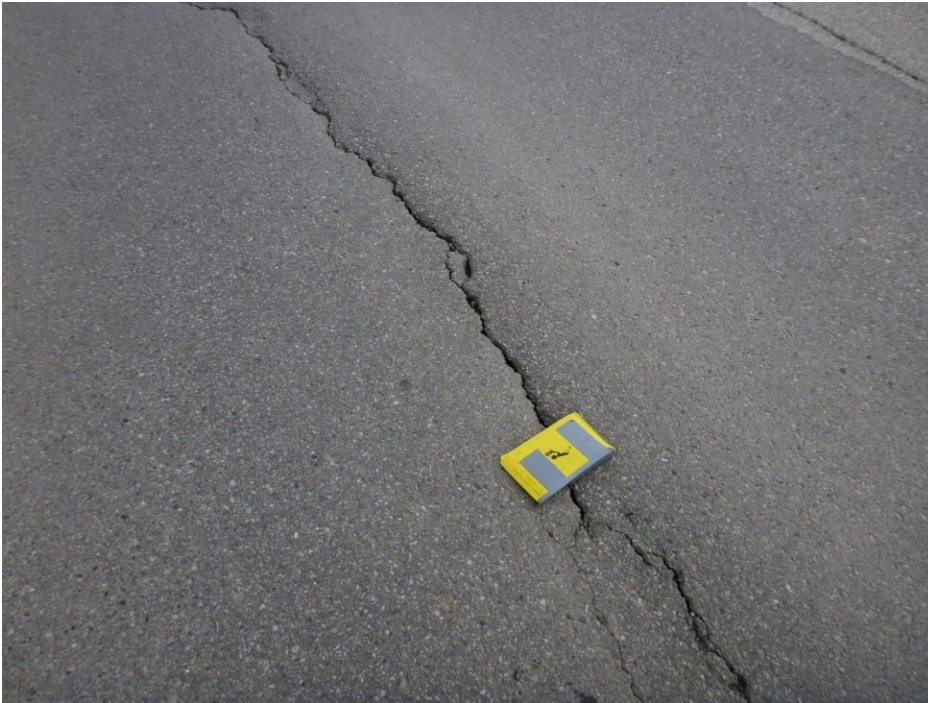
Photo 2 Close-up view of cracking through patch in southbound lane. Photo taken July 9, 2019.

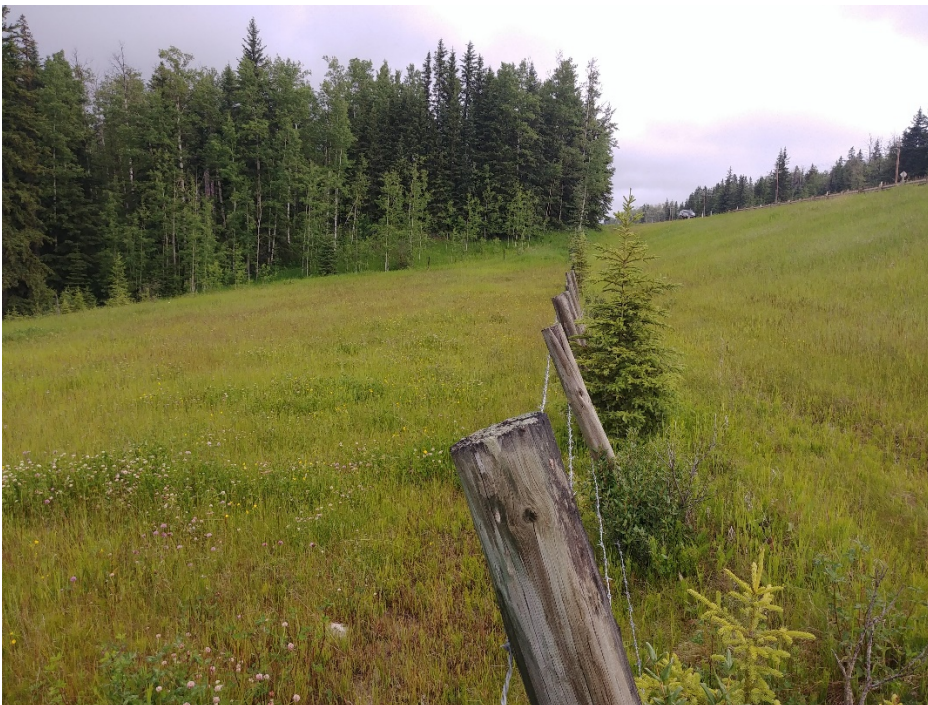
Photo 3 The fence line at the toe of the slide is deflected but shows little change since 2018 inspection. Photo taken July 9, 2019 looking north.

A geotechnical site investigation (e.g., drilling, laboratory testing, and instrumentation installation and monitoring program) should be conducted on the west slope to assess subsurface conditions; and to monitor depth of movement, and groundwater conditions.

Discussed remedial actions: Repair of the upper slide area could include excavating the slide area and reconstructing the upper portion of the slope with geosynthetic reinforced fill, with a shear key and subsurface drainage. The bridge culvert should be inspected with a remotely operated video camera, and a hydrologic assessment should be conducted to assess the discharge capacity of the culvert. If needed, a new culvert could be drilled through the base of the embankment.
