January 11, 2019

Alberta Transportation
4th Floor, Provincial Building
4920 51 Street
Red Deer, Alberta
T4N 6K8

**CON0017608 Central Region GRMP Instrumentation Monitoring
Site C070; H27:10, km 18.932 and 33.102 West and East Slides
Section C – 2018 Fall Readings
Second Draft**

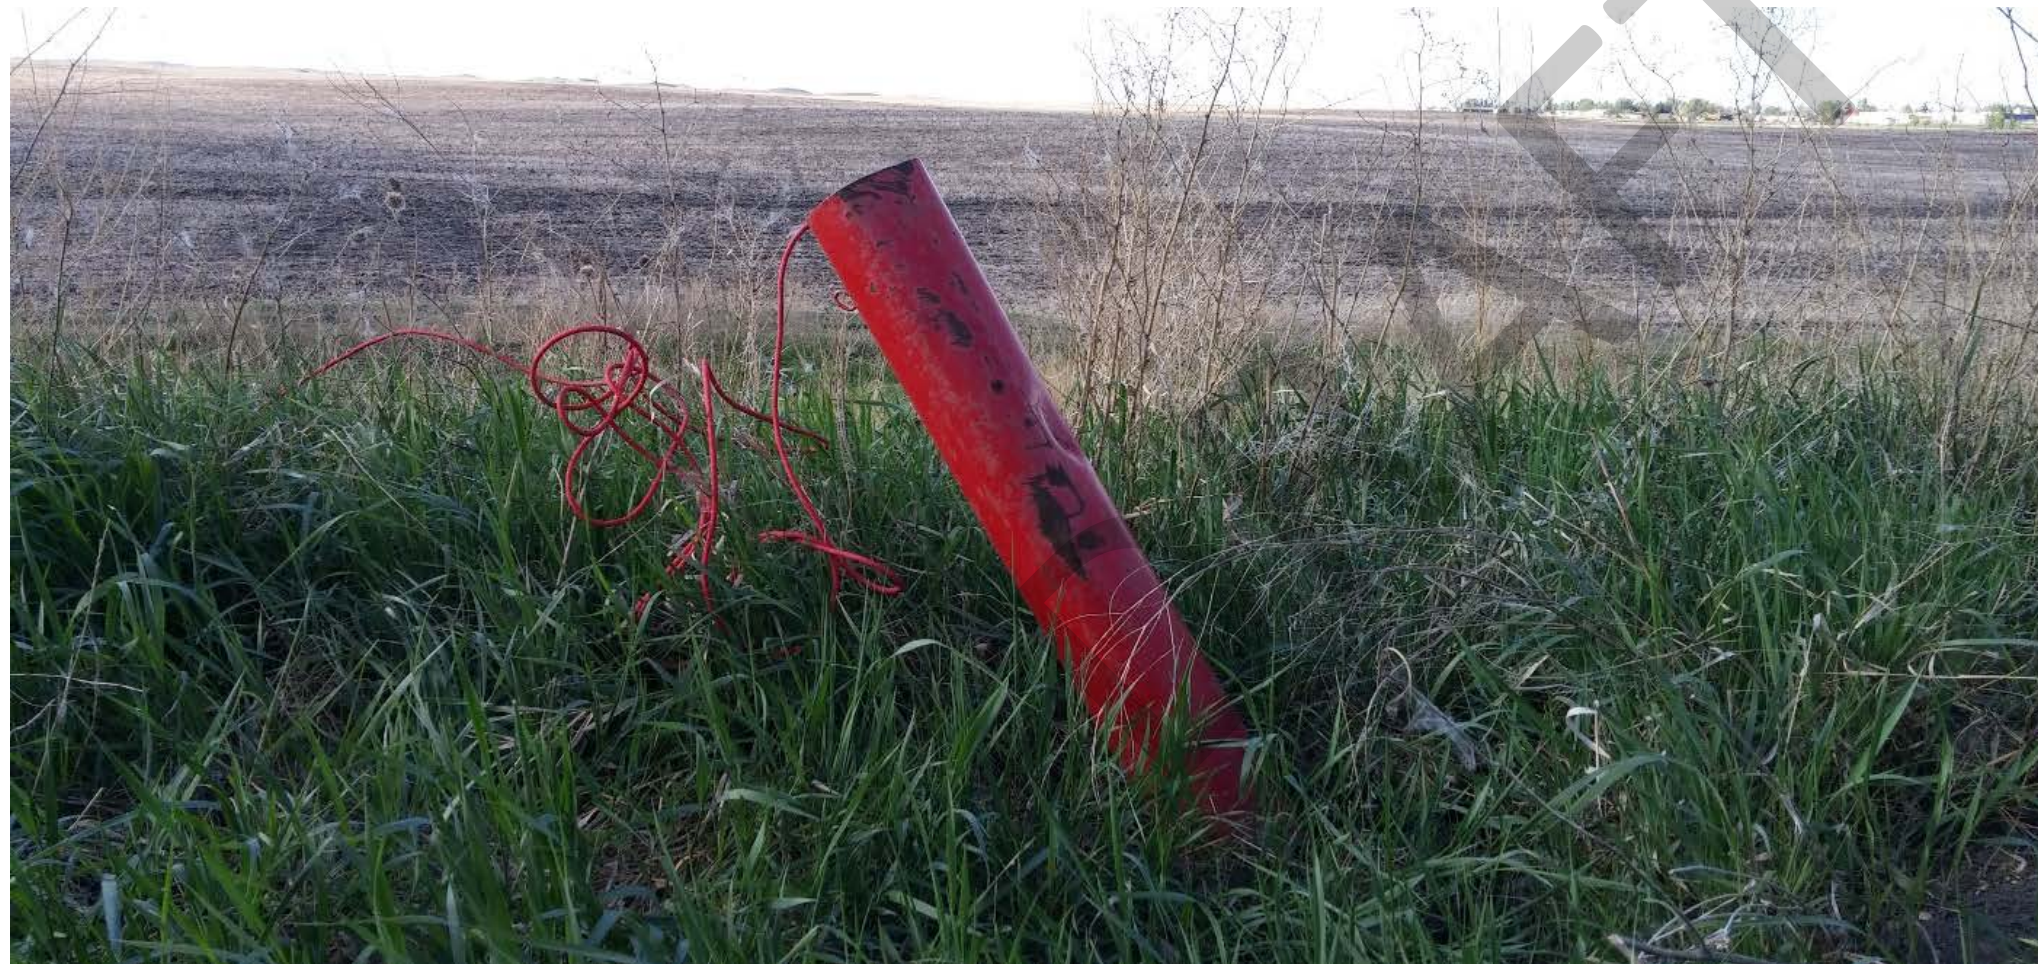
During the Spring 2018 readings, the instruments at the east slide area (SI17-C70E-01 and VW42618) were found to be inoperable. It appears that a vehicle or other piece of equipment had collided with the above ground casing protector damaging the instruments (Photo 1).

Photo 1 SI17-C70E-01 and VW42618 are inoperable after being damaged between September 2017 and May 2018.

An attempt should be made to repair the instruments at the east slide area (S117-C70E-01 and VW42618).

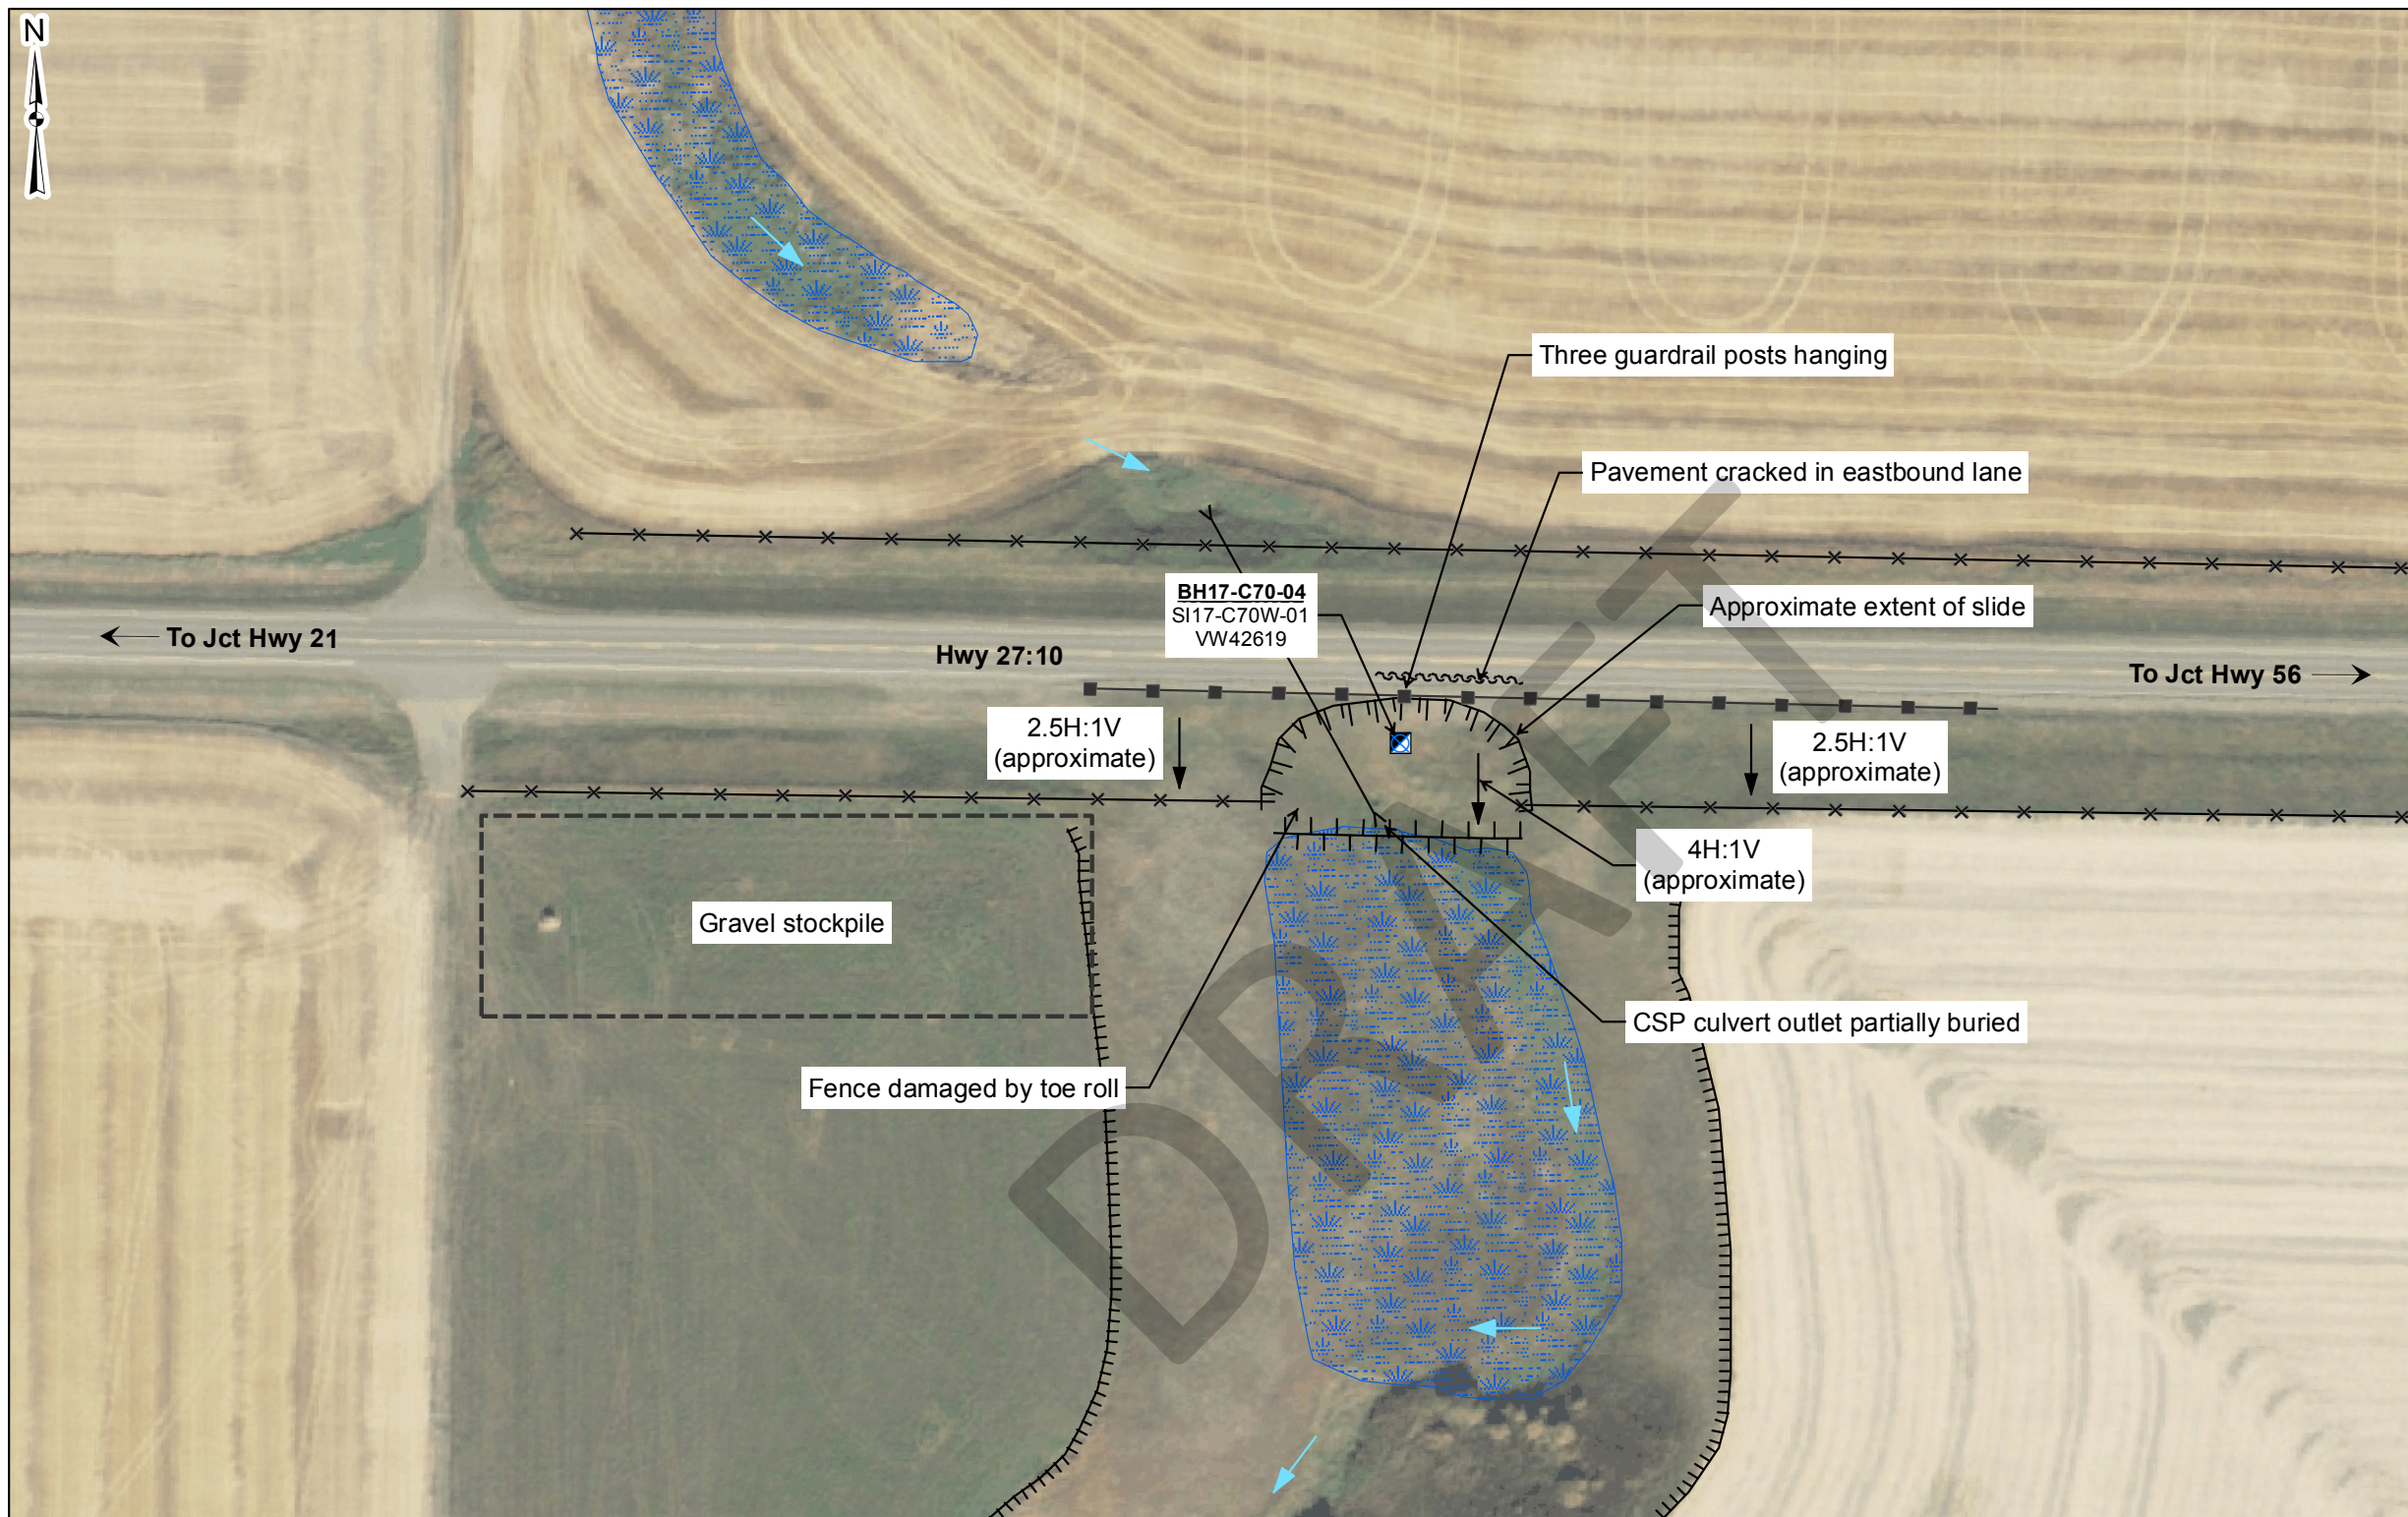
PROJECT CENTRAL REGION GEOHAZARD RISK MANAGEMENT PROGRAM		
TITLE Site Plan C070 - West Slide Hwy 27:10, km 18.932		
SCALE 1:1,200	PROJECT No. A05115A02	FIG No. 2

The upper movements being recorded in SI17-C70W-01 and SI17-C70E-01 appear to be occurring within the previously failed embankment fill, and in the failed material that was pushed upslope to create an access ramp and pad for the drilling rig.

The instrumentation at the west slide (SI17-C70W-01 and VW42619) is installed at the base of the backscarp, and therefore is unable to monitor for movements under the highway embankment, which pose the greatest risk to the safety of the highway.

Both sites should be repaired and drainage improvements implemented to limit the potential for future instability (e.g., lateral expansion of the slide along the highway embankment, or retrogression of the backscarp onto the highway) and impacts on the adjacent farmland.

Repair options for both sites are currently being assessed by KCB and Alberta Transportation, and may include the excavation and reconstruction of the slopes with geosynthetic reinforced fill, with subsurface drainage.
