<b>SITE NUMBER AND NAME:</b> C070 West and East Slides		<b>HIGHWAY &amp; KM:</b> 27:10, 18.932 & 33.102	<b>PREVIOUS INSPECTION DATE:</b> June 13 & 14, 2017	<b>INSPECTION DATE:</b> June 13, 2018
<b>LEGAL DESCRIPTION:</b> 02-18-031-21 W4M 15-07-031-21 W4M 02-16-031-20 W4M	<b>NAD 83 COORDINATES:</b> UTM    Northing    Easting 12      5723837    363877 12      5723487    377005		<b>RISK ASSESSMENT:</b> PF: 9    CF: 4    TOTAL: 36 PF: 9    CF: 4    TOTAL: 36	
<b>AVERAGE ANNUAL DAILY TRAFFIC (AADT):</b> 1790 (west) & 1850 (east) (Ref No. 108260 is between both sites)			<b>CONTRACT MAINTENANCE AREA (CMA):</b> 20

**PRIMARY SITE ISSUE:** Two shallow slope failures in the highway embankment fill that are triggered by surface water flowing onto the slide area during periods of heavy or prolonged rainfall, and a high groundwater table. The West Slide and East Slide are located on the south (eastbound lane) and north (westbound lane) side of Hwy 27, respectively. Both slides have reached the edge of pavement, and the west slide has undermined the guardrail.

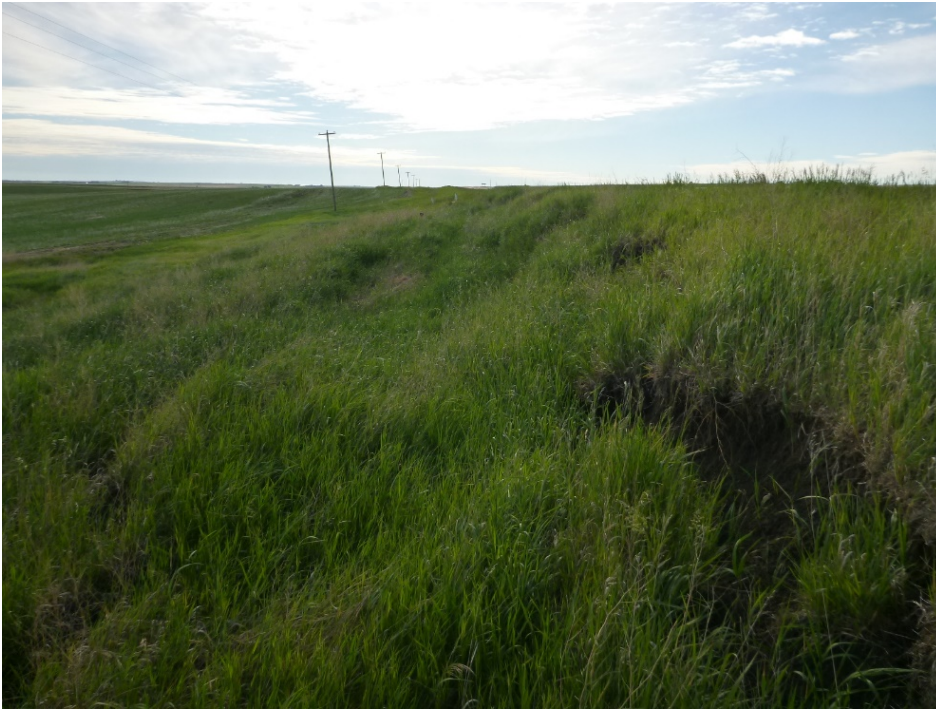
- Slide area has become well vegetated with numerous cracks along the slope
- CNRL gas well access road to the north of the slide area has been reclaimed and seeded, with some fill removed.
- Slide has widened towards the west by 1.5 to 2.0m
- Slide head scarp is approximately 1.7 m high at edge of pavement (waypoint 702)

**Photo 1** View of the C070E slide area. Cracking can be observed along the well vegetated slope. Photo taken June 13, 2018 looking east.

<p>Repair of both sites is expected to be completed in Fall 2018 as part of the works included in the Alberta Transportation Tender TND0019153. The repair will involve excavating the failed slopes and backfilling with geosynthetic reinforced gravel fill with a shear key.</p>

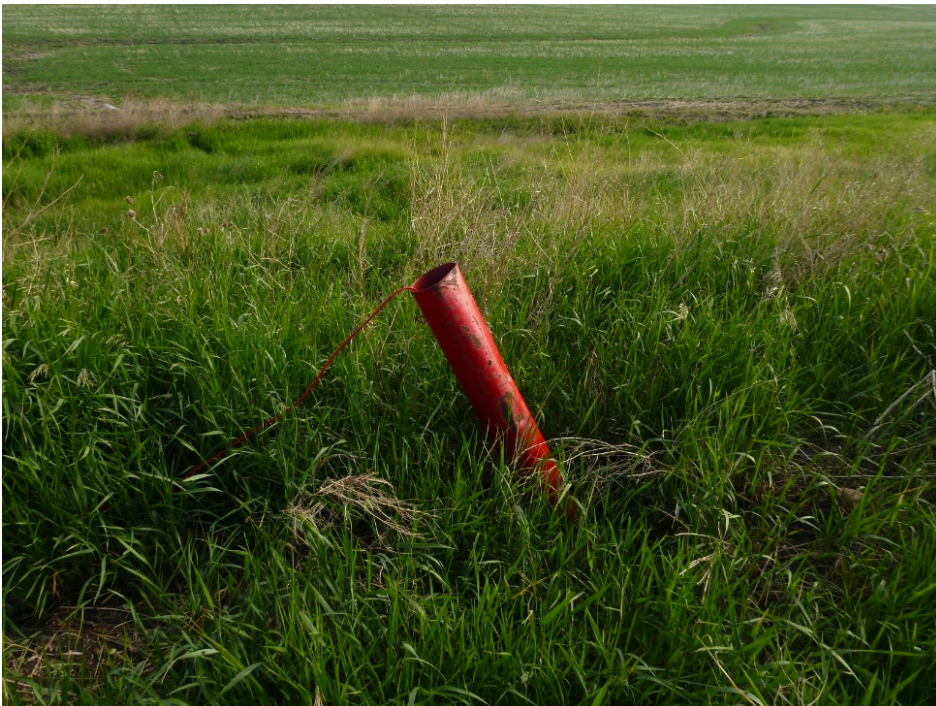
ITEM	CONDITION EXISTS		DESCRIPTION AND LOCATION	NOTICABLE CHANGE FROM LAST INSPECTION	
	YES	NO		YES	NO
			<ul style="list-style-type: none"> <li>Between the 2017 inspection and Spring 2018 instrument readings, the instruments (VWP and SI) at the site were struck by a vehicle and destroyed.</li> </ul>		
			<p>At the West Slide:</p> <ul style="list-style-type: none"> <li>No discernable movement observed since inspection in 2017</li> <li>Three guardrail posts remain unsupported and the south edge of pavement continues to be impacted (approximately 0.3 m of asphalt lost)</li> </ul>		
			<p>KCB and AT discussed the idea of using material from existing stockpile at C070W located southwest of the slide area for the scheduled repairs at C070E and C070W. The pad could also be used to stockpile waste material from both sites.</p>		
			<p>Based on instrumentation data collected and visual observations, the slides appear to be rotational-embankment failures caused by placing poor quality and/or compacted fill beneath the slopes of the embankment, as well as poor foundation preparation. In addition to poor quality fill, the slide movements are likely exacerbated by poor surface drainage.</p>

**Photo 2** View of the destroyed VWP and SI that was installed in March 2017 at C070E. Photo taken June 13, 2018 looking north.

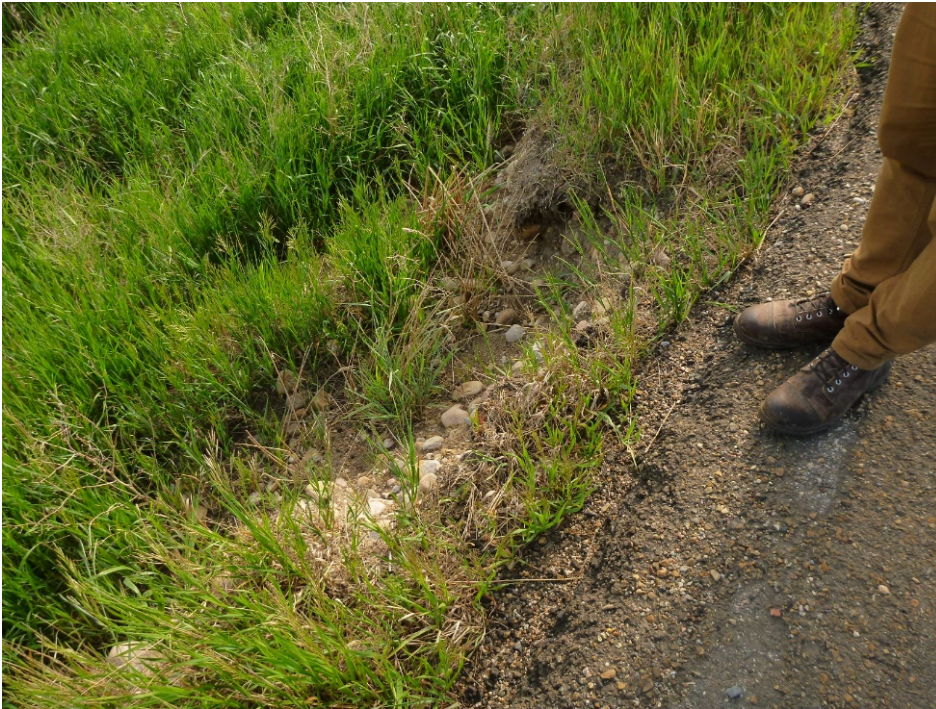
**Photo 3** Location where the head scarp is at the edge of asphalt at C070E (waypoint 702). Photo taken June 13, 2018 looking northeast

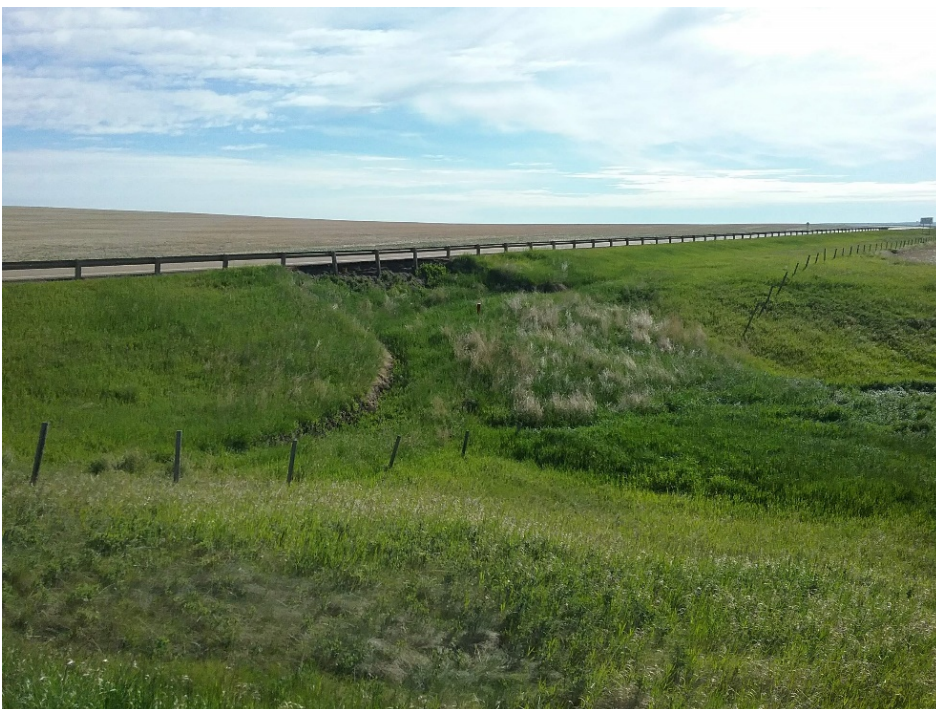
**Photo 4** View of the C070W slide area. No discernible movement of the backscarp was observed. Three guardrail posts remain unsupported. Photo taken June 13, 2018 looking northeast.

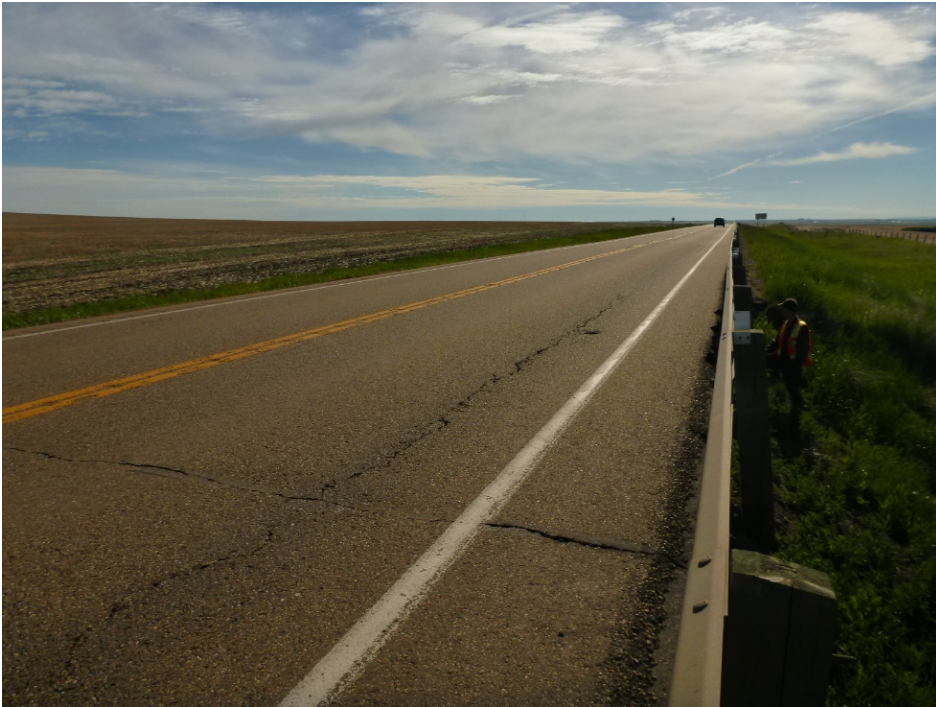
**Photo 5** Longitudinal cracking in the eastbound lane at C070W appears slightly wider since the 2017 inspection. Photo taken June 13, 2018 looking northeast.

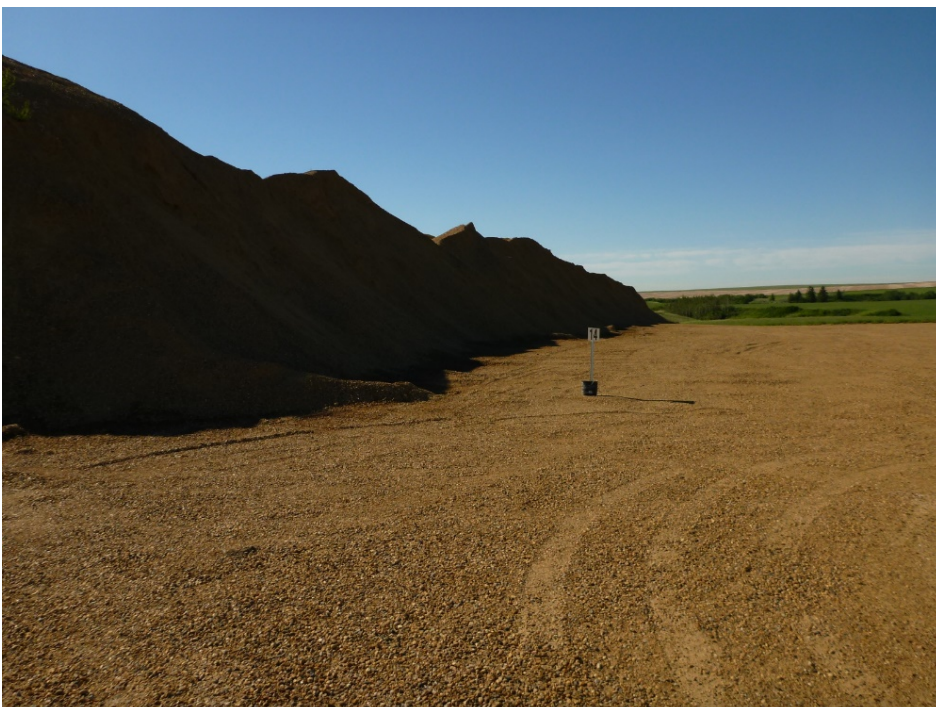
**Photo 6** Gravel stockpile and pad adjacent to C070W that could be used for the C070 repairs as well as an area to stockpile waste (as part of pad base material). Photo taken June 13, 2018 looking south.
