<b>SITE NUMBER AND NAME:</b> C070 West and East Slides		<b>HIGHWAY &amp; KM:</b> 27:10, 18.932 & 33.102	<b>PREVIOUS INSPECTION DATE:</b> June 13, 2018	<b>INSPECTION DATE:</b> June 24, 2021
<b>LEGAL DESCRIPTION:</b> 02-18-31-21 W4M 15-07-31-21 W4M 02-16-31-20 W4M	<b>NAD 83 COORDINATES:</b> UTM    Northing    Easting 12     5723837    363877 12     5723487    377005		<b>RISK ASSESSMENT:</b> PF: 1    CF: 2    TOTAL: 2 PF: 1    CF: 2    TOTAL: 2	
<b>AVERAGE ANNUAL DAILY TRAFFIC (AADT):</b> 1310 (west) & 1410 (east) (Ref No. 108260 is between both sites)			<b>CONTRACT MAINTENANCE AREA (CMA):</b> 517

PROJECT CENTRAL REGION GEOHAZARD RISK MANAGEMENT PROGRAM	
TITLE Site Plan C070 - West Slide Hwy 27:10, km 18.932	
SCALE	FIG No. 1
PROJECT No. A05116A02

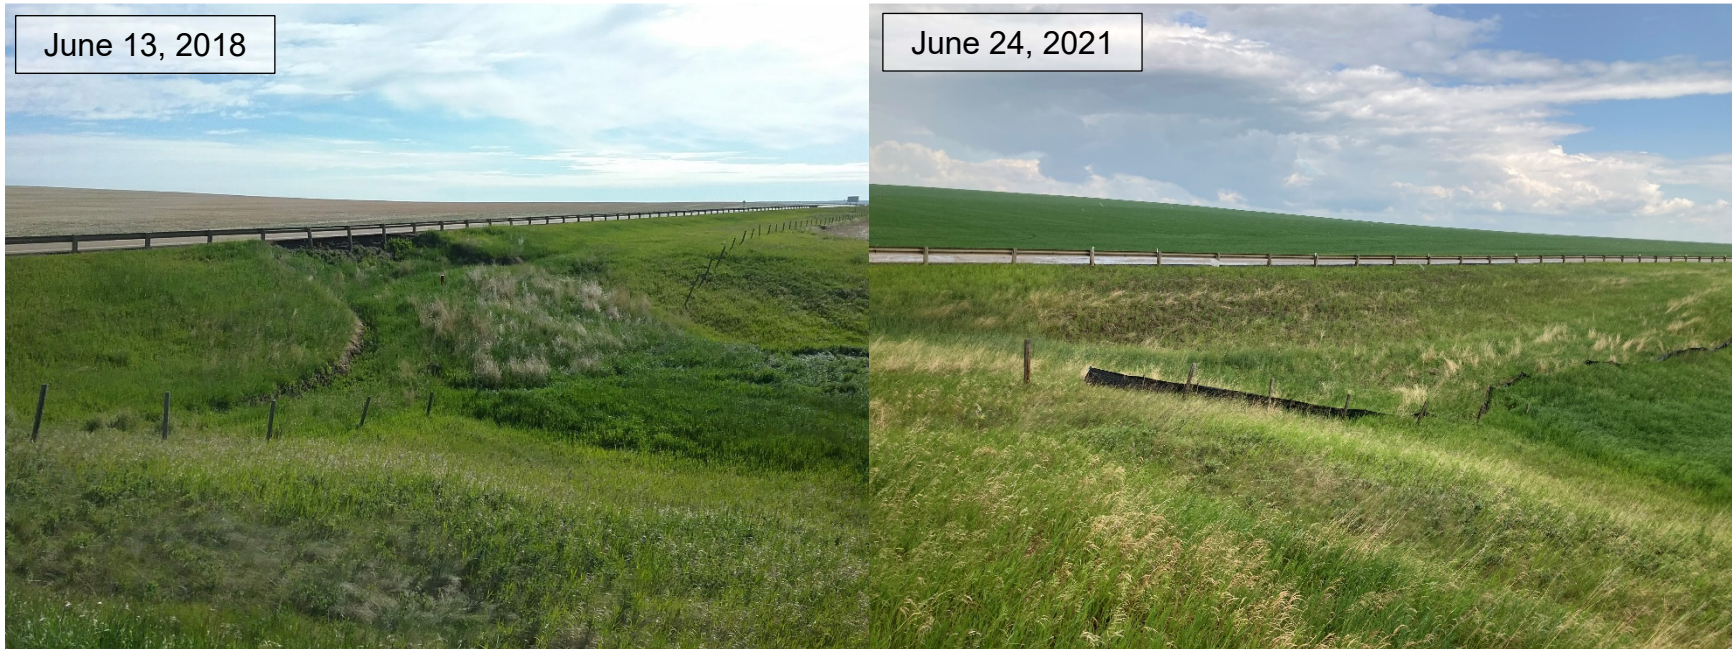
**Photo 1** An overview of the C070W slide area, before and after repairs were completed. Photo taken June 13, 2018 and June 24, 2021 looking northeast.

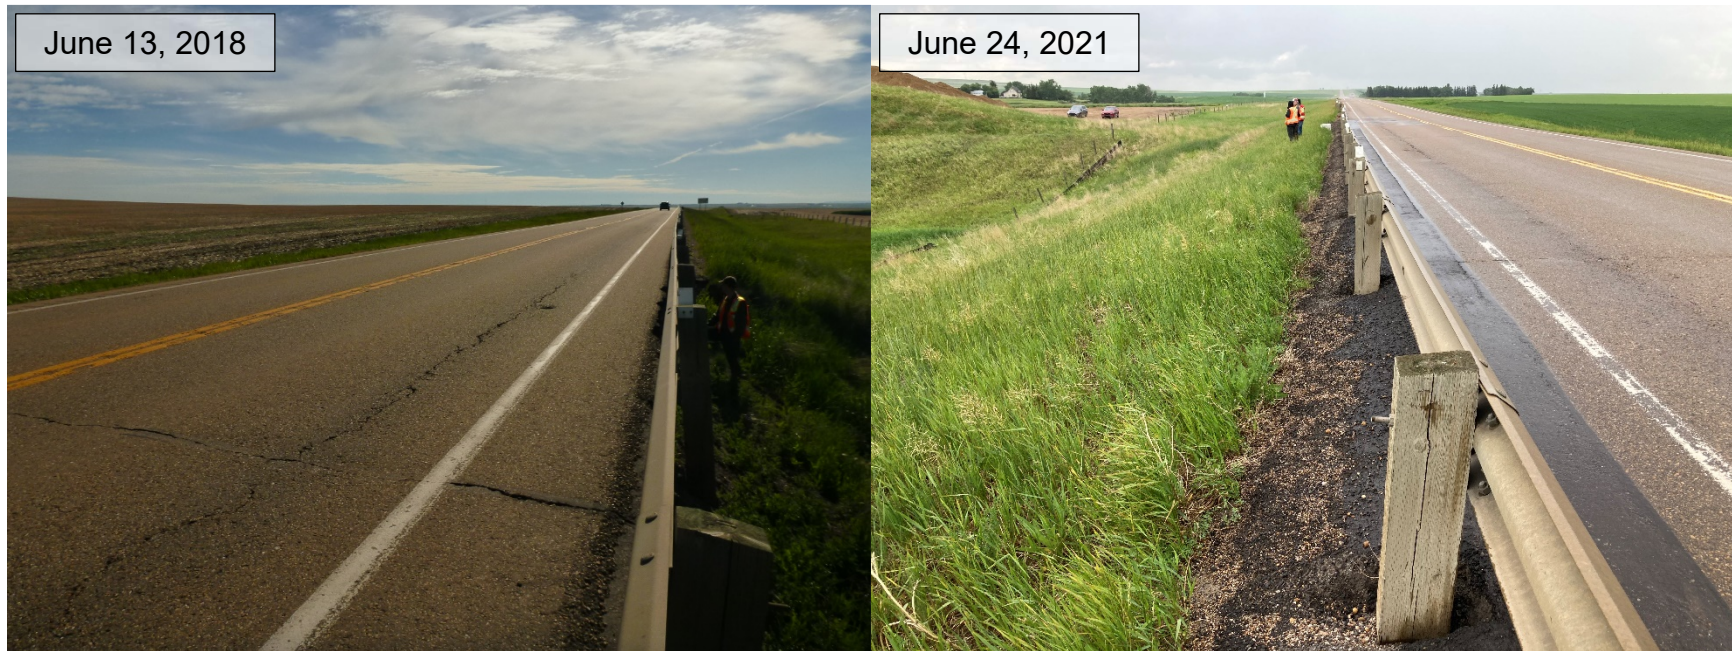
**Photo 2** Longitudinal cracking in the eastbound lane before and after repairs were completed. Photos taken June 13, 2018 and June 24, 2021 looking northeast and southwest, respectively.
