SITE NUMBER AND NAME: C062 Back Slope Failure North of Vermillion Dam		HIGHWAY & KM: 41:20, 2.889	PREVIOUS INSPECTION DATE: June 24, 2020	INSPECTION DATE: June 29, 2021
LEGAL DESCRIPTION: 16-31-050-06 W4M	NAD 83 COORDINATES: UTM Northing Easting 12 5912662 509163		RISK ASSESSMENT: PF: 9 CF: 3 TOTAL: 27	
Average Annual Daily Traffic (AADT): 3070 (north) (Ref No. 997074)			CONTRACTOR MAINTENANCE AREA (CMA): 512

PROJECT CENTRAL REGION GEOHAZARD RISK MANAGEMENT PROGRAM		
TITLE Site Plan C062 - Back Slope Failure North of Vermilion Dam Hwy 41:02, km 2.889		
SCALE 1:1,500	PROJECT No. A05116A02	FIG No. 1

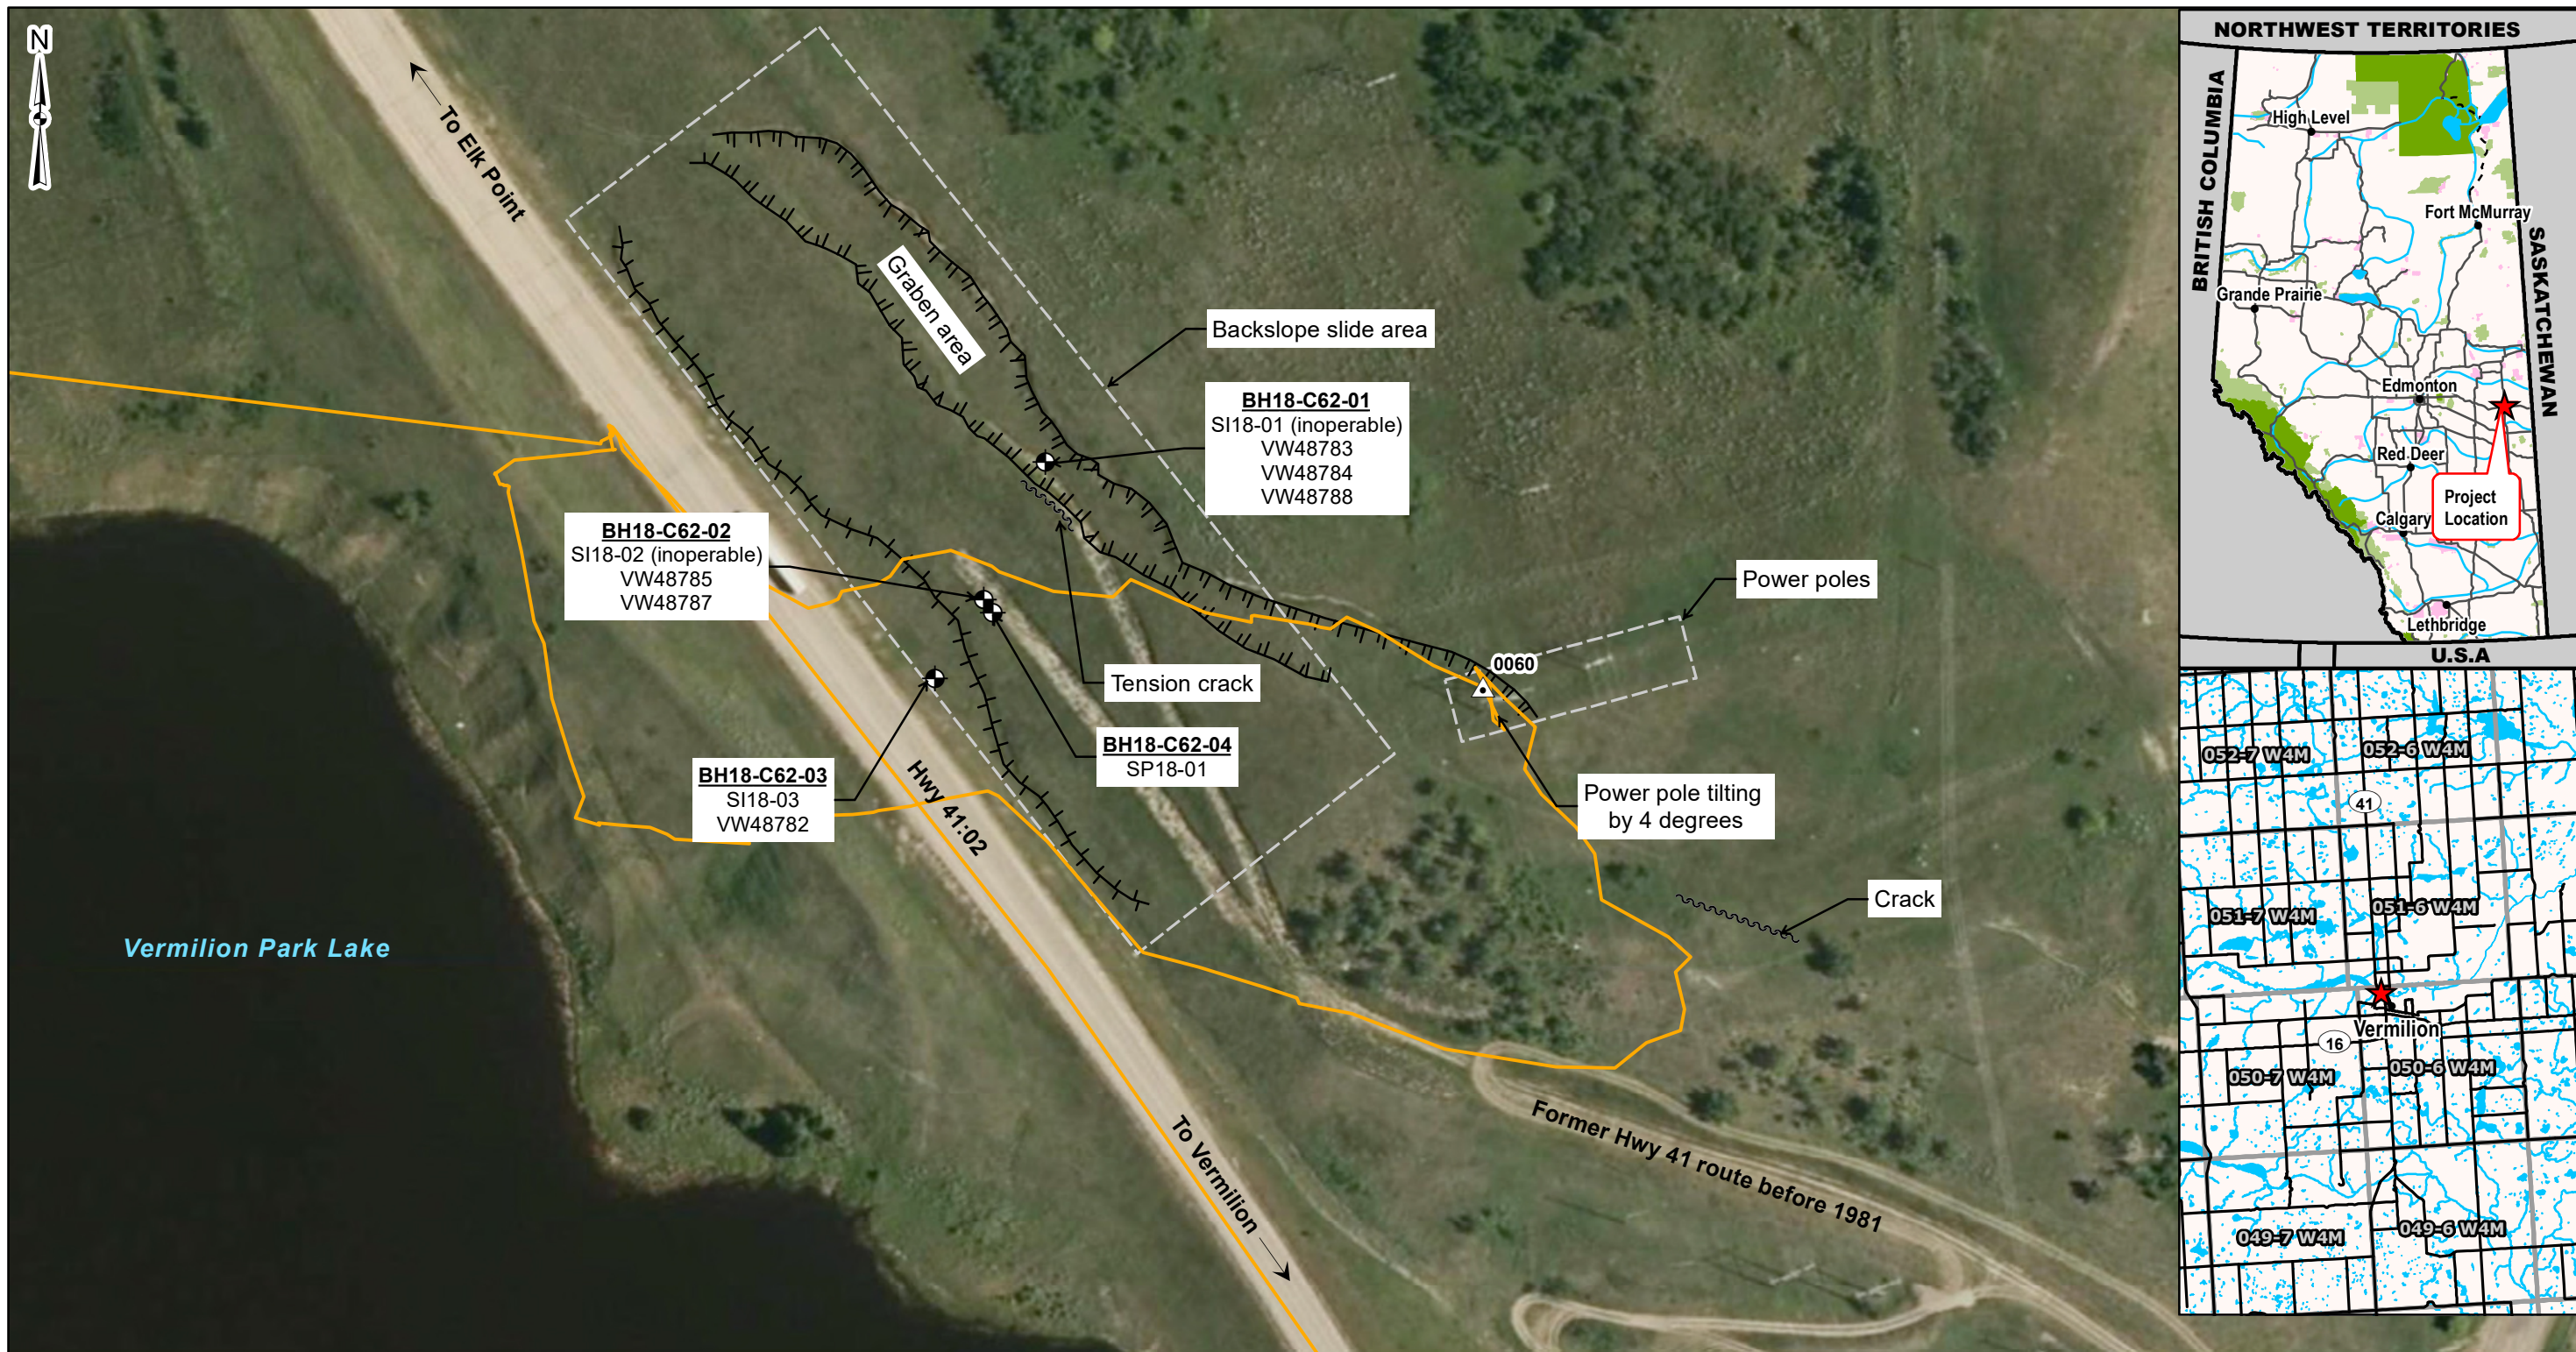
COMMENTS
Slide area extends along the crest of the back slope to the river valley slope south of the power poles. Bench on river valley slope is located at the previous Hwy 41 alignment, before it was realigned across Vermillion Dam in 1981.
Since the 2020 inspection, the toe roll of the slide appears to have deformed further into the ditch. However, due to the height of the vegetation, the amount of movement was difficult to determine.
Cracking was observed in 2020 on the river valley slope (southeast of Waypoint 0060) and directly north of the outlet channel from the Vermillion Dam spillway. The grass on the backslope and river valley slope is approximately 2 ft high (0.6 m) and may be obscuring other slide features.
The backscarp has extended further to the southwest (past Waypoint 0060) as further settlement was observed near the power poles and on the slope below the power poles. The settlement/cracking observed was

- Install either horizontal drains or flatten the slope (i.e., excavating the head of the slide). If AT decides they want to flatten the slope to increase slope stability, they should consult with the Town of Vermilion on a material stockpile location or if there is any local uses for the removed material.
- With AT's permission, KCB contacted ATCO and Alberta Environment and Parks (AEP) on July 18, 2019 and advised them of the possible impact of slide movement to the powerline tower and outlet channel from Vermilion Dam spillway, respectively. AEP had the slide area reviewed in a recent dam safety review and the slide was judged to not be an issue to the dam spillway. KCB has not heard from Fortis.

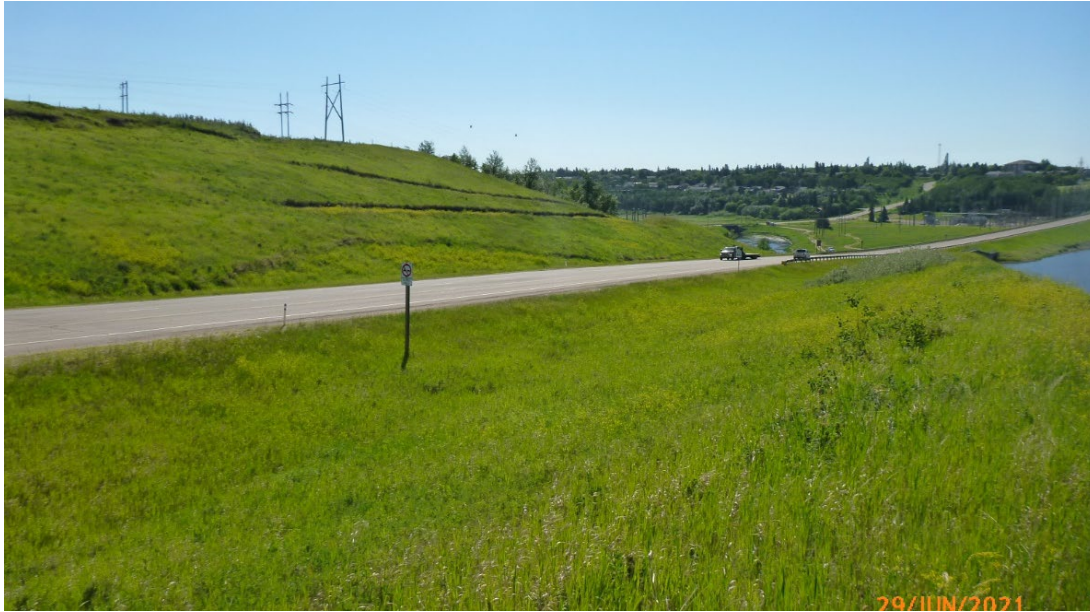
Photo 1 Backscarp and toe roll of slide. Benches cut into slope were completed during KCB's 2018 drilling and instrumentation installation program. Photo taken June 29, 2021 looking southeast.

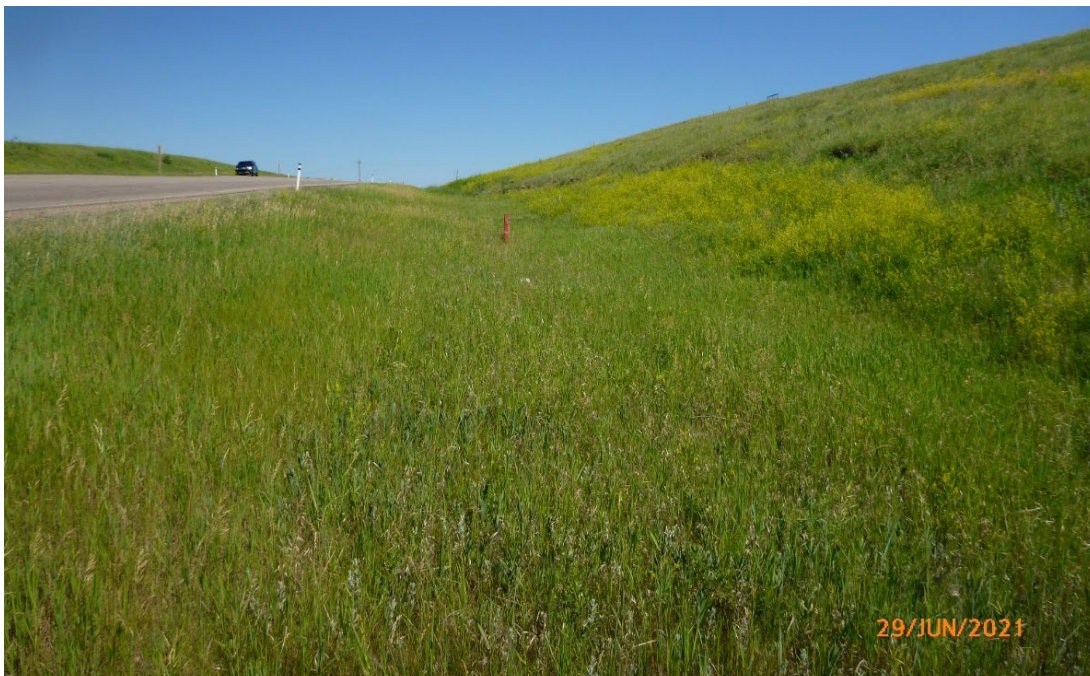
Photo 2 Ditch bottom and toe roll of the slope east of Hwy 41:02. Recent movement difficult to determine due to height of the vegetation on the slope. Photos taken June 29, 2021 looking northwest.

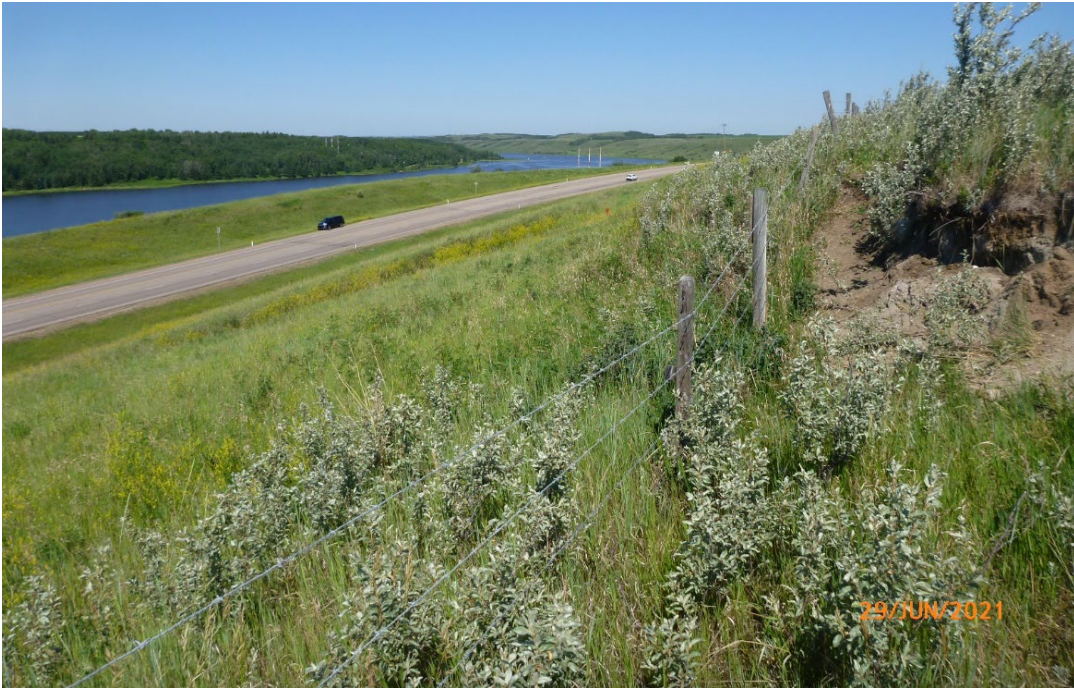
Photo 3 Very little change in the slope, head scarp, and fence line at the top of the slope. Photo taken June 29, 2021 facing north.

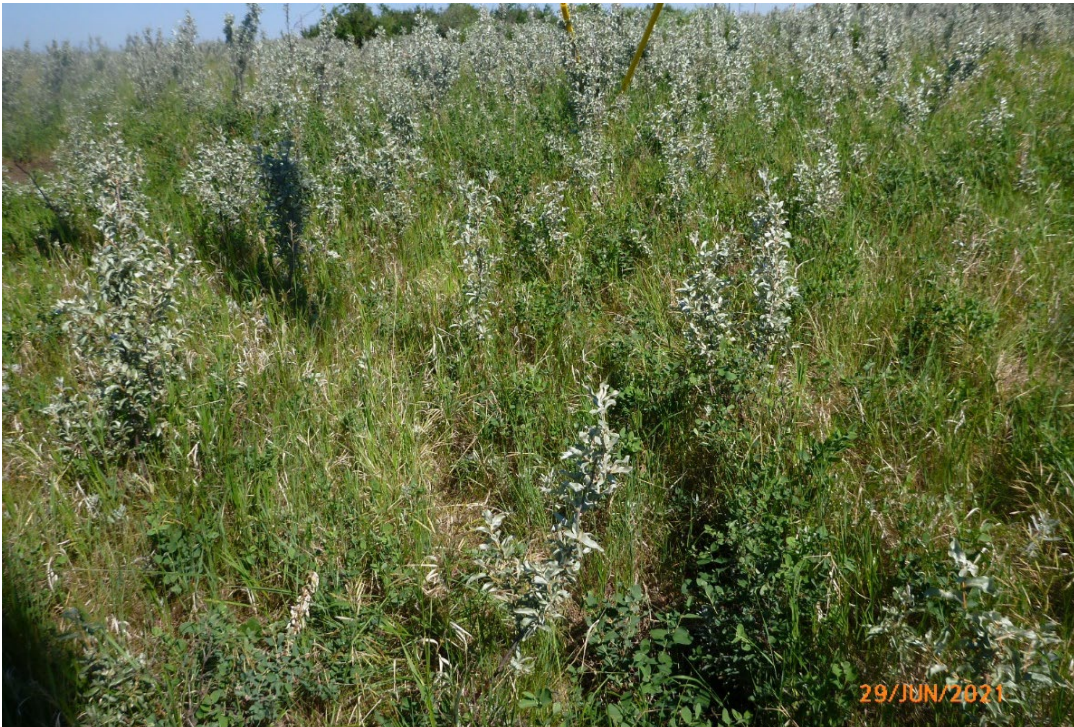
approximately 0.3 m wide by 0.5 m deep. A sinkhole approximately 1 m long and 0.3 m wide was observed during the June 2021 inspection, near the cracking that was observed in 2020 (WP0060).

Photo 4 Location of a sinkhole (approximately long 1.0 m and 0.3 m wide) near the power poles at the top of the slope. Sinkhole at WP0060 obscured by tall vegetation. Photo taken June 29, 2021 facing north.
