November 29, 2022

Alberta Transportation
4th Floor, Provincial Building
4920 – 51st Street
Red Deer, Alberta
T4N 6K8

**CON0022160 Central Region GRMP Instrumentation Monitoring
Site C062; H41:02, km 2.889 Vermillion Backslope
Section C – 2022 Fall Readings**

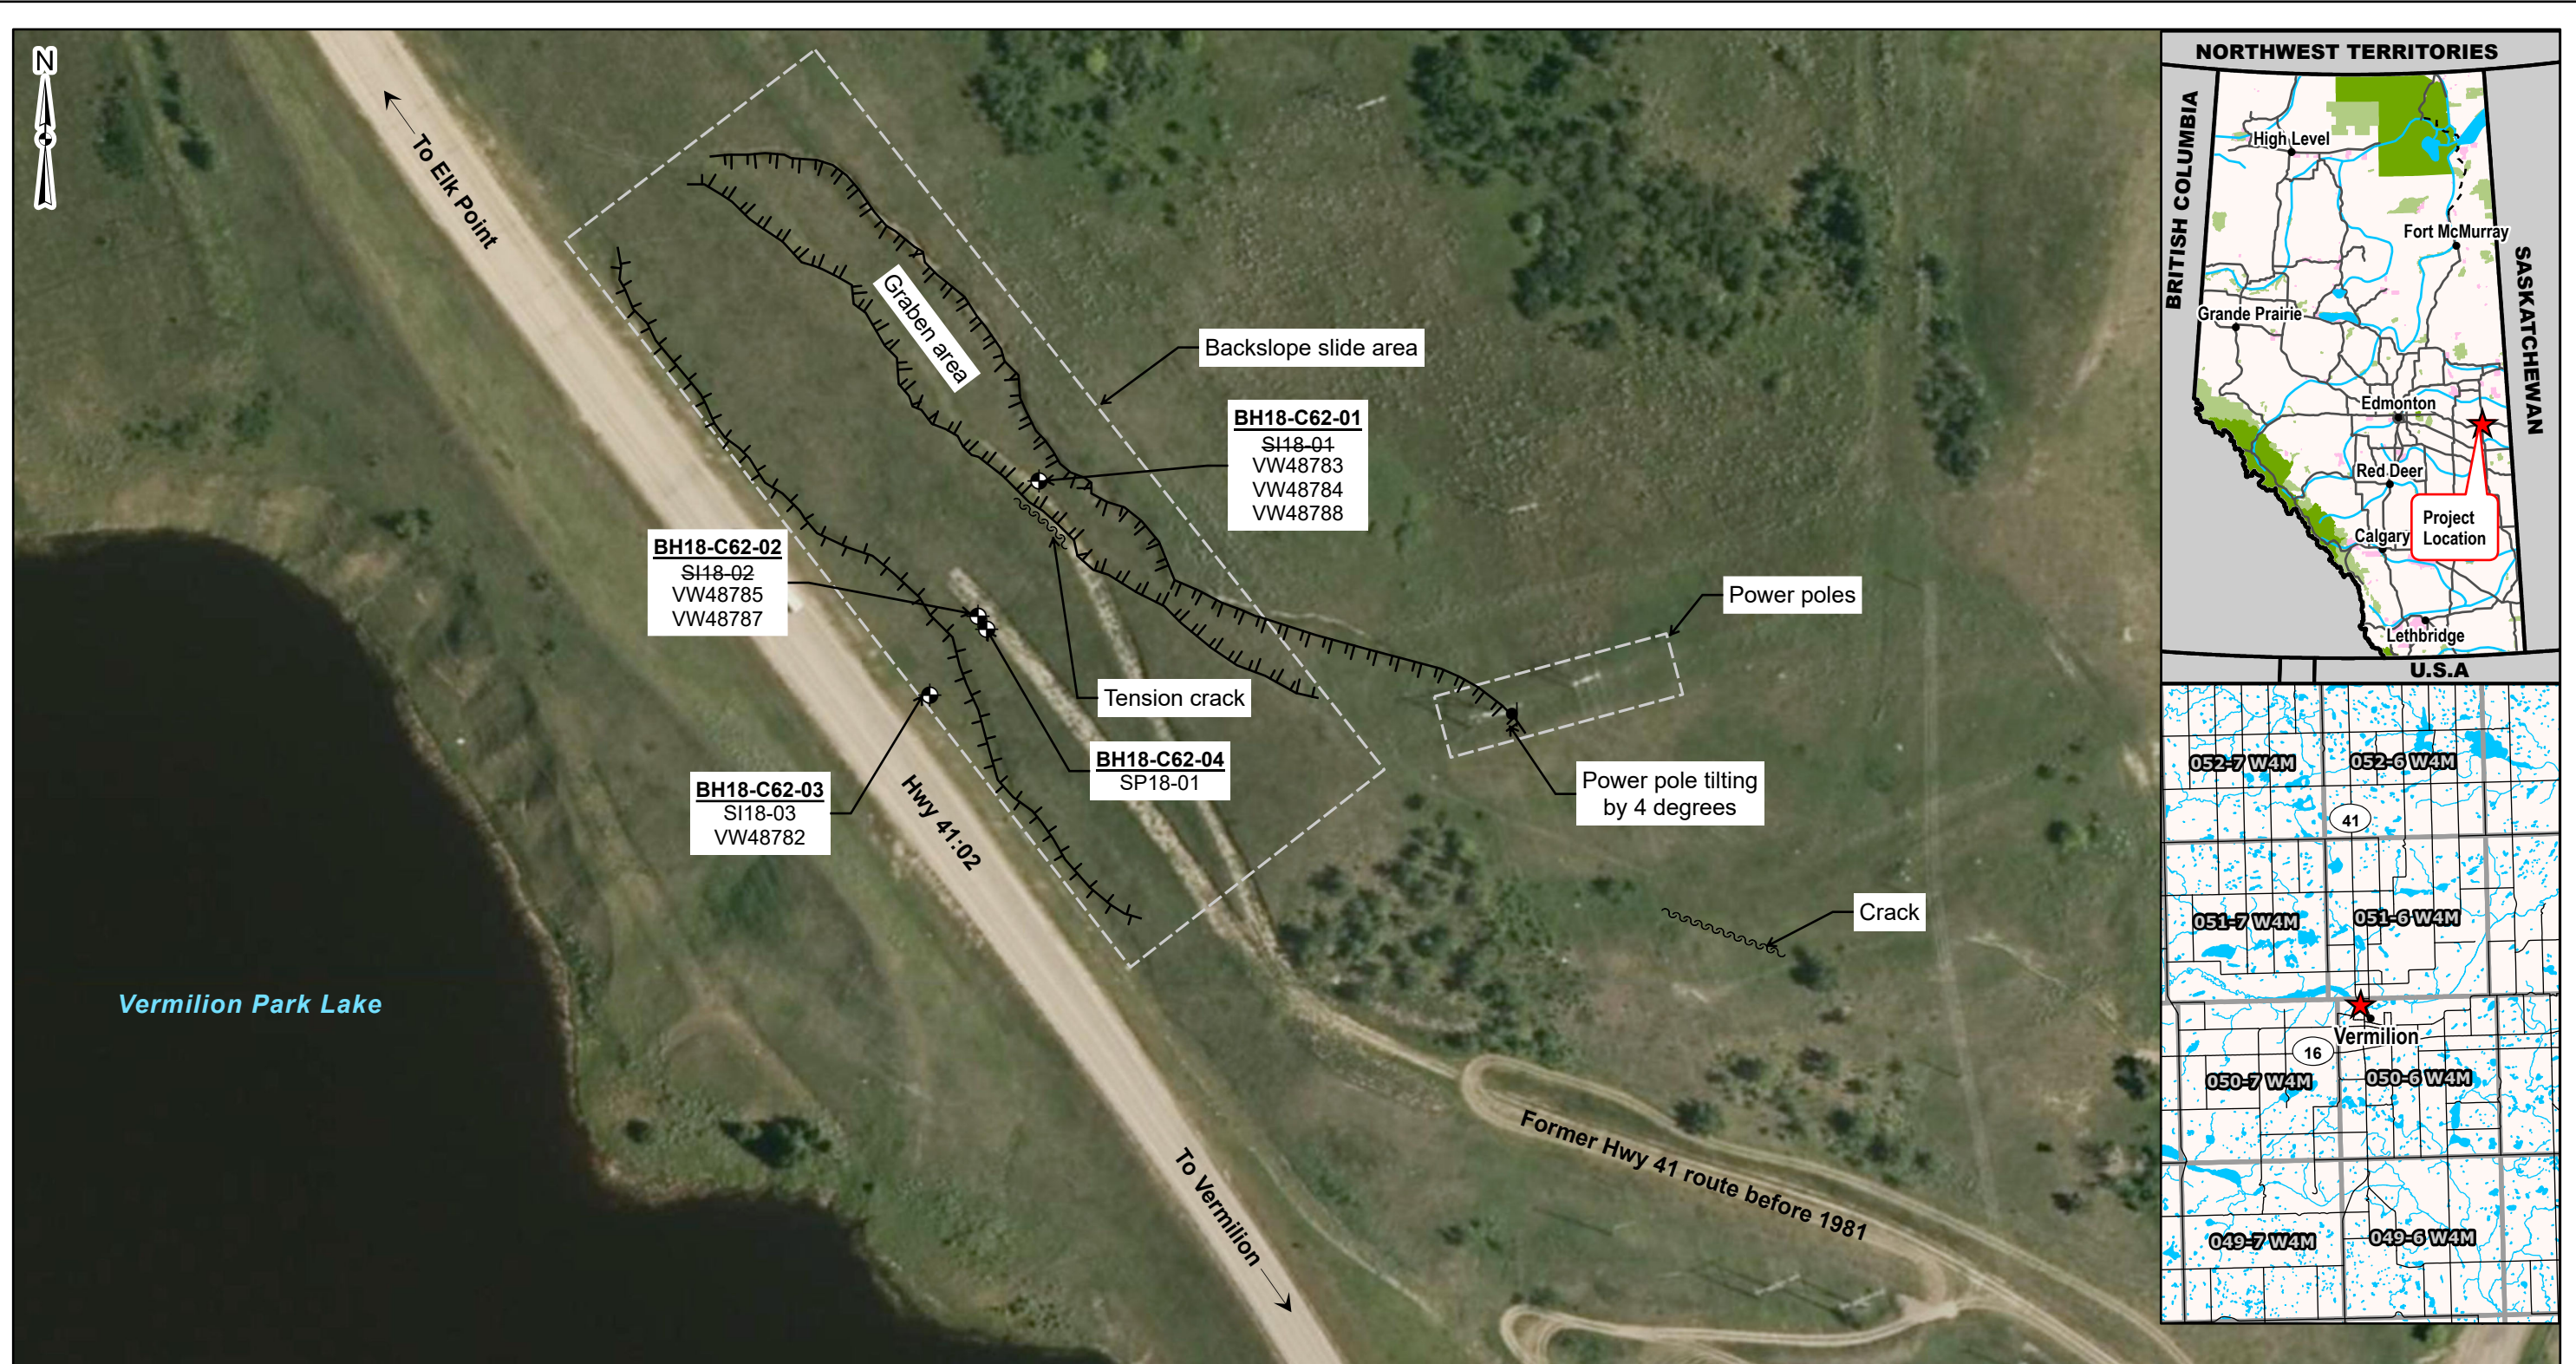
PROJECT CENTRAL REGION GEOHAZARD RISK MANAGEMENT PROGRAM		
TITLE Site Plan C062 - Vermillion Backslope Hwy 41:02, km 2.889		
SCALE 1:1,500	PROJECT No. A05116A02	FIG No. 1

The geohazard at the C062 site consists of a large, deep-seated-translational earth slide on the east backslope (northbound lane) of Hwy 41:02.

Remedial options are currently being assessed by KCB and Alberta Transportation (AT) and may include installing horizontal drains and/or flattening the slope. At this time, the highway below the slide has not been affected by slope movements, but the toe roll is starting to block the ditch. If the rate of movement is observed to be increasing, as assessed by visual observations at the toe and crest of the slide, or the ditch becomes blocked, AT will need to take action to ensure that the highway is not impacted.

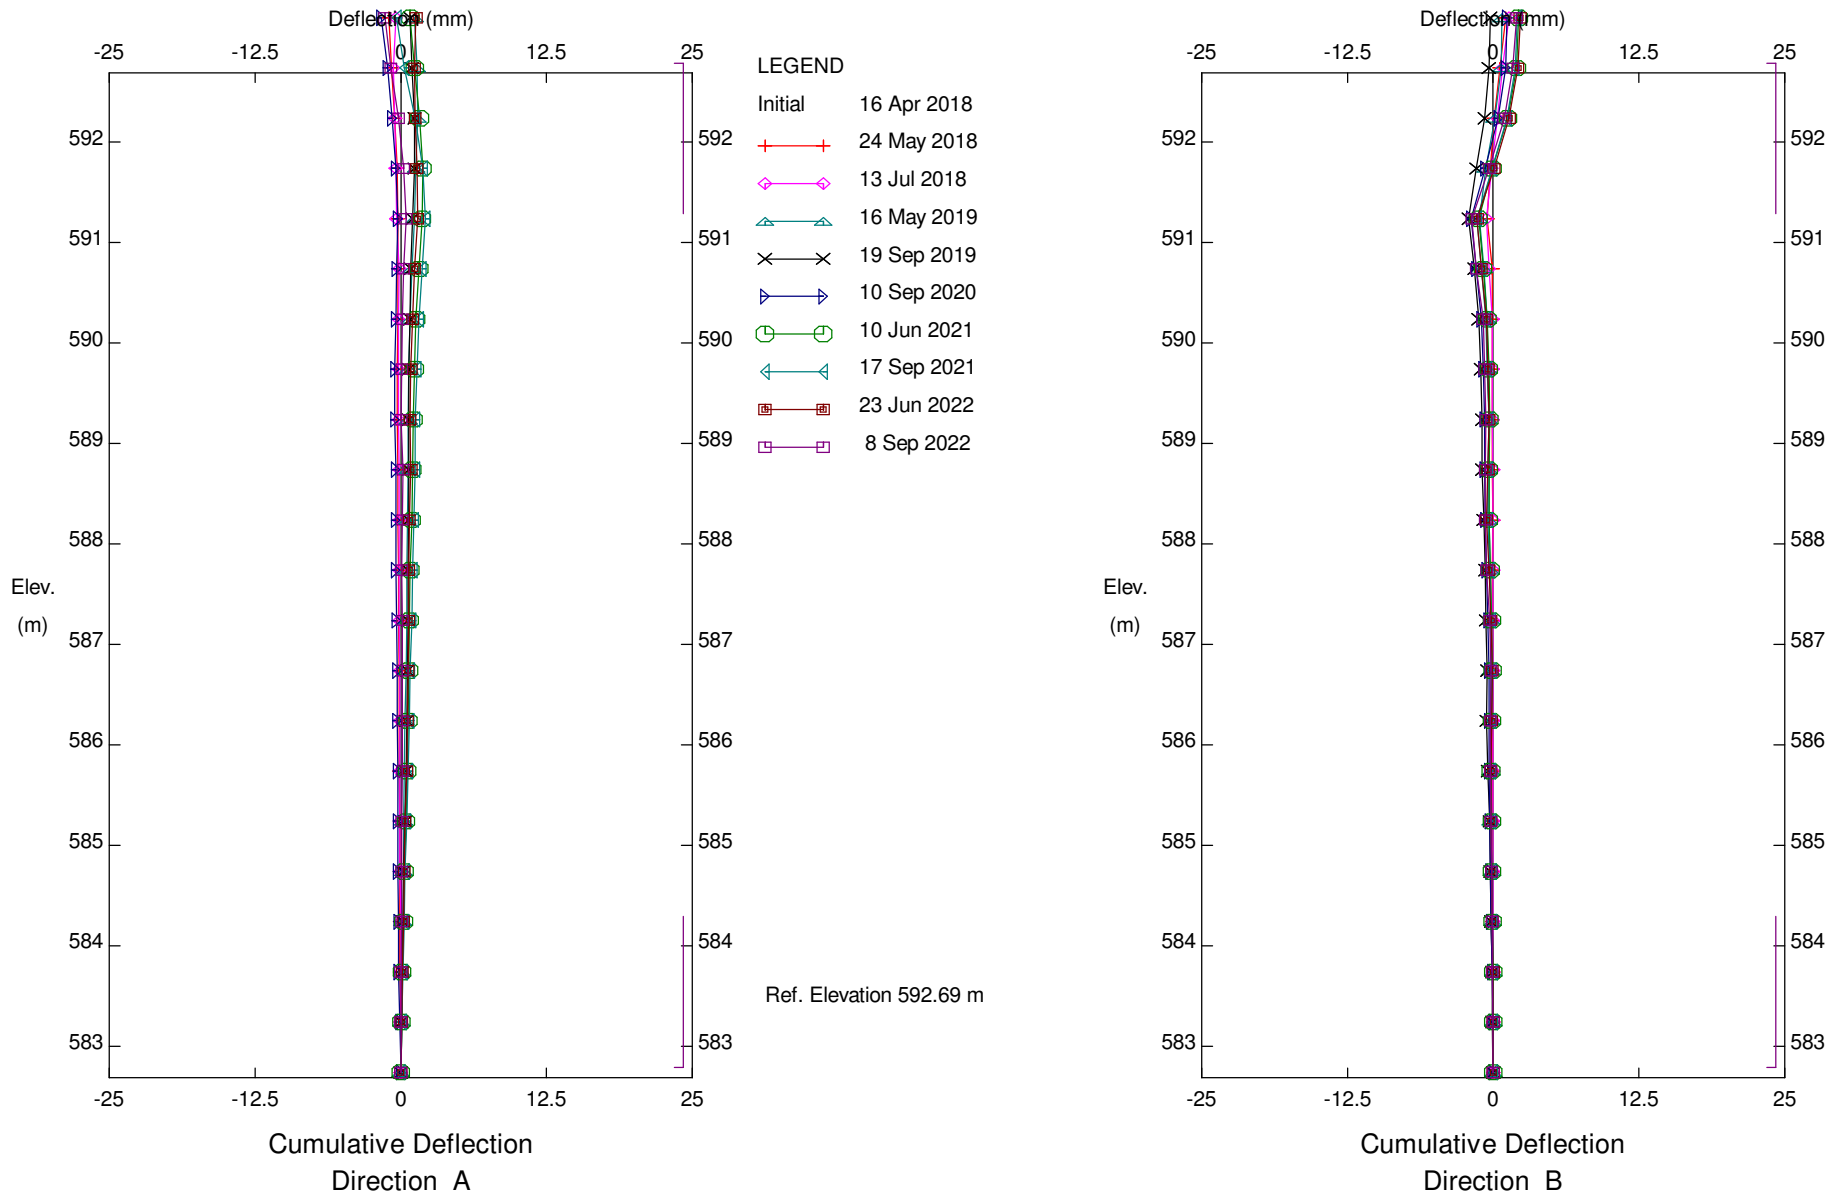
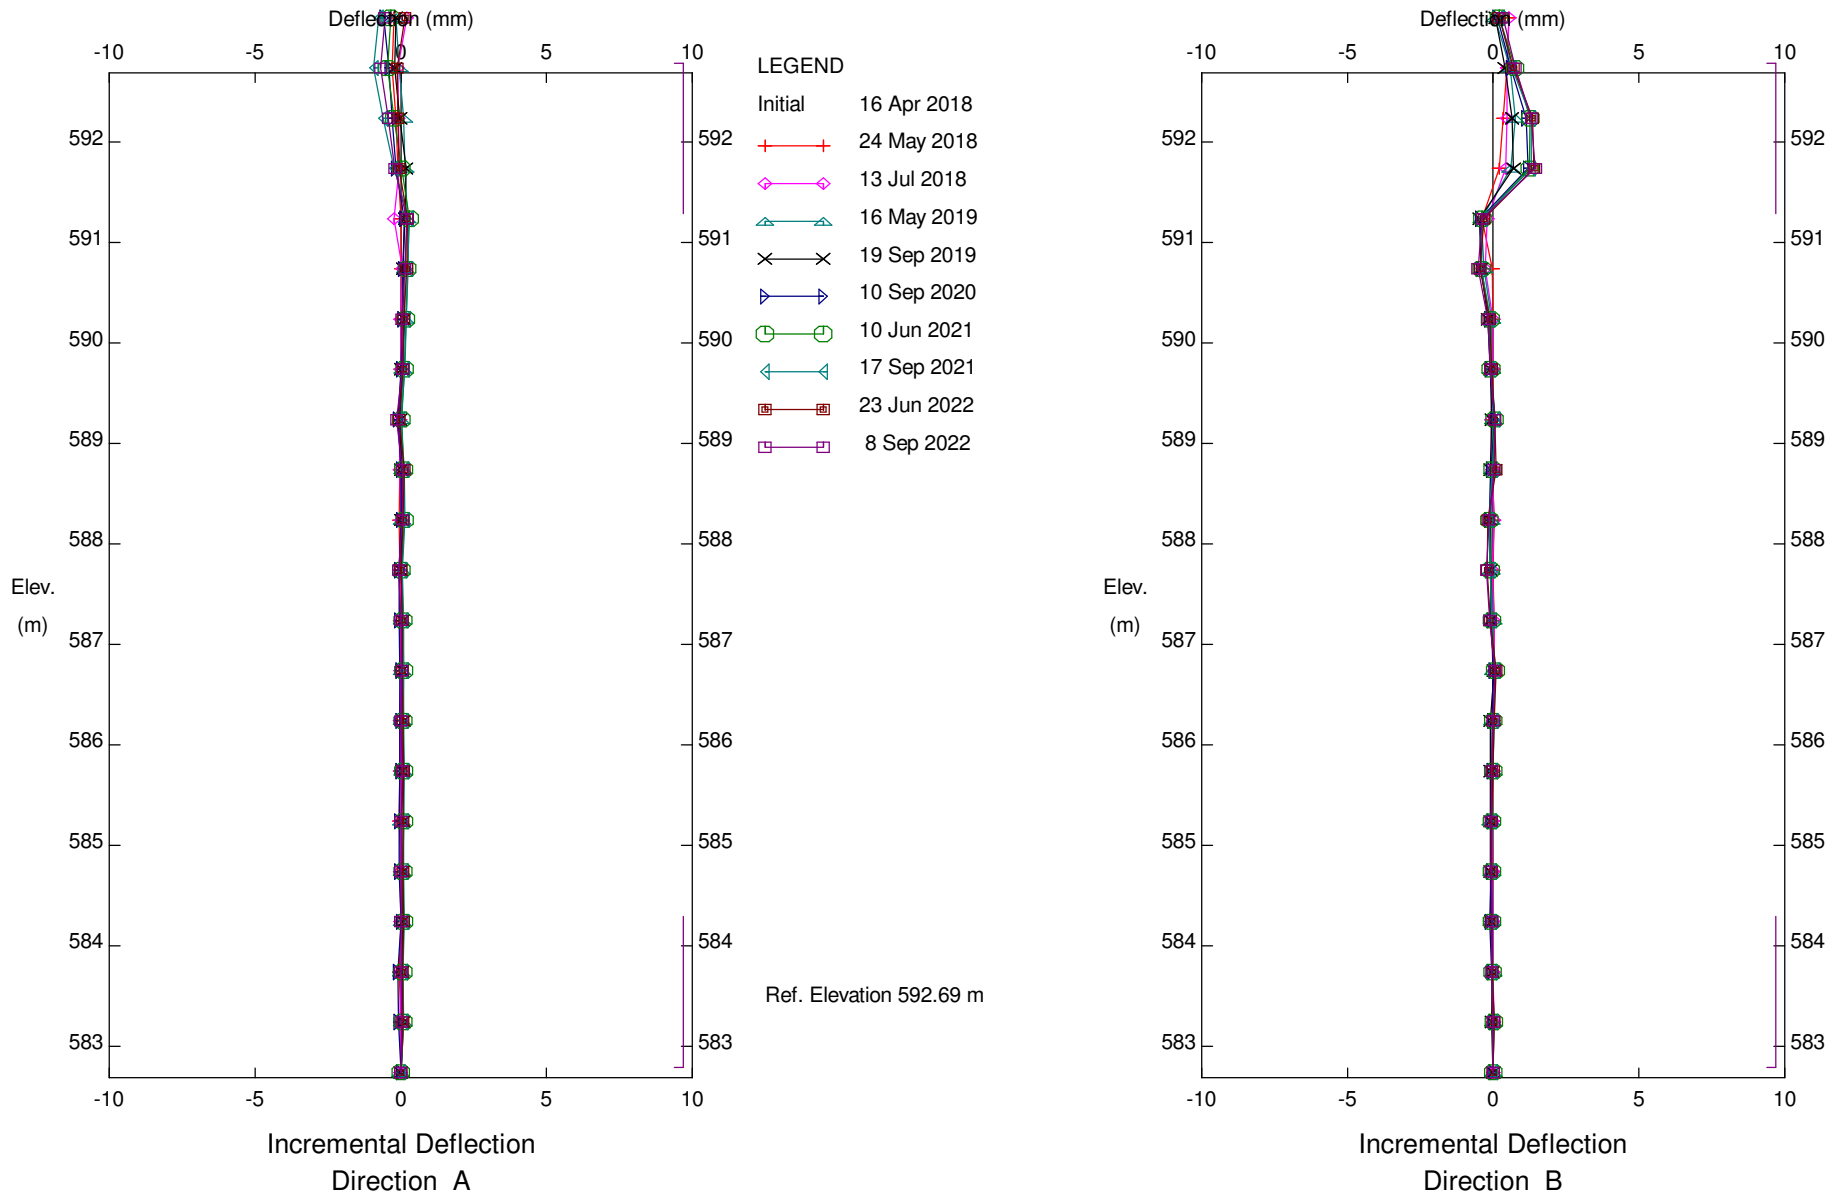
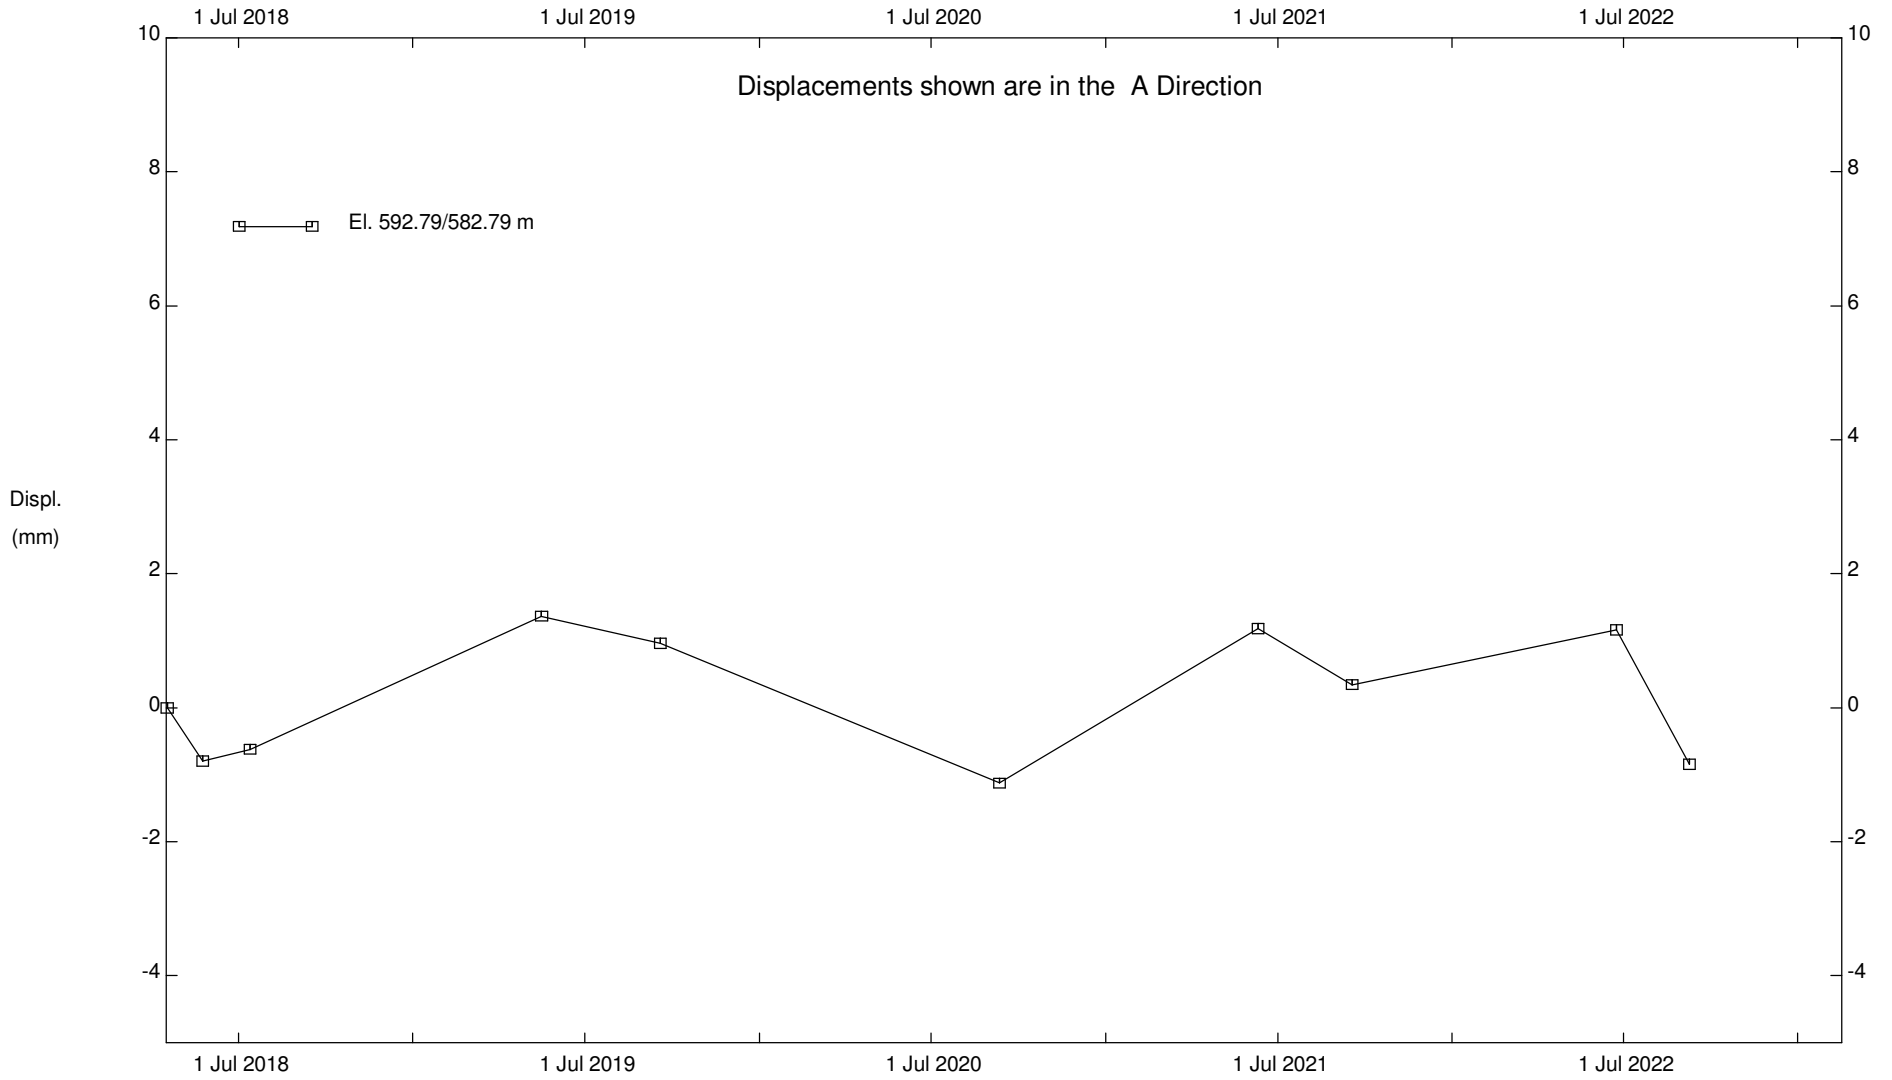
C062; H41:02, Vermilion Backslope, Inclinator SI18-C62-03
 Alberta Transportation

Since installation, no discernible movement has been recorded in SI18-C62-03 (toe of slope).

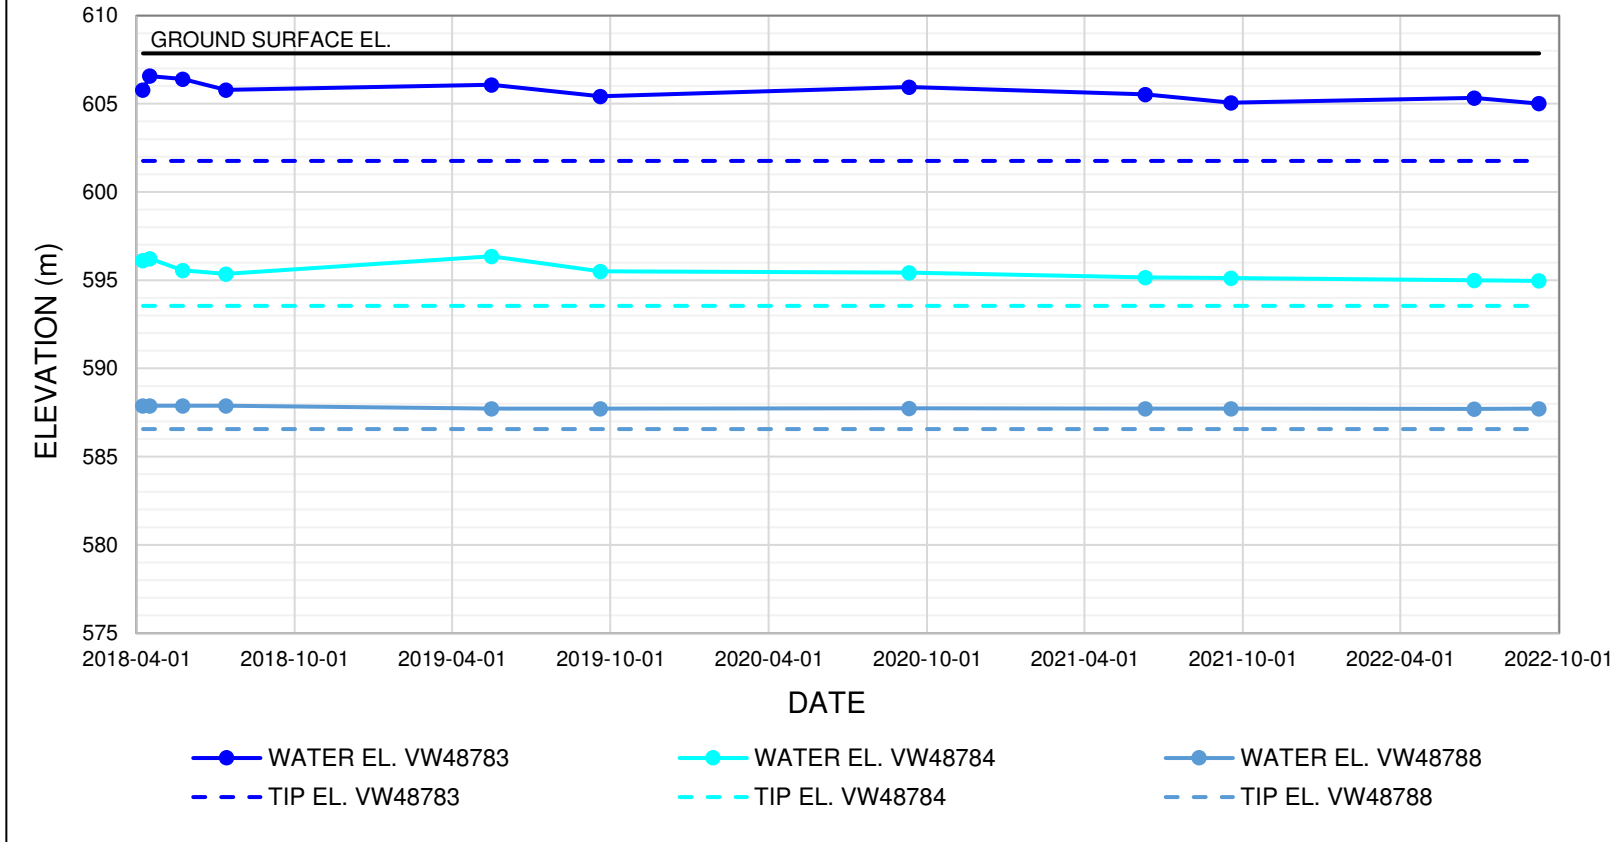
VW48783, VW48784, AND VW48788 (CREST OF SLOPE)

The piezometers have been either relatively steady (± 1.35 m) or dry since installation. The September 2022 reading of the piezometers was consistent with historical trends observed in these instruments.

In the nested piezometers installed in BH18-C62-01 (VW48783, VW48784, and VW48788) at the crest of the slope two independent water levels were detected in the clay till, which could indicate the presence of two perched groundwater tables. This is likely due to the presence of sand and silt lenses found interbedded within the clay till layer.
