Alberta Transportation and Economic Corridors

Hwy 53:12, km 0.684; East of Battle River Slide

Call-Out Report

**CON0022160 Central Region GRMP
Unnumbered Site; H53:12, km 0.684 East of Battle River Slide
Section D – Call-Out Report – DRAFT**

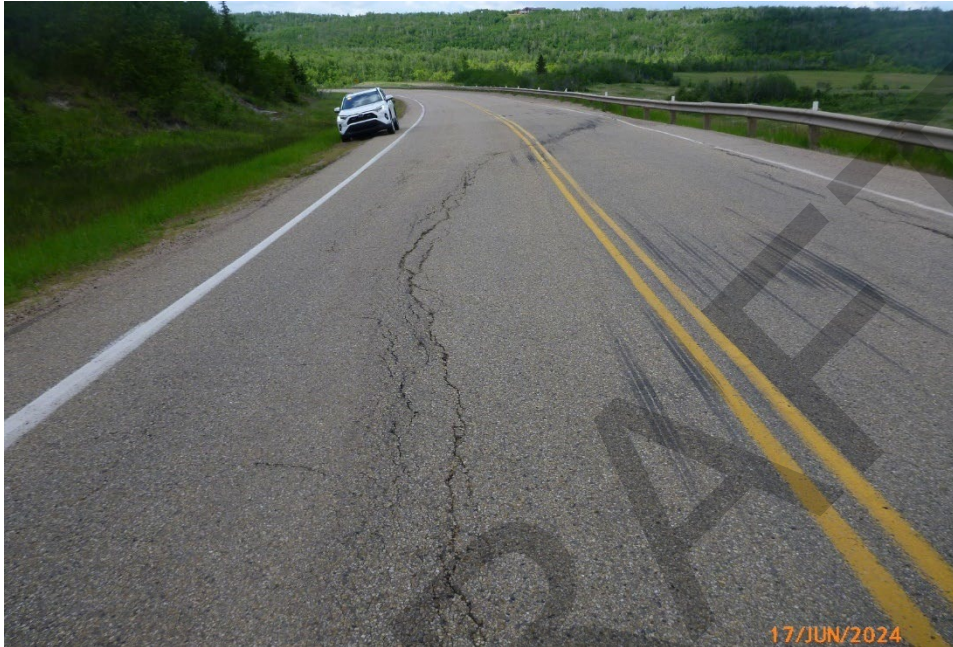
- Pavement distress in the form of tension cracks and settlement was observed along the slide extents in the south (eastbound) and north (westbound) lanes.

- ◆ The pavement cracking is approximately 35 m long and is up to approximately 5 mm wide. (Photos 1 and 2).
 - ◆ The settlement observed was approximately 25 mm to 50 mm and in the north (westbound) lane. Black skid marks were observed in the settlement area, indicating where vehicles have been braking before driving over the site (Photo 2).

- Photo 1** **Pavement distress (tension cracks and settlement) in the eastbound and westbound lanes above the slide. Pavement cracking extends across the north (westbound) lane into the middle of the south (eastbound) lane. Settlement was estimated to be between approximately 25 mm to 50 mm. Photo taken June 17, 2024, facing west.**

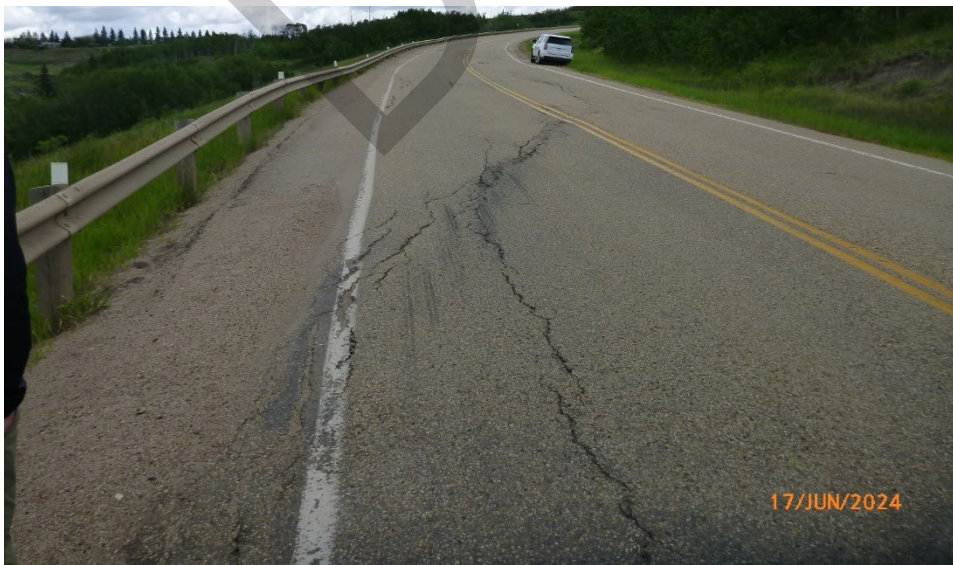
- The shape and extent of the pavement distress indicates a well-developed slide movement pattern.
- A dip in the north (westbound) guardrail was observed above the slide (Photos 1 and 2).

- The pavement settlement along the head scarp is significant enough that there is evidence (i.e., black skid marks) of vehicles braking before/while driving over the site once the road users realize the degree of settlement. During the inspection, westbound motorists were observed slowing down and moving into the eastbound lane to avoid the area of settlement. Additional settlement could further reduce the driveability of this section of the highway. It could also increase the risk of a collision due to westbound motorists moving into the eastbound lane, as the site has poor site lines due to the horizontal and vertical alignment of the highway.

- Photo 2** **Tension cracking in north (westbound) lane extending into the south (eastbound) lane. Photo taken June 17, 2024, facing east.**

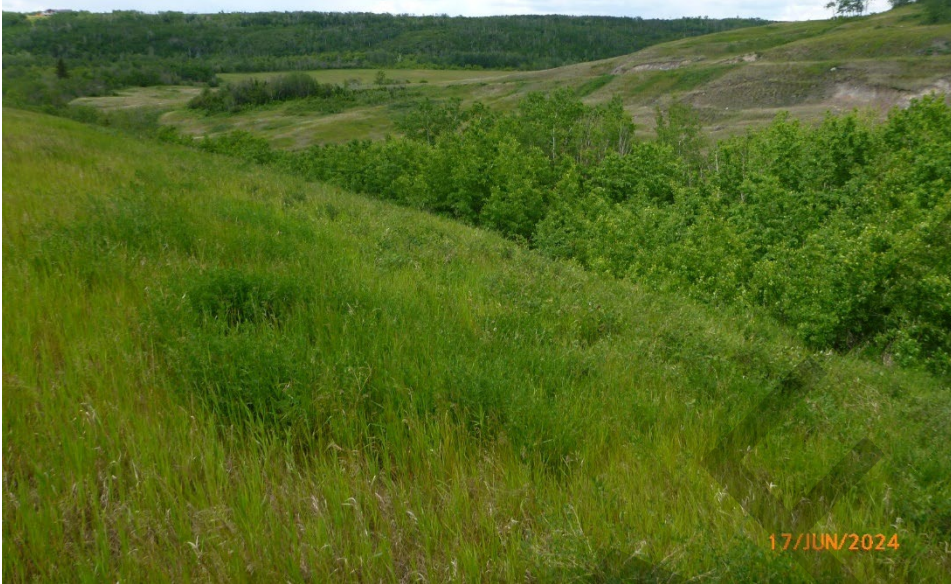
- During the inspection, some vehicles were observed slowing down and moving into the south (eastbound) lane to avoid the area of pavement settlement.
- Ground cracks were observed in the north highway embankment slope, approximately 10 m offset from the north guardrail, along and approximately parallel to the tree line. The embankment slope is well-vegetated with grass, shrubs, and trees, which could have hidden additional ground cracks and/or settlement (Photo 3).

Photo 3 The north (westbound) highway embankment slope is well vegetated, potentially obscuring ground cracks and/or settlement. Photo taken June 17, 2024, facing northwest.

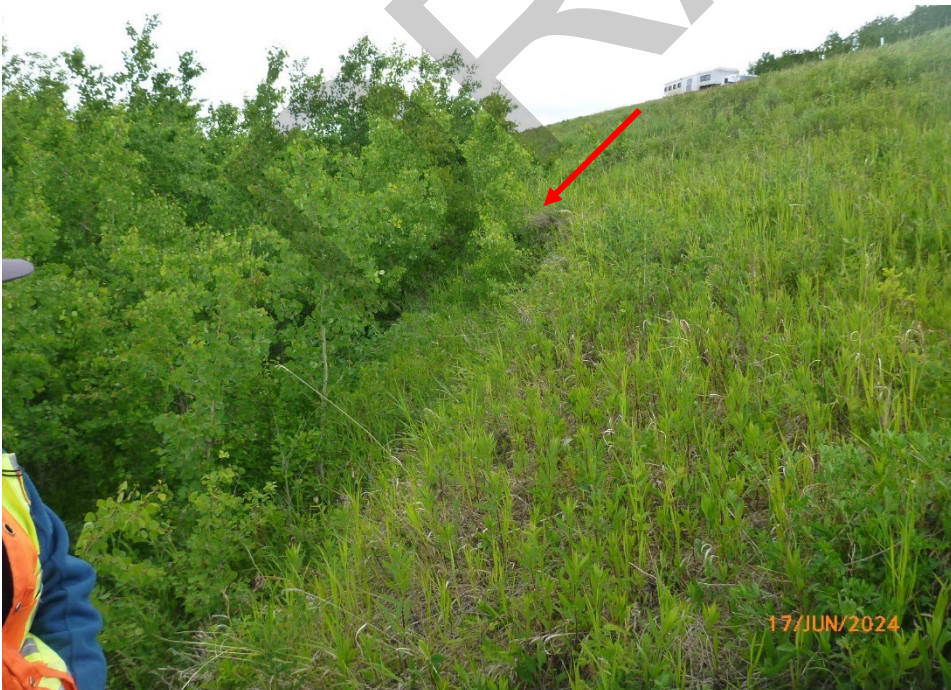
- A minor scarp (height up to 1 m tall) was observed approximately 10 m to 15 m downslope of the guardrail (Photo 4). The minor scarp is located where the embankment slope steepens (i.e., transitions from approximately 2H:1V to 1H:1V). Based on a review of Google Maps (2024) imagery, KCB estimates the secondary scarp is between 75 m and 80 m long.

Photo 4 Minor scarp (indicated by red arrow) located approximately 10 m downslope (north) of the guardrail. The minor scarp is approximately 1 m in height. Photo taken June 17, 2024, facing southeast.

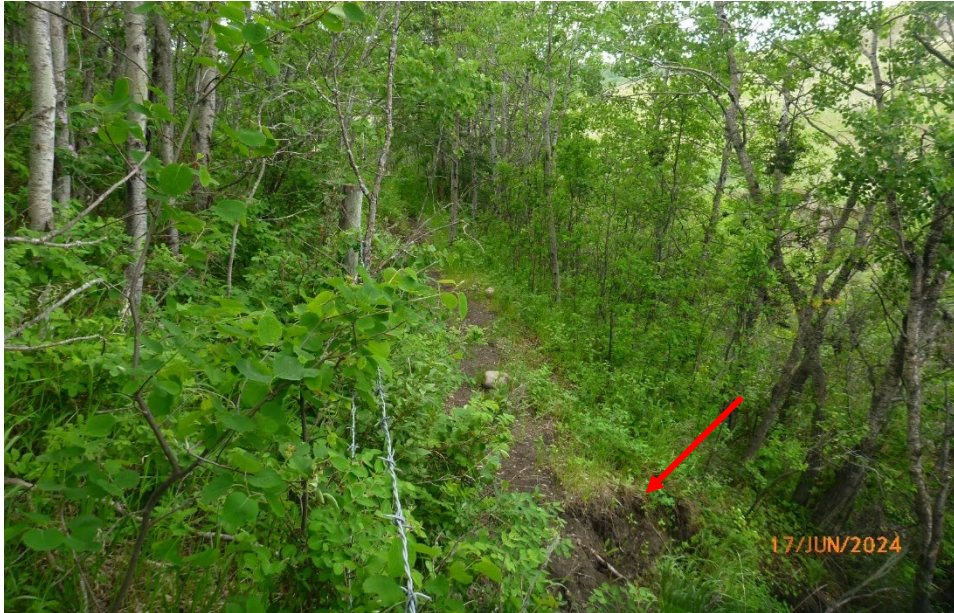
- A private fence along the highway passes through the treed area, limiting KCB and TEC's ability to inspect the lower portion of the highway embankment slope (Photo 5). Downslope of the fence, evidence of movement (sliding) and erosion was observed in the bottom third of the slope. The unnamed creek along the toe of the slope is likely exacerbating the erosion along the bottom portion of the slope.
- Dense vegetation was observed in the south (eastbound) ditch, which could indicate poor drainage, as ponded water may be infiltrating the highway embankment, raising the groundwater level within the embankment and foundation, contributing to slope instability (Photo 6).

Photo 5 Private fence located downslope of the highway and minor scarp. Evidence of a movement and erosion was observed downslope (north) of the fence (indicated by red arrow). Photo take June 27, 2024, facing west.

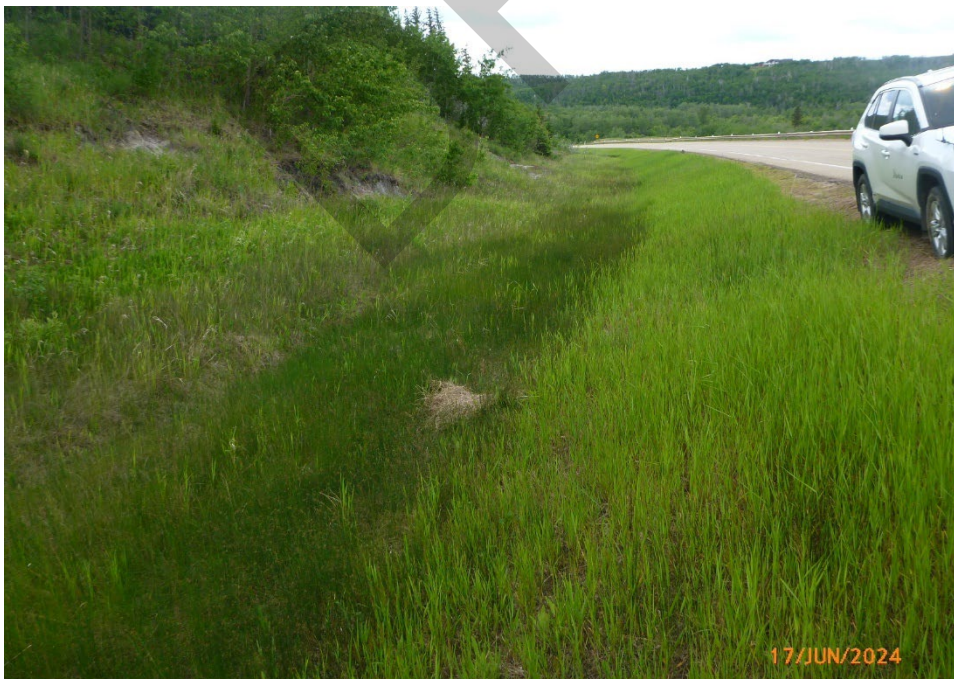
- The dense vegetation and uneven grade (i.e., localized flatter sections) of the south (eastbound) ditch upslope of the area of embankment instability is likely causing poor drainage at the site. After significant precipitation events, the ponded water upstream will likely infiltrate into the embankment and potentially raise the ground water table within it.

Photo 6 Area of dense vegetation in south (eastbound) lane could indicate an area with poor drainage and surface water infiltration into the highway embankment (overall, the ditch is graded to facilitate positive drainage). Photo taken June 17, 2024, facing west.
