**CON0022160 Central Region GRMP Instrumentation Monitoring
Site C079; H53:12, km 0.684; Hwy 53 East of Battle River Slide
Section C – 2025 Fall Readings**

Site Plan
C079 – H53 East of Battle River Slide
Hwy 53:12

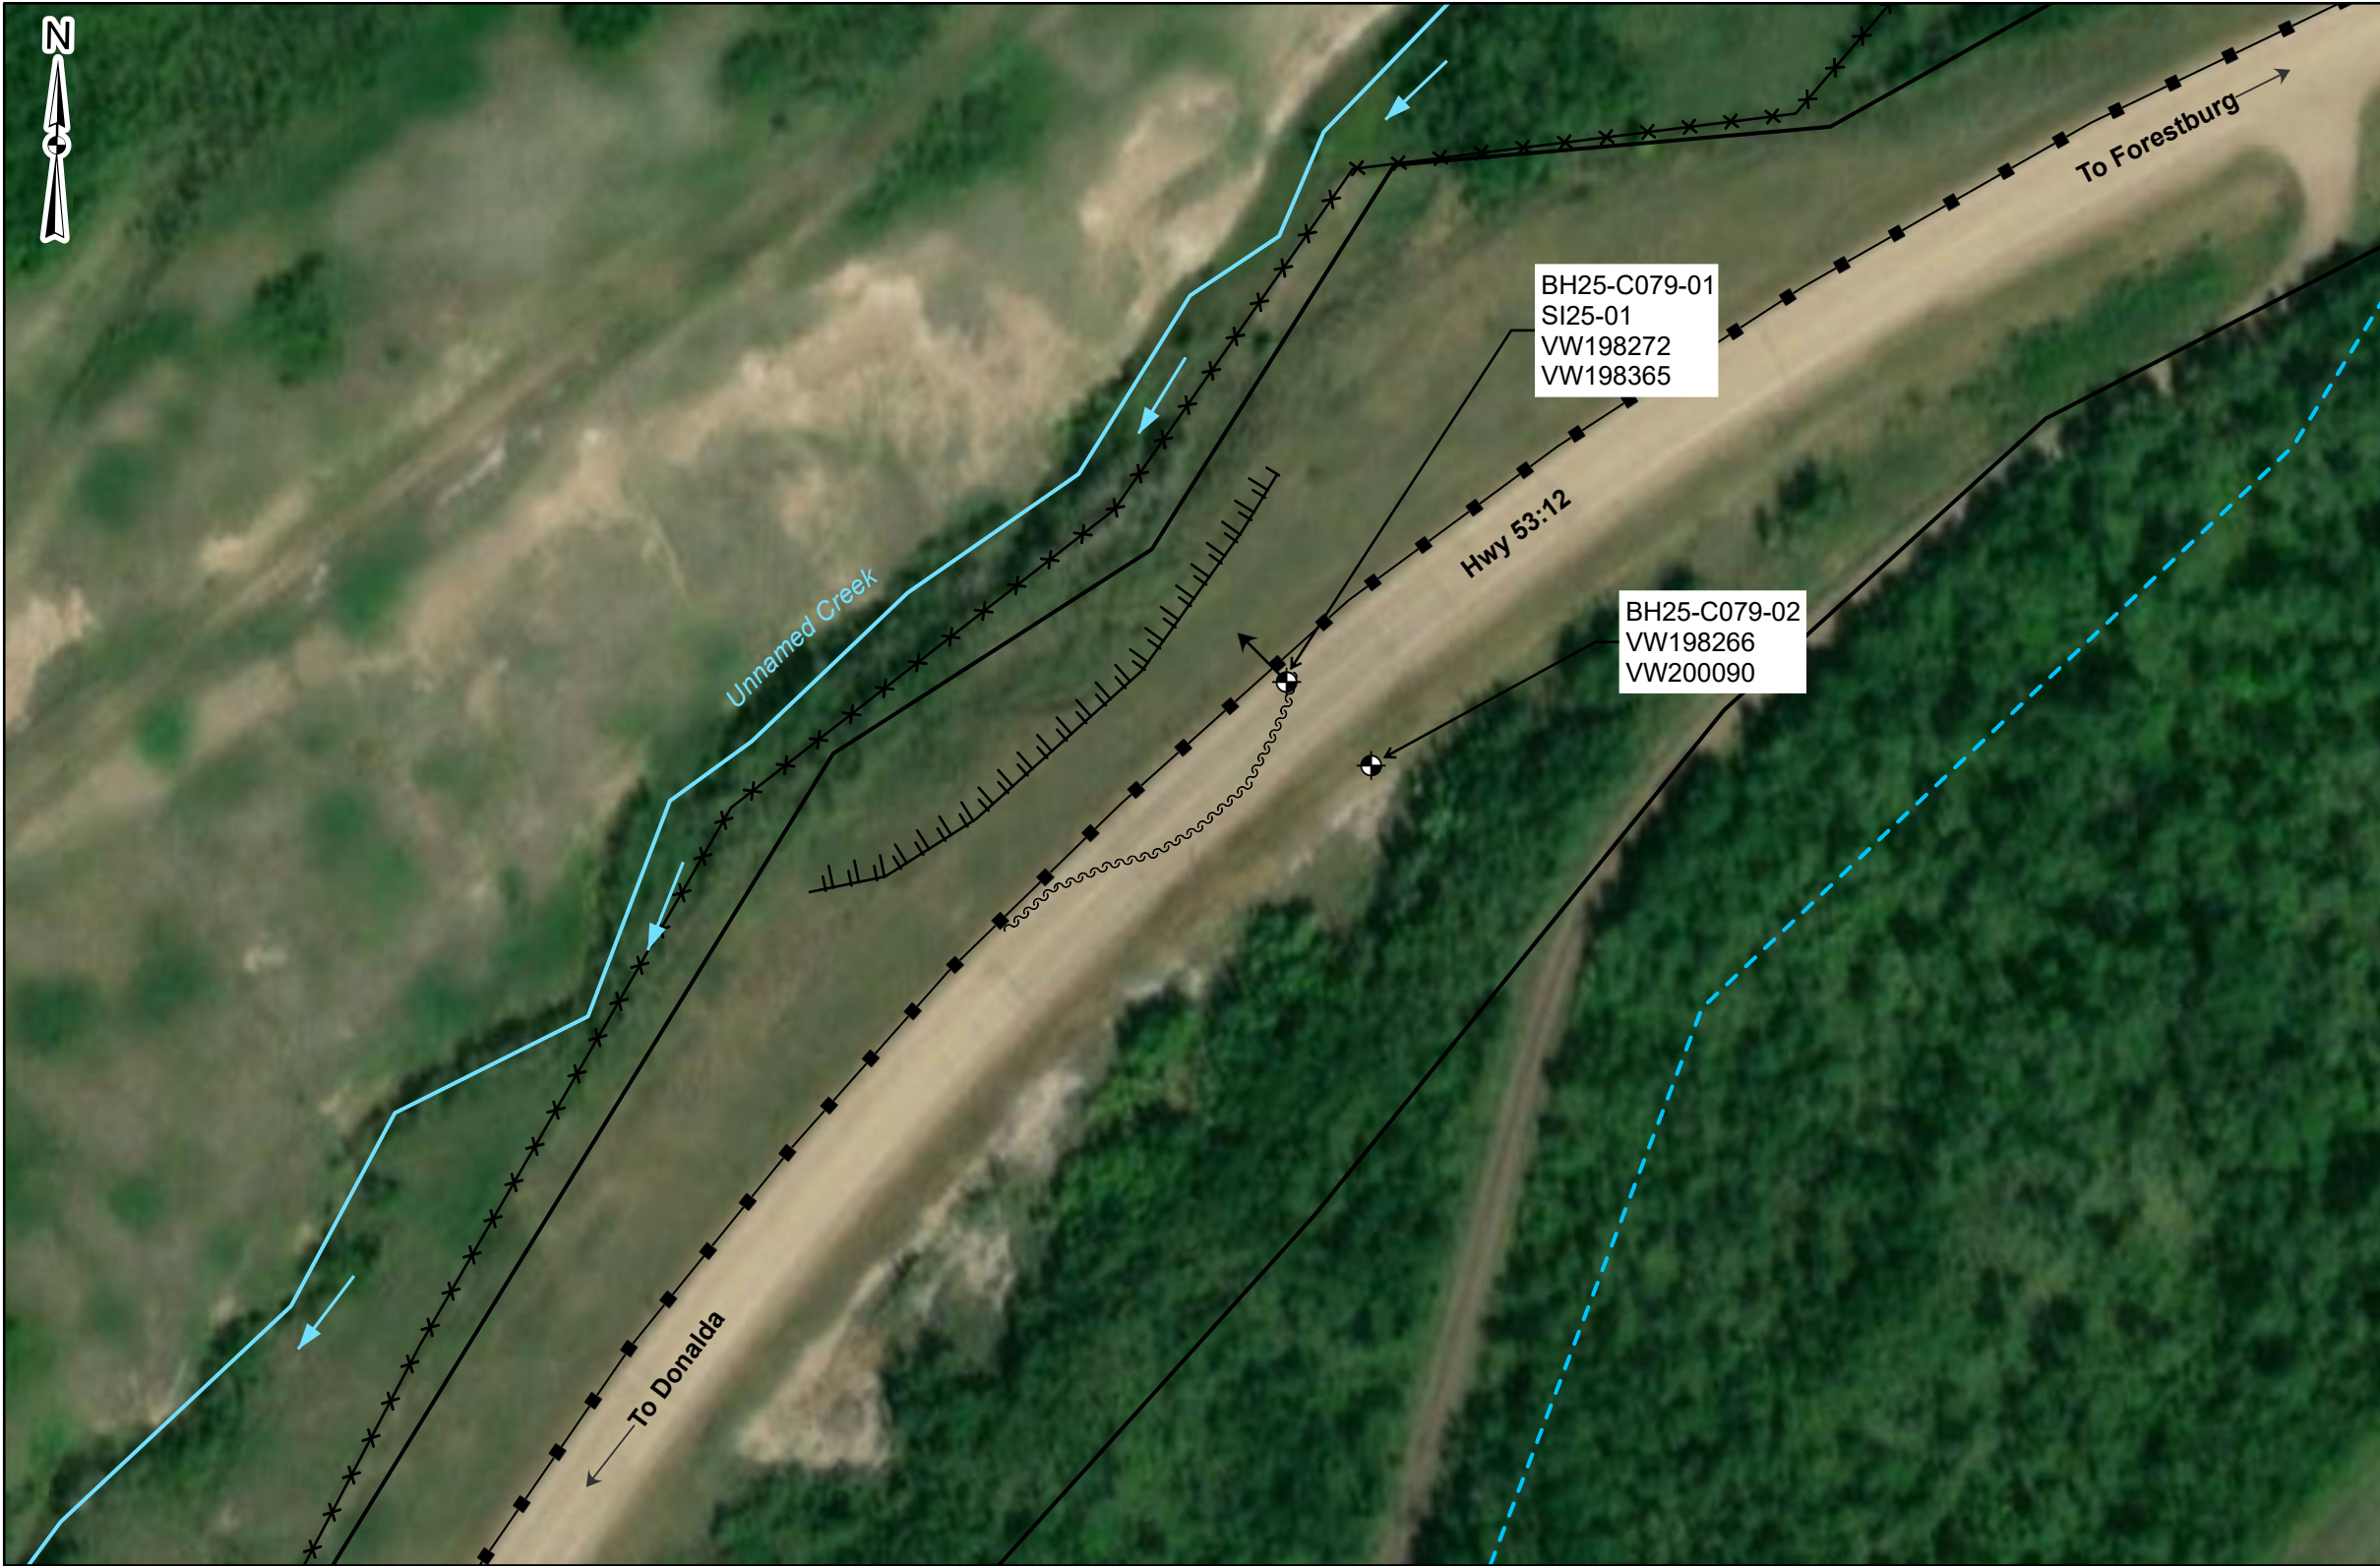
The geohazard at the site is instability of the north highway embankment slope that is impacting the guardrail (settlement) and pavement surface (cracking and settlement). The highway embankment slope at the site is a compound slope approximately 15 m tall with a slope of approximately 3H:1V for the upper 5 m and 2H:1V for the lower 10 m of the slope. The crest of the embankment slide is estimated to be 35 m wide. The site was first inspected by KCB and TEC in June 2025 during the 2025 Section B Inspection tour.

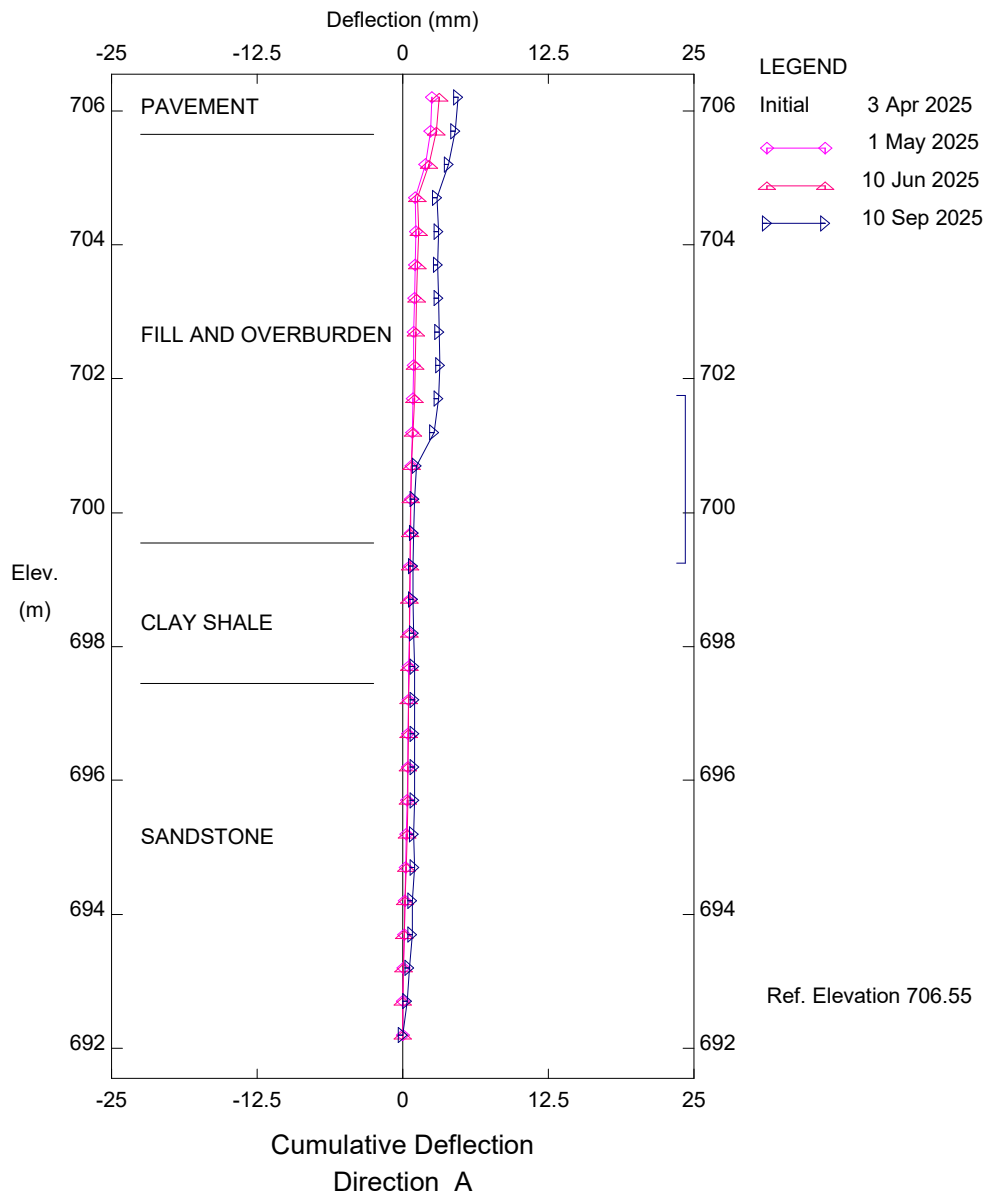
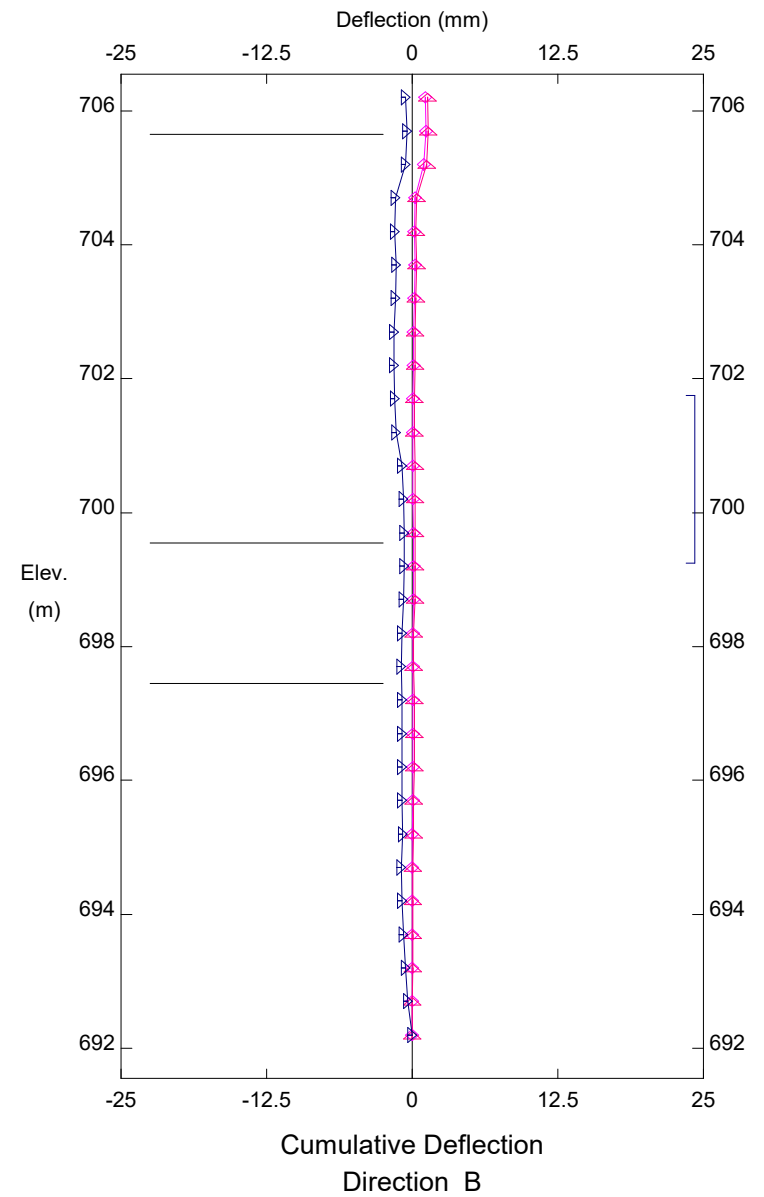
H53 East of Battle River Slide, Inclinometer SI25-01
Alberta Transportation

There has been a small amount of shallow discrete movement recorded in the upper 2 m and also recorded at approximately 5 m to 6 m below ground surface in SI25-C079-01.

The shallow movement recorded in top 2 m of SI25-C079-01 may be attributed to a soft zone of embankment fill or foundation material (e.g., poorly compacted fill or in-situ material that should have been sub-excavated during construction) where no recovery was observed during drilling (from approximately 1.5 m to 3.0 m below ground surface). The deeper zone of movement from approximately 5 m to 6 m below ground surface is approximately 1.5 m above the top bedrock (clay shale) and close to the elevation of a minor scarp observed on the highway embankment slope during the 2025 Section B Inspection. The deeper movement is recorded near a relatively soft zone observed during drilling (high plastic silt with some sand).

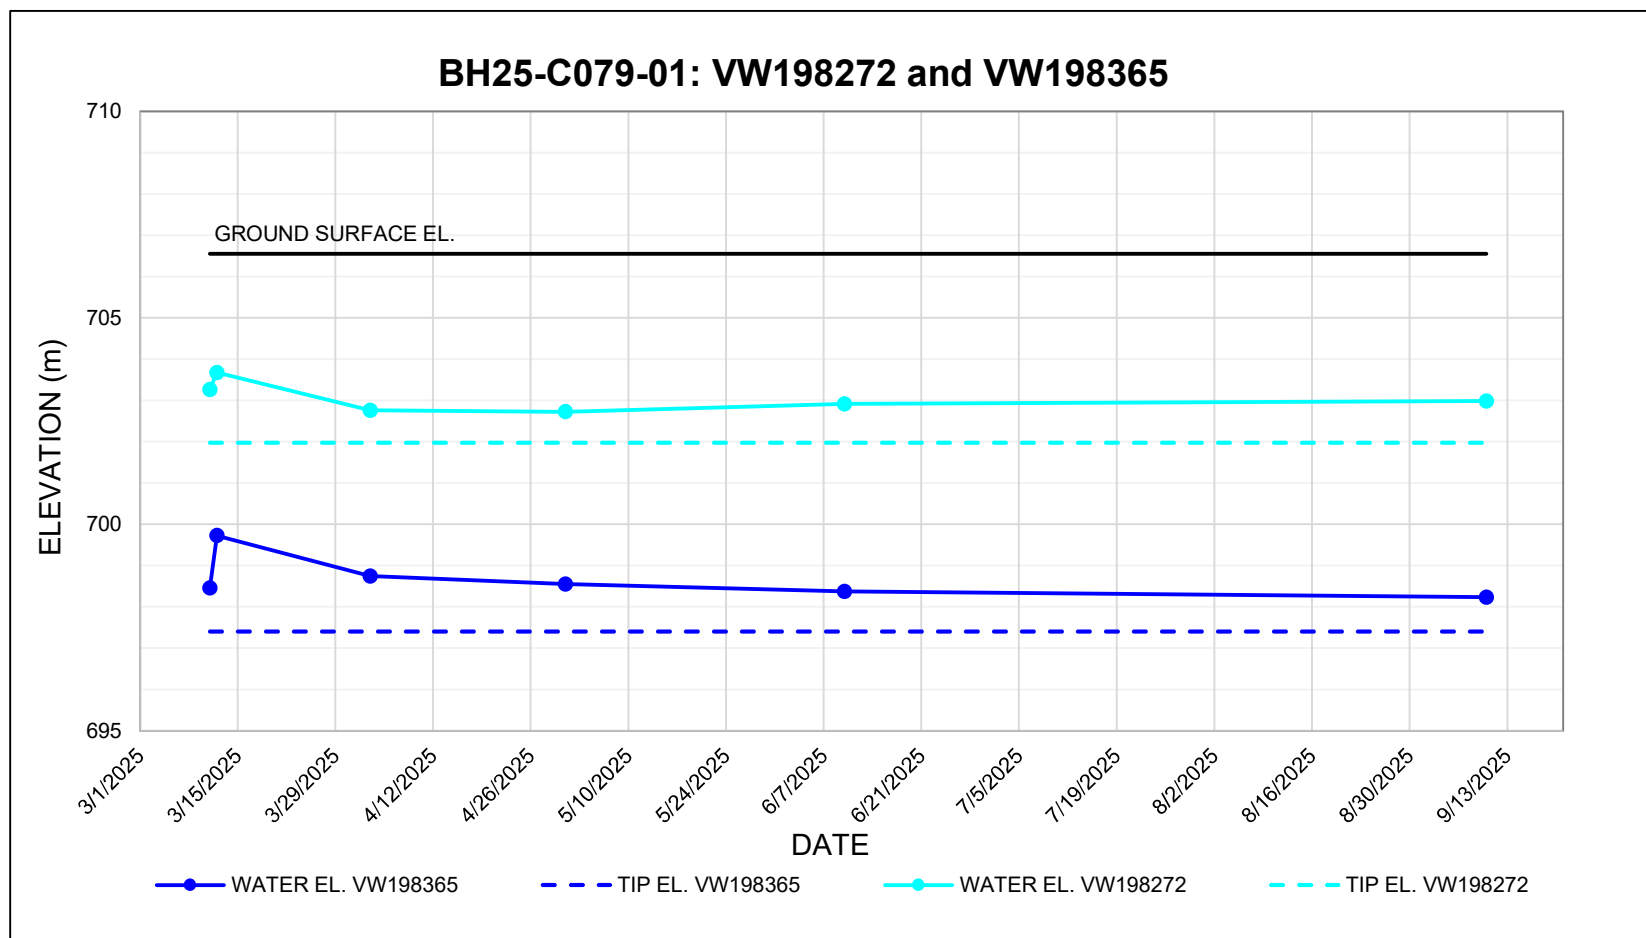
PROJECT CENTRAL REGION GEOHAZARD RISK MANAGEMENT PROGRAM		
	TITLE Piezometer Data C079 Hwy 53 East of Battle River Slide Hwy 53:12, km 0.684		
SCALE	N/A	PROJECT No.	01A05116O02
FIG No.			I-4

Since the water level stabilized shortly after installation, the recorded water levels have been relatively steady (± 0.1 m) or decreasing (decreases between approximately 0.5 m and 0.9 m). Two instruments were installed in each borehole in the overburden and foundation materials. Based on the recorded water levels for each instrument, there appears to be two independent water tables at the site (one in the overburden and one in the foundation).

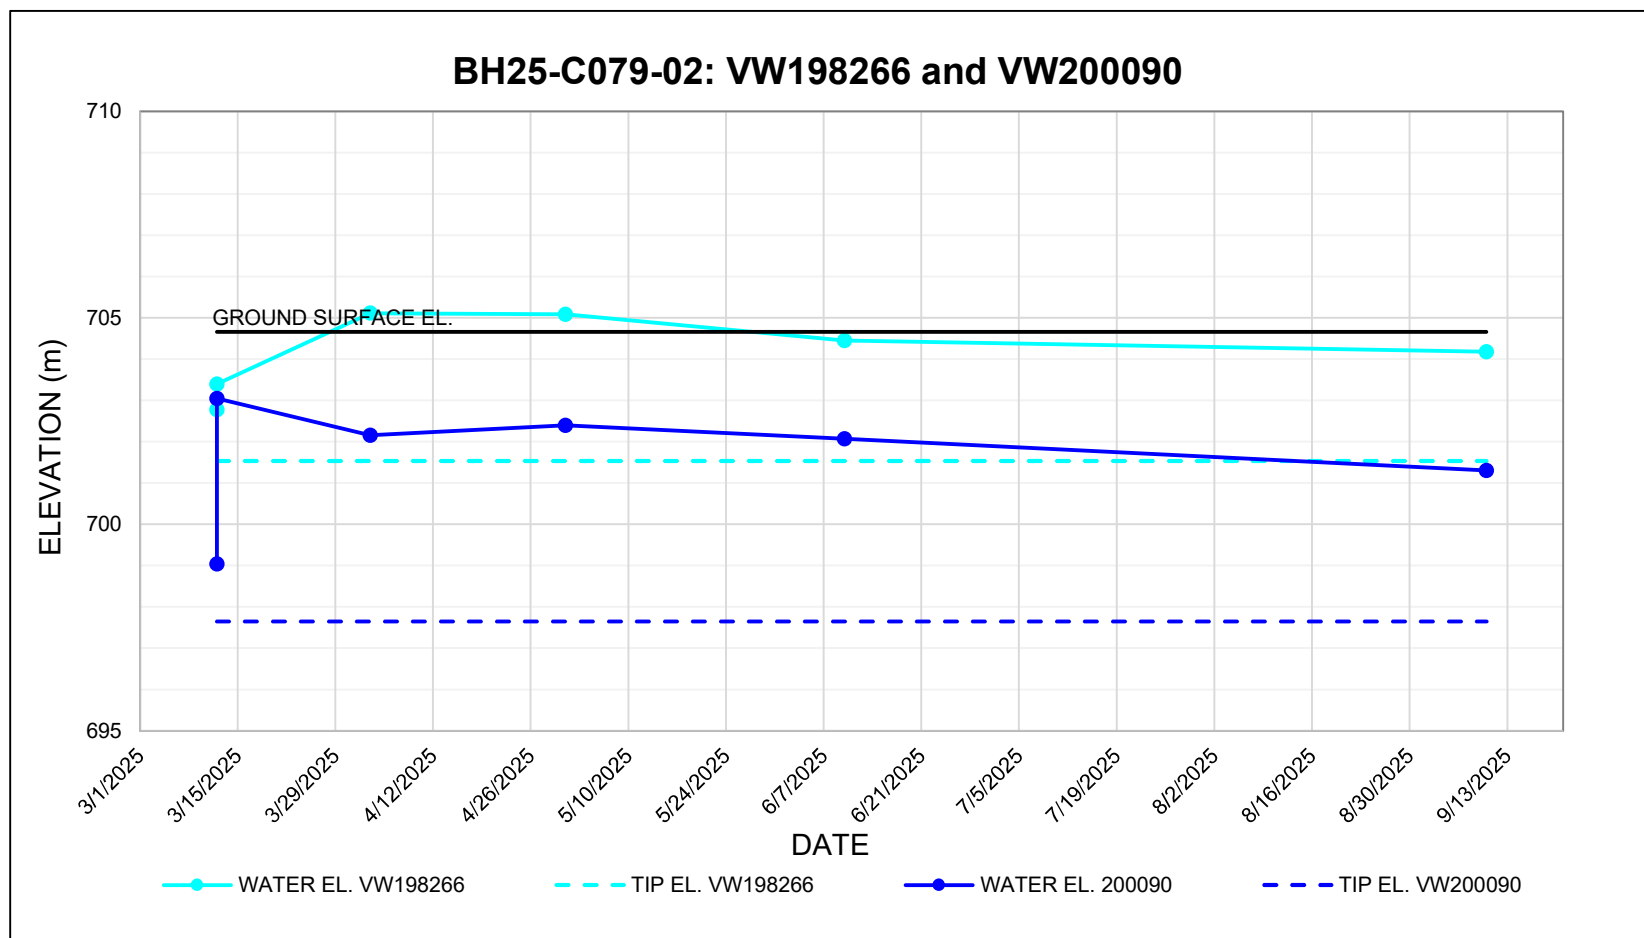
</div>	<div>PROJECT</div> <div>CENTRAL REGION GEOHAZARD RISK MANAGEMENT PROGRAM</div>		
	<div>TITLE</div> <div> Piezometer Data C079 Hwy 53 East of Battle River Slide Hwy 53:12, km 0.684 </div>		
SCALE	N/A	PROJECT No.	01A05116O02
		FIG No.	I-5

The near-surface water level recorded in the piezometer below the south (eastbound) ditch (VW198266) could indicate the ditch has relatively poor drainage (i.e., a flatter length of the ditch above the slide) which could lead to increased infiltration resulting in increased rates of movement after spring freshet or after periods of prolonged or increased rainfall.
