October 7, 2020

Alberta Transportation  
4th Floor, Provincial Building  
4920 51 Street  
Red Deer, Alberta  
T4N 6K8

**CON0017608 Central Region GRMP Instrumentation Monitoring  
Site C025; H569:02. km 18.469 Western Monarch Slide  
Section C – 2019 Fall Readings**

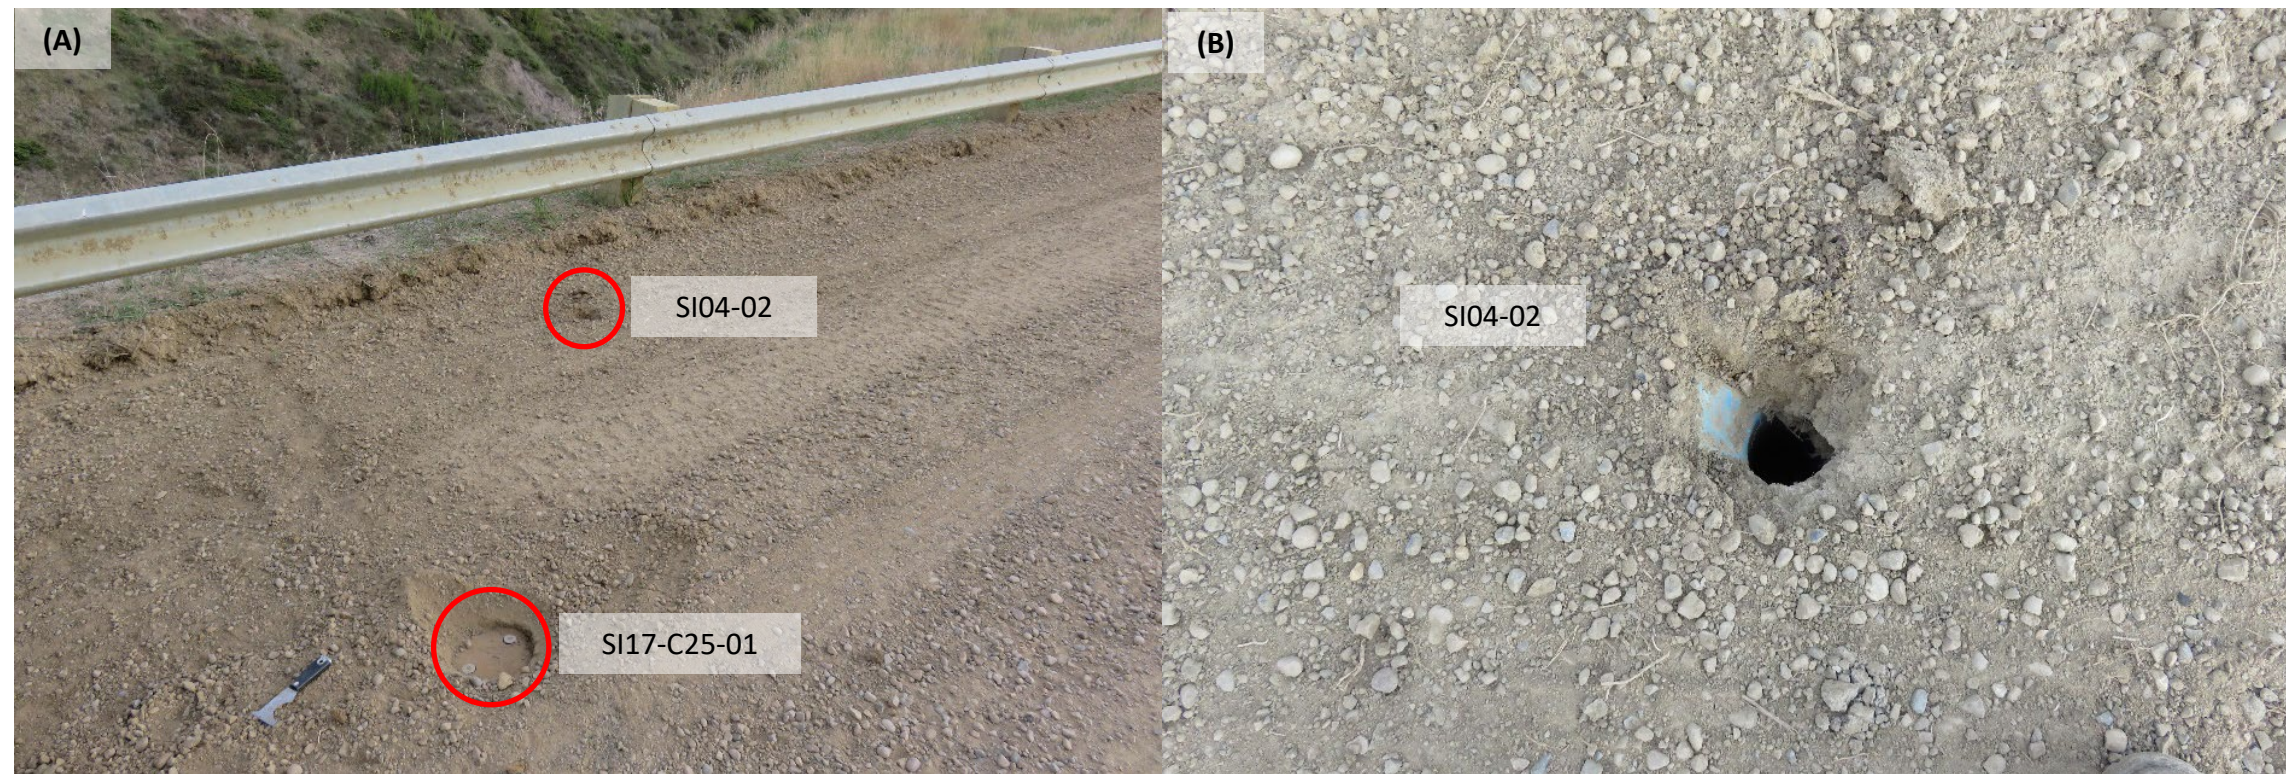
**Photo 1 SI04-02 has been shattered at ground surface.**

SI04-02 was exposed during the 2017 spring reading, but the top of the casing was shattered (Photo 1), and SI17-C25-01 is sheared at an approximate depth of 0.6 m below ground surface. Additional readings of SI04-02 might be possible if the casing is carefully exposed, repaired, and backfilled. KCB will attempt to expose SI04-02 and read the instrument with a dummy probe during the spring 2020 readings.

VW42616 is the only operational instrument remaining at C025 and has been dry since installation. KCB recommends that the C025 site be removed from the spring 2020 Section C instrument readings. If need be, KCB could facilitate backfilling the inoperable SIs with grout during a future drilling investigation near the site. Alternatively, the MCI could attempt to backfill the SIs with a “home-made” grout mix.

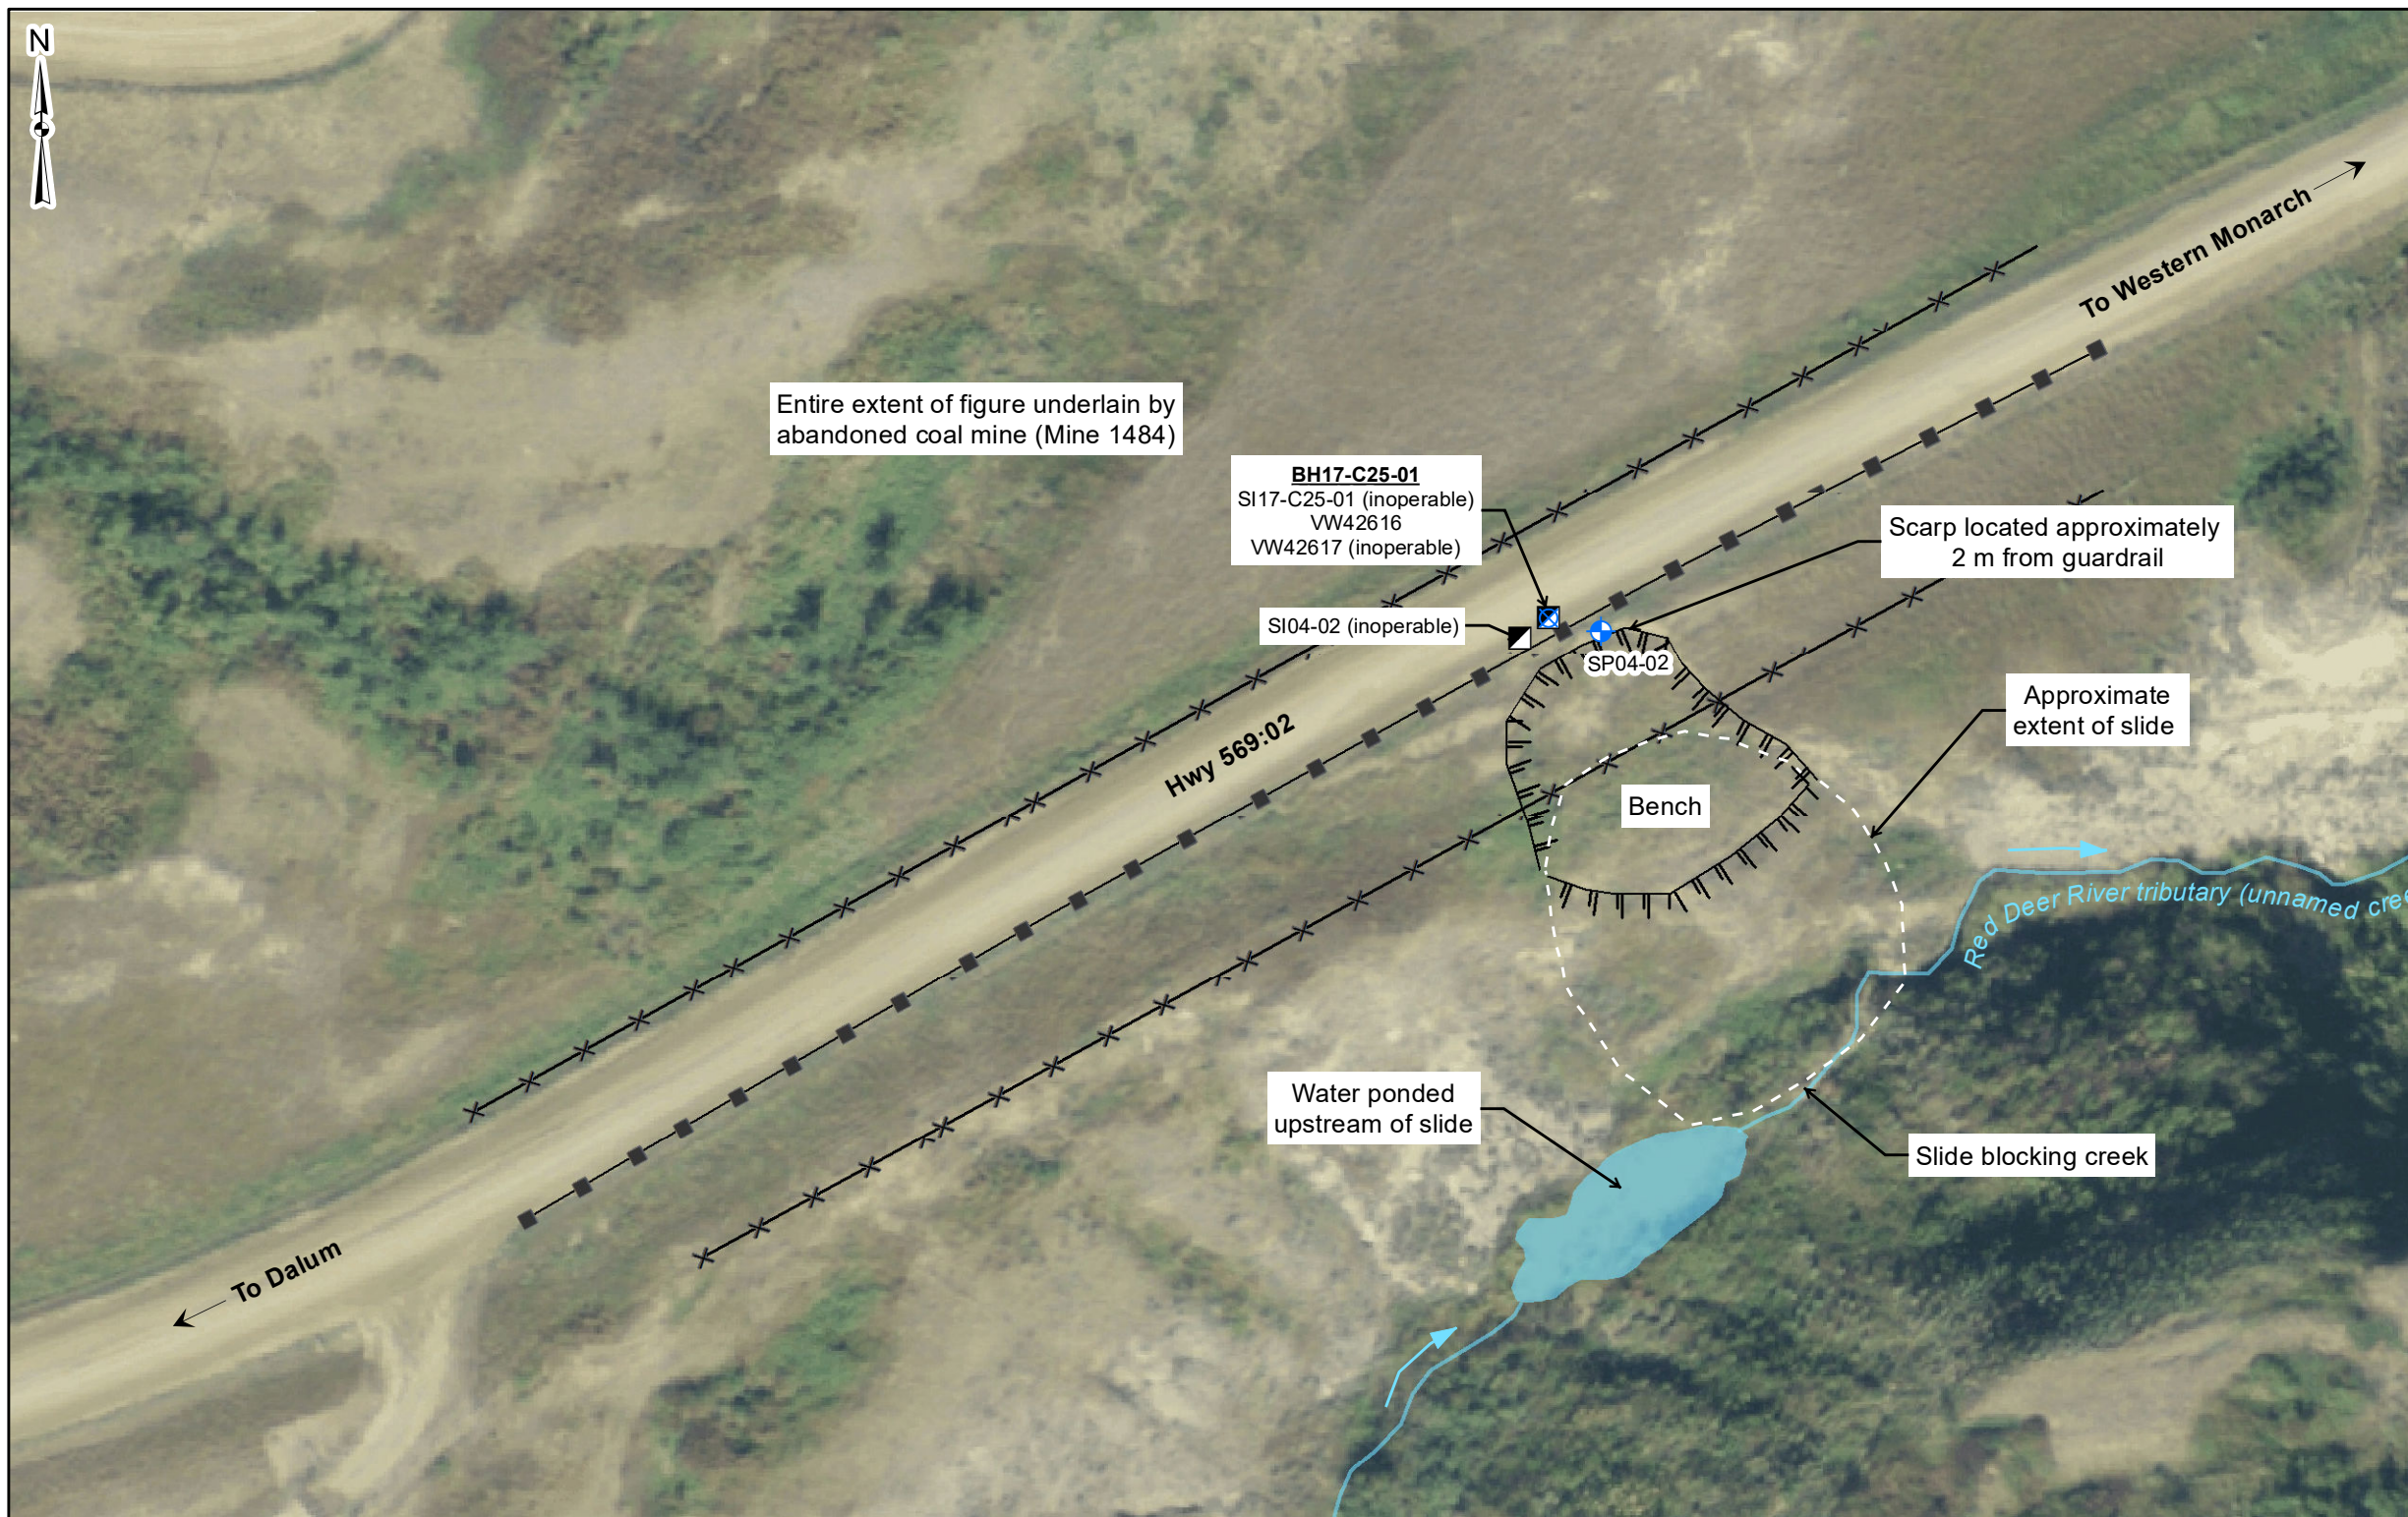
PROJECT	CENTRAL REGION GEOHAZARD RISK MANAGEMENT PROGRAM	
TITLE	Site Plan C025 - Western Monarch Slide Hwy 569:02, km 18.469	
SCALE	PROJECT No.	FIG No.
1:1,000	A05115A02	1

Entire extent of figure underlain by abandoned coal mine (Mine 1484)

Scarp located approximately 2 m from guardrail

Approximate extent of slide

Water ponded upstream of slide

Slide blocking creek
