SITE NUMBER AND NAME: C025 Western Monarch Slide		HIGHWAY & KM: 569:02, 18.469	PREVIOUS INSPECTION DATE: June 10, 2020	INSPECTION DATE: June 24, 2021
LEGAL DESCRIPTION: 02-20-027-18 W4M	NAD 83 COORDINATES: UTM Northing Easting 12 5686096 395423		RISK ASSESSMENT: PF: 7 CF: 4 TOTAL: 28	
AVERAGE ANNUAL DAILY TRAFFIC (AADT): 100 (west) (Ref No. 113210)			CONTRACT MAINTENANCE AREA (CMA): 521

Inspection Photographs

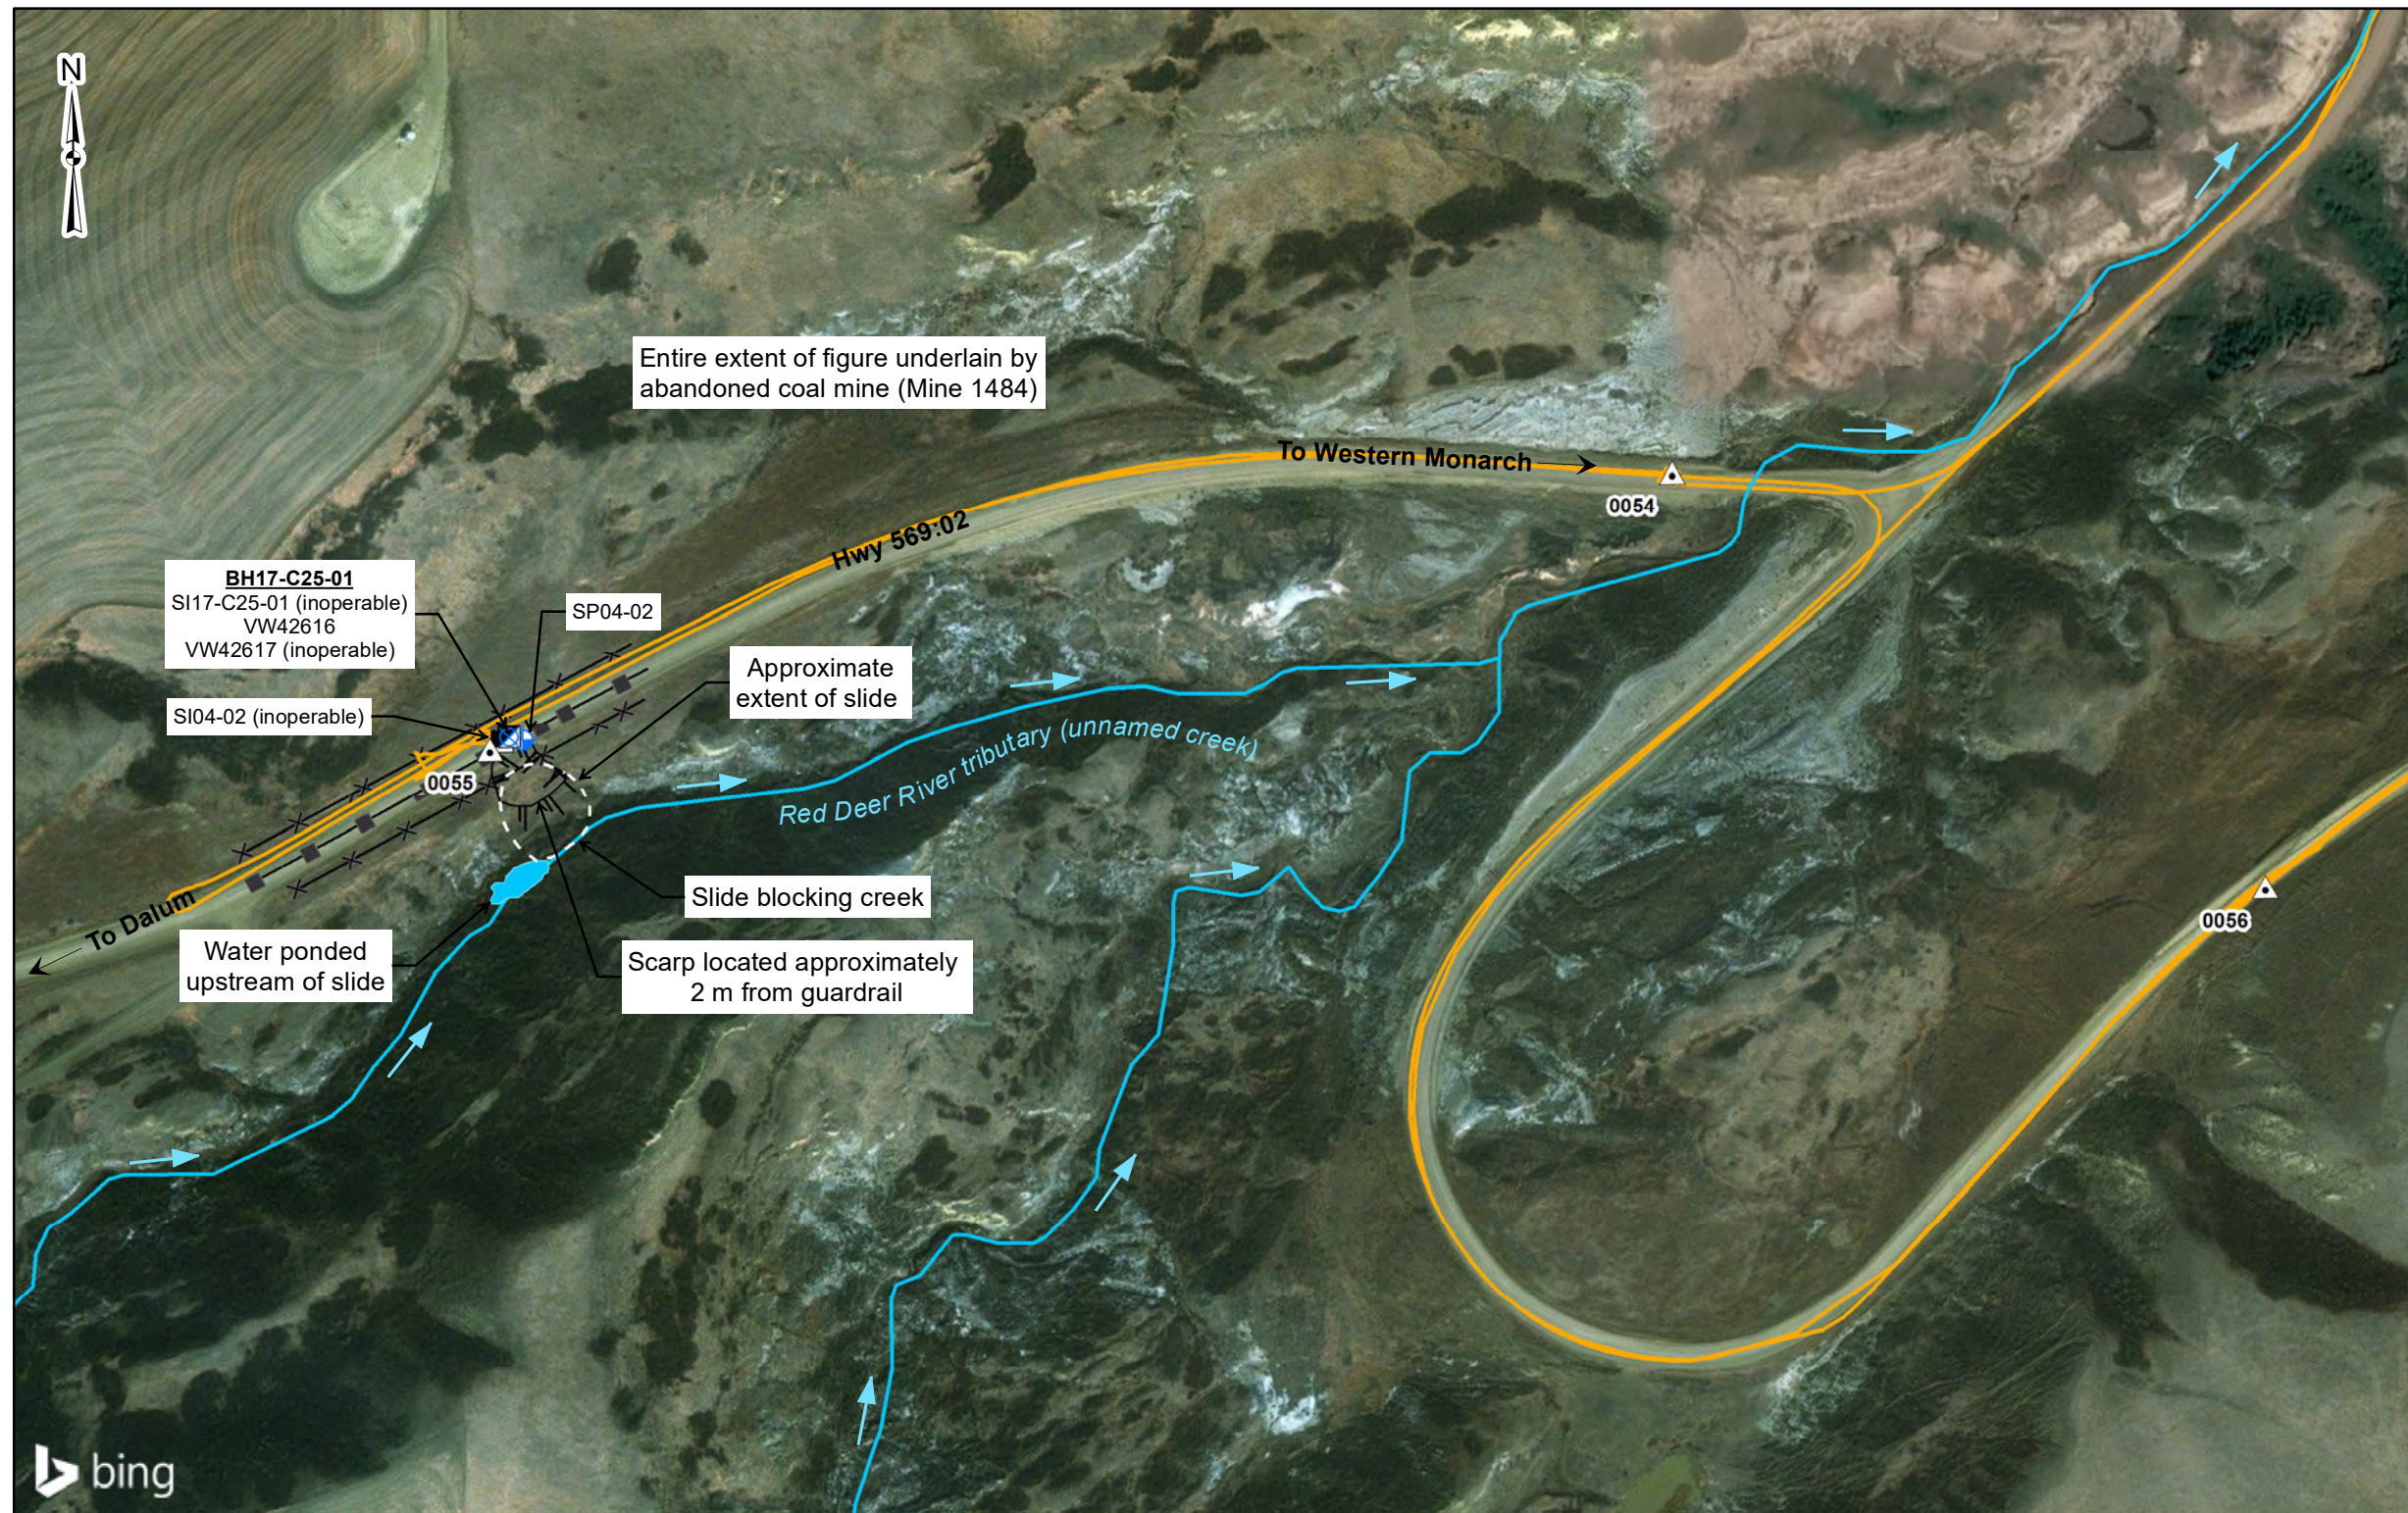
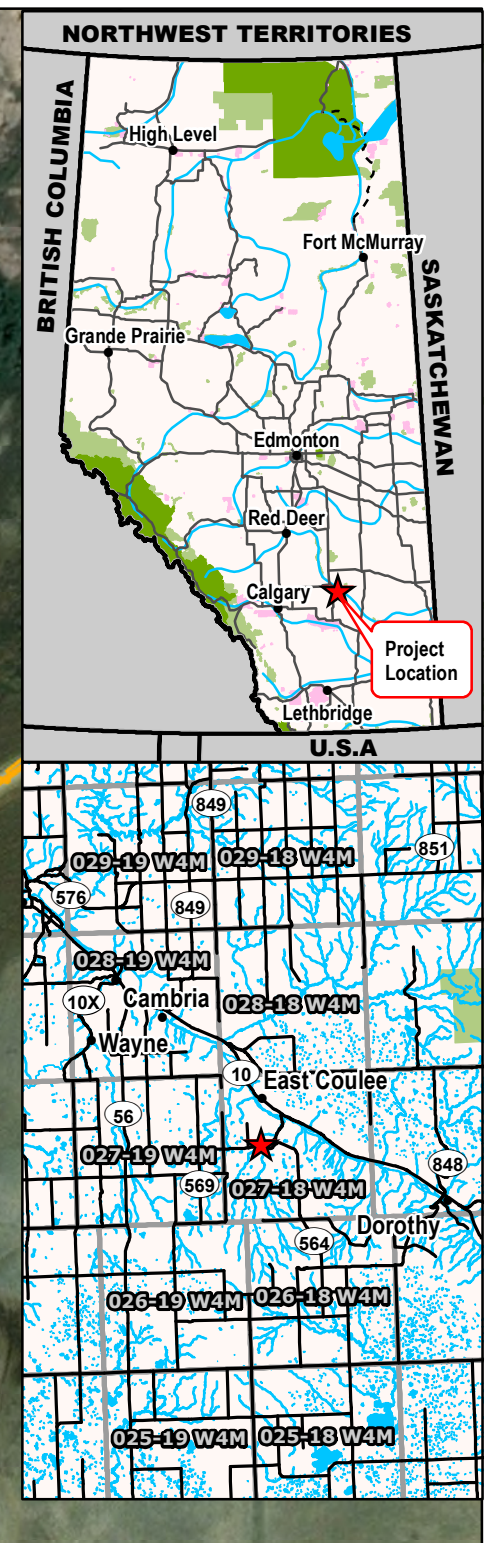
COMMENTS
Minimal change in the slide over the past few years.
Drainage at the site is poor. Surface water flows onto the slide area, and rills have formed along the south shoulder (eastbound lane) of the highway.
The slope and slide area, except for the near-vertical back and side scarps, are well vegetated with grass.

- Realignment of the road upslope (i.e., north) towards the backslope, which would require land acquisition. The realignment would need to avoid areas undermined by coal mining (e.g., near the intersection of Hwy 569 and Hwy 10).
- For all options, improvements to drainage would be made (e.g., construct ditches).
- During the 2019 inspection, AT and KCB inspected the top of the backslope to further assess highway re-alignment. Benches in the backslope above the highway could be part of a larger historic landslide or they could be remains of earthworks from historic coal-mining activity. A drilling investigation with instrument installation will be required to assess the stability of the backslope and to assess subsurface conditions before road relocation and associated excavations are undertaken.

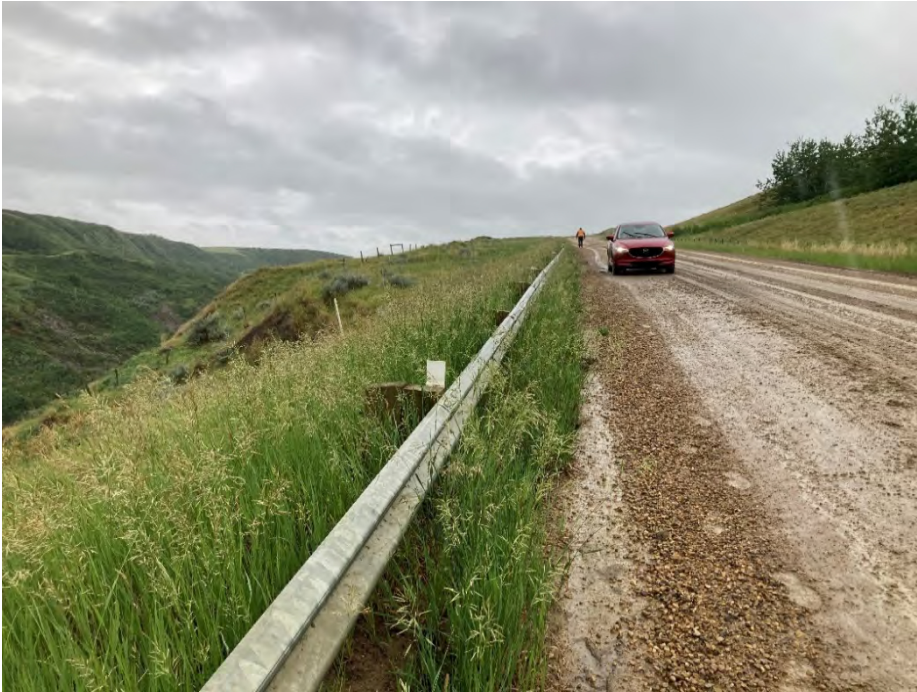
Photo 1 Guardrail on the south side of Hwy 569. Photo taken June 24, 2021 facing west.

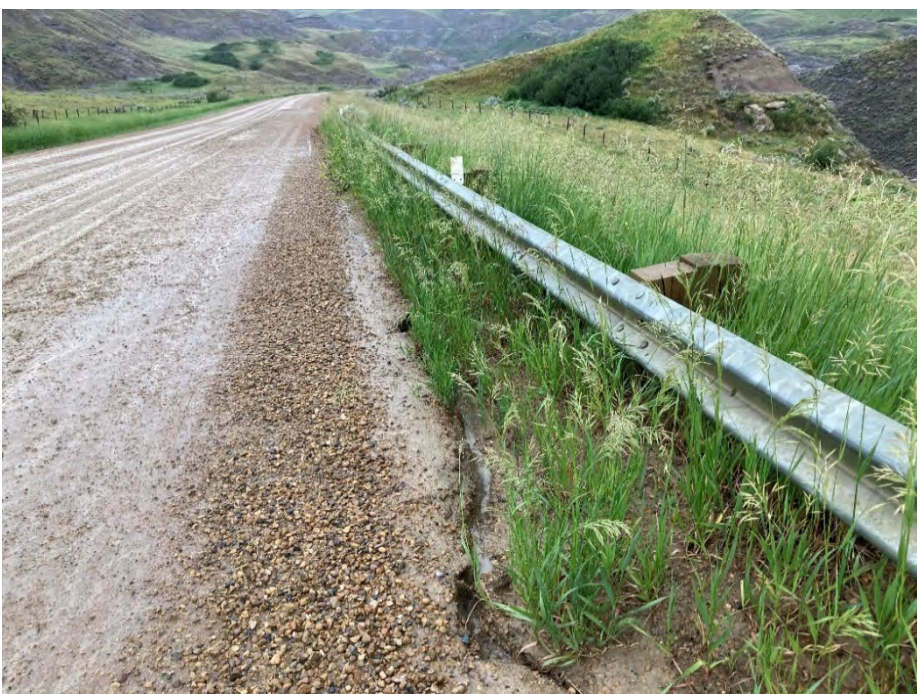
Photo 2 Small amount of erosion adjacent to the guardrail south of Hwy 569. Photo taken June 24, 2021 facing east.

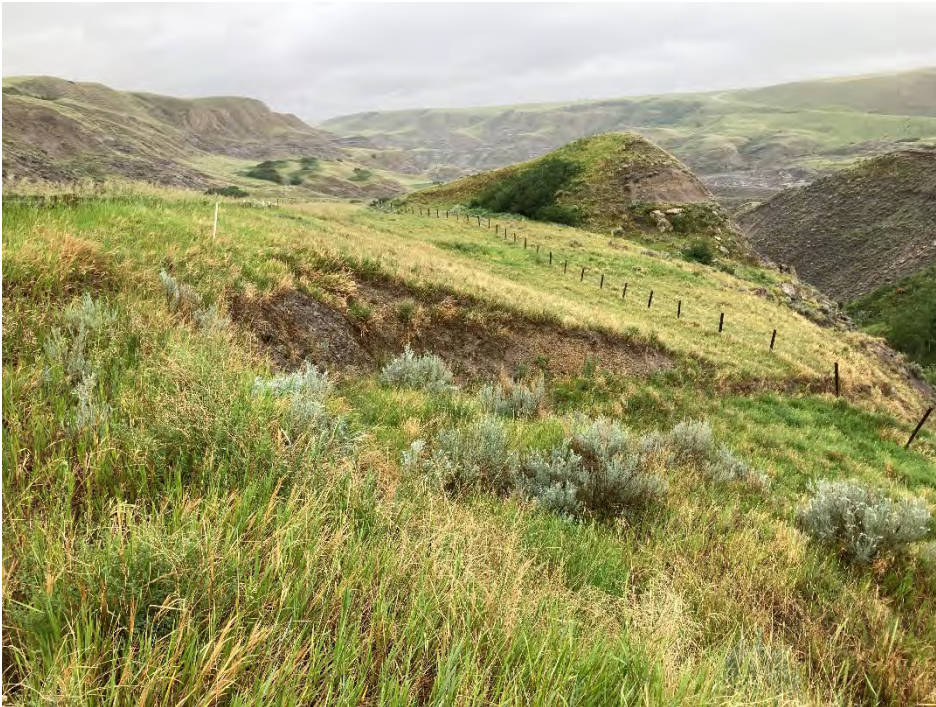
Photo 3 Eastern flank of the slide. Small amount of ongoing erosion occurring on the vertical face where there is no vegetation. Photo taken June 14, 2021 facing east.

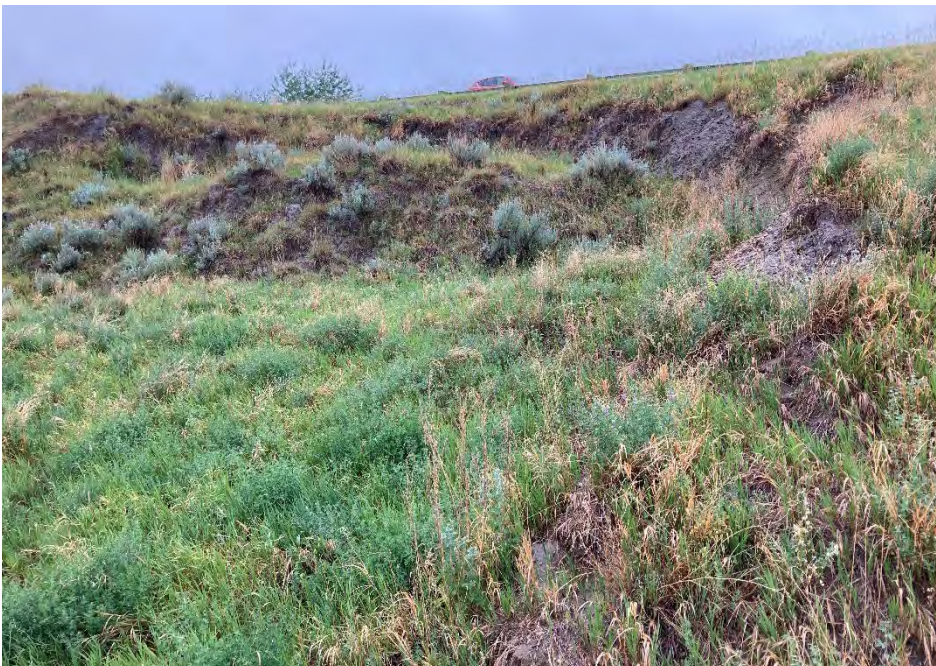
Photo 4 Backscarp of the slide south of Hwy 569. The slide does not appear to have progressed since the inspection in 2020 and appears to be inactive, excluding some minor erosion on the near-vertical backscarp. Photo taken June 24, 2021 facing north.

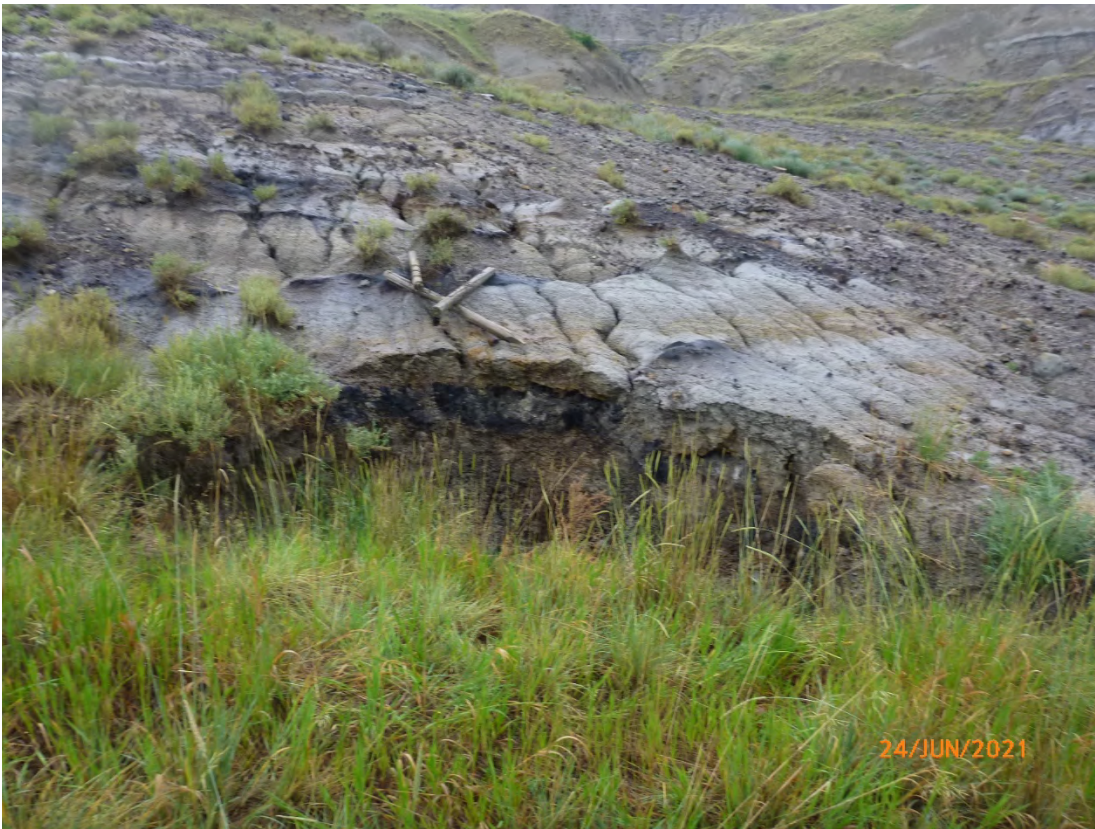
Coal slack waste piles from historic mining activities at this site are present to the northeast of the site. The C025 site is underlain by old mine workings (from AER database on coal-mine workings). A potential coal-mine void sinkhole was observed during the June 23, 2021 inspection, in the westbound ditch, near the intersection of Hwy 569 and Hwy 564. Waypoint 0054 is at the approximate location of the sinkhole. The thickness of the overburden material appears to be less near the intersection, at a lower elevation (the coal-seam would have been generally horizontal) which means that sinkholes from coal-mine roof collapse would be more likely to be present at surface.

Photo 5 Potential coal-mine sinkhole located at WP 0054/ Photo take on June 24, 2021 facing northwest.
