SITE NUMBER AND NAME: C025 Western Monarch Slide		HIGHWAY & KM: 569:02, 18.469	PREVIOUS INSPECTION DATE: June 24, 2021	INSPECTION DATE: May 31, 2022
LEGAL DESCRIPTION: 02-20-27-18-W4M	NAD 83 COORDINATES: UTM Northing Easting 12 5686096 395423		RISK ASSESSMENT: PF: 7 CF: 4 TOTAL: 28	
AVERAGE ANNUAL DAILY TRAFFIC (AADT): 80 (west) (Reference No. 113210)			CONTRACT MAINTENANCE AREA (CMA): 521

PROJECT CENTRAL REGION GEOHAZARD RISK MANAGEMENT PROGRAM		
TITLE Site Plan C025 - Western Monarch Slide Hwy 569:02, km 18.469		
SCALE 1:2,750	PROJECT No. A05116A02	FIG No. 1

Inspection Photographs

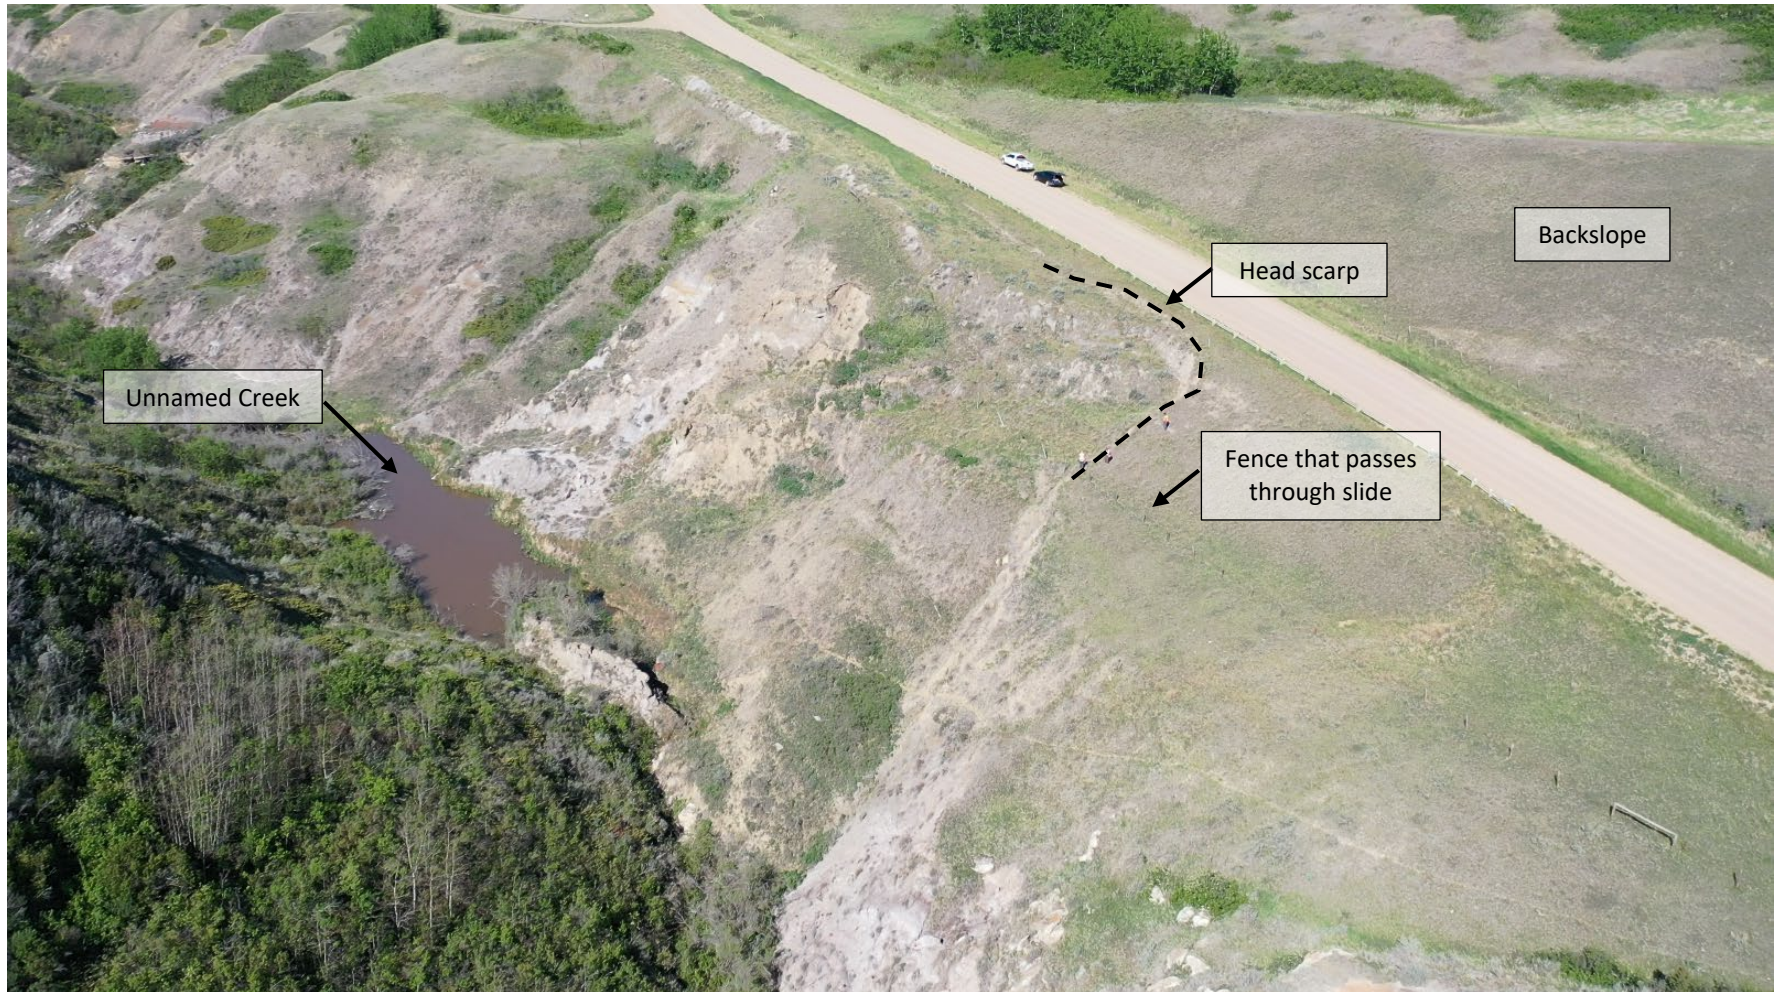
The slope and slide area, except for the near-vertical back and side scarps, are well vegetated with grass (Photos 1 through 4). The north edge of the slide is at the tree line (WP 167)

Photo 1 Oblique aerial photo of the C025 slide. Photo taken May 31, 2022, facing northwest.

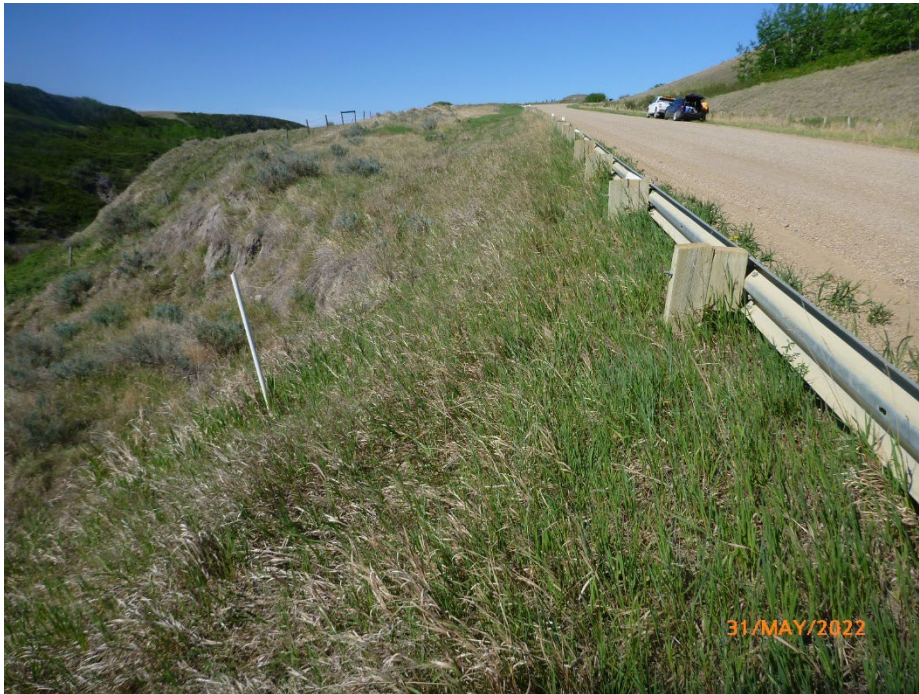
Photo 2 Guardrail on the south side of Hwy 569. Photo taken June 24, 2021, facing west.

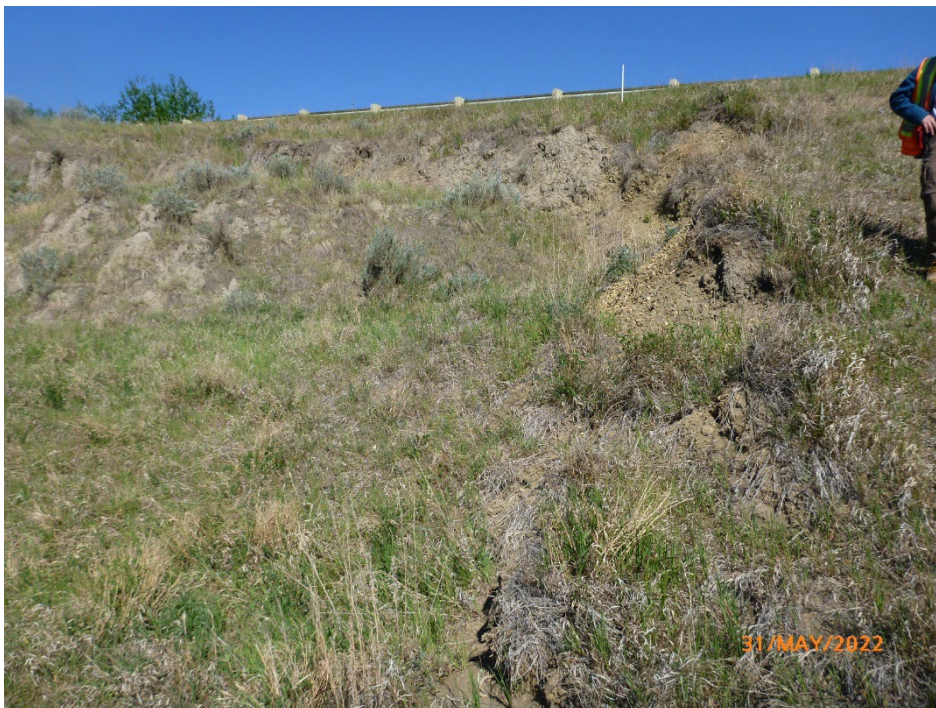
Photo 3 Eastern flank of the slide. Small amount of ongoing erosion occurring on the vertical face where there is no vegetation (Waypoint 167). Photo taken June 14, 2021, facing north.

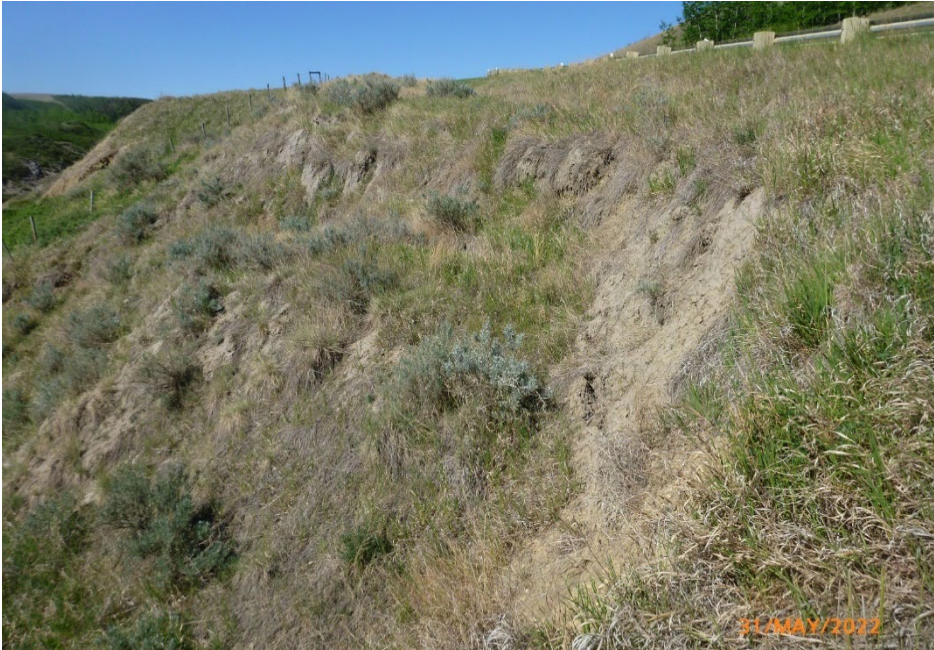
Photo 4 Backscarp of the slide south of Hwy 569. The slide does not appear to have progressed since the 2021 inspection and appears to be inactive, excluding some minor erosion on the near-vertical backscarp. Photo taken June 24, 2021, facing northwest.

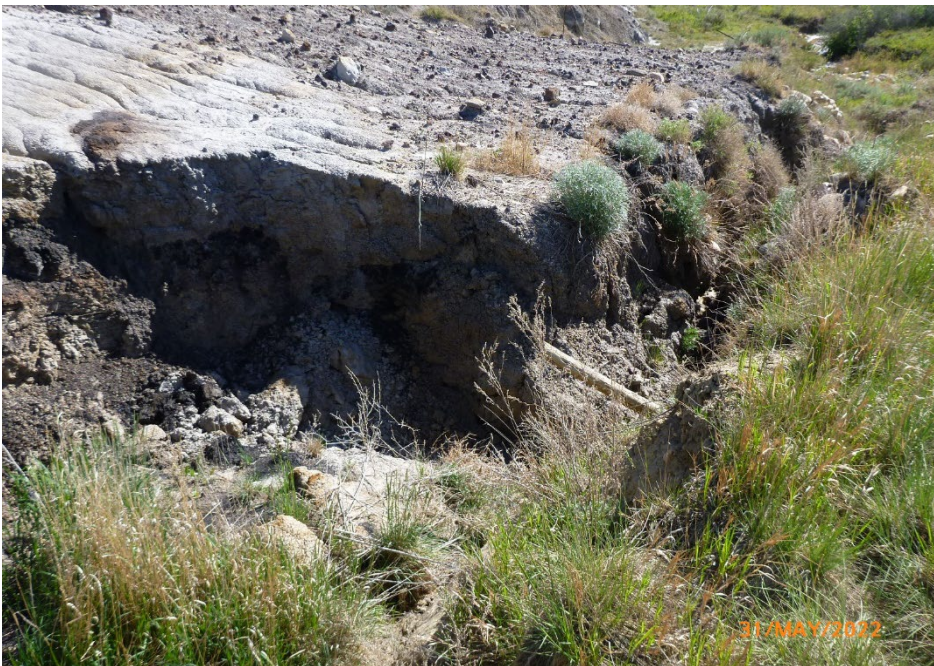
Coal slack waste piles from historic mining activities at this site are present to the northeast of the site. The C025 site is underlain by old mine workings (from AER database on coal-mine workings). A potential coal-mine void sinkhole was first observed during the 2021 inspection, in the westbound ditch, near the intersection of Hwy 569 and Hwy 10/Hwy 564 (WP 166). The sinkhole appears to have increased in size since the 2021 inspection.

The thickness of the overburden material appears to be less near the intersection, at a lower elevation (the coal-seam would have been generally horizontal) which means that sinkholes from coal-mine roof collapse would be more likely to be present at surface.

Photo 5 Potential coal-mine sinkhole first observed during the 2021 inspection, located at Waypoint 166. Photo take on June 24, 2021, facing northeast.
