SITE NUMBER AND NAME: <b>C058-I, II, &amp; III Sinkholes</b>		HIGHWAY & KM: 570:02, 8.3, 9.2, 9.8	PREVIOUS INSPECTION DATE: June 12, 2018	INSPECTION DATE: <b>July 10, 2019</b>
LEGAL DESCRIPTION: 10-08-027-17 W4M	NAD 83 COORDINATES: UTM Northing Easting		RISK ASSESSMENT:	
	<b>C058-I</b>	12 5683470 405475	PF: 8	CF: 5 TOTAL: 40
	<b>C058-II</b>	12 5683845 404934	PF: 8	CF: 5 TOTAL: 40
	<b>C058-III</b>	12 5684148 404224	PF: 8	CF: 5 TOTAL: 40
AVERAGE ANNUAL DAILY TRAFFIC (AADT): 510 (west) & 360 (east) (Ref No. 116220 & 997198)			CONTRACT MAINTENANCE AREA (CMA): 21

SUMMARY OF SITE INSTRUMENTATION:  None	INSPECTED BY: Chris Gräpel (KCB) Ryan Gazley (KCB) Rishi Adhikari (AT) Tony Penney (AT)
LAST READING DATE: n/a	
PRIMARY SITE ISSUE: Settlement of Hwy 570 due to the presence of dispersive-soil voids beneath the highway surface.	
APPROXIMATE DIMENSIONS: Numerous soil voids along a 1.5 km stretch of Hwy 570.	
DATE OF ANY REMEDIAL ACTION: May 3, 2010 – remediated using foam injection; May 29, 2015 – excavated (deep) and reconstructed with gravel fill and a culvert; unknown – sinkholes in ditch backfilled; speed reduction signs to 50 km/h and hazard markers installed. Sinkhole at C058-I on ne

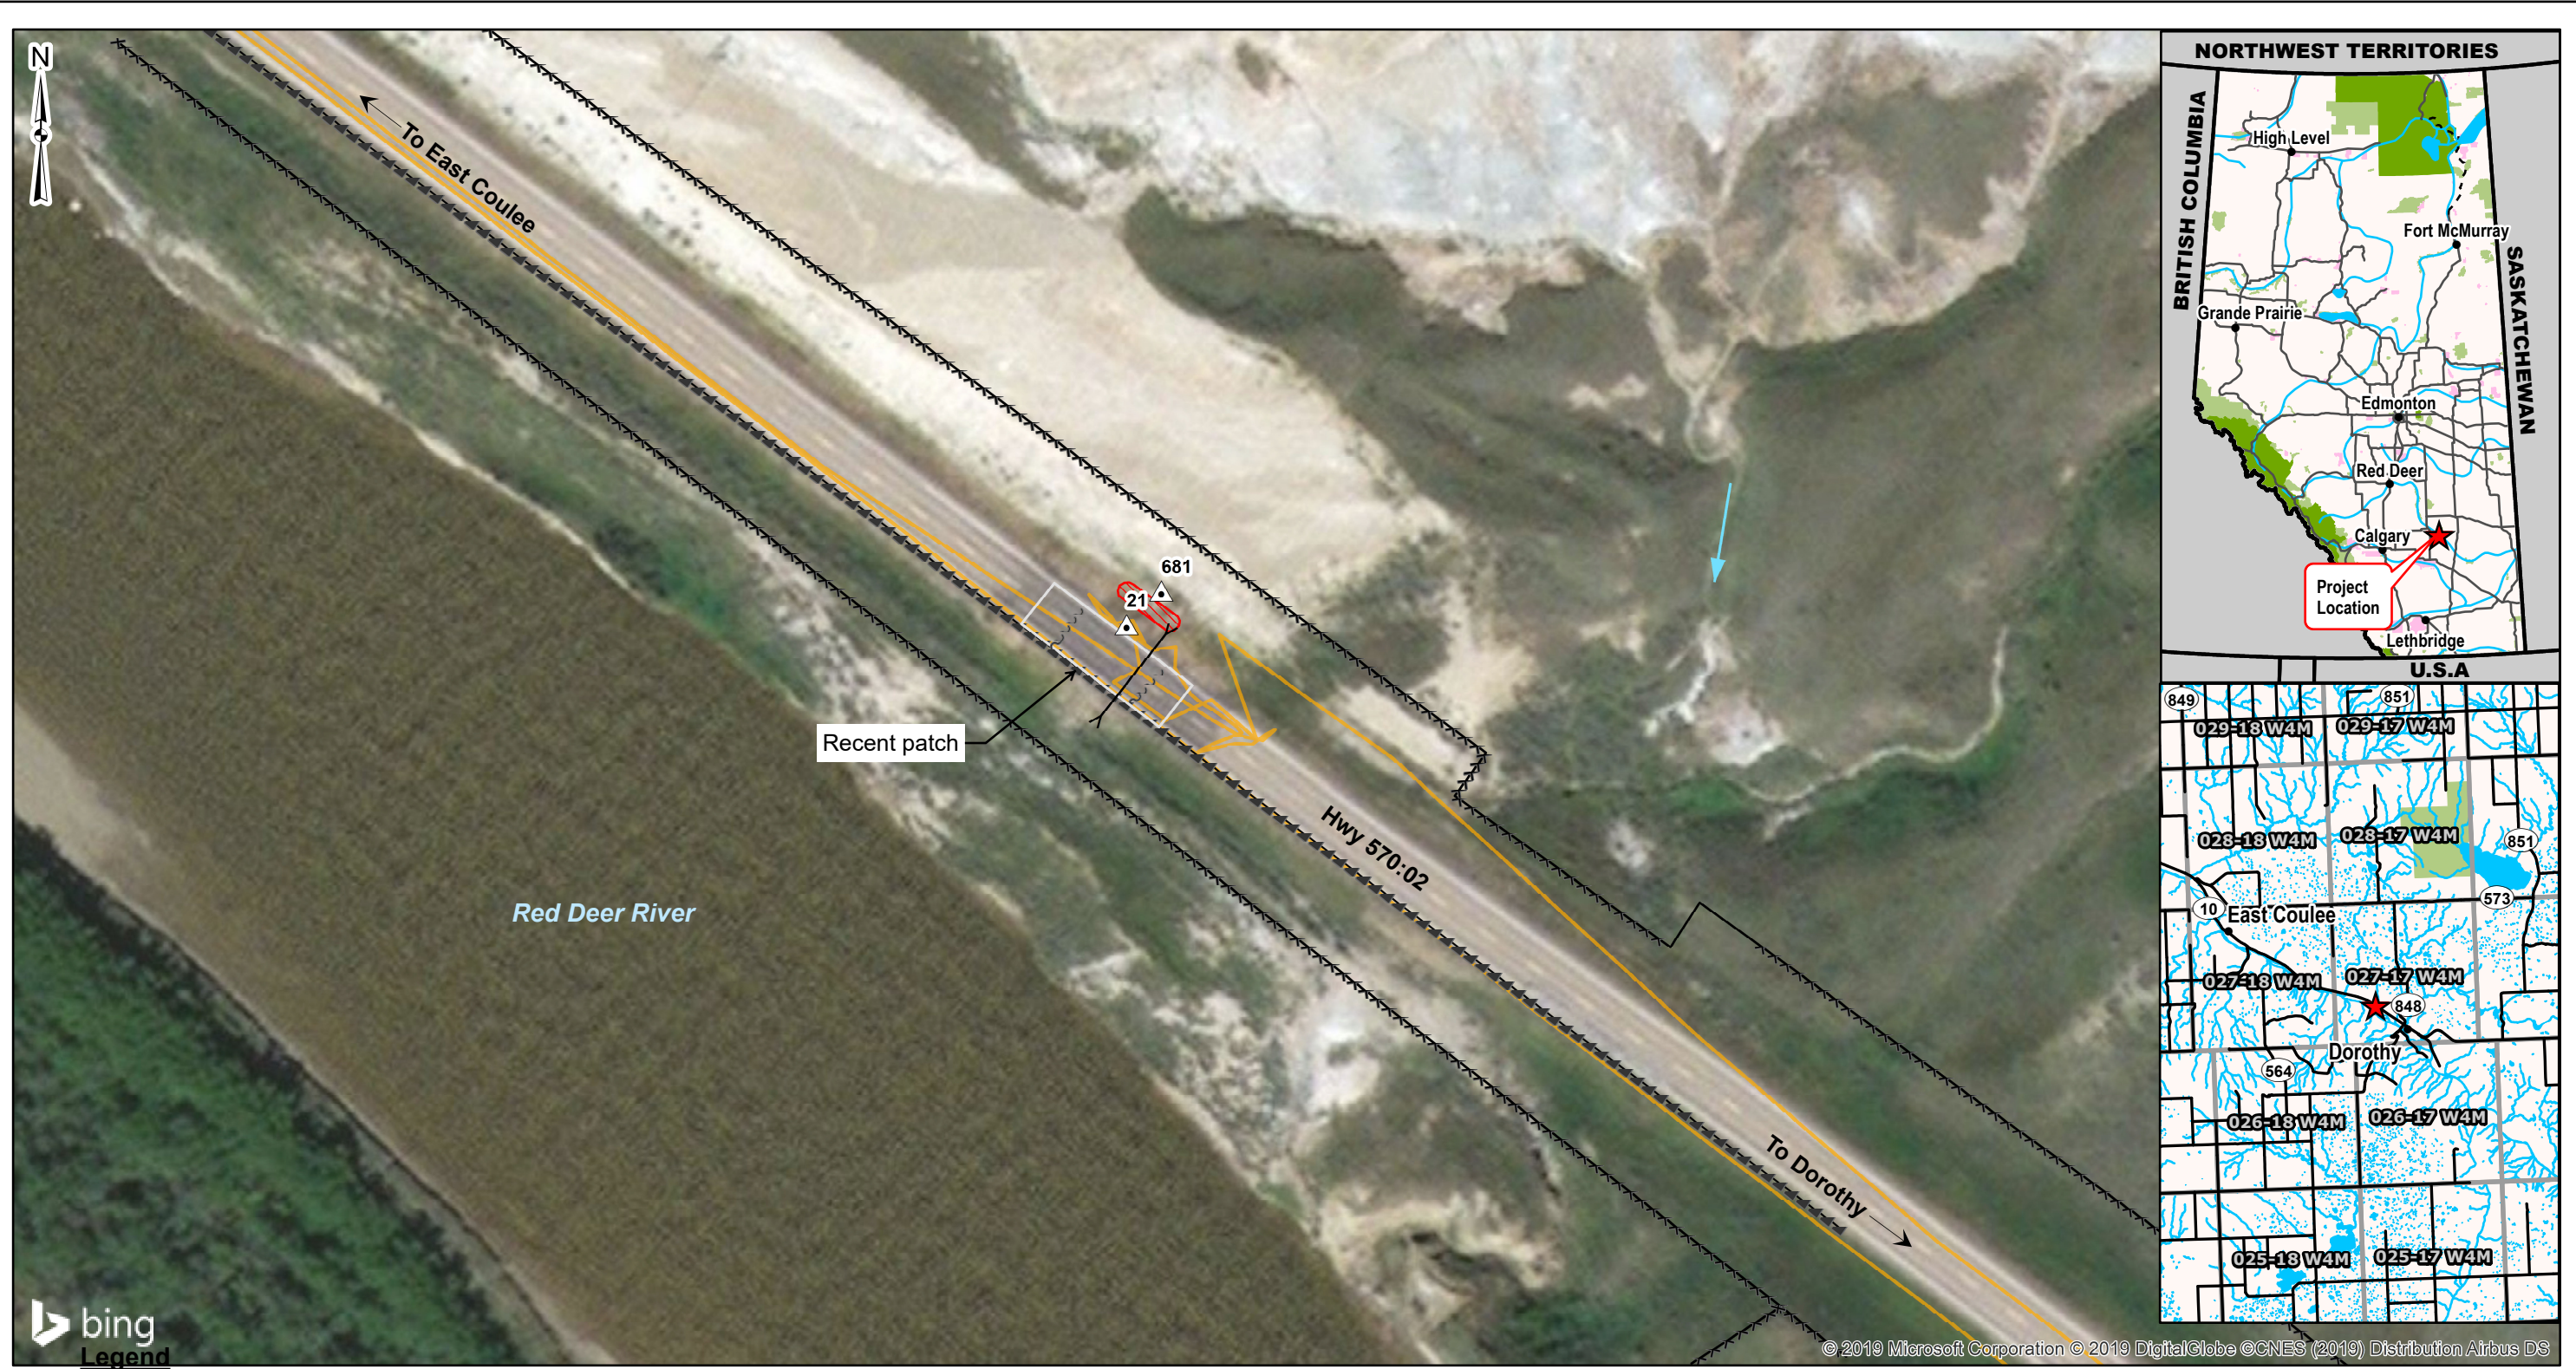
<b>COMMENTS</b>
C058-I (Figure 1): <ul style="list-style-type: none"> <li>Pavement has been recently patched in both lanes. A small sinkhole (0.3 to 0.5 m in diameter) has formed on the north edge of the pavement (waypoint 21). The sinkhole is located across the highway diagonally from a dip in the pavement surface on the south side of the highway indicating the presence of a void.</li> <li>A sinkhole at the culvert inlet (north of the highway) was filled with 4 m<sup>3</sup> of grout in October 2018</li> </ul>

(waypoint 681). The grout is intact and has not subsided since 2018.

C058-I and C058-II: Reinforced subgrade or asphalt to prevent collapse of roadway surface.

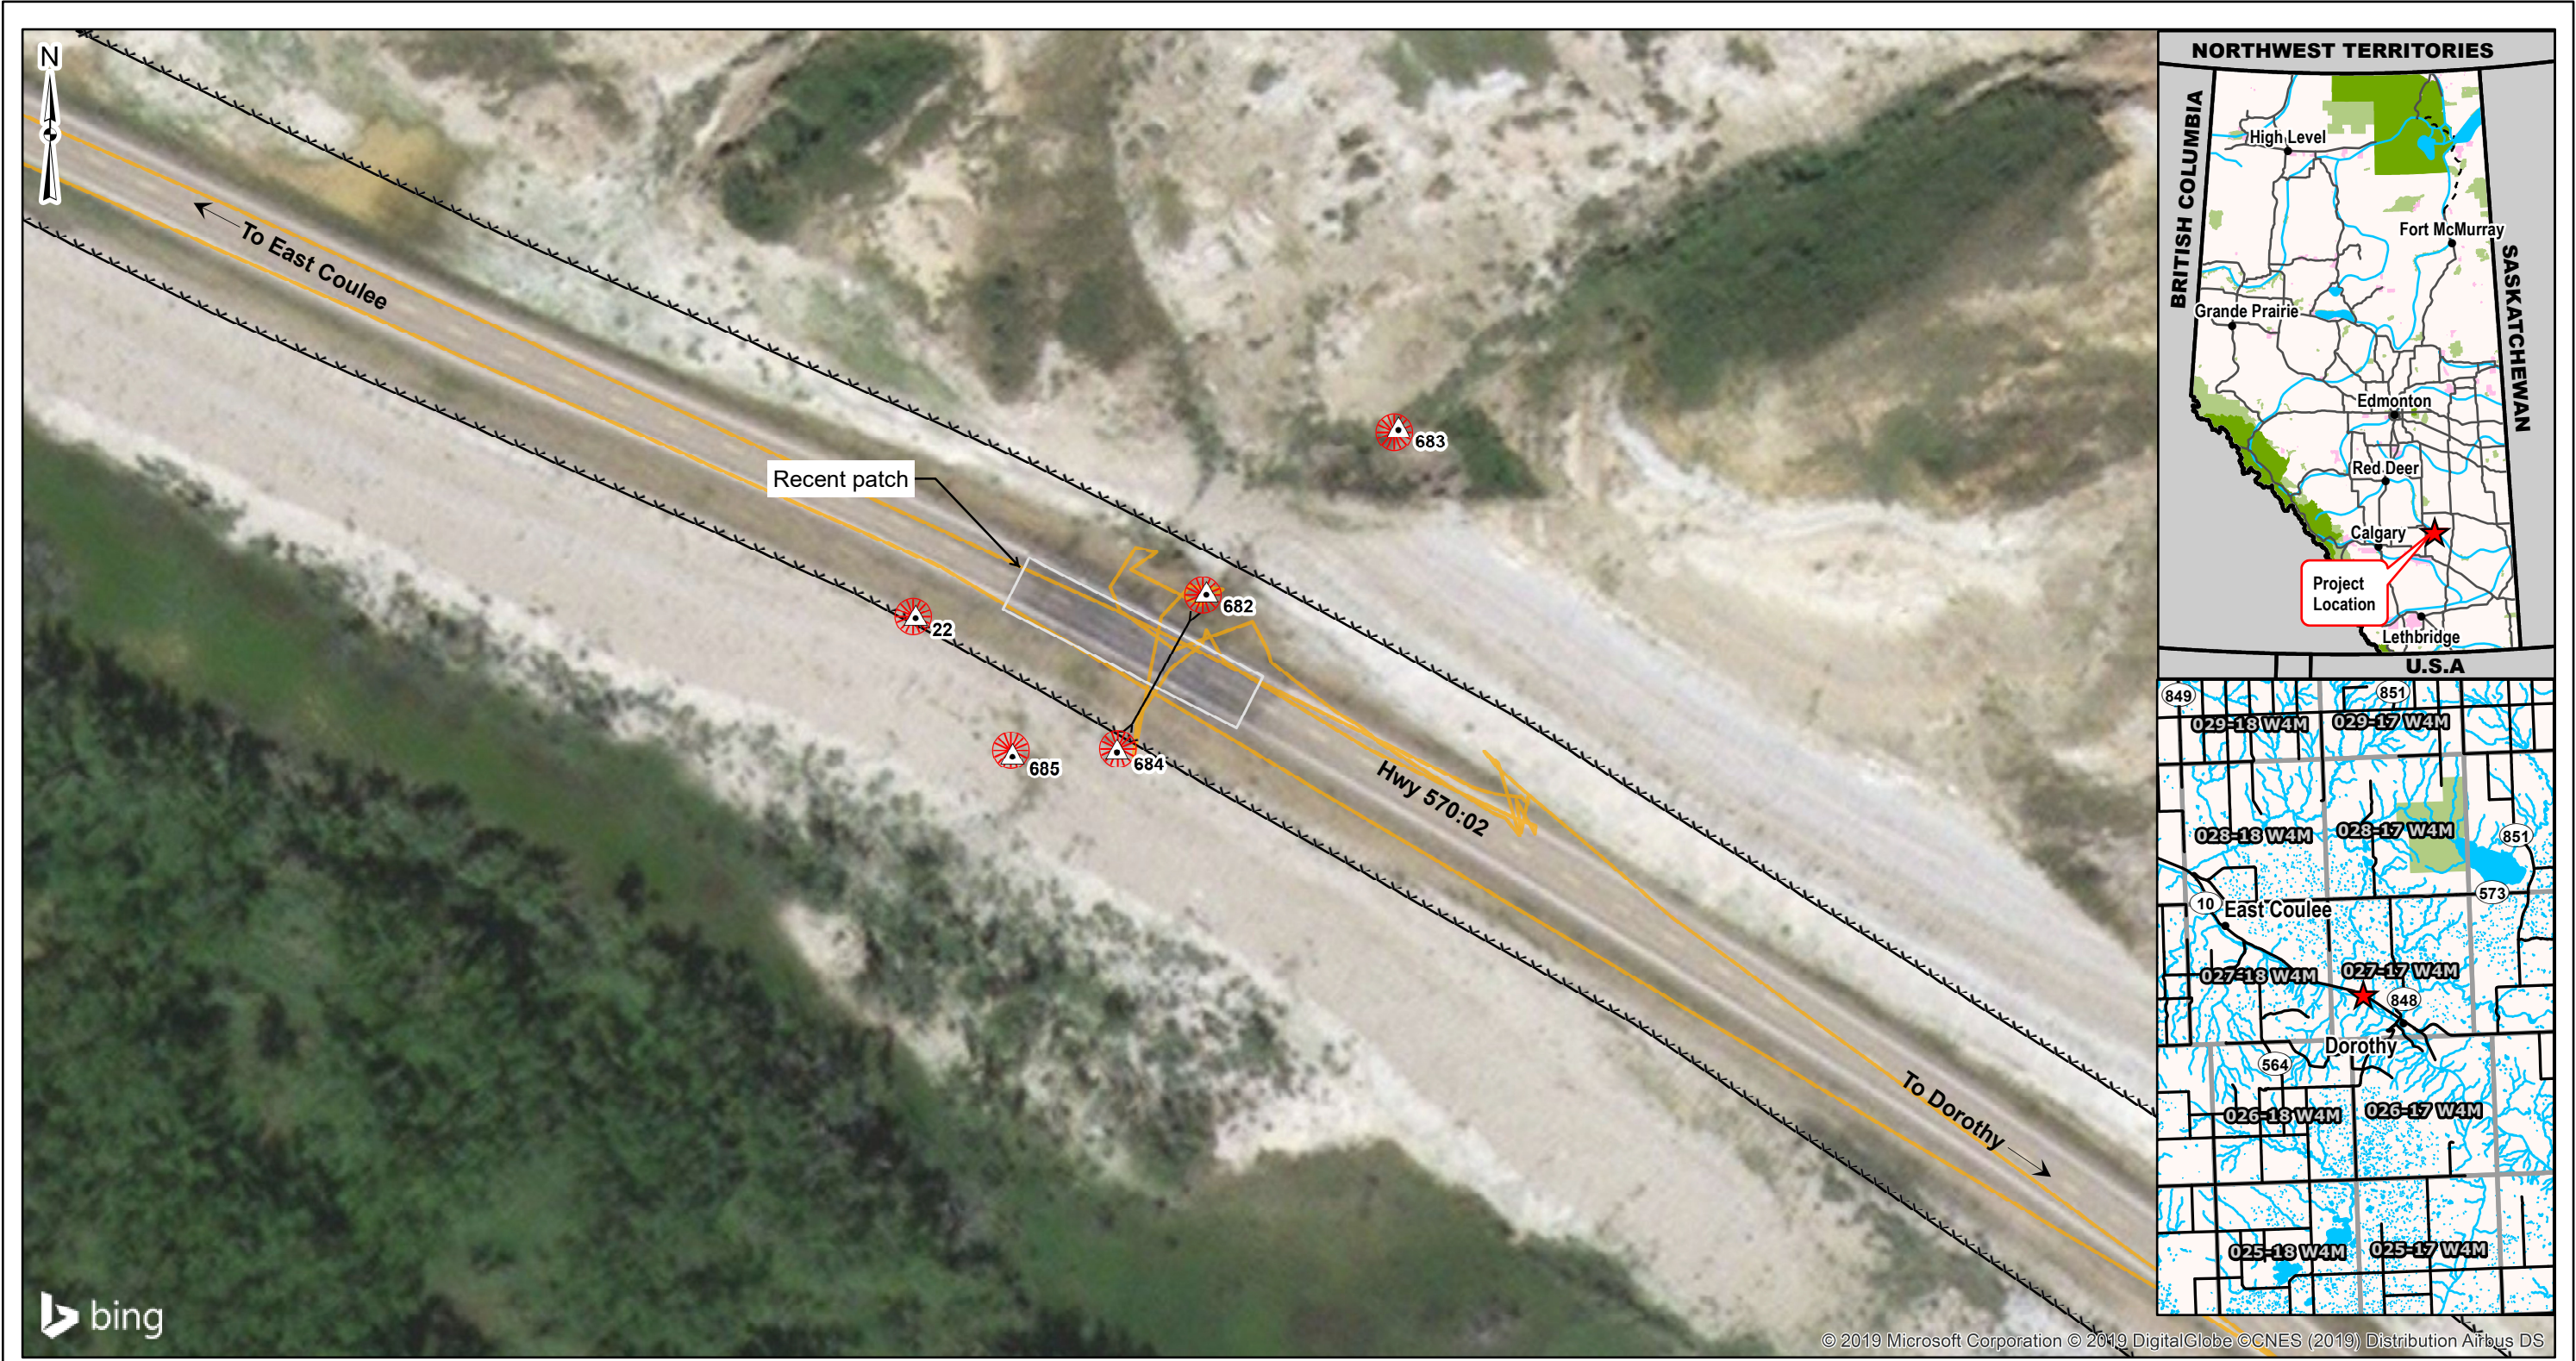
C058-II (Figure 2)

- Pavement has been recently patched in both lanes.
- A large sinkhole was discovered north of the highway at the fence line (waypoint 682) during the 2018 inspection. The sinkhole does not appear to have expanded since 2018.
- A sinkhole was discovered along the valley draw above the highway in 2018 (waypoint 683) that lines up with the sinkhole at waypoint 682 down to the road.
- Additional sinkholes (waypoint 684 and 685) were discovered during the 2018 inspection below the fence line on the south side of highway at the culvert outlet and near the toe of the slope, respectively.
- During the 2019 inspection, a series of small sinkholes (waypoint 22) were found near the fence line on the south side of the highway.

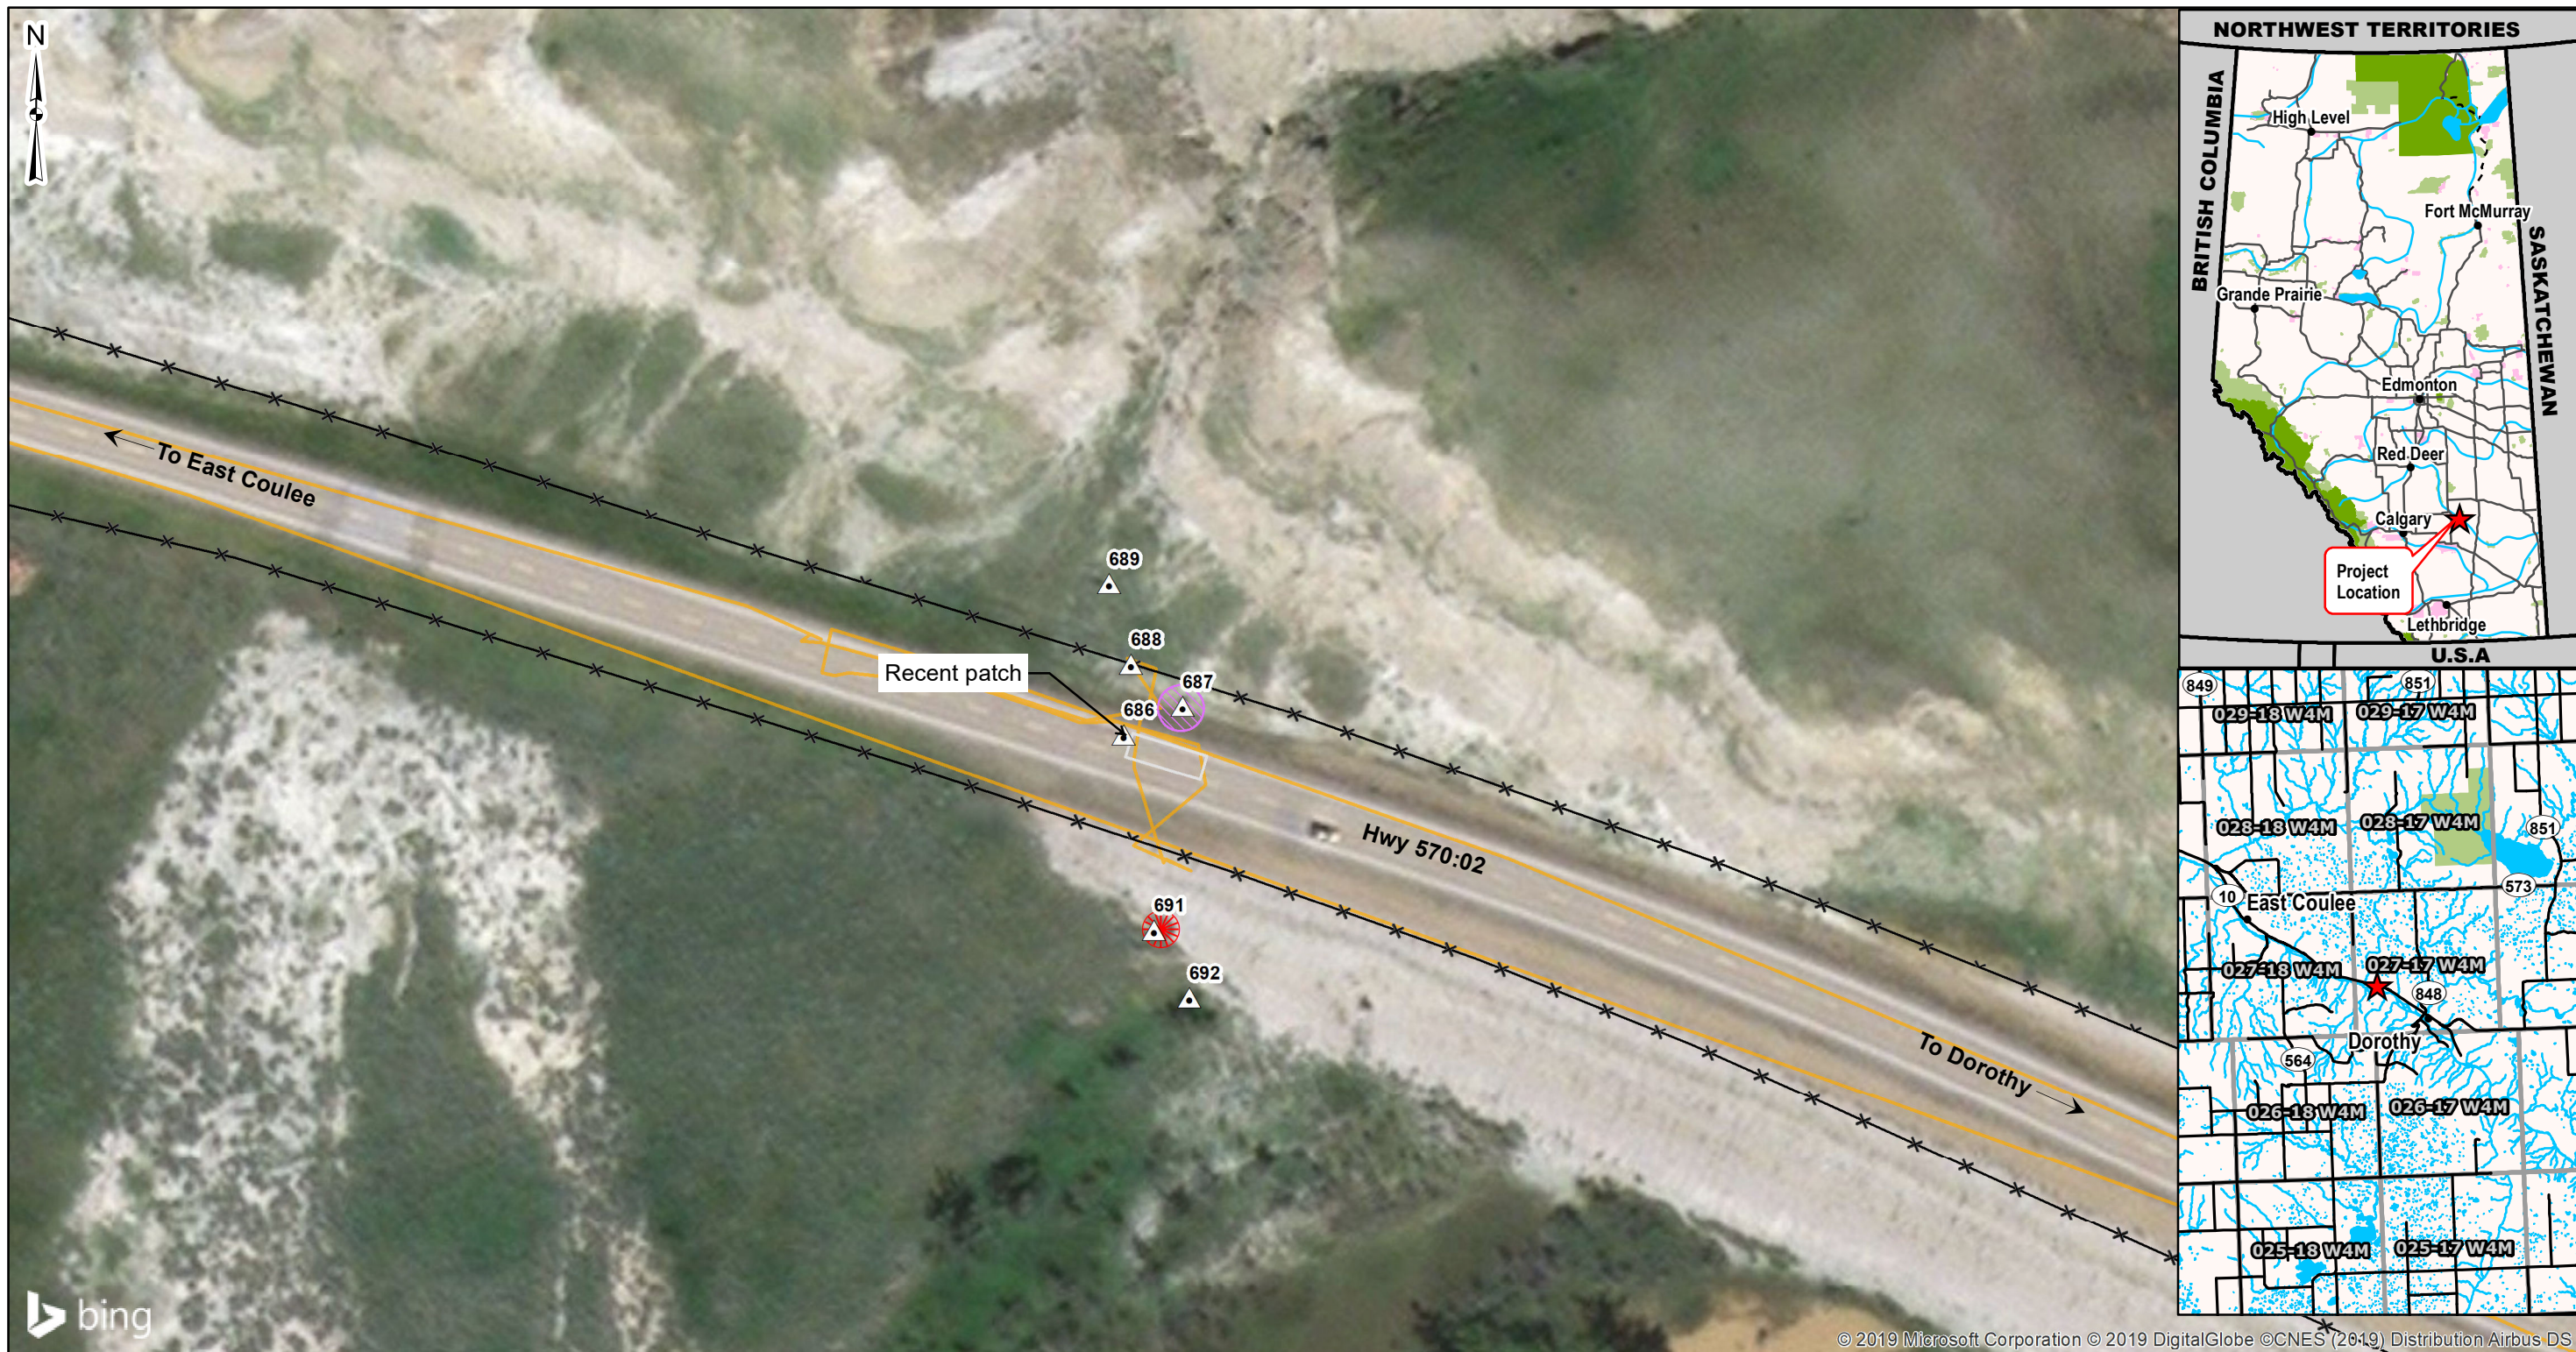
C058-III (Figure 3)

- North (westbound lane) of highway recently patched where sinkhole was observed during 2018 inspection (waypoint 686).
- A sinkhole in the ditch (waypoint 687) was filled with grout in 2018. The grout appeared to be heaving from groundwater pressure during the 2018 inspection. The grout cap and sinkhole are now buried with soil deposits and gravel fill.
- During the 2018 inspection, two sinkholes marked with 2x4 posts (waypoint 688 and 689) were full of water following filling of the sinkhole at waypoint 687 with grout, indicating that the void had been plugged.
- Two large sinkholes were found near the toe of the embankment on the south side of the highway during the 2018 inspection (waypoint 691 and 692). Sinkhole at waypoint 691 does not appear to have expanded since 2018 inspection.
- A continuous void (or voids) is believed to be present under the entire highway at this location.

C058-III: Install a cut-off wall in the ephemeral creek valley upslope of the highway to force groundwater to the surface and prevent further subsurface erosion.

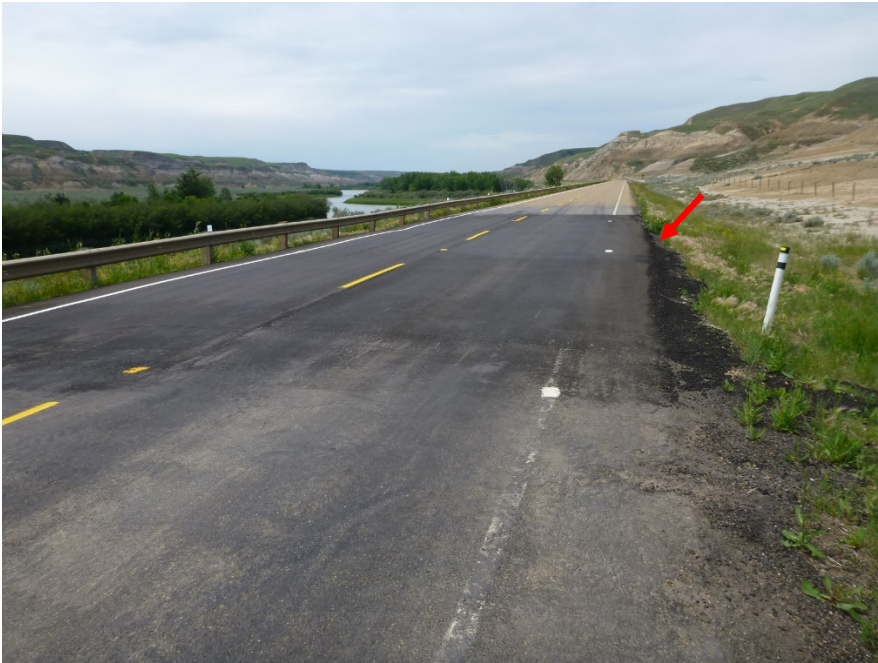
**Photo 1** Both lanes at C058-I have been recently patched. A small sinkhole has formed on the north edge of the pavement at waypoint 21 (red arrow; photo 2). Photo taken July 10, 2019 looking northwest.

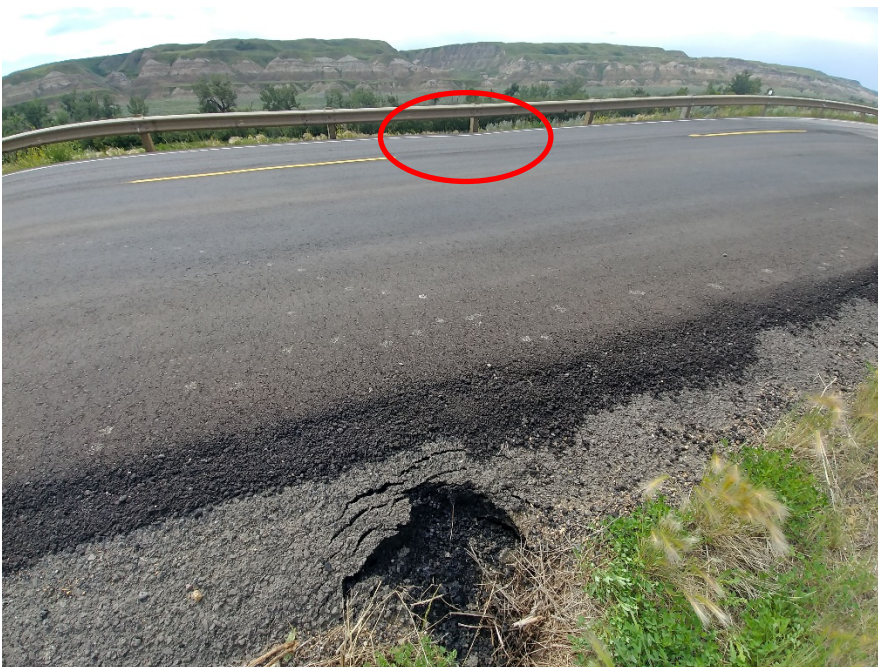
**Photo 2** Small sinkhole (0.3 to 0.5 m diameter) along the north edge of pavement at C058-I. Sinkhole is located diagonally from dip in pavement on south side of highway (red circle). Photo taken July 10, 2019 looking southwest.

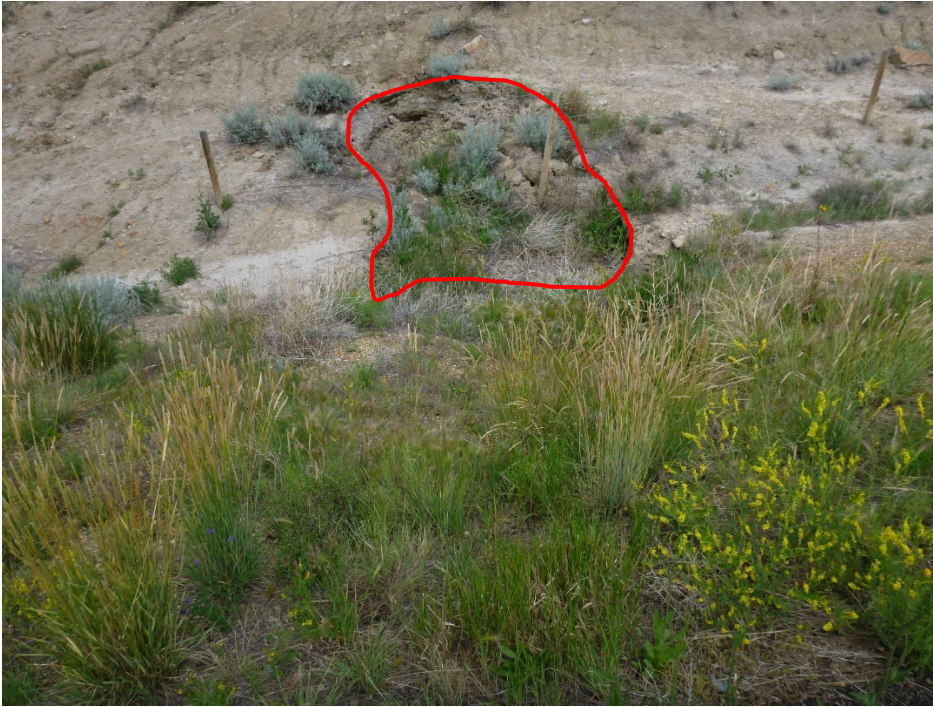
**Photo 3** Large sinkhole (red outline) on the north side of the highway at C058-II (waypoint 682). Sinkhole has not expanded since 2018 inspection. Photo taken July 10, 2019 looking north.

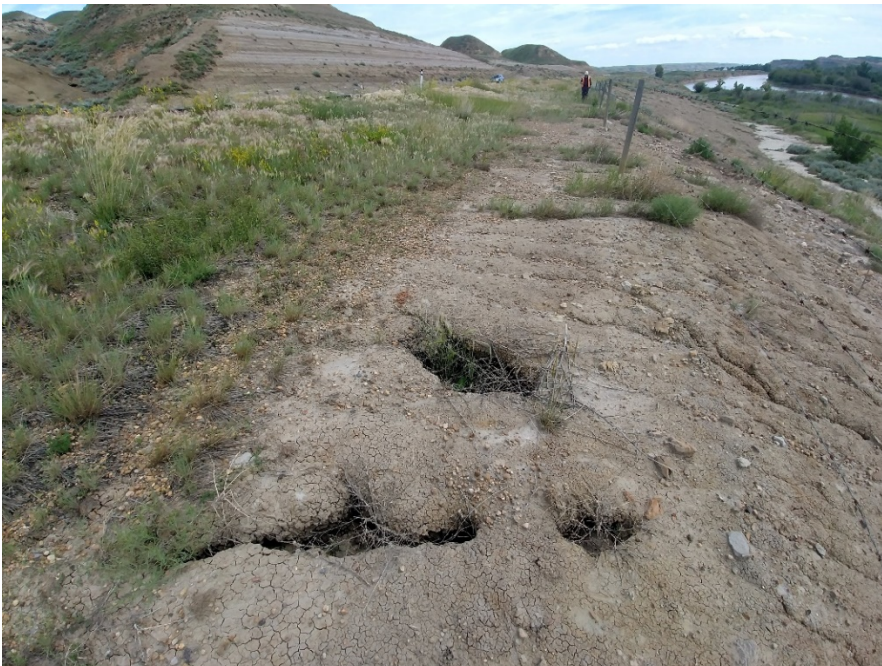
**Photo 4** Small sinkholes along the south side of the highway near the fence line at C055-II, west of the culvert outlet (waypoint 22). Photo taken July 10, 2019 looking southeast.

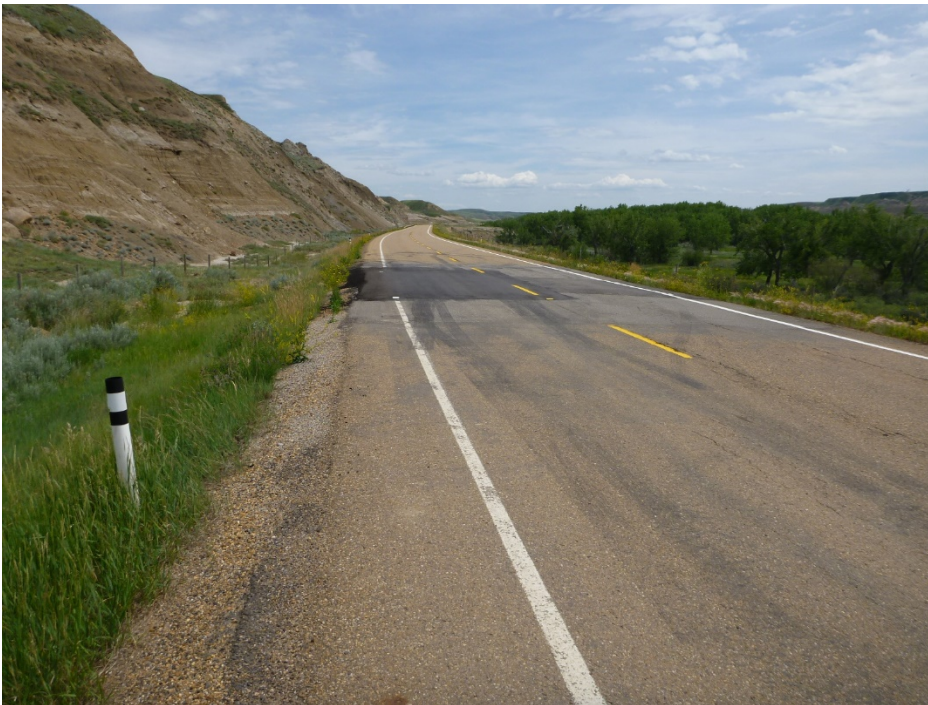
**Photo 4** Westbound lane at C058-III recently patched, covering existing sinkhole at waypoint 686. Photo taken July 10, 2019 looking southeast.

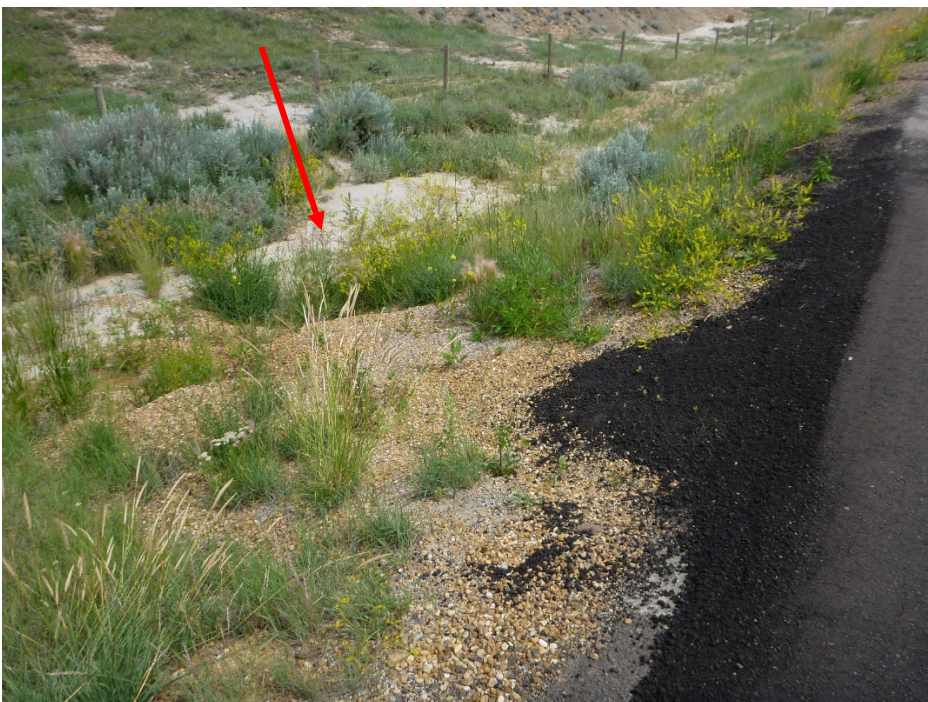
**Photo 5** Large sinkhole (red arrow) on north side of highway at the C058-III site grouted in 2018 no longer visible below soil deposits and gravel fill (waypoint 687). Photo taken July 10, 2019 looking east.

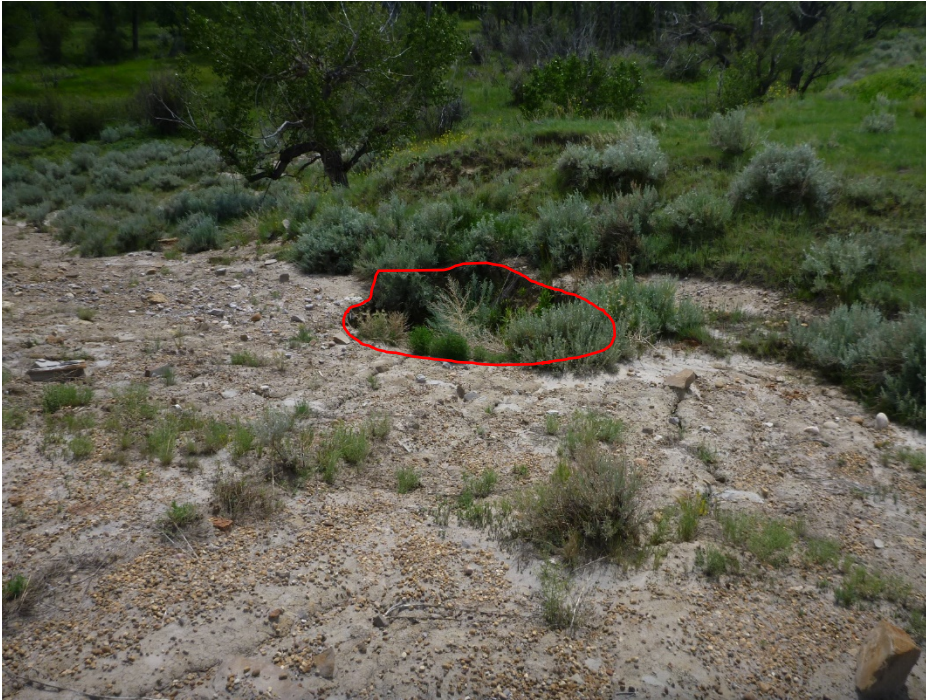
**Photo 6** Large sinkhole (red outline) at the toe of the south slope below highway at C058-III (waypoint 691) has not expanded since 2018 inspection. Photo taken July 10, 2019 looking south.
