SITE NUMBER AND NAME: <b>C058-I, -II, &amp; -III Sinkholes</b>		HIGHWAY & KM: 570:02, 8.3, 9.2, 9.8	PREVIOUS INSPECTION DATE: July 10, 2019	INSPECTION DATE: <b>June 24, 2021</b>
LEGAL DESCRIPTION: 10-08-027-17 W4M	NAD 83 COORDINATES: UTM Northing Easting <b>C058-I</b> 12 5683470 405475 <b>C058-II</b> 12 5683845 404934 <b>C058-III</b> 12 5684148 404224		RISK ASSESSMENT: PF: 8 CF: 5 TOTAL: 40 PF: 8 CF: 5 TOTAL: 40 PF: 8 CF: 5 TOTAL: 40	
AVERAGE ANNUAL DAILY TRAFFIC (AADT): 510 (west) & 360 (east) (Ref No. 116220 & 997198)			CONTRACT MAINTENANCE AREA (CMA): 521

SUMMARY OF SITE INSTRUMENTATION:  There is no instrumentation at the C058 site.  LAST READING DATE: N/A	INSPECTED BY: Chris Gräpel (KCB) James Lyons (KCB) Roger Skirrow (AT) Tony Penney (AT)
PRIMARY SITE ISSUE: Settlement of Hwy 570 due to the presence of dispersive-soil voids beneath the highway surface.	
APPROXIMATE DIMENSIONS: Numerous soil voids along a 1.5 km stretch of Hwy 570.	
DATE OF ANY REMEDIAL ACTION: May 3, 2010 – remediated using foam injection; May 29, 2015 – excavated (deep) and reconstructed with gravel fill and a culvert; unknown – sinkholes in ditch backfilled; speed reduction signs to 50 km/h and hazard mar

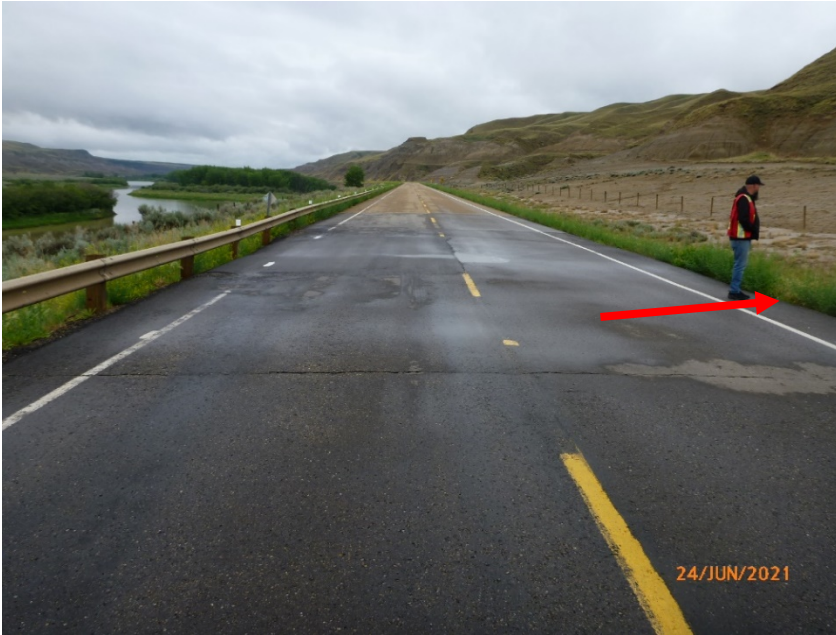
<b>COMMENTS</b>
C058-I: <ul style="list-style-type: none"> <li>Pavement has been recently patched in both lanes. A small sinkhole (0.3 to 0.5 m in diameter) has formed on the north edge of the pavement (Waypoint 21). The sinkhole is located across the highway diagonally from a dip in the pavement surface on the south side of the highway indicating the presence of a void.</li> </ul>

- Photo 1** Both lanes at C058-I have been recently patched. A small sinkhole (first observed in 2018) is on the north edge of the pavement indicated by red arrow). Photo taken June 24, 2021 looking west.

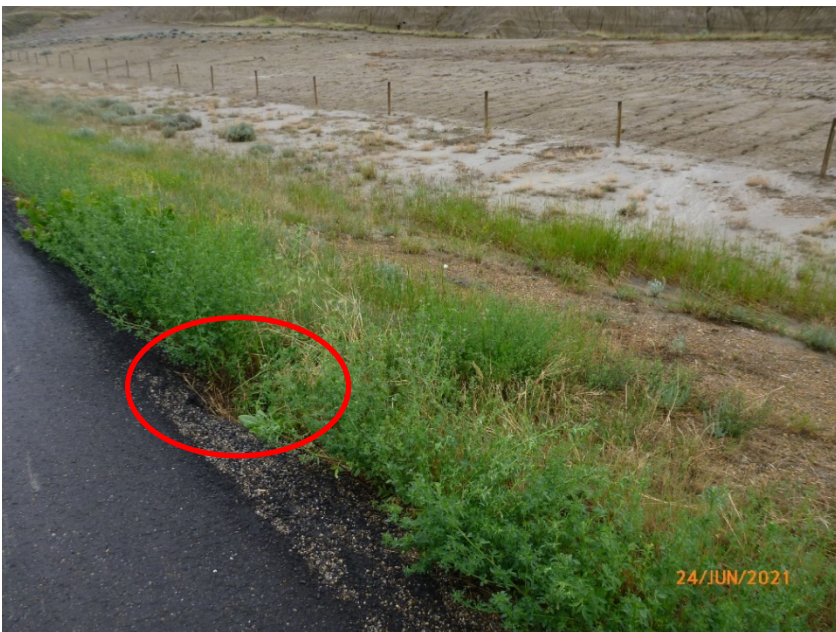
- Photo 2** Small sinkhole (0.3 m to 0.5 m diameter) along the north edge of pavement at C058-I. Sinkhole is located diagonally from dip in pavement on south side of highway (red circle). Photo taken June 24, 2021 looking northwest.

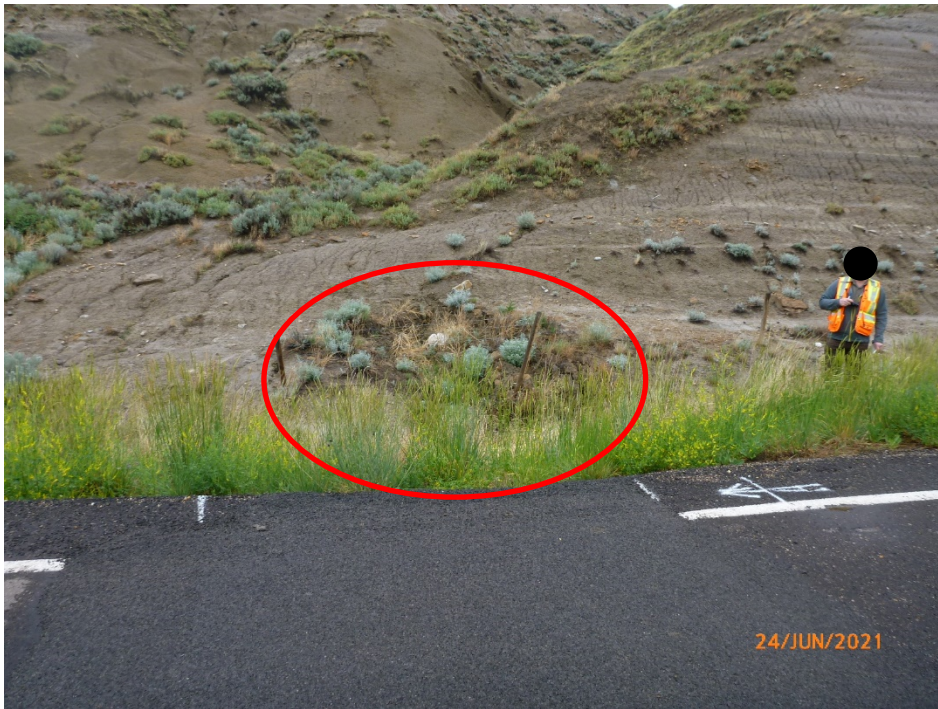
**Photo 3** Large sinkhole (indicated by black circle) on the north side of the highway at C058-II has expanded since the 2019 inspection. Photo taken June 24, 2021 looking north.

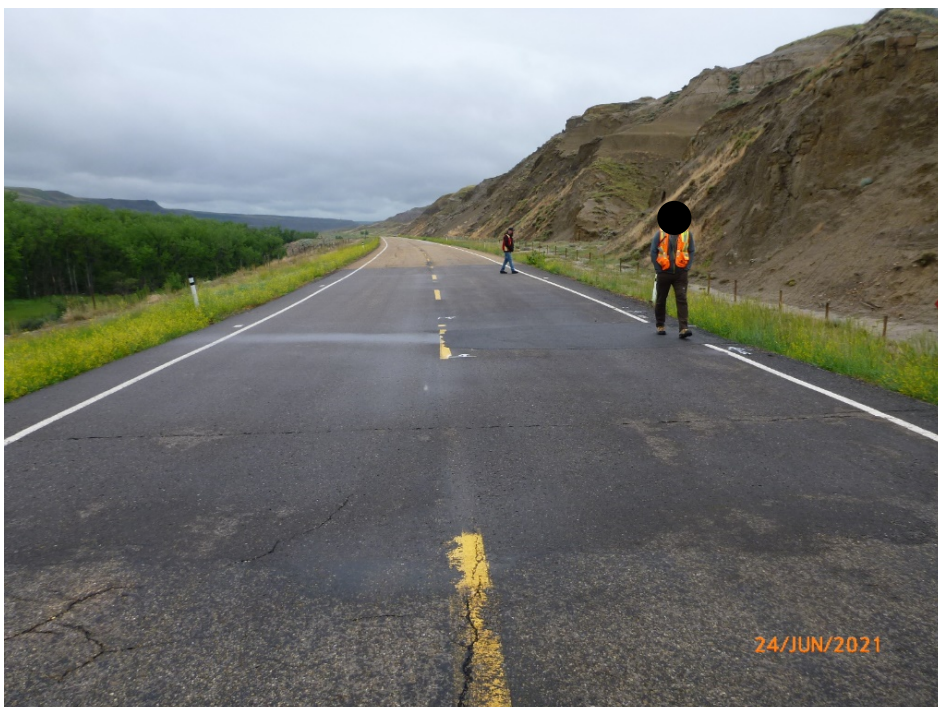
- Pavement has been recently patched in both lanes. The patch has settled since completion, with ponded water from recent rain showing in the dip location.
- A large sinkhole was discovered north of the highway at the fence line during the 2018 inspection. The sinkhole has expanded since the 2018 and 2019 inspections (in line with asphalt settlement).
- A sinkhole was discovered along the valley draw above the highway in 2018 that lines up with the sinkhole downslope of the road.
- Additional sinkholes were discovered during the 2018 inspection below the fence line on the south side of highway at the culvert outlet and near the toe of the slope, respectively.
- During the 2019 inspection, a series of small sinkholes were found near the fence line on the south side of the highway.

**Photo 4** New asphalt patch at C058-II. Settlement in the westbound lane that was holding water from recent precipitation is above the existing culvert. Photo taken June 24, 2021 looking west.

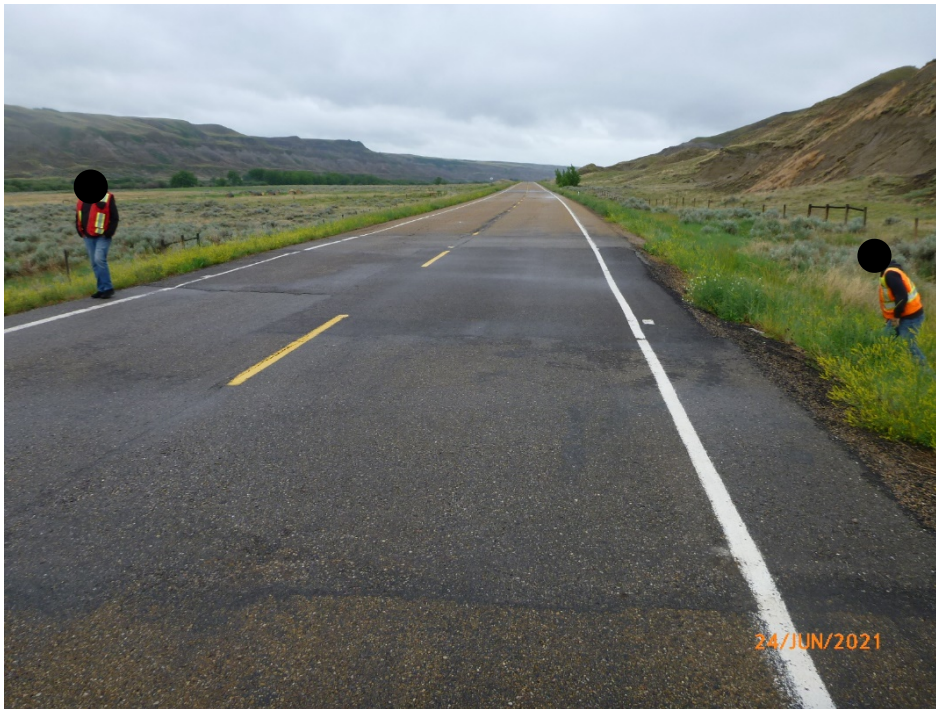
- North (westbound lane) of highway recently patched where sinkhole was observed during 2018 inspection.
- A sinkhole in the north ditch was filled with grout in 2018. The grout appeared to be heaving from groundwater pressure during the 2018 inspection. The grout cap and sinkhole are now buried with soil deposits and gravel fill.

**Photo 5** C058-III was recently patched, covering the previously observed sinkhole. Photo taken June 24, 2021 facing west.

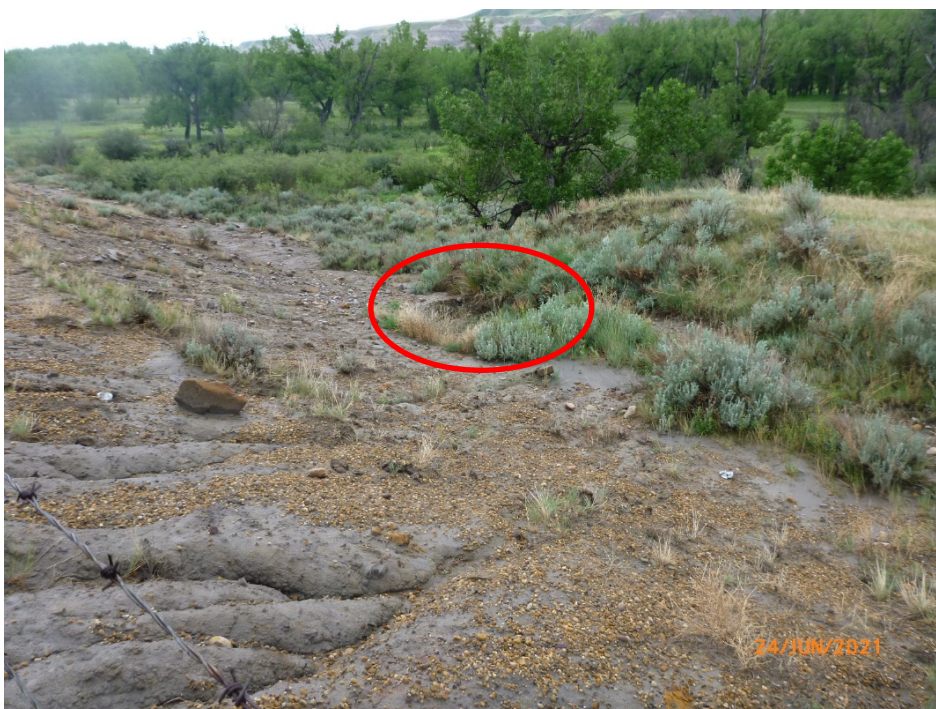
- Two large sinkholes were found near the toe of the embankment on the south side of the highway during the 2018 inspection (Waypoint 691 and 692). Sinkhole at Waypoint 691 does not appear to have expanded since 2018 inspection.

**Photo 6** Large sinkhole (indicated by a red circle) at the toe of the south slope below highway at C058-III has not expanded since 2019 inspection. Photo taken June 24, 2021 looking southeast.
