SITE NUMBER AND NAME: C058 Erosion and Sinkholes	HIGHWAY & KM: 570:01, 8.3, 9.2, 9.8	PREVIOUS INSPECTION DATE: June 26, 2023	INSPECTION DATE: June 10, 2025
LEGAL DESCRIPTION: 10-08-27-17 W4M	NAD 83 COORDINATES: UTM Northing Easting C058-1 12 5683470 405475 C058-2 12 5683845 404934 C058-3 12 5684148 404224	RISK ASSESSMENT: C058-1: PF: 8 CF: 5 TOTAL: 40 C058-2: PF: 8 CF: 5 TOTAL: 40 C058-3: PF: 8 CF: 5 TOTAL: 40	
HIGHWAY CLASSIFICATION NUMBER: 3		CONTRACT MAINTENANCE AREA (CMA): 521	
AVERAGE ANNUAL DAILY TRAFFIC (AADT): 500 (west) & 400 (east) (Ref No. 116220 & 997198)

SUMMARY OF SITE INSTRUMENTATION: There is no instrumentation at the C058 site. LAST READING DATE: N/A	INSPECTED BY: Chris Gräpel (KCB) James Lyons (KCB) Tony Penney (TEC) Chris Newman (TEC) Imram Mehmood (TEC)
PRIMARY SITE ISSUE: Settlement of Hwy 570:01 due to the presence of dispersive-soil voids beneath the highway surface.	
APPROXIMATE DIMENSIONS: Numerous subsurface voids along an approximate 1.5 km stretch of Hwy 570:01.	
DATE OF ANY REMEDIAL ACTION: May 3, 2010 – remediated using foam injection; May 29, 2015 – excavated (deep) and reconstructed with gravel fill and a culvert; unknown – sinkholes in ditch backfi

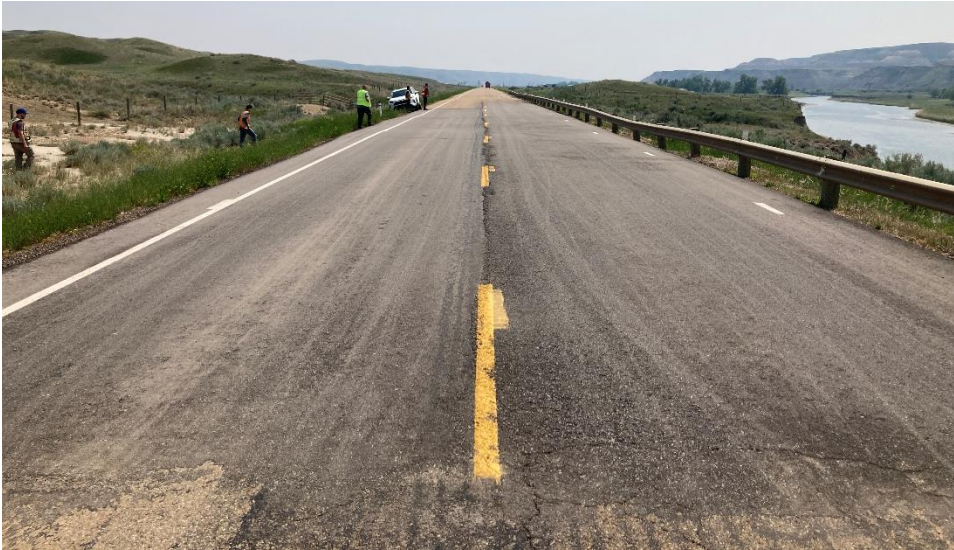
- The highway was patched between the 2023 and 2025 inspections (Photo 1). The dip in the highway surface (across both lanes) did not appear to have significantly changed between the 2023 and 2025 inspections.

Photo 1 Pavement patch completed at the C058-1 site between the 2023 and 2025 inspections. Photo taken June 10, 2025 facing west.

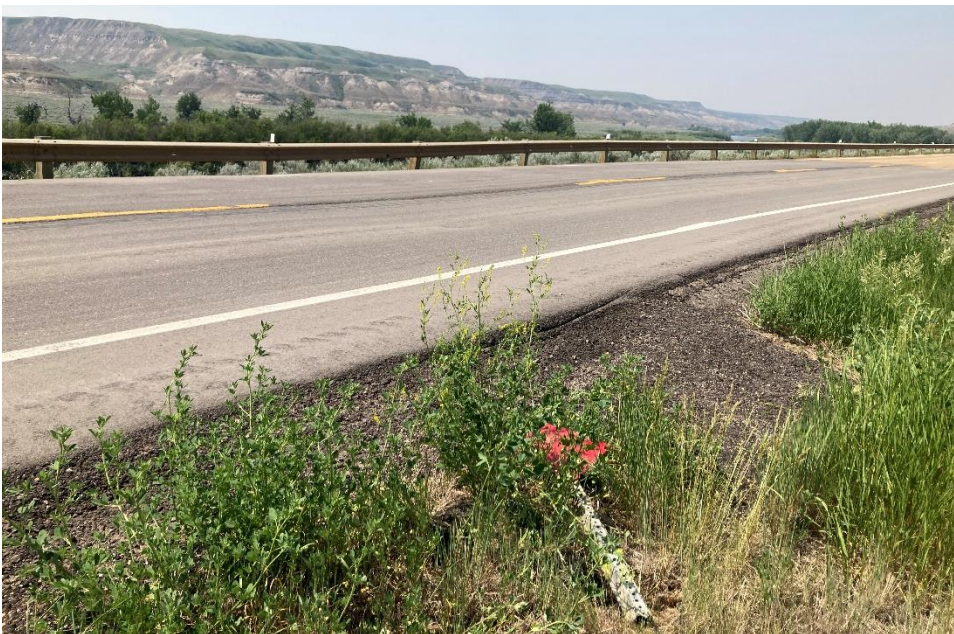
- An existing sinkhole (previously estimated to be between approximately 0.3 m to 0.5 m in diameter) was on the north edge of the pavement and has been backfilled with pavement during pavement patching (Photo 2). A red diamond hazard marker, used to identify the sinkhole location, was lying on the ground beside the sinkhole during the 2025 inspection.

Photo 2 Pavement settlement and sinkhole backfilled with asphalt at the north edge of the highway surface. Red diamond hazard sign lying at the edge of the road. Photo taken June 10, 2025 facing southwest.

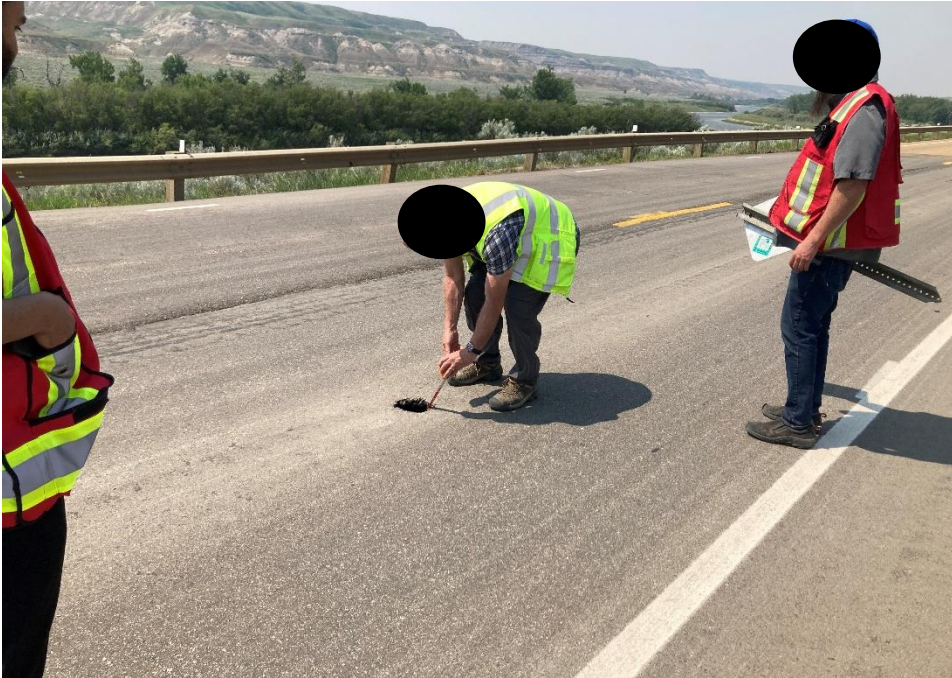
- During the 2025 inspection, a subsurface void was discovered below the north (westbound) lane (Photo 3 and 4). At surface, there is a relatively small hole through the highway surface, approximately 150 mm (6") in diameter. However, below surface, KCB and TEC estimated (using a flashlight and tape measure) the void was approximately 1 m deep, 1.5 m wide, and 2 m long.

Photo 3 Sinkhole (approximately 1 m deep, 1.5 m wide, and 2 m long) below the middle of the north (westbound) lane discovered during the 2025 inspection. Photo taken June 10, 2025 facing southwest.

- TEC immediately implemented temporary traffic control measures (single lane closure) to divert traffic to the south (westbound) lane.
 - KCB drove to an area of cell reception and notified the Maintenance Contract Inspector (MCI) of the void discovered below the highway surface. The MCI told KCB they would immediately contact the Highway Maintenance Contractor (HMC) who would mobilize to site to set up traffic accommodations and backfill the void. The HMC was on-site within 1 hour of notifying the MCI.

- TEC informed KCB after the site inspection that the HMC backfilled the void with "dirty" gravel.
- A sinkhole near the culvert inlet (north of the highway) was filled in October 2018. The grout is intact and has not subsided since 2018. There is vegetation (small shrubs) in the north ditch near the culvert inlet (Photo 5).

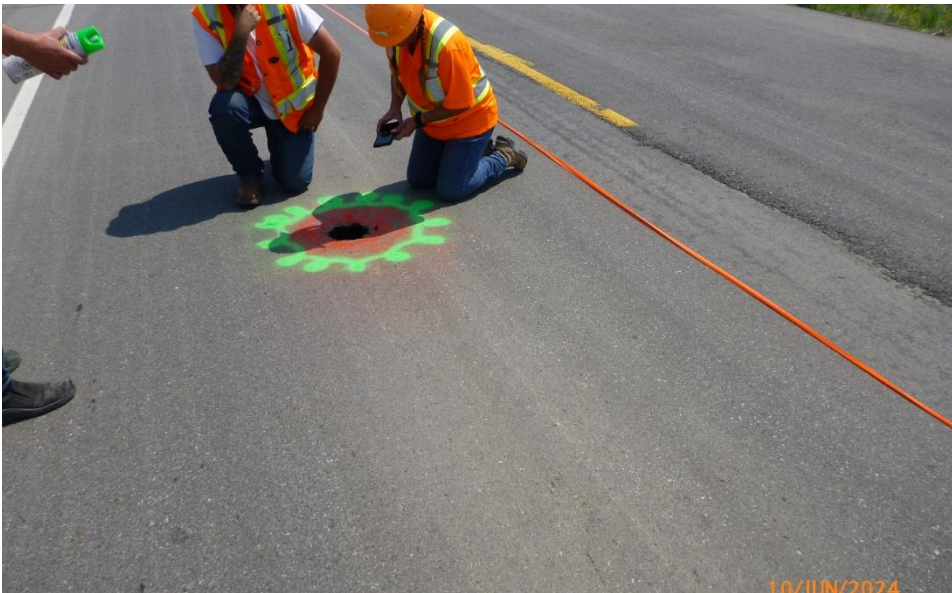
Photo 4 Highway Maintenance Contractor applying spray paint around sinkhole opening. Photo taken June 10, 2025 facing east.

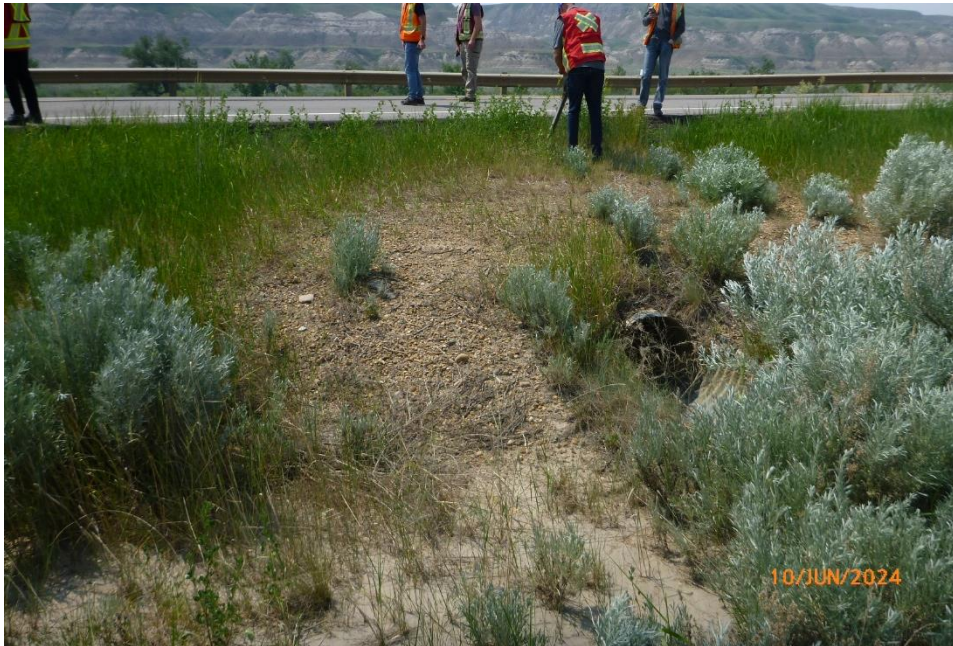
Photo 5 Culvert inlet in the north (westbound) ditch. Photo taken June 10, 2025 facing south.

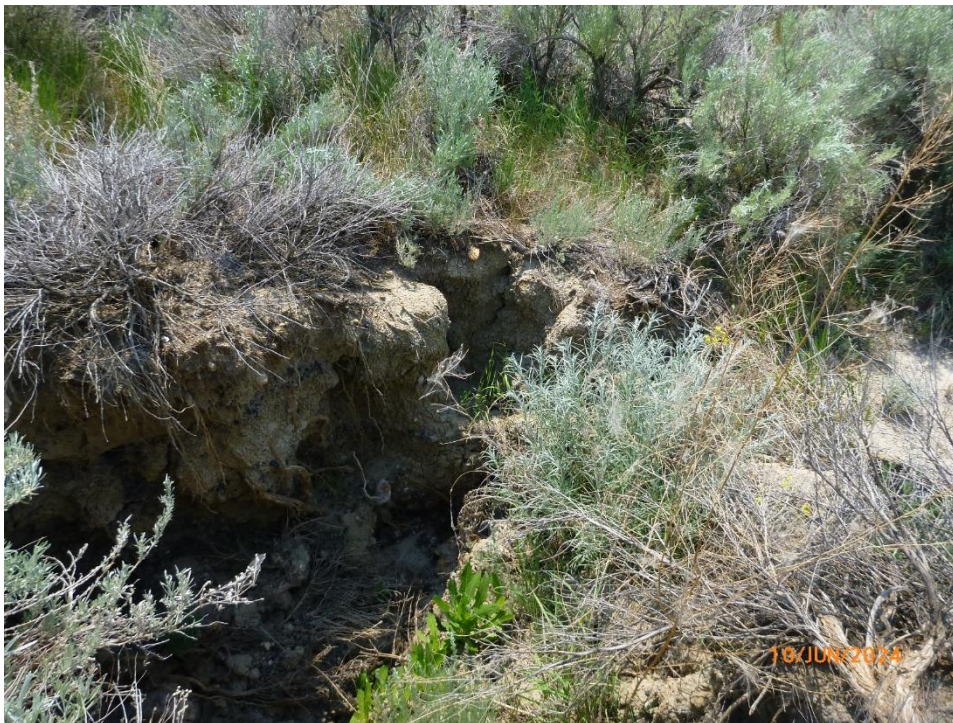
- A void was observed in the bottom portion of the riverbank, approximately 1 m to 2 m above the water level (Photo 7), and a linear erosion feature (up to 1 m deep, Photo 6) located on the south side of the highway. The linear erosion feature was located downstream of the culvert outlet (Photo 6 and 7). The two erosion features were located across the highway diagonally from the dip in the pavement surface and subsurface void observed during the 2025 inspection. This may indicate the presence of a series of voids below the highway surface along a preferential drainage path.

Photo 6 Erosion gully on downstream (south) highway embankment slope. Photo taken June 10, 2025 facing south.

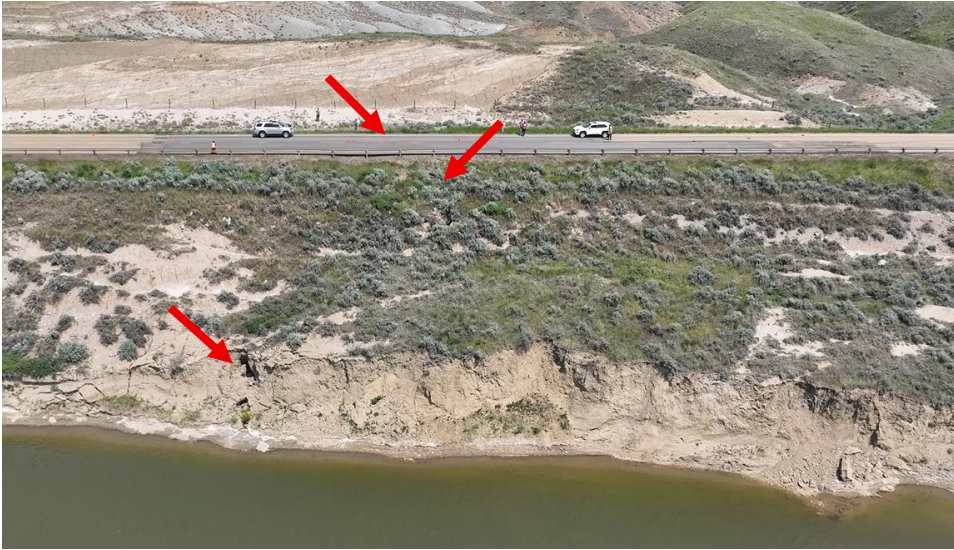
- A drone flight was completed while KCB and TEC were waiting for the HMC to arrive on site. During the drone flight, KCB observed two sinkholes/voids south of the pavement patch on the riverbank approximately 1 m to 2 m above the Red Deer River (Photo 7). Water was flowing out of the sinkholes during the inspection.

Photo 7 Void (indicated by red arrow) observed on the north riverbank slope during the 2025 inspection, downslope of the sinkhole observed beneath the highway surface (indicated by red arrow). Culvert outlet and linear erosion feature (up to 1 m deep) indicated by red arrow. Water was flowing out the void during the inspection. Photo taken June 10, 2025 facing north.

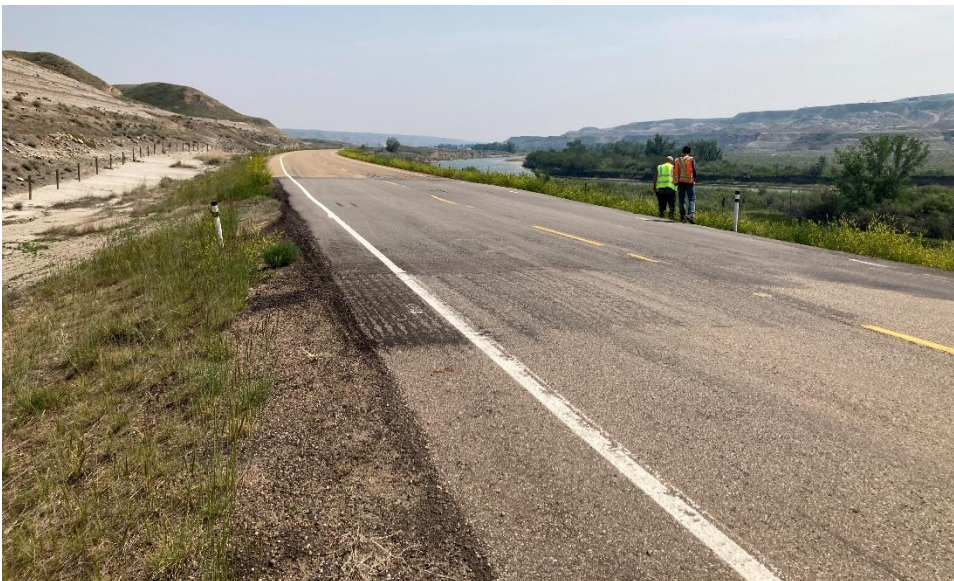
- A pavement patch was completed between the 2023 and 2025 inspections (Photo 8). The settlement appeared similar to during the 2023 inspection (Photo 9).

Photo 8 Pavement patch (completed between 2023 and 2025) at the C058-2 site. Photo taken June 10, 2025 facing west.

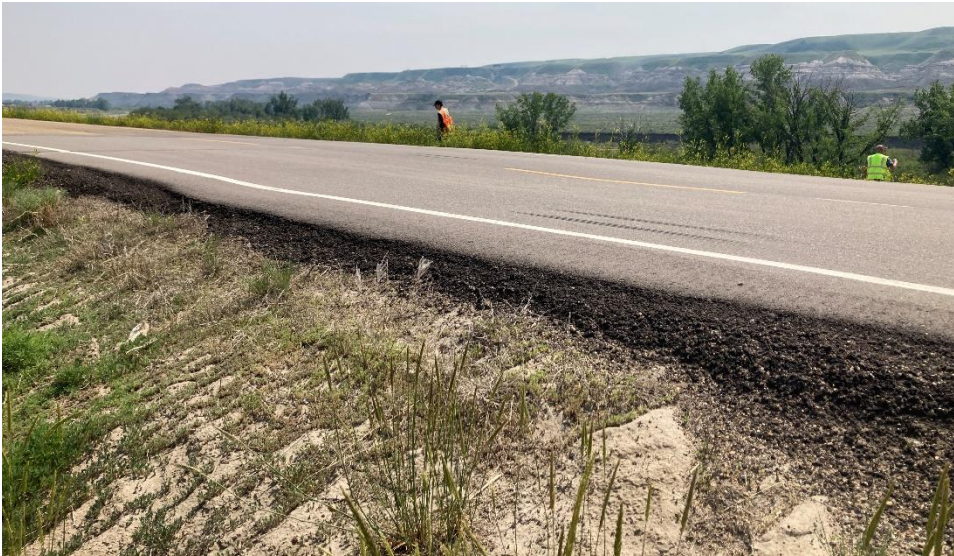
Photo 9 **Dip in highway surface at the C058-2 site. Photo taken June 10, 2025 facing southeast.**

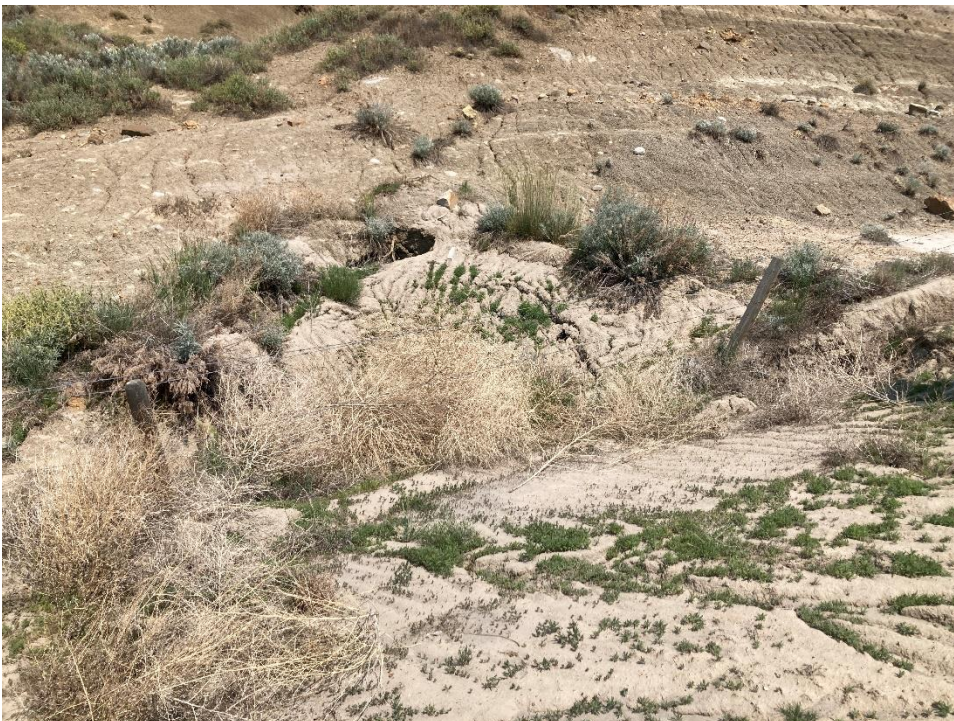
- A large sinkhole was first observed north of the highway (north of the pavement patch) at the fence line during the 2018 inspection. The sinkhole has expanded between the 2023 and 2025 inspections and was approximately 3 m in diameter (Photo 10 and 11).

- Local material was placed in the north (westbound) highway ditch, east of the culvert inlet (Photo 10). This fill was most likely placed to backfill erosion features on the north highway embankment slope and ditch.

Photo 10 **Large sinkhole (approximately 3 m in diameter) in the north (westbound) ditch that is impacting the fence. Photo taken June 10, 2025 facing north.**

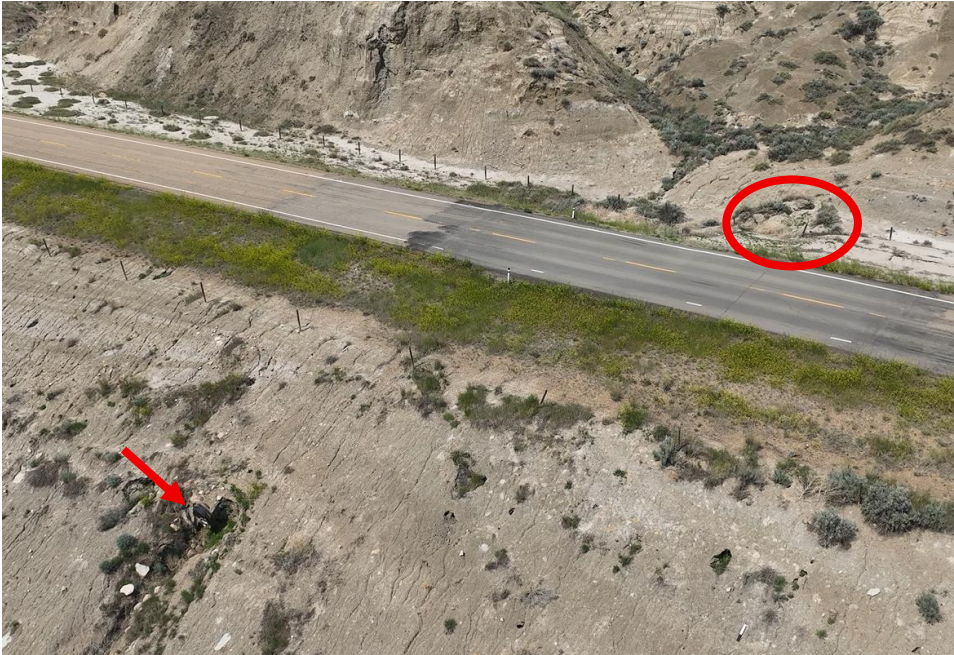
- Since 2018, additional sinkholes have been observed at the site, below the fence line on the south side of highway at the culvert outlet, and near the toe of the slope (Photo 11).

Photo 11 Aerial photo of the C58-2 site showing the pavement patch, culvert outlet (indicated by red arrow), and large sinkhole (indicated by red circle). Photo taken June 10, 2025 facing northwest.

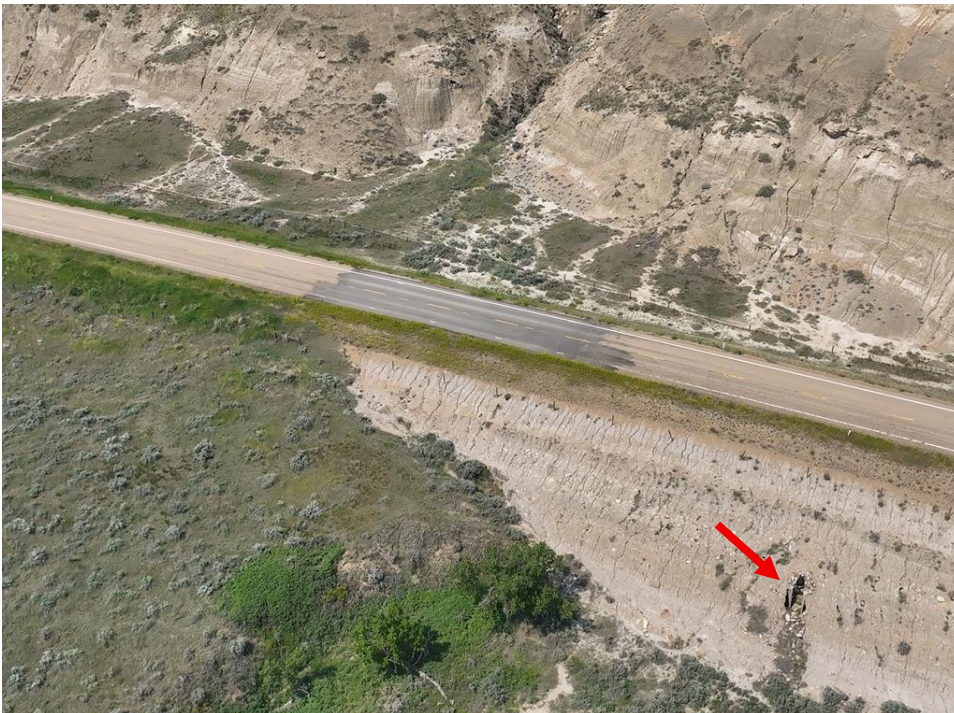
- A large sinkhole was located at the toe of the south highway embankment slope (first observed during the 2018 inspection) (Photo 12). The sinkhole did not appear to have enlarged significantly since the 2023 inspection.

Photo 12 Aerial photo of the C058-3 site showing the pavement patch and culvert outlet (indicated by red circle). Photo taken June 10, 2025 facing north.
