Klohn Crippen Berger

Alberta Transportation

Hwy 570:01, km 8.8 (Near Dorothy) Call-Out Report

October 2022

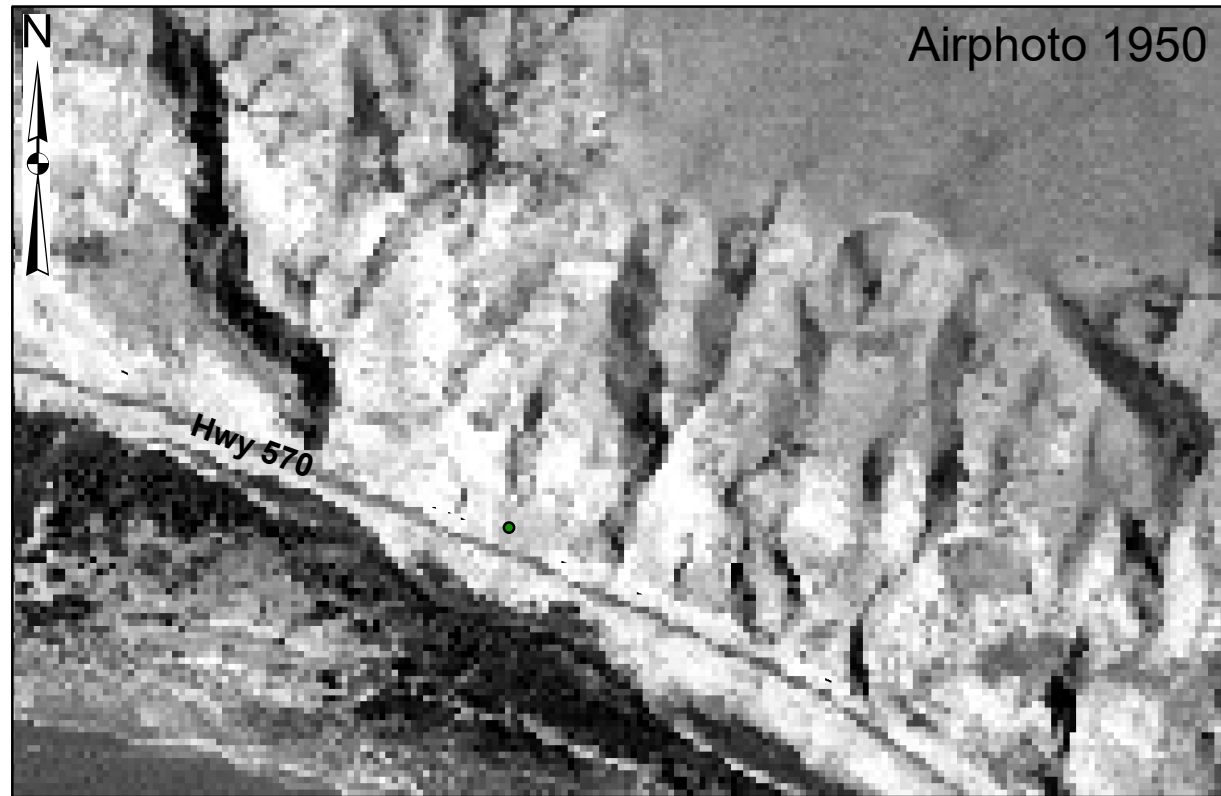
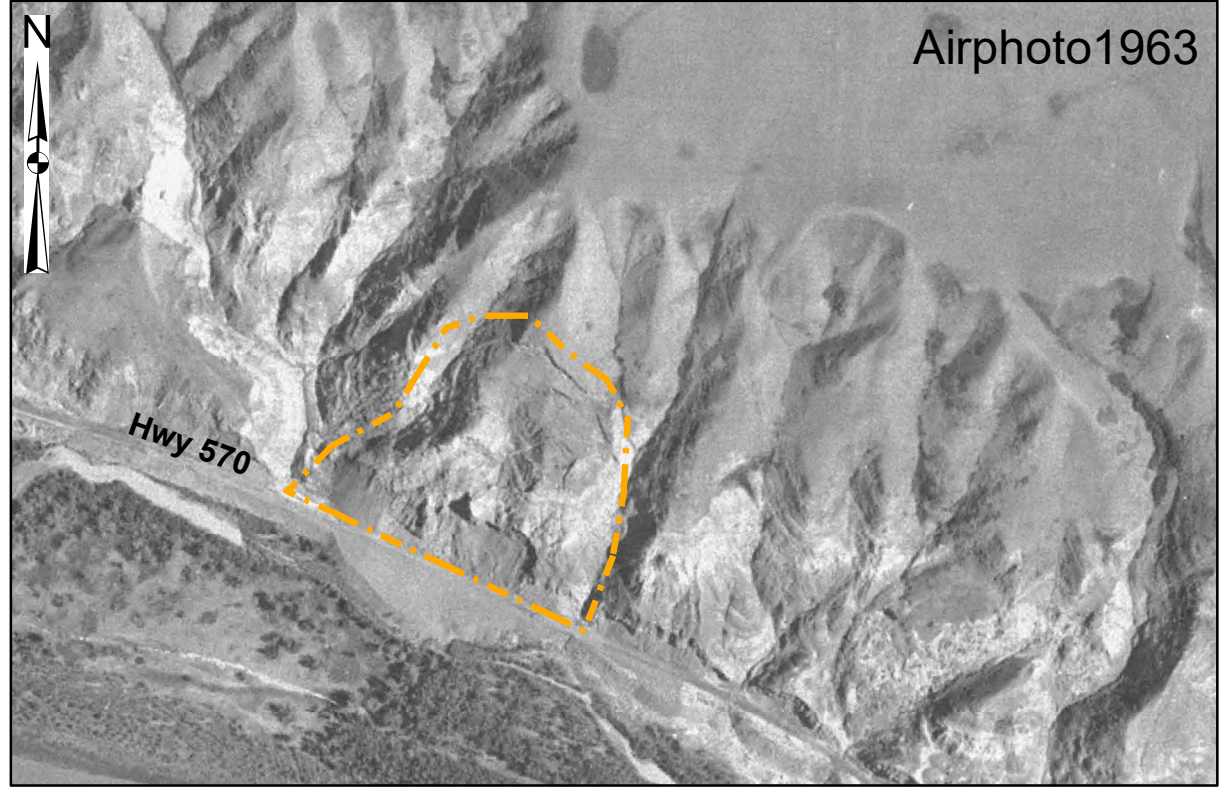
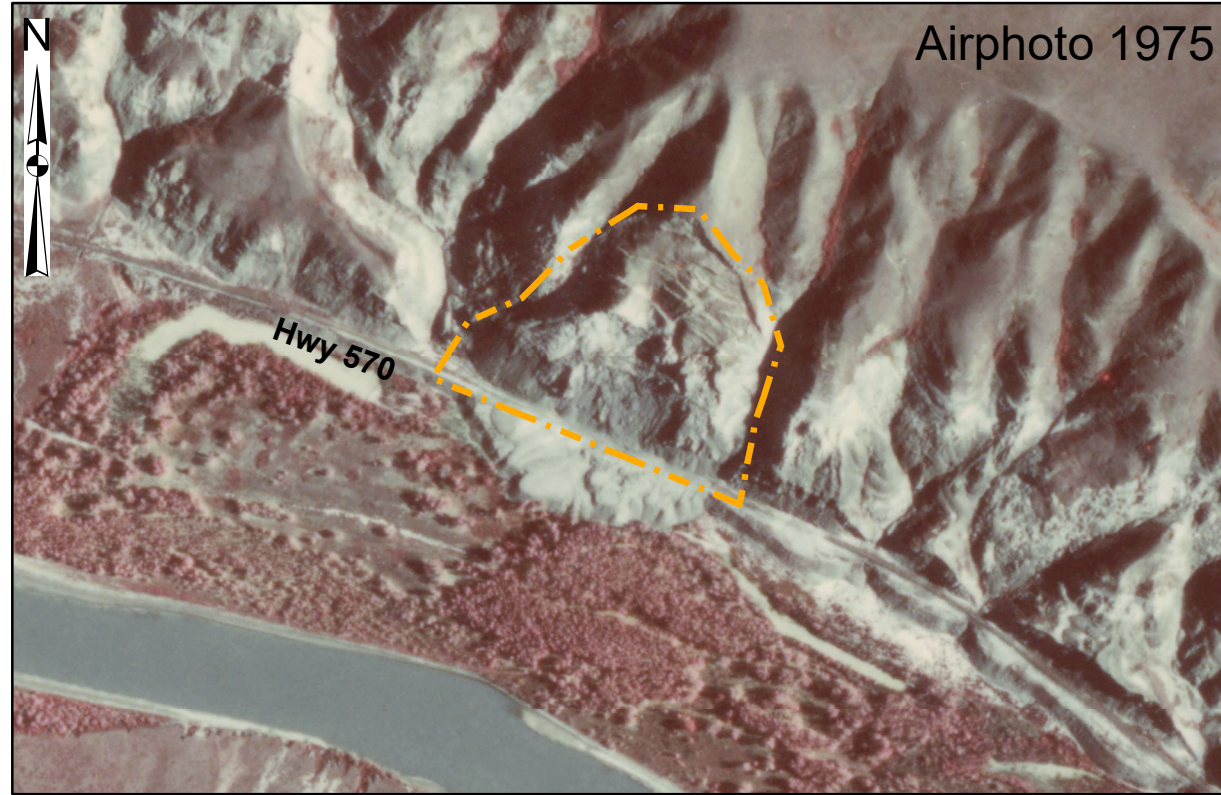
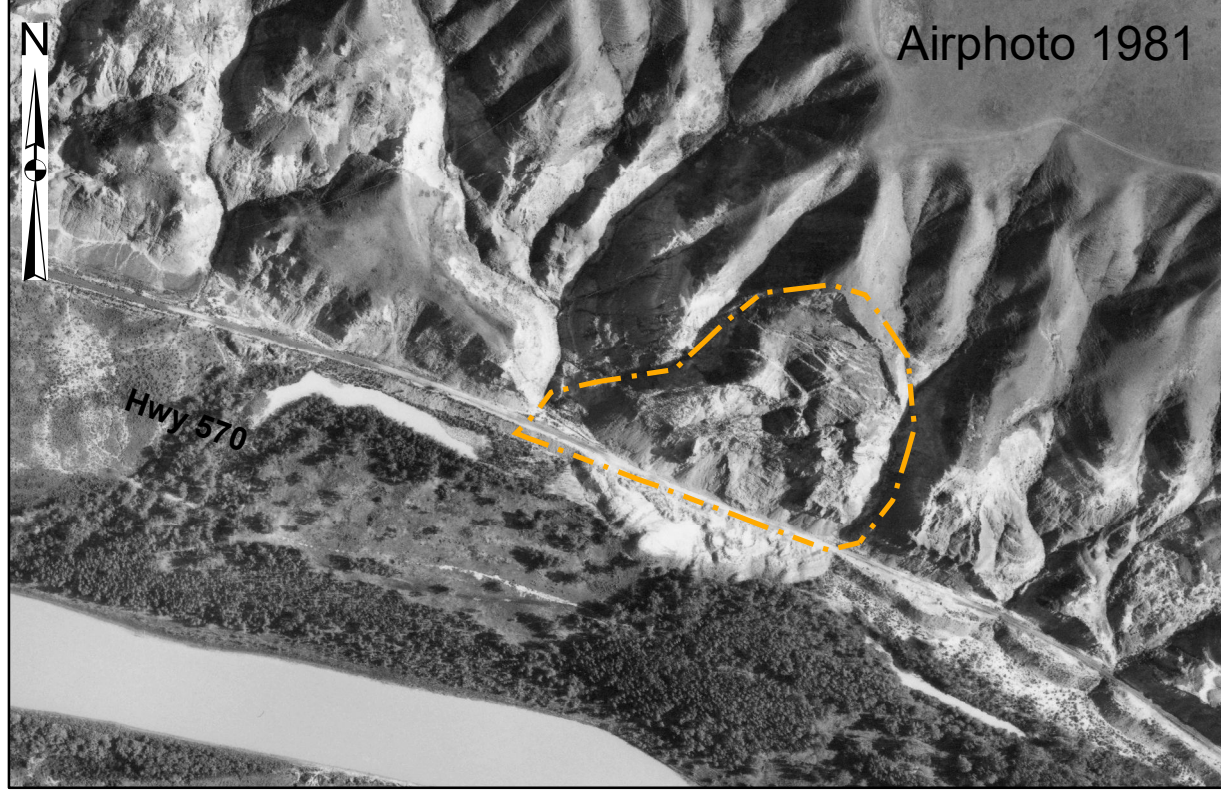
- The railway appeared to be in place in 1950 and the highway was constructed by 1986. The scale of the air photos does not permit assessment on if highway construction involved excavating the toe of the natural valley slope at the site;

- The earliest evidence of cracking and slope deformation in the upper part of the slope is from 1963.

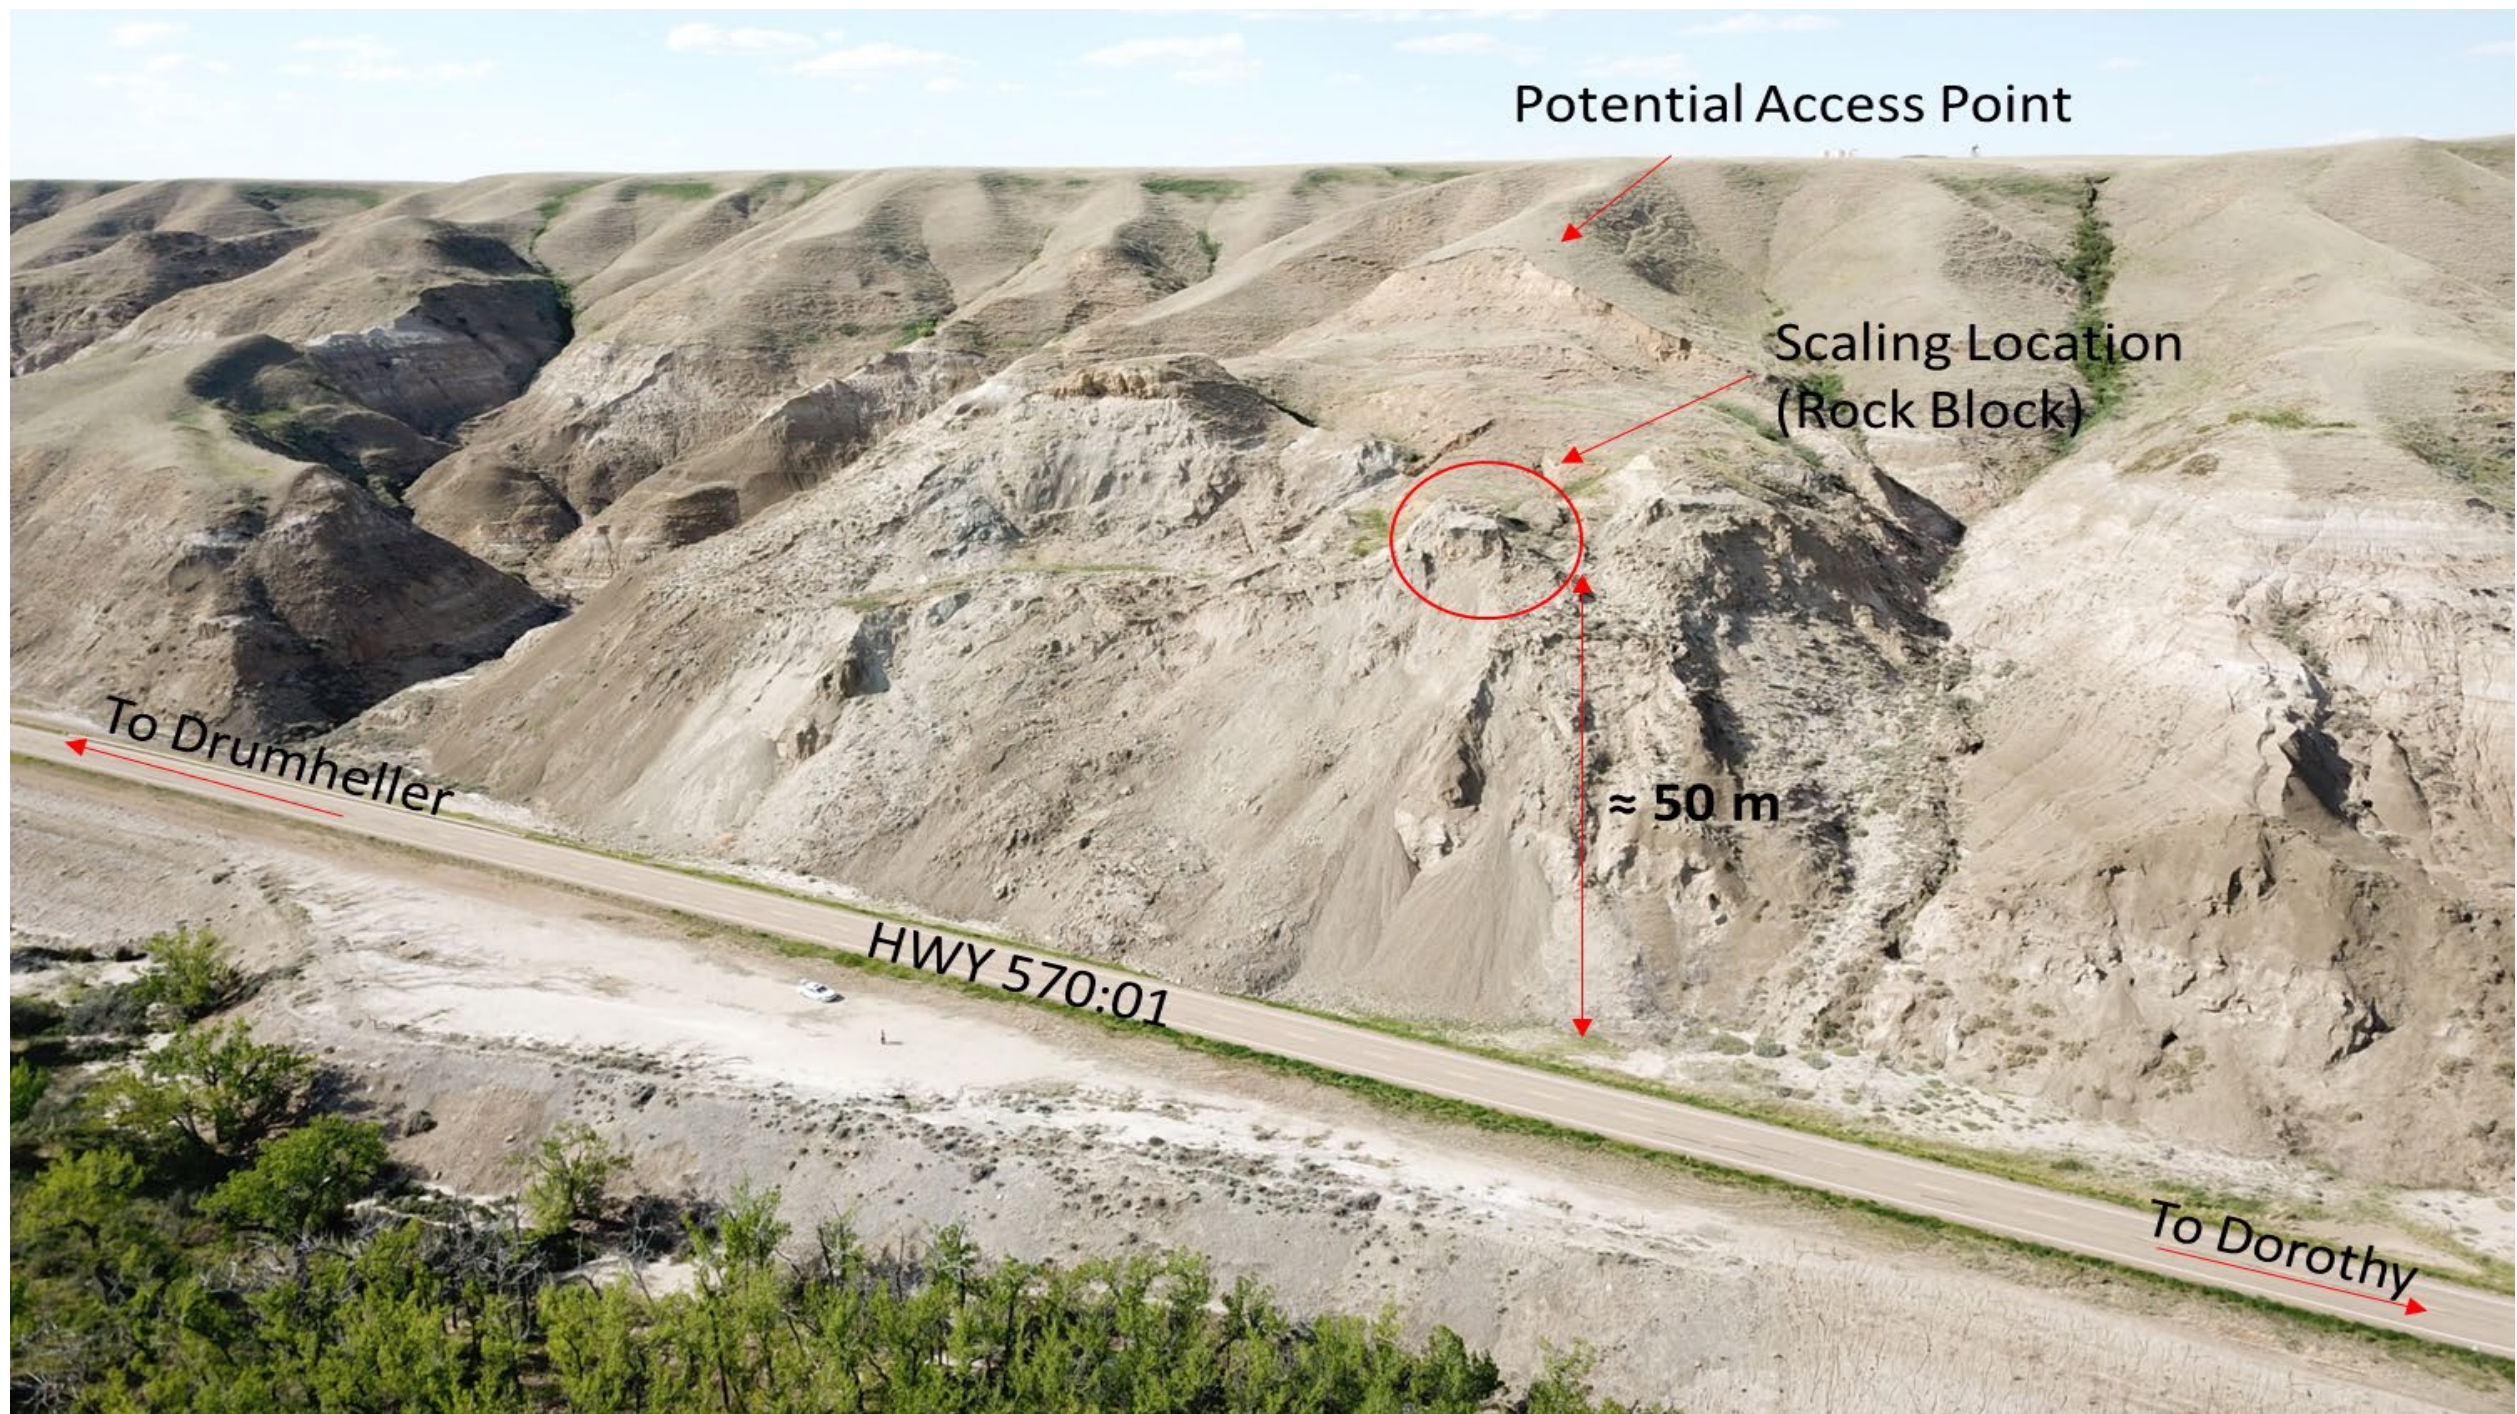
TITLE		Panoramic View and Height of Rock Blocks Section D Call-Out Response Hwy 570:01 km 8.8	
				SCALE	PROJECT No.	FIG No.	
				A05116E02		4

- At the site the differential erosion process of the bedrock and the displacement of the landslide mass allowed for the formation, distortion and fracturing of quasi-vertical rock blocks. The rock blocks located approximately at mid-slope height have released rock blocks and debris that have reached the ditch and rolled across the highway. The rock blocks at mid-slope were visible from the highway (See Figure 4).

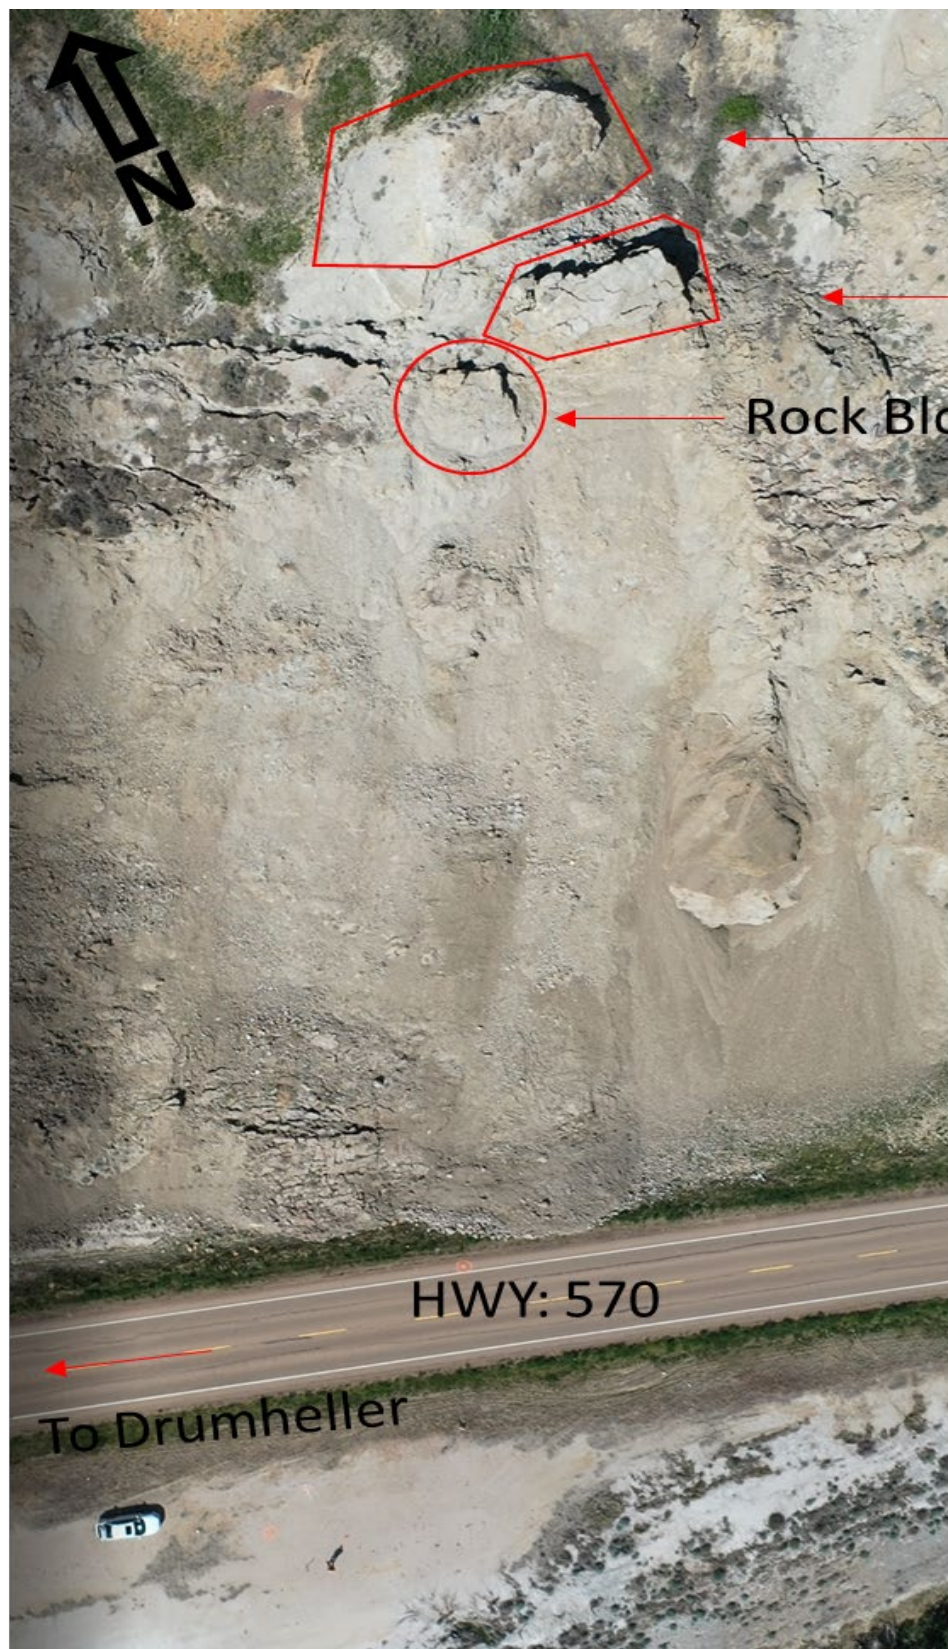
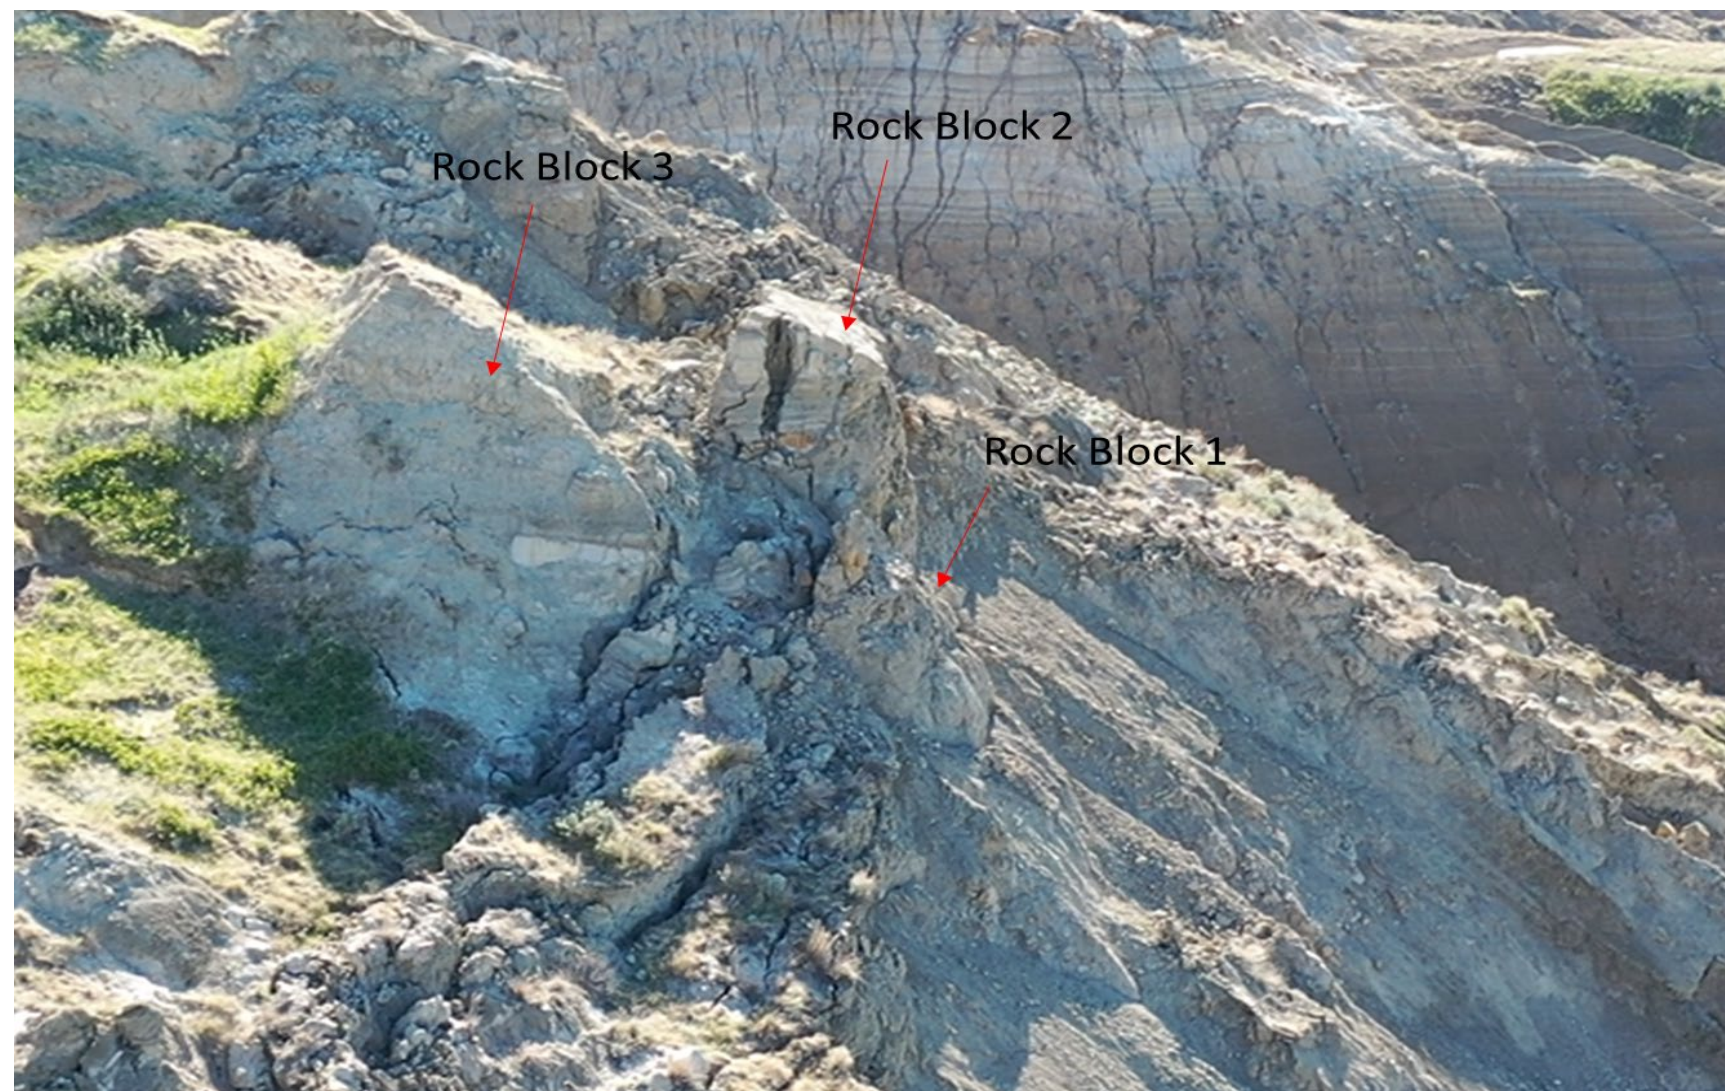
PROJECT		CENTRAL REGION GEOHAZARD RISK MANAGEMENT PROGRAM	
TITLE		Close Up View of the Three Blocks Section D Call-Out Response Hwy 570:01 km 8.8	
SCALE	PROJECT No.	FIG No.	
	A05116E02		5

- ◆ There are potential graben features visible in the upper part of the slope which could indicate translational sliding on a weak horizontal layer.
 - ◆ Three rock blocks perched at the brow of the slope have been distorted and fractured by ongoing slope movements. Two of the rock blocks to the east of the slope were isolated near vertical blocks of rock. The slope and rock blocks at the brow of the slope above the highway have been weathering over time and have the potential to topple or disaggregate into smaller blocks as indicated by recent slope movements (See Figure 4, 5, and Photos 6, 7 and 8 in Appendix I);

- The three blocks that are of most pressing concern to the safe operation of Hwy 570 are located on the east side of the slope approximately 50 m above the highway, as shown in Photos 6, 7 and 8 in Appendix I. Weathering processes around the blocks have left the sides with a vertical dip as shown in Figure 5. KCB believes that continuing and eventual weathering processes of the three blocks will result in the potential release and fall of large rock blocks that would reach Hwy 570, creating a hazard to road users.

- Jersey barriers to reduce the potential for material to roll across the highway should be installed (this was completed within two days of our site inspection, one day after we spoke to AT about the risk to the public at the site).
- The three blocks located on the east end of the slope should be removed (this was completed on June 27 and 28, 2022).
- The vertical rock slab located on the west rock outcrop should be removed (this was completed on June 27 and 28, 2022).
- The ledge along the slope should be reshaped removing vertically standing rock or soil blocks (this was completed on June 27 and 28, 2022).
- Drainage along the ditch next to the highway shall be re-established.
- The MCI should monitor the site for increased movement and rock fall hazard during or after high-runoff events.

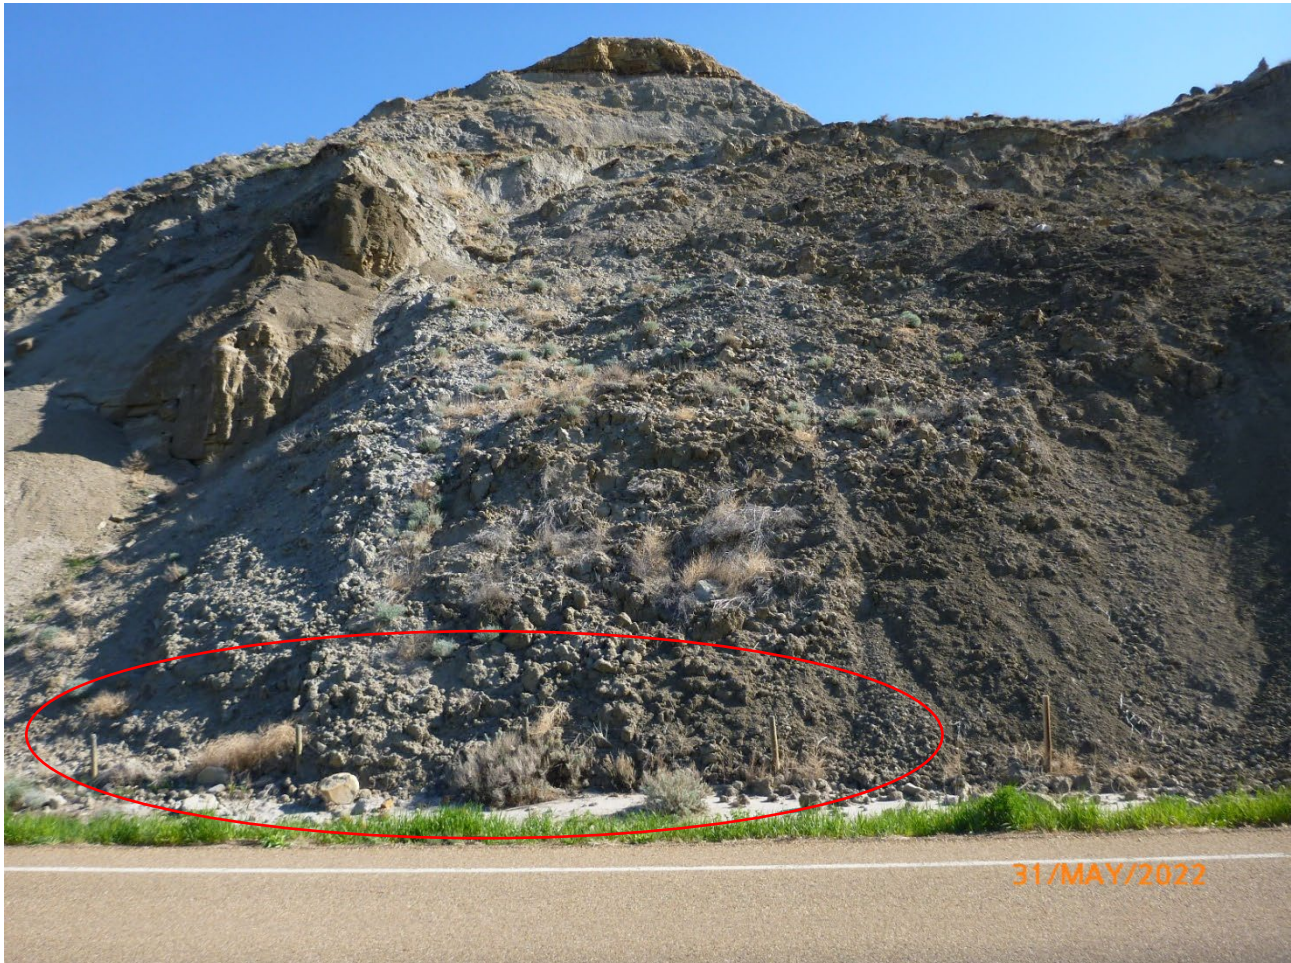
- KCB and AT noticed that a wire fence along the highway and at the toe of the slope had been covered by the eroded material for the slope (See Photos 2 and 3 in Appendix I). The regional AT Maintenance Contract Inspector (MCI), Carson Elliot, noticed the accumulation of failed material at the toe of the slope about two weeks before.

- The material in the ditch has buried a barbed-wire fence that was unburied when KCB last visited this area in 2021. The ditch is now blocked and water is ponded at the east end of the site.

Photo 2 Barbed wire fence covered with talus material along the highway. Photo taken May 31, 2022, facing north.

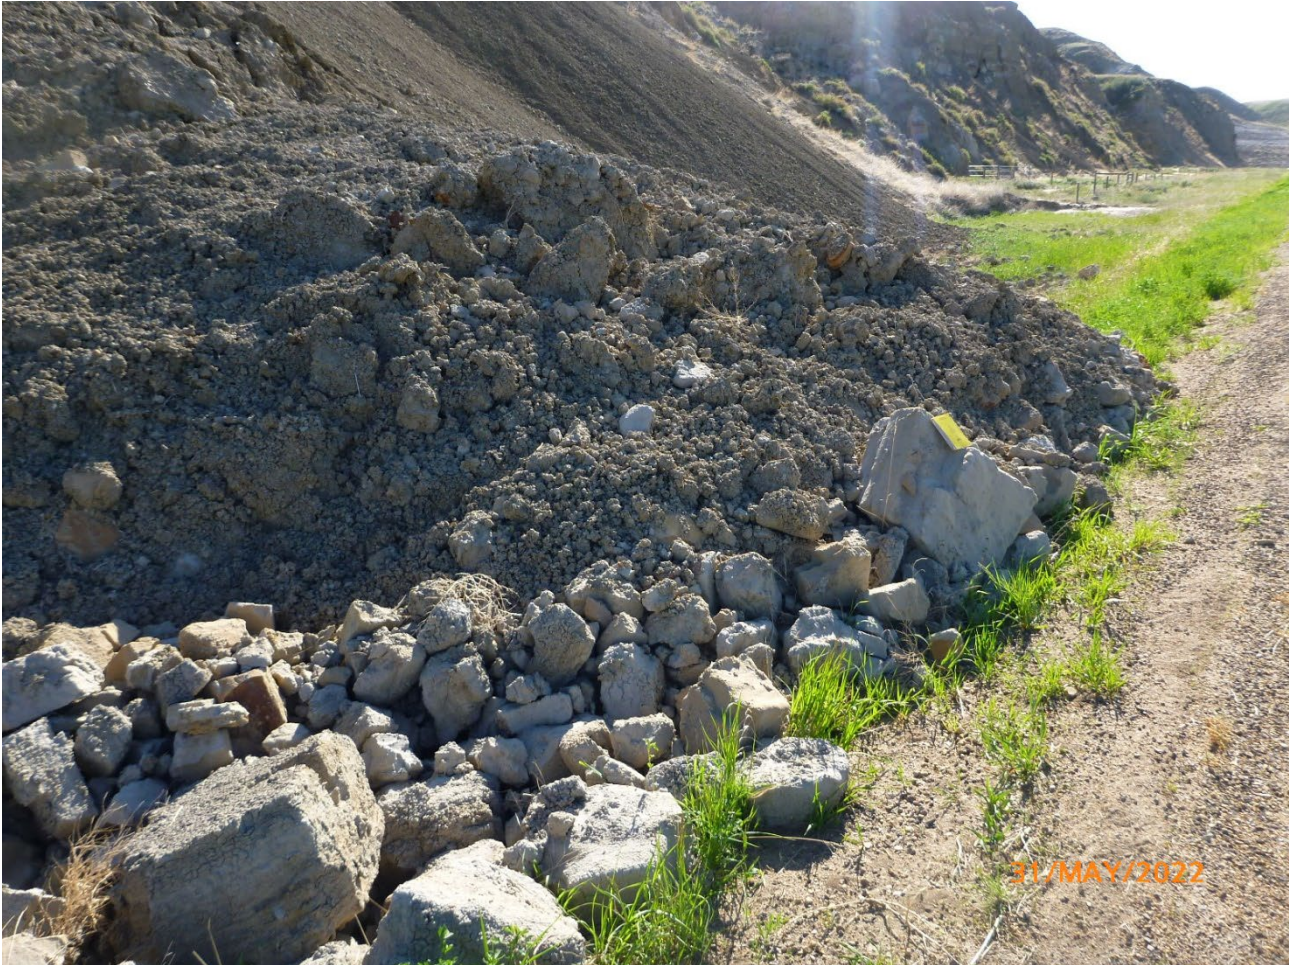
- The disaggregated material and rock blocks that fell previously have accumulated and filled up most of the catchment ditch at the toe of the slope, impeding highway drainage and ponding water near the toe of the landslide where there appears to be a weak horizontal layer. Softening and saturation of the weak layer could trigger more deep-seated movements that could accelerate rockfall occurrence;

Photo 3 Failed material accumulated in the ditch. Photo taken May 31, 2022, facing east.

- Establish the Hwy 570 site as a new monitoring site for GRMP in the Central Region;
- Implement spring and fall change detection surveys using a UAV to assess if slope movements continue in response to periods of wet weather, including complete the change detection assessment that will be submitted in a separate report;
- Continue monitoring of the site during the spring and fall with change detection methods to evaluate the rate of movement and active zones of the earth slide;
- Removal of rockfall materials should not excavate the toe of the intact slope. Excavating the toe of the slope could accelerate deep-seated movements which could correspondingly increase the rockfall hazard; and
- Re-establish ditch drainage to eliminate water ponding at the toe of the slope.

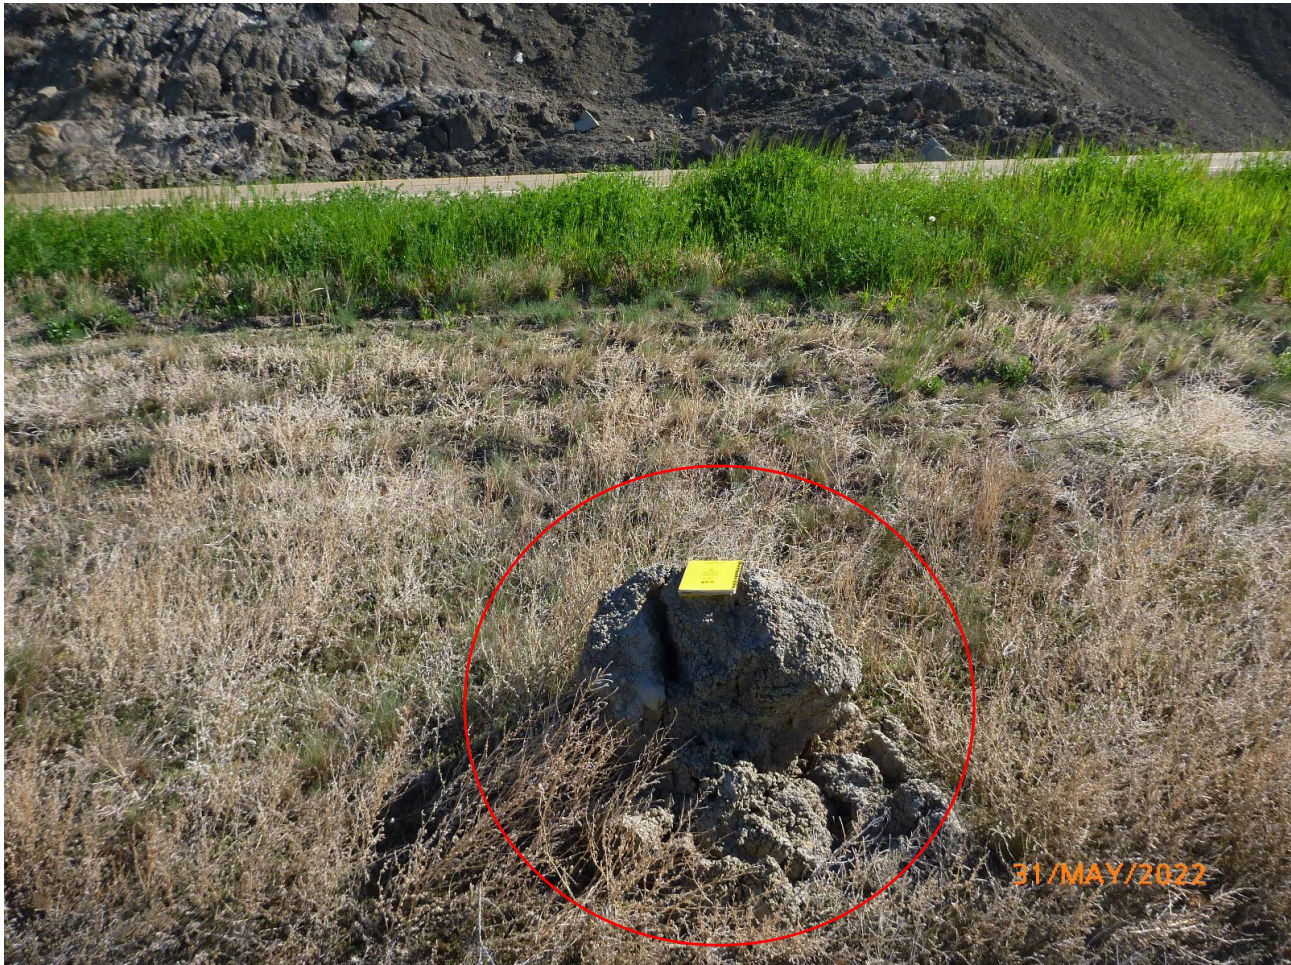
- One boulder (approximately dimensions 0.8 m x 0.8 m x 0.8 m) was observed to have crossed the highway (See Photo 4 in Appendix I).
- No payment cracks or dents or other evidence of large rock blocks striking and damaging the pavement were observed along the highway below the slope.

Photo 4 Boulder found across the Highway. Photo taken May 31, 2022, facing north.

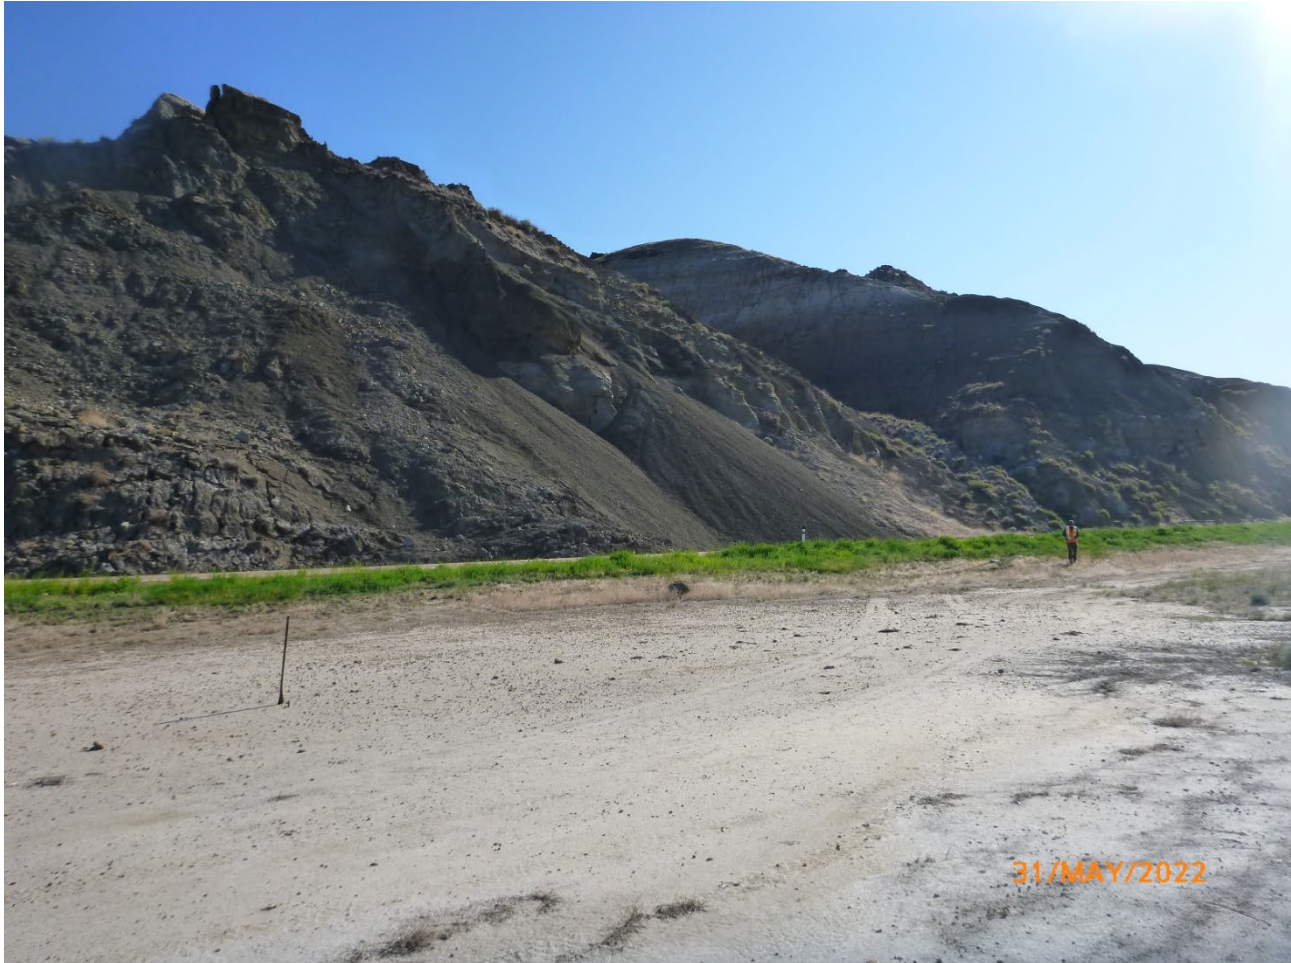
- There was a large pad of bedrock fill material located across from the landslide and KCB believes that the pad is failed material from the slope that has been placed over the years as the highway was cleared of slope failure materials (See Photo 5 in Appendix I). We have contacted the previous, now retired, MCI to request additional background information on

Photo 5 Former natural ground area (ridge) that was excavated for railway and highway construction. Photo taken May 31, 2022, facing northeast.

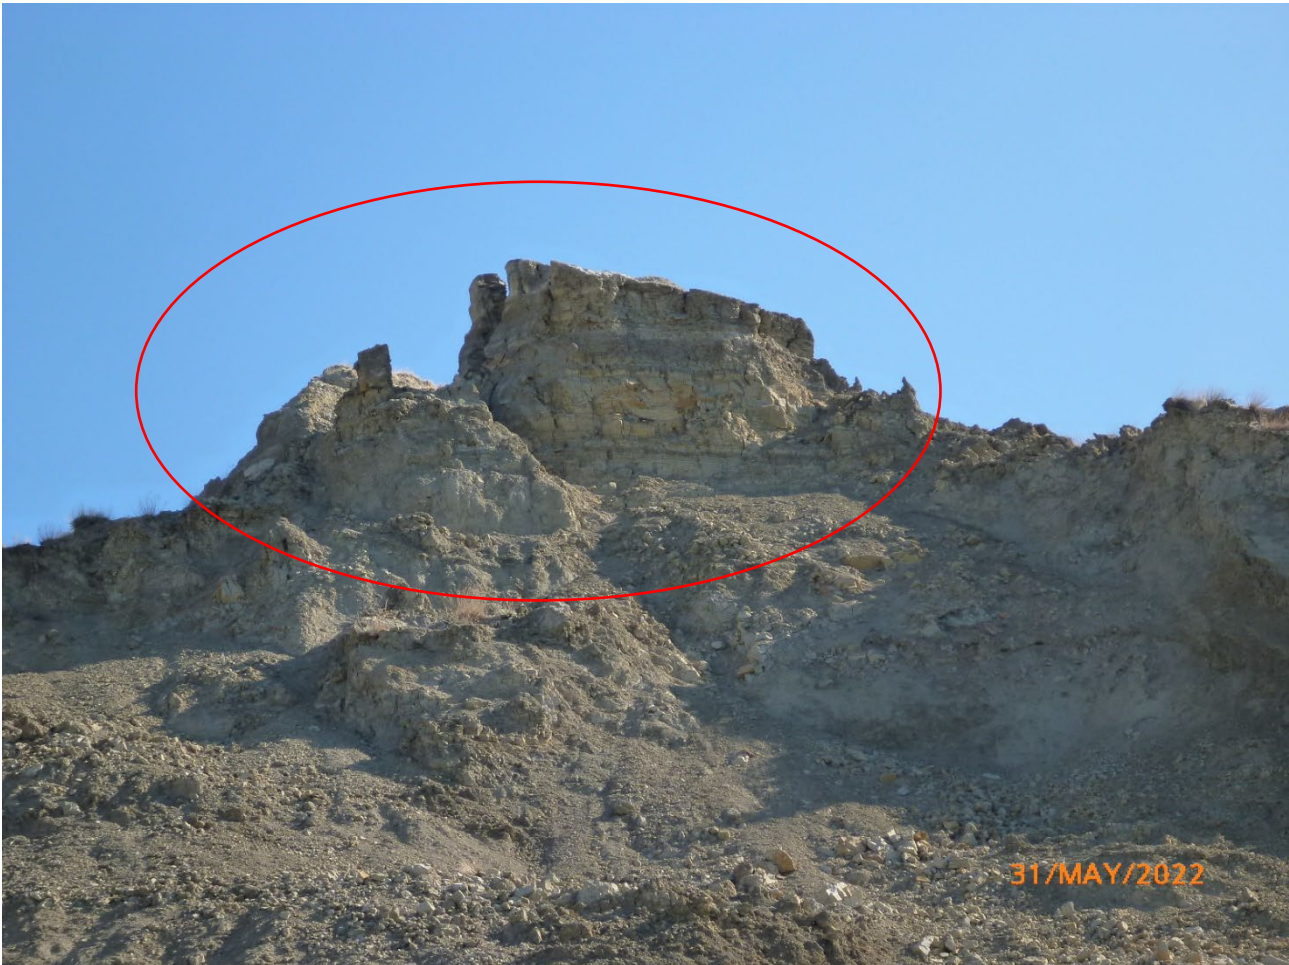
Photo 6 **Rock blocks on the east side of the slope. Photo taken May 31, 2022, facing north.**

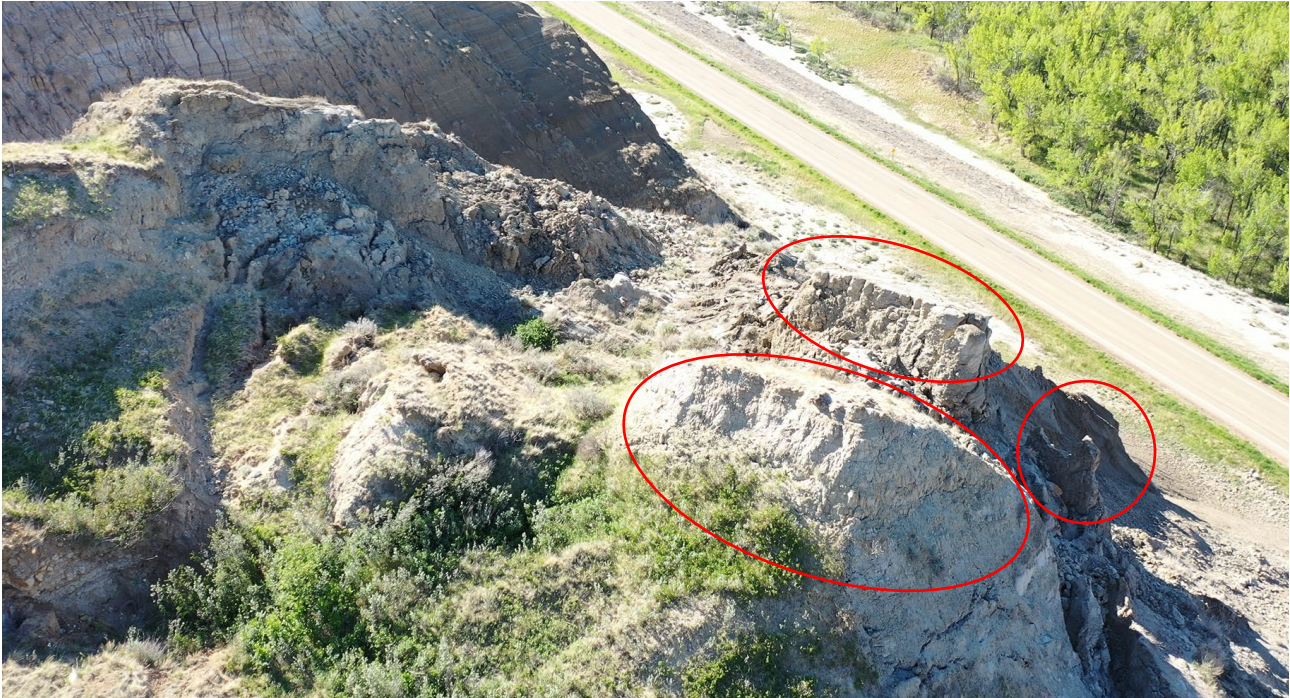
Photo 7 **Oblique photo behind the three weathered rock blocks. Photo taken from the UAV on May 31, 2022, facing south.**

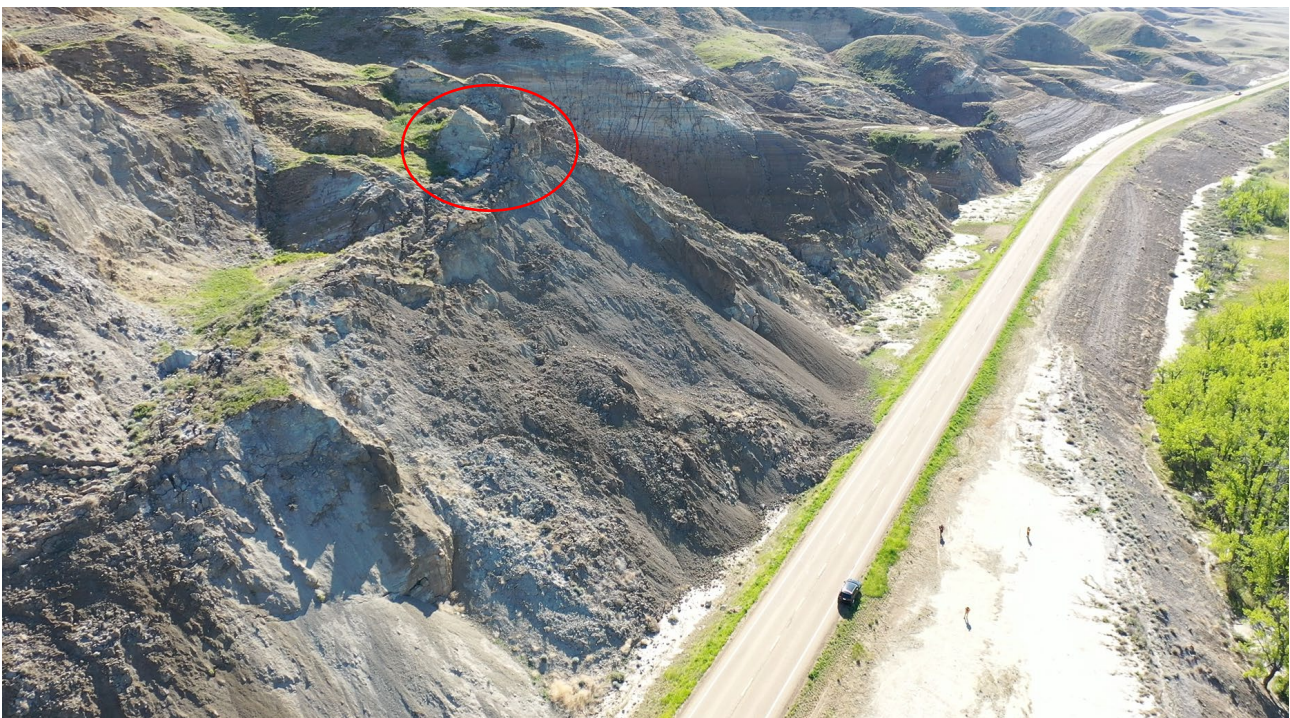
Photo 8 **Oblique photo of the three rock blocks on the east side of the slope. Photo taken from the UAV on May 31, 2022, facing east.**

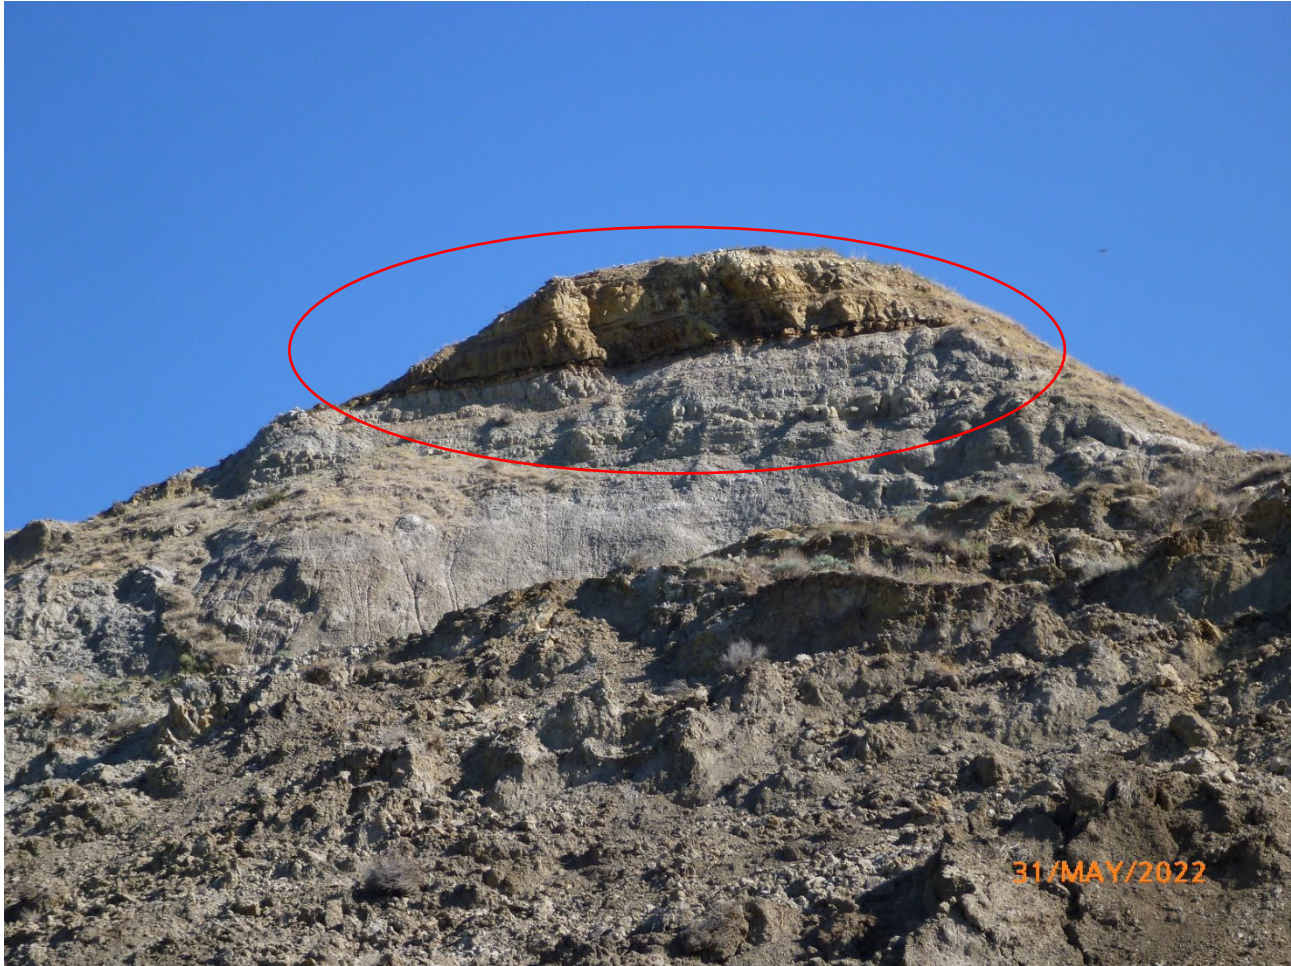
- ◆ There is a vertical rock outcrop, very fractured and weathered, located on the west side of the slope that has the potential of releasing large rock blocks onto the highway (See Photo 9 in Appendix I).

Photo 9 Rock outcrop on the west side of the slope. Photo taken May 31, 2022, facing north.
