SITE NUMBER AND NAME: C077 H570 Slide and Rockfall	HIGHWAY & KM: 570:01, 8.8	PREVIOUS INSPECTION DATE: June 18, 2024	INSPECTION DATE: June 10, 2025
LEGAL DESCRIPTION: 04-17-027-17 W4M 03-07-027-17 W4M 13-08-027-17 W4M 14-08-027-17 W4M	NAD 83 COORDINATES: UTM Northing Easting 12 5684270 404558	RISK ASSESSMENT: Slide: PF: 9 CF: 4 TOTAL: 36 Rockfall: PF: 11 CF: 4 TOTAL: 44	
HIGHWAY CLASSIFICATION LEVEL: 3		CONTRACT MAINTENANCE AREA (CMA): 519	
AVERAGE ANNUAL DAILY TRAFFIC (AADT): 500 (west) & 400 (east) (Ref No. 116220 & 997198)

CENTRAL REGION GEOHAZARD RISK MANAGEMENT PROGRAM

Site Plan
C077 - H570 Slide and Rockfall
Hwy 570:01, km 8.8

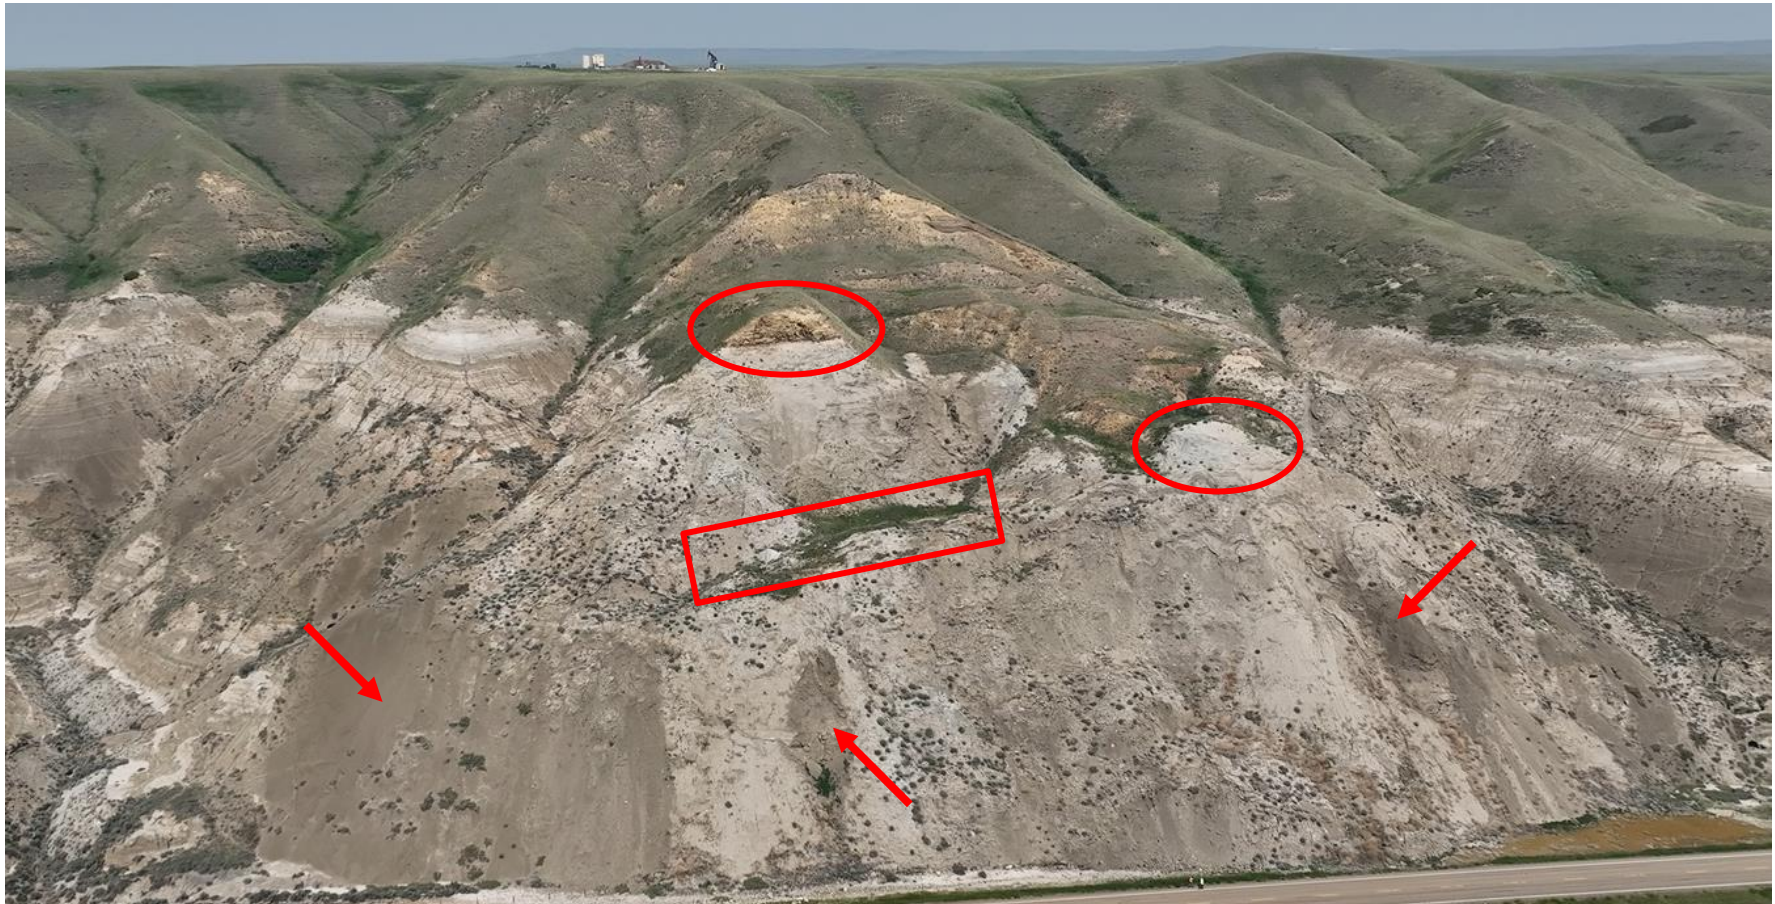
- A weathered and fractured bedrock outcrop was observed near the west extent of the site, approximately midslope and above an area of sliding within the talus slope (Photos 1 through 4)

- Ground cracking has been observed near the west portion of the site at a near-vertical rock scarp (Photos 1 and 4)
- A weathered bedrock outcrop was observed near the east side of the site, east of the where cracking was observed (Photos 1 and 3). The bedrock outcrop is located approximately halfway to two-thirds up the slope.

- Additional material appeared to have accumulated in the north (westbound) ditch between the 2024 and 2025 inspections (Photos 1 through 3, and 5). The material was blocking drainage in the ditch and water was ponding east of the site (Photo 7). The area of ponding water was near the C058-2 site where sinkholes and voids have been previously observed.

Photo 1 Aerial photo of the C077 site. Locations of recent movement are indicated by red arrows, location of cracking observed on the slope is indicated by red rectangle, and previous scaling completed in 2022 is indicated by red circles (note the area of ground cracking was also scaled in 2022). Photo taken June 10, 2025 facing north.

- The site should continue to be regularly inspected by TEC's Maintenance Contract Inspector (MCI) and TEC and KCB should be notified if they observe any changes to the site.
- The site should be inspected annually as part of the Central Region GRMP Section B Inspections.
- The material that has accumulated in the north (westbound) ditch should be removed to restore storage capacity and improve drainage.
- KCB has budget for one more Unmanned Aerial Vehicle (UAV) survey of the site to monitor the rate of displacement of the site. The final survey should be completed after significant precipitation event(s) or if significant additional movement/deposited material is observed.

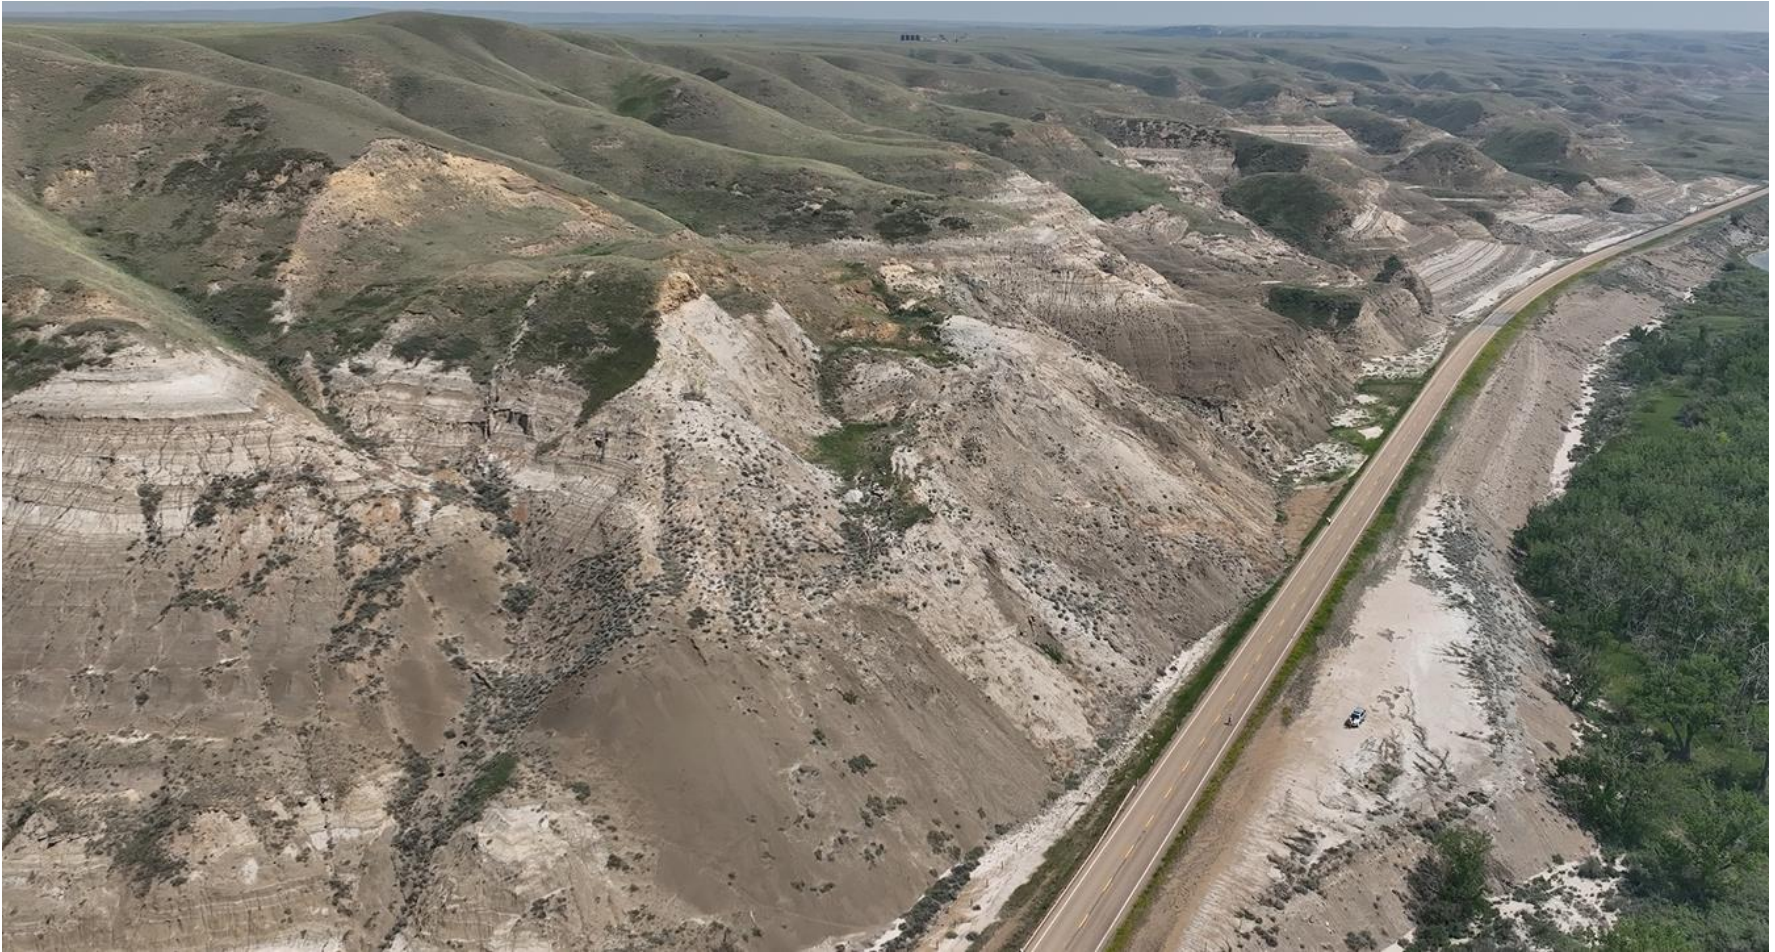
Photo 2 **Oblique aerial view of the site. Photo taken June 10, 2025 facing northeast.**

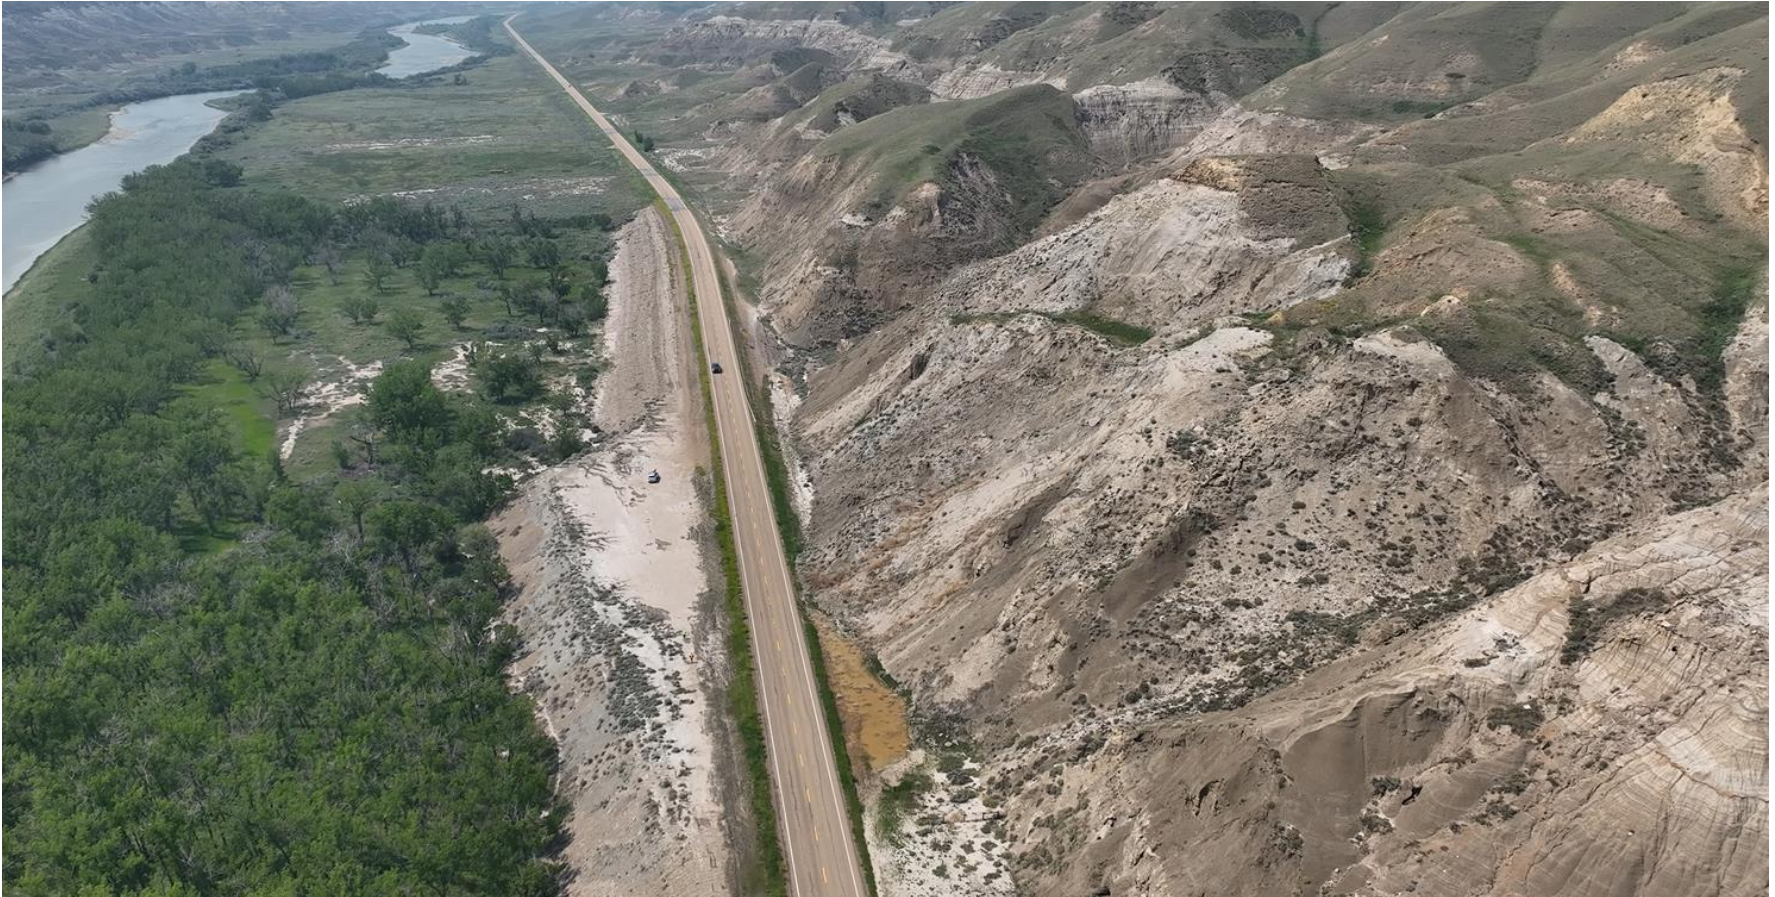
Photo 3 **Oblique aerial view of the site. Photo taken June 10, 2025 facing west.**

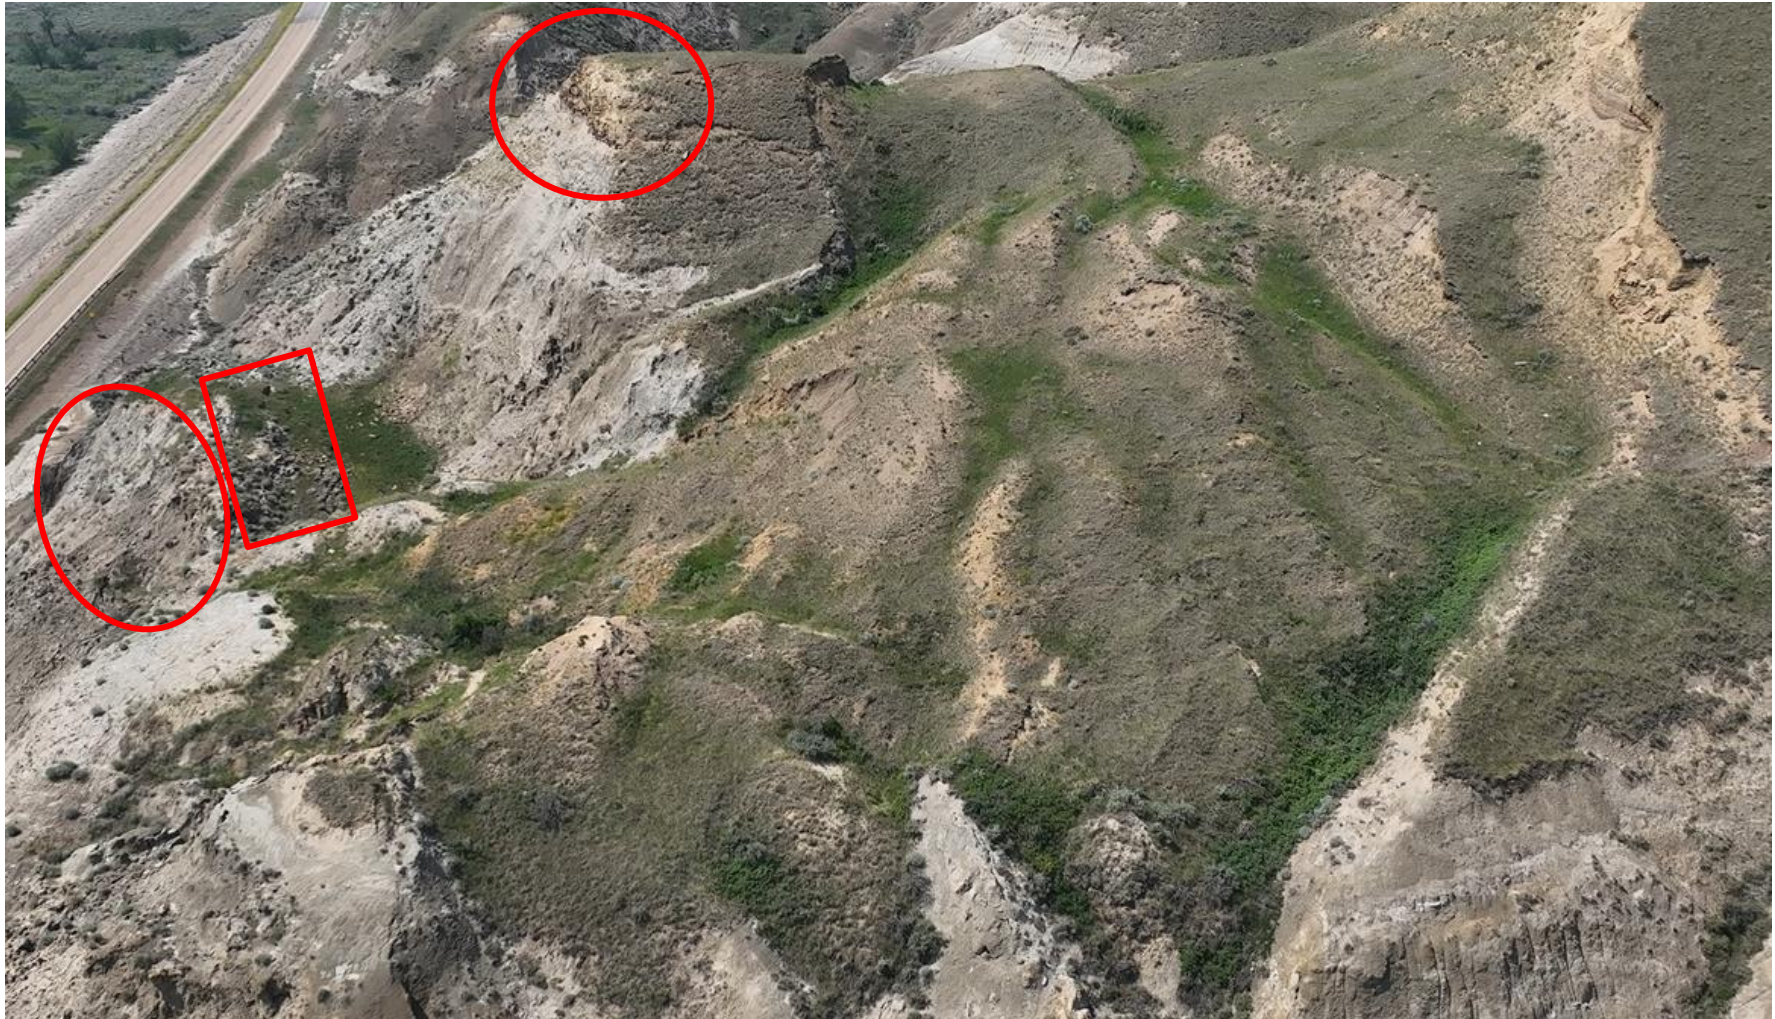
Photo 4 Aerial photo of the upper portion of the slope. Area where ground cracks have been observed indicated by red rectangle and areas previously scaled in 2022 are indicated by red circles. Photo taken June 10, 2025 facing west.

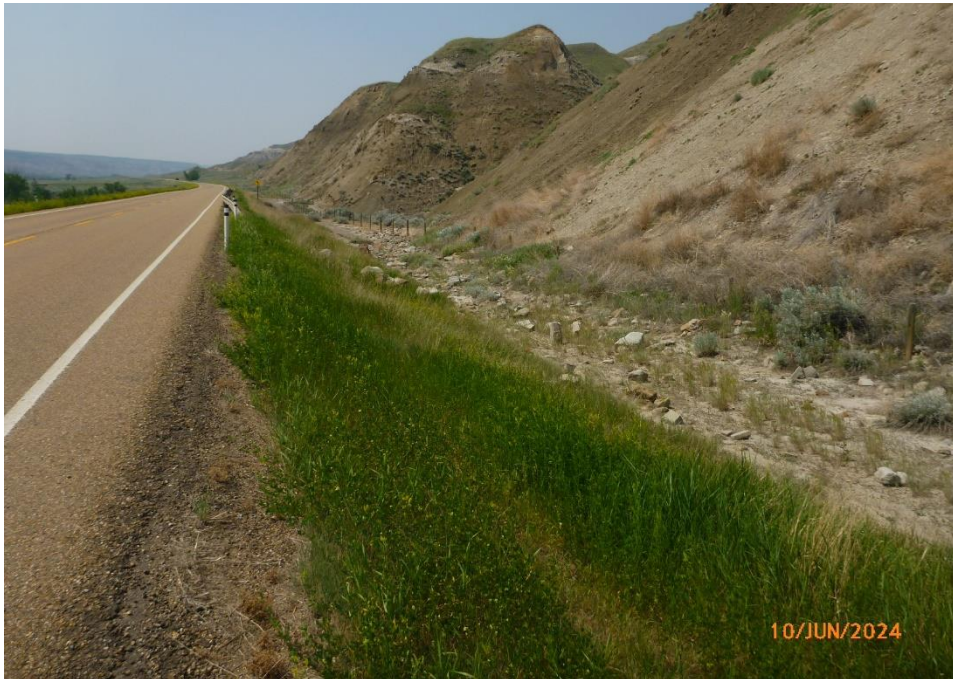
- During the 2025 inspection, no new rockfall particles were observed on the highway surface or on the south side of the highway.
- Rock particles have been observed in the north (westbound) highway ditch (up to approximately 1 m x 0.6 m x 0.6 m) (Photo 5). KCB suspected the particles were from the 2022 scaling work that was completed at the site, since the particles edges did not appear fresh and blue spray paint was observed on several of the particles.

Photo 5 Particles observed in the north (westbound) ditch along the toe of the slope. Photo taken June 10, 2025 facing west.

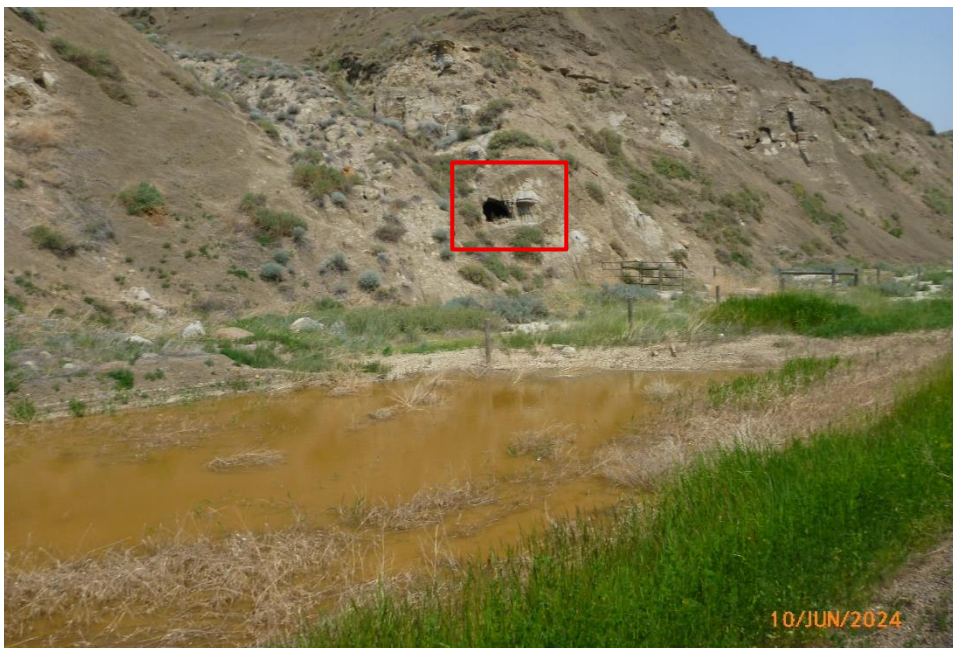
Photo 6 Ponded water along the north (westbound) ditch near the east extent of the site. Sinkhole observed in north slope indicated by red rectangle. Photo taken June 10, 2025 facing northeast.

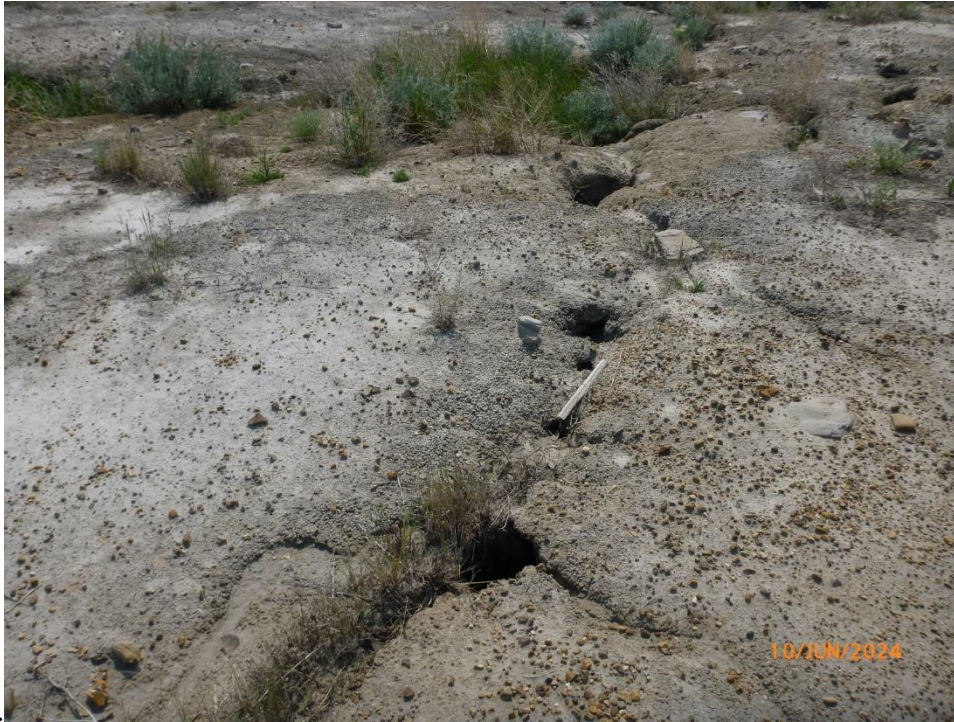
COMMENTS
<u>General:</u> <ul style="list-style-type: none"> The C077 site is located just west of the Central Region C058 site, where sinkholes and voids (in the ditches and below the highway surface) have been observed due to dispersive soils at the site. A sinkhole (approximately 1 m tall and 1.5 m wide) was observed in the north valley slope, just east of the site (Photo 6). During the 2025 inspection, sinkholes up to approximately 0.3 m in diameter were observed on the south side of Hwy 570:01, downslope of the site (Photo 7). The sinkholes are in an area of a former bedrock

knoll and are generally in line. This could indicate a subsurface preferential drainage path where there is potential for void formation.

Photo 7 Sinkholes observed on the south side of the highway downslope of the site in an area of shallow bedrock. Photo taken June 10, 2025 facing south.
