SITE NUMBER AND NAME: C017-I, -II, and -III Truckstop Slide	HIGHWAY & KM: 575:04, 26.631 to 26.050	PREVIOUS INSPECTION DATE: June 10, 2020	INSPECTION DATE: June 23, 2021
LEGAL DESCRIPTION: C017-I 04-26-29-21 W4M C017-II 01-27-29-21 W4M C017-III 01-27-29-21 W4M	NAD 83 COORDINATES: UTM Northing Easting 12 5707574 370869 12 5707733 370415 12 5707738 370340	RISK ASSESSMENT: PF: 4 CF: 3 TOTAL: 12 PF: 7 CF: 4 TOTAL: 28 PF: 10 CF: 4 TOTAL: 40	
AVERAGE ANNUAL DAILY TRAFFIC (AADT): 800 (east) and 870 (west) (Ref No. 105240 & 106230)		CONTRACT MAINTENANCE AREA (CMA): 517

SUMMARY OF SITE INSTRUMENTATION: One slope inclinometer (SI) and two vibrating wire piezometers (VWPs) were installed in fall 2020 at C017-III. LAST READING DATE: June 12, 2021	INSPECTED BY: Chris Gräpel (KCB) James Lyons (KCB) Roger Skirrow (AT) Tony Penney (AT)
PRIMARY SITE ISSUE: C017 – I: a shallow embankment slope failure on the north side (eastbound lane) of Hwy 575; C017 – II: an erosion gully that has formed downslope of a culvert outlet on the north side of Hwy 575; and C017 – III: a moderately deep-seated slide (5 to 6 m deep based on an SI installed in 2019) on the north side of Hwy 575 where the highway crosses

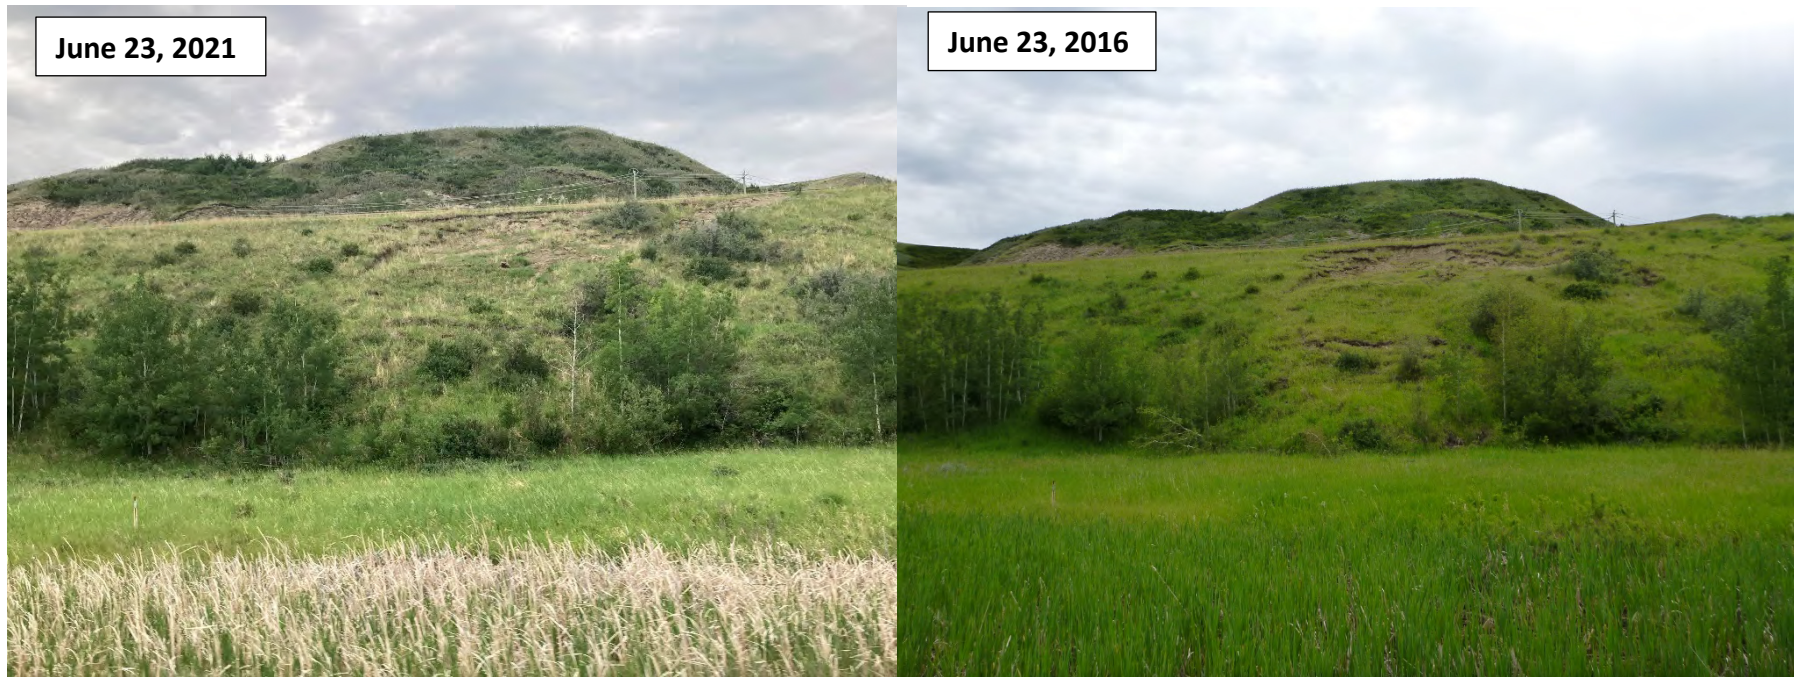
COMMENTS
At C017 – I:
<ul style="list-style-type: none"> Slide shows little to no change since 2020 inspection. No new cracks or deformations observed in road surface and the lateral extent of the slide has not changed.
At C017 – II:
<ul style="list-style-type: none"> The erosion gully is similar in size as during the 2020 inspection. However, the erosion gully was partially backfilled in fall 2020 to allow access for the excavator completing test pits at the C017-III site (monitored

Photo 1 Comparison of the C017-I slope failure from Hwy 837 in 2020 and 2016. Photos taken looking southwest.

- An excavate and replace repair option was considered in 2020 and not conducted because of the high backslopes that would be left above the contractor when excavating the failure plane. The estimated cost of excavate and replace was also quite high, due to the limited access and risks associated with the high backslope. In 2021 KCB and AT concluded that a soil-nail reinforced backslope would help maintain and protect the highway surface, while allowing the lower part of the slide to progress with potential need for additional stabilization with soil nails in the future. The advantage of soil nails is that they could be installed from the highway surface, addressing the limited access working on the steep highway embankment slope. An additional borehole should be drilled in the westbound lane to assess ground conditions for a soil nail repair.

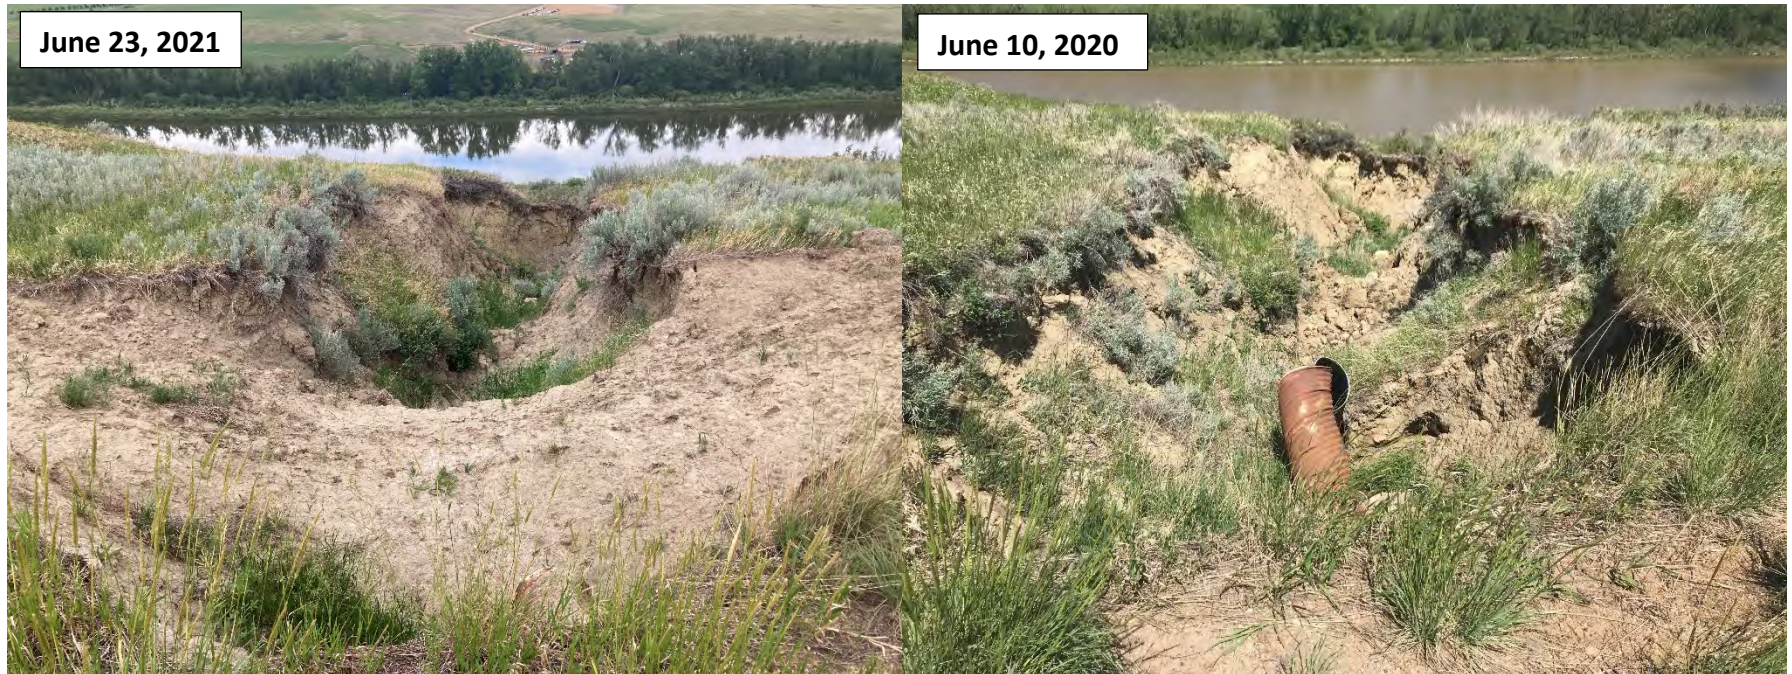
by KCB). The culvert inlet on the south side of the highway is completely buried with eroded materials deposited over the inlet. Flow through the culvert towards the C17-II erosion gully could be re-established in the culvert during a heavy rainfall event leading to increased erosion in the gully.

Photo 2 Comparison of the C017-II erosion gully in 2020 and 2021. Gully appears to have been partially backfilled since June 2020, likely due to a traffic accident that resulted in an 18-wheeler truck crashing through the guardrail and into this gully. The inlet of the culvert is locked with soil in the south ditch, but erosion could result in flows discharging into the gully again. The outlet of the 600 mm CSP culvert is detached and hanging. Photos taken looking northeast.

- Decommission and permanently block the 600-mm-diameter CSP culvert underlying Hwy 575 and divert drainage down slope in the south ditch with consideration for the downstream impacts and erosion control in the south ditch. The existing south ditch needs to be repaired. AT is currently backfilling the ditch with material excavated from the C018 site, and it will eventually erode and reform the ditch gullies.

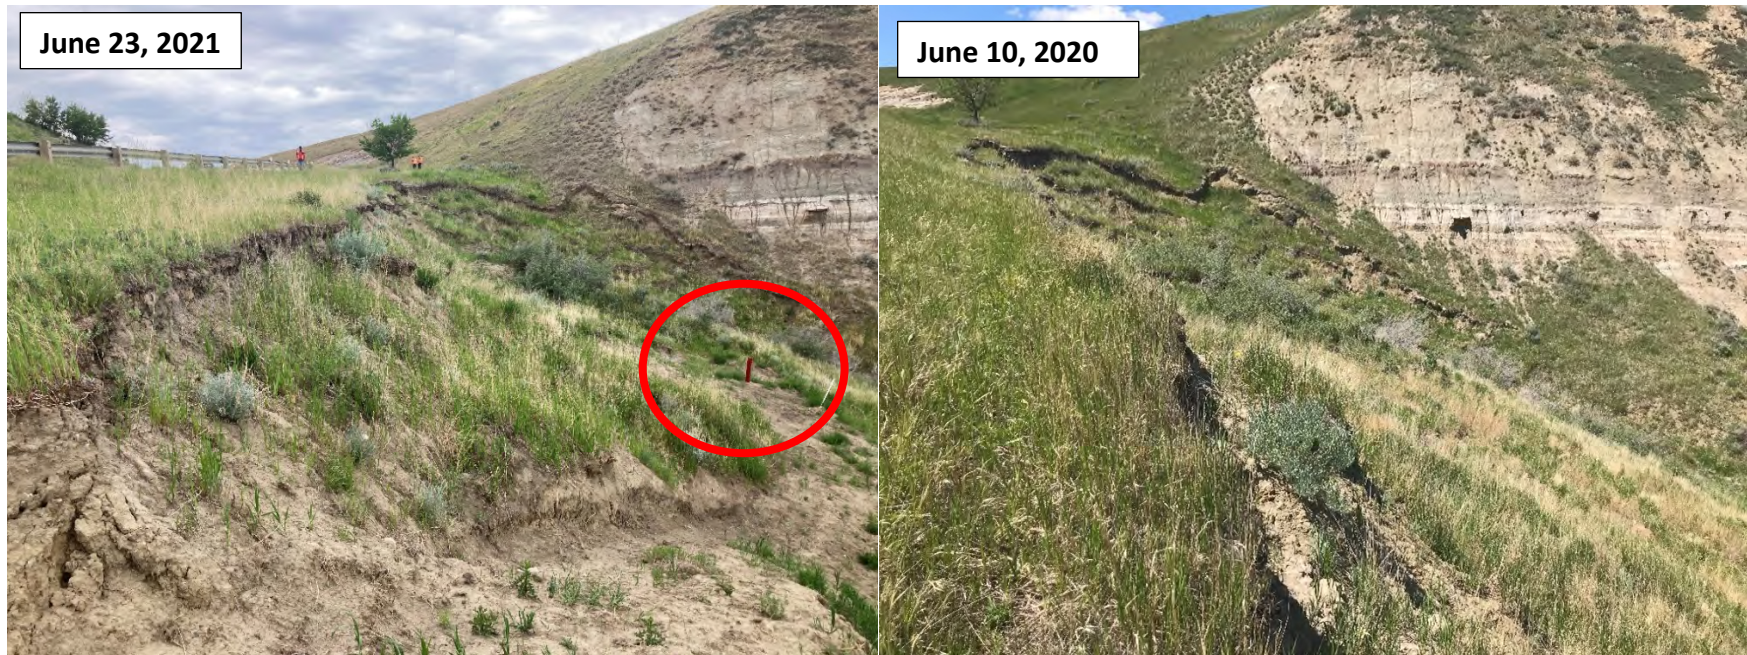
Photo 3 Comparison of the C017-III head-scarp in 2020 and 2021. The slight appears to be relatively inactive since 2020. Instrumentation installed in October 2020 are indicated by black circle. Photos taken looking east.

- Since the failure plane appears to be approximately 5 m to 6 m below ground surface, the backscarp should be reinforced with soil nails. The slide may continue to move and require additional soil nail stabilization in the future. Like the C017-I site, the soil nail repair could be conducted by working from the highway surface. An additional borehole should be drilled in the westbound lane to assess ground conditions for a soil nail repair. Surface water flows from the ditch north of the slide should be re-routed to the toe of the slope with an intake structure installed in the ditch bottom, a buried pipe from the intake structure to the toe of the slope, and energy dissipating structure at the pipe outlet.

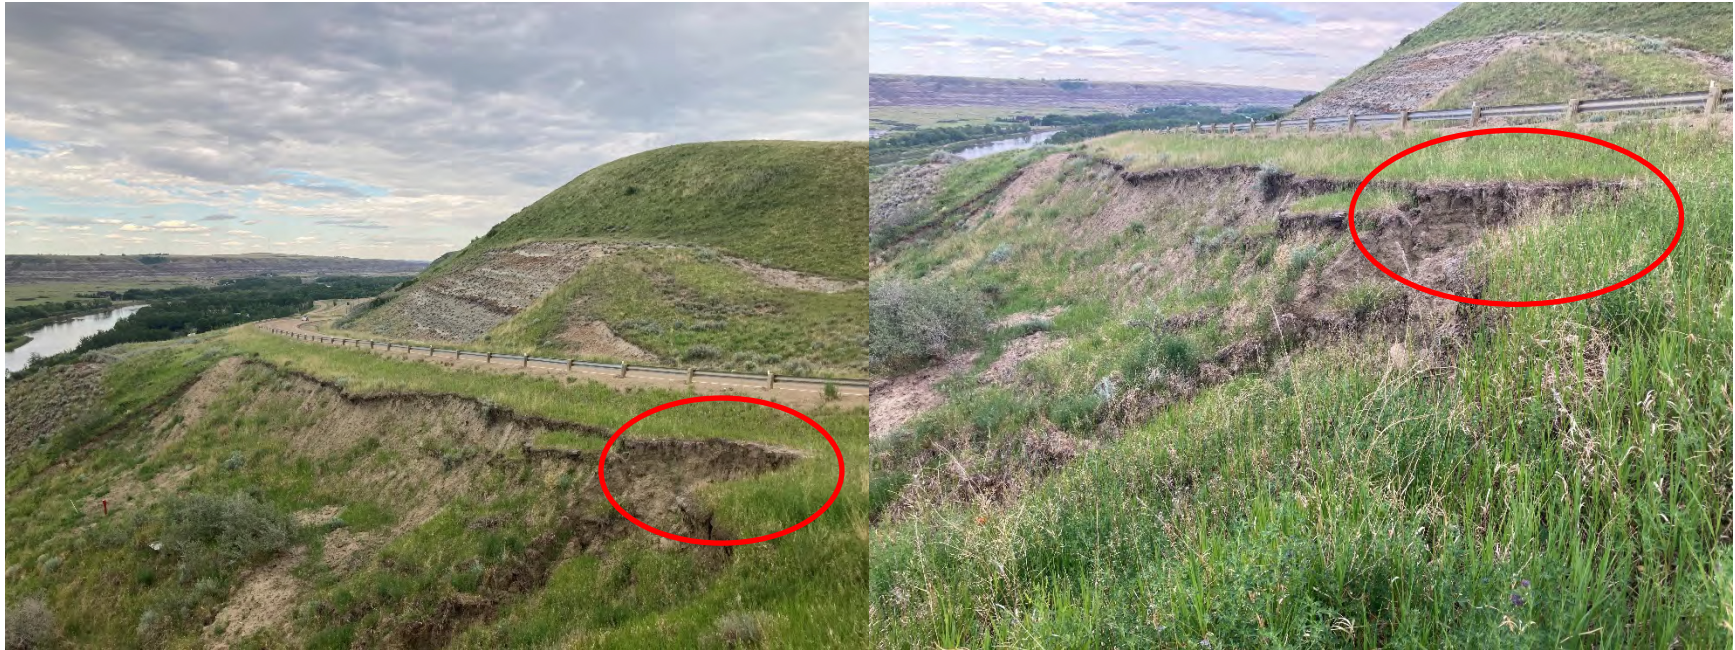
- Slide expansion was observed in 2021, near the north end of the backscarp, where an erosion gully approximately 2 m wide and 1.5 m has formed since the 2020 inspection.
- A longitudinal crack was observed between the backscarp and the shoulder of Hwy 575 since the 2020 inspection. Longitudinal cracking in the westbound lane could indicate potential retrogression of the backscarp onto the highway.
- The north ditch is conveying surface water flow over the slide area.
- Ditch erosion in the south (eastbound) ditch between C017-II and C017-III continues worsen, with gullies up to 1.2 m in depth.

Photo 4 The headscarp of the C017-III slide is approximately 1.5 m to 2.0 m in height. The area of the headscarp that has retrogressed towards the highway since 2020 is indicated by red circles. Photos taken June 23, 2021 looking southeast.

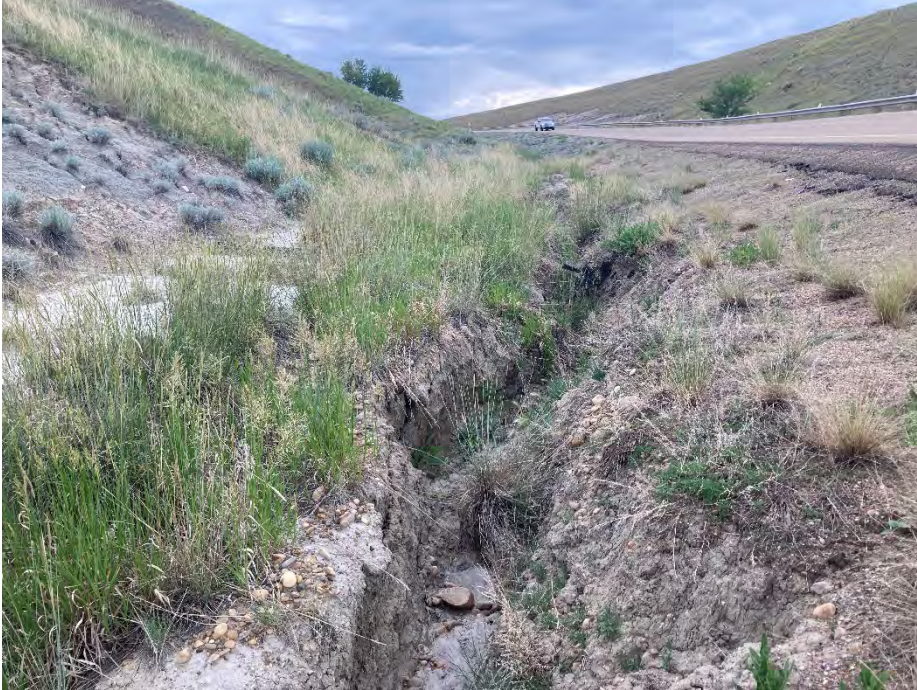
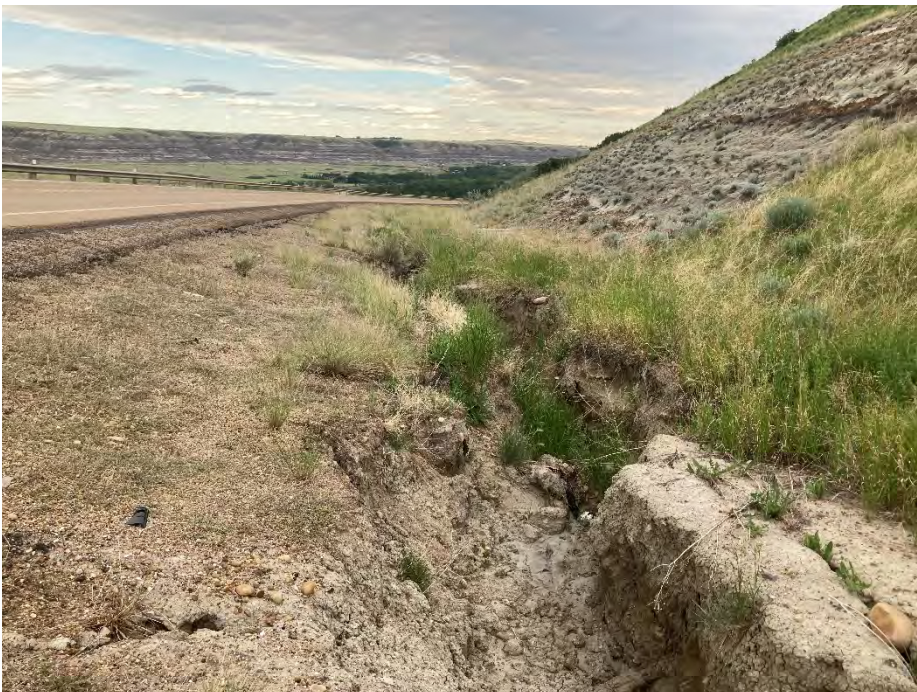
Photo 5 Gully erosion in the ditch south of Hwy 575 has expanded slightly since 2020. Photo taken June 13, 2021 facing north.
