November 29, 2022

Alberta Transportation  
4<sup>th</sup> Floor, Provincial Building  
4920 – 51<sup>st</sup> Street  
Red Deer, Alberta  
T4N 6K8

**CON0022160 Central Region GRMP Instrumentation Monitoring  
Site C017-III; H575:04, km 26.631 Truckstop Slide  
Section C – 2022 Fall Readings**

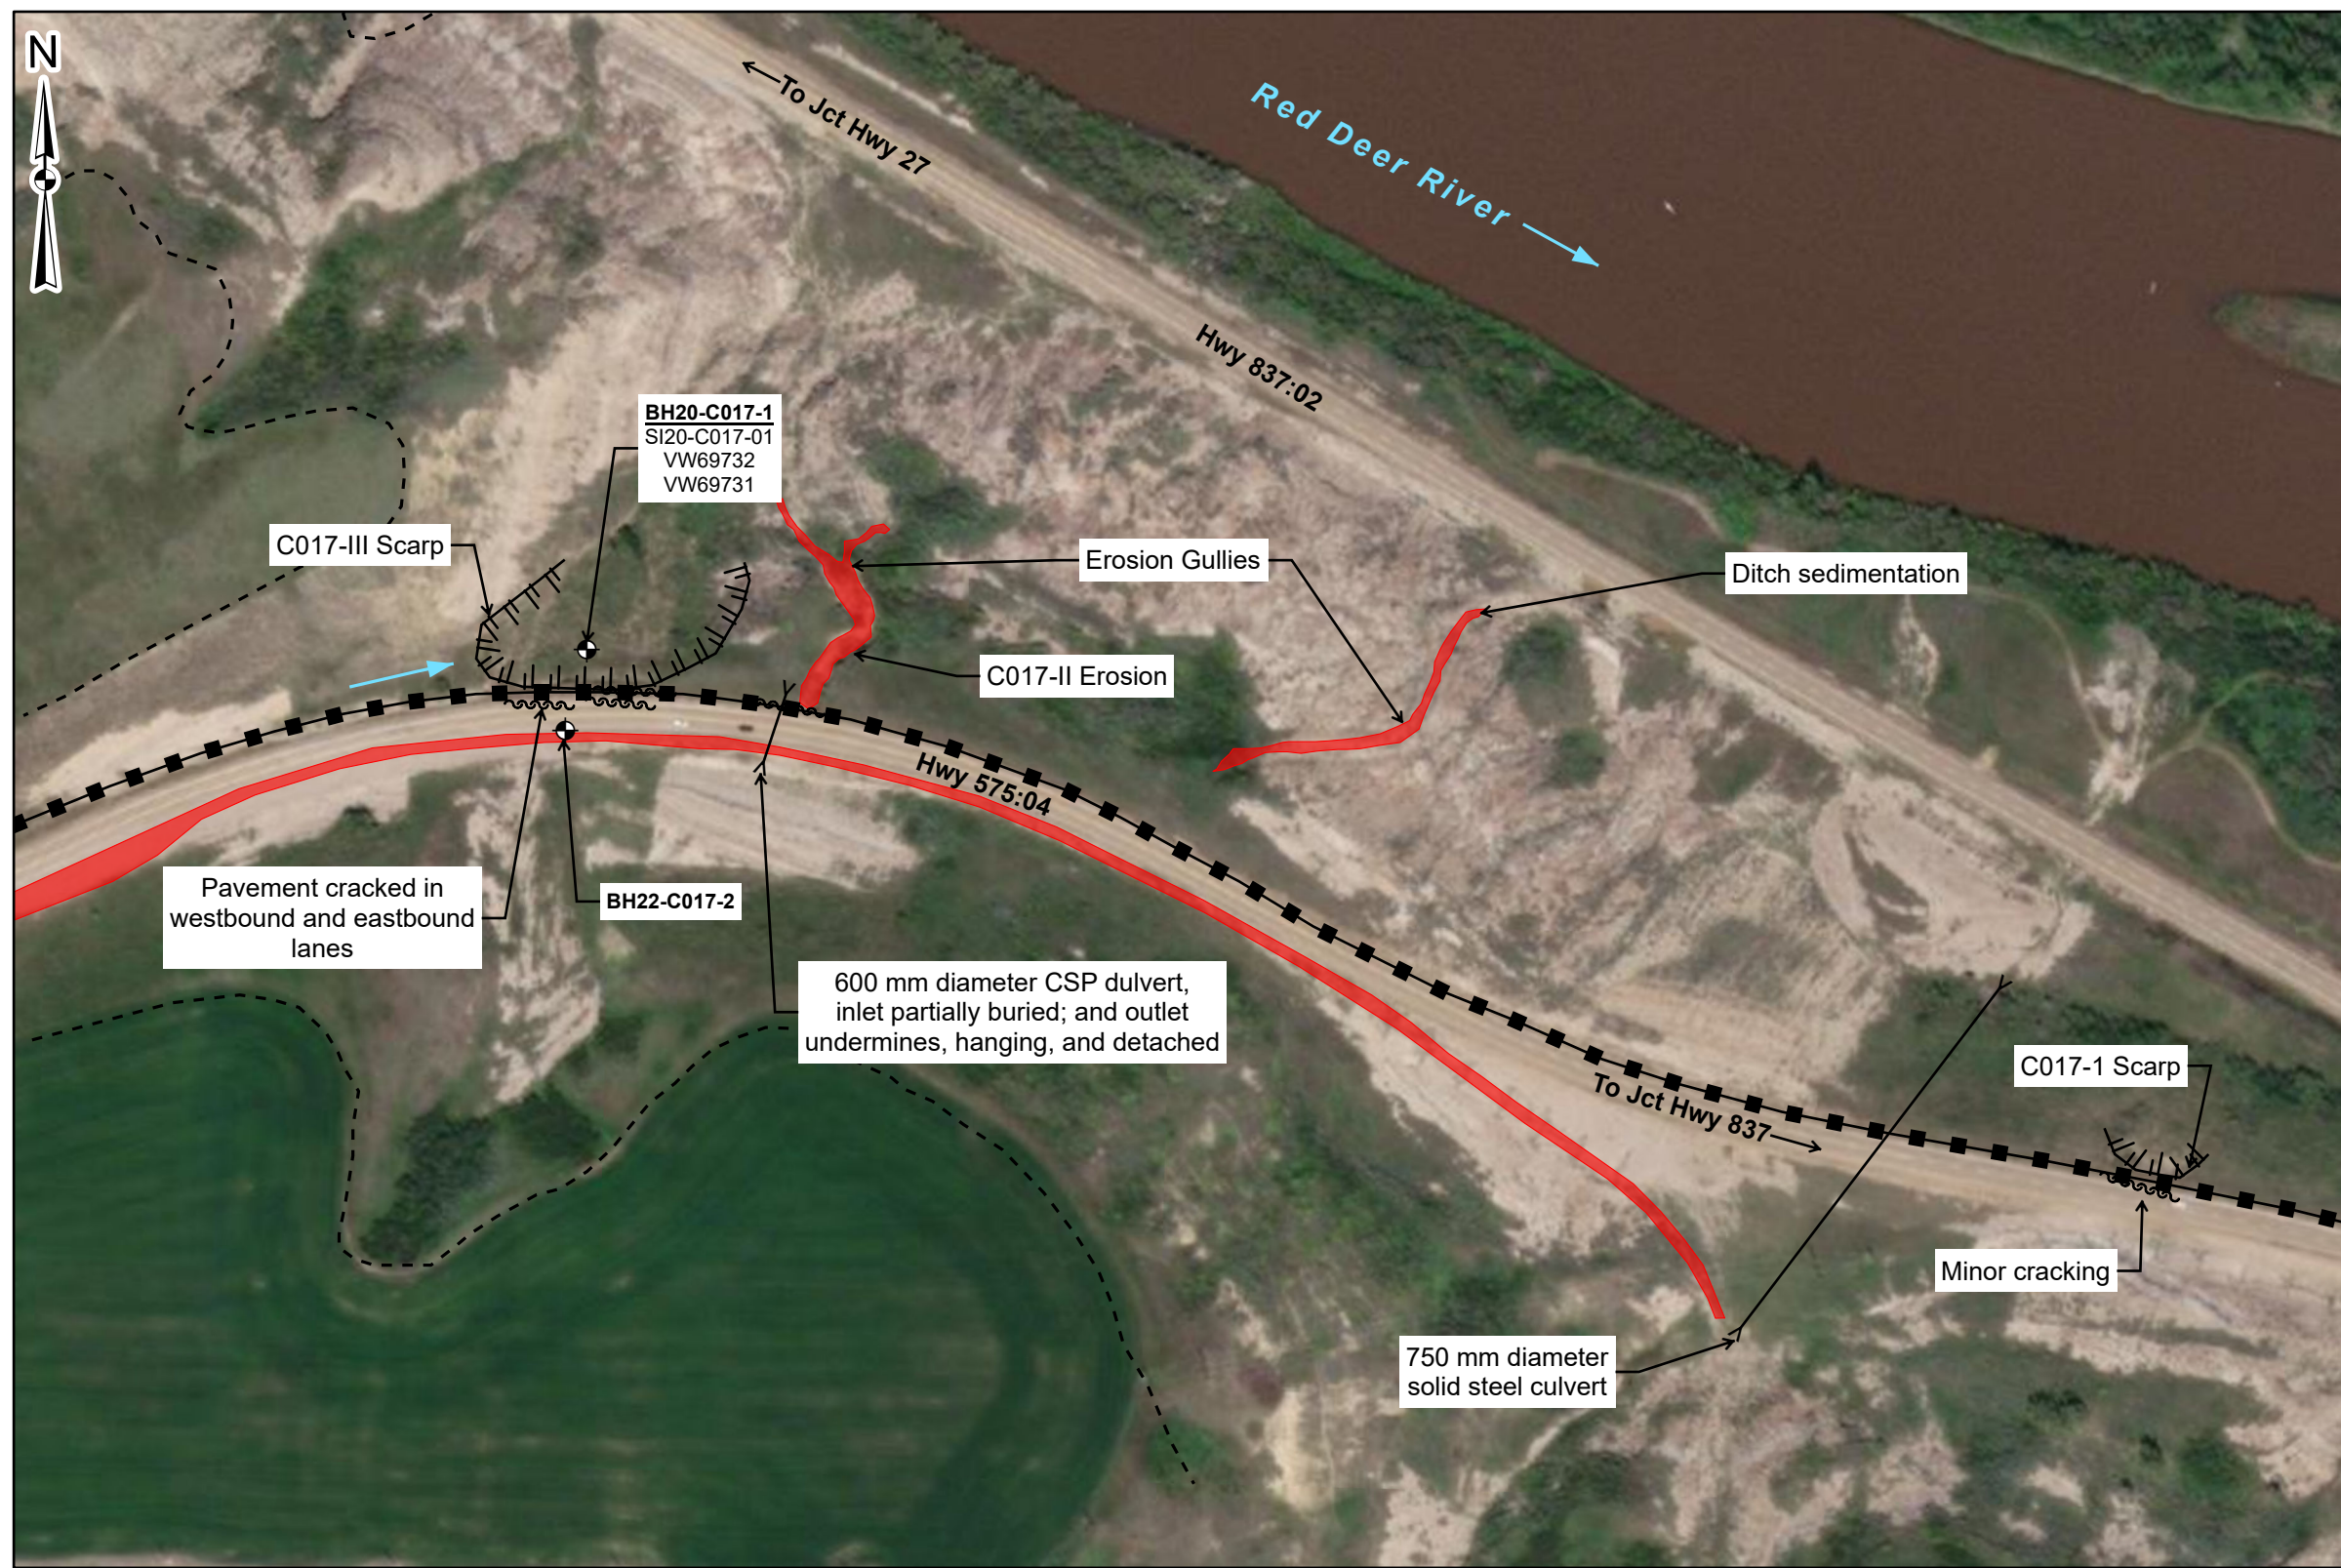
TITLE  
 Site Plan  
 C017-I, -II, and -III Truckstop Slide  
 Hwy 575:04, km 26.631

- C017-I: a shallow embankment slope failure on the north side (westbound lane) of Hwy 575:04,
- C017-II: an erosion gully that has formed downslope of a culvert outlet on the north side (westbound lane) of Hwy 575:04,
- C017-III: a moderately deep-seated slide on the north side (westbound lane) of Hwy 575:04 where the highway crosses a creek and enters a cut section in the valley wall.

In October 2020, KCB installed one SI (SI20-C017-01) and two VWPs (VW69731 and VW69732) to monitor depth of movement and groundwater conditions, respectively. The instruments were installed in a borehole (BH20-C017-1) located on the north (downslope) side of Hwy 575:04, within the C017-III slide mass.

KCB is in the process of completing a design repair for the C017 site (backfilling and armouring the C017-II site, installing a ditch block and culvert upslope of C017-III, and soil nailing at the C017-I and C017-III sites). The design will be completed in fall 2022 and construction is anticipated to start in 2023.

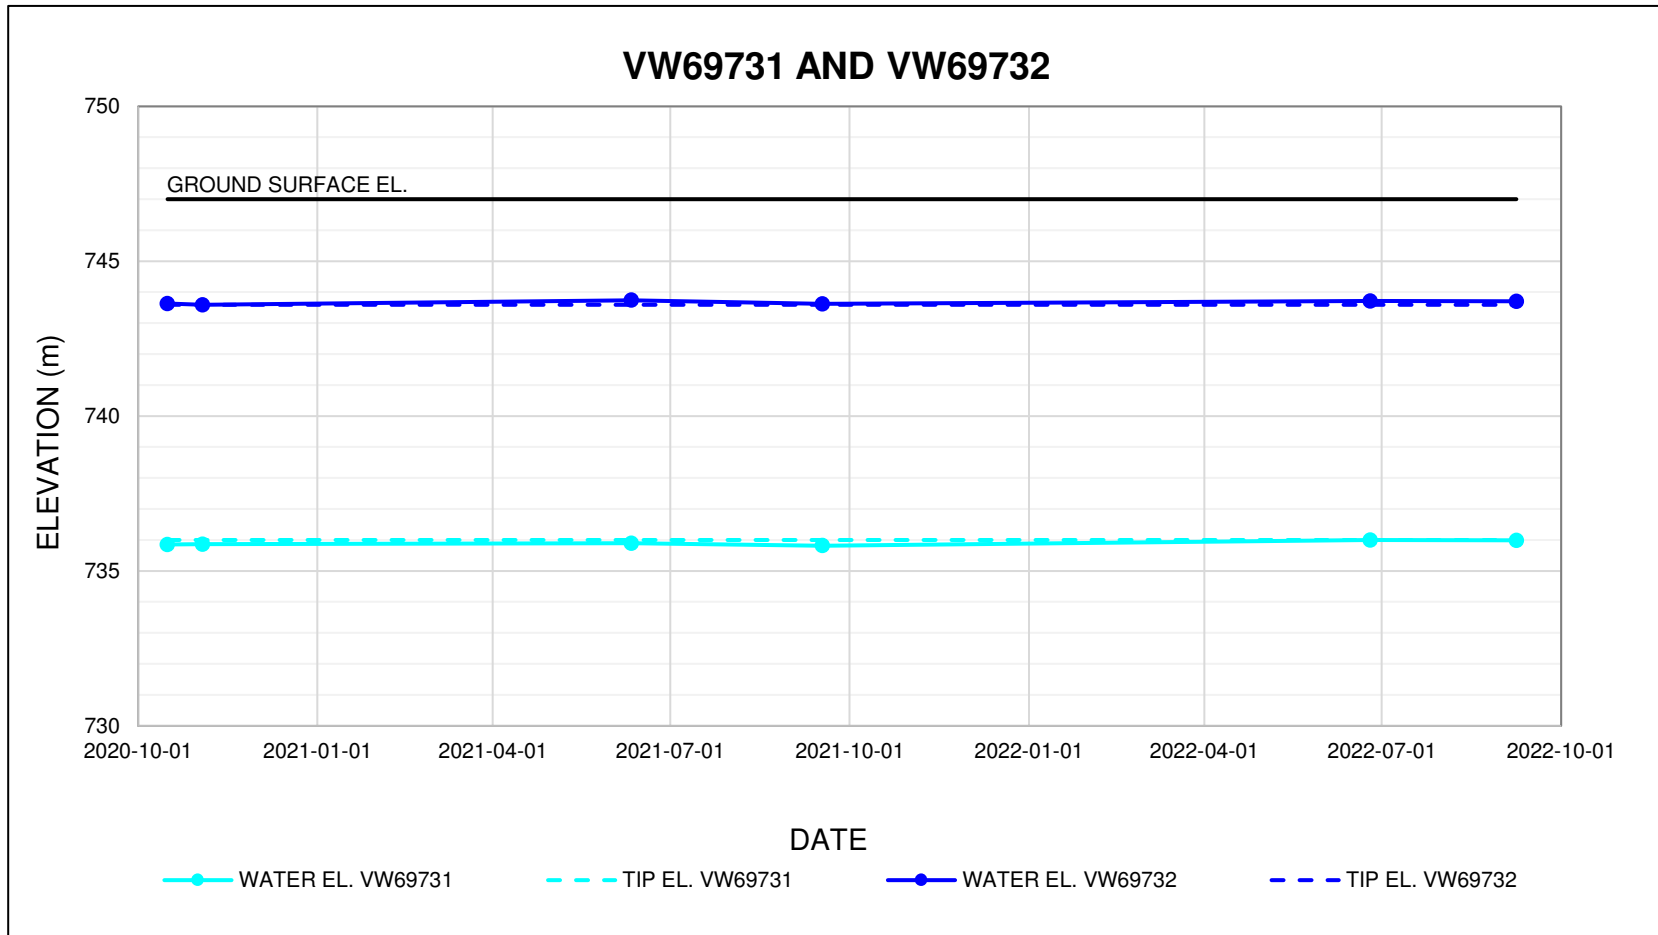
TITLE	
		Piezometer Data C017-III - Truck Stop Slide Hwy 575:04, km 26.341	
SCALE	PROJECT No.	A05116A02	FIG No.

Since installation in October 2020, porewater pressures recorded in the two VWPs (VW69731 and VW69732) have been within  $\pm 0.1$  m of each instruments tip elevation, indicating these instruments are dry. Since an elevated groundwater level is believed to be one of the factors driving instability of the slide at the C017-III site, KCB believes the piezometers may have been installed at depths that do not record transient changes in groundwater or that the current bi-annual reading frequency of the instruments does not capture short-term fluctuations (i.e., increases and decreases) in water level that could be occurring in response to heavy rainfall events or freshet infiltration between readings.

No instrument repairs or maintenance is required. However, installation of a data logger on one or more of the VWPs may be beneficial, as more frequent readings may capture short-term fluctuations (i.e., increases and decreases) in groundwater level that could be occurring in response to periods of heavy or prolonged rainfall or freshet infiltration between readings.

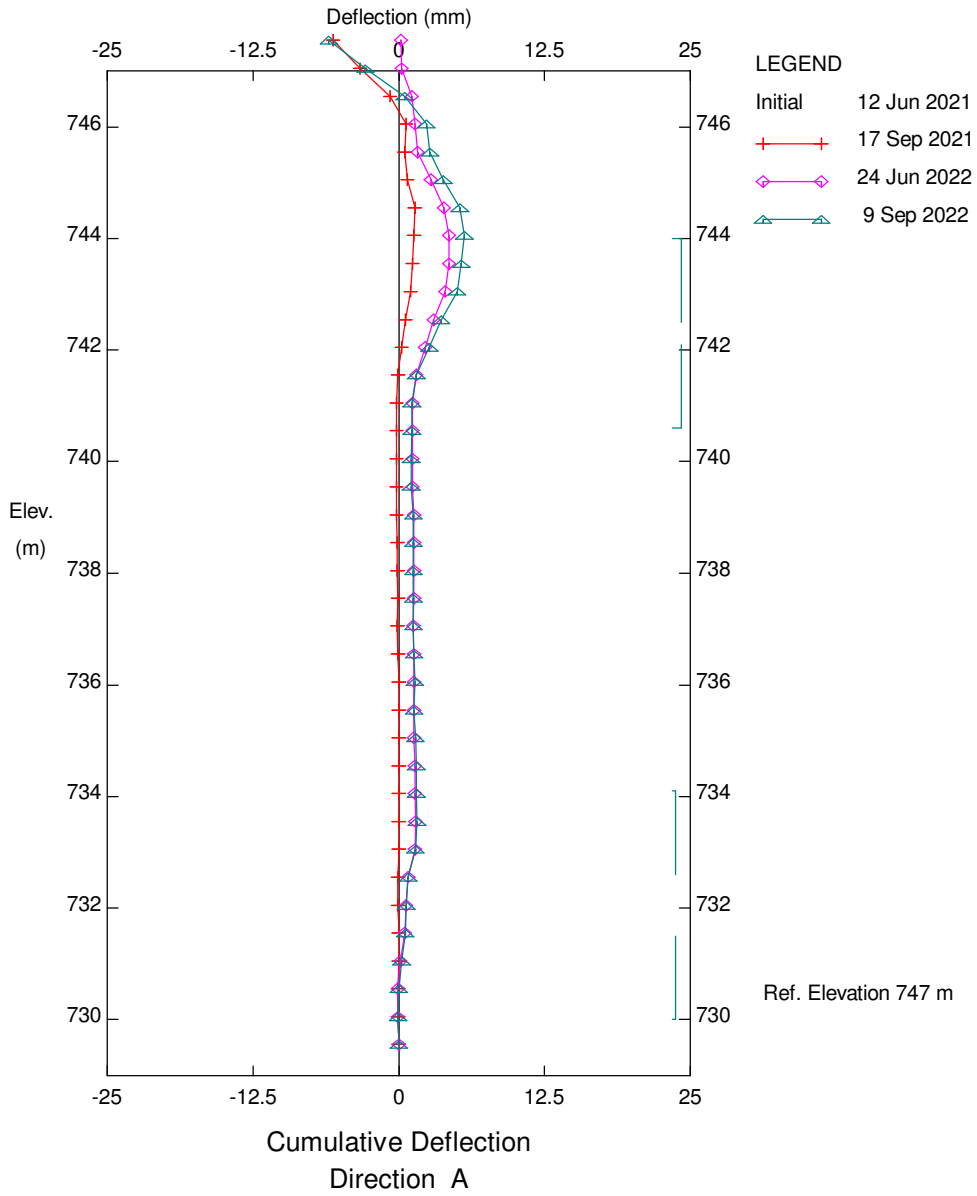
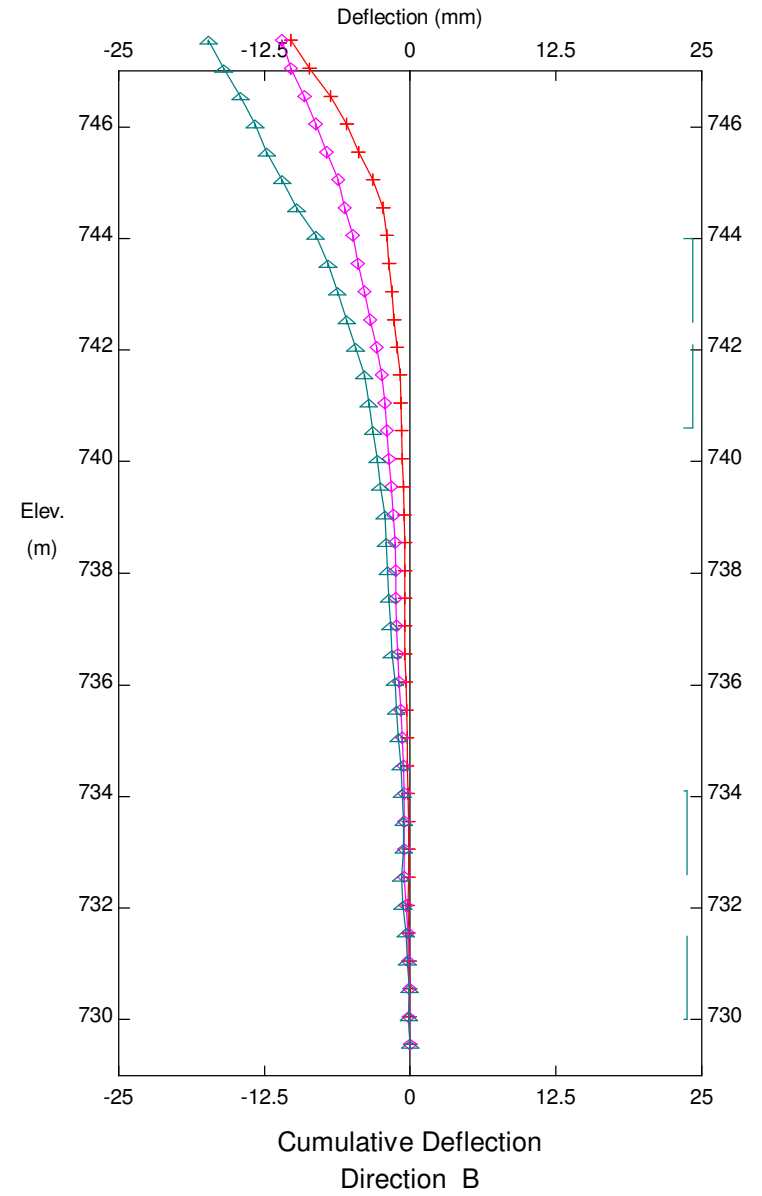
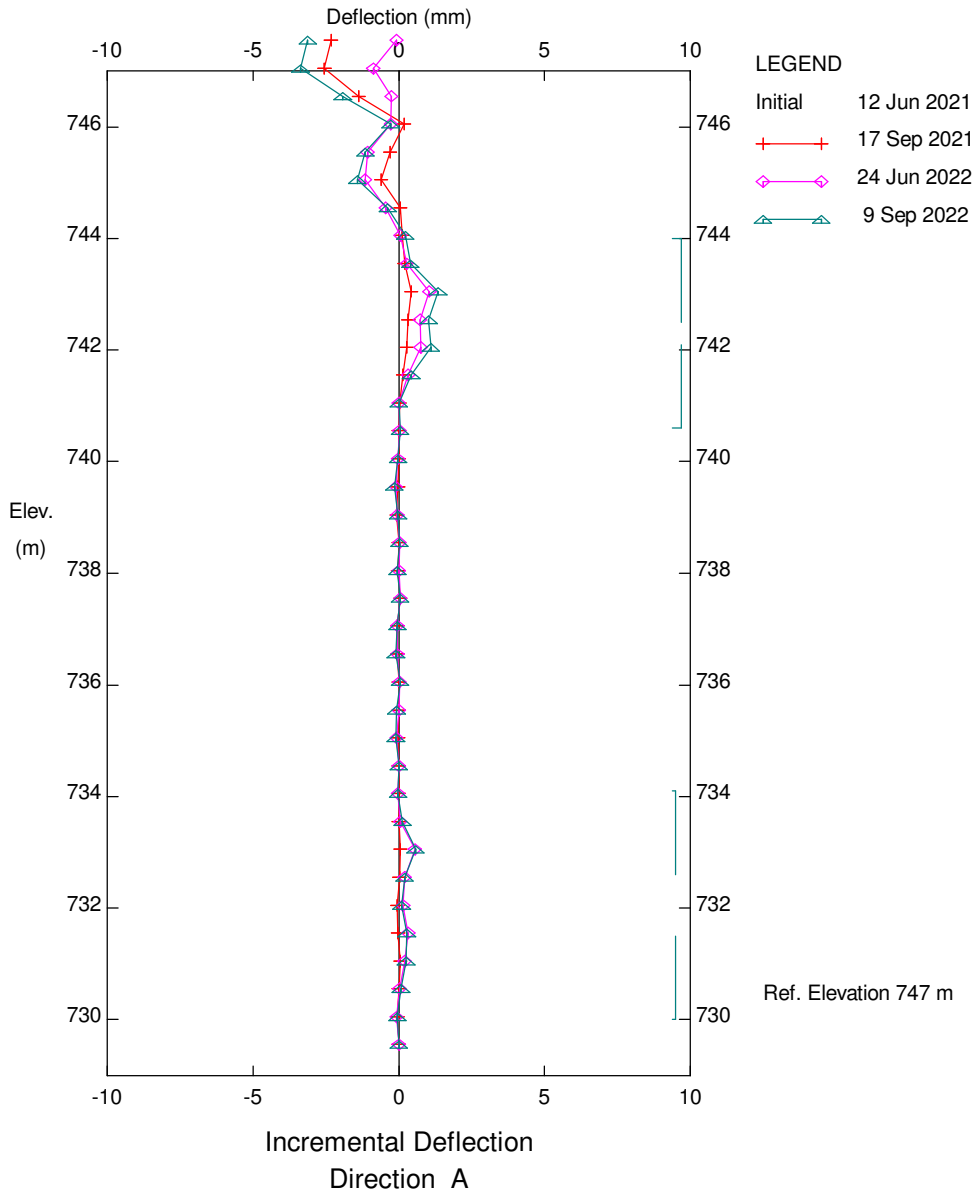
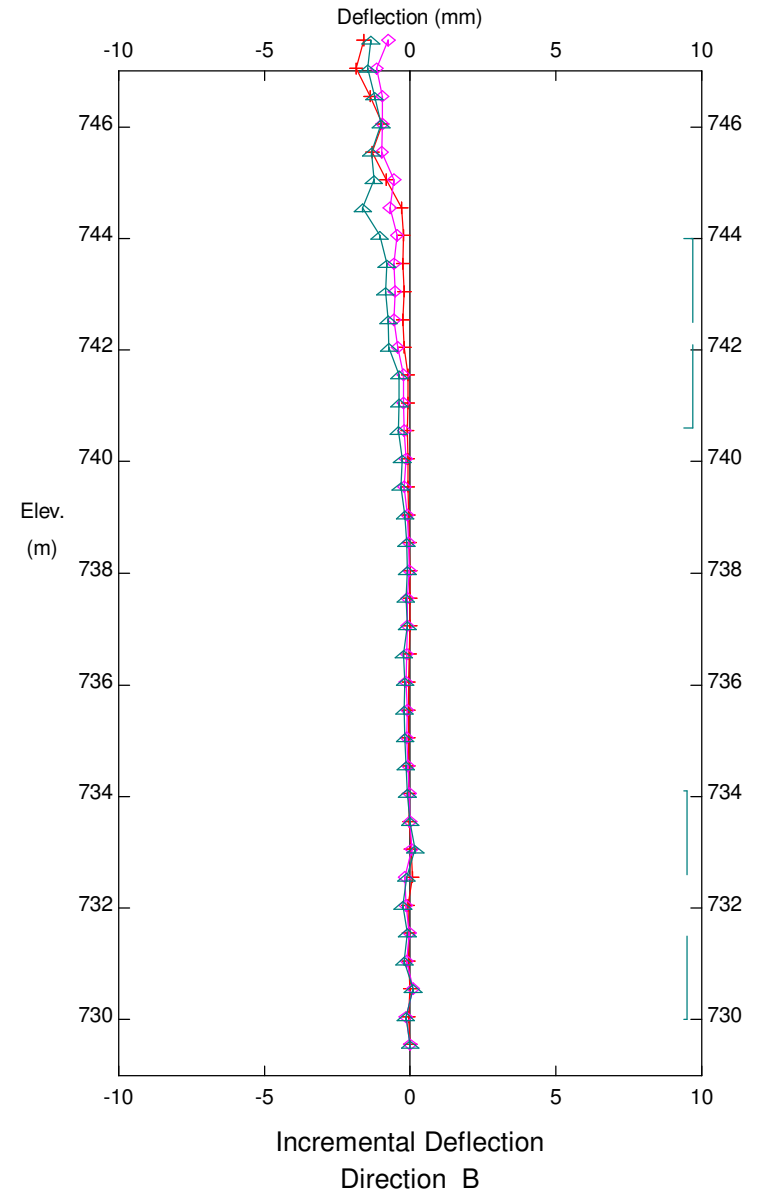
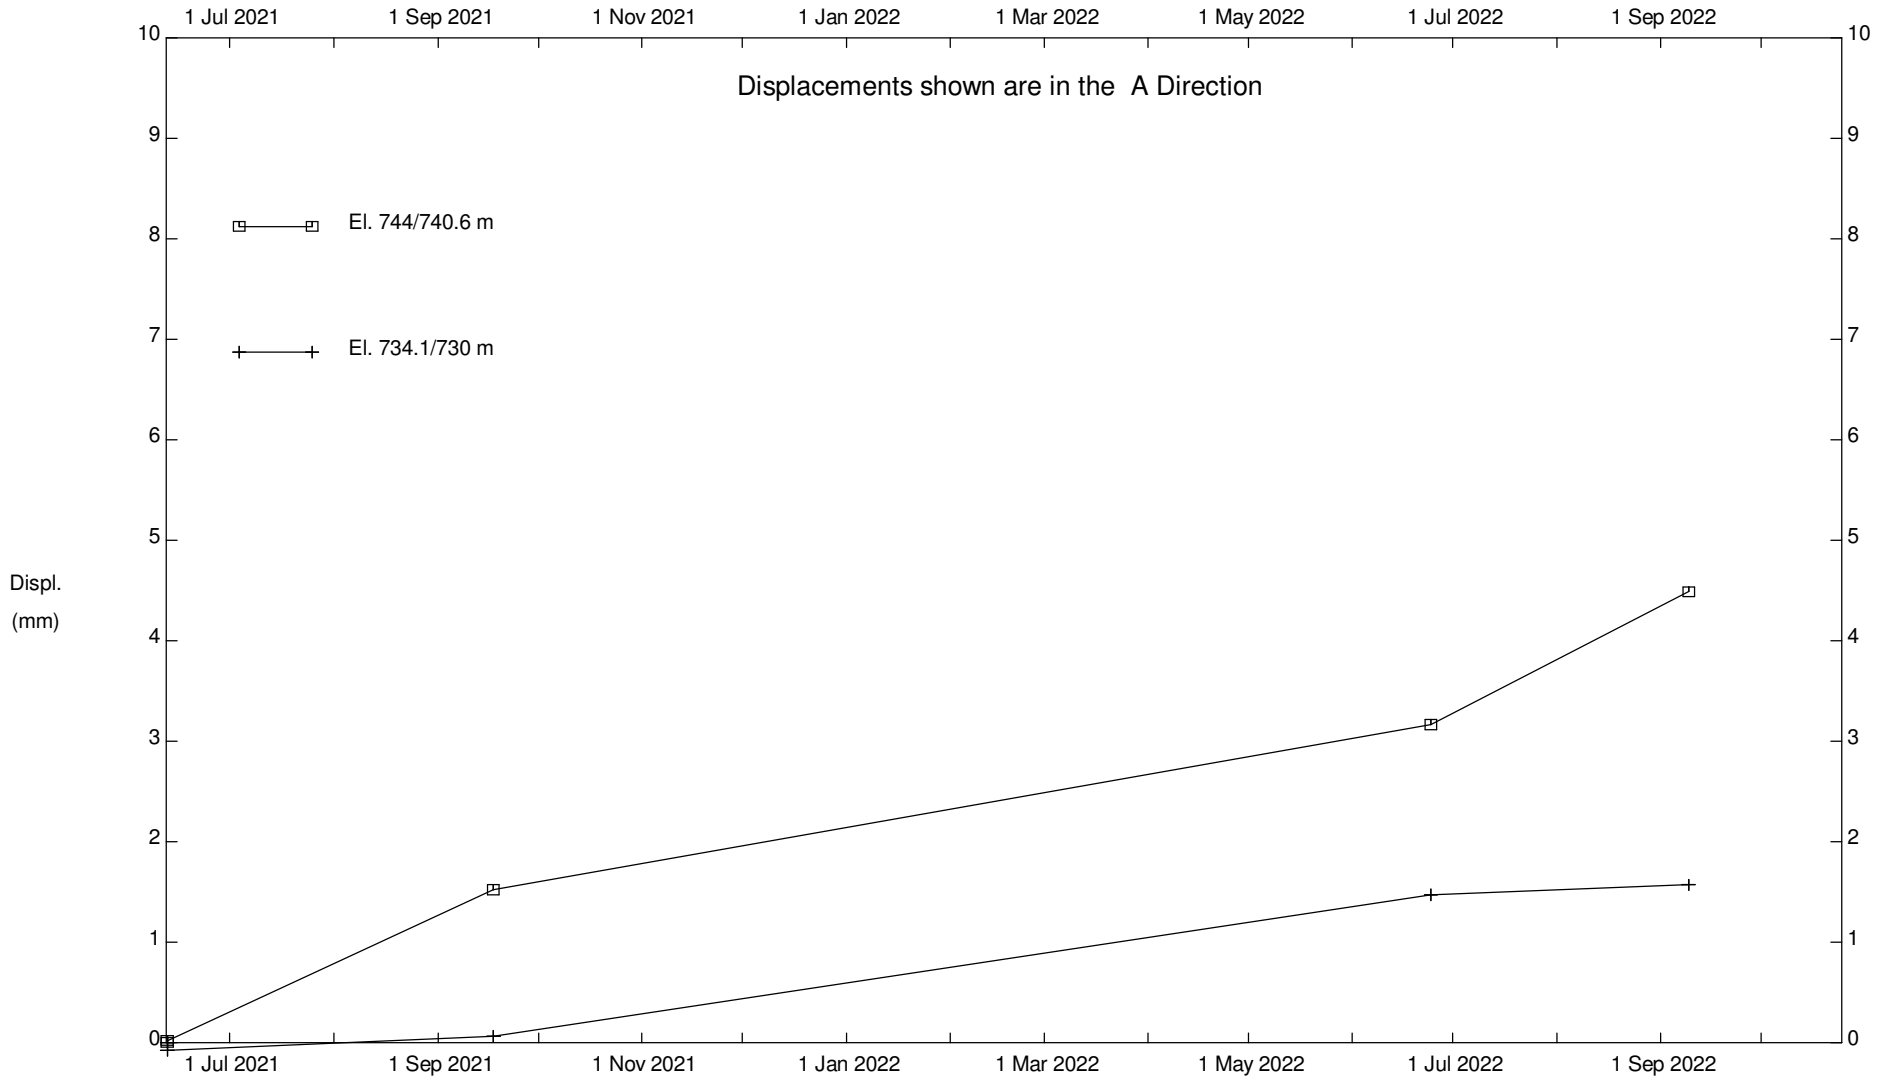
C017-III; H575:04; Truckstop Slide, Inclinator SI20-01

Distributed movement is being recorded in SI20-C017-01 in the upper 6.5 m and discrete movement at an approximate depth of 16 m below ground surface. The lower zone of movement was first observed during the June 2022 reading. This instrument was installed in October 2021 and more data is needed to confirm the depth and rate of movement.

Based on the stratigraphy encountered during the 2020 drilling investigation, the upper and lower zones of movement recorded in SI20-C017-01 appear to be occurring in a soft zone in the embankment fill (silty clay and sand) and in the underlying overburden (sandy silt), respectively.

An overall relatively slow rate of movement (less than 7 mm/year) has been recorded in the SI since it was installed in October 2021. Increased movement may occur in response to periods of heavy or prolonged rainfall or freshet infiltration, resulting in a higher groundwater level. More data is needed to assess long-term trends for this instrument (and the VWPs).

All operable instruments should continue to be read twice per year (spring and fall).
