DATE OF ANY REMEDIAL ACTION: Unknown.

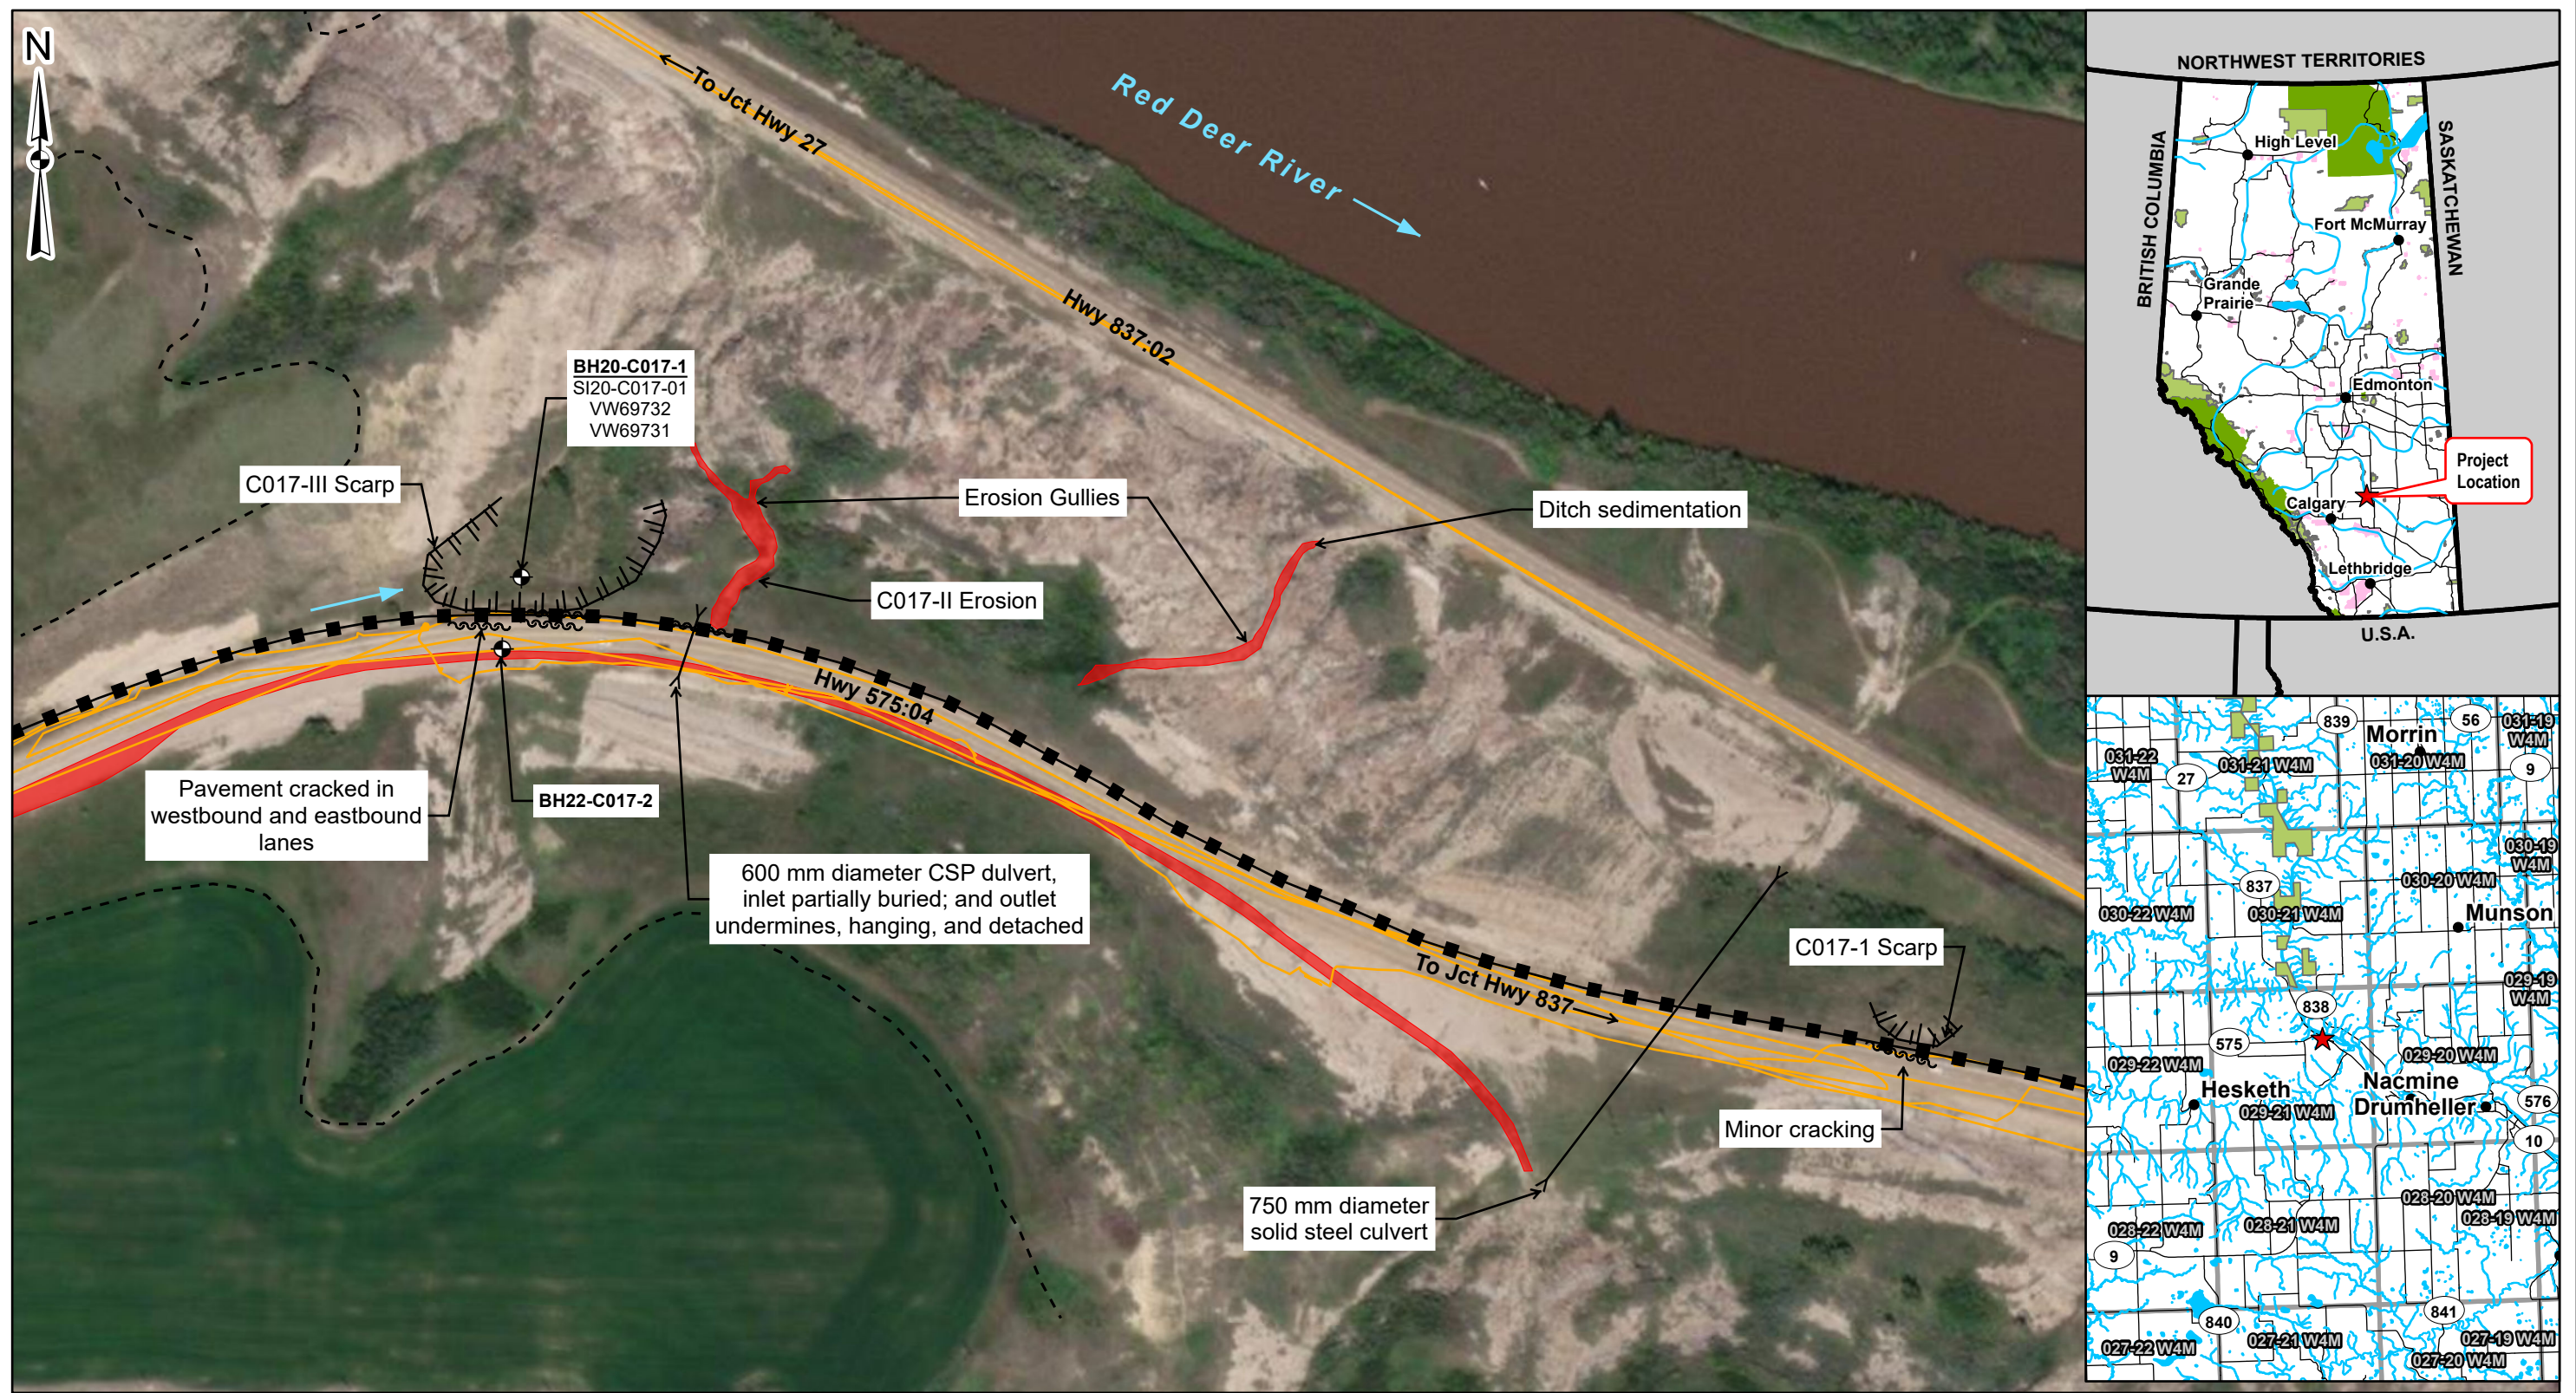
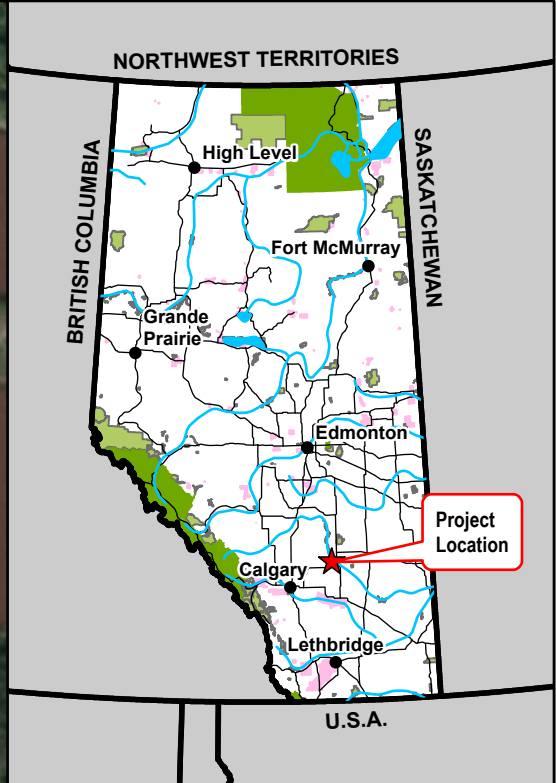
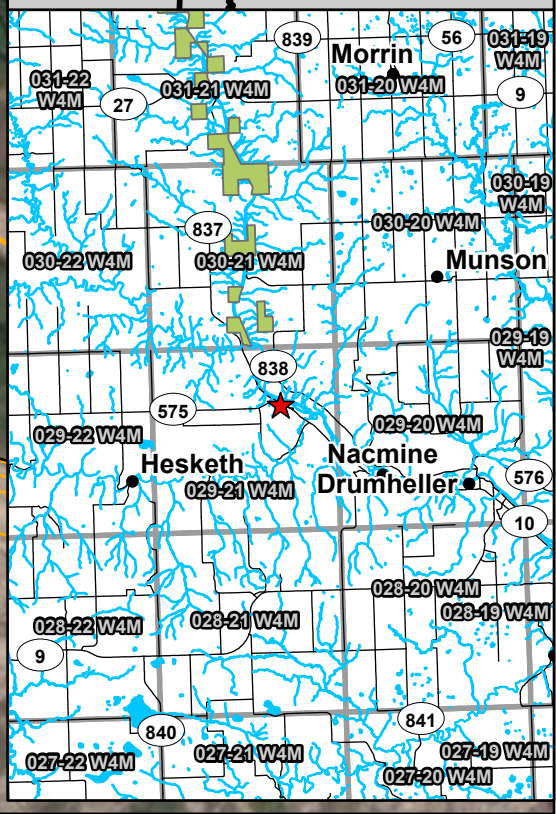
- Legend**
- Borehole
 - GPS Track (May 30, 2022)
 - Flow Direction
 - Top of Bank
 - Scarp
 - Guardrail
 - Culvert
 - Crack
 - Erosion

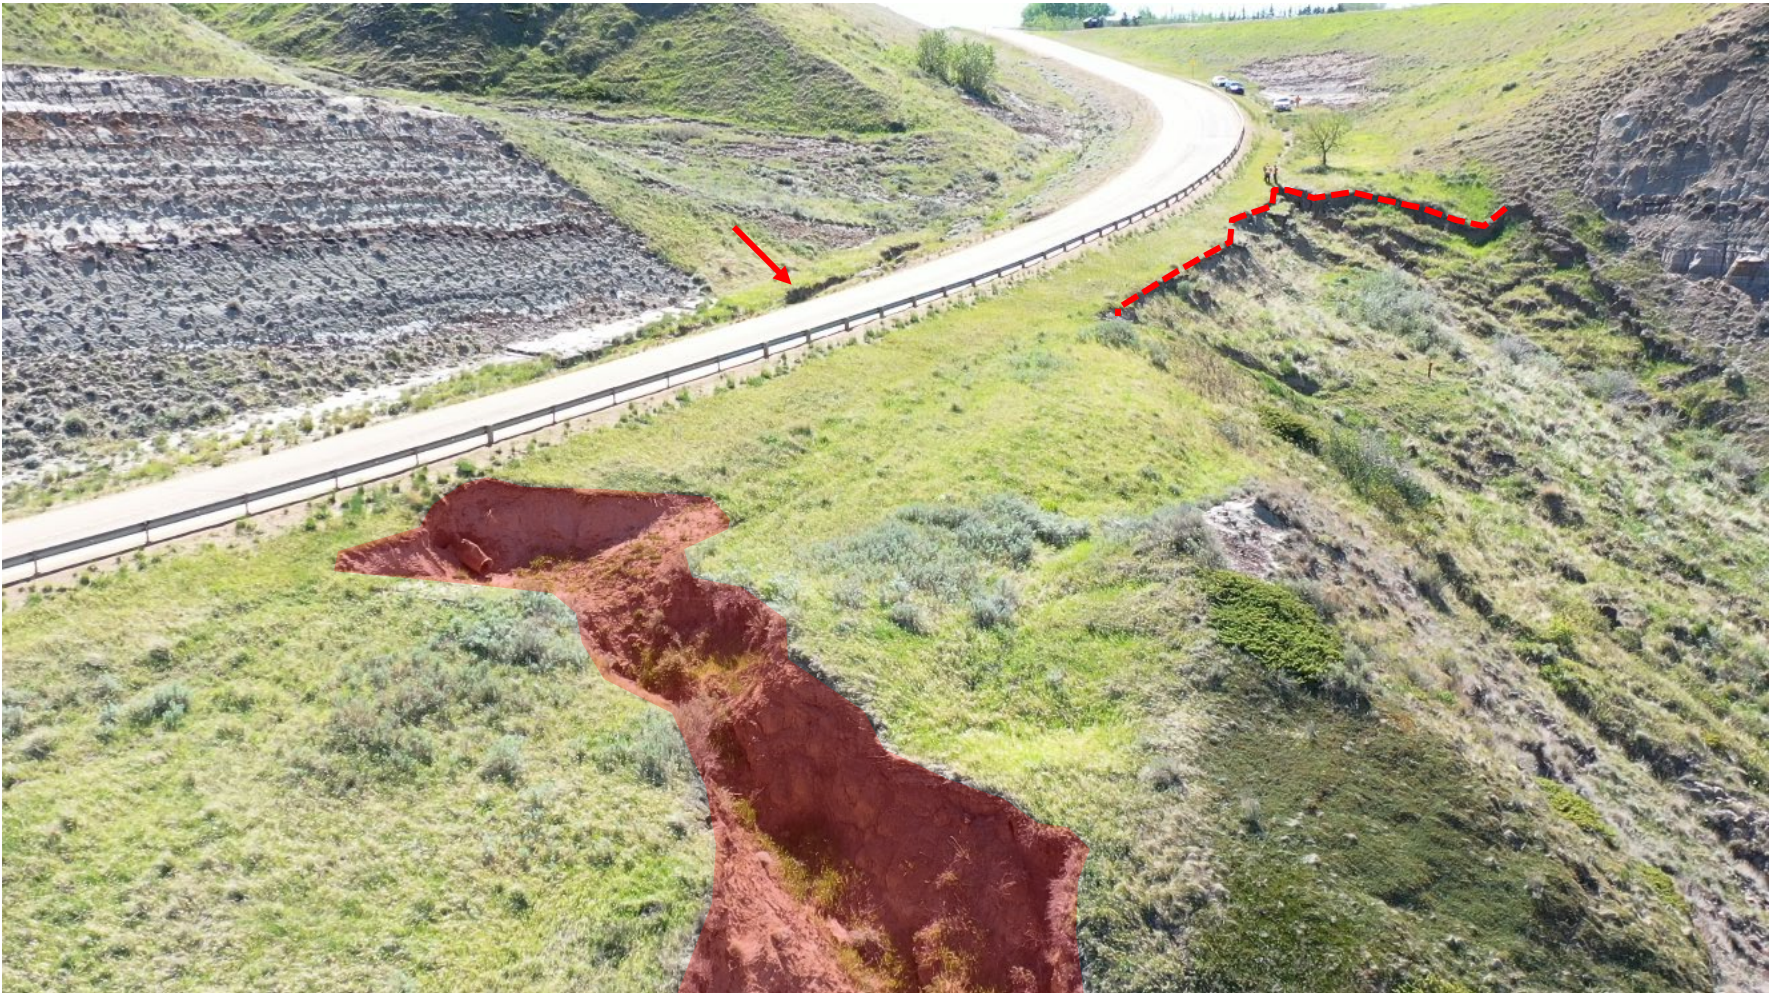
Photo 2 Aerial photo of the C017-III site, highlighting the upper portion of the slide. Ground cracking, erosion, and the 2020 instrumentation are highlighted by the red arrow, shading, and circle, respectively. Photo taken May 30, 2022, facing southwest.

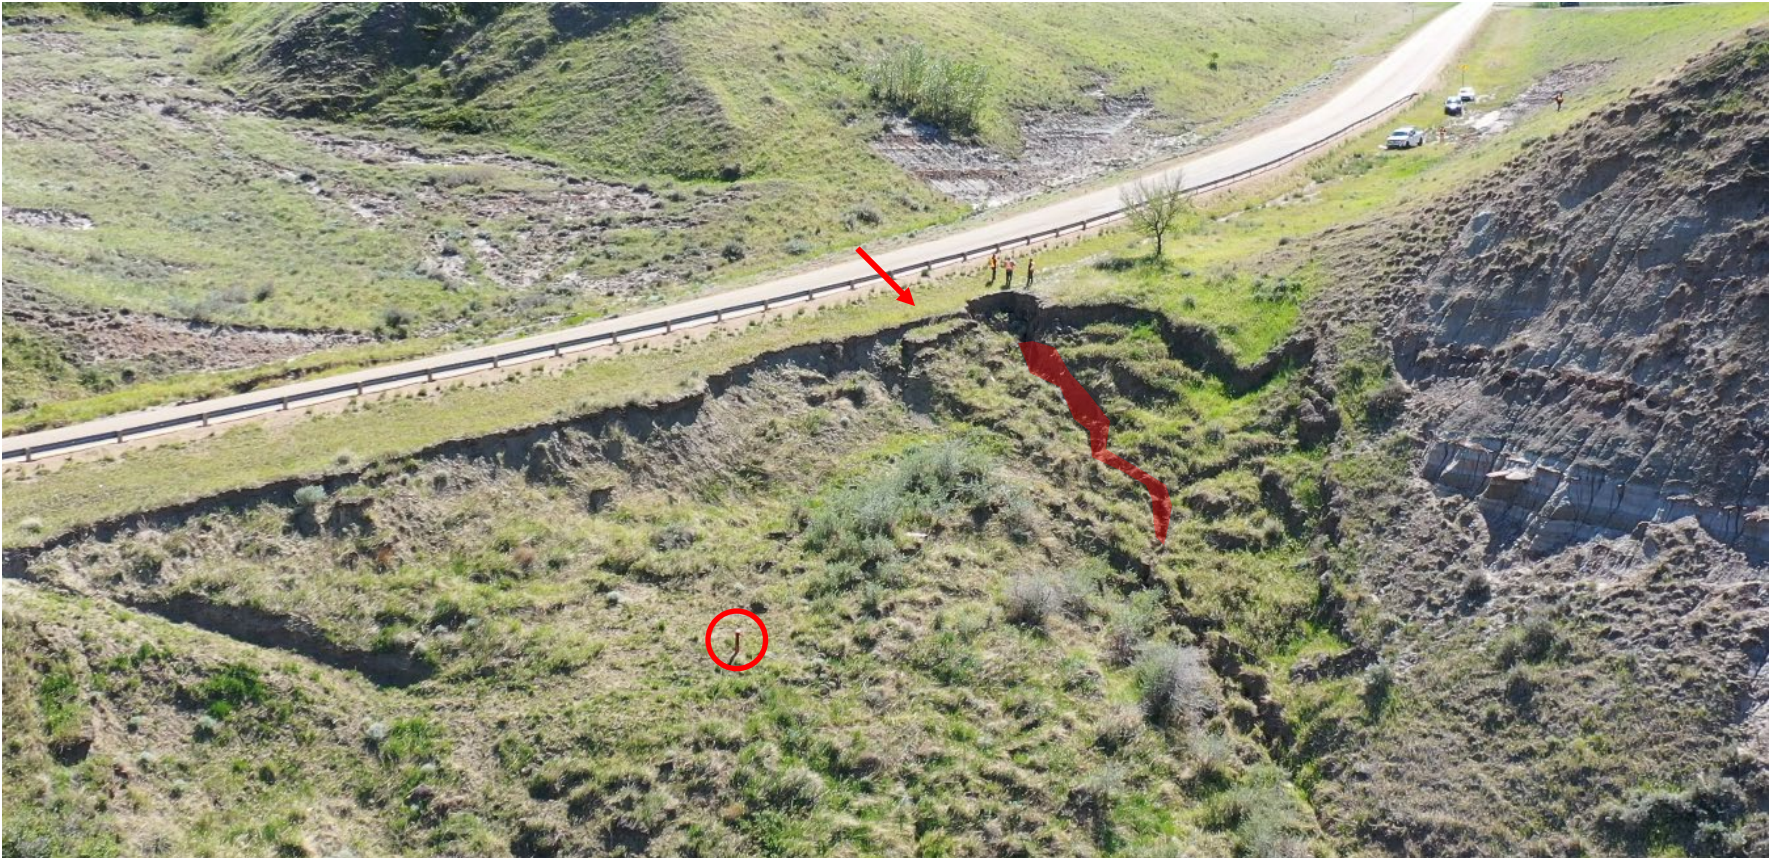
Photo 3 Aerial photo of the northwest portion of the C017-III slide, highlighting the recent movement since the 2021 inspection and erosion gully forming through the failed material. The erosion is most likely attributed to surface runoff from the north (westbound ditch). Photo taken May 30, 2022, facing southwest.

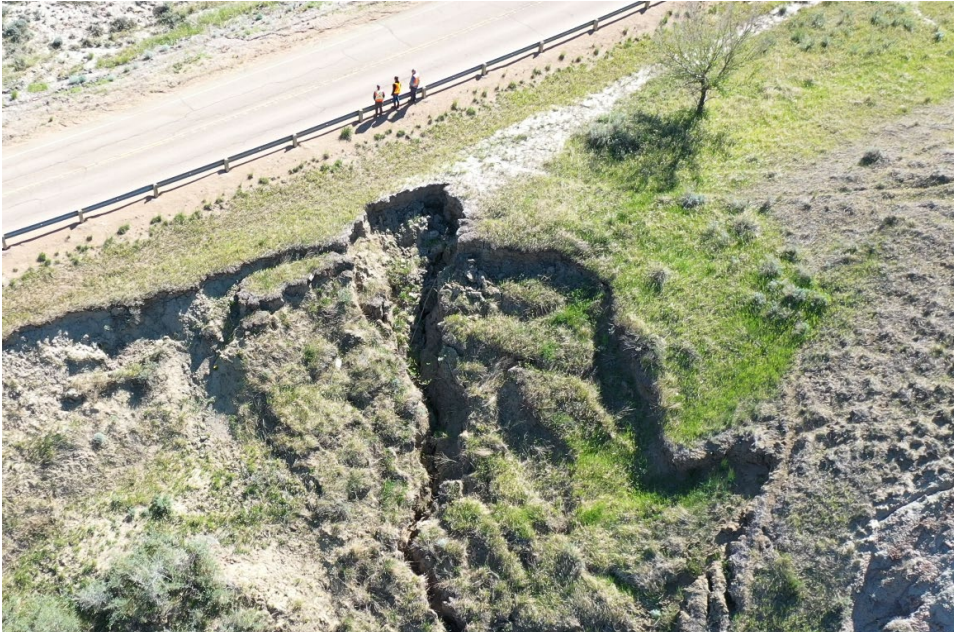
Photo 4 The headscarp at the C017-III slide is retrogression towards the highway and has worsened since the 2021 inspection. Material is failing into the slide area and ground cracking was observed between the edge of pavement and headscarp. Photo taken May 30, 2022, facing northwest.

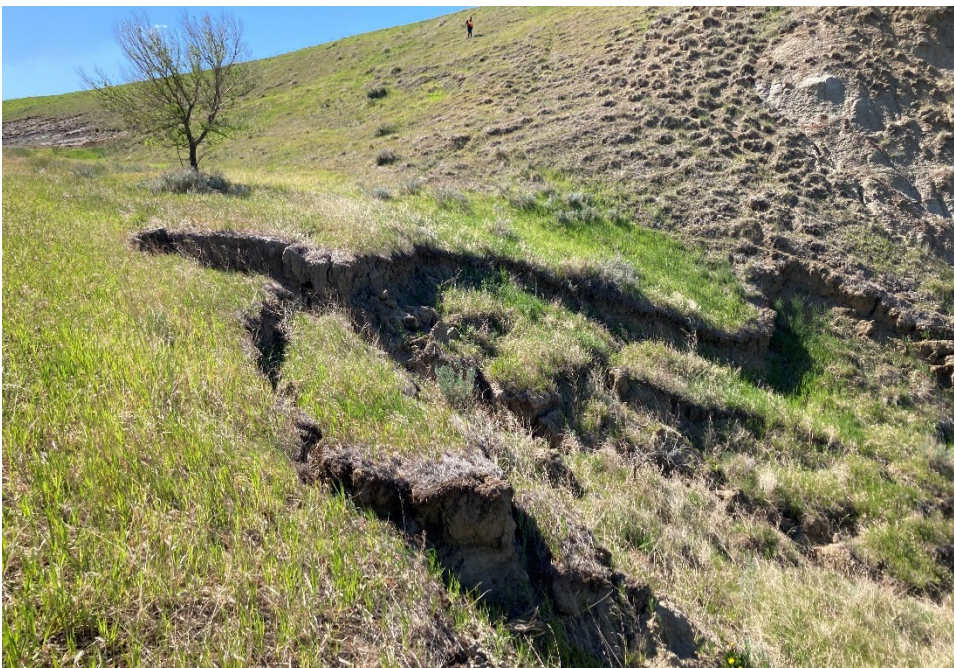
Photo 5 Aerial photo of the C017-II site, including the ditch erosion in the south (eastbound) ditch (indicated by red arrow) and the erosion gully downstream of the CSP culvert outlet (indicated by red ellipse). Photo taken May 30, 2022, facing northwest.
