SITE NUMBER AND NAME: C017-1, -2, and -3 Truckstop Slide	HIGHWAY & KM: 575:04, 26.631 to 26.050	PREVIOUS INSPECTION DATE: June 26, 2023	INSPECTION DATE: June 18, 2024
LEGAL DESCRIPTION: C017-1 04-26-29-21 W4M C017-2 01-27-29-21 W4M C017-3 01-27-29-21 W4M	NAD 83 COORDINATES: UTM Northing Easting 12 5707574 370869 12 5707733 370415 12 5707738 370340	RISK ASSESSMENT: C017-1 PF: 9 CF: 4 TOTAL: 36 C017-2 PF: 10 CF: 3 TOTAL: 30 C017-3 PF: 9 CF: 4 TOTAL: 36	
AVERAGE ANNUAL DAILY TRAFFIC (AADT): 930 (east) and 1000 (west) (Ref No. 105240 & 106230)		CONTRACT MAINTENANCE AREA (CMA): 517

PROJECT
CENTRAL REGION GEOHAZARD RISK MANAGEMENT PROGRAM

TITLE
 Site Plan
 C017-1, -2, and -3 Truckstop Slide
 Hwy 575:04, km 26.631

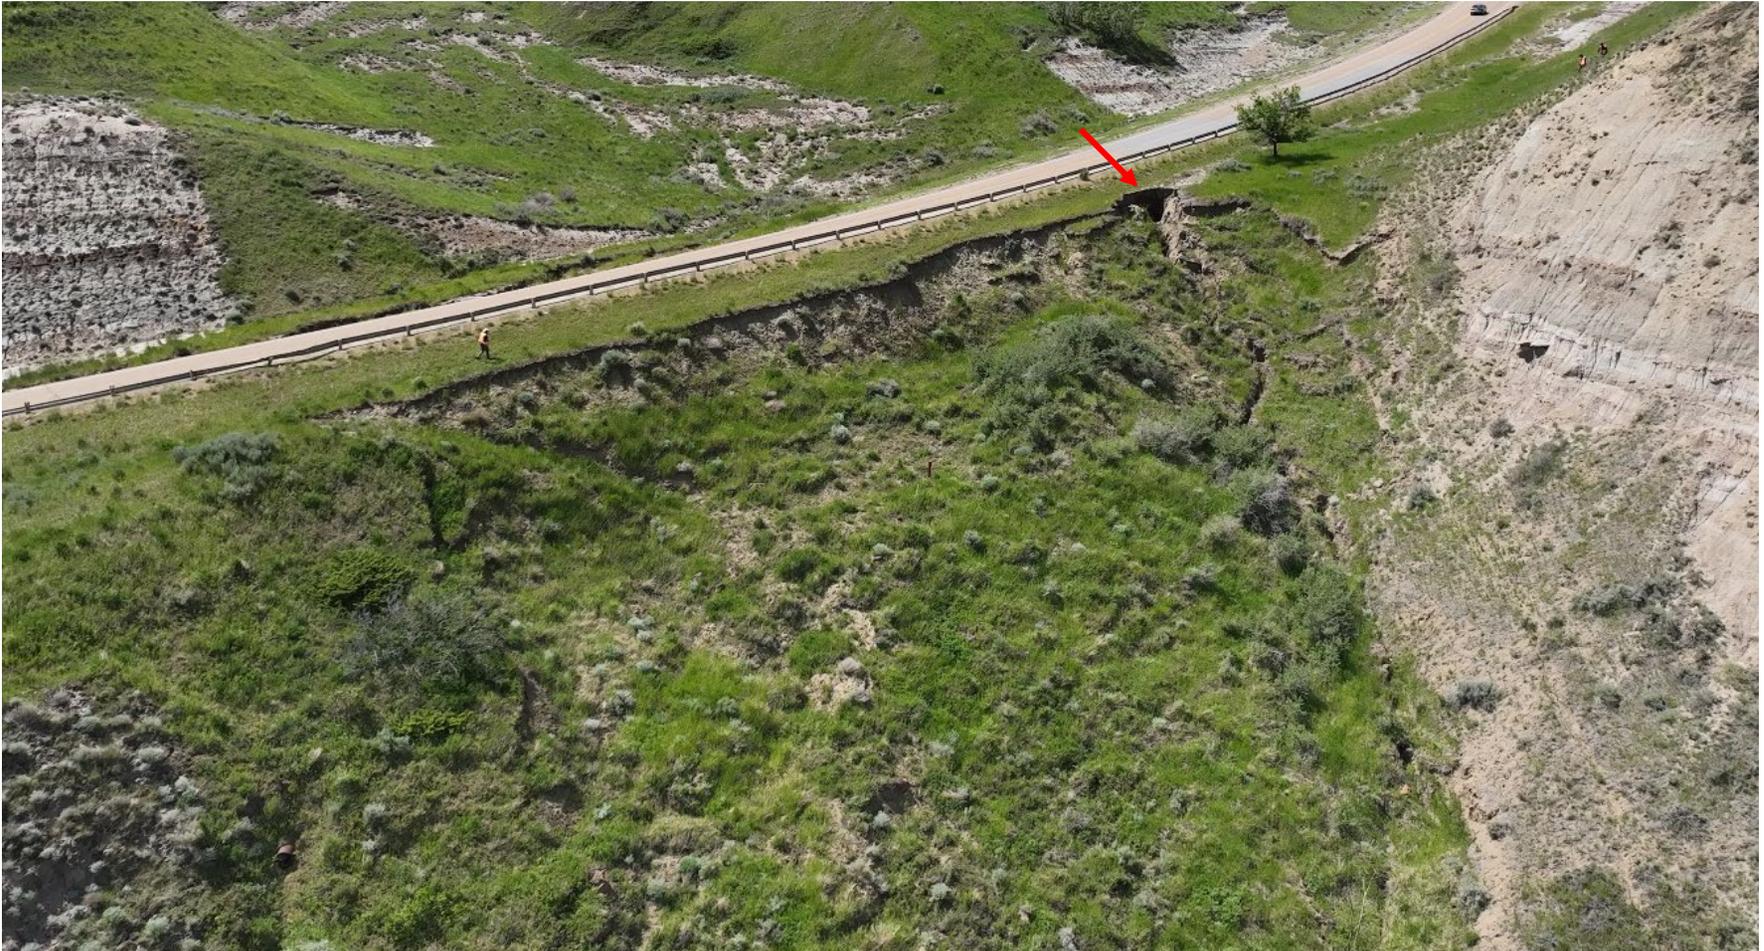
- The slide has expanded significantly (up to approximately 1 m closer the highway) near the northwest (left side of the backscarp, most likely attributed to additional slide movement and erosion from surface water flow from the north (westbound) ditch (Photos 1 and 2). The gullying was first observed during the 2021 inspections and erosion has progressed between 2021 and 2024 (most significantly between 2023 and 2024).

Photo 1 Aerial oblique photo of the C017-3 site. The slide appears to be in similar condition as during the 2023 inspection, but the amount of erosion of the west (left) side of the head scarp has increased (location indicated by red arrow). Photo taken June 18, 2024, facing southwest.

- Surface water flows from the north (westbound) ditch upstream of the C017-3 slide should be re-routed as the surface water flow is exacerbating the erosion of the west (left) extent of the head scarp (retrogressing towards the highway surface) and discharging onto the slide mass (which could lead to higher groundwater levels and increased rates of movement).
- Stabilizing the slide includes the installation of 116 soil nails installed in four rows (1.5 m vertical spacing, 2.0 m horizontal spacing, and 14.0 m deep) in the upper portion of the north slope. This repair is included as part of Tender No. TND0022533 and is anticipated to be repaired in summer or fall of 2024.

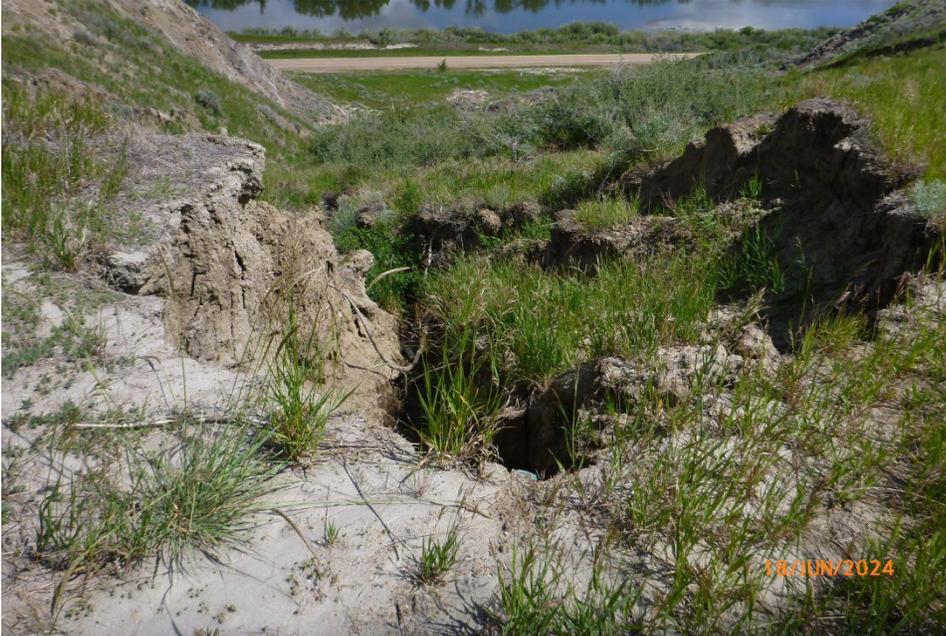
Photo 2 The severity of erosion at the west (left) flank of the C017-3 slide has increased since the 2023 inspection. Photo taken June 18, 2024, facing north.

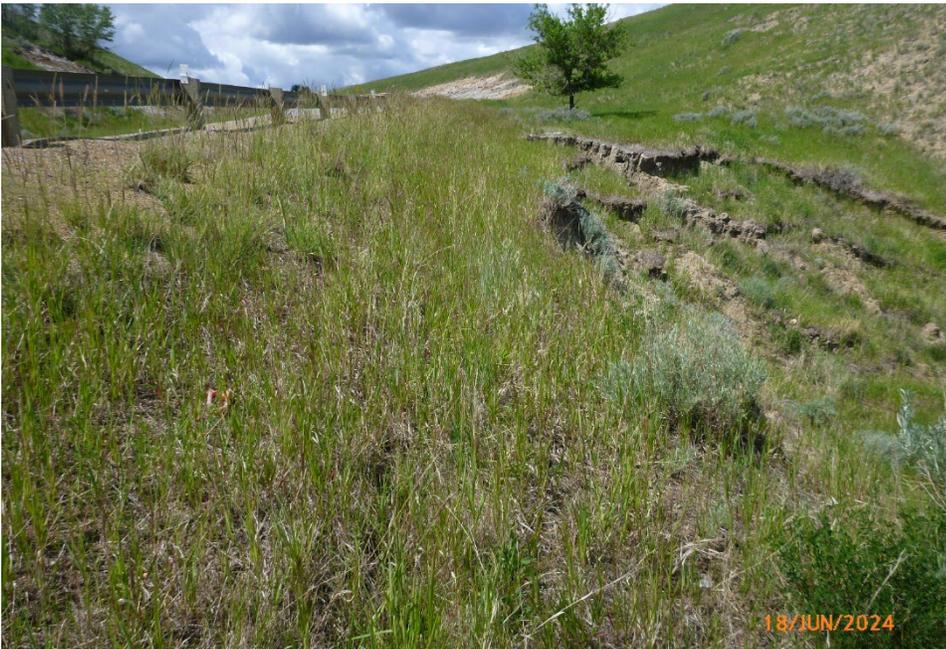
- Longitudinal ground cracking (Photo 3) has been observed between the backscarp and the shoulder of Hwy 575 since the 2021 inspection. The cracks are approximately 1.5 m from the backscarp and 3 m from the guardrail.

Photo 3 Ground cracking between 1 m to 1.5 m upslope of the head scarp (within 3 m of the guardrail) was observed during the 2024 inspection. Photo taken June 18, 2024, facing west.

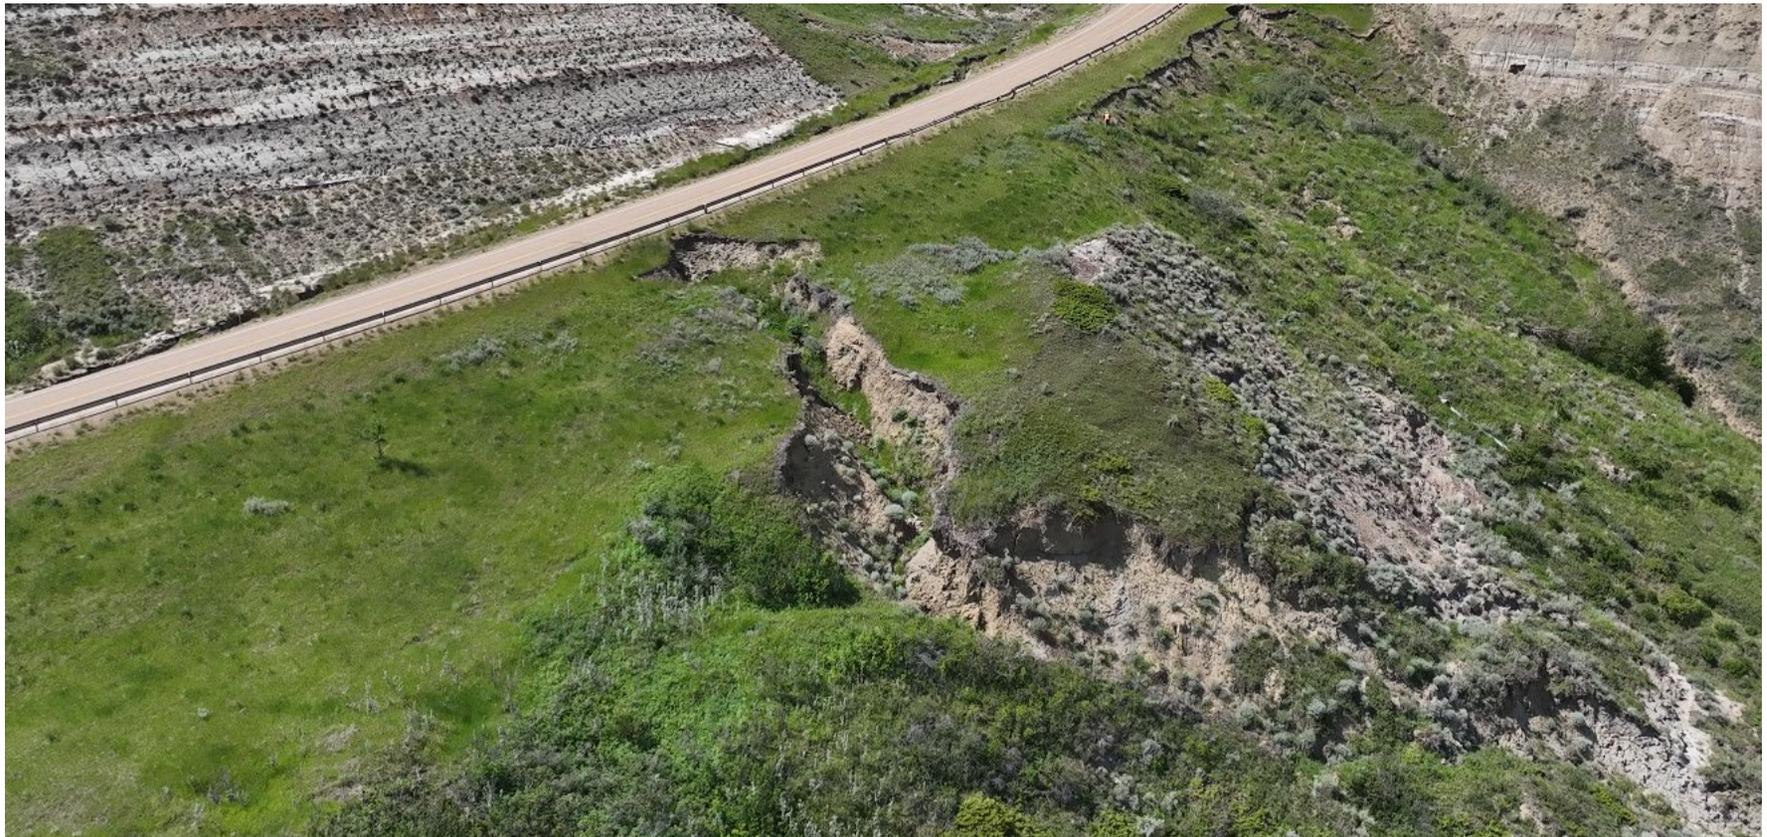
- The erosion gully downstream of the inoperable corrugated-steel-pipe (CSP) culvert is similar in size as during the 2023 inspection (Photo 4). The gully was partially backfilled in fall 2020 to allow access for the excavator completing test pits at the C017-3 site (monitored by KCB). The access road for test pitting was partially eroded between the 2021 and 2022 inspections, but no significant erosion has occurred between 2022 and 2024.

Photo 4 **Aerial oblique photo of the C017-2 site. The degree of erosion appears to be similar as during the 2023 inspection.**
Photo taken June 18, 2024, facing southwest.

- In 2022, KCB completed a design to decommission and permanently block the 600-mm-diameter CSP culvert underlying Hwy 575 (oriented approximately northeast-southwest) and repair the ditch erosion in the south (eastbound) ditch. The ditch repair will include backfilling the erosion gullies, grading the ditch into a channel shape, lining the base of the ditch with non-woven geotextile, and armouring the ditch with a Turf Reinforced Mat (TRM) product. Check trenches (0.5 m deep and 1.0 m wide) would be installed at 10 m spacing along the ditch bottom to reduce the likelihood of undermining the TRM and non-woven geotextile.
- In 2023, TEC requested that KCB exclude this repair from tender, as the tender will only include the slide repair work for C017-1, C017-3, and C018-1. The repair for the ditch erosion along C017-2 is in on hold.

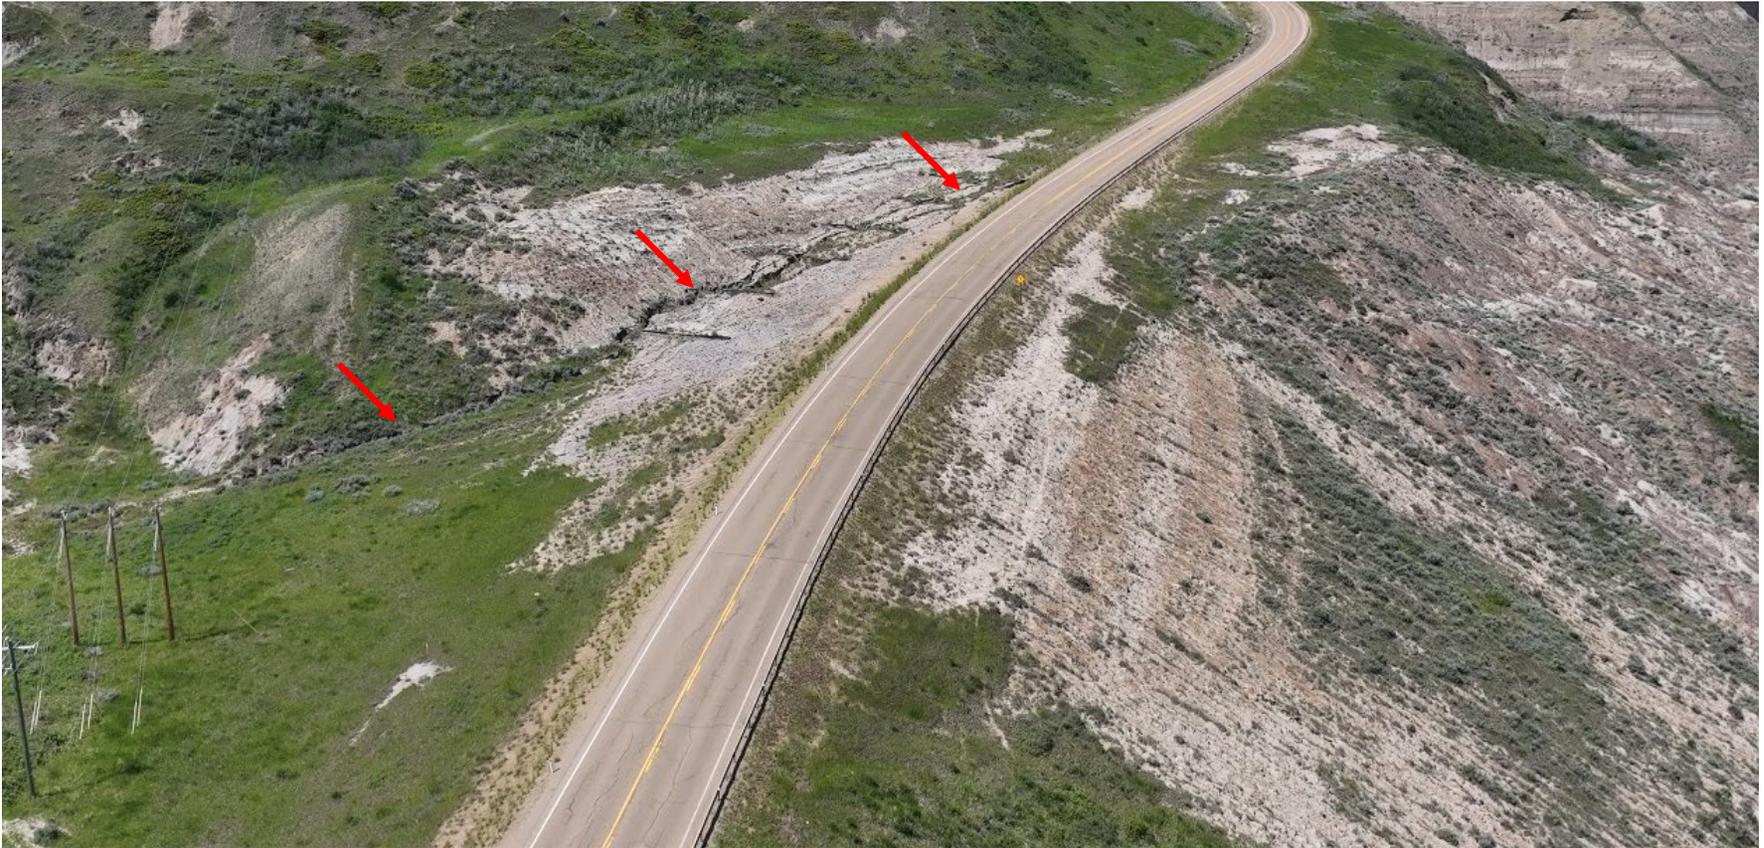
- The ongoing erosion in the south (eastbound) ditch does not appear to have changed significantly since the 2023 inspection (Photo 5 and 7). The erosion gullies are 1.0 m to 1.5 m deep and 1 m to 2 m wide.

Photo 5 Aerial photo showing the east extent of the C017-2 site (ditch erosion indicated by red arrows) where the ditch grade increases to between approximately 15% and 20%. Photo taken June 18, 2024, facing west.

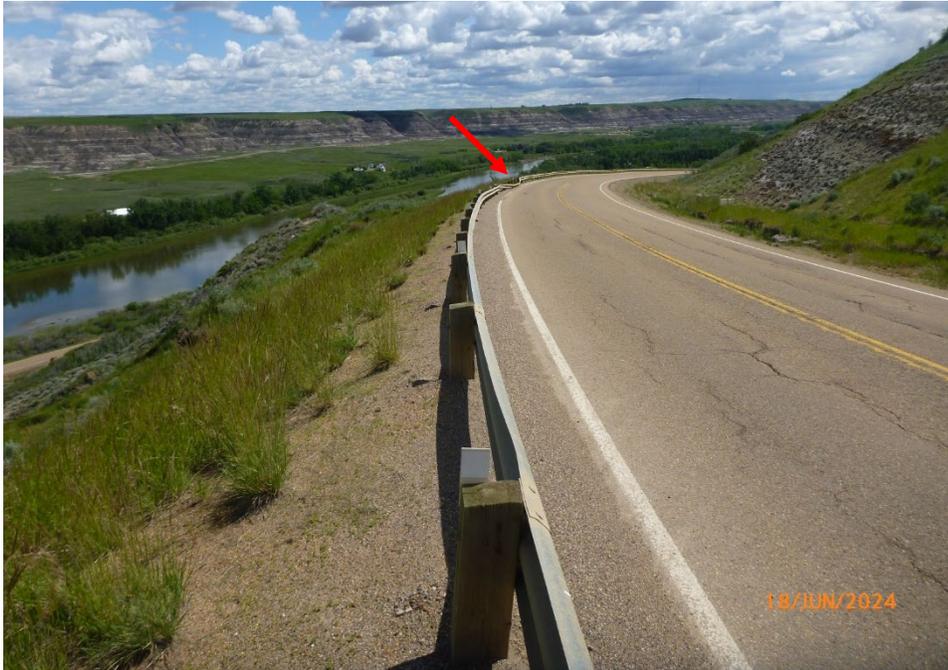
- Near the midpoint of the site, the erosion is beginning to get closer to the highway and is approximately 2 m from the edge of movement (Photo 7).
- The guardrail near the east (right) extent of the slide appears to have been struck by a vehicle between the 2023 and 2024 inspections and is damaged (Photo 6).

Photo 6 The guardrail between the C017-2 and -3 sites appears to have been struck by a vehicle between the 2023 and 2024 inspections (location indicated by red arrow). Photo taken June 18, 2024, facing east.

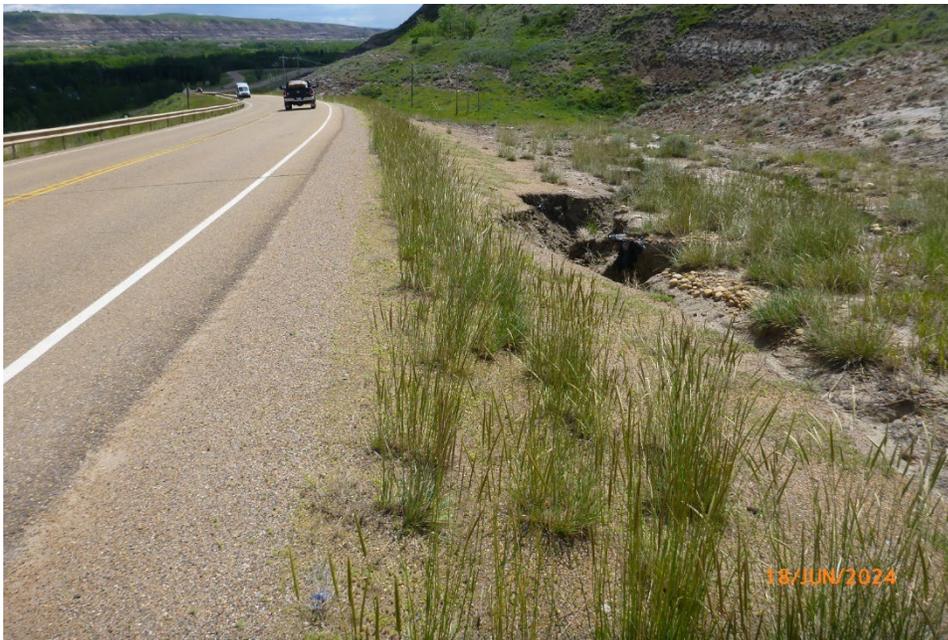
Photo 7 The erosion in the south (eastbound) lane near the midpoint of the C017-2 site is expanding and it within 2 m of the edge of pavement. Photo taken June 18, 2024, facing east.

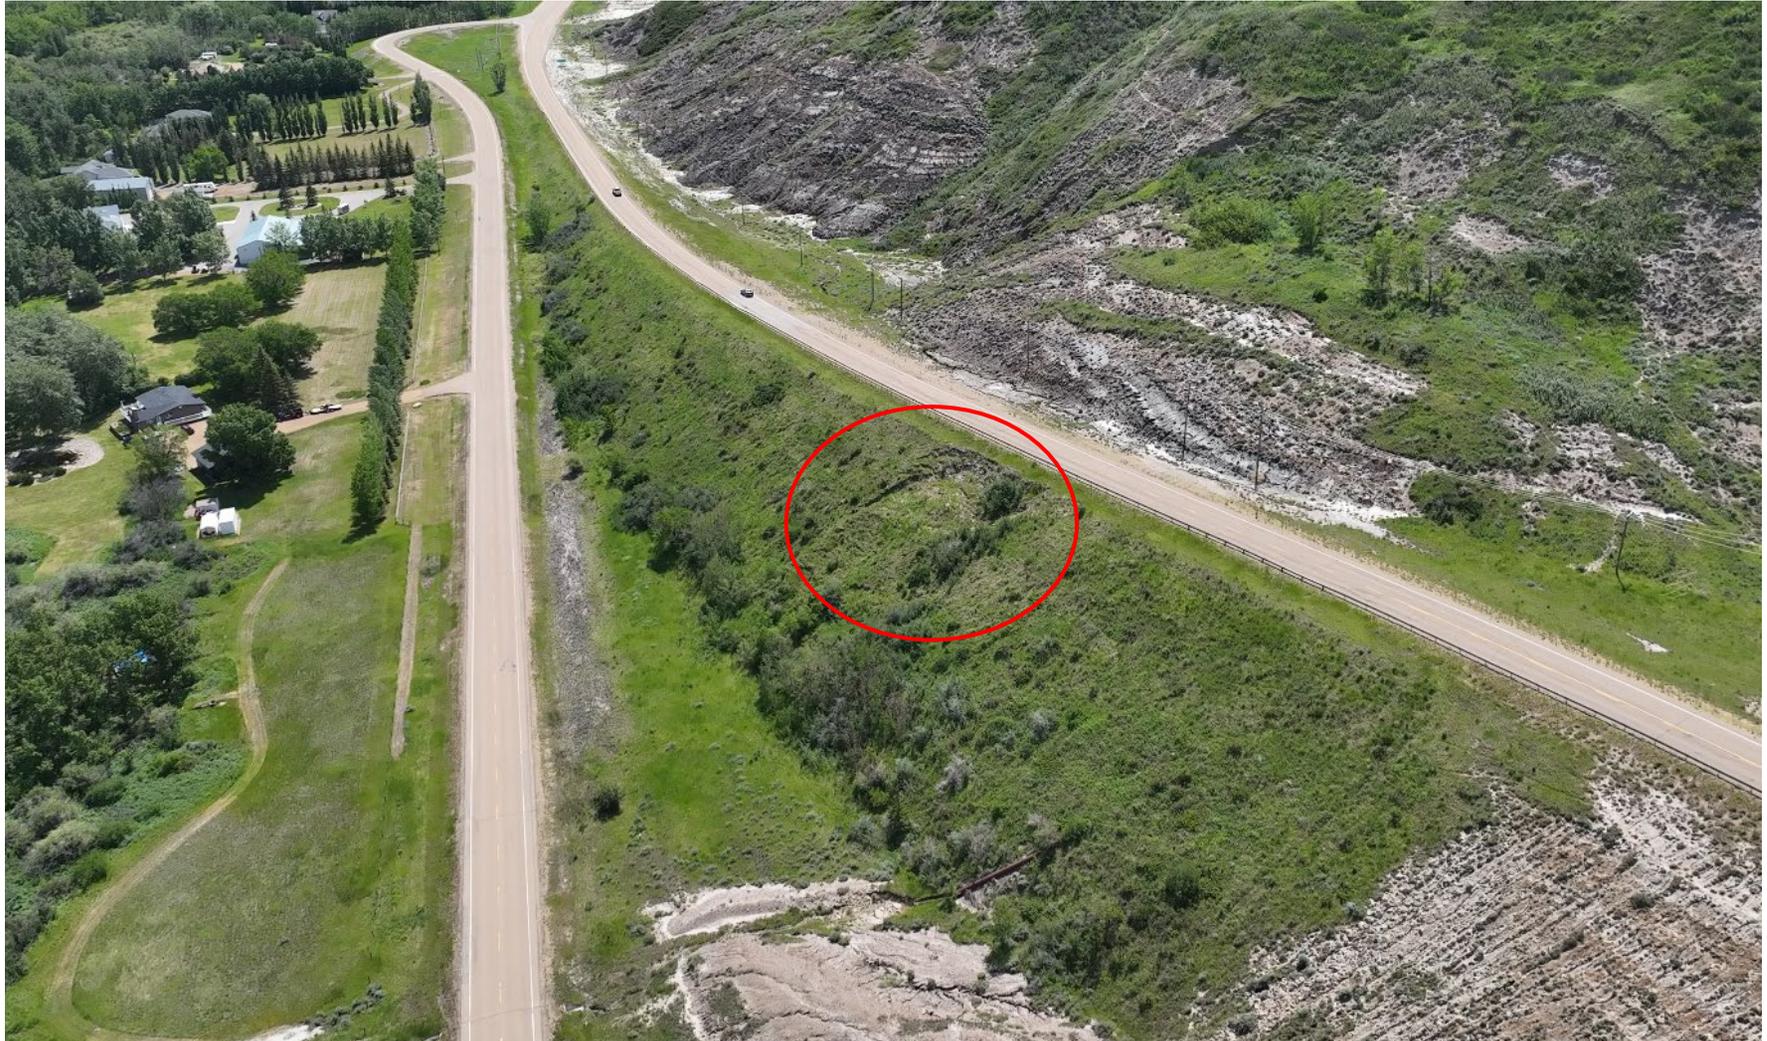
- No significant changes were observed since the 2023 inspection (Photo 8).
- In 2024, ground cracks were observed between 0.3 m to 1.0 m behind (upslope) of the head scarp.
- The upper 1 m of the slide head scarp is unvegetated and is susceptible to erosion.
- A ground depression was observed near the right (east) flank of the slide. However, KCB suspects this irregularity may be a depression from highway construction and not from additional movement/lateral expansion of the slide.

Photo 8 Aerial photo of the C017-1 site (location indicated by red circle). Photo taken June 18, 2024, facing east.

- In 2022, KCB completed a design to reinforcement the head scarp of the slide with 84 soil nails. The soil nails will be installed in three rows (1.5 m vertical spacing, 2.0 m horizontal spacing, and 14.0 m deep) through the upper half of the slide. This repair is included as part of Tender No. TND0022533 and is anticipated to be repaired in summer or fall of 2024.
